Flood Control Project Maintenance Levee Inspections

Fall 2022 Levee Maintenance Deficiency Summary Report

Sacramento River Basin

Sutter Maintenance Yard Murphy Slough at M&T Ranch

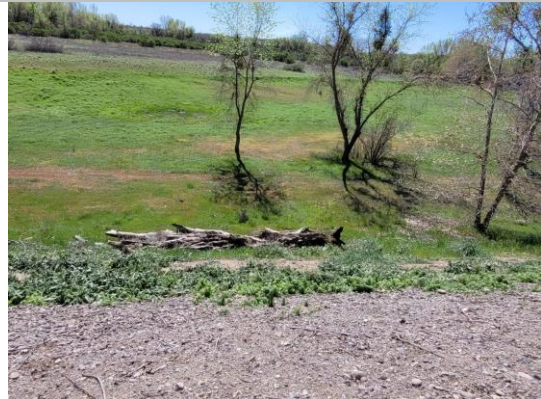
Photo 1 of 1 : FA_2022_ST0014_372_8_20220906_00001.jpg

LM Start	0.31	Rating **	M	Issue No.	8
LM End	0.31	Issue Type +	Ma	Location *	LS
Category	Earthen Levee			GPS Latitude/Longitude	
				Start	End
Item	Trim / Thin Trees			39.666319 °	39.666319 °
				-121.964544 °	-121.964544 °
DWR ID	DWR_ST0014_01_s_ 2019_8				
Comment Code					
T2 : Tree or limb.					
Inspector Comment					
The downed tree should be removed from the landside toe.

View of the downed tree at the landside toe. Spring 2022.

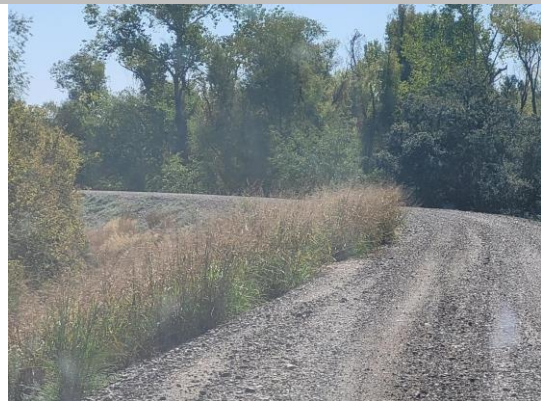
Photo 1 of 1 : FA_2022_ST0014_372_7_20221011_00002.jpg

LM Start	0.58	Rating **	M	Issue No.	7
LM End	0.61	Issue Type +	Ma	Location *	WS
Category	Earthen Levee			GPS Latitude/Longitude	
				Start	End
Item	Vegetation			39.667252 °	39.667687 °
				-121.968972 °	-121.969070 °
DWR ID	DWR_ST0014_01_f_ 2022_7				
Comment Code					
V1 : Control annual grass and weeds on the levee slopes and easements.					
Inspector Comment

View of the vegetation along the waterside slope. Fall 2022.
