**Flood Control Project Maintenance
Levee Inspections
Fall 2023 Levee Maintenance Deficiency Summary Report**

Sacramento River Basin

Levee Inspection Report By Mile - Fall 2023

Waterway	Bank	Unit Miles	Inspection Start/End	Inspector
Unit No. 01 Murphy Slough at M&T Ranch	Left	0.83	10/11/2023 10/11/2023	Makar Sokol

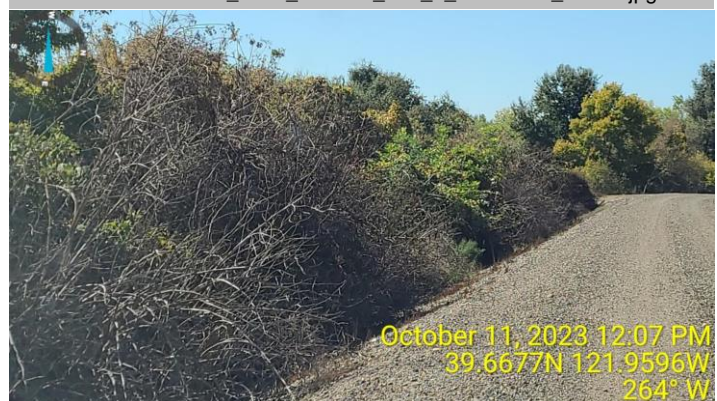
Photo 1 of 1 : FA_2023_ST0014_372_4_20231016_00001.jpg

LM Start	0.04	Rating **	M	Issue No.	4
LM End	0.08	Issue Type +	Ma	Location *	LS
Category	Earthen Levee			GPS Latitude/Longitude	
				Start	End
Item	Vegetation			39.667429°	39.667089°
				-121.959774°	-121.960357°
DWR ID	DWR_NA0014_01_s_2012_4				
Comment Code					
V4 : Elderberries are blocking visibility and flood fight capability.					
Inspector Comment

View of wild growth along the landside slope. Fall 2023.
