## Flood Control Project Maintenance Levee Inspections

### Fall 2024 Levee Maintenance Deficiency Summary Report

#### Sacramento River Basin

Sutter Maintenance Yard Murphy Slough at M&T Ranch

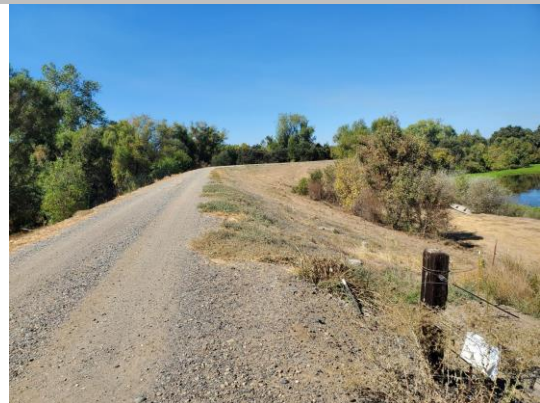
Photo 1 of 1 : FA\_2024\_ST0014\_372\_1\_20241016\_00001.jpg

LM Start	0.53	Rating **	A	Issue No.	1
LM End	0.53	Issue Type +	Ma	Location *	WS
Category	Earthen Levee			GPS Latitude/Longitude	
				Start	End
Item	Vegetation			39.666701 °	39.666701 °
				-121.968600 °	-121.968600 °
DWR ID	DWR_ST0014_01_f_2024_1				
Comment Code					
V1 : Control annual grass and weeds on the levee slopes and easements.					
Inspector Comment					
Good vegetation control along the levee slopes.

View of good vegetation control along the waterside slope. Fall 2024.
