**Flood Control Project Maintenance
Levee Inspections**
LMA District Cover Sheet
Spring 2015 Levee Inspection Results

Sutter Maintenance Yard Murphy Slough at M&T Ranch

Spring 2015 Levee Inspection Results

Levee Inspection Report By Mile - Spring 2015

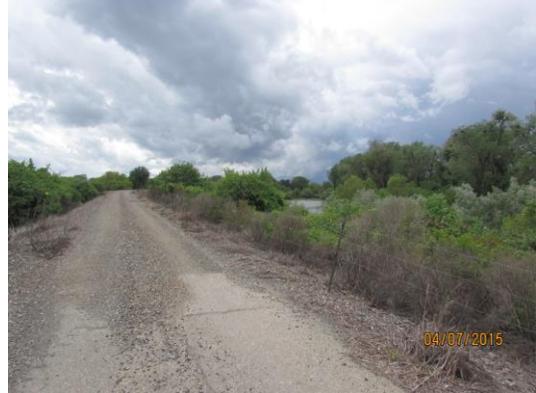
Photo 1 of 1 : SP_2015_ST0014_372_1_20150420_00006.jpg

LM Start	0.00	Rating **	M	Issue No.	1
LM End	0.09	Issue Type +	Ma	Location *	WS
Category	Earthen Levee		GPS Latitude/Longitude		
			Start	End	
Item	Vegetation		39.667534 °	39.666836 °	
			-121.959612 °	-121.960897 °	
DWR ID	DWR_NA0014_01_s_2012_1				
Action/Comments					
Elderberries are blocking visibility and flood fight capability.

View of the elderberries along the waterside slope.

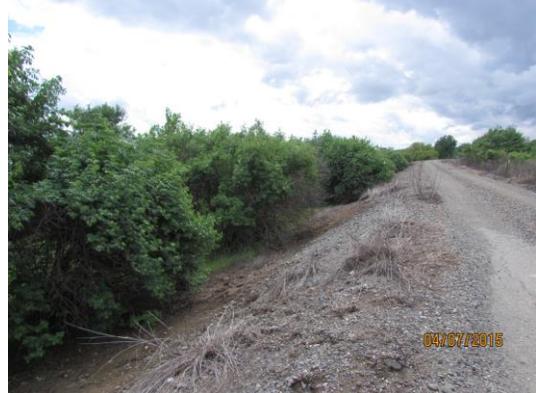
Photo 1 of 1 : SP_2015_ST0014_372_4_20150420_00005.jpg

LM Start	0.00	Rating **	M	Issue No.	4
LM End	0.09	Issue Type +	Ma	Location *	LS
Category	Earthen Levee		GPS Latitude/Longitude		
			Start	End	
Item	Vegetation		39.667708 °	39.666983 °	
			-121.959817 °	-121.960997 °	
DWR ID	DWR_NA0014_01_s_2012_4				
Action/Comments					
Elderberries are blocking visibility and flood fight capability.

View of the elderberries along the landside toe.

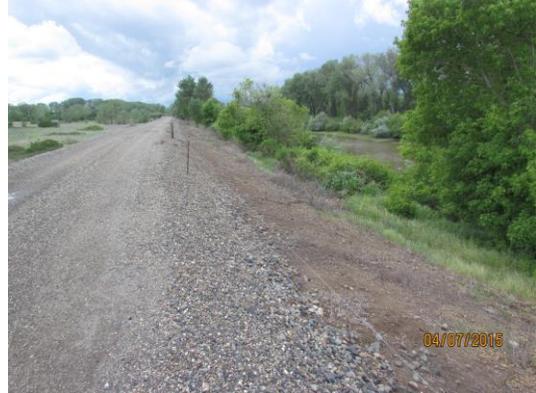
Photo 1 of 1 : SP_2015_ST0014_372_5_20150420_00007.jpg

View of the vegetation along the waterside slope.

LM Start	0.00	Rating **	M	Issue No.	5
LM End	0.20	Issue Type +	Ma	Location *	WS
Category	Earthen Levee		GPS Latitude/Longitude		
			Start	End	
Item	Vegetation		39.666988 °	39.666988 °	
			-121.960993 °	-121.960993 °	
DWR ID	DWR_NA0014_01_s_2012_5				
Action/Comments					
Remove the wild growth other than native grasses from the levee slopes.

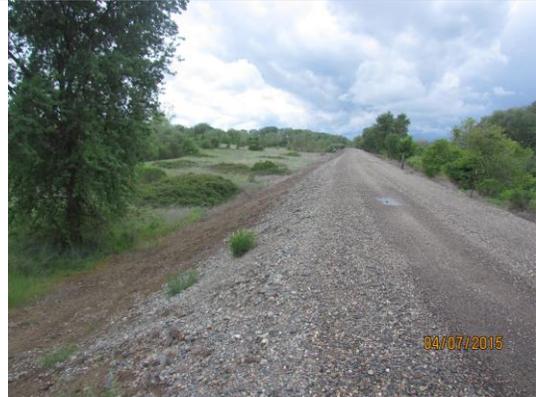
Photo 1 of 1 : SP_2015_ST0014_372_7_20150420_00008.jpg

View of the landside with no vegetation.

LM Start	0.09	Rating **	A	Issue No.	7
LM End	0.83	Issue Type +	Ma	Location *	LS
Category	Earthen Levee			GPS Latitude/Longitude	
				Start	End
Item	Vegetation			39.666840 °	39.671103 °
				-121.960840 °	-121.970523 °
DWR ID	DWR_ST0014_01_s_2015_7				
Action/Comments					
Control annual grass and weeds on the levee slopes and easements.
