**Flood Control Project Maintenance  
Levee Inspections**  
**LMA District Cover Sheet**  
**Spring 2016 Levee Inspection Results**

**Sutter Maintenance Yard East-West Interceptor**

**Levee Inspection Report By Mile - Spring 2016**

| Unit No. 01 West Levee | Right | 1.75 | 03/17/2016<br>03/17/2016 | Keith Millard |

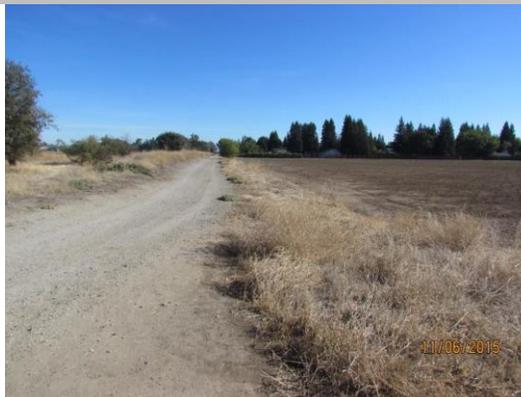
Photo 1 of 1 : SP\_2016\_ST0020\_213\_5\_20160316\_00006.jpg

View of the vegetation along the landside toe.

| Remove the vegetation from the landside toe. | | | | | |

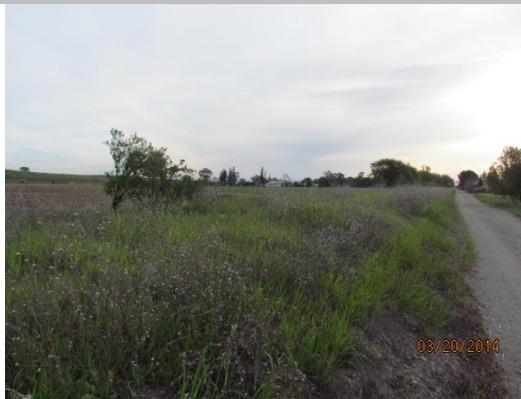
Photo 1 of 1 : SP\_2016\_ST0020\_213\_7\_20160316\_00009.jpg

View of the vegetation along the w/s toe.

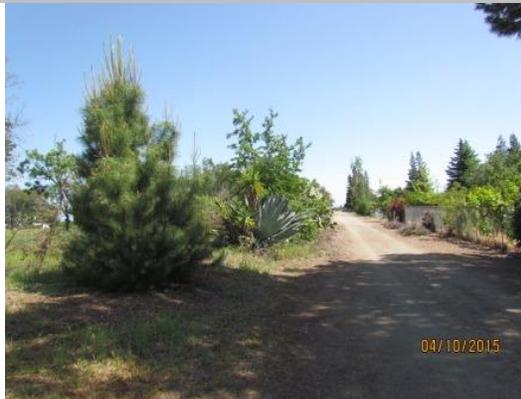
Photo 1 of 2 : SP\_2016\_ST0020\_213\_2\_20160316\_00002.jpg

View of the cactus and pine trees along the waterside berm.

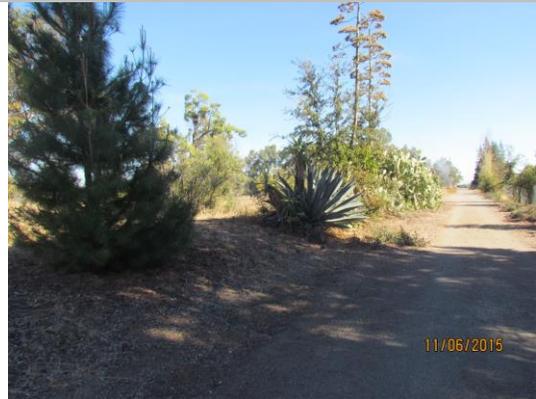
Photo 2 of 2 : SP\_2016\_ST0020\_213\_2\_20160316\_00003.jpg

View of the cactus and pine trees along the waterside berm.

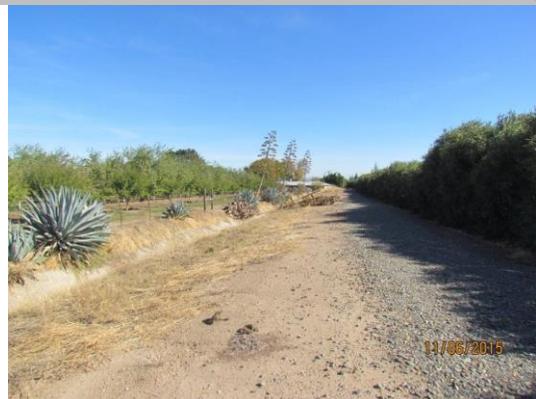
Photo 1 of 1 : SP\_2016\_ST0020\_213\_1\_20160316\_00001.jpg

View of the cactus tree that has fallen on the waterside slope.

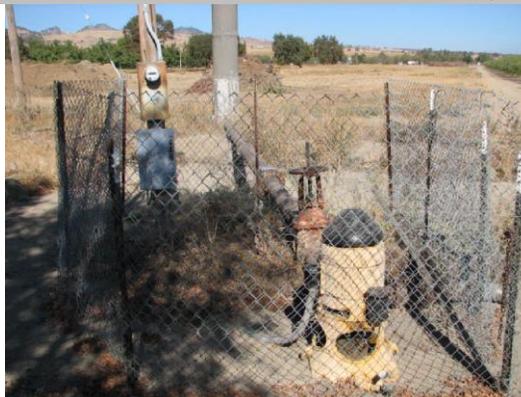
Photo 1 of 2 : UCIP\_SP\_2016\_48117\_11344.jpg

| FS_ID:48117<br>DS_ID:19417<br>EP_NO: N/A<br>Repair Type: Non-Urgent<br>Crossing Status: Found<br>UCIP Comments: 4/19/2106 Meter has been removed from the power box and the power lines have been disconnected from the pole and pump. Appears this crossing may have been abandoned.5/12/2015 Crossing appears in good condition. No noticeable issues to report.11/17/2014 Same as last inspection.5/12/2014 Same as last inspection.11/4/2013 Same as last inspection.5/15/2013 Same as last inspection.<br>FIELD_STRUCT_DESC: 12-inch steel irrigation pipe crosses over canal above crown elevation. Chain link enclosure on the landside (LS) with pump, power line, and shutoff valve. 24-inch concrete standpipe on unprotected side of canal. [Additional Reference(s): DWR Levee Log, Revised 1990]<br>FS Date: 5/2/2016 10:29:00 AM | | | | | |

Pump, meter, power pole, slide gate, and chainlink fence on LS with 24-inch concrete standpipe on unprotected side of canal.

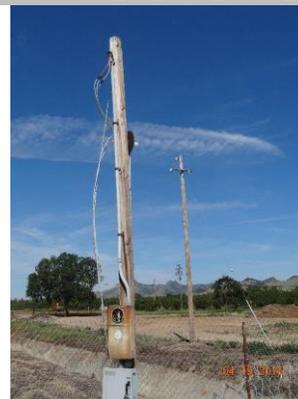
Photo 2 of 2 : UCIP\_SP\_2016\_48117\_74963.jpg

Meter removed from box and disconnected power lines

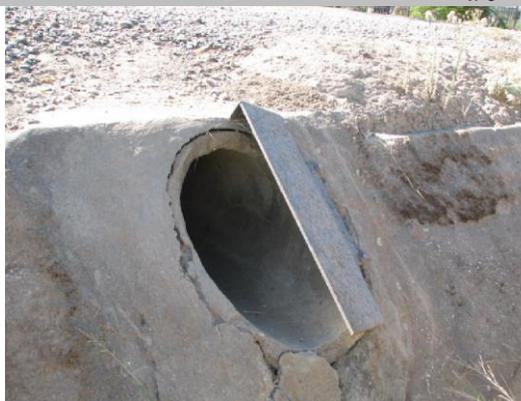
Photo 1 of 1 : UCIP\_SP\_2016\_48146\_11345.jpg

| FS_ID:48146<br>DS_ID:19434<br>EP_NO: 12746<br>Repair Type: Urgent<br>Crossing Status: Found<br>UCIP Comments: 4/19/2016 Crossing appears to be in good condition. Still no flapgate installed on the WS but unsure if its even necessary.5/12/2015 Still no flap gate on pipe end but i believe the LS inlet is high enough to not allow water to flow through pipe.11/17/2014 Same as last inspection.5/12/2014 Same as last inspection.11/4/2013 Same as last inspection.5/15/2013 Same as last inspection.10/16/2012 There is no flap gate or other device to prevent water from flowing back through the pipe at the outlet.<br>FIELD_STRUCT_DESC: 24-inch concrete storm drain pipe through the levee 2 feet below the crown with a steel deflector at outlet located on waterside (WS). No flap gate installed as of April 2016. (Permit No. 12746, 1979-Dan Garcia; named change and flap gate authorized under Permit No. 12746-1, 2016-County of Sutter).<br>FS Date: 5/2/2016 10:25:00 AM | | | | | |

Outlet in channel with steel deflector over pipe outlet.

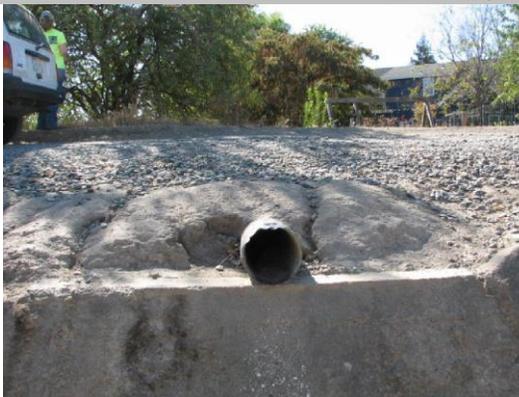
Photo 1 of 2 : UCIP\_SP\_2016\_48147\_64242.jpg

| FS_ID:48147<br>DS_ID:20115<br>EP_NO: N/A<br>Repair Type: Non-Urgent<br>Crossing Status: Found<br>UCIP Comments: 4/19/2016 Crossing appears to be in good condition.5/12/2015 Crossing appears in good condition. No noticeable issues to report.11/17/2014 Same as last inspection.5/12/2014 New flapgate installed on WS pipe end.11/4/2013 Same as last inspection.5/15/2013 Same as last inspection.10/16/2012 Pipe not permitted and has no flap gate.<br>FIELD_STRUCT_DESC: 8-inch corrugated metal drainage pipe through the levee, 1.5 feet below the crown. Outlet visible on waterside (WS). Unable to locate the inlet on landside (LS). No permit has been identified since crossing was field discovered in 2012.<br>FS Date: 5/2/2016 10:27:00 AM | | | | | |

Pipe at outlet on WS crown.

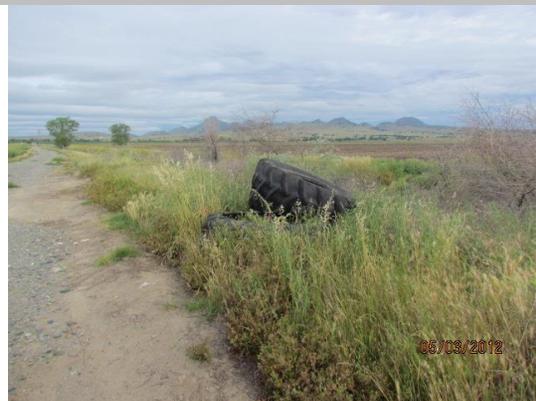
Photo 1 of 1 : SP\_2016\_ST0020\_214\_12\_20160316\_00012.jpg

View of the tires along the W/S toe.

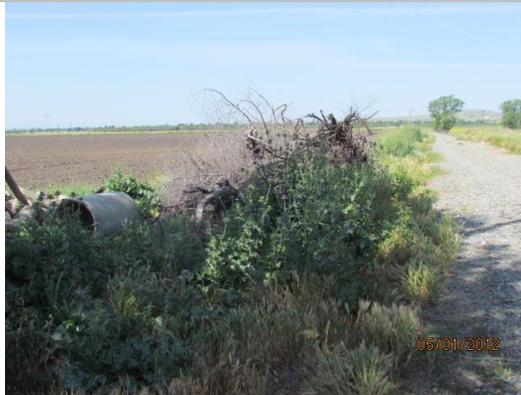
Photo 1 of 1 : SP\_2016\_ST0020\_214\_9\_20160316\_00010.jpg

View of the debris along the L/S toe.

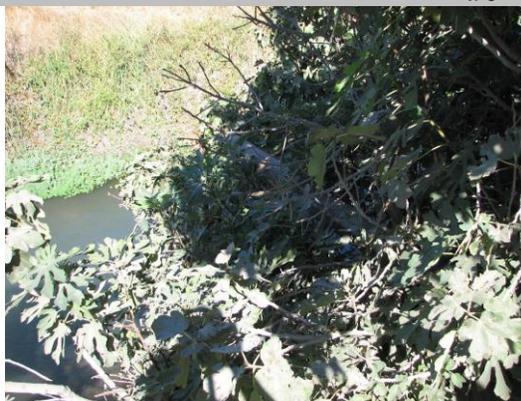
Photo 1 of 2 : UCIP\_SP\_2016\_48154\_11363.jpg

| FS_ID:48154<br>DS_ID:19425<br>EP_NO: N/A<br>Repair Type: Non-Urgent<br>Crossing Status: Found<br>UCIP Comments: 4/19/2016 Abandoned crossing.5/12/2015 Abandoned crossing.11/17/2014 Same as last inspection.5/12/2014 Same as last inspection.11/4/2013 Same as last inspection.5/15/2013 Same as last inspection.10/16/2012 Pipe and pump abandoned. Pipe should be removed or properly abandoned.<br>FIELD_STRUCT_DESC: 8-inch iron irrigation pipe through the levee, 2 feet below crown. 7.5 HP Pump in canal. [Additional Reference(s): DWR Levee Log, Revised 1990. USACE Sacramento O&M Manual 135, revision May 1953, As-builts Dwg. 50-10-2816.]<br>FS Date: 5/2/2016 10:40:00 AM | | | | | |

Pipe on LS slope.

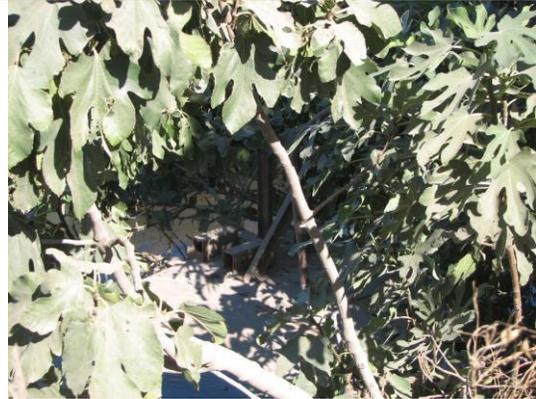
Photo 2 of 2 : UCIP\_SP\_2016\_48154\_11362.jpg

| FS_ID:48154<br>DS_ID:19425<br>EP_NO: N/A<br>Repair Type: Non-Urgent<br>Crossing Status: Found<br>UCIP Comments: 4/19/2016 Abandoned crossing.5/12/2015 Abandoned crossing.11/17/2014 Same as last inspection.5/12/2014 Same as last inspection.11/4/2013 Same as last inspection.5/15/2013 Same as last inspection.10/16/2012 Pipe and pump abandoned. Pipe should be removed or properly abandoned.<br>FIELD_STRUCT_DESC: 8-inch iron irrigation pipe through the levee, 2 feet below crown. 7.5 HP Pump in canal. [Additional Reference(s): DWR Levee Log, Revised 1990. USACE Sacramento O&M Manual 135, revision May 1953, As-builts Dwg. 50-10-2816.]<br>FS Date: 5/2/2016 10:40:00 AM | | | | | |

Pump platform on LS slope.

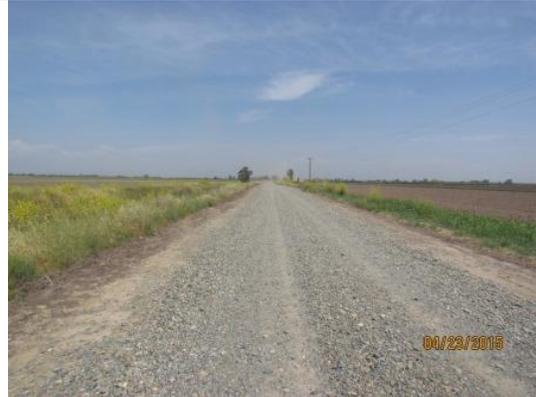
Photo 1 of 2 : SP\_2016\_ST0020\_214\_2\_20160316\_00002.jpg

View of the vegetation on both slopes.

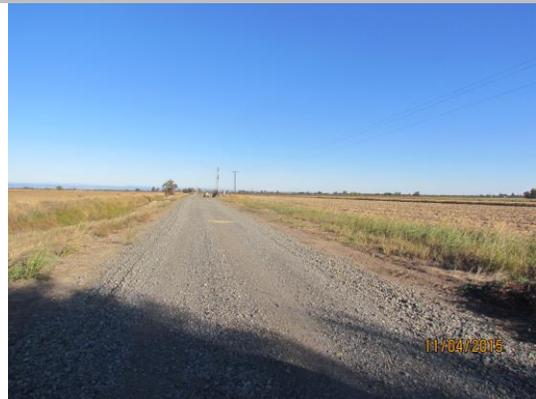
Photo 2 of 2 : SP\_2016\_ST0020\_214\_2\_20160316\_00003.jpg

View of the vegetation on both slopes.

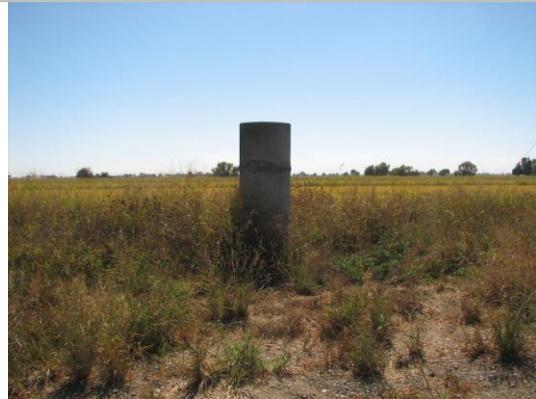
Photo 1 of 2 : UCIP\_SP\_2016\_48155\_11391.jpg

FS\_ID:48155  
 DS\_ID:19426  
 EP\_NO: N/A  
 Repair Type: Non-Urgent  
 Crossing Status: Found  
 UCIP Comments: 4/19/2016 Abandoned crossing.5/12/2015 Abandoned crossing. Needs to be properly abandoned.11/17/2014 Same as last inspection.5/12/2014 Same as last inspection.11/4/2013 Same as last inspection.5/15/2013 Same as last inspection.10/16/2012 Pumping plant abandoned. Pipe abandoned and only visible at bottom of concrete standpipe. Pipe needs to be abandoned properly.  
 FIELD\_STRUCT\_DESC: 12-inch iron irrigation pipe through the levee 6 feet below the crown. Power pole on waterside (WS) shoulder with pump on berm. 36-inch concrete standpipe on landside (LS) shoulder.  
 [Additional Reference(s): DWR Levee Log, Revised 1990. USACE Sacramento O&M Manual 135, May 1953, As-builts Dwg. 50-10-2816]  
 FS Date: 5/2/2016 10:41:00 AM

Concrete standpipe on LS shoulder.

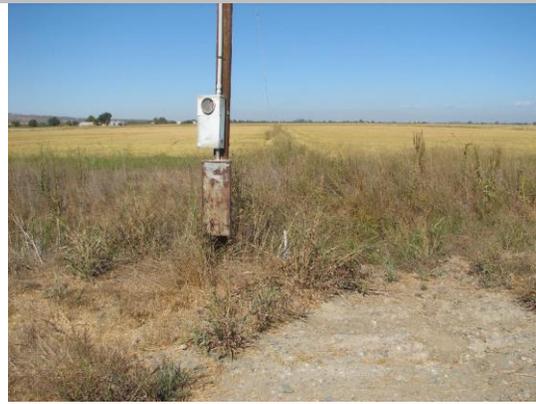
Photo 2 of 2 : UCIP\_SP\_2016\_48155\_11390.jpg

Powerpole on WS shoulder.

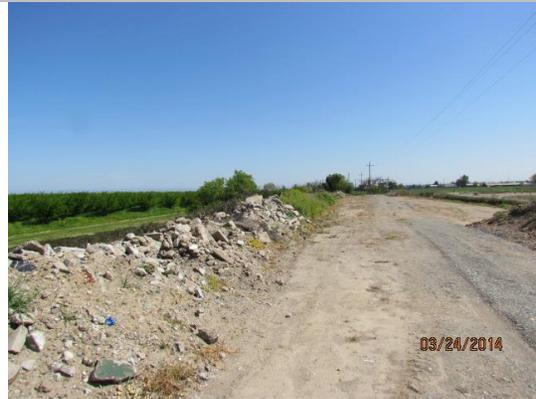
Photo 1 of 2 : SP\_2016\_ST0020\_214\_3\_20160316\_00004.jpg

View of the piles of broken concrete.

| Remove the broken concrete. | | | | | |

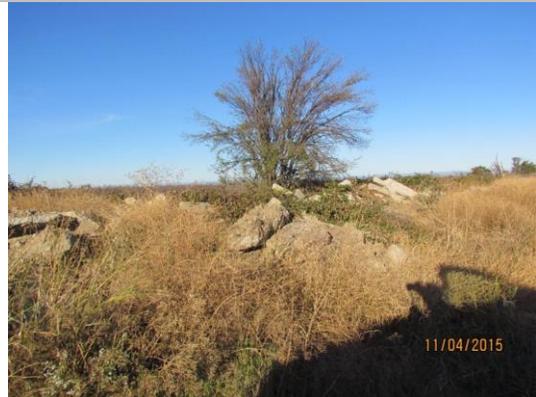
Photo 2 of 2 : SP\_2016\_ST0020\_214\_3\_20160316\_00005.jpg

View of the pile of broken concrete.

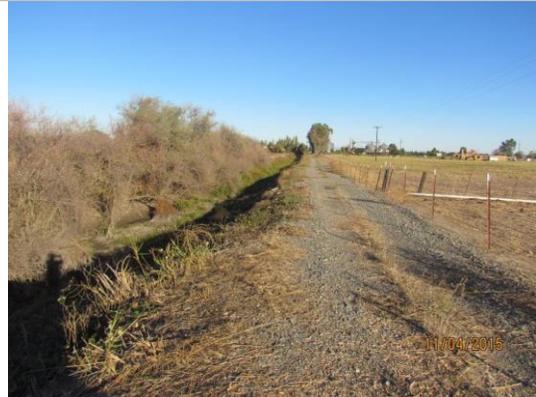
Photo 2 of 2 : SP\_2016\_ST0020\_214\_4\_20160316\_00007.jpg

View of the erosion along the waterside slope.

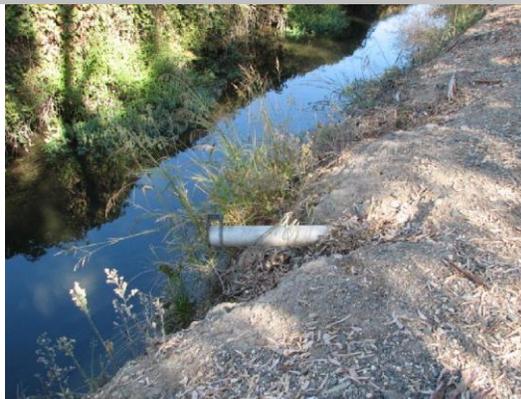
Photo 1 of 2 : UCIP\_SP\_2016\_48162\_14335.jpg

| FS_ID:48162<br>DS_ID:20119<br>EP_NO: N/A<br>Repair Type: Non-Urgent<br>Crossing Status: Found<br>UCIP Comments: 4/19/2016 Crossing appears to be in good condition.5/12/2015 Crossing appears in good condition. No noticeable issues to report.11/17/2014 Same as last inspection.5/12/2014 Same as last inspection.11/4/2013 Same as last inspection.5/15/2013 Same as last inspection.10/16/2012 No permit identified for crossing.<br>FIELD_STRUCT_DESC: 5-inch aluminum storm drain pipe through the levee, 1 foot below the crown. Flap gate on waterside (WS) with concrete headwall block on landside (LS). No permit has been identified since crossing was field discovered in 2012.<br>FS Date: 5/2/2016 10:52:00 AM | | | | | |

pipe with flap gate on WS shoulder.

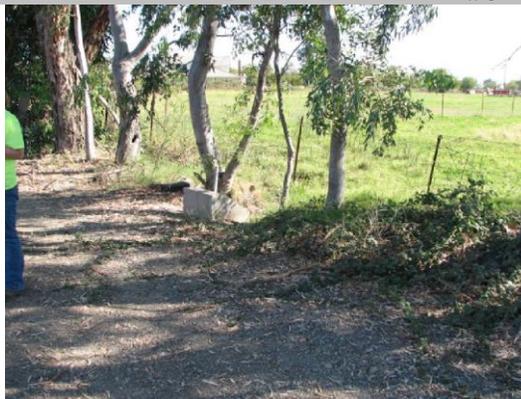
Photo 2 of 2 : UCIP\_SP\_2016\_48162\_14334.jpg

Concrete headwall on LS shoulder.

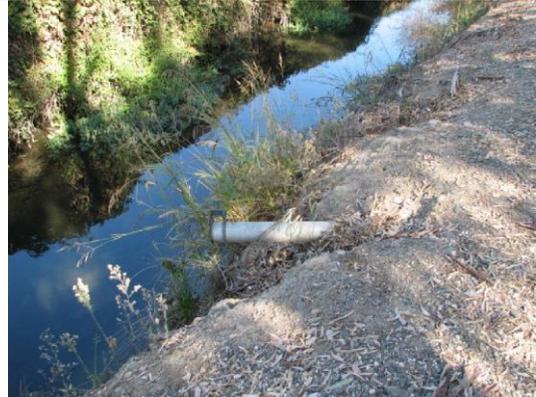
Photo 1 of 1 : UCIP\_SP\_2016\_48163\_14341.jpg

| FS_ID:48163<br>DS_ID:20122<br>EP_NO: N/A<br>Repair Type: Non-Urgent<br>Crossing Status: Found<br>UCIP Comments: 4/19/2016 Crossing appears to be in good condition.5/12/2015 Crossing appears in good condition. No noticeable issues to report.11/17/2014 Same as last inspection.5/12/2014 Same as last inspection.11/4/2013 Same as last inspection.5/15/2013 Same as last inspection.10/16/2012 No permit identified for crossing.<br>FIELD_STRUCT_DESC: 7-inch flexible high-density polyethylene (HDPE) storm drain pipe through the levee, 1 foot below the crown. No permit has been identified since crossing was field discovered in 2012.<br>FS Date: 5/2/2016 10:52:00 AM | | | | | |

HDPE pipe on upstream side of aluminum pipe shown in picture.

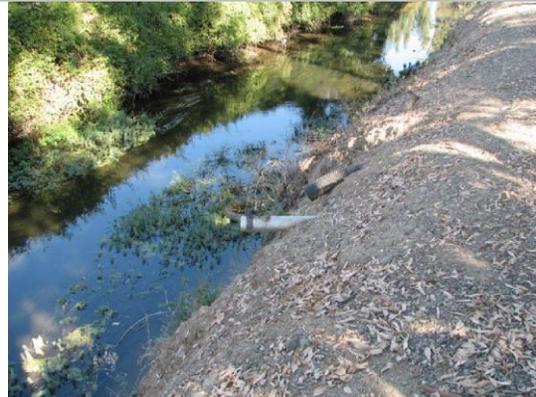
Photo 1 of 2 : UCIP\_SP\_2016\_48164\_14339.jpg

| FS_ID:48164<br>DS_ID:20120<br>EP_NO: N/A<br>Repair Type: Non-Urgent<br>Crossing Status: Found<br>UCIP Comments: 4/19/2016 Crossing appears to be in good condition.5/12/2015 Crossing appears in good condition. No noticeable issues to report.11/17/2014 Same as last inspection.5/12/2014 Same as last inspection.11/4/2013 Same as last inspection.5/15/2013 Same as last inspection.10/16/2012 No permit identified for crossing.<br>FIELD_STRUCT_DESC: 5-inch aluminum storm drain pipe through the levee, 1 foot below the crown. Flap gate on waterside (WS) with concrete headwall block on landside (LS). No permit has been identified since crossing was field discovered in 2012.<br>FS Date: 5/2/2016 10:53:00 AM | | | | | |

Pipe and flap gate on WS shoulder.

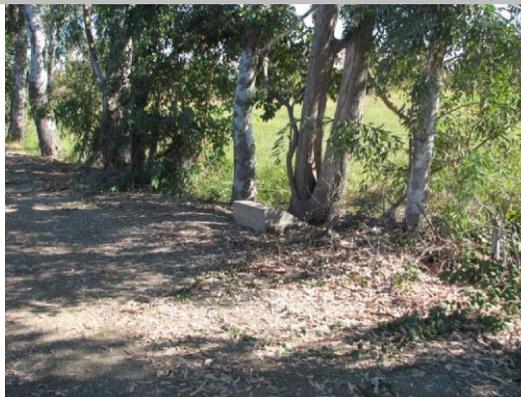
Photo 2 of 2 : UCIP\_SP\_2016\_48164\_14338.jpg

Concrete headwall on LS shoulder.

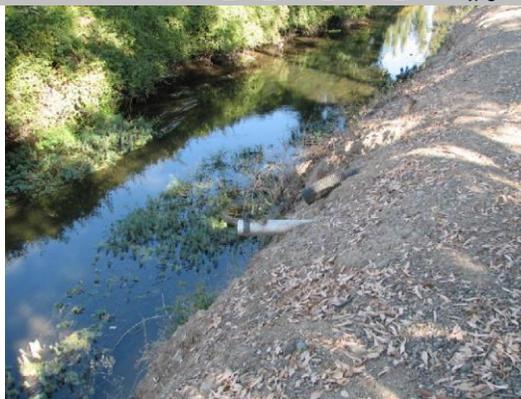
Photo 1 of 1 : UCIP\_SP\_2016\_48165\_14340.jpg

| FS_ID:48165<br>DS_ID:20121<br>EP_NO: N/A<br>Repair Type: Non-Urgent<br>Crossing Status: Found<br>UCIP Comments: 4/19/2016 Crossing appears to be in good condition.5/12/2015 Crossing appears in good condition. No noticeable issues to report.11/17/2014 Same as last inspection.5/12/2014 Same as last inspection.11/4/2013 Same as last inspection.5/15/2013 Same as last inspection.10/16/2012 No permit identified for crossing.<br>FIELD_STRUCT_DESC: 7-inch flexible high-density polyethylene (HDPE) storm drain pipe through the levee, 1 foot below the crown. No permit has been identified since crossing was field discovered in 2012.<br>FS Date: 5/2/2016 10:53:00 AM | | | | | |

HDPE pipe on WS shoulder.

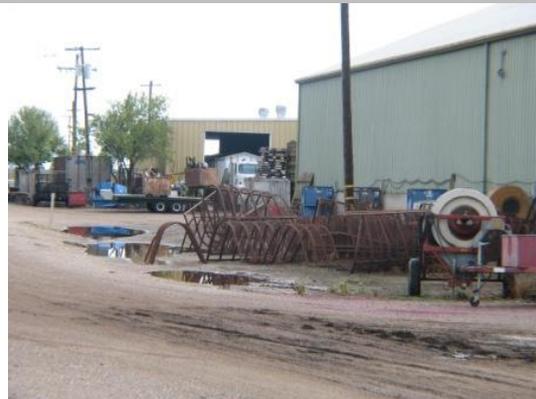
Photo 1 of 1 : SP\_2016\_ST0020\_214\_5\_20160316\_00008.jpg

View of the equipment and buildings next to the landside berm.

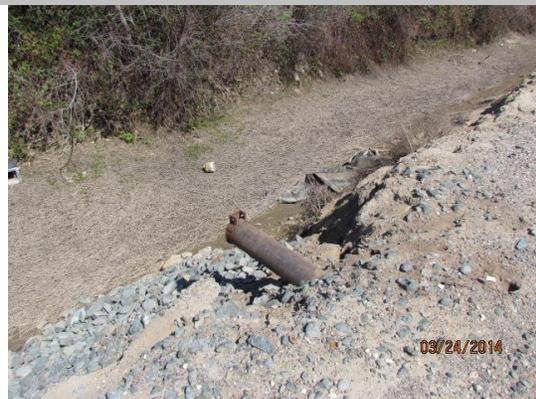
Photo 1 of 1 : SP\_2016\_ST0020\_214\_26\_20160316\_00015.jpg

View of the unauthorized pipe going through the crown of the levee.

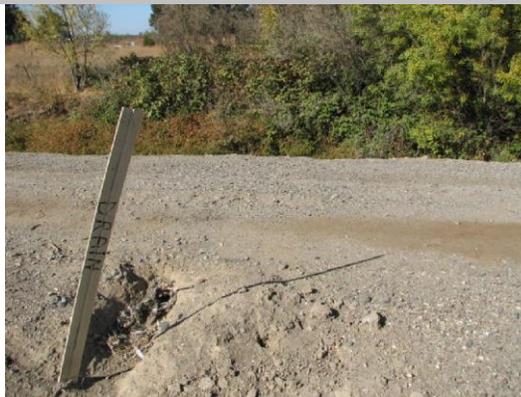
Photo 1 of 2 : UCIP\_SP\_2016\_48167\_21743.jpg

FS\_ID:48167  
 DS\_ID:20123  
 EP\_NO: N/A  
 Repair Type: Non-Urgent  
 Crossing Status: Found  
 UCIP Comments: 4/19/2016 Crossing appears to be in good condition.5/12/2015 Crossing appears in good condition. No noticeable issues to report.11/17/2014 Same as last inspection.5/12/2014 Same as last inspection.5/22/2013 Erosion under pipe outlet has been repaired. Bank lined with rock to prevent future erosion.5/15/2013 Flexible pipe has been replaced with 6.5 inch steel with flap gate on WS. Erosion under WS outlet.11/4/2013 Same as last inspection.10/16/2012 No permit identified for crossing.  
 FIELD\_STRUCT\_DESC: 7-inch flexible high-density polyethylene (HDPE) storm drain pipe through the levee, 1 foot below the crown. Signage for crossing is visible on landside (LS) shoulder. Outlet visible on waterside (WS) shoulder. No permit has been identified since crossing was field discovered in 2012.

Inlet and signage for crossing on LS shoulder.

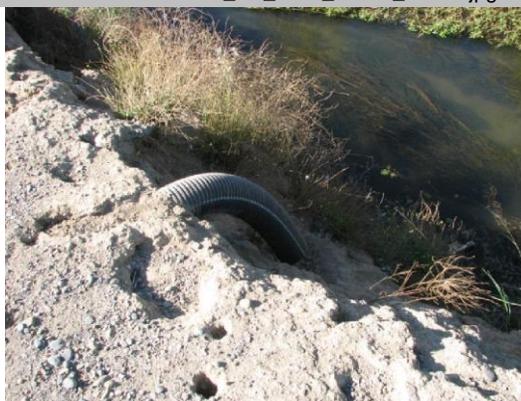
Photo 2 of 2 : UCIP\_SP\_2016\_48167\_21742.jpg

Outlet for crossing on WS shoulder.

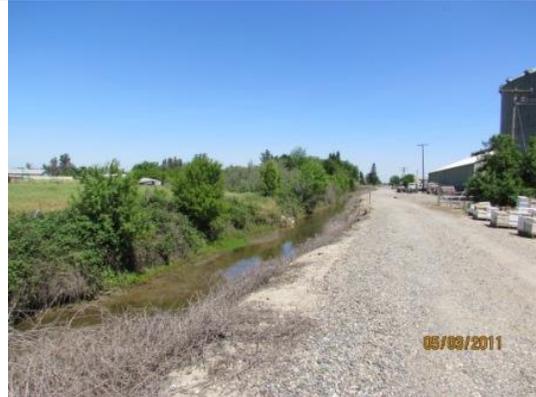
Photo 1 of 1 : SP\_2016\_ST0020\_214\_6\_20160316\_00009.jpg

View of the erosion along the W/S slope.

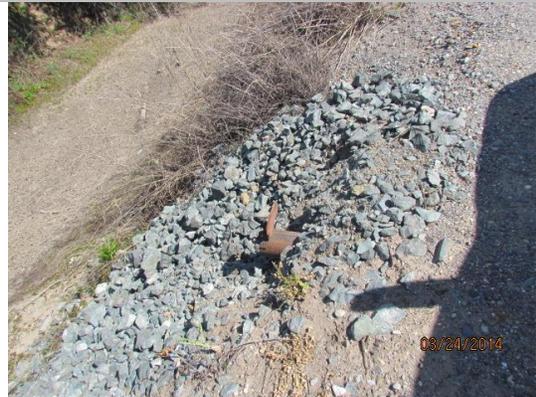
Photo 1 of 1 : SP\_2016\_ST0020\_214\_27\_20160316\_00016.jpg

View of the unauthorized pipe going through the crown of the levee.

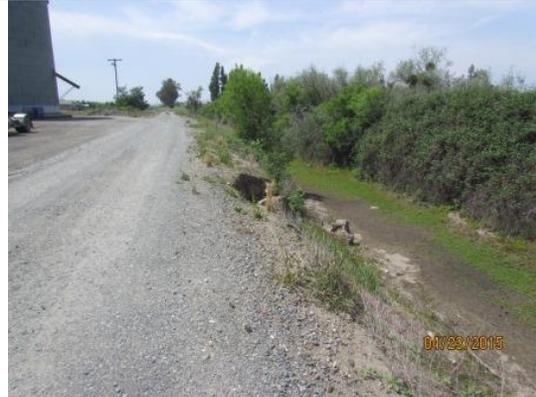
Photo 1 of 1 : SP\_2016\_ST0020\_214\_17\_20160316\_00013.jpg

View of the erosion along the waterside slope.

| Repair the erosion along the waterside slope. | | | | | |

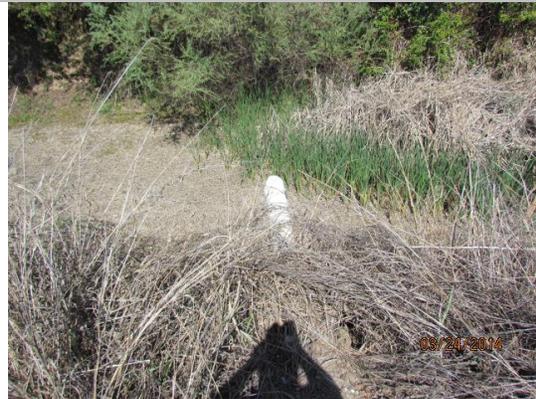
Photo 1 of 1 : SP\_2016\_ST0020\_214\_18\_20160316\_00014.jpg

View of the unauthorized pipe going through the crown of the levee.

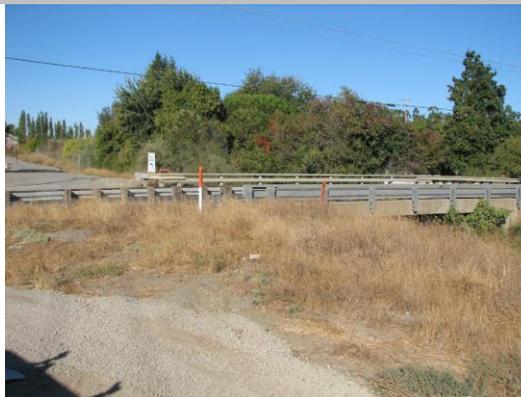
Photo 1 of 2 : UCIP\_SP\_2016\_48170\_14369.jpg

| FS_ID:48170<br>DS_ID:20125<br>EP_NO: N/A<br>Repair Type: Non-Urgent<br>Crossing Status: Found<br>UCIP Comments: 4/19/2016 Crossing appears to be in good condition.5/12/2015 Crossing appears in good condition. No noticeable issues to report.11/17/2014 Same as last inspection.5/12/2014 Same as last inspection.11/4/2013 Same as last inspection.5/15/2013 Same as last inspection.10/16/2012 No permit identified for this crossing.<br>FIELD_STRUCT_DESC: Fiber optic line through the levee at an unknown depth. Crossing is located on the east side of Township road bridge. Marker visible on east side of N. Township Drive, south of interceptor. Owner is Pacific and their contact number is 1-877-735-7366. No permit has been identified since crossing was field discovered in 2012.<br>FS Date: 5/2/2016 10:56:00 AM | | | | | |

Marker on east side of N Township Drive, south of interceptor.

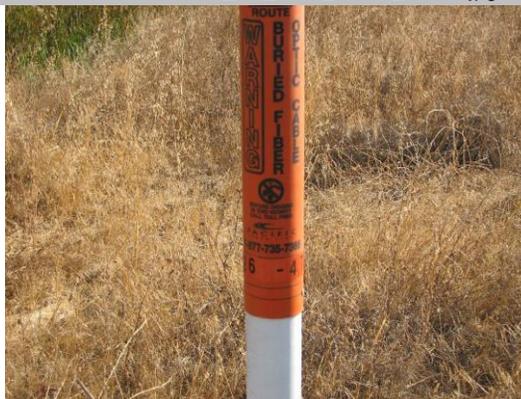
Photo 2 of 2 : UCIP\_SP\_2016\_48170\_14368.jpg

Closeup of marker.

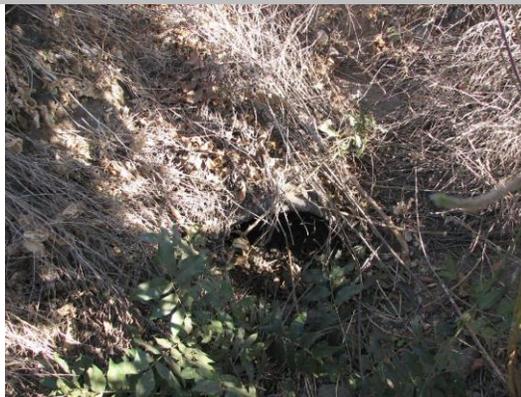
Photo 1 of 2 : UCIP\_SP\_2016\_48172\_14374.jpg

| FS_ID:48172<br>DS_ID:20127<br>EP_NO: N/A<br>Repair Type: Non-Urgent<br>Crossing Status: Found<br>UCIP Comments: 4/19/2016 Crossing appears to be in good condition.5/12/2015 Crossing appears in good condition. No noticeable issues to report.11/17/2014 Same as last inspection.5/12/2014 Same as last inspection.5/15/2013 Same as last inspection.11/4/2013 Same as last inspection.10/16/2012 No permit identified for this crossing.<br>FIELD_STRUCT_DESC: 18-inch asphalt coated corrugated metal storm drain pipe through the levee, 6 feet below the crown. Flap gate is located on waterside (WS). Pipe is visible on landside (LS) toe. No permit has been identified since crossing was field discovered in 2012.<br>FS Date: 5/2/2016 10:57:00 AM | | | | | |

Pipe on LS toe.

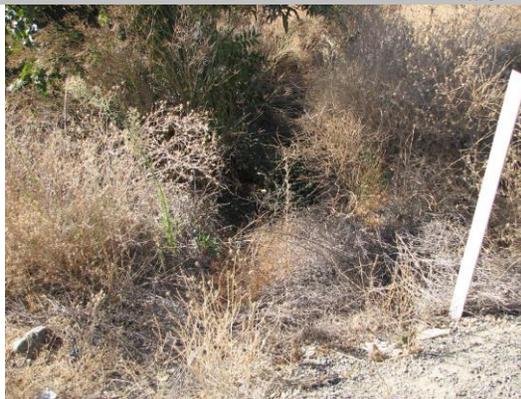
Photo 2 of 2 : UCIP\_SP\_2016\_48172\_14373.jpg

Location of pipe on LS toe.

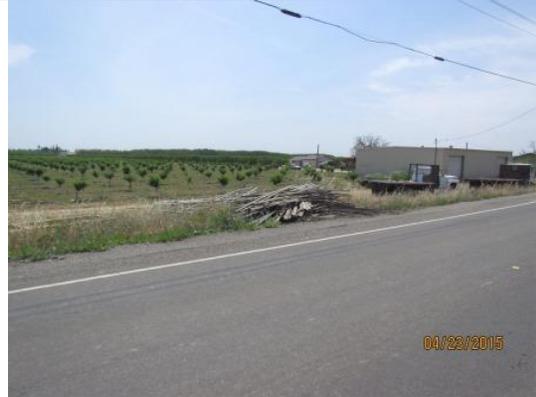
Photo 1 of 1 : SP\_2016\_ST0020\_214\_10\_20160316\_00011.jpg

View of the material, garbage and equipment along the landside toe
