**Flood Control Project Maintenance
Levee Inspections**

Maintenance Issue Types Only, Levee Inspection Report By Mile - Spring 2015

Sutter Maintenance Yard East-West Interceptor

Waterway	Bank	Unit Miles	Inspection Start/End	Inspector
Unit No. 01 West Levee	Right	1.75	04/14/2015 04/14/2015	Bob Duffey

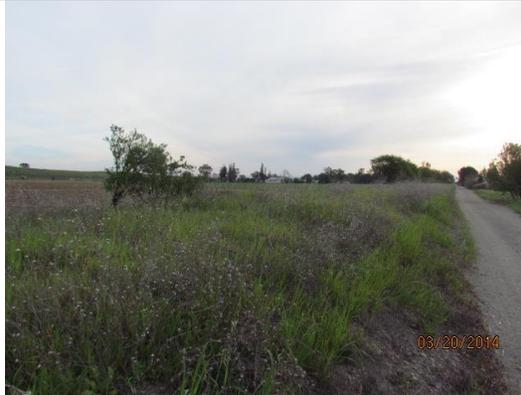
Photo 1 of 1 : SP_2015_ST0020_213_7_20150310_00004.jpg

LM Start	0.00	Rating **	M	Issue No.	7
LM End	0.32	Issue Type +	Ma	Location *	WS
Category	Earthen Levee		GPS Latitude/Longitude		
			Start	End	
Item	Vegetation		39.171577 °	39.171481 °	
			-121.760019 °	-121.754826 °	
DWR ID	DWR_NA0020_01_s_2012_7				
Action/Comments					
Remove the wild growth other than native grasses from the levee slopes.

View of the vegetation along the w/s toe.

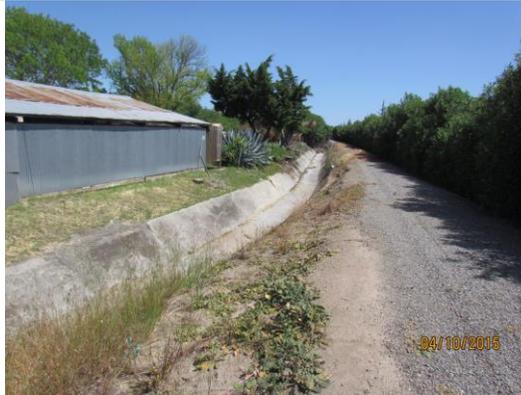
Photo 1 of 1 : SP_2015_ST0020_213_4_20150420_00009.jpg

LM Start	0.62	Rating **	U	Issue No.	4
LM End	0.65	Issue Type +	Ma	Location *	WS
Category	Earthen Levee		GPS Latitude/Longitude		
			Start	End	
Item	Erosion / Bank Caving		39.171292 °	39.171232 °	
			-121.748868 °	-121.748175 °	
DWR ID	DWR_NA0020_01_s_2012_4				
Action/Comments					
Schedule repair of erosion site prior to the next inspection. Inspector Comments: Repair the erosion along the concrete ditch before winter.

Repair the erosion along the concrete ditch before winter.

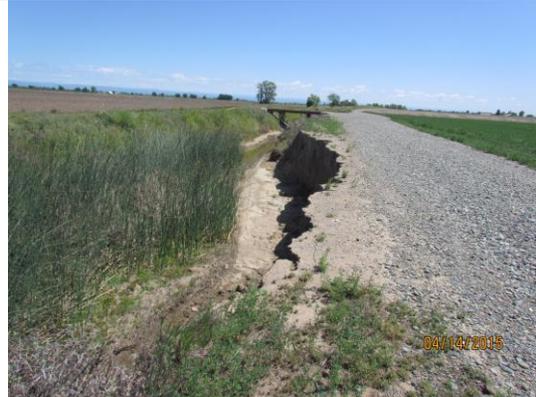
Photo 1 of 1 : SP_2015_ST0020_213_6_20150420_00010.jpg

LM Start	1.67	Rating **	U	Issue No.	6
LM End	1.67	Issue Type +	Ma	Location *	WS
Category	Rivers, Channels & Designated Floodways			GPS Latitude/Longitude	
				Start	End
Item	Erosion / Bank Caving			39.171128 °	39.171128 °
				-121.729235 °	-121.729235 °
DWR ID	DWR_NA0020_01_s_2012_6				
Action/Comments					
Inspector Comments: Sutter Yard needs to repair the erosion before winter.

Repair the erosion along the waterside slope.

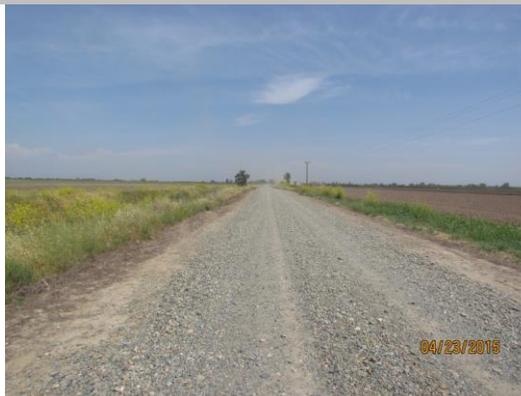
Photo 1 of 1 : SP_2015_ST0020_214_2_20150428_00016.jpg

LM Start	0.55	Rating **	M	Issue No.	2
LM End	2.72	Issue Type +	Ma	Location *	WS
Category	Earthen Levee		GPS Latitude/Longitude		
			Start	End	
Item	Vegetation		39.171002 °	39.170507 °	
			-121.716293 °	-121.676212 °	
DWR ID	DWR_NA0020_02_s_2012_2				
Action/Comments					
Remove the wild growth other than native grasses from the levee slopes. Inspector Comments: Remove the vegetation from both slopes.

View of the vegetation on both slopes.

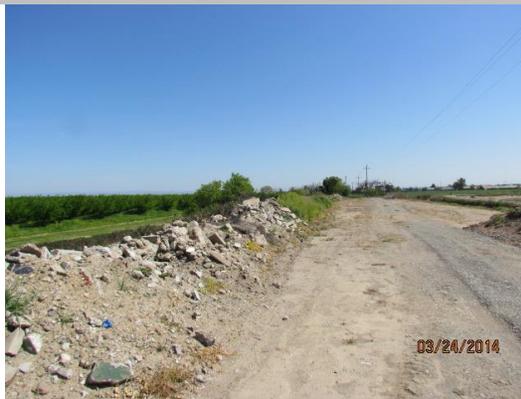
Photo 1 of 1 : SP_2015_ST0020_214_3_20150310_00003.jpg

LM Start	1.43	Rating **	M	Issue No.	3
LM End	1.55	Issue Type +	Ma	Location *	LS
Category	Earthen Levee		GPS Latitude/Longitude		
			Start	End	
Item	Encroachments		39.170782 °	39.170817 °	
			-121.700167 °	-121.698203 °	
DWR ID	DWR_NA0020_02_s_2012_3				
Action/Comments					
Debris

View of the piles of broken concrete next to the levee.

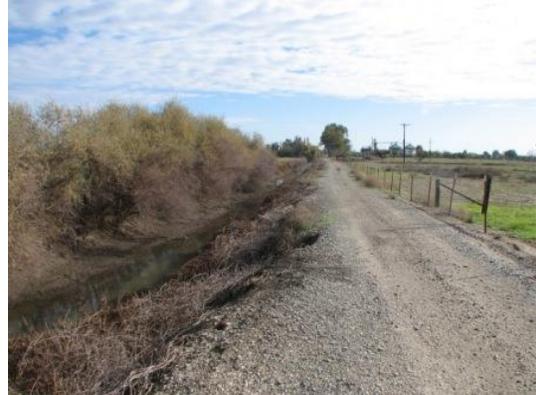
Photo 1 of 1 : SP_2015_ST0020_214_4_20150310_00004.jpg

LM Start	1.54	Rating **	M	Issue No.	4
LM End	1.93	Issue Type +	Ma	Location *	WS
Category	Earthen Levee		GPS Latitude/Longitude		
			Start	End	
Item	Erosion / Bank Caving		39.170800 °	39.170702 °	
			-121.698105 °	-121.690788 °	
DWR ID	DWR_NA0020_02_s_2012_4				
Action/Comments					
Note and monitor erosion site.

View of the erosion along the waterside slope.

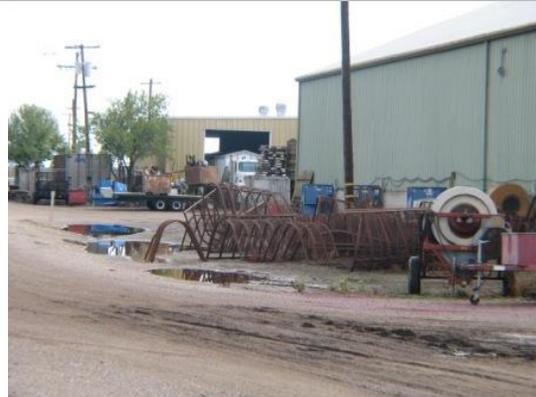
Photo 1 of 1 : SP_2015_ST0020_214_5_20150310_00005.jpg

LM Start	1.92	Rating **	M	Issue No.	5
LM End	2.04	Issue Type +	Ma	Location *	LS
Category	Earthen Levee		GPS Latitude/Longitude		
			Start	End	
Item	Encroachments		39.171104 °	39.171104 °	
			-121.718880 °	-121.718876 °	
DWR ID	DWR_NA0020_02_s_2012_5				
Action/Comments					
Equipment

View of the equipment and buildings next to the landside berm.

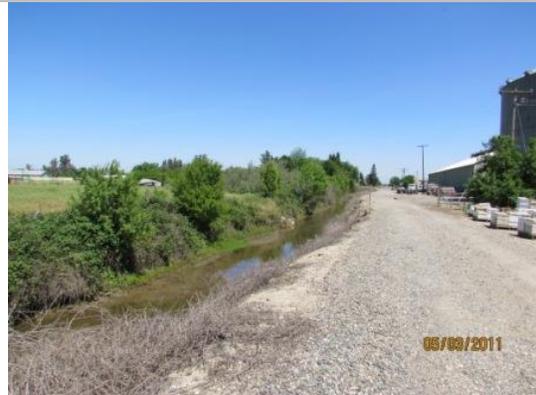
Photo 1 of 1 : SP_2015_ST0020_214_6_20150310_00006.jpg

LM Start	1.95	Rating **	M	Issue No.	6
LM End	1.98	Issue Type +	Ma	Location *	LS
Category	Earthen Levee		GPS Latitude/Longitude		
			Start	End	
Item	Erosion / Bank Caving		39.170775 °	39.170775 °	
			-121.691252 °	-121.691255 °	
DWR ID	DWR_NA0020_02_s_2012_6				
Action/Comments					
Note and monitor erosion site.

View of the erosion along the W/S slope.

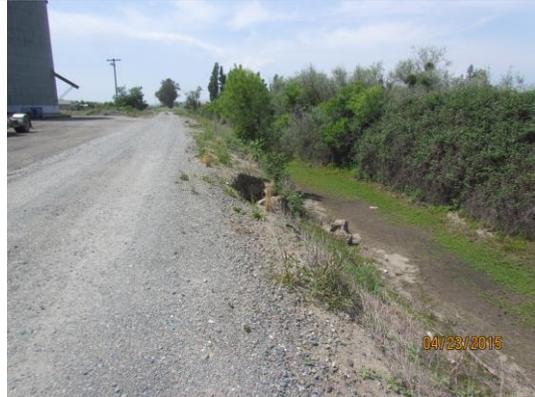
Photo 1 of 1 : SP_2015_ST0020_214_17_20150428_00018.jpg

LM Start	2.02	Rating **	M	Issue No.	17
LM End	2.02	Issue Type +	Ma	Location *	WS
Category	Earthen Levee			GPS Latitude/Longitude	
				Start	End
Item	Erosion / Bank Caving			39.170756 °	39.170756 °
				-121.689841 °	-121.689841 °
DWR ID	DWR_NA0020_02_s_2013_17				
Action/Comments					
Note and monitor erosion site. Inspector Comments: Repair the erosion along the waterside slope.

View of the erosion along the waterside slope.

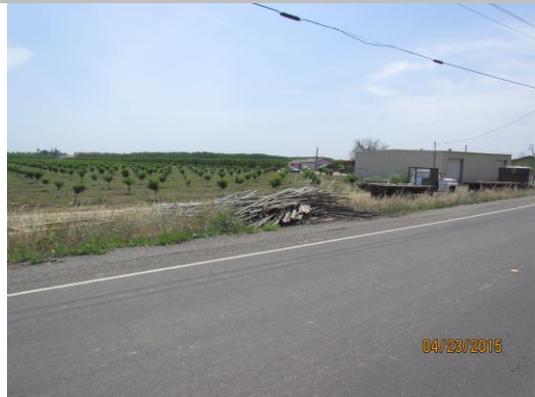
Photo 1 of 1 : SP_2015_ST0020_214_10_20150428_00015.jpg

LM Start	2.71	Rating **	M	Issue No.	10
LM End	2.71	Issue Type +	Ma	Location *	LS
Category	Earthen Levee			GPS Latitude/Longitude	
				Start	End
Item	Encroachments			39.170548 °	39.170548 °
				-121.675970 °	-121.675970 °
DWR ID	DWR_NA0020_02_s_2012_10				
Action/Comments					
Material Inspector Comments: Remove the lumber, garbage and equipment from the landside toe.

View of the material, garbage and equipment along the landside toe
