**Flood Control Project Maintenance
Levee Inspections**

Maintenance Issue Types Only, Levee Inspection Report By Mile - Spring 2016

Sutter Maintenance Yard East-West Interceptor

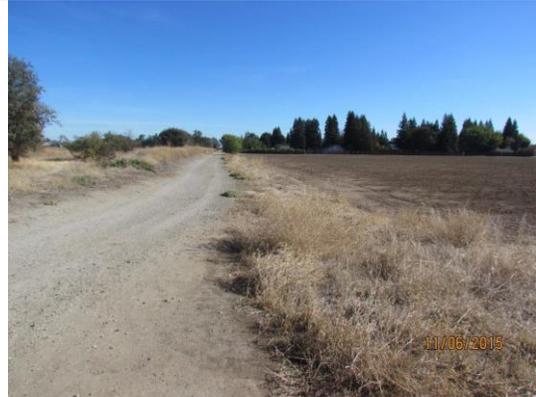
Photo 1 of 1 : SP_2016_ST0020_213_5_20160316_00006.jpg

LM Start	0.00	Rating **	M	Issue No.	5
LM End	0.13	Issue Type +	Ma	Location *	LS
Category	Earthen Levee		GPS Latitude/Longitude		
			Start	End	
Item	Vegetation		39.171577 °	39.171543 °	
			-121.760019 °	-121.758291 °	
DWR ID	DWR_NA0020_01_s_2012_5				
Comment Code					
V2 : Remove the wild growth other than native grasses from the levee slopes.					
Inspector Comment					
Remove the vegetation from the landside toe.

View of the vegetation along the landside toe.

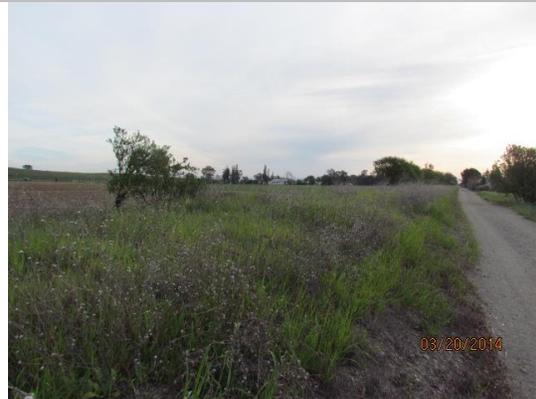
Photo 1 of 1 : SP_2016_ST0020_213_7_20160316_00009.jpg

LM Start	0.00	Rating **	M	Issue No.	7
LM End	0.32	Issue Type +	Ma	Location *	WS
Category	Earthen Levee		GPS Latitude/Longitude		
			Start	End	
Item	Vegetation		39.171577 °	39.171481 °	
			-121.760019 °	-121.754826 °	
DWR ID	DWR_NA0020_01_s_2012_7				
Comment Code					
V2 : Remove the wild growth other than native grasses from the levee slopes.					
Inspector Comment

View of the vegetation along the w/s toe.

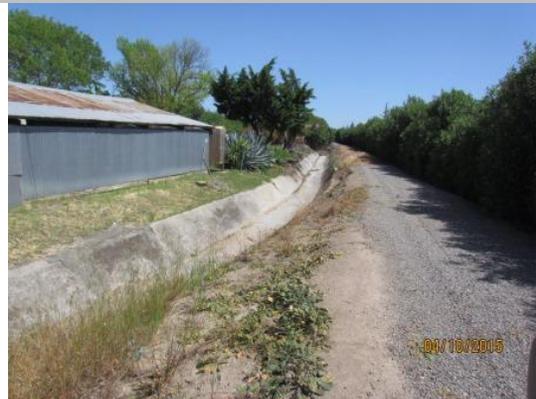
Photo 1 of 2 : SP_2016_ST0020_213_4_20160316_00004.jpg

LM Start	0.62	Rating **	U	Issue No.	4
LM End	0.65	Issue Type +	Ma	Location *	WS
Category	Earthen Levee		GPS Latitude/Longitude		
			Start	End	
Item	Erosion / Bank Caving		39.171292 °	39.171232 °	
			-121.748868 °	-121.748175 °	
DWR ID	DWR_NA0020_01_s_2012_4				
Comment Code					
E2 : Schedule repair of erosion site prior to the next inspection.					
Inspector Comment					
Repair the erosion along the concrete ditch.

Repair the erosion along the concrete ditch before winter.

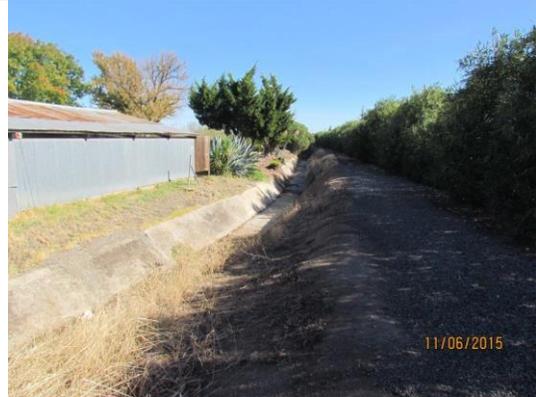
Photo 2 of 2 : SP_2016_ST0020_213_4_20160316_00005.jpg

LM Start	0.62	Rating **	U	Issue No.	4 (cont)
LM End	0.65	Issue Type +	Ma	Location *	WS
Category	Earthen Levee		GPS Latitude/Longitude		
			Start	End	
Item	Erosion / Bank Caving		39.171292°	39.171232°	
			-121.748868°	-121.748175°	
DWR ID	DWR_NA0020_01_s_2012_4				
Comment Code					
E2 : Schedule repair of erosion site prior to the next inspection.					
Inspector Comment					
Repair the erosion along the concrete ditch.

Repair the erosion along the concrete ditch.

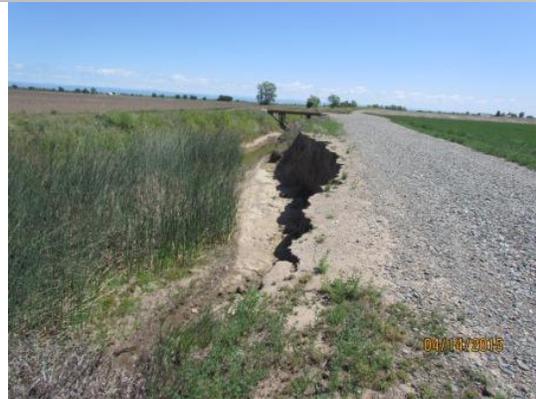
Photo 1 of 2 : SP_2016_ST0020_213_6_20160316_00007.jpg

LM Start	1.67	Rating **	U	Issue No.	6
LM End	1.67	Issue Type +	Ma	Location *	WS
Category	Rivers, Channels & Designated Floodways		GPS Latitude/Longitude		
			Start	End	
Item	Erosion / Bank Caving		39.171128°	39.171128°	
			-121.729235°	-121.729235°	
DWR ID	DWR_NA0020_01_s_2012_6				
Comment Code					
Inspector Comment					
Sutter Yard needs to repair the erosion before winter.

Repair the erosion along the waterside slope.

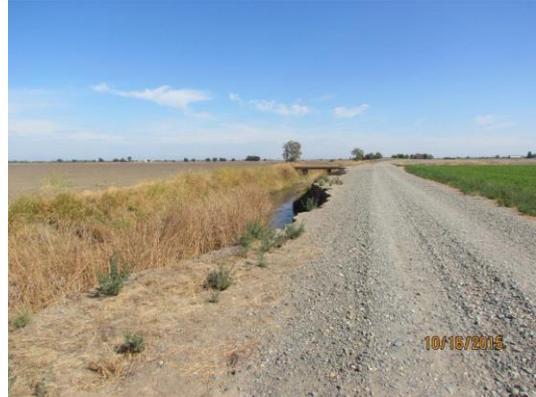
Photo 2 of 2 : SP_2016_ST0020_213_6_20160316_00008.jpg

LM Start	1.67	Rating **	U	Issue No.	6 (cont)
LM End	1.67	Issue Type +	Ma	Location *	WS

Repair the erosion along the waterside slope.

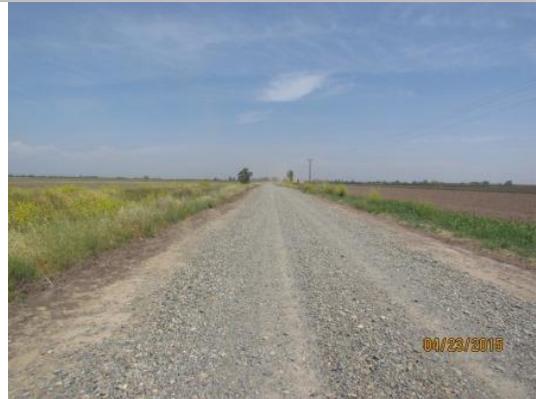
Photo 1 of 2 : SP_2016_ST0020_214_2_20160316_00002.jpg

LM Start	0.55	Rating **	M	Issue No.	2
LM End	2.72	Issue Type +	Ma	Location *	WS
Category	Earthen Levee		GPS Latitude/Longitude		
			Start	End	
Item	Vegetation		39.171002°	39.170507°	
			-121.716293°	-121.676212°	
DWR ID	DWR_NA0020_02_s_2012_2				
Comment Code					
V2 : Remove the wild growth other than native grasses from the levee slopes.					
Inspector Comment					
Remove the vegetation from both slopes.

View of the vegetation on both slopes.

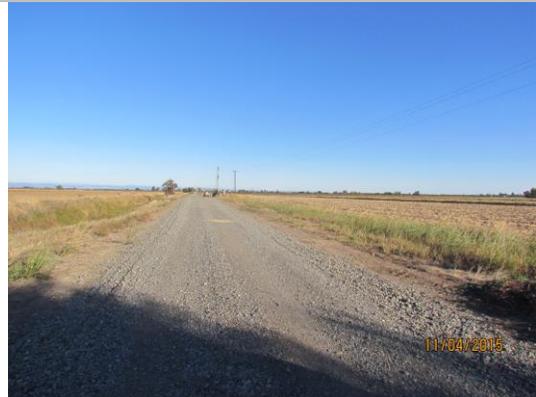
Photo 2 of 2 : SP_2016_ST0020_214_2_20160316_00003.jpg

LM Start	0.55	Rating **	M	Issue No.	2 (cont)
LM End	2.72	Issue Type +	Ma	Location *	WS

View of the vegetation on both slopes.

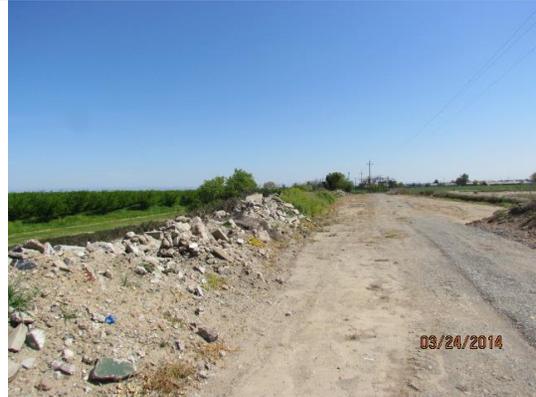
Photo 1 of 2 : SP_2016_ST0020_214_3_20160316_00004.jpg

LM Start	1.43	Rating **	M	Issue No.	3
LM End	1.55	Issue Type +	Ma	Location *	LS
Category	Earthen Levee		GPS Latitude/Longitude		
			Start	End	
Item	Encroachments		39.170782 °	39.170817 °	
			-121.700167 °	-121.698203 °	
DWR ID	DWR_NA0020_02_s_2012_3				
Comment Code					
DE : Debris					
Inspector Comment					
Remove the broken concrete.

View of the piles of broken concrete.

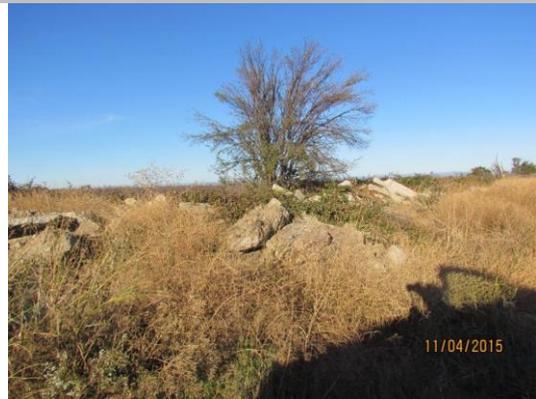
Photo 2 of 2 : SP_2016_ST0020_214_3_20160316_00005.jpg

LM Start	1.43	Rating **	M	Issue No.	3 (cont)
LM End	1.55	Issue Type +	Ma	Location *	LS

View of the pile of broken concrete.

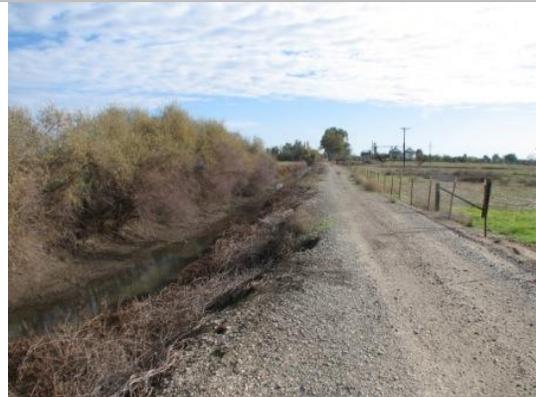
Photo 1 of 2 : SP_2016_ST0020_214_4_20160316_00006.jpg

LM Start	1.54	Rating **	M	Issue No.	4
LM End	1.93	Issue Type +	Ma	Location *	WS
Category	Earthen Levee		GPS Latitude/Longitude		
			Start	End	
Item	Erosion / Bank Caving		39.170800 °	39.170702 °	
			-121.698105 °	-121.690788 °	
DWR ID	DWR_NA0020_02_s_2012_4				
Comment Code					
E1 : Note and monitor erosion site.					
Inspector Comment					
Monitor the erosion along the waterside slope.

View of the erosion along the waterside slope.

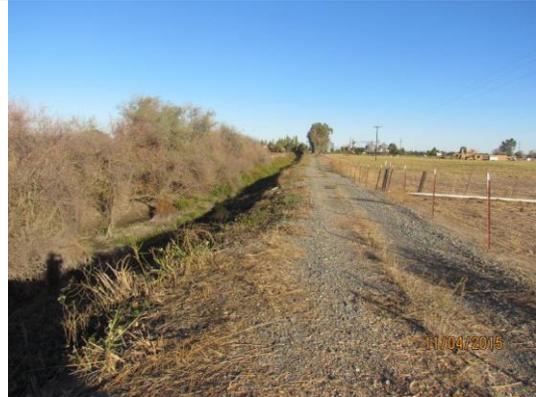
Photo 2 of 2 : SP_2016_ST0020_214_4_20160316_00007.jpg

LM Start	1.54	Rating **	M	Issue No.	4 (cont)
LM End	1.93	Issue Type +	Ma	Location *	WS
Category	Earthen Levee		GPS Latitude/Longitude		
			Start	End	
Item	Erosion / Bank Caving		39.170800 °	39.170702 °	
			-121.698105 °	-121.690788 °	
DWR ID	DWR_NA0020_02_s_2012_4				
Comment Code					
E1 : Note and monitor erosion site.					
Inspector Comment					
Monitor the erosion along the waterside slope.

View of the erosion along the waterside slope.

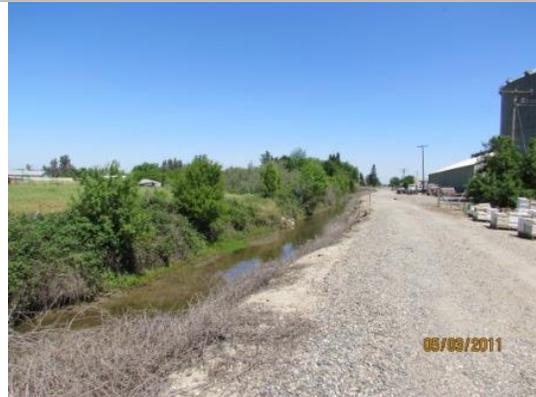
Photo 1 of 1 : SP_2016_ST0020_214_6_20160316_00009.jpg

LM Start	1.95	Rating **	M	Issue No.	6
LM End	1.98	Issue Type +	Ma	Location *	LS
Category	Earthen Levee		GPS Latitude/Longitude		
			Start	End	
Item	Erosion / Bank Caving		39.170775 °	39.170775 °	
			-121.691252 °	-121.691255 °	
DWR ID	DWR_NA0020_02_s_2012_6				
Comment Code					
E1 : Note and monitor erosion site.					
Inspector Comment

View of the erosion along the W/S slope.

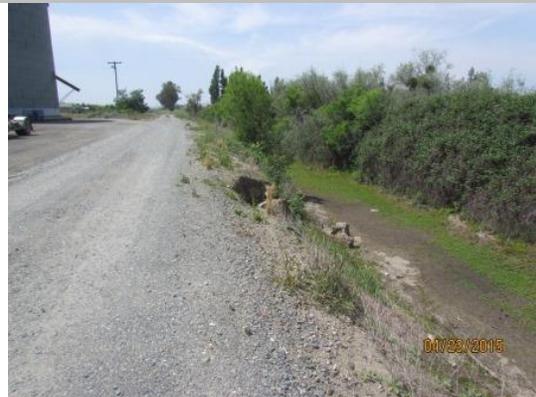
Photo 1 of 1 : SP_2016_ST0020_214_17_20160316_00013.jpg

LM Start	2.02	Rating **	M	Issue No.	17
LM End	2.02	Issue Type +	Ma	Location *	WS
Category	Earthen Levee		GPS Latitude/Longitude		
			Start	End	
Item	Erosion / Bank Caving		39.170756 °	39.170756 °	
			-121.689841 °	-121.689841 °	
DWR ID	DWR_NA0020_02_s_2013_17				
Comment Code					
E1 : Note and monitor erosion site.					
Inspector Comment					
Repair the erosion along the waterside slope.

View of the erosion along the waterside slope.

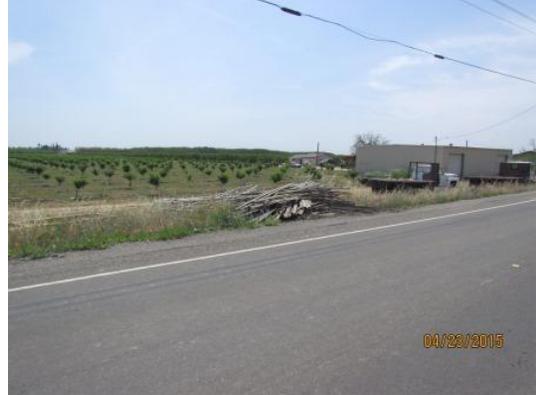
Photo 1 of 1 : SP_2016_ST0020_214_10_20160316_00011.jpg

LM Start	2.71	Rating **	M	Issue No.	10
LM End	2.71	Issue Type +	Ma	Location *	LS
Category	Earthen Levee		GPS Latitude/Longitude		
			Start	End	
Item	Encroachments		39.170548 °	39.170548 °	
			-121.675970 °	-121.675970 °	
DWR ID	DWR_NA0020_02_s_2012_10				
Comment Code					
MA : Material					
Inspector Comment					
Remove the lumber, garbage and equipment from the landside toe.

View of the material, garbage and equipment along the landside toe
