LMA: **NA0010 U23 Lower San Joaquin Levee District**

Waterway: **RB San Joaquin River**

Site ID: **NA0010U23RM224.27**

Status: **Repaired Site**

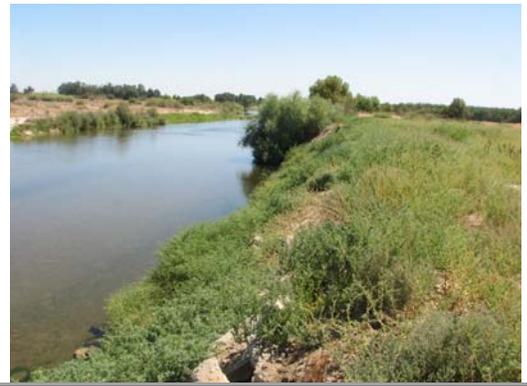
07/24/2012: Site has been repaired with riprap rocks and broken concrete blocks, but loose material and cracking are visible at the top of the repaired site. The site needs close monitoring for performance evaluation.

Looking downstream at the repaired site

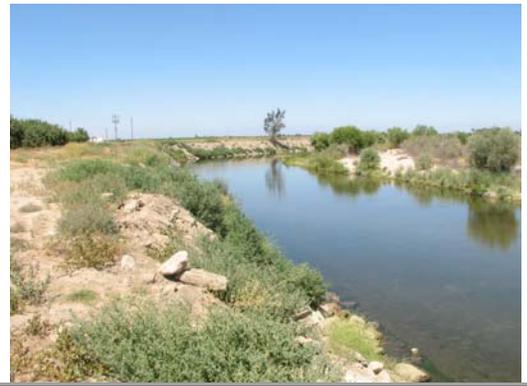
07/24/2012: The site has been repaired with clay material, riprap rocks, and broken concrete blocks, but the loose material and large crackings at the repaired site are visible. Need monitoring for the performance during the coming high flow events.

Looking upstream at the repaired site.

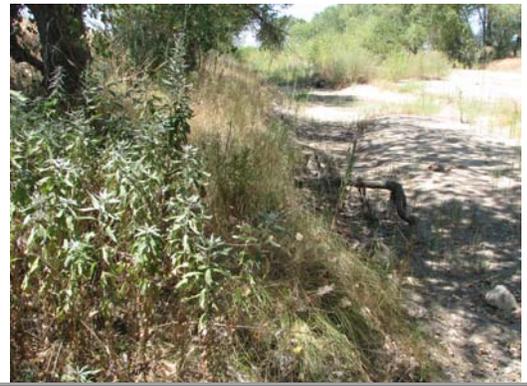
07/31/2012: Site was visited on 07/24/2012. No significant change observed. Dense vegetation around the site
 08/09/2011: Site was inspected. No visible change was observed from the previous condition. A fallen tree was seen at the levee toe about 20 feet upstream, and tree root exposed. There has been no report from the district that this site was corrected.
 11/30/2010: Site was not inspected due to time constraints. There have been no reports from the district that the site was corrected. Continue to monitor site during flood events.
 08/05/2010: Recommended for annual assessment and monitoring during flood events, per CLRO.
 2009: Site is recommended as a local maintenance issue, per Critical Levee Repair Office, Critical Erosion Sites Evaluation 2008 Report; site was previously rated "M"
 9/6/2007: Undercutting of the toe; several trees along the WS slope with roots exposed.

Close-in view at the erosion site

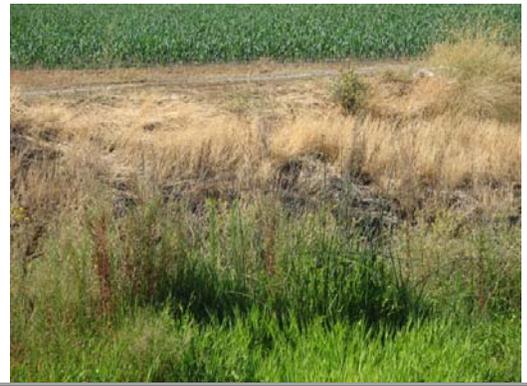
07/31/2012: Site was visited on 07/26/2012. No significant changes observed. Dense vegetation presents at the site.
 08/16/2011: No visible change. 100 percent vegetation coverage with star thistles. Minor cracking visible on the waterside slope.
 11/30/2010: Site was not inspected this year due to time constraint. There have been no reports from the district that this site was corrected. Continue to monitor during flood events.
 2009: Site is recommended as local maintenance issue, per CLRO CES Evaluation 2008 Report; it was previously rated "U".
 8/26/2008: Terracetting erosion; frequent livestock traversing the slopes has caused deformation of the waterside levee slope.
 9/11/2007: GPS extended from opposite bank using Google Earth.

A close look at the site, which is covered by thick vegetation

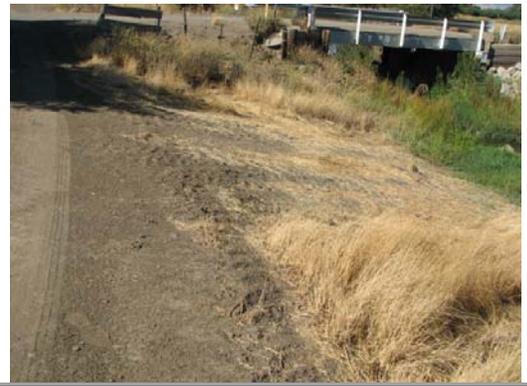
07/31/2012: Site was visited on 07/24/2012. No significant changes observed. Dried grass covered the site. Dense vegetation.
 08/16/2011: No visible change. 100 percent vegetation coverage with star thistles. Minor cracking visible on the waterside slope. Burrow holes visible.
 11/30/2010: Site was not inspected this year due to time constraint. There have been no reports from the district that the site was repaired. Continue to monitor during flood events.
 2009: Bank erosion scour that is immediately downstream of Mission Avenue bridge; noticeable terracetting damage from livestock traversing the slope; site is recommended as local maintenance issue, per CLRO Evaluation 2008 Report; site was previously rated "M".
 8/26/2008: Terracetting damage from livestock; there is now a pocket erosion developing on the levee toe; site is 100 feet downstream of Mission Avenue bridge.

The site is covered with dense thistles.

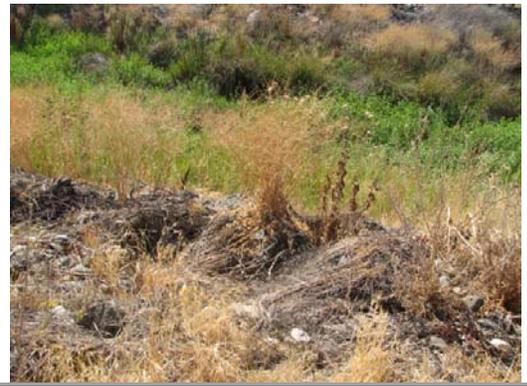
07/24/2012: No significant changes observed.
 08/16/2011: No visible significant changes. 100 percent vegetation coverage with star thistles. Minor cracking visible on the waterside slope.
 11/30/2010: Site was not inspected this year due to time constraints. There have been no reports from the district that the site has been corrected.
 2009: Site is recommended as local maintenance issue, per CLRO CES Evaluation 2008 Report; terracing damage from livestock traversing; there is a wooden platform installed on site; landside is on high ground; site was previously rated "M".
 9/10/2007: GPS extended from opposite bank using Google Earth; GPS on file is correct.

Direct look at the site

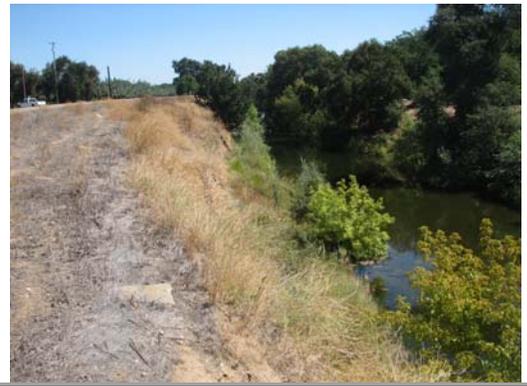
08/22/2012: Site has been revisited. No significant changes observed on erosion site
 09/02/2011: No significant changes observed on site.
 11/02/2010: No significant changes observed on site. The mile-long erosion continues to degrade the bank. There are a few trees along the mile-long stretch on the lower bank slope that are affected by the scarp. WS Levee Slope was changed to 2:1. As a result, normalized score increased from 62 to 65.
 08/05/2010: Recommended for waterside repair, per CLRO; "water velocity is a major factor for accelerating bank slope erosion."
 8/12/2009: Near-vertical bank erosion; degrading channel is incising the banks; recommend annual assessment and monitoring of critical erosion site, per CLRO CES Evaluation 2008 Report; district is monitoring site for changes in condition; site was previously rated "U".
 2007: Visited site 02/06/2007; possible critical site.

Looking upstream

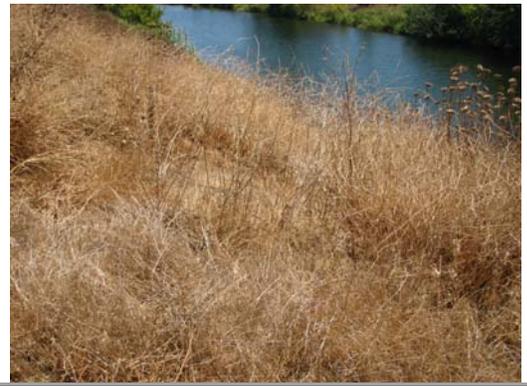
08/22/2012: Site was visited. No new erosion has been found. Dense vegetation developed at the repaired site.
 09/02/2011: Site was repaired in 2011 summer by the district. Needs to monitor during the next flood season for performance. The site was previously rated "U".
 11/02/2010: No significant changes observed on site. Bank erosion extends approximately 100 feet downstream and 250 feet upstream of the drop structure.
 8/12/2009: No major change observed; erosion is upstream and downstream of drop structure; bank erosion is associated with high velocities; it is recommended for annual assessment and monitoring of critical erosion site per CLRO CES Evaluation 2008 Report; it was previously rated "U".
 2007: Visited site 02/06/2007.

Looking at the repaired site. Dense vegetation covered the repaired slope.

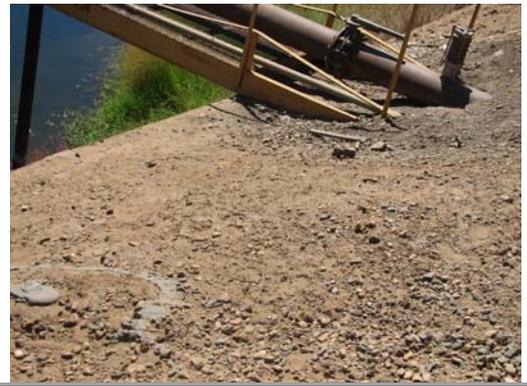
08/22/2012: Site is visited and no new erosion discovered.
 09/02/2011: Site was fixed in April 2011 by the district. Suggest continue to monitor performance during flooding. The site was previously rated "M".
 11/02/2010: No significant changes observed on site. Upon further inspection, it appears that a slab of aging concrete lining on the bank slope has slipped, possibly due to a weakend subsoil layer. Fissure cracks have developed and now extend outward from where the initial slip occurred. Erosion of the subsoil layer could further weaken the bank and intrude into the levee prism. It could also affect the stability of the pump structure.
 8/12/2009: Downward creep of the soil that was possibly caused during pipe installation; erosion is between 2 to 3 feet cut into the bank; vertical pump inlet is located adjacent to erosion; District personnel Jay Howdigi and Jim Caruso were present during the site visit.

Looking down at the repaired site.

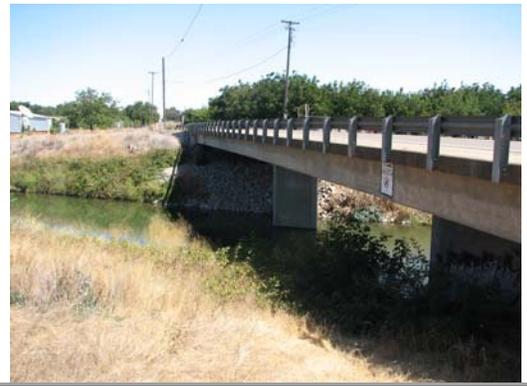
08/22/2012: Site is visited and no new erosion activity found at the repaired site, but new pocket erosion has developed at the toe downstream of the bridge.
 09/02/2011: The site has been repaired by the district. The site was previously rated "M".
 11/02/2010: No significant changes observed on site. Bridge scour has created a pocket erosion, exposing a portion of the underlying concrete padding.
 8/11/2009: Site is adjacent to abutment on Milton Road Bridge; pocket erosion has developed and will continue to expose the bridge foundation; this erosion appears to be critical as it may affect the bridge foundation.

Looking at the site from right bank, immediately upstream of the bridge

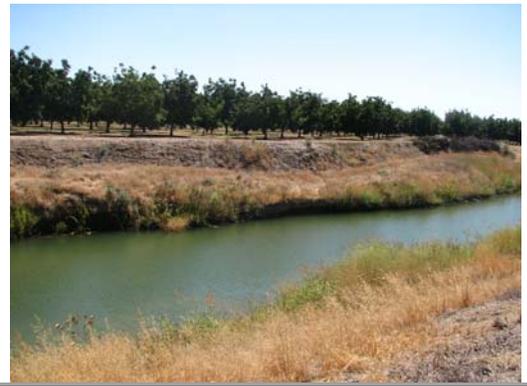
08/22/2012: Erosion is on berm. The berm width is estimated.

Looking downstream at the erosion

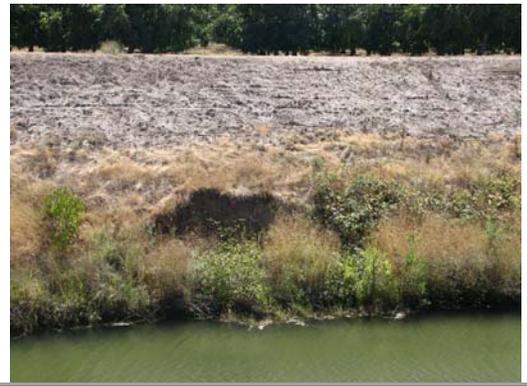
08/22/2012: Pocket erosion at the levee toe and slope. The erosion is covered with dense vegetation.

Front view of erosion

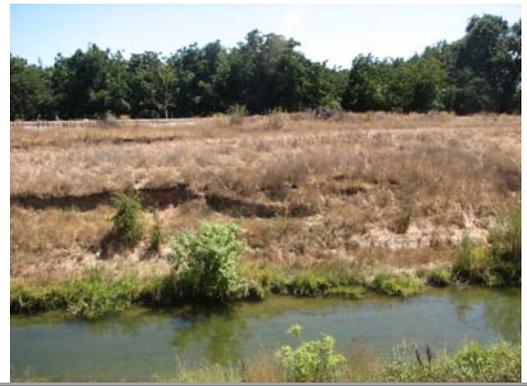
08/22/2012: Erosion occurred on a berm of approximately 25 ft wide. Site is covered with dense vegetation.

Front view of erosion

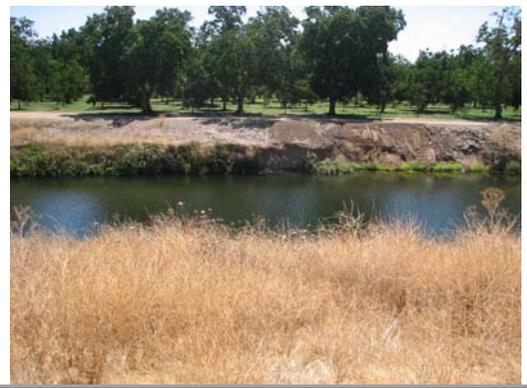
08/22/2012: The erosion was firstly reported in 2012 spring levee inspection report. Fresh soil exposed at the site as a result of possible effort for levee slope enhancement.

Front view of the site.

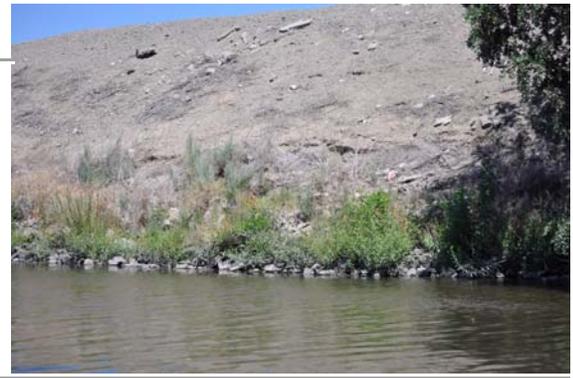
08/07/2012: The erosion is at the confluence of Old River and one of its tributary.

Front view of the erosion

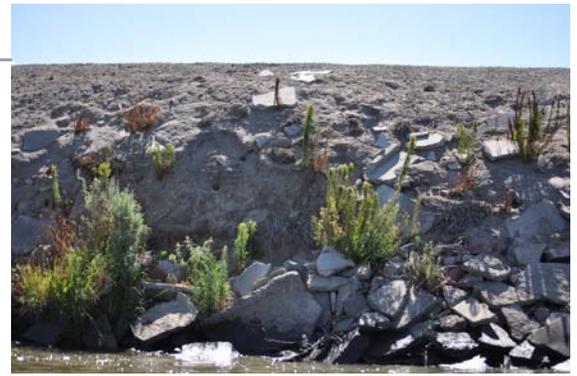
08/07/2012: The erosion is nearly verticle, and has developed upward to halfway of the levee slope. The protecting concrete blocks have been washed away. Animal activities are visible.

Front view of erosion site. Note the concrete blocks and vegetation.

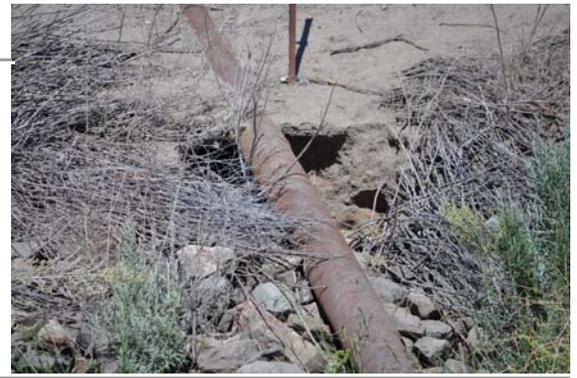
08/07/2012: Erosion is underneath an irrigation pipe. The likely cause of the erosion is the pipe leakage.

Close view of the erosion and the pipe

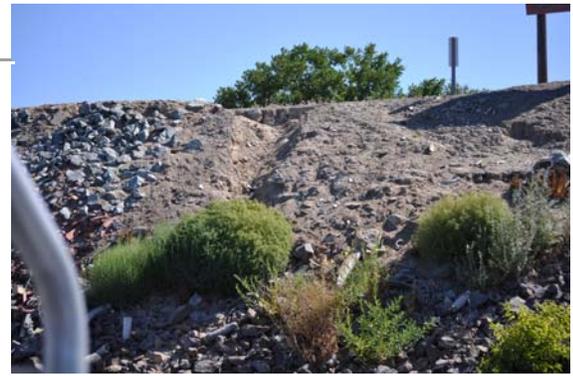
08/07/2012: The erosion is immediately upstream of riprap protection section. The possible cause of the erosion is the rainfall runoff washout.

Front view of the site. Note the riprap protection next to the site.

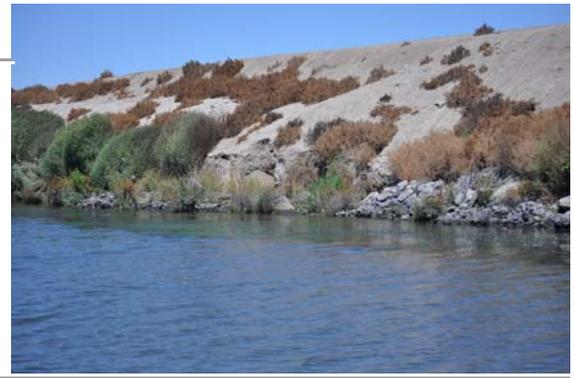
08/07/2012: The site has been visited by boat survey. The erosion has developed in size, and more pocket erosions found.
 8/23/2011: Pockets erosions observed by last survey seem have progressed during the last food season. Continuous monitoring of this site suggested
 9/07/2010: No significant change observed on site. There is emergent vegetation at the water line. Several pocket erosions lined along the lower slope that stretches from RM 40.86 to RM 41.14.
 9/30/2009: No major change observed; the site was combined with other existing sites are RM's 40.93, 40.98, and 41.14 as one site; several pocket erosion just above non-uniform toe rip rap; previously rated "U"; bare spots along the upper slope.
 2008: Possibly caused by wave wash erosion; several pocket erosion along the lower slope; site is inside of a bend.
 2006: Visited site 09/12/06.

Downstream view of Site. Progressing pocket erosion visible.

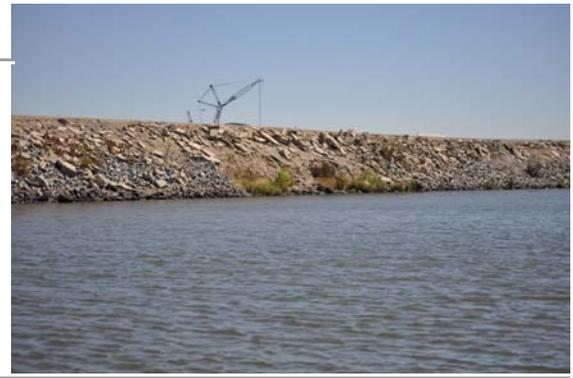
8/7/2012: The erosion is next to a repaired site and approximately 400 feet downstream of a river bend. There are broken concretes at the upper levee slope, but not visible at the levee toe or lower slope. Likely the protection concrete blocks have been washed away

Downstream view of the site.

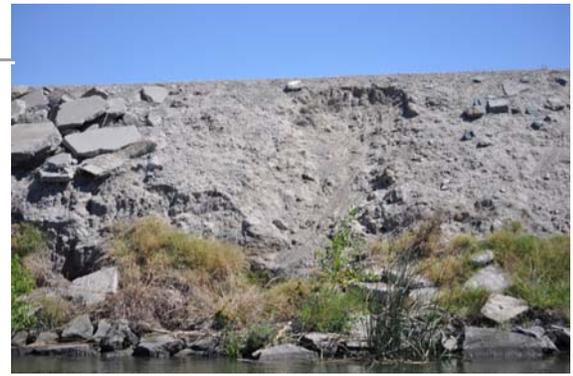
08/07/2012: The site was first discovered by levee inspector in the spring inspection. Levee slope was protected with broken concrete blocks, but those blocks have been washed away during high flows.

Front view of the erosion. Note the slumping erosion at upper slope.

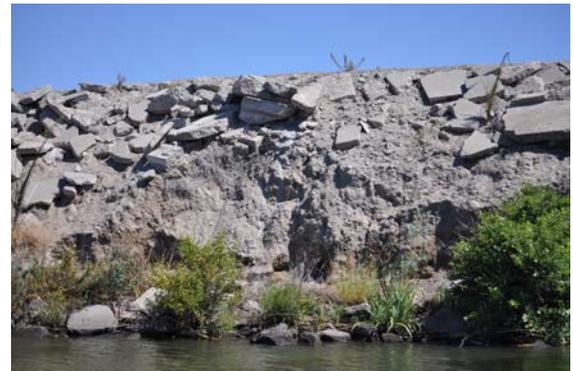
Front view of erosion. Note the broken concrete blocks at the slope.

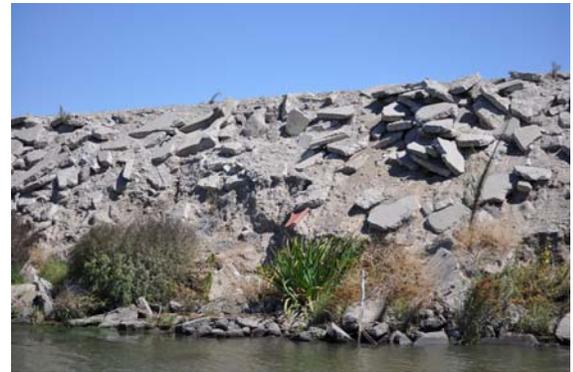
Front view of the erosion.

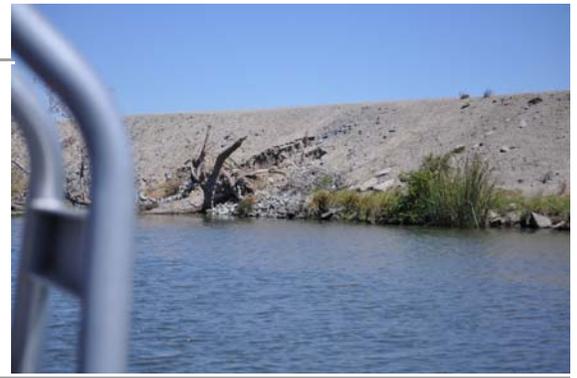
08/07/2012: The rootball of a fallen tree removed material from the levee. Immediately action needed to remove the fallen tree trunk and repair the damage.

Upstream view of the site

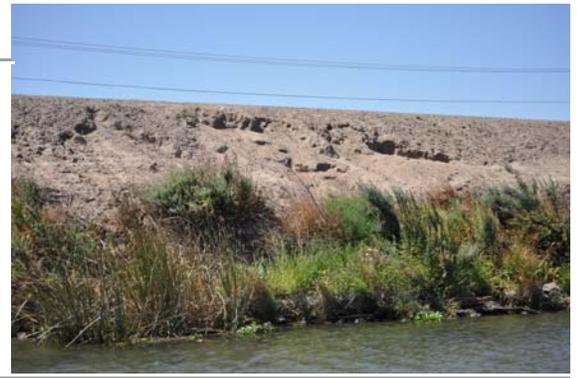
8/7/2012: Erosion is at the upper levee slope, and likely caused by slope slip. The lower levee slope is covered with dense vegetation.

Front view of erosion site. Note the vegetation at the levee toe and lower slope

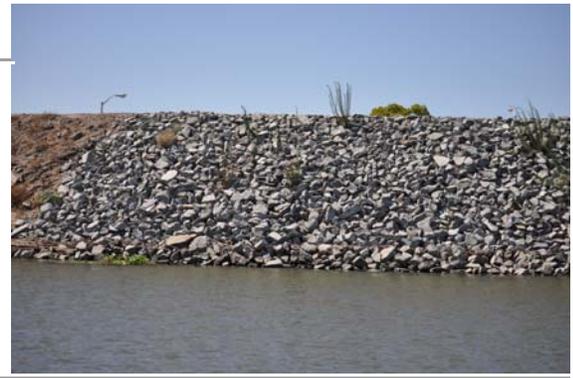
08/07/2012: The site has been visited by boat survey. The site seems to have been repaired.
 08/23/2011: No significant changes observed on site.
 09/07/2010: No significant changes observed on site. Some emergent vegetation at the lower and middle slope. Existing revetment is no longer adequately protecting the oversteepened slope. Some of the broken concrete used as revetment has slid, dragging levee materials away from the slope and creating notches.
 09/29/2009: Erosion site extends from RM 41.11 to 41.18; existing revetment is no longer adequately protecting the oversteepened slope.
 2008: Existing concrete slabs were placed as temporary fix; some of the slabs have started to slide, dragging levee materials away from the slope and creating notches; note that a sewage treatment plant is located on the landside of the levee.

Direct view of the site.

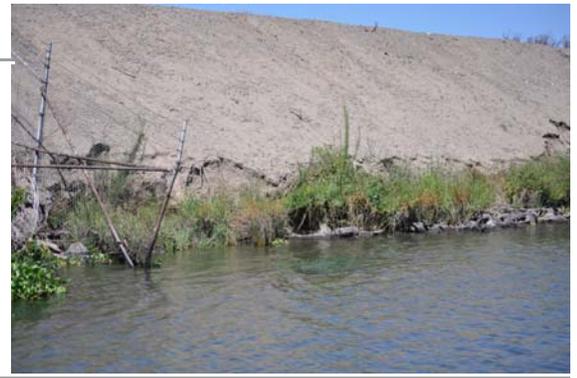
08/07/2012: The site has been visited by boat survey. No significant change observed
 08/23/2011: The site is located immediately upstream of a Railroad bridge. Dense vegetation at the water line interferes the view of erosion.

Upstream view of the erosion site. Note the railroad bridge.

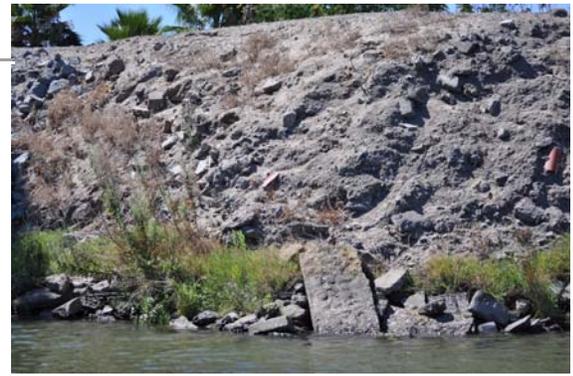
08/07/2012: The site has been visited by boat survey. Site has been repaired, but new erosion occurred at the levee slope and immediately upstream of the repaired site.
 08/23/2011: The site is about 500 ft downstream of bridge. The levee toe seems to be protected, but the protection is being washed away.

Close view of site. New minor erosion developed at the levee slope erosion.

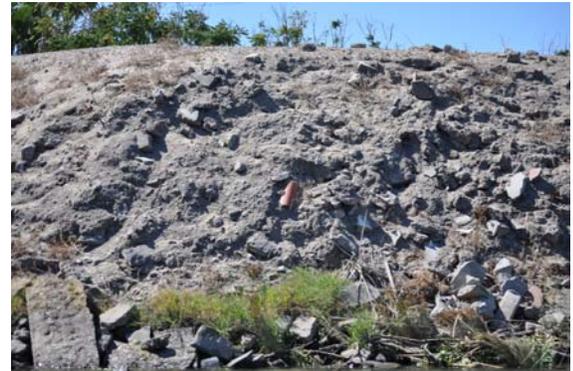
Close view of the erosion. The protection has been loosened and washed away.

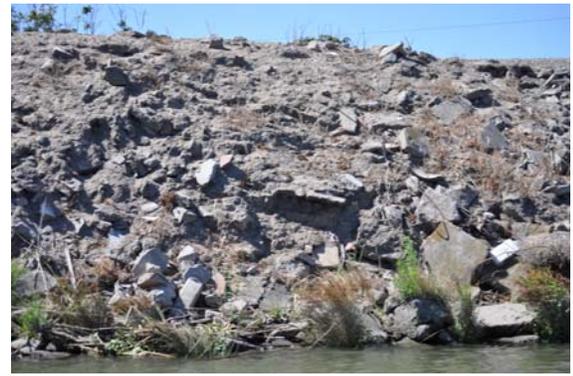
Front view of the site

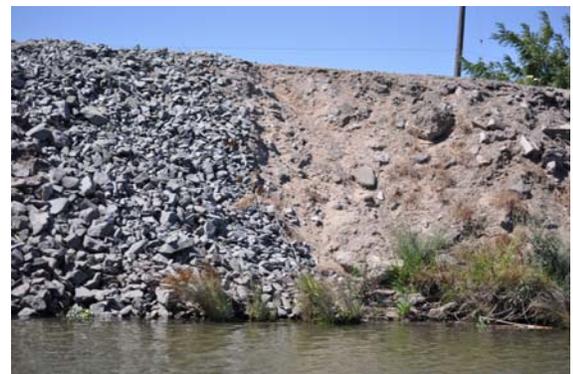
Front view of the erosion. New erosion has developed immediately upstream of the repaired site,

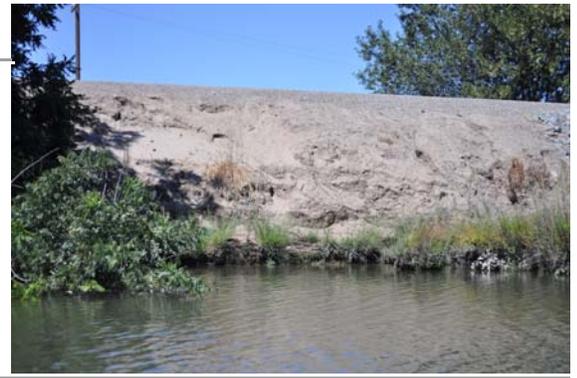
08/07/2012: The site has been visited by boat survey. No significant changes observed
 08/23/2011: No significant changes observed on site.
 9/07/2010: No significant changes observed on site. Some emergent vegetation at the water line. There is an exposed pipe discharge partially hanging at the mid-slope, possibly still used for discharging irrigation/runoff water. There is minimal rip rap protection along the bank, and what's left of it is no longer adequately protecting the bank.
 9/29/2009: Site consists of a 400-foot long eroding bank with minimal vegetation and protection; the existing rip rap has sloughed, rendering it useless; note that there is an exposed section of a pipe.
 10/18/2006: There is extensive loss of rip rap on some sections; sewage disposal pond is on the landside of the levee; there is an exposed pipe outlet "hanging" from the upper slope.

Direct view of the site.

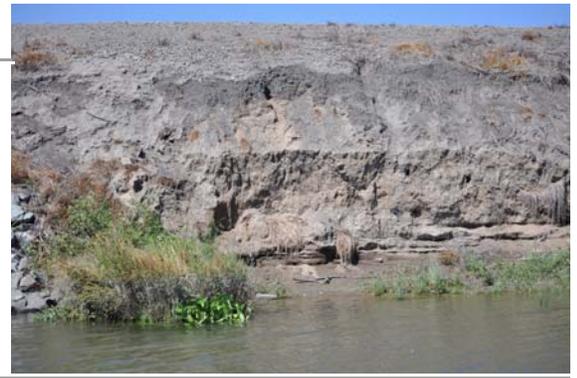
08/07/2012: The site was first reported in 2012 spring levee inspection report.

close view of the erosion

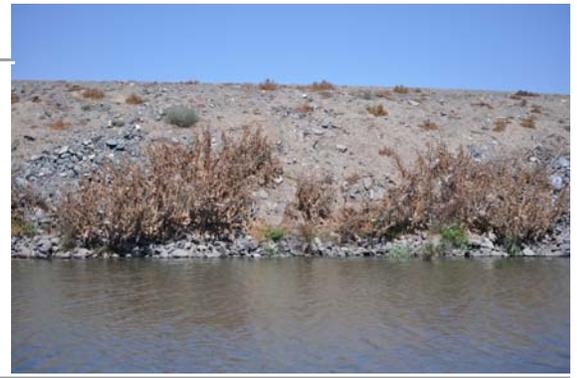
08/07/2012: The site was first reported in 2012 spring levee inspection report. The site is located about 750 ft downstream of SR 4 Bridge.

Upstream view of the erosion

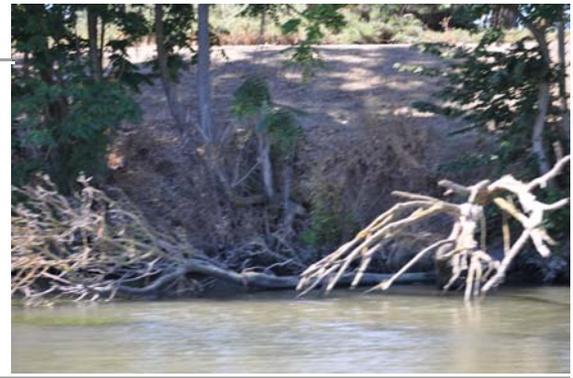
08/07/2012: : The site has been visited by boat survey. No significant change observed
 08/23/2011: No significant changes observed on site. Trees concerned still in place.
 09/07/2010: No significant changes observed on site. The concern here is the undermining of the levee toe where most of trees are. There are erosion pockets lined along the lower slope and at the base of the trees, exposing tree roots. There is minimal slope protection.
 09/29/2009: The lower slope is lined with minor erosion pockets; some tree roots are exposed; there is visible undermining of the levee toe; site is immediately upstream of the Highway 4 Bridge; the bridge is possibly causing a scour to occur, eroding the bank.

Front view of the site where undermining has occurred.

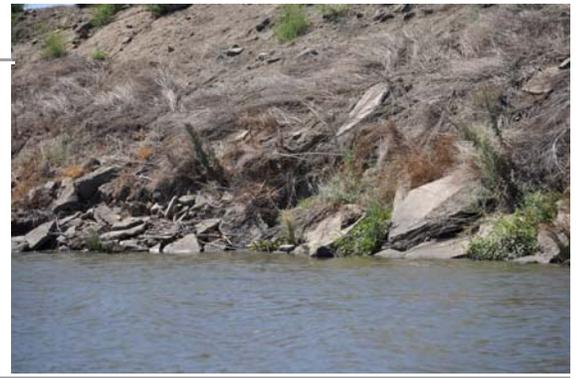
08/07/2012: The site was first reported in 2012 spring levee inspection report.

Close view of the pocket erosion

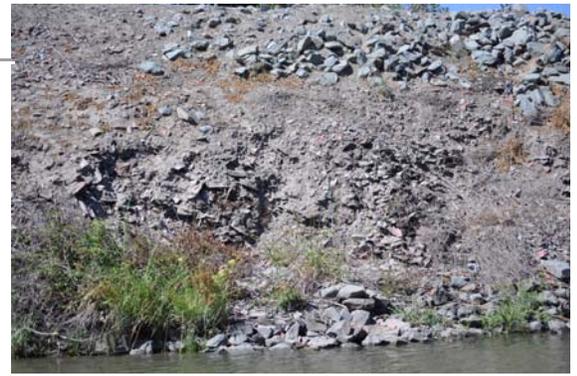
08/07/2012: The site was first reported in 2012 spring levee inspection report. The site is located at the inside corner of a river bend.

Close look of the site.

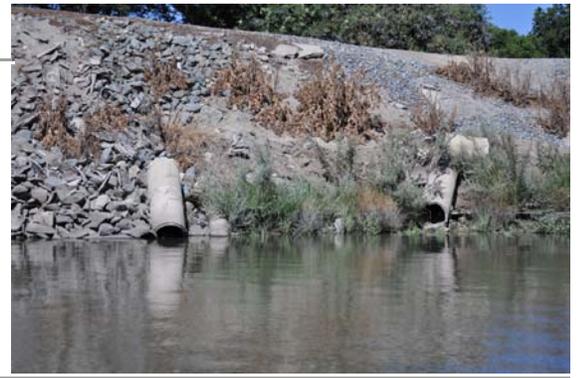
08/07/2012: The site was first reported in 2012 spring levee inspection report.

Upstream view of erosion

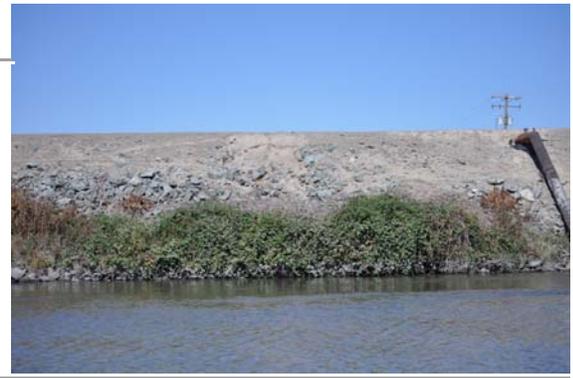
08/07/2012: The site was first reported in 2012 spring levee inspection report.

Front view of erosion

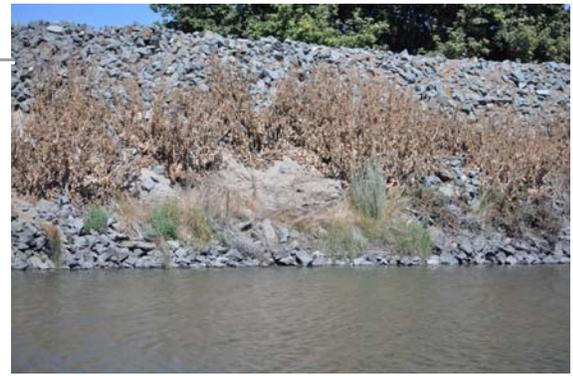
Comments:
 08/07/2012: The site has been repaired. Protecting riprap revetment has been placed at the levee shoulder and slope, but minor erosions are visible at the levee toe.
 08/23/2011: Sloughing rip rap is visible on the site

Direct view of the site.

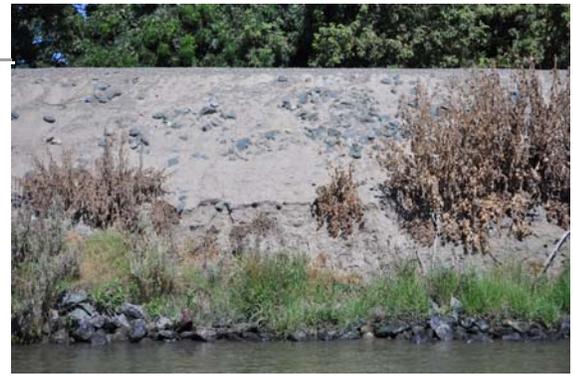
08/07/2012: The levee toe has been cut off along a 150ft long river stretch. The erosion is located just upstream of a river bend.

Front view of erosion

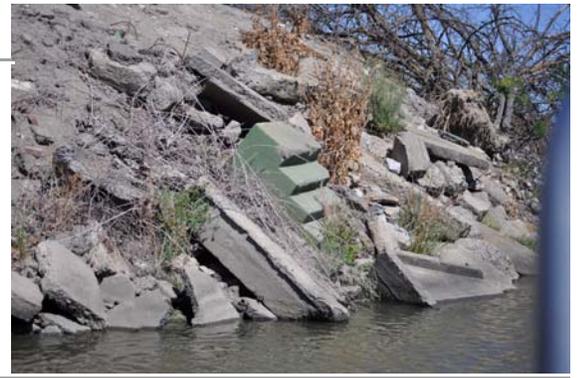
08/07/2012: Erosion is located at the inside of a river bend. Site is covered with broken concrete blocks and other debris.

Front view of the site. Note the loosely placed concrete blocks.

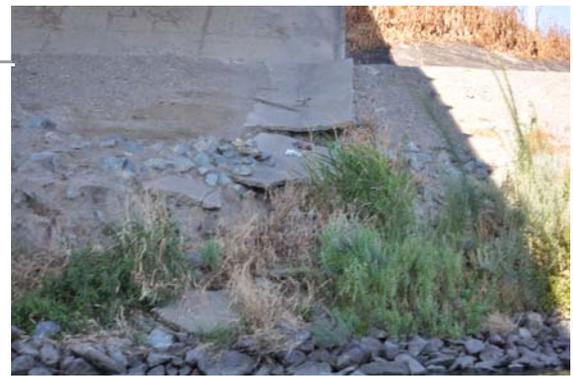
08/07/2012: : The site has been visited by boat survey. No significant change observed
 08/23/2011: No significant changes observed on site.
 09/07/2010: No significant changes observed on site. Erosion site is located beneath Howard Road Bridge. Majority of the existing rip rap has slipped, dragging away levee materials and exposing the underlying soft soil.
 08/06/2010: Recommend for annual assessment and monitoring during flood events, per CLRO.
 09/30/2009: No major changes observed since the last visit; upper portion of existing revetment has slipped, exposing the degrading bank; note that site # is the same as RM46.30, LM5.69 found in the CLRO CES Evaluation 2008 Report; site was previously rated "M".
 11/04/2008: Previously repaired using rock revetment; upper portion of th revetment is sliding, causing deformation on the levee slope; site is upstream of Howards Road Bridge.

Sloughing rip rap just below the Howard Bridge abutment.

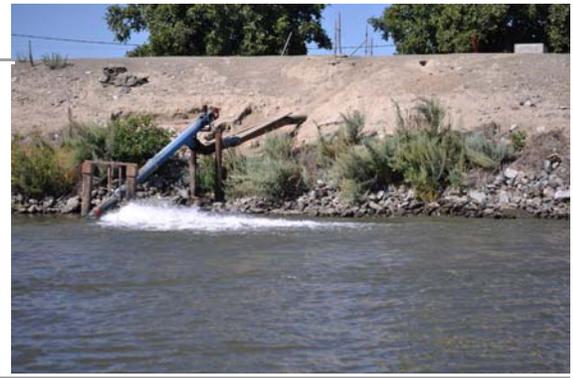
08/07/2012: The erosion is near a water-intake structure. Pipe leakage likely caused the erosion.

Front view of the site

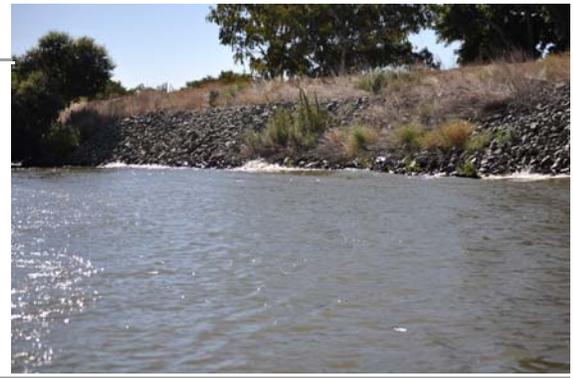
08/07/2012: :The site has been visited by boat survey. The site has been repaired with riprap protection. Rotten tree roots and minor erosion visible immediately upstream of the site
 08/23/2011: No significant changes observed on site.
 09/07/2010: No significant changes observed on site. There are minor pockets of erosion lining the lower slope and undermining of the toe. There are annual grasses and emergent vegetation at the lower slope. Burrow holes were observed along the slope and persist throughout the 200-foot long site.
 08/05/2010: Recommended for annual assessment and monitoring during flood events, per CLRO.
 09/30/2009: No major change observed since last visit; despite dense vegetation, the bank continues to erode and slough; the levee toe is being undermined; note the tree on site; the site was previously rated "U".
 10/21/2008: Undermining of the levee toe; rodent holes in several location; trees with roots partially exposed; sloughing on slope.

Upstream view of the repaired site

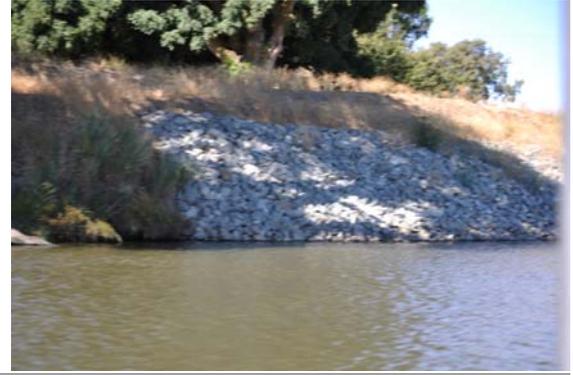
Front view of the repaired site

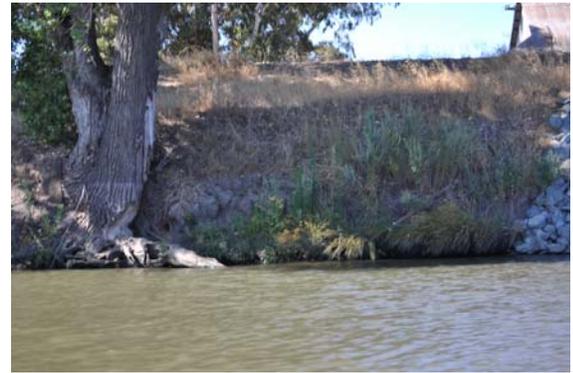
Front view of the site. Rotten tree roots and minor erosion visible immediately upstream of the site

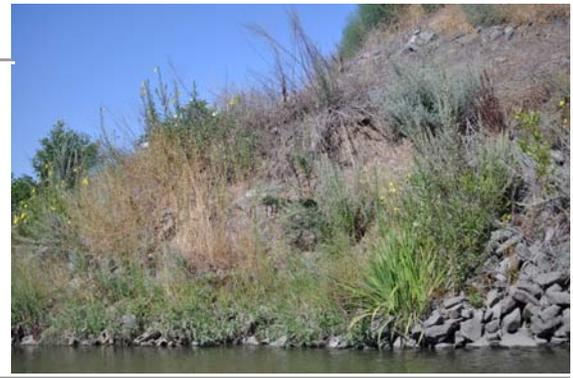
08/07/2012: Erosion is right at the inside of a river bend. Dense vegetation visible at the site.

Front view of erosion

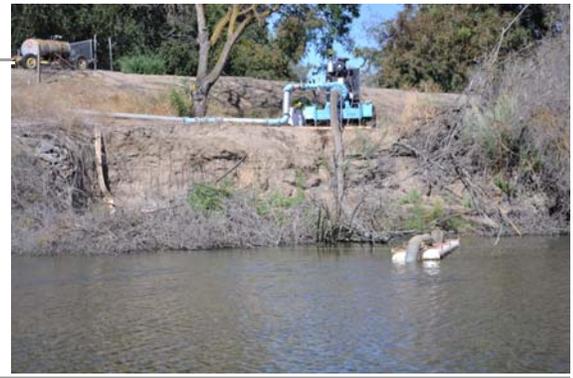
08/07/2012: Erosion is immediately upstream of a river bend. Dense vegetaion is visible at the erosion site.

Front view of the erosion. The pumping machine unlikely the cause of the erosion.

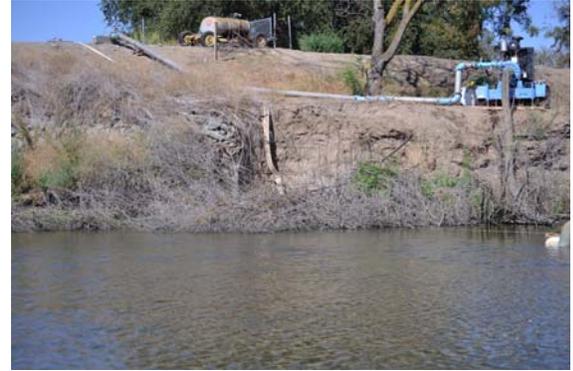
Front view of the site. Note the dense vegetation and rocks immediately upstream of the erosion

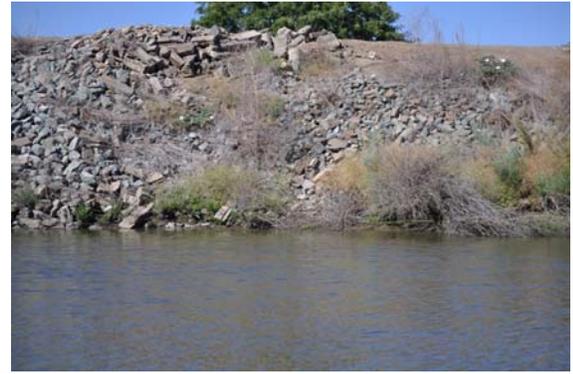
Upstream of the site is protected by rocks and broken concrete

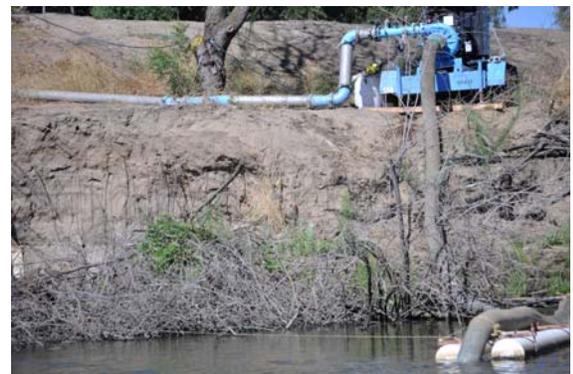
Close view of the site

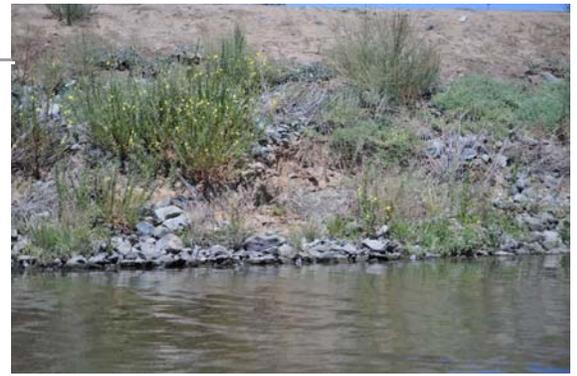
08/07/2012: Series of pocket erosion were discovered at the levee toe during the boat survey. The area is covered with vegetation and riprap rocks, but the rocks have been washed away.

Front view of pocket erosion. Note the vegetation and riprap rocks at the site

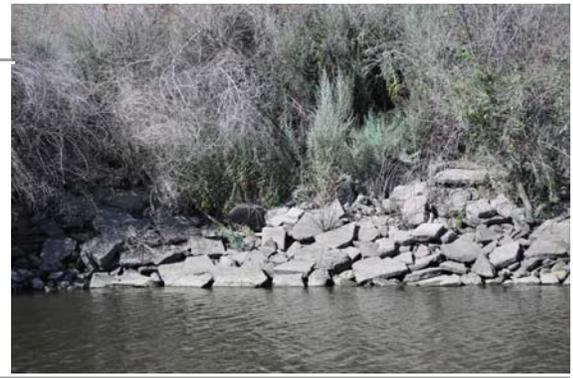
08/07/2012: The site has been visited by boat survey. No significant change observed
 08/23/2011: No significant changes observed on site. Vegetation on the slope. There is a bridge construction site just upstream of the erosion. The impact of the construction may need to be monitored.
 09/07/2010: No significant changes observed on site. Sloughing of the existing rip rap revetment on the lower slope has developed into an erosion pocket. There is moderate annual grass growth on the slope.
 08/06/2010: Recommended as local maintenance issue, per CLRO.
 03/09/2010: Per Michael Moncrief of MBK, site is scheduled for repair this year.
 2009: Landside ground surface has been raised to the height of the levee crown; sloughing of the existing rip rap revetment on the lower slope that has created a pocket, exposing underlying soil; Site # is the same RM54.34,LM1.08; previously rated "M".
 2006: Previously marked with stake.

Front view of the erosion site

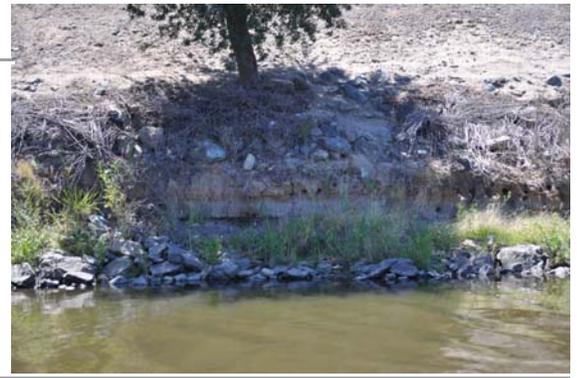
08/07/2012: The site has been visited by boat survey. No significant change observed
 08/23/2011: Site is at the upstream of a drainage ditch.

Front view of erosion

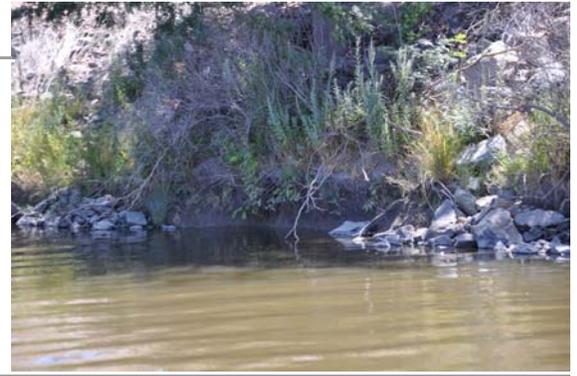
08/07/2012: The site has been visited by boat survey. No significant change observed
 08/23/2011: The protection at the levee toe has been washed away.

Direct view of the site. The erosion is vertical

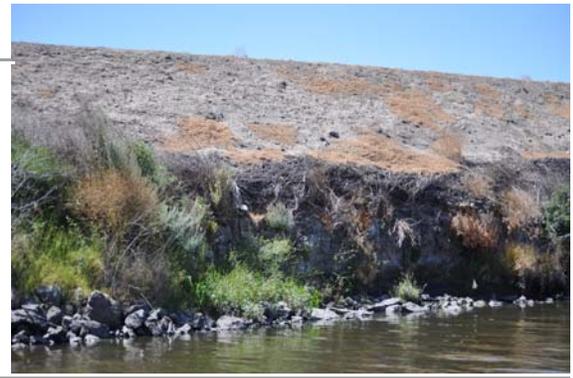
11/05/2008: Top of vertical scarp has rip rap that appears to be sliding; rodent holes; existing toe rip rap.

Front view of the 5-ft vertical scarp .

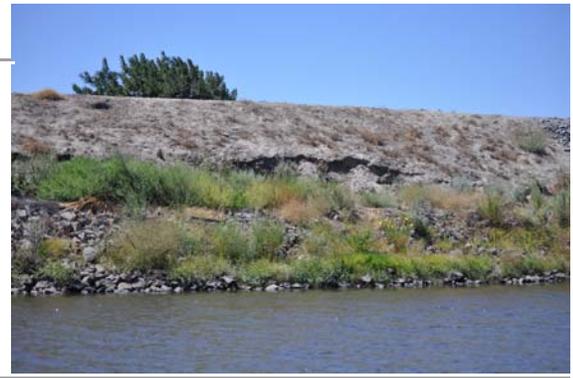
09/14/2006: 1-2' into prism.

Front view of the site. Existing scalloped erosion is immediately downstream of rip rap section.

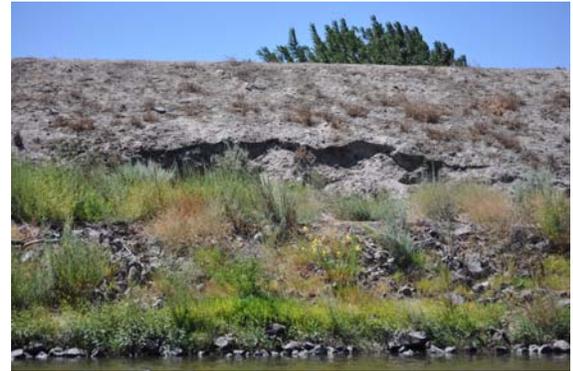
Front view of the site. Note the lateral crack along the middle slope

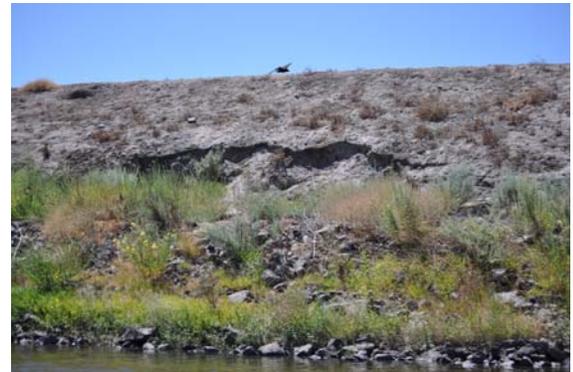
Front view of the site just above existing rip rap.

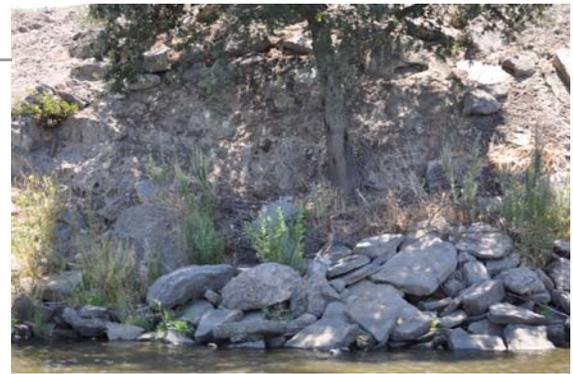
Close view of the site where a small to medium sized Oak tree is located.

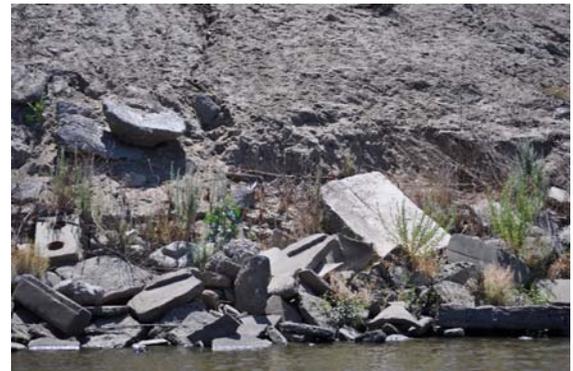
Front view of the site. Note existing broken concrete on the upper slope as well as on the lower slope and at the toe.

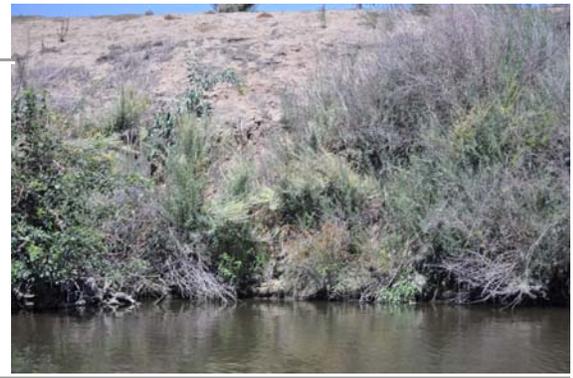
Front view of the site. The scarp is visible on the slope.

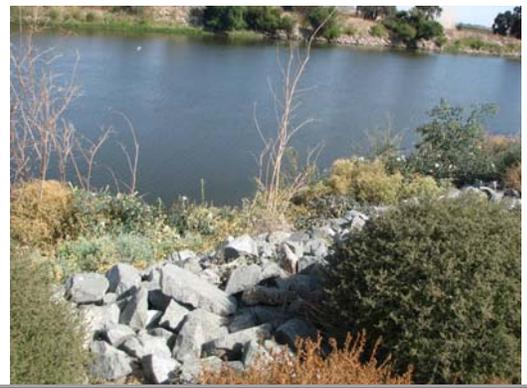
View from levee slope. The dense vegetation on the site block the view of the erosion
