**State of California
The Resources Agency
DEPARTMENT OF WATER RESOURCES**

**2005
PROJECT CHANNEL REPORT**

**INSPECTION OF
FLOOD CONTROL PROJECT CHANNELS ON THE
SACRAMENTO AND SAN JOAQUIN RIVERS AND
THEIR TRIBUTARIES AND THE TRUCKEE RIVER**

**Prepared By The
Flood Operations Branch
Flood Project Inspection Section**

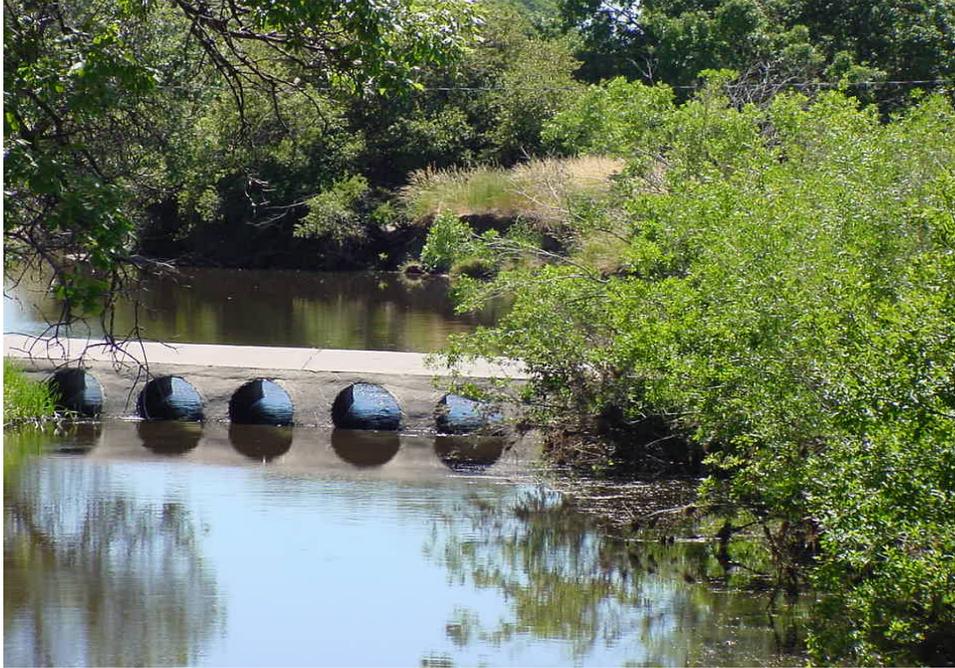
Downstream from Ash Street, moderate tree growth and bank erosion

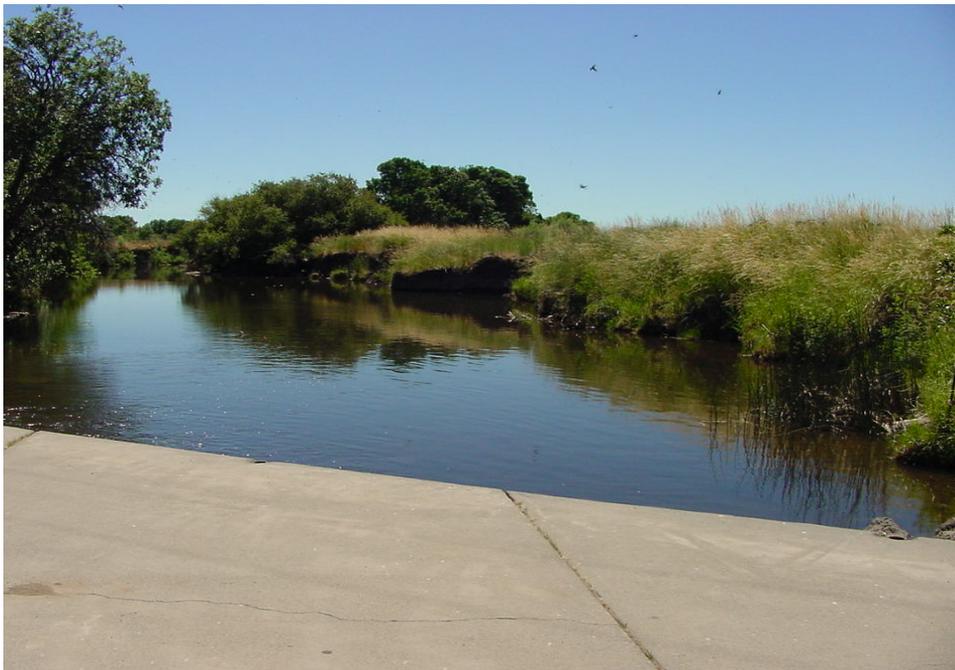
Downstream at a sharp left bend moderate erosion on both banks

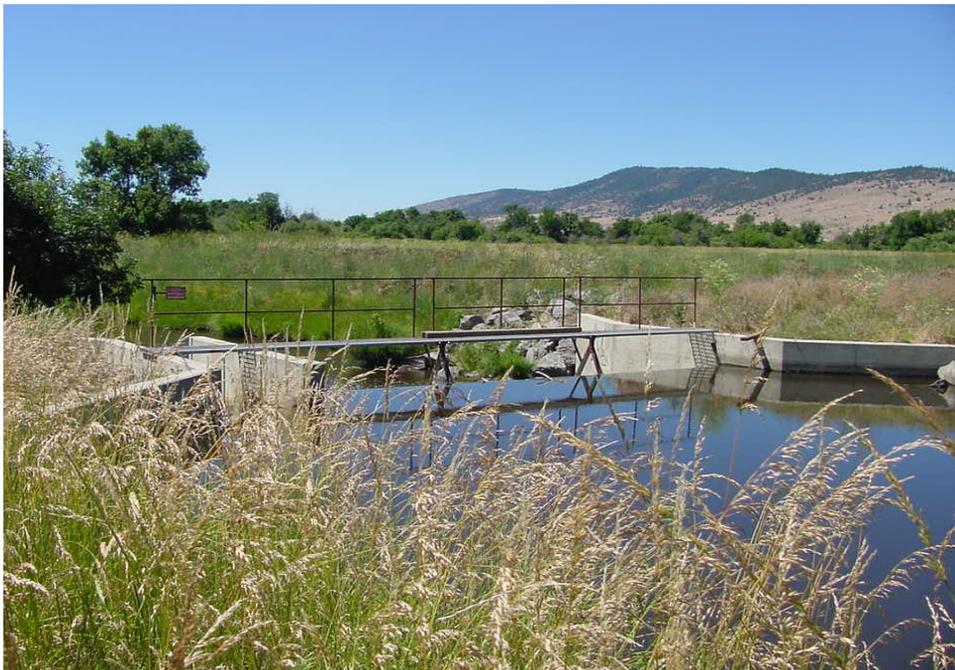
Dam with fish ladder and metal walkway, constructed Oct. 1999 by the Dept. of Fish and Game

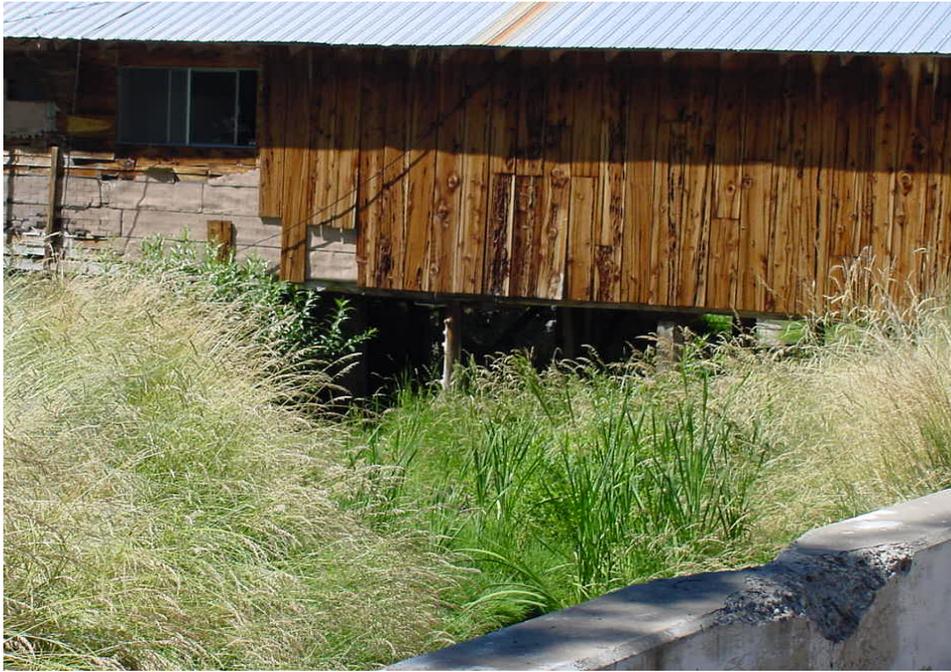
Downstream from Main Street (Highway 299), moderate growth in channel

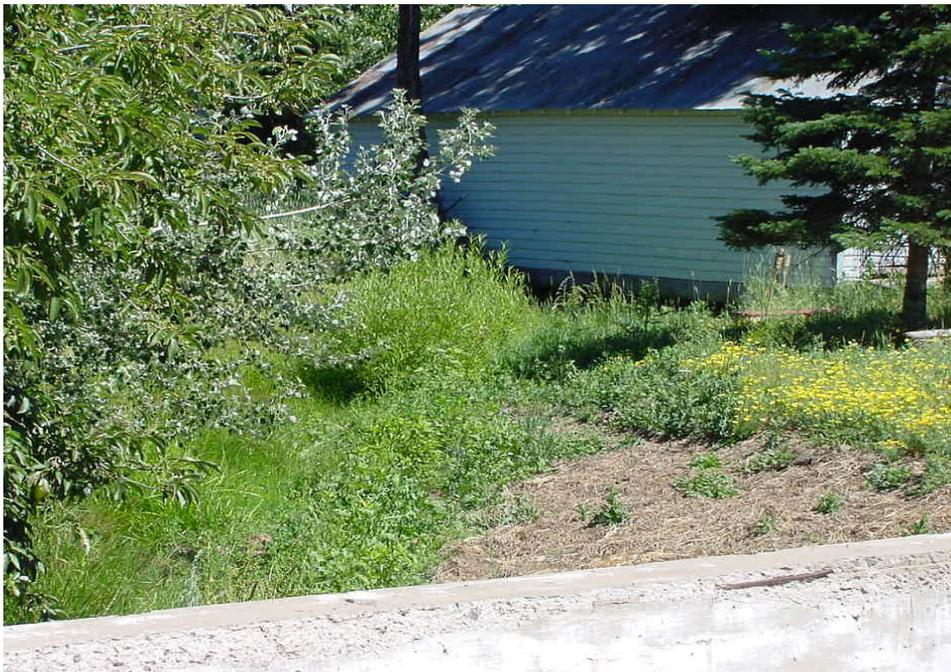
Upstream from Main street (highway 299), moderate growth in channel

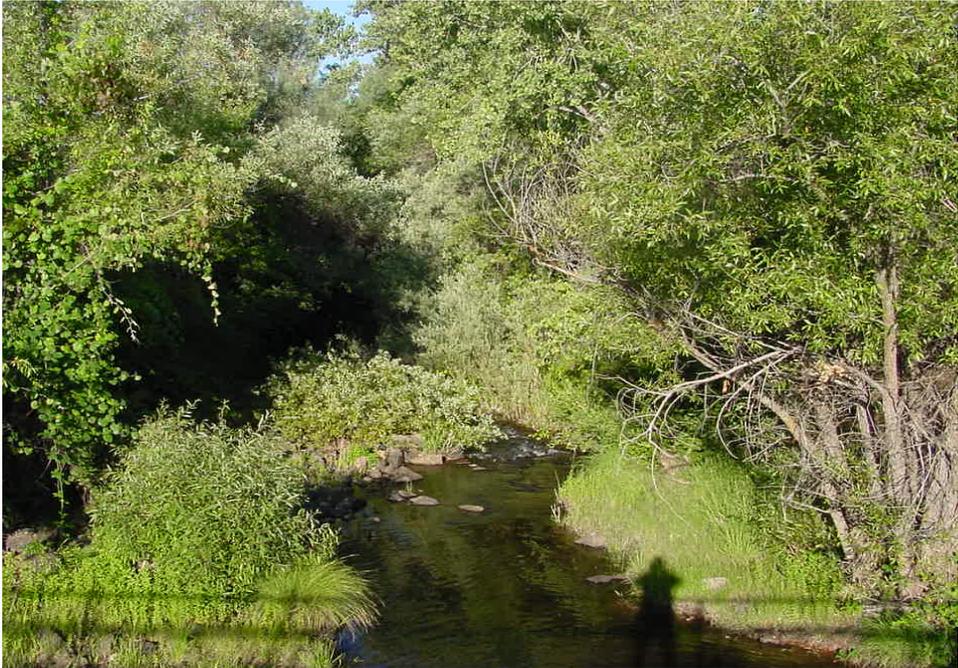
**Downstream from the control structure on Little Chico Creek
moderate growth in the channel**

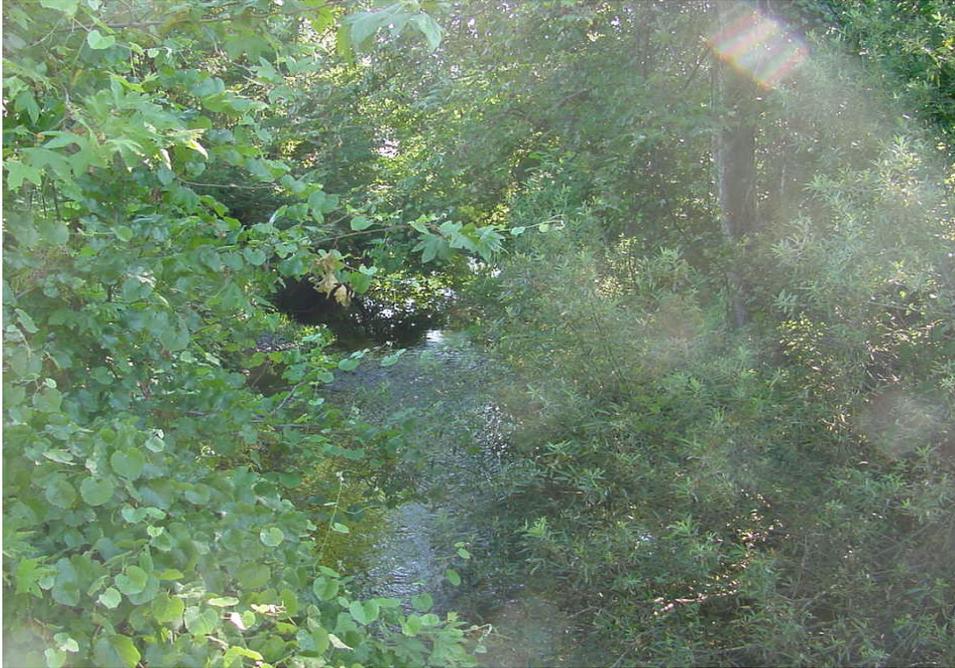
Upstream from Boucher Street. Dense growth on both banks

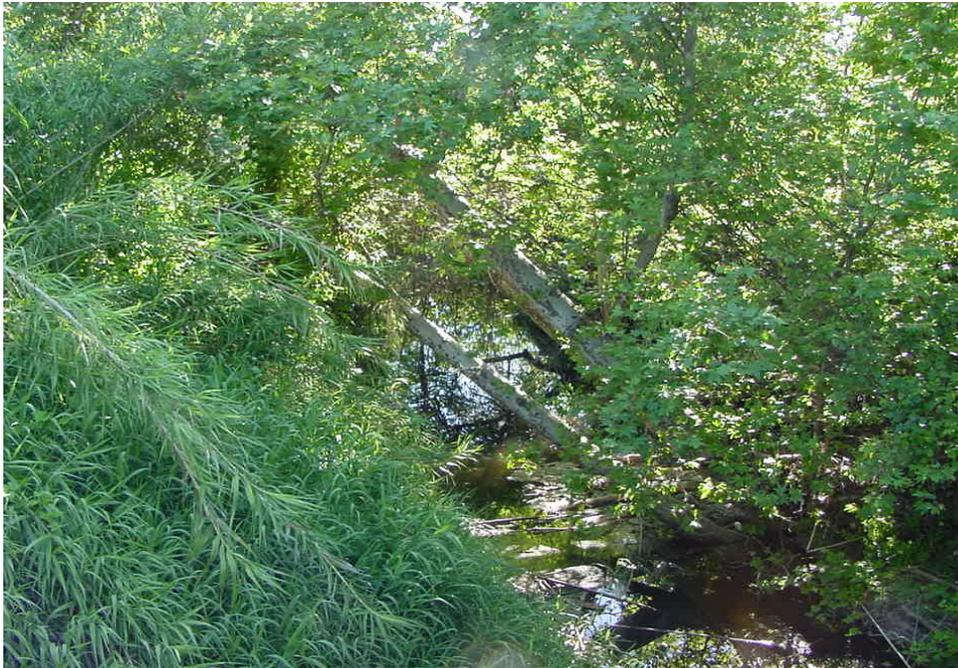
Downstream from Mill Street. Dense growth on both banks

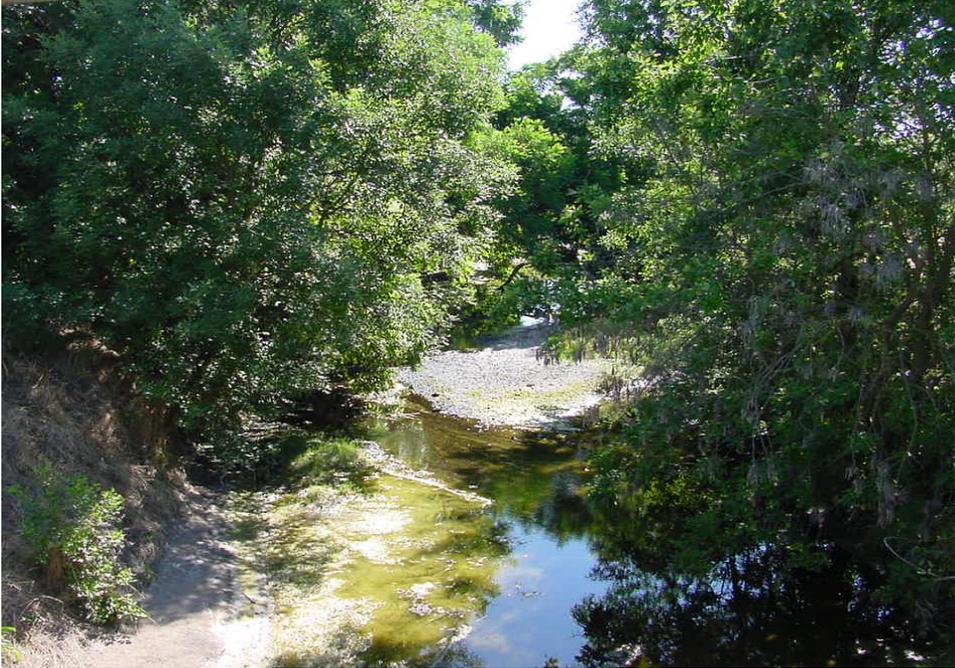
Upstream from Alberton Avenue Scouring on left bank and in channel

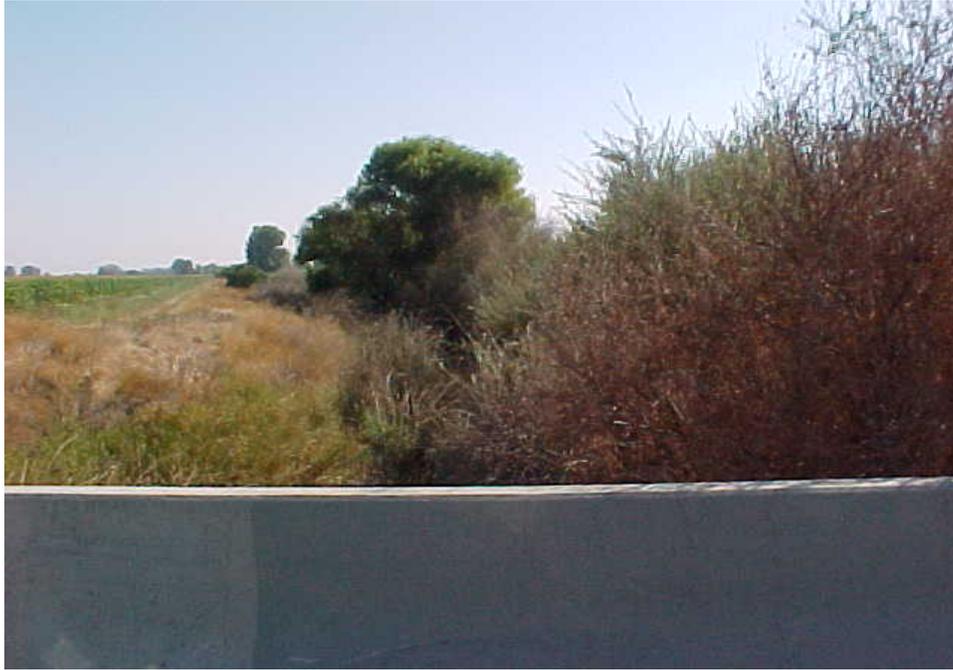
**Upstream from Highway 59.
The channel is overgrown with wild growth**
