**State of California  
The Resources Agency  
DEPARTMENT OF WATER RESOURCES**

**2007  
PROJECT CHANNEL REPORT**

**INSPECTION OF  
FLOOD CONTROL PROJECT CHANNELS ON THE  
SACRAMENTO AND SAN JOAQUIN RIVERS AND  
THEIR TRIBUTARIES AND THE TRUCKEE RIVER**

**Prepared By The  
Flood Operations Branch  
Flood Project Inspection Section**

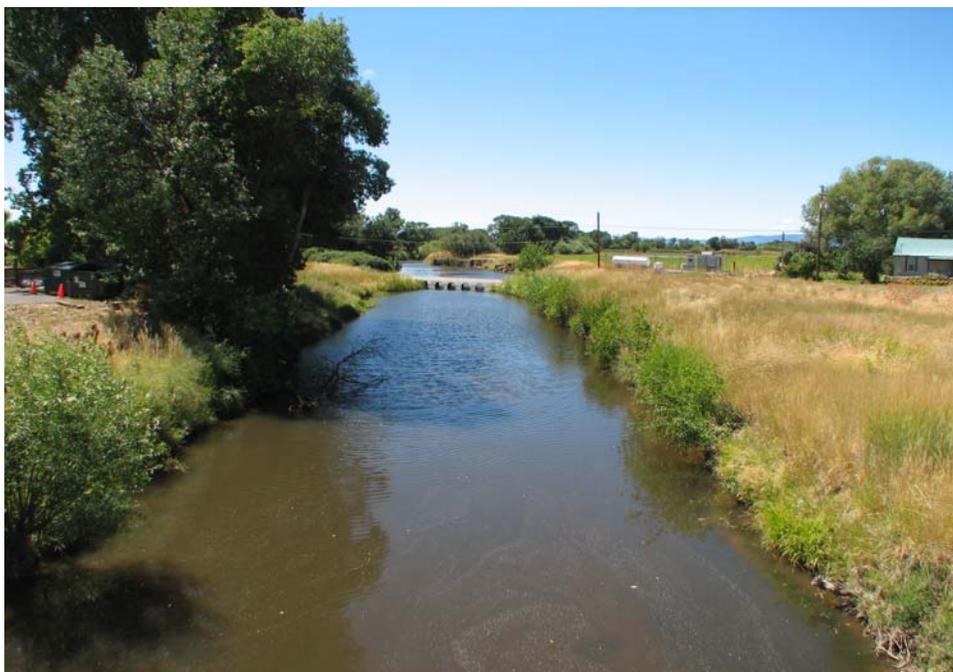
**Downstream from Main Street (Hwy. 299) at the Ash St. low water crossing**

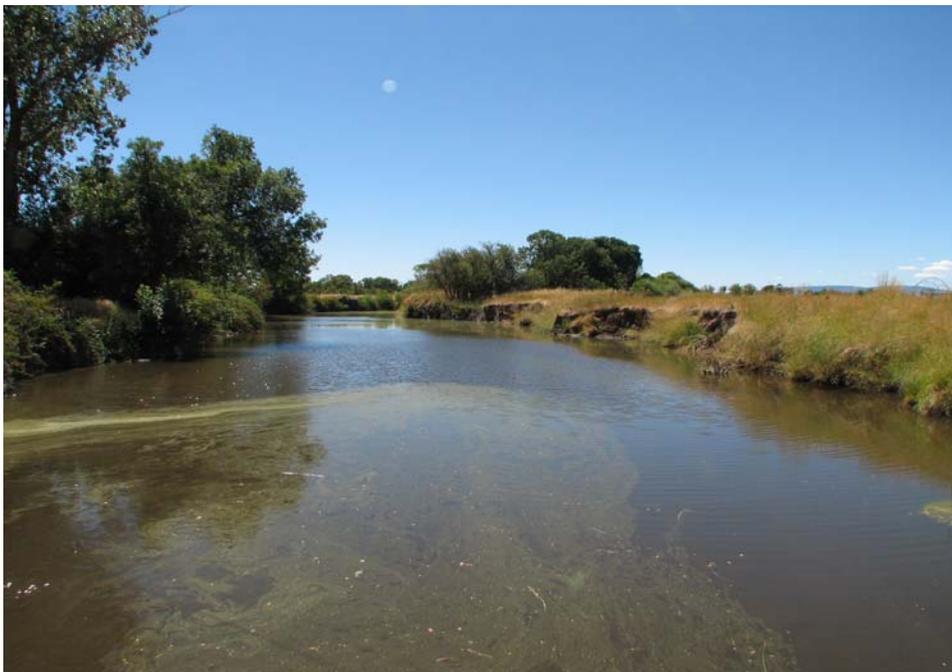
**Downstream at a sharp left bend moderate erosion on both banks**

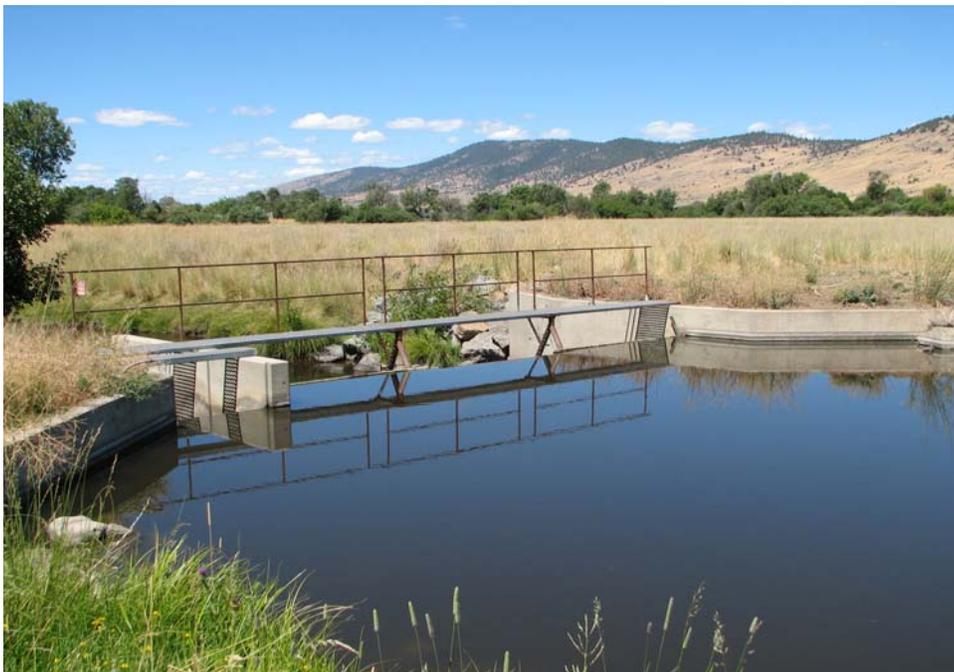
**Dam with fish ladder and metal walkway, constructed Oct. 1999 by the Dept. of Fish and Game**

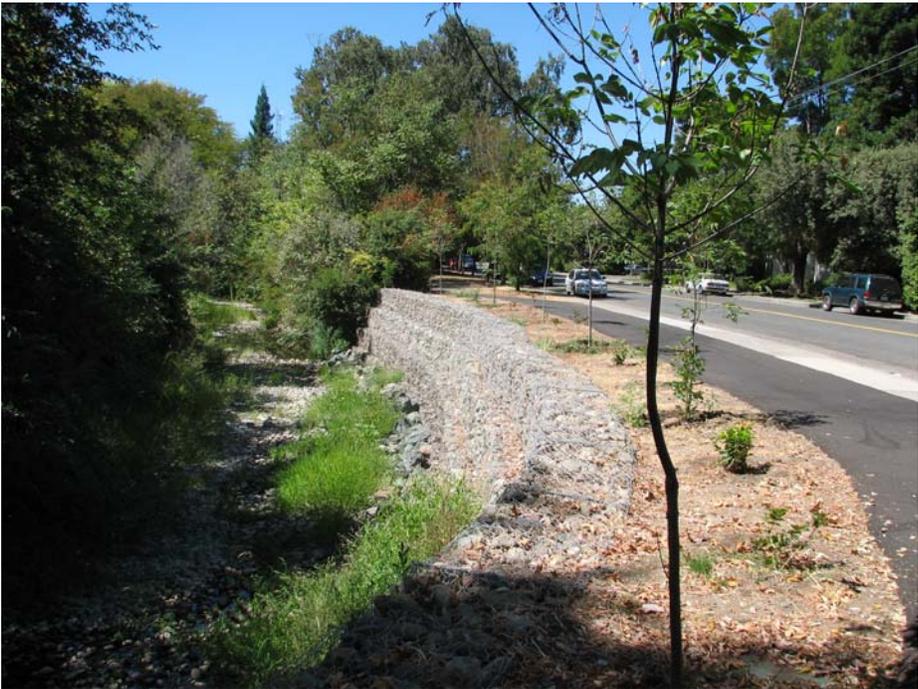
**Erosion repair site, upstream of Highway 99**

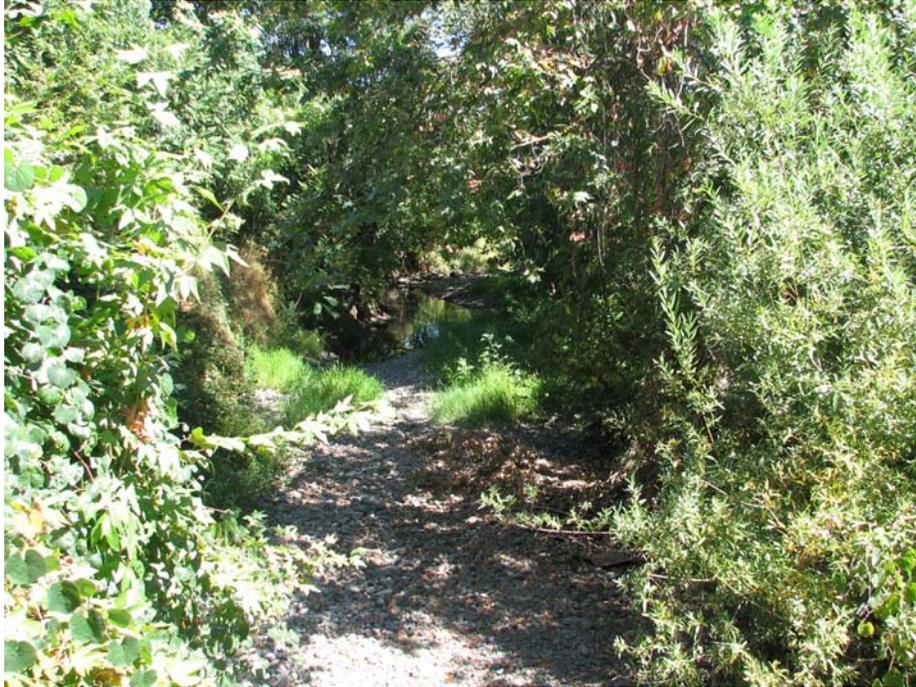
**Upstream from Boucher Street. Dense growth on both banks**

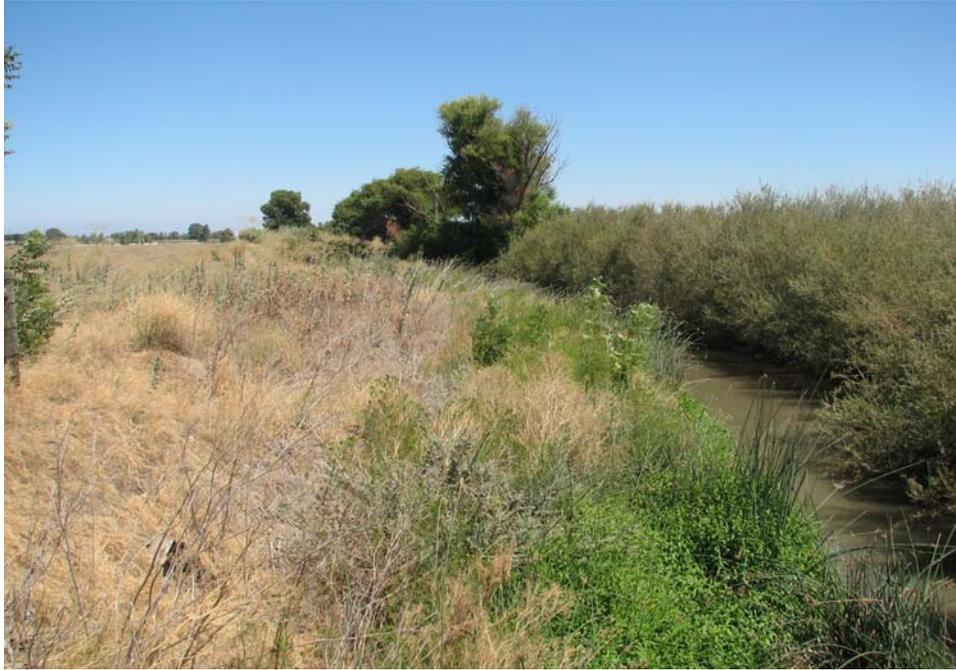
**Upstream from Highway 59.  
The channel is overgrown with wild growth**

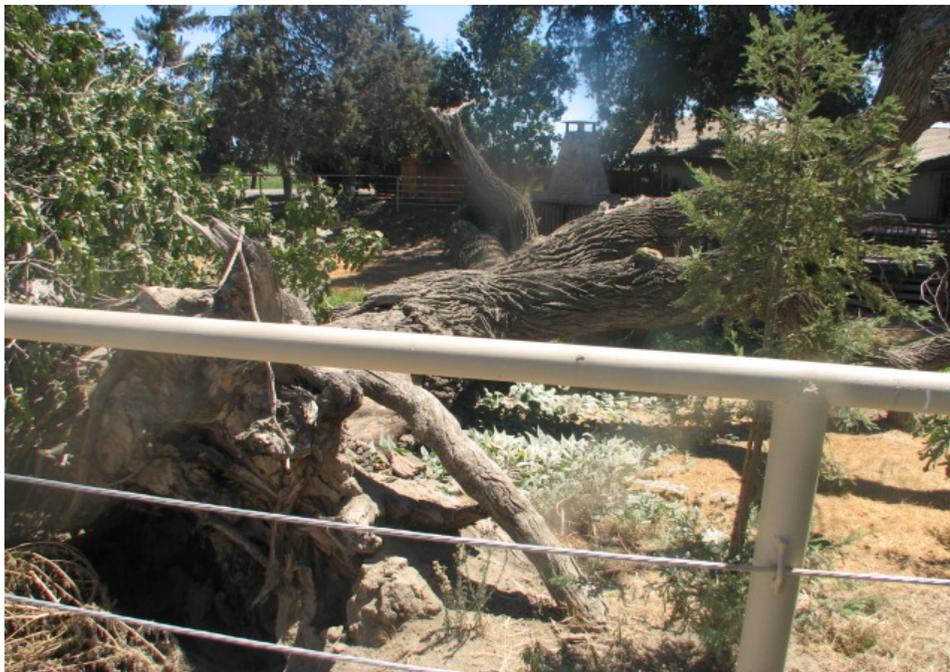
**Down tree across channel upstream of Road 11 (GPS 37.12673 -120.33671)**

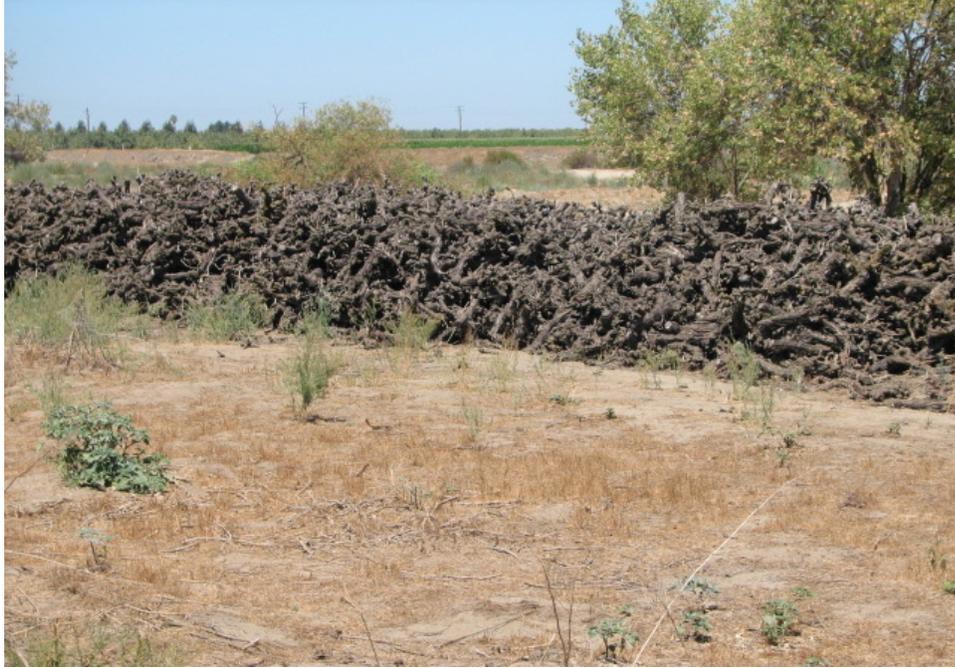
Downstream from Granada Avenue Farmer has stocked piled grape stalk cuttings  
(3) piles, 9-foot wide 3-4 foot high 2-250' parallel to channel.
