State of California
The California Natural Resources Agency
Department of Water Resources
Division of Flood Management

2011
INSPECTION REPORT
OF THE
CENTRAL VALLEY STATE-FEDERAL
FLOOD PROTECTION SYSTEM

PUBLISHED IN DECEMBER 2011

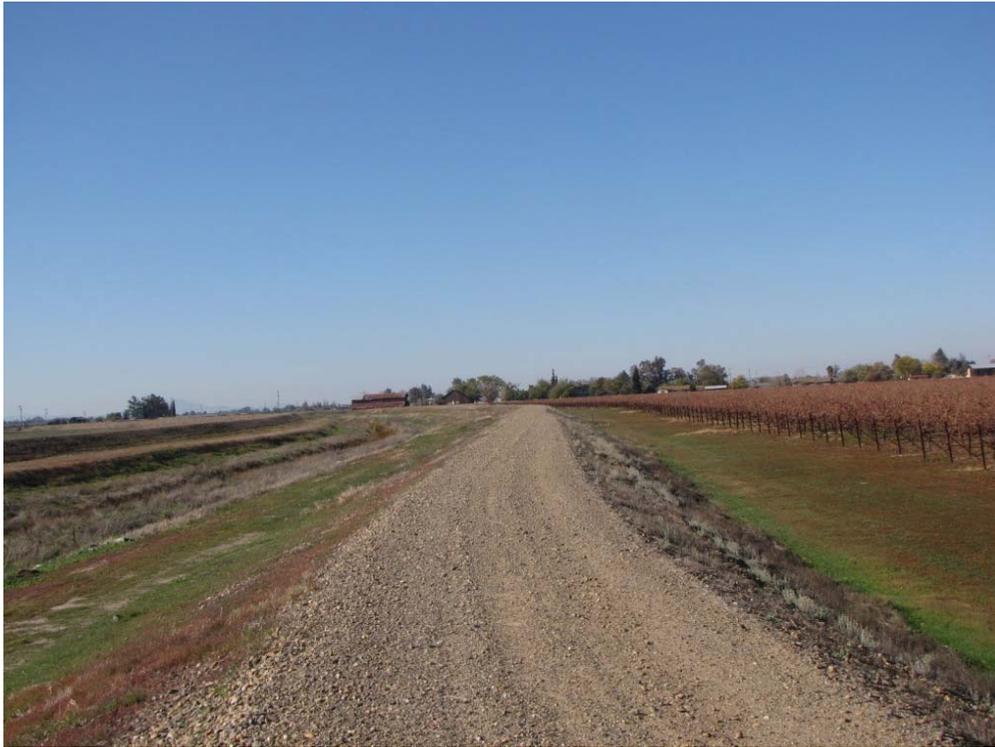
Acceptable Vegetation Maintenance: Good grass coverage with no grass or brush over 12" tall

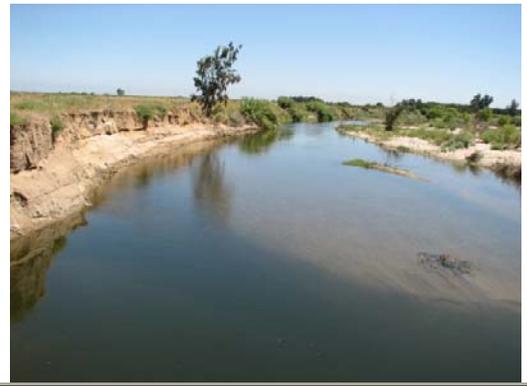
08/16/2011: The erosion is cutting into the levee. The site is located at the outside of a river bend, and the erosions were caused by river flows during the last flooding season. The ground was covered by dense grasses. Animal burrow holes are visible.

The tree in the image marks the starting point of this erosion site.

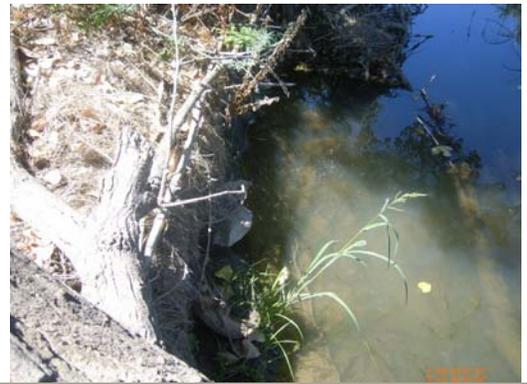
08/09/2011: Site was inspected. No visible change was observed from the previous condition. A fallen tree was seen at the levee toe about 20 feet upstream, and tree root exposed. There has been no report from the district that this site was corrected.
 11/30/2010: Site was not inspected due to time constraints. There have been no reports from the district that the site was corrected. Continue to monitor site during flood events.
 08/05/2010: Recommended for annual assessment and monitoring during flood events, per CLRO.
 2009: Site is recommended as a local maintenance issue, per Critical Levee Repair Office, Critical Erosion Sites Evaluation 2008 Report; site was previously rated "M"
 9/6/2007: Undercutting of the toe; several trees along the WS slope with roots exposed.

Close-in view at the erosion site

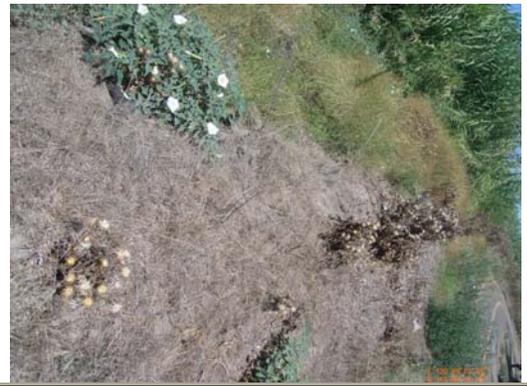
08/09/2011: Site was inspected. No visible change was observed from the previous condition. There have been no reports from the district that this site was corrected.
 11/30/2010: Site was not inspected this year due to time constraints. There have been no reports from the district that this site was corrected. Continue monitor during flood events.
 08/05/2010: Recommended for annual assessment and monitoring during flood events, per CLRO.
 2009: Site is recommended as a local maintenance issue, per CLRO CES Evaluation 2008 Report; it was previously rated "M".
 8/26/2008: Undulating waterside slope surface; vehicular damage along the waterside slope possibly caused by farming equipment; levee crown is composed of sandy material; there is a collection of concrete rubble on the waterside crown hinge; vehicular damage extends from levee toe to crown surface.
 9/6/2007: Farmer degraded levee on waterward slope and crown.

Close look at the site

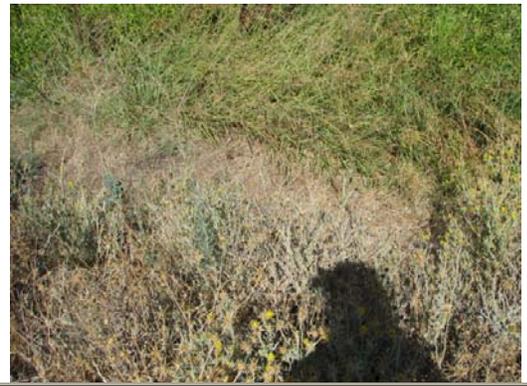
08/16/2011: No visible change. 100 percent vegetation coverage with star thistles. Minor cracking visible on the waterside slope.
 11/30/2010: Site was not inspected this year due to time constraint. There have been no reports from the district that this site was corrected. Continue to monitor during flood events.
 2009: Site is recommended as local maintenance issue, per CLRO CES Evaluation 2008 Report; it was previously rated "U".
 8/26/2008: Terracetting erosion; frequent livestock traversing the slopes has caused deformation of the waterside levee slope.
 9/11/2007: GPS extended from opposite bank using Google Earth.

A close look at the site, which is covered by thick star thistles.

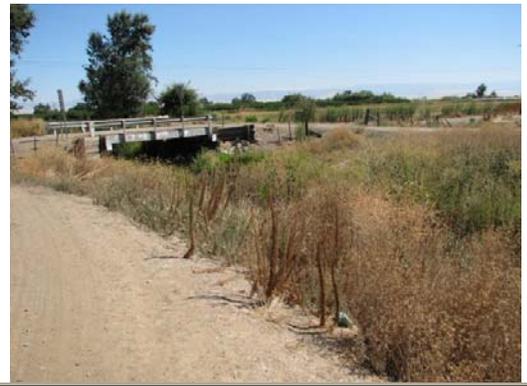
08/16/2011: No visible change. 100 percent vegetation coverage with star thistles. Minor cracking visible on the waterside slope. Burrow holes visible.
 11/30/2010: Site was not inspected this year due to time constraint. There have been no reports from the district that the site was repaired. Continue to monitor during flood events.
 2009: Bank erosion scour that is immediately downstream of Mission Avenue bridge; noticeable terracetting damage from livestock traversing the slope; site is recommended as local maintenance issue, per CLRO Evaluation 2008 Report; site was previously rated "M".
 8/26/2008: Terracetting damage from livestock; there is now a pocket erosion developing on the levee toe; site is 100 feet downstream of Mission Avenue bridge.

The site is covered with dense thistles.

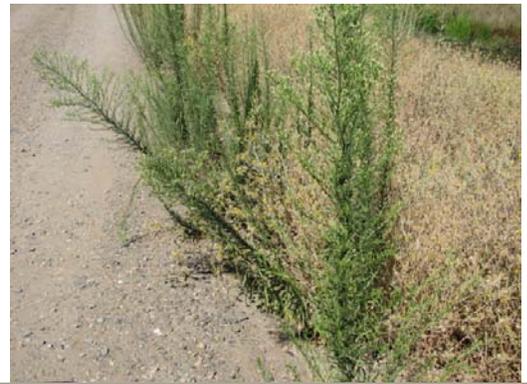
08/16/2011: No significant change was visible. Minor cracking on the waterside levee slope was spotted. 100 percent vegetation coverage with star thistles.
 11/30/2010: Site was not inspected this year due to time constraints. There have been no reports from the district that the site has been corrected.
 2009: Site recommended as local maintenance issue, per CLRO CES Evaluation 2008 Report; previously rated "U".
 9/10/2007: GPS extended from opposite bank using Google Earth; signs of vehicular damage on levee.

The site is covered with dense star thistles. No significant changes visible

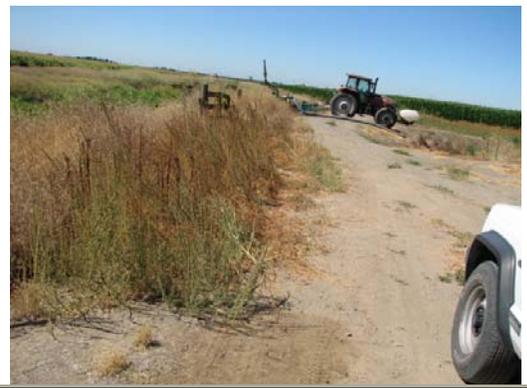
08/16/2011: No visible significant changes. 100 percent vegetation coverage with star thistles. Minor cracking visible on the waterside slope.
 11/30/2010: Site was not inspected this year due to time constraints. There have been no reports from the district that the site has been corrected.
 2009: Site is recommended as local maintenance issue, per CLRO CES Evaluation 2008 Report; terracing damage from livestock traversing; there is a wooden platform installed on site; landside is on high ground; site was previously rated "M".
 9/10/2007: GPS extended from opposite bank using Google Earth; GPS on file is correct.

The site is covered with thick vegetation

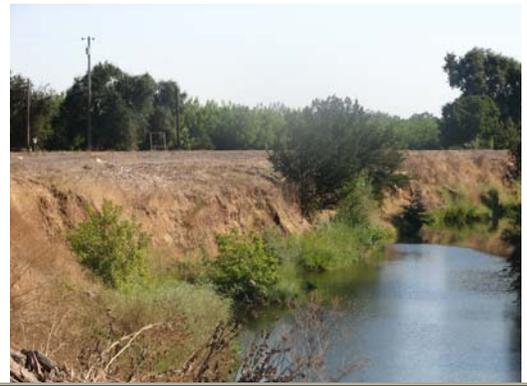
09/02/2011: No significant changes observed on site.
 11/02/2010: No significant changes observed on site. The mile-long erosion continues to degrade the bank. There are a few trees along the mile-long stretch on the lower bank slope that are affected by the scarp. WS Levee Slope was changed to 2:1. As a result, normalized score increased from 62 to 65.
 08/05/2010: Recommended for waterside repair, per CLRO; "water velocity is a major factor for accelerating bank slope erosion."
 8/12/2009: Near-vertical bank erosion; degrading channel is incising the banks; recommend annual assessment and monitoring of critical erosion site, per CLRO CES Evaluation 2008 Report; district is monitoring site for changes in condition; site was previously rated "U".
 2007: Visited site 02/06/2007; possible critical site.

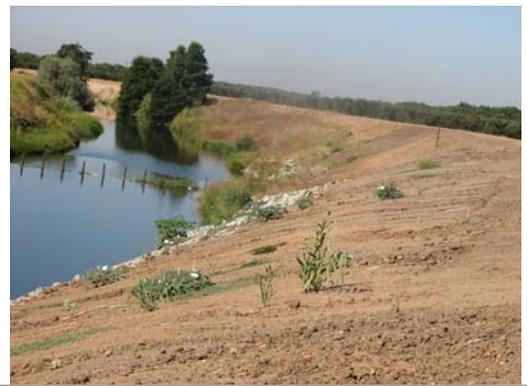
09/02/2011: Site was repaired in 2011 summer by the district. Needs to monitor during the next flood season for performance. The site was previously rated "U".
 11/02/2010: No significant changes observed on site. Bank erosion extends approximately 100 feet downstream and 250 feet upstream of the drop structure.
 8/12/2009: No major change observed; erosion is upstream and downstream of drop structure; bank erosion is associated with high velocities; it is recommended for annual assessment and monitoring of critical erosion site per CLRO CES Evaluation 2008 Report; it was previously rated "U".
 2007: Visited site 02/06/2007.

Looking at the repaired site upstream of the drop structure.

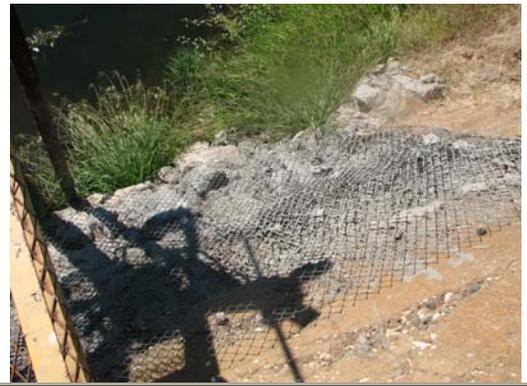
09/02/2011: Site was fixed in April 2011 by the district. Suggest continue to monitor performance during flooding. The site was previously rated "M".
 11/02/2010: No significant changes observed on site. Upon further inspection, it appears that a slab of aging concrete lining on the bank slope has slipped, possibly due to a weakend subsoil layer. Fissure cracks have developed and now extend outward from where the initial slip occurred. Erosion of the subsoil layer could further weaken the bank and intrude into the levee prism. It could also affect the stability of the pump structure.
 8/12/2009: Downward creep of the soil that was possibly caused during pipe installation; erosion is between 2 to 3 feet cut into the bank; vertical pump inlet is located adjacent to erosion; District personnel Jay Howdigi and Jim Caruso were present during the site visit.

Looking down at the repaired site.

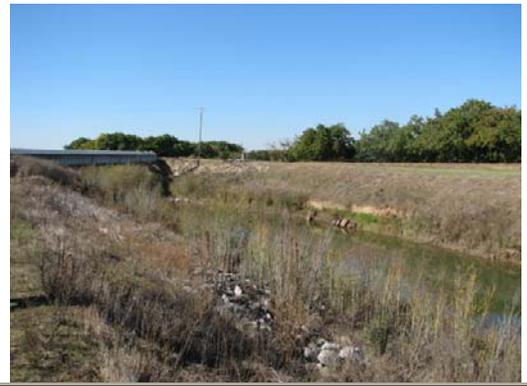
09/02/2011: Found no erosion resembling the one pictured in the 2009 Report.
 11/02/2010: Upon review of the site, we found no erosion resembling the one pictured in the 2009 Report. Our team went upstream and downstream of the GPS location and did not find any erosion as described and pictured in the 2009 Report. There is, however, a scarp on the bank that is approximately 20 feet long and a 30 feet wide berm. This item will be removed from the inventory. Site was previously rated "M".
 8/12/2009: Near-vertical scarp on the slope; note that levee is on high ground.

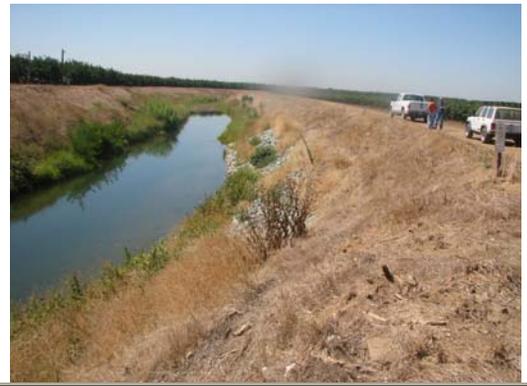
09/02/2011: A pocket erosion was found downstream of the repaired site. The pocket erosion is at the lower slope of the levee, with a size of approximately 5ft long and 3 ft in height.
 11/02/2010: The site has been repaired by the district. It was previously rated "M."
 8/12/2009: Erosion is incising into the levee; a pipe outlet is located on the levee toe; there are traces of concrete lining originally placed over the WS slope; landside is on high ground; inspect for pipe condition.

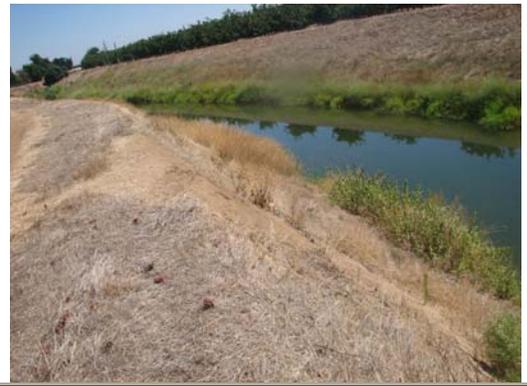
09/02/2011: No sign of new erosion activities found.
 11/02/2010: Site has been repaired by the district. It was previously rated "M."
 8/11/2009: Near-vertical cut of 1 to 2 feet into the levee along lower 1/2 slope; Note that landside is on high ground.

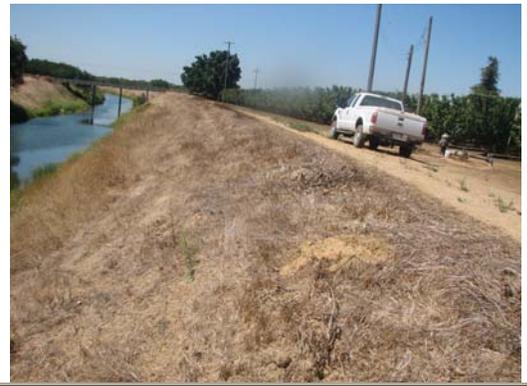
08/12/2009: Localized erosion; sloughing at the lower slope; minor pocket erosion developing.

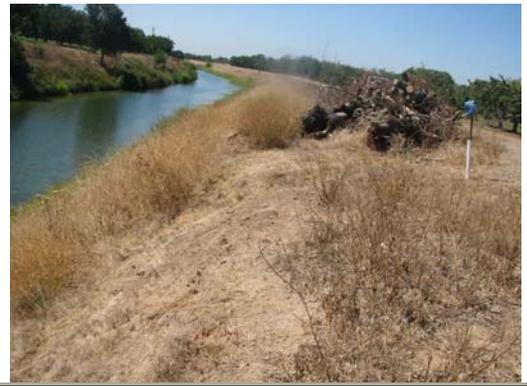
09/02/2011: A minor pocket erosion was found at the toe upstream of the repaired site. The erosion is clearly visible from the levee top, and looks stable, covered with vegetation.
 11/02/2010: Erosion site has been repaired by the district. It was previously rated "M."
 8/12/2009: Scarp with varying height of 1 to 5 ft; landside is on high ground; erosion occurs just downstream of rip rap section; at the time of survey, there were burn piles at various location along the waterside levee slope.

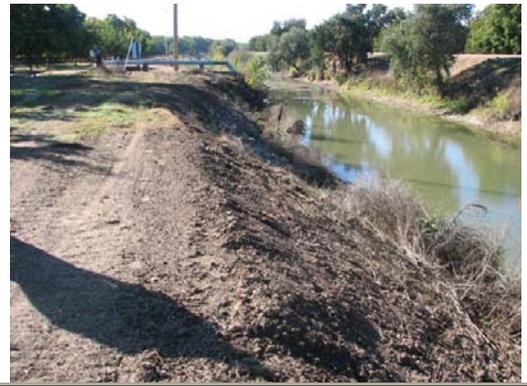
09/02/2011: No sign of new erosion activity.
 11/02/2010: Erosion site has been repaired by the district. Site was previously rated "M."
 8/12/2009: Differential settlement of 1 to 2 feet; erosion appears to be a shallow slide caused by undercutting; settlement has carved into the crown; area adjacent to site was recently repaired for burrow den activity on the lower slope; rocks were placed on the repair site.

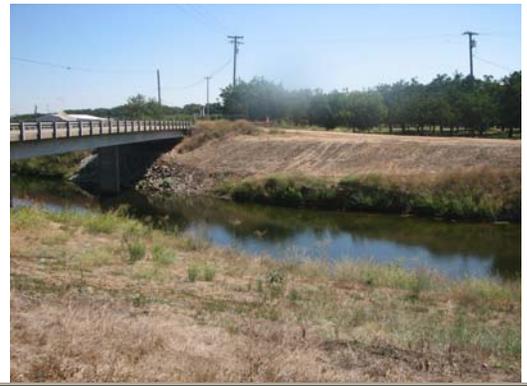
09/02/2011: The site has been repaired by the district. The site was previously rated "M".
 11/02/2010: No significant changes observed on site. Bridge scour has created a pocket erosion, exposing a portion of the underlying concrete padding.
 8/11/2009: Site is adjacent to abutment on Milton Road Bridge; pocket erosion has developed and will continue to expose the bridge foundation; this erosion appears to be critical as it may affect the bridge foundation.

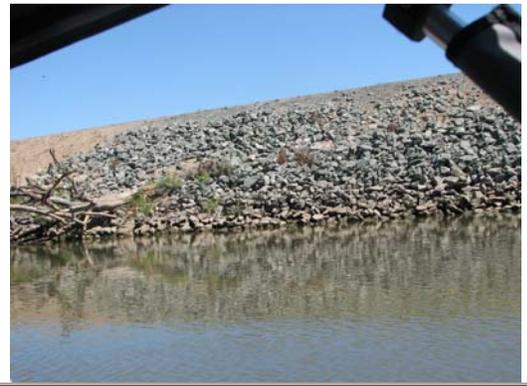
08/23/2011: Repaired site shows no new signs of erosion. Vegetation and dead trees visible on the site.
 9/07/2010: Site appears to have been repaired by using shot rock as revetment along the lower slope. There are some emergent vegetation at the water line. Site was previously rated "M".
 9/29/2009: Undercutting of the toe just above the existing rip rap; note there is housing development on the landside of levee (refer to Aerial Atlas).

Vegetation and dead trees visible on the site.

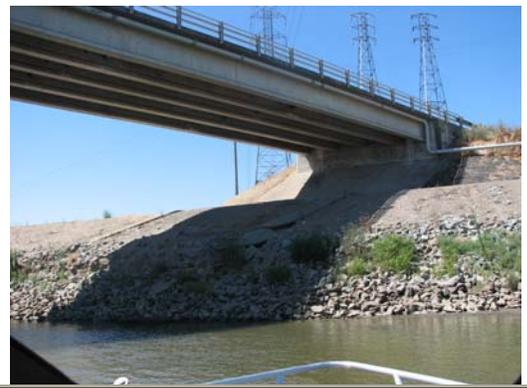
08/23/2011: The repaired site shows no sign of new erosion activity. Vegetation visible on the site.
 9/07/2010: Site has been repaired. Shot rock was placed on site. Site was previously rated "M".
 9/29/2009: Pocket erosion just below and across the abutment of Howard Road Bridge; existing toe rip rap and concrete slabs in place; erosion may develop into a larger pocket erosion if no corrective action is taken.

Direct view of the repaired site. Vegetation visible on site.

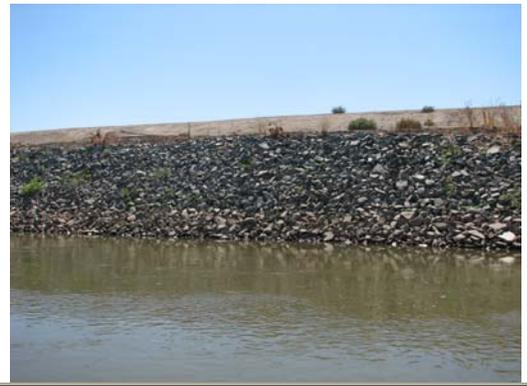
08/23/2011: The repaired site shows no sign of new erosion activity. Vegetation visible on the site.
 9/07/2010: Site has been repaired by placing shot rock as revetment. Site was previously rated "M".
 9/28/2009: A 50 feet section of the lower slump has slumped just above existing rip rap; there is also a rip rap protection along the levee toe.

Direct view of the repaired site. Vegetation visible

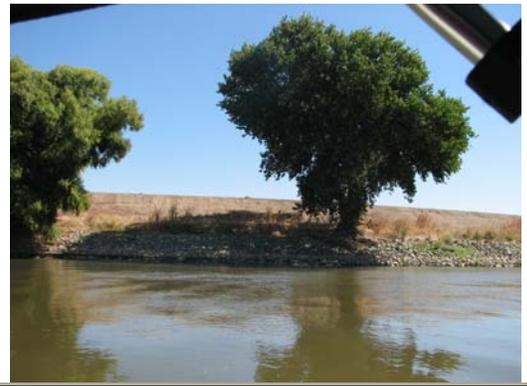
08/23/2011: The repaired site shows no sign of new erosion activity. Vegetation and trees visible on the site.
 09/07/2010: Site appears to have been repaired by placing shot rock revetment on the lower slope. Some emergent vegetation at the lower slope. Site was previously rated "U."
 08/05/2010: Recommended for annual assessment and monitoring during flood events, per CLRO.
 9/29/2009: No major change observed; erosion site is immediately upstream of a rehabilitation site; recommend annual monitoring of site, per Critical Erosion Sites Evaluation 2008 Report; note site # is the same as RM53.7; previously rated "U".
 20089: Observed to be caused by wave-wash erosion.
 2007: Visited site 06/07/2007; site could be combined with Site 32.

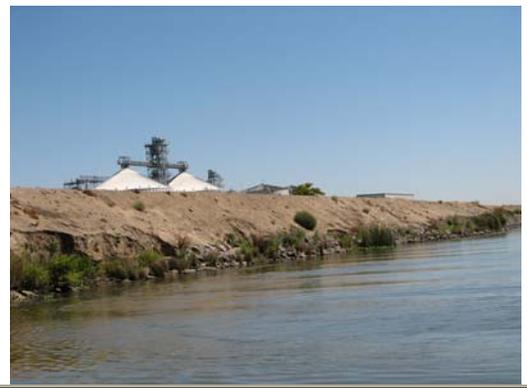
Upstream view of Site. Progressing pocket erosion visible.

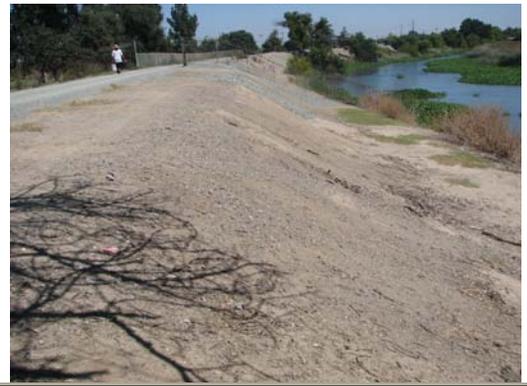
09/02/2011: Site has been repaired with added soil and crashed rock. No new erosion activities found on site.
 11/30/2010: Site was not inspected this year due to time constraints. There has been no reports from the district that the site was corrected. Continue to monitor during flood events.
 08/05/2010: Recommended for annual assessment and monitoring during flood events, per CLRO.
 2009: Erosion appears to be maintenance-related, and not caused by riverflow; recommend annual assessment and monitoring of erosion site, per Critical Erosion Sites Evaluation 2008 Report; previously rated "U".
 9/12/2006: Headward erosion along the levee bank; erosion has created "notches" estimated to be about 12 feet in height; erosion appears to be maintenance related; DWR Inspector for the area says the erosion has been present for years.

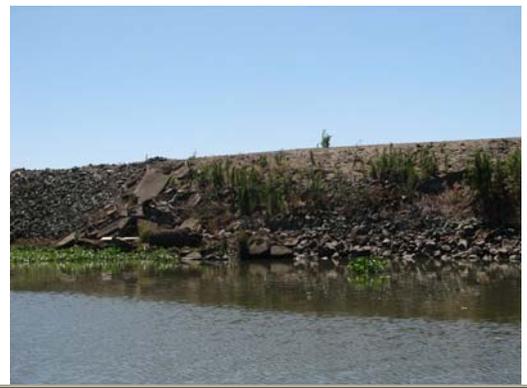
08/23/2011: No significant changes observed on site.
 09/07/2010: No significant changes observed on site. Some emergent vegetation at the lower and middle slope. Existing revetment is no longer adequately protecting the oversteepened slope. Some of the broken concrete used as revetment has slid, dragging levee materials away from the slope and creating notches.
 09/29/2009: Erosion site extends from RM 41.11 to 41.18; existing revetment is no longer adequately protecting the oversteepened slope.
 2008: Existing concrete slabs were placed as temporary fix; some of the slabs have started to slide, dragging levee materials away from the slope and creating notches; note that a sewage treatment plant is located on the landside of the levee.

Upstream view of the site. Broken concrete used as revetment is sliding, dragging down levee materials.

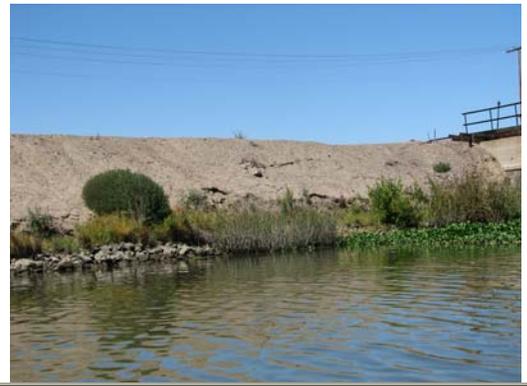
08/23/2011: The site is located immediately upstream of a Railroad bridge. Dense vegetation at the water line interferes the view of erosion.

Upstream view of the erosion site. Note the railroad bridge.

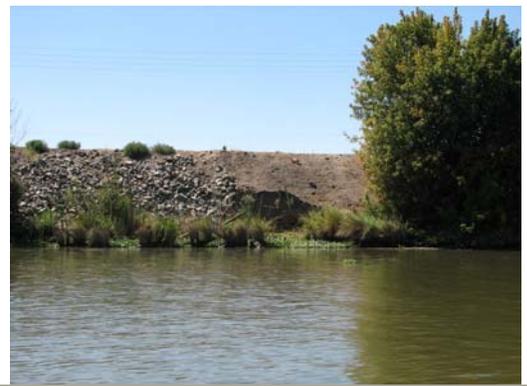
08/23/2011: The erosion site is immediately donstream of the riprap protection.

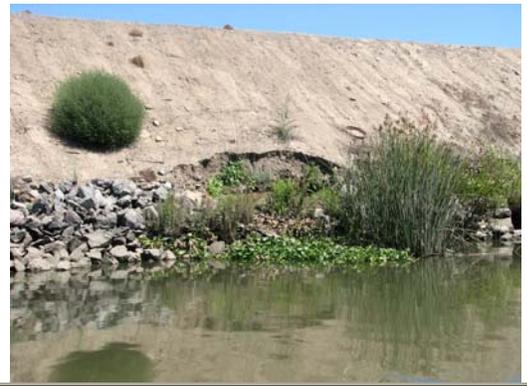
08/23/2011: The site is about 500 ft downstream of bridge. The levee toe seems to be protected, but the protection is being washed away.

Close view of the erosion. Note that the riprap protection next to the erosion.

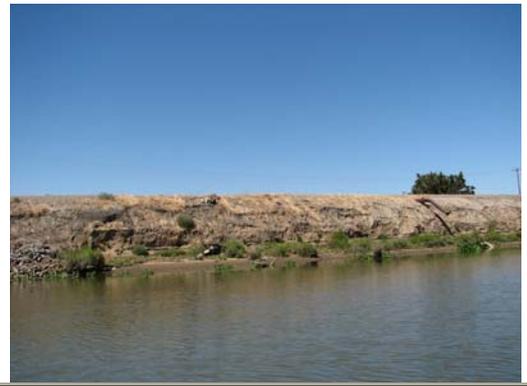
08/23/2011: No significant changes observed on site.
 9/07/2010: No significant changes observed on site. Some emergent vegetation at the water line. There is an exposed pipe discharge partially hanging at the mid-slope, possibly still used for discharging irrigation/runoff water. There is minimal rip rap protection along the bank, and what's left of it is no longer adequately protecting the bank.
 9/29/2009: Site consists of a 400-foot long eroding bank with minimal vegetation and protection; the existing rip rap has sloughed, rendering it useless; note that there is an exposed section of a pipe.
 10/18/2006: There is extensive loss of rip rap on some sections; sewage disposal pond is on the landside of the levee; there is an exposed pipe outlet "hanging" from the upper slope.

Downstream view of the site where sloughing is occurring.

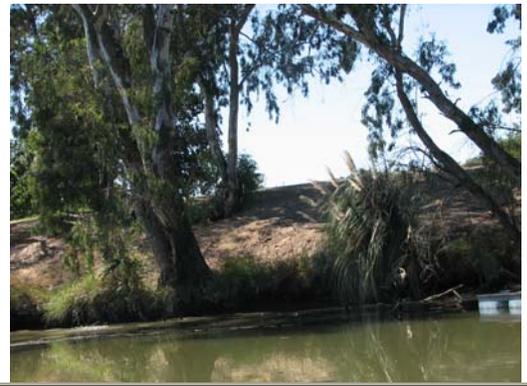
08/23/2011: No significant changes observed on site. Trees concerned still in place.
 09/07/2010: No significant changes observed on site. The concern here is the undermining of the levee toe where most of trees are. There are erosion pockets lined along the lower slope and at the base of the trees, exposing tree roots. There is minimal slope protection.
 09/29/2009: The lower slope is lined with minor erosion pockets; some tree roots are exposed; there is visible undermining of the levee toe; site is immediately upstream of the Highway 4 Bridge; the bridge is possibly causing a scour to occur, eroding the bank.

Front view of the site where undermining has occurred.

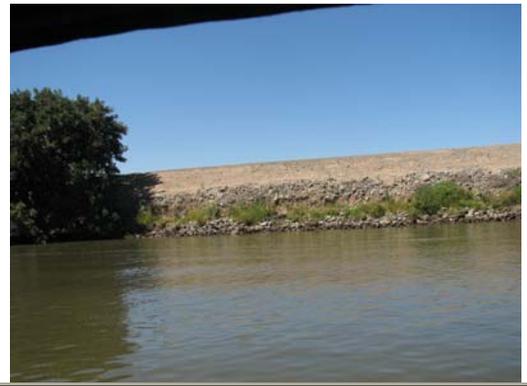
08/23/2011: Sloughing rip rap is visible on the site

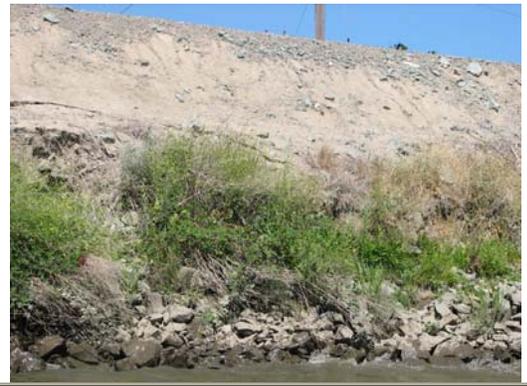
08/23/2011: Cracking erosion along the levee bank. Erosion appears to be caused by river flows.

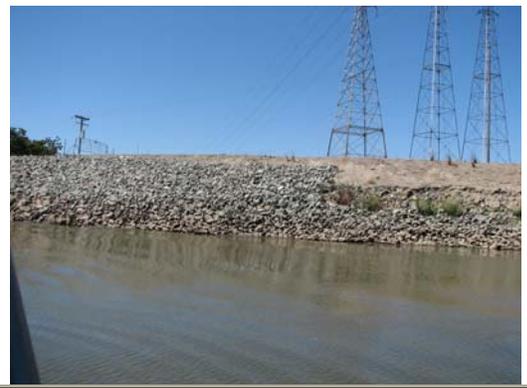
08/23/2011: No significant changes observed on site.
 09/07/2010: No significant changes observed on site. Erosion site is located beneath Howard Road Bridge. Majority of the existing rip rap has slipped, dragging away levee materials and exposing the underlying soft soil.
 08/06/2010: Recommend for annual assessment and monitoring during flood events, per CLRO.
 09/30/2009: No major changes observed since the last visit; upper portion of existing revetment has slipped, exposing the degrading bank; note that site # is the same as RM46.30, LM5.69 found in the CLRO CES Evaluation 2008 Report; site was previously rated "M".
 11/04/2008: Previously repaired using rock revetment; upper portion of th revetment is sliding, causing deformation on the levee slope; site is upstream of Howards Road Bridge.

Sloughing rip rap just below the Howard Bridge abutment.

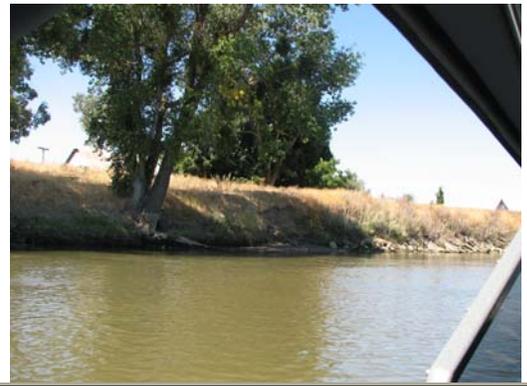
08/23/2011: No significant changes observed on site.
09/07/2010: No significant changes observed on site. There are minor pockets of erosion lining the lower slope and undermining of the toe. There are annual grasses and emergent vegetation at the lower slope. Burrow holes were observed along the slope and persist throughout the 200-foot long site.
08/05/2010: Recommended for annual assessment and monitoring during flood events, per CLRO.
09/30/2009: No major change observed since last visit; despite dense vegetation, the bank continues to erode and slough; the levee toe is being undermined; note the tree on site; the site was previously rated "U".
10/21/2008: Undermining of the levee toe; rodent holes in several location; trees with roots partially exposed; sloughing on slope.

Downstream view of the site where a 4-foot vertical scarp has occurred.

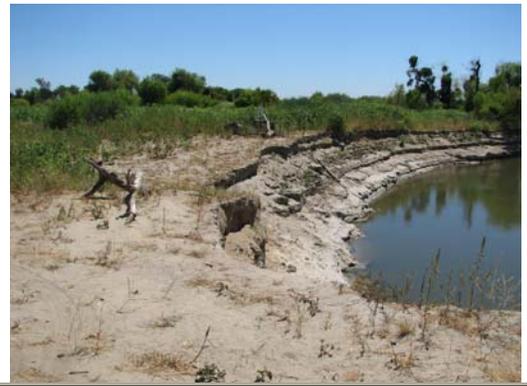
08/18/2011: No significant changes observed on the site. Dead trees and animal activities visible. The closest point of the erosion site to the levee toe is about 100 ft.
 10/19/2010: There is active scouring occurring on the bank due to the nature of the flow and the lack of armor protection. There is also a fallen log immediately downstream of where the erosion has occurred and is protruding outward, possibly creating an eddy and scouring the bank. With the remaining 100-foot wide berm, the levee prism is not yet affected. However, the bank will continue to degrade, and eventually intrude into the levee prism if no protection is put in place. Erosion site is recommended for annual assessment and monitoring during flood events.

From the berm looking upstream. This the closest point to the levee toe.

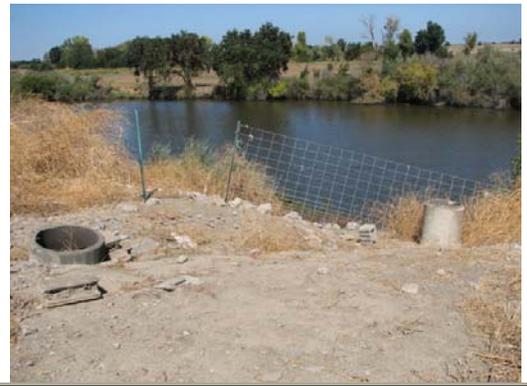
09/02/2011: Site was not visited due to the time limit.
 09/22/2010: No significant changes observed. Vegetation downstream, upstream and on the lower slope of the site have been recently sprayed. These areas were also fenced off during the site visit, making it difficult for us to examine the condition of the lower slope. Possible leak or spill from the siphon breaker is creating notches along the slope and developing into a headward erosion. If the problem continues, it will erode the slope and fully expose the pipe to outside elements.
 07/23/2009: A possible leak or spill from a siphon breaker is eroding the slope and developing into a headward erosion; a portion of the buried pipe is exposed; the lower slope seems to be lined with chunks of concrete debris or other rock material.

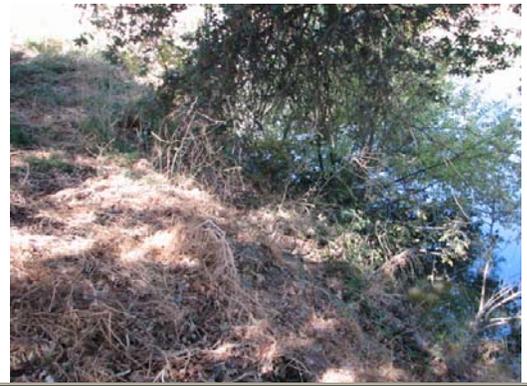
09/02/2011: This site was not visited due to the time limit.
 09/22/2010: No significant changes observed. Minor pocket erosions are lined at the lower bank. Upper slope and bench were recently sprayed for vegetation control. Two large Oak and Willow trees are on midslope and bench. The remaining bench was re-measured and found to be approximately 10 feet. There was no indication of active erosion on site during the site visit.
 08/05/2010: Recommended for annual assessment and monitoring of site during flood events, per CLRO.
 07/23/2009: No major change observed since last visit; site is a 200-ft. long near-vertical berm erosion; recommend annual assessment and monitoring of erosion site, per CLRO CES Evaluation 2008 Report; Site # is the same site previously reported as RM4.0,LM4.51; previously rated "U".
 09/10/2008: Two large trees (2-3' DBH) with partial roots exposed.
 2007: Visited site 03/13/2007.

Downstream view. Seasonal vegetation covering one of several pocket erosions lined along the bank.

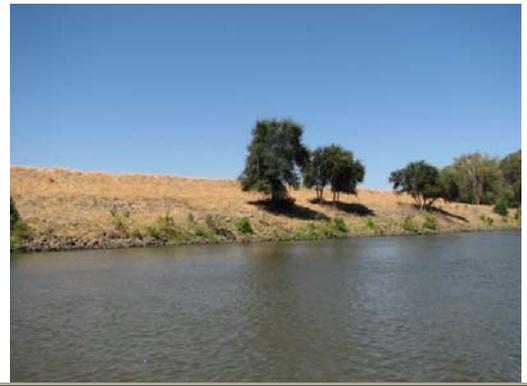
08/23/2011: No new erosion activity visible. The site is removed from the watchlist.
 09/07/2010: After further review of site, it will be removed from the inventory. Erosion is minimal. There is sufficient berm to provide levee protection. Annual vegetation also provides added protection.
 08/06/2010: Recommended for annual assessment and monitoring during flood events, per CLRO.
 03/09/2010: As discussed with Michael Moncrief of MBK, site will be removed from list; there is wide berm with thick vegetation.
 2009: Not visited; portion of the rip rap has slipped ,leaving an exposed section; there is dense vegetation surrounding site; landside ground surface has been raised to height of levee crown; Site # same as RM55.75,LM2.25; previously rated "U".
 09/14/2006: Pocket erosion approximately 0.3-0.4 miles downstream from SPRR Bridge.

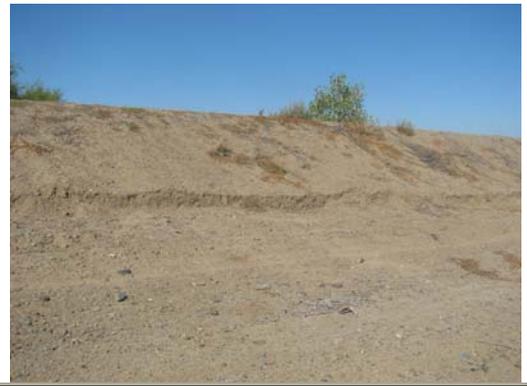
Downstream view of site. Note the vertical scarp at the toe.

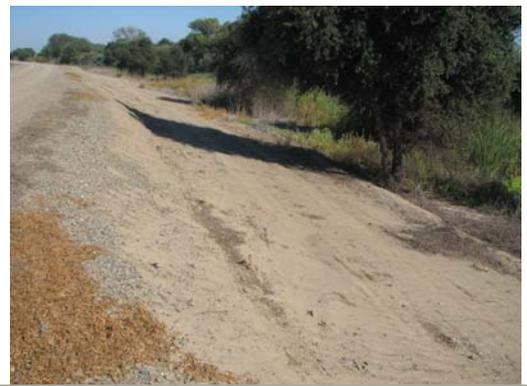
Downstream view of scarp caused by a maintenance equipment.

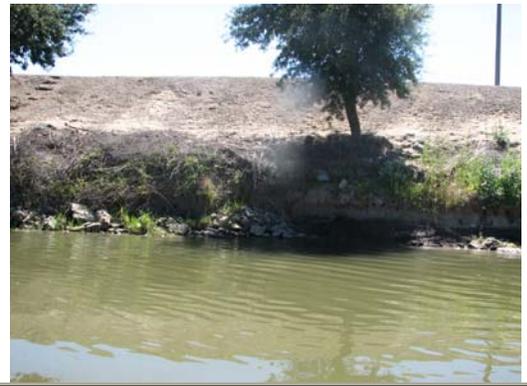
08/23/2011: Site is at the upstream of a drainage ditch.

Front view of erosion at the most upstream of the site

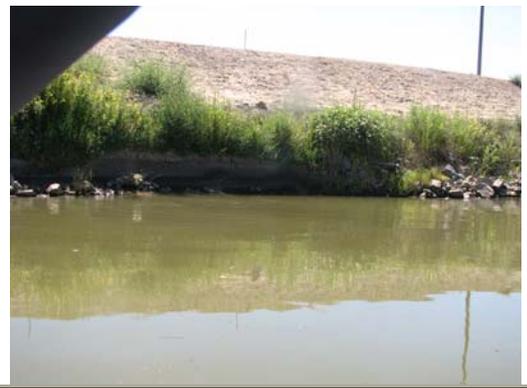
08/23/2011: The protection at the levee toe has been washed away.

Direct view of the site. The erosion is vertical

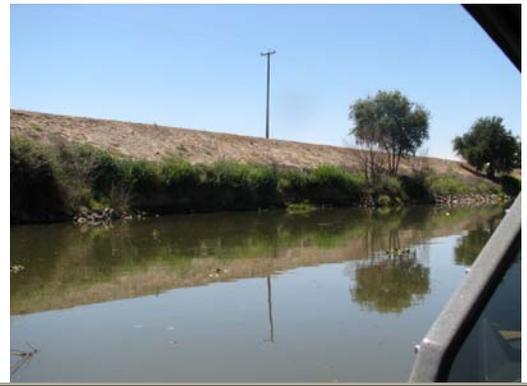
Downstream view of the 5-ft vertical scarp .

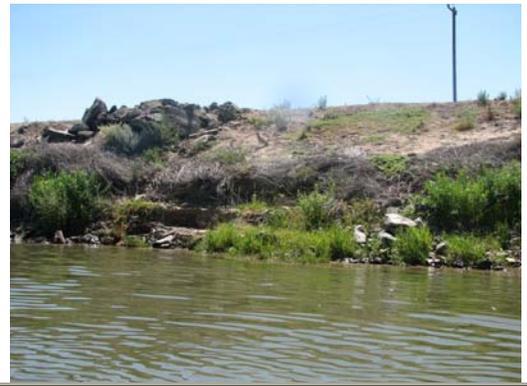
Direct view of the erosion. Note the broken concrete near the site.

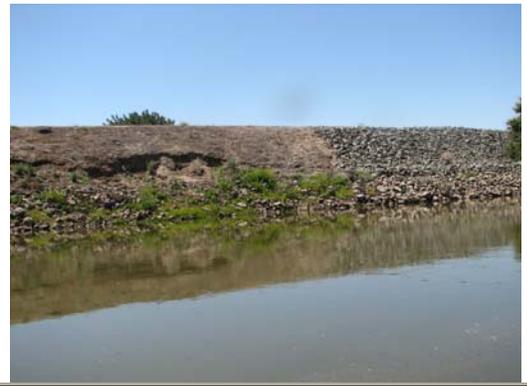
Front view of the site. Existing scalloped erosion is immediately downstream of rip rap section.

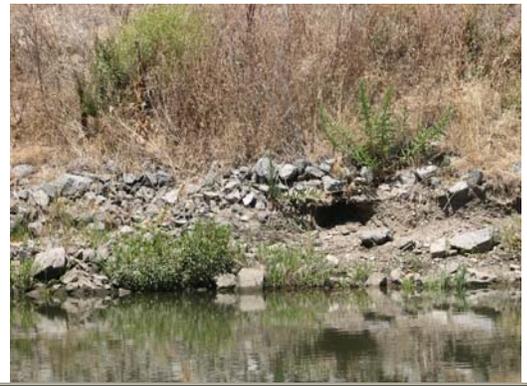
A close view of the minor erosion activities.

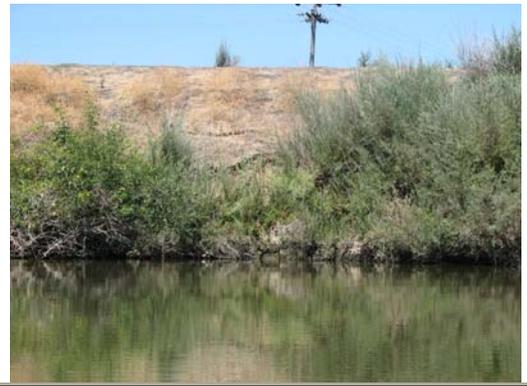
Front view of the site. The scarp is visible on the slope.

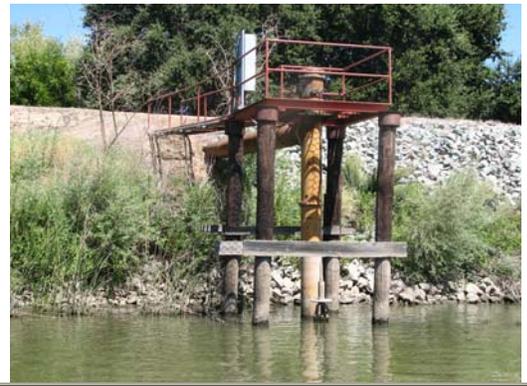
Front view of the site. Note the color of material around the pipe crossing.

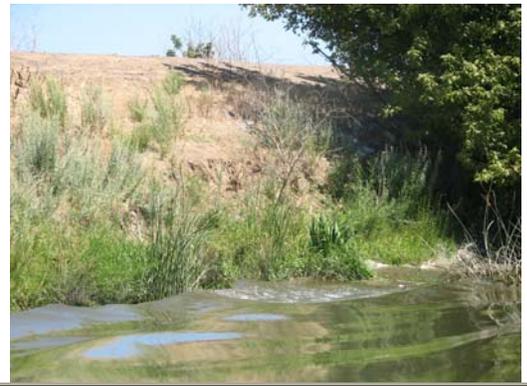
Upstream view of the site where minor erosion activities observed.

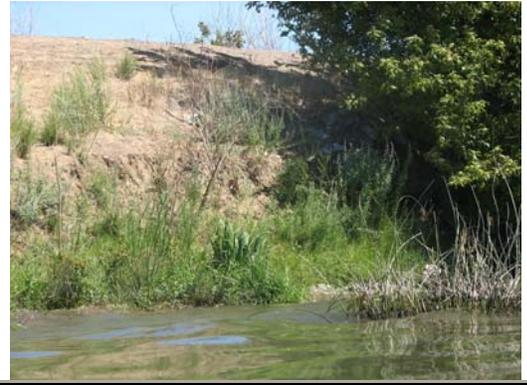
A closer look of the site with minor erosions.

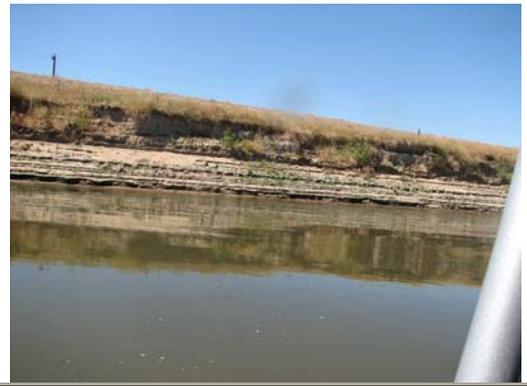
Front view of the site. Note dense vegetation on the berm.

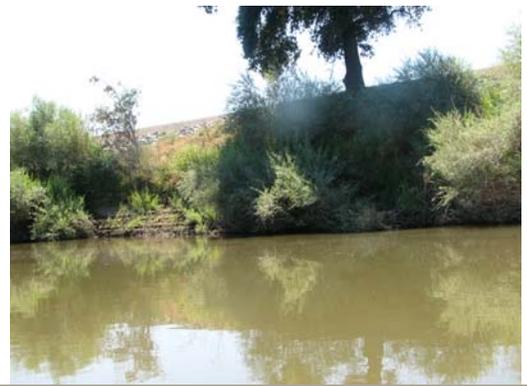
Direct view of the erosion. Note dense vegetation on site
