State of California
The Resources Agency
Department of Water Resources
Division of Flood Management

2005
INSPECTION & INTEGRITY
REPORT
OF THE
FLOOD CONTROL PROJECT
MAINTENANCE AND REPAIR

PUBLISHED IN FEBRUARY 2006

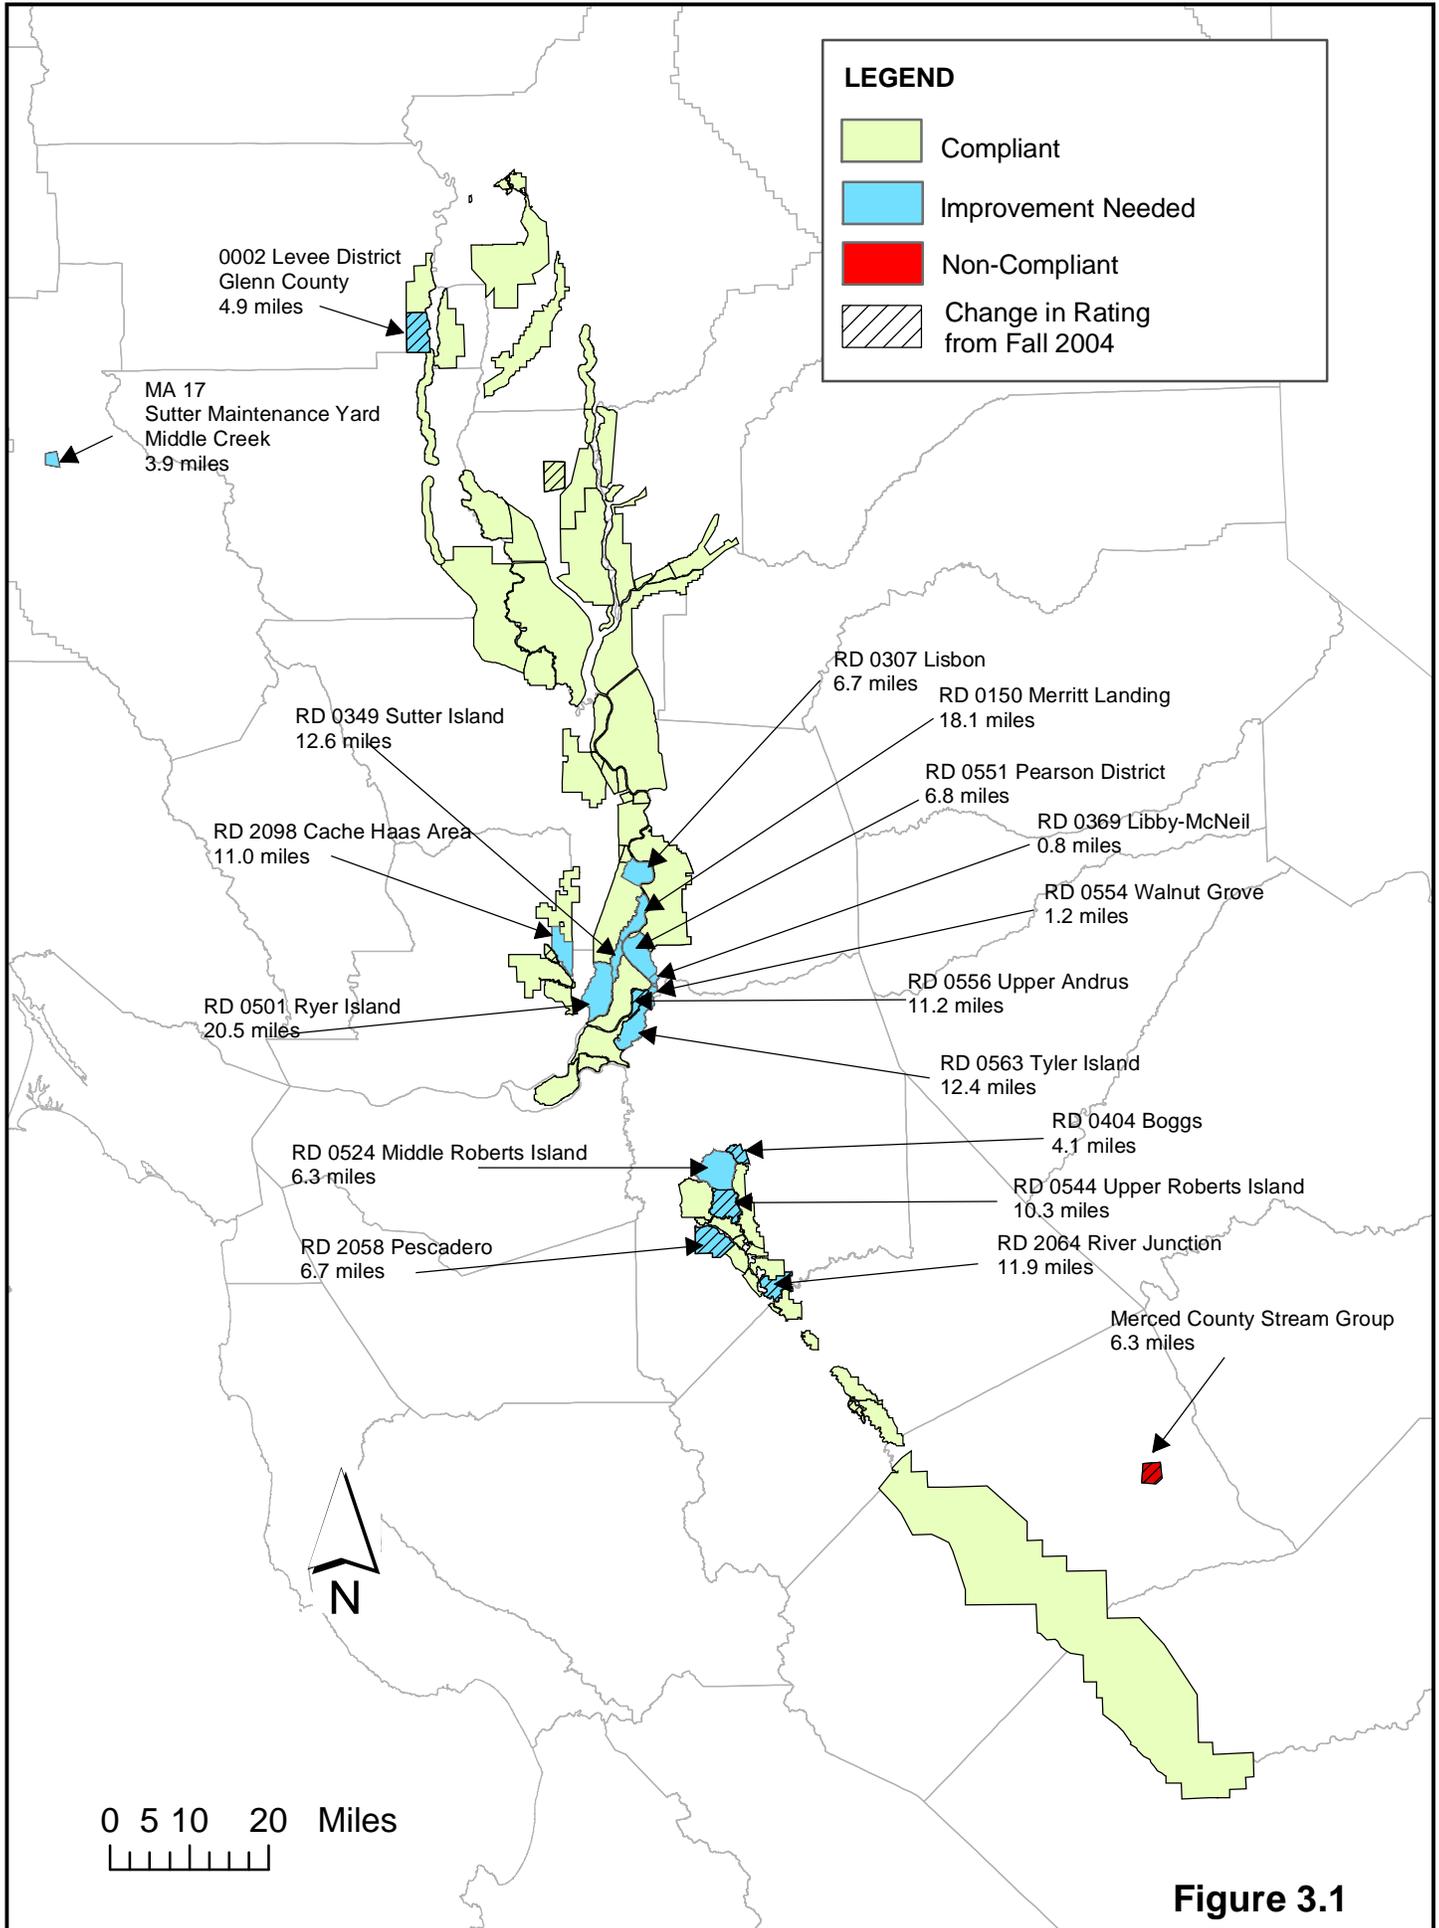
Overall levee maintenance ratings are assigned to each LMA based on each inspector's observations as reported during the fall joint inspection. The overall ratings given are very subjective and depend on each inspector's interpretation of the overall condition of the levees. A summary of the overall status of the maintenance of the flood control system levees is provided in Figure 3.1, which shows of the 95 LMA's, 77 are compliant with required maintenance practices, 17 have been assigned an improvement needed rating, and 1 is non-compliant. Figure 3.1 also indicates those districts that have a change in status from the 2004 fall inspections. Table A-3 lists the improvement needed and non-compliant districts and the total levee miles associated with each rating criterion.

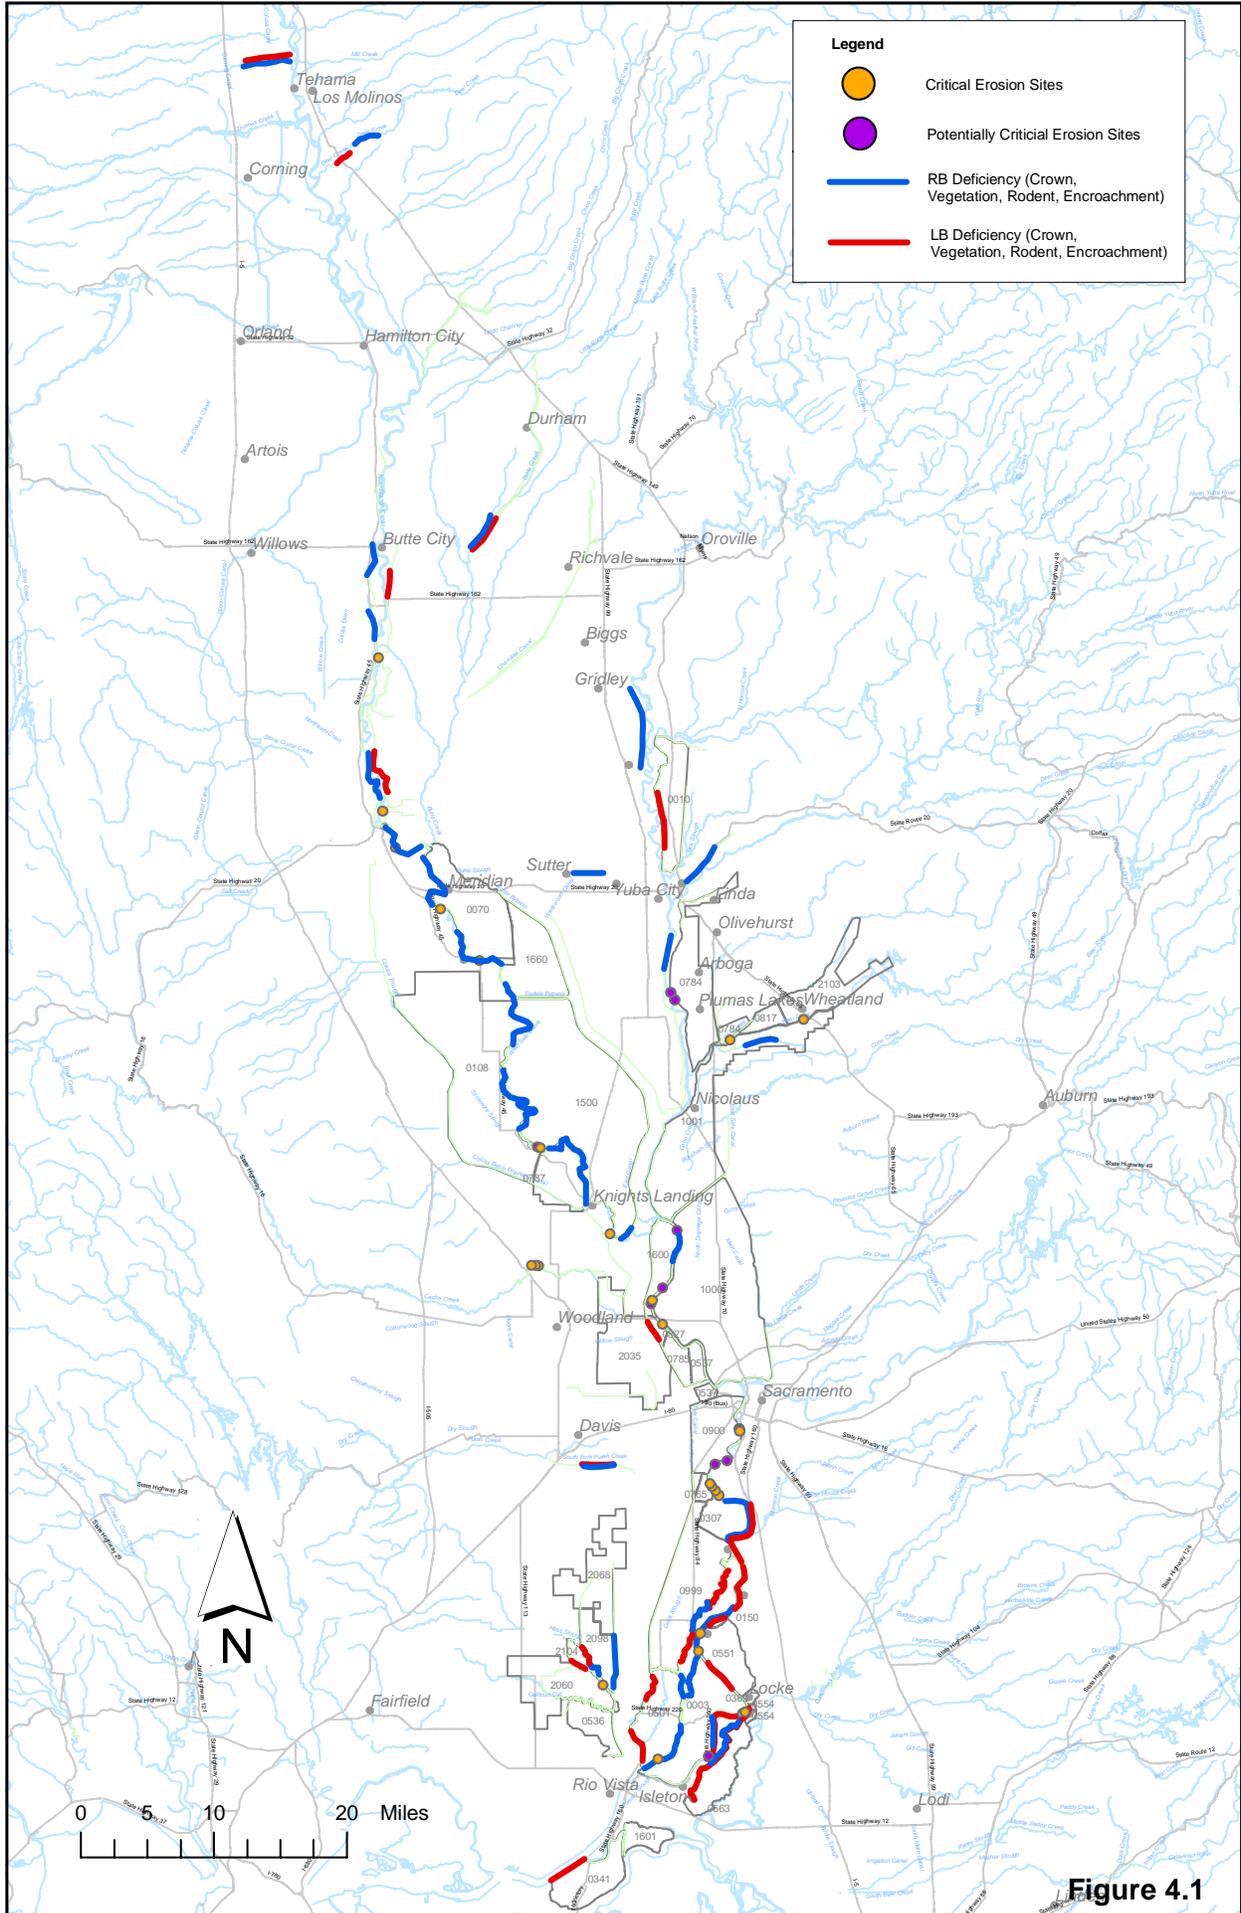
SACRAMENTO RIVER SYSTEM DEFICIENCIES

Sacramento River System – The Sacramento River Flood Control System is inventoried annually by boat to determine critical and potentially-critical sites. Table 4-1 represents the repair status of various critical erosion sites identified in both the 2004 and 2005 Ayres reports titled “Ayres Atlas of Bank Erosion Sites”. In the year 2004, 31 sites were classified as critical; repairs have been completed on 8 of these sites and 2 were removed from the critical list in 2005. Twenty-four critical sites have yet to be repaired as of December 2005. The approximate cost to repair these sites has been estimated at \$75 million to \$100 million. These sites are shown in Figure 4.1.

Table 4-2 represents the repair status of various *potentially*-critical erosion sites identified in both the 2004 and 2005 Ayres reports titled “Ayres Atlas of Bank Erosion Sites”. In the year 2004, 9 sites were classified as potentially critical, which were increased to 11 in the year 2005. None of these sites have been repaired, and the repair cost estimate for these sites is \$27 million. These sites are also shown in Figure 4.1.

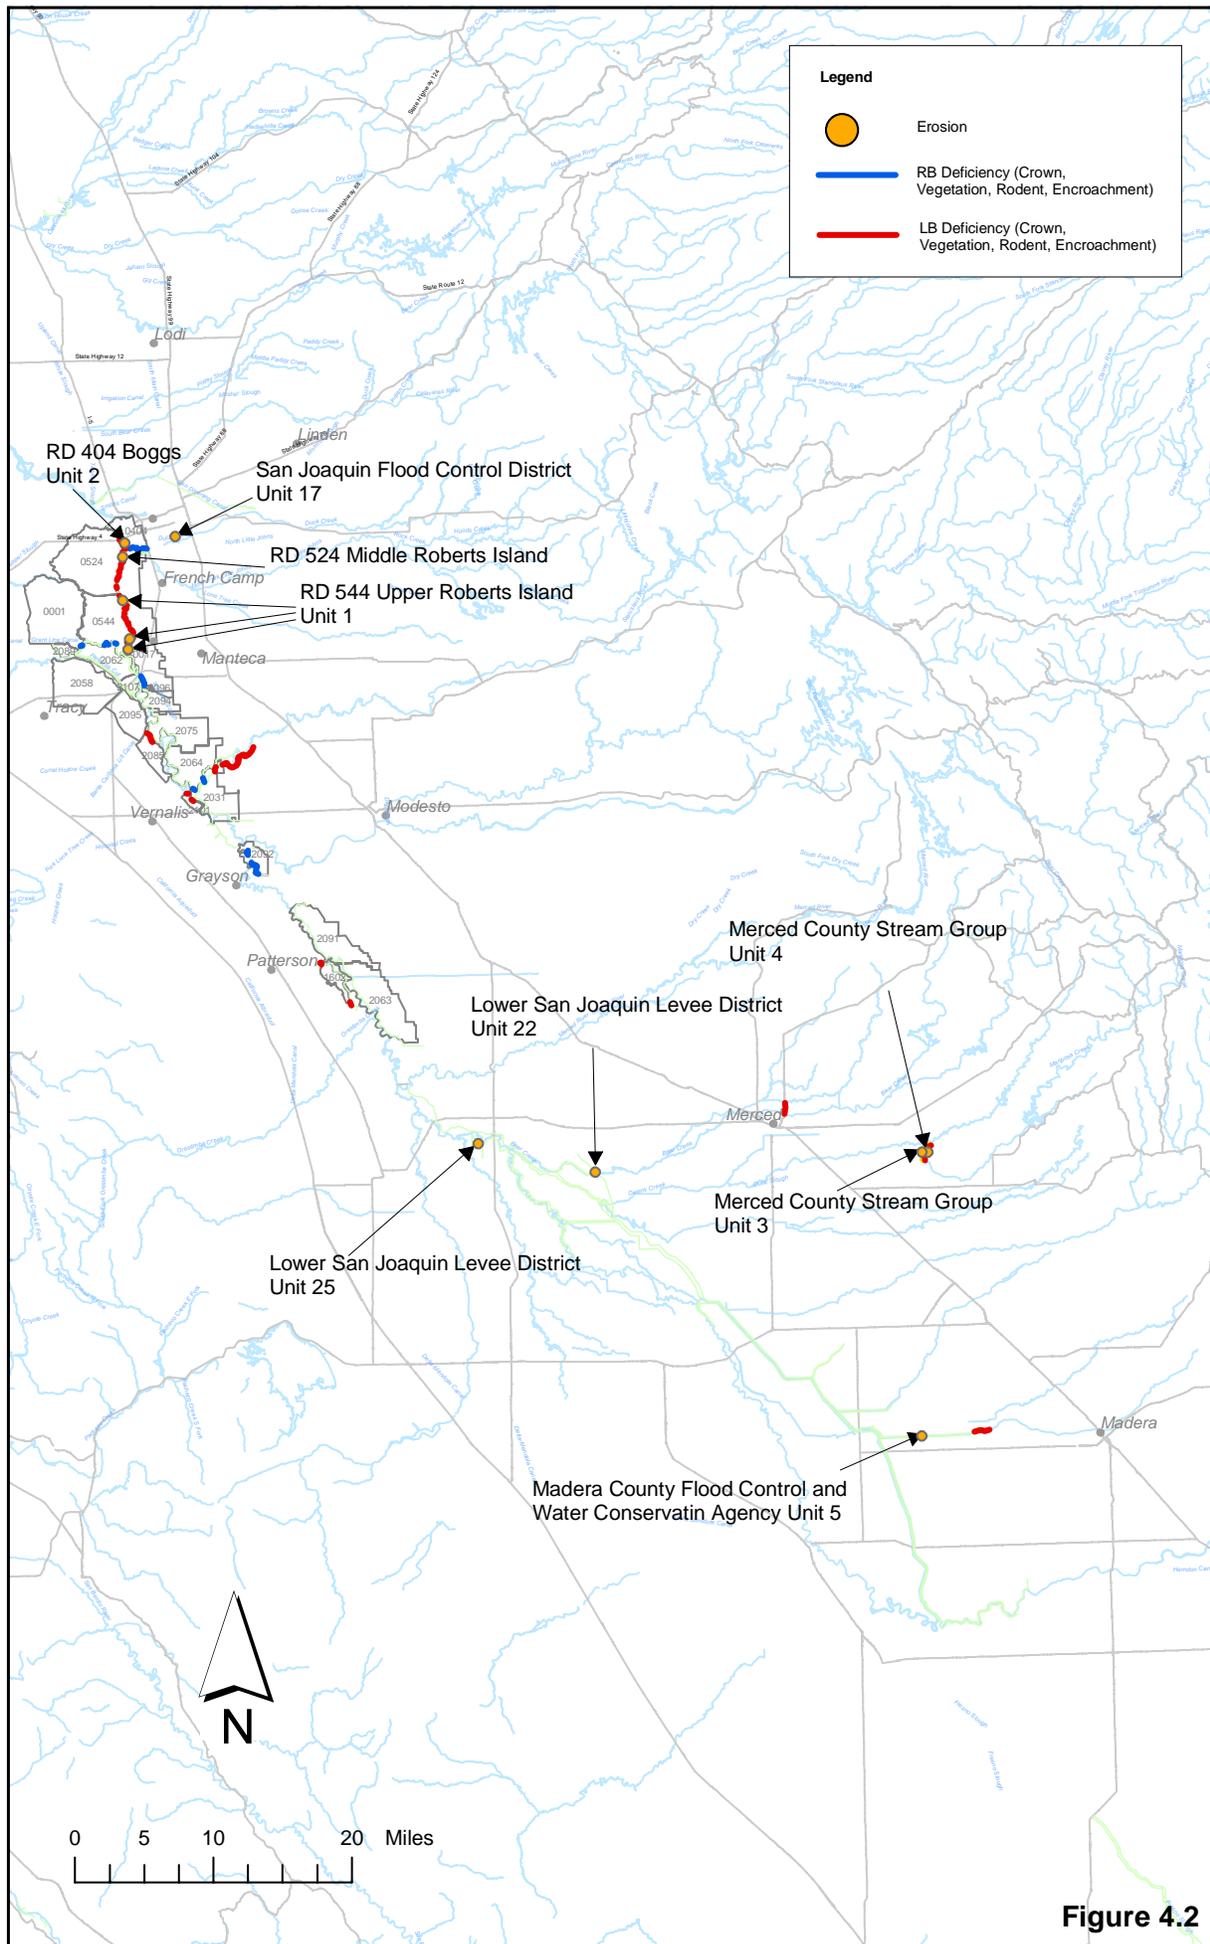
Figure 4.2

determine critical and potentially-critical sites, the San Joaquin system is evaluated by our levee inspectors during routine inspections. As a result, the LMA's in Table 4-3 do not delineate between critical and potentially-critical sites. Table 4-3 shows those locations where deficiencies exist and various improvements are needed. This table is based on the fall 2005 inspections. These deficiencies are shown in Figure 4.2.
