State of California
The Resources Agency
Department of Water Resources
Division of Flood Management

2006
INSPECTION REPORT
OF THE
FLOOD CONTROL PROJECT
MAINTENANCE AND REPAIR

PUBLISHED IN AUGUST 2007

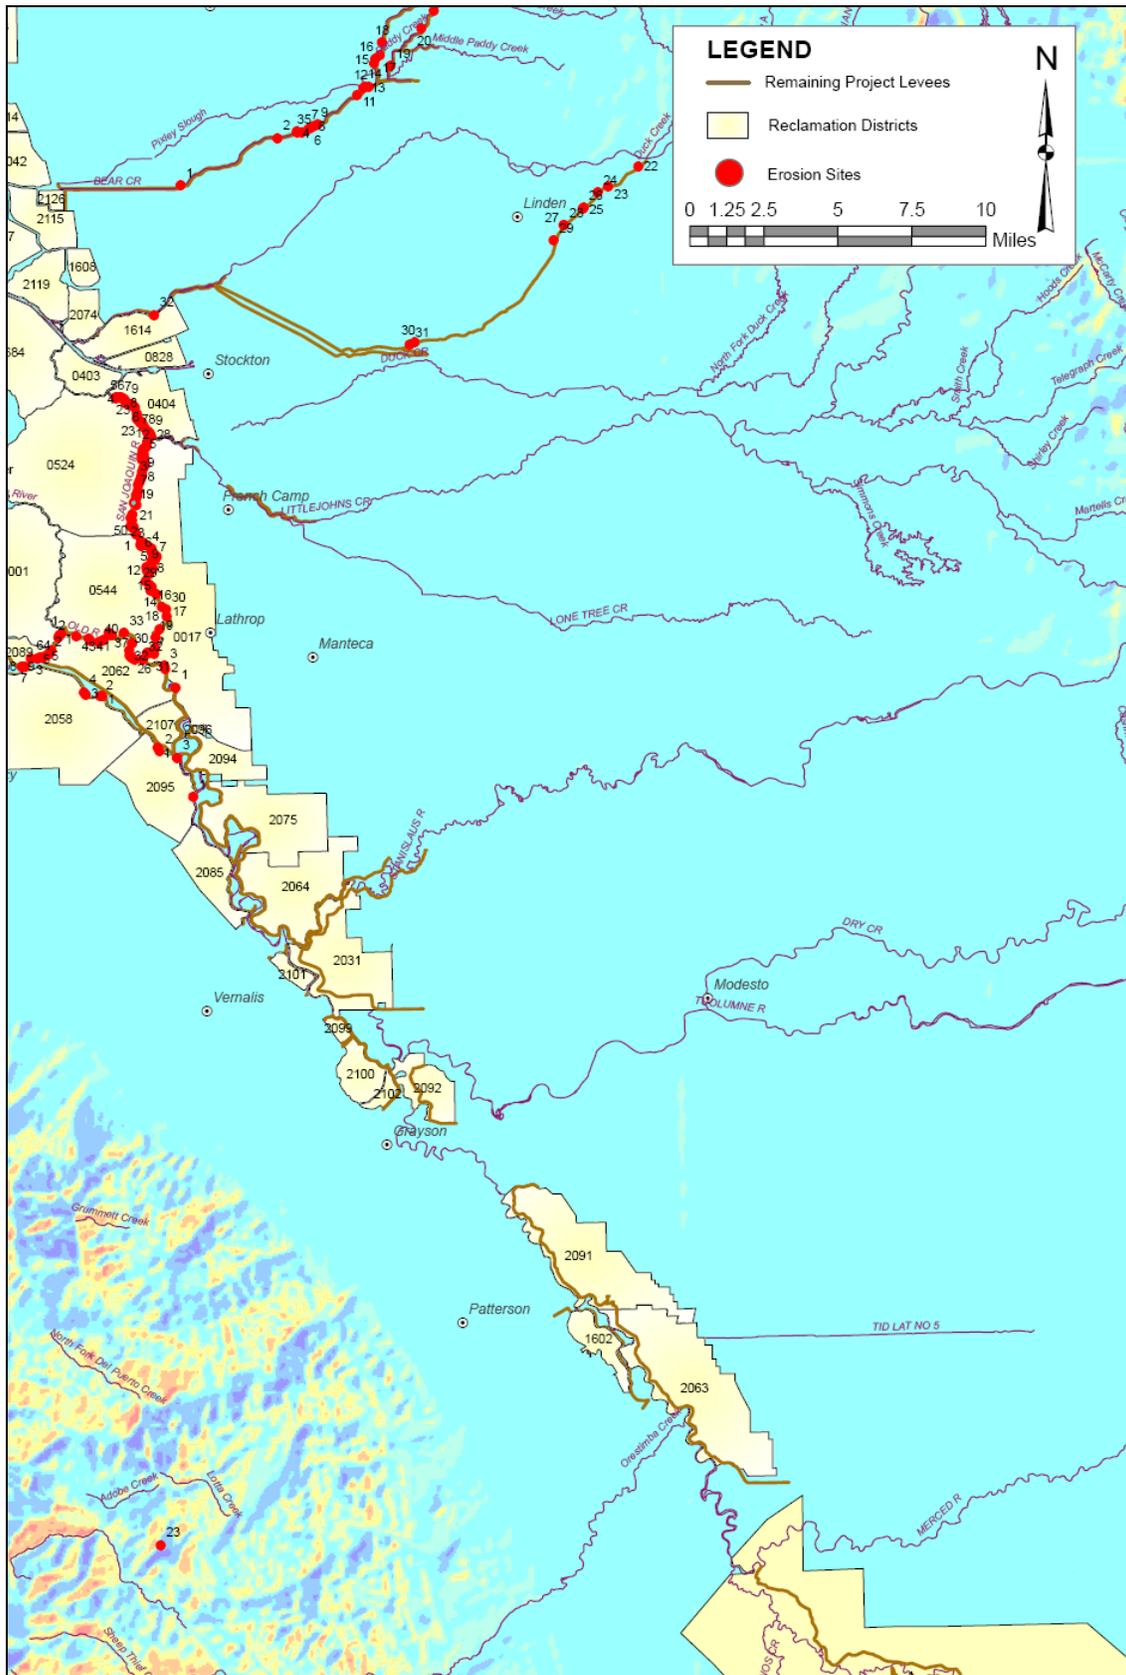
The erosion sites for the San Joaquin River system have been plotted onto an aerial atlas very similar to the Ayres report for the Sacramento River system. Figure 4.1 shows the general location of the San Joaquin River system erosion sites identified in this survey.
