State of California
The Resources Agency
Department of Water Resources
Division of Flood Management

2007
INSPECTION REPORT
OF THE
FLOOD CONTROL PROJECT
MAINTENANCE AND REPAIR

PUBLISHED IN JUNE 2008

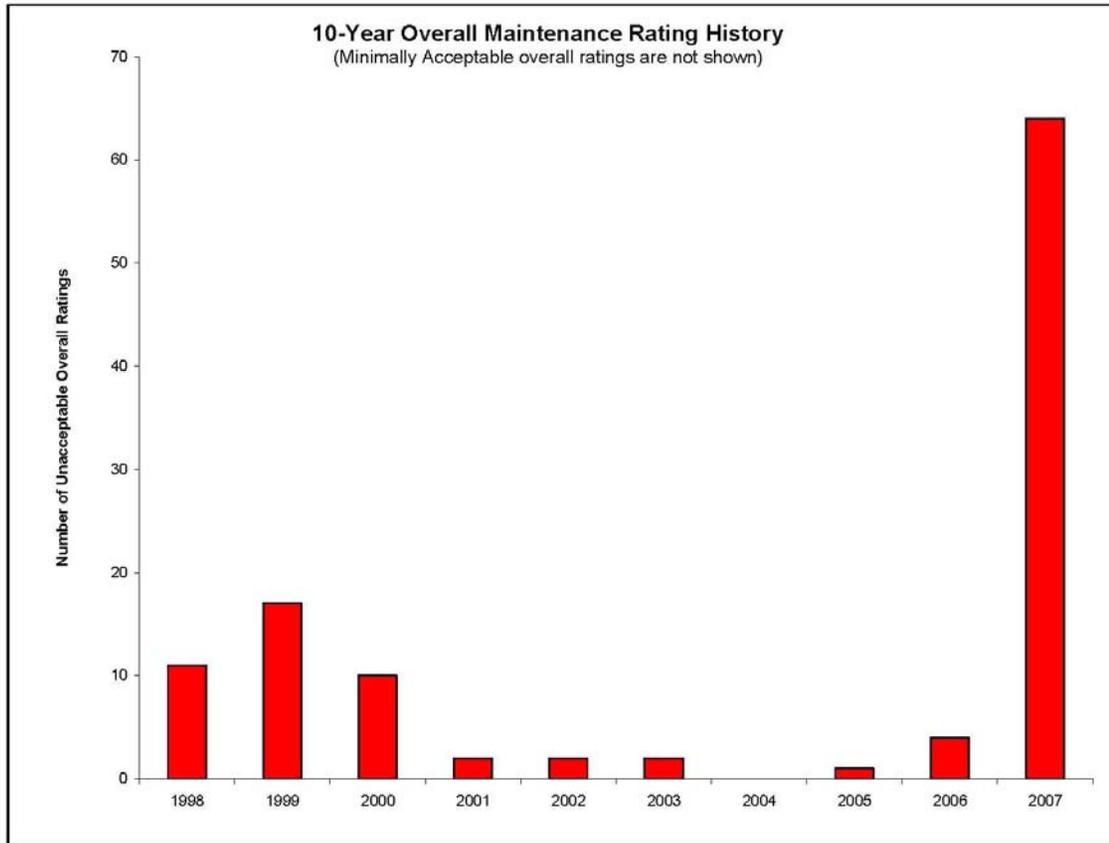
Figure 4.1 shows the annual 2007 overall levee maintenance rating for 107 LMAs inspected by DWR and compares it with the annual levee maintenance ratings since 1998. Note that vegetation (non-trees) and trees are presented separately in Figure 4.2. Total vegetation deficiency percentage would be the total of both of these categories. As shown in Figure 4.2, vegetation deficiency is the largest category reflecting a more comprehensive application of inspection criteria for vegetation. A total of 893.2 miles (56.8%) of levee were found to be Minimally Acceptable and 100.8 miles (6.4%) were found to be Unacceptable out of the total 1,571.1 miles of system levee that were inspected in fall 2007 (rock sites and inactive levees were not included in these totals).

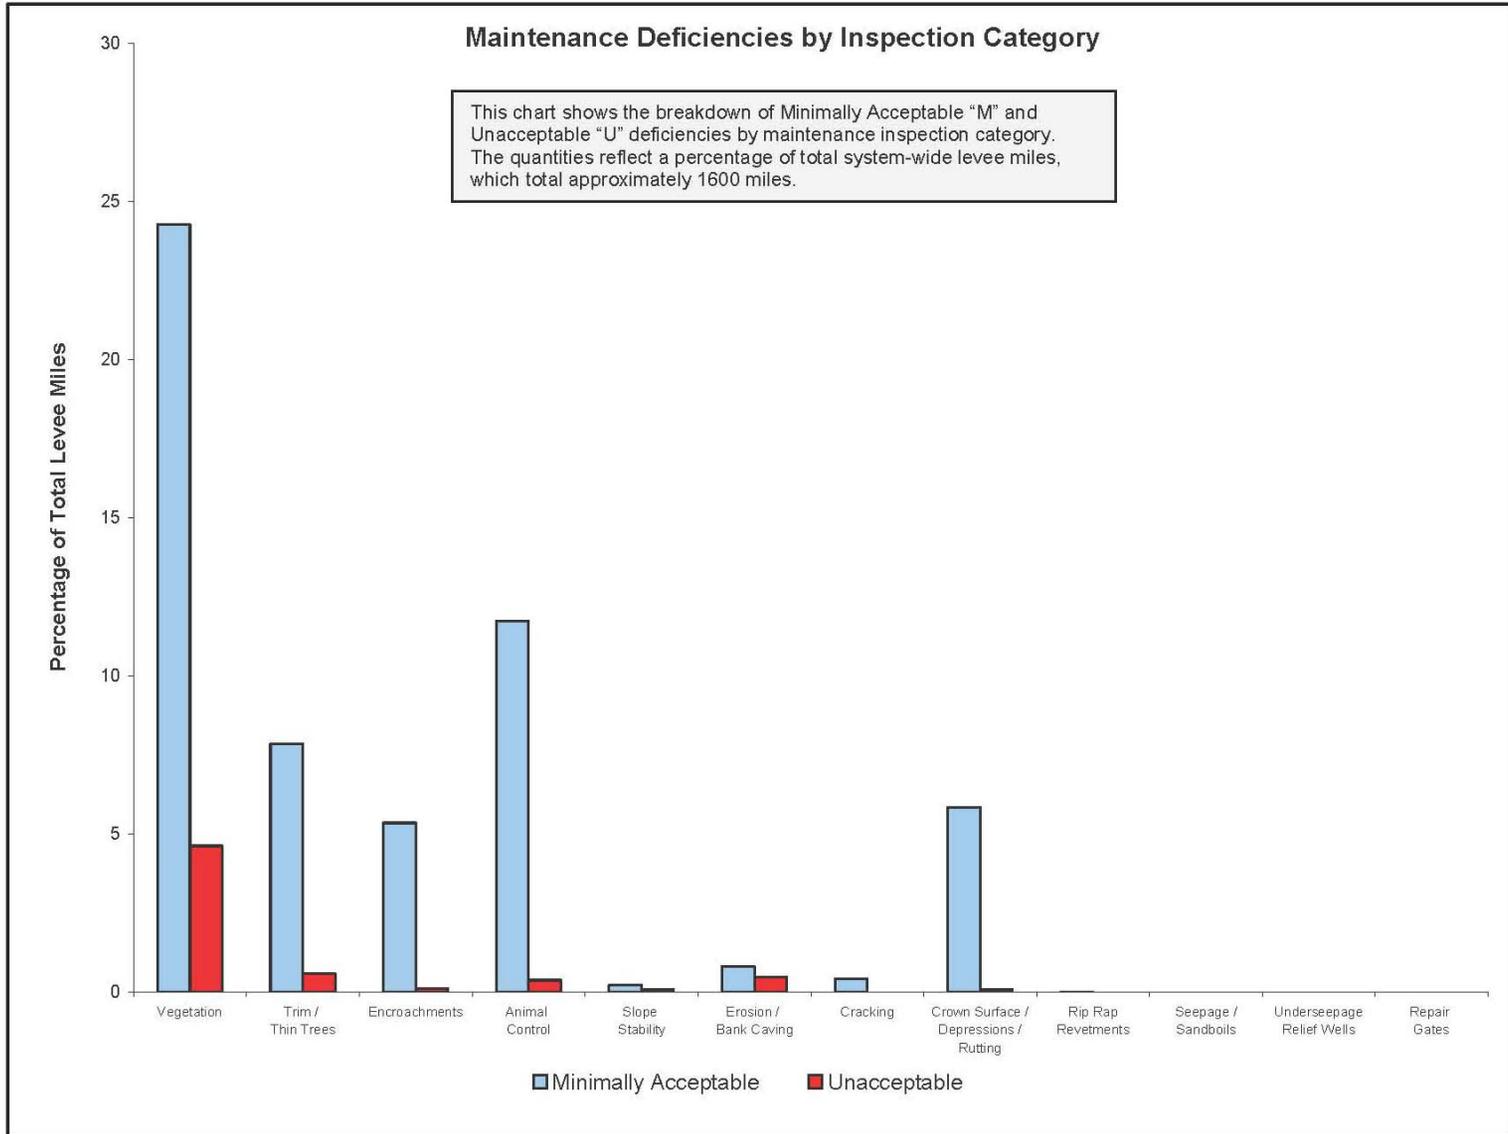
Figure 4.2

Figures 4.1 and 4.2 summarize the annual 2007 overall levee maintenance ratings for the 107 LMAs inspected by DWR. The results reflect implementation of the October 2007 interim vegetation criteria, which are aimed at improving public safety by providing visibility for inspections, eliminating vegetation conflicts that could hamper flood fight activities, and improving access for overall maintenance. Deficiencies in vegetation maintenance, trimming, and thinning of trees, encroachments, animal control, and levee crown surface conditions were most prominent in the makeup of the Unacceptable ratings (see Figure 4.2).

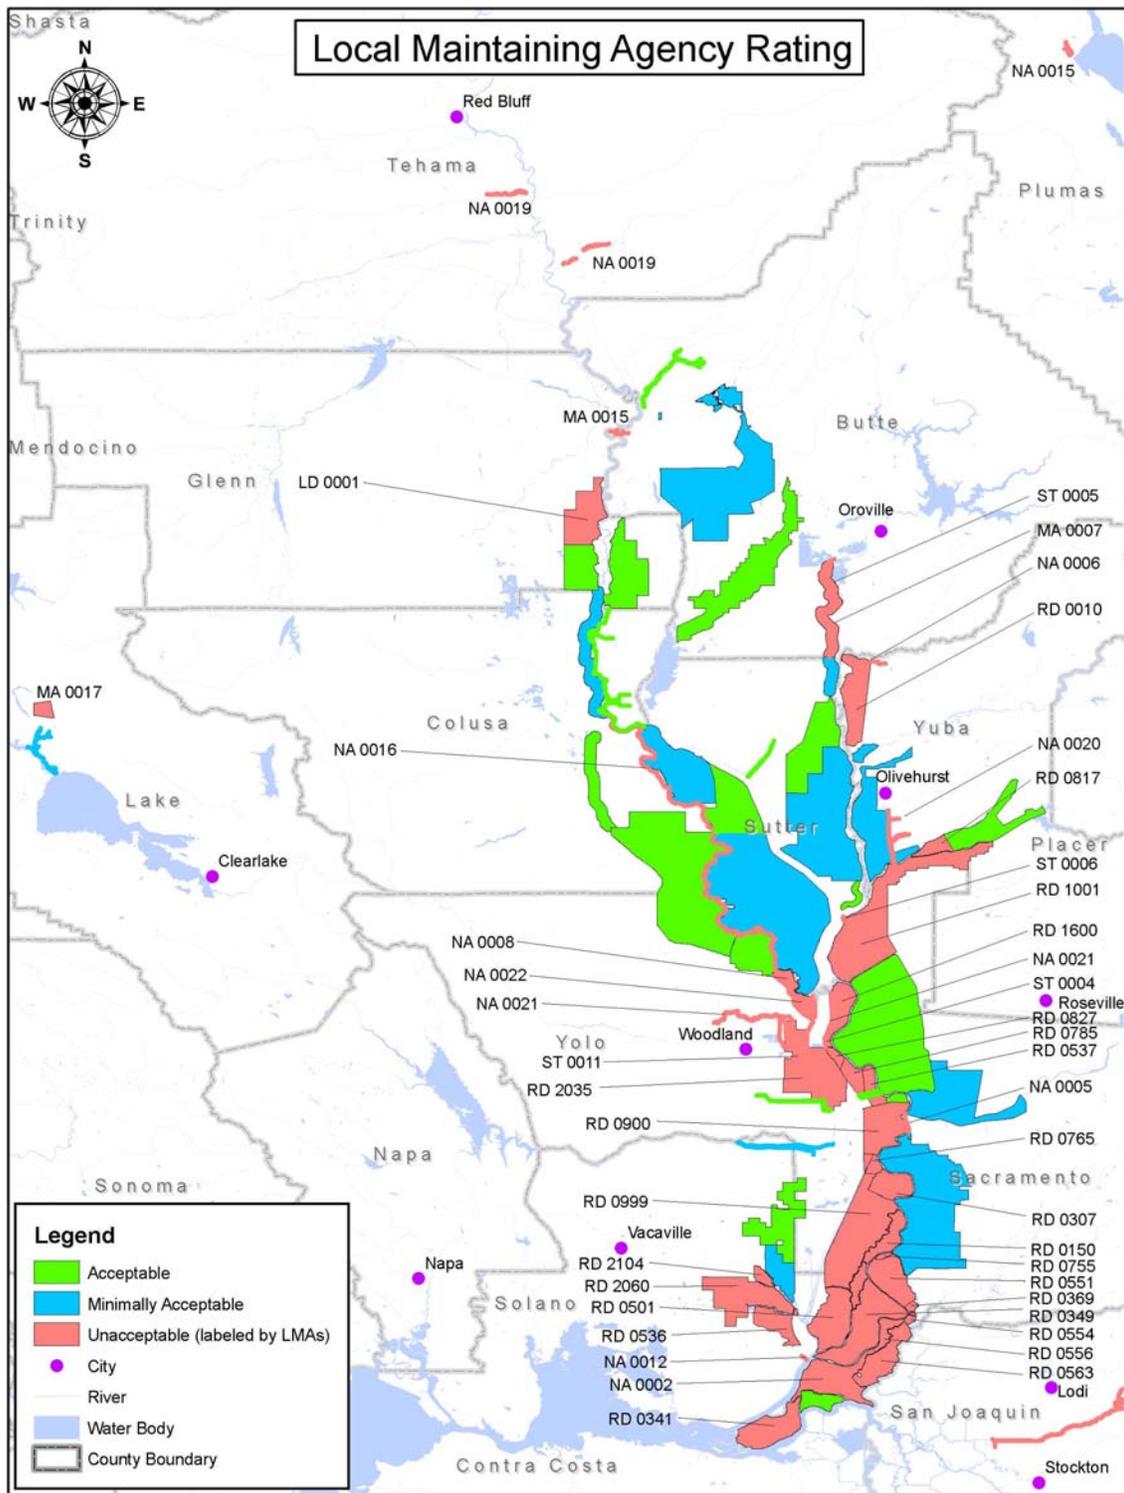
Figure 4.4

Figures 4.4 and 4.5, *Local Maintaining Agency Rating*, are maps of the Sacramento and San Joaquin systems, showing the location and rating of each LMA. Note that due to space constraints, only LMAs with Unacceptable ratings are identified by name on the map. To find the general location of a district, refer to Plates 1 and 1A at the end of this report. All plates can also be found on the DWR website after July 1, 2008 at: <http://www.water.ca.gov/dfm/hafoo/fpiib/fpinss/> and can be expanded for easier reading.
