State of California
The Natural Resources Agency
Department of Water Resources
Division of Flood Management

2009
INSPECTION REPORT
OF THE
CENTRAL VALLEY STATE-FEDERAL
FLOOD PROTECTION SYSTEM

PUBLISHED IN JANUARY 2010

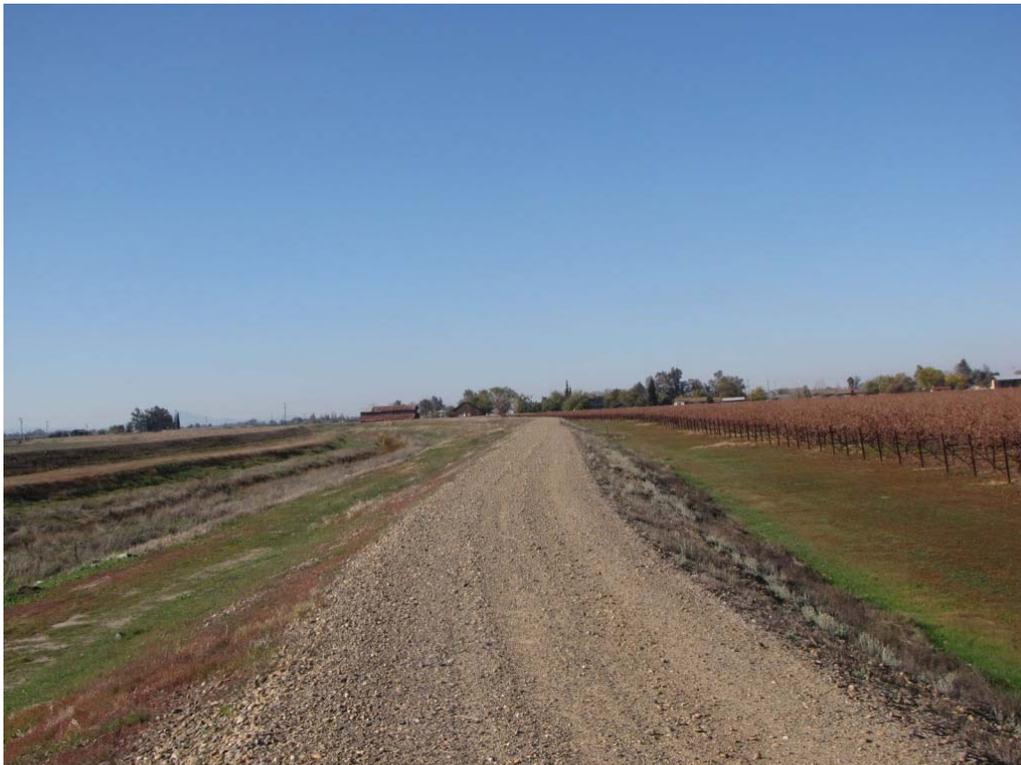
Acceptable Vegetation Maintenance: Good grass coverage with no grass or brush over 12" tall

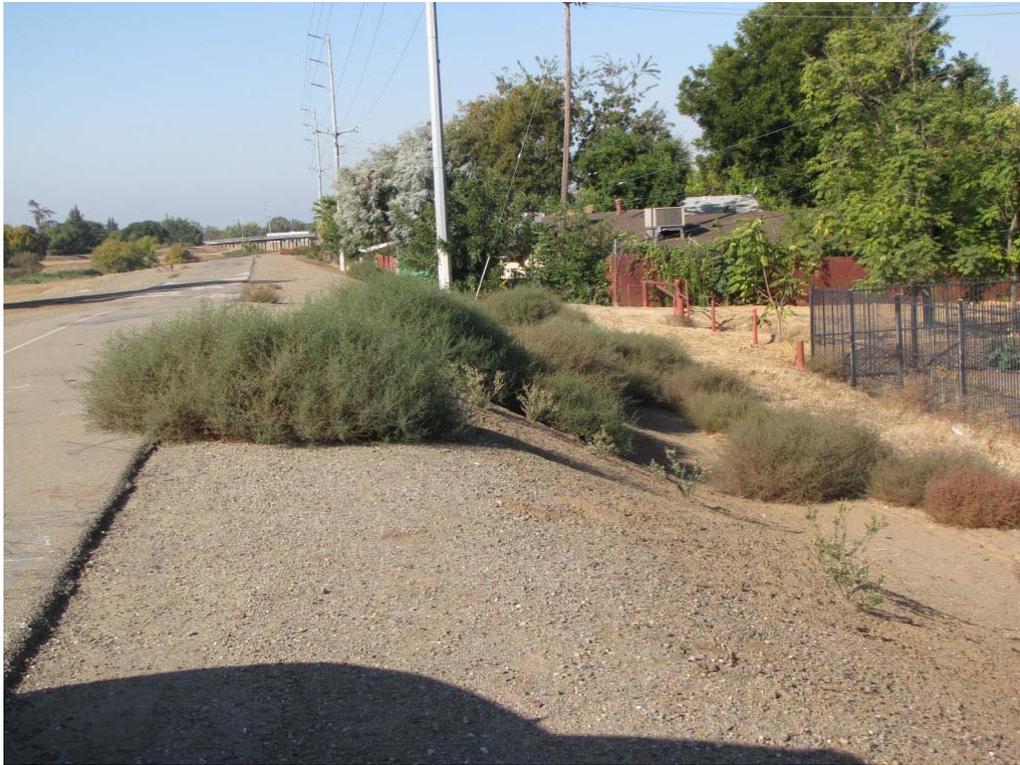
Minimally Acceptable Maintenance: Grass or brush partially obstruct visibility and access

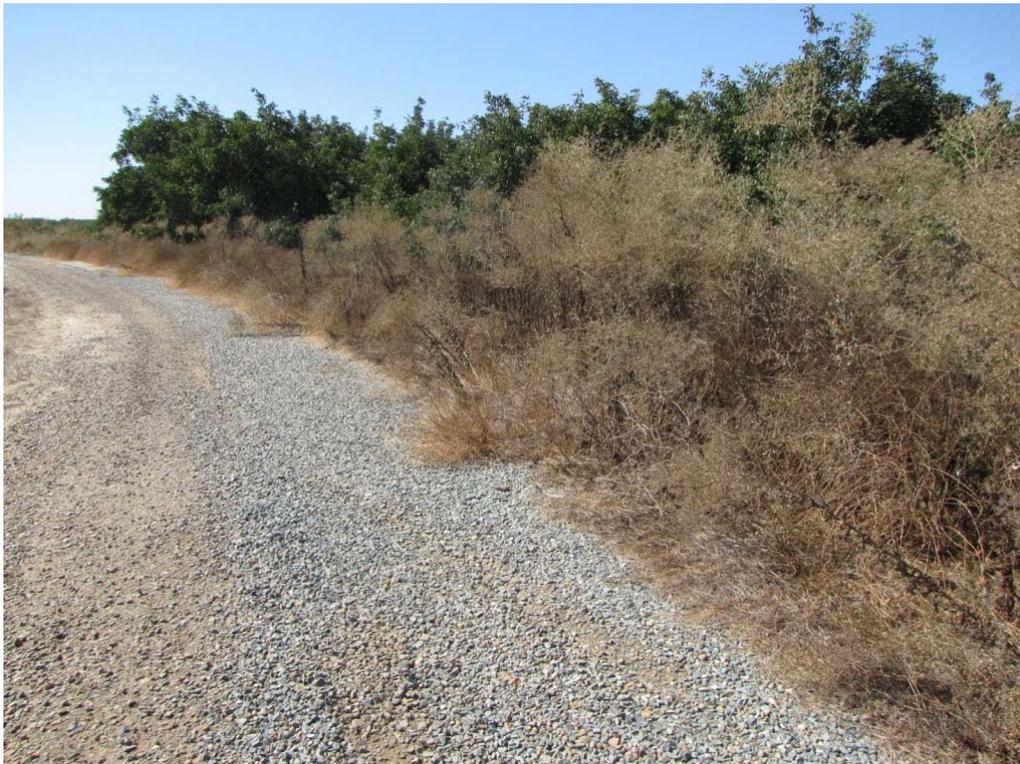
Unacceptable Maintenance: Grass or brush completely obstruct visibility and access

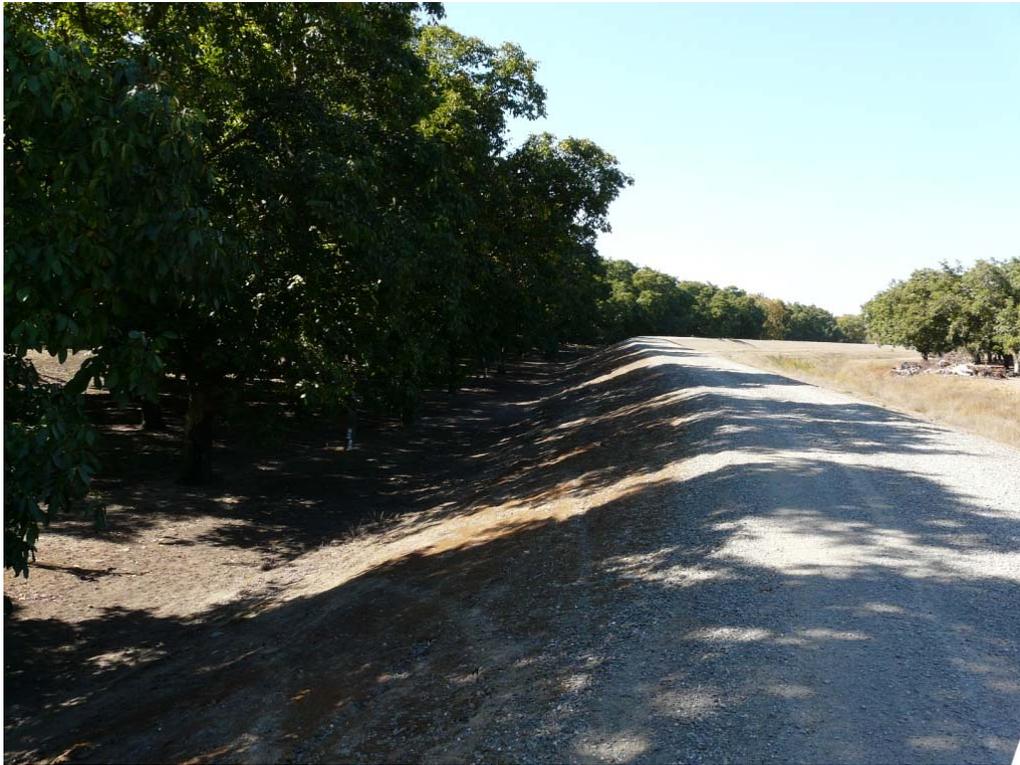
Acceptable Tree Maintenance: No limbs within 5' of the levee obstruct visibility or access

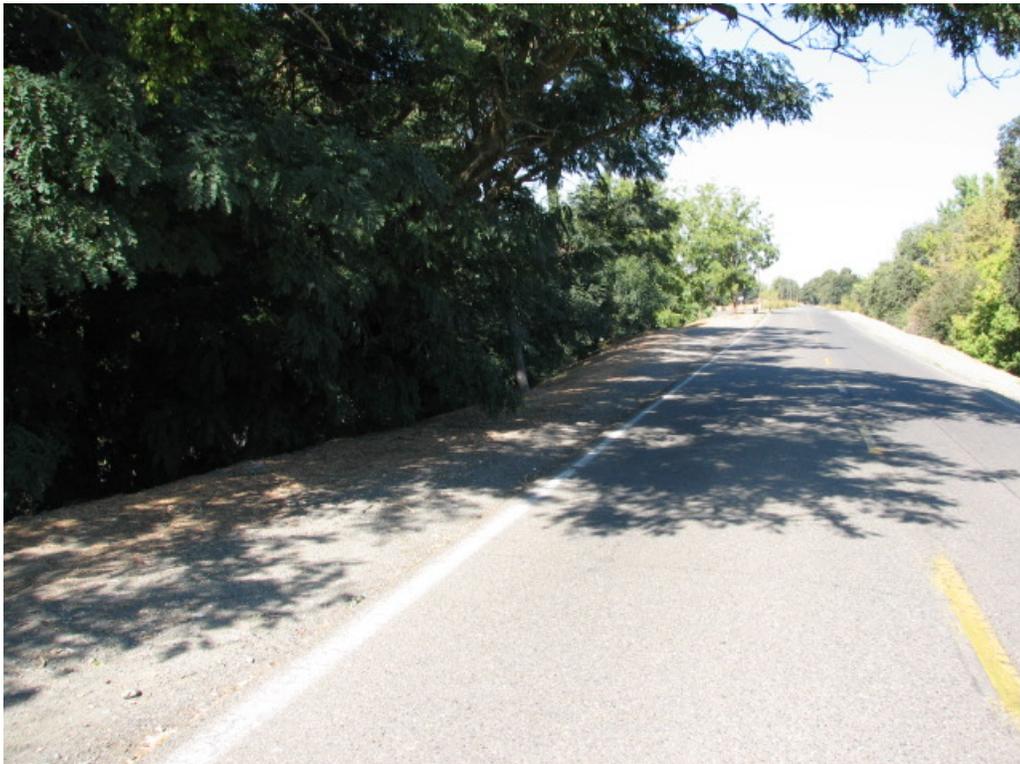
Minimally Acceptable Tree Maintenance: Moderate density of tree limbs partially obstruct visibility and access

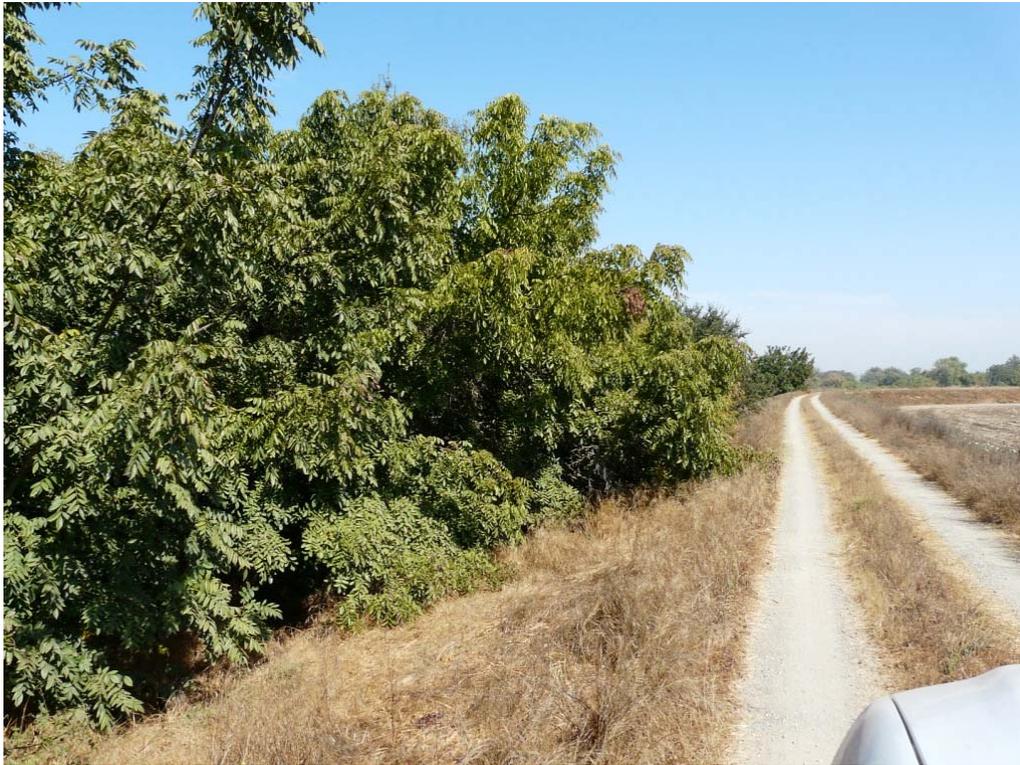
Unacceptable Tree Maintenance: Significant density of tree limbs completely obstruct visibility and access
