**Flood Control Project Maintenance
Levee Inspections
2008 Channel Summary Report
Overall Unit and Item Ratings**

Madera County

Inspection Report - Channel 2008

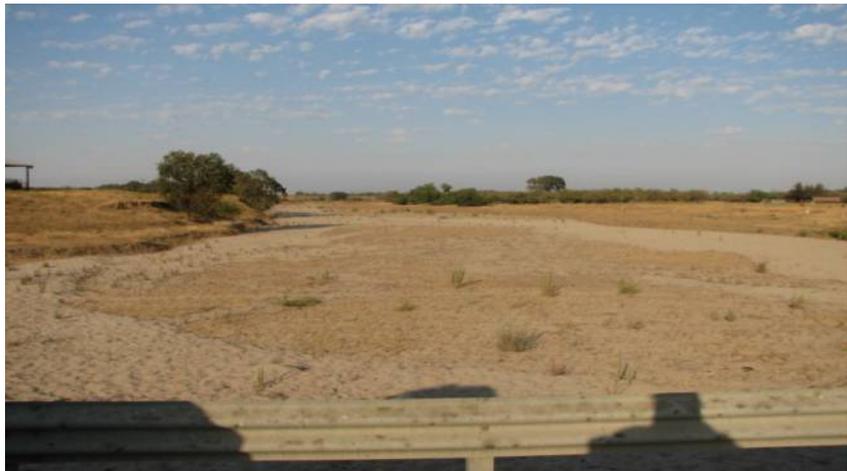
Report Line	1
Location	
Category	Rivers, Channels & Designated Floodways
Item	Vegetation & Obstructions

Upstream from Santa Fe Drive.

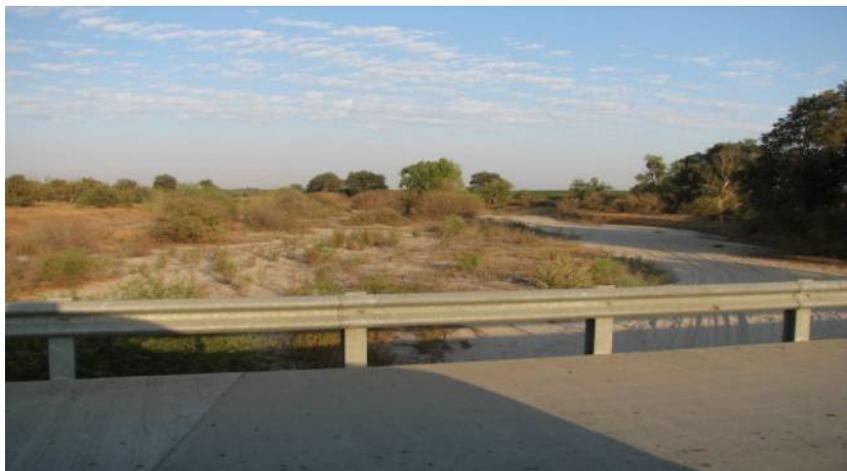
Report Line	2
Location	
Category	Rivers, Channels & Designated Floodways
Item	Vegetation & Obstructions

Upstream from Road 19, marginal gage in channel, from bridge there is atleast 2-300 yards of clearance.

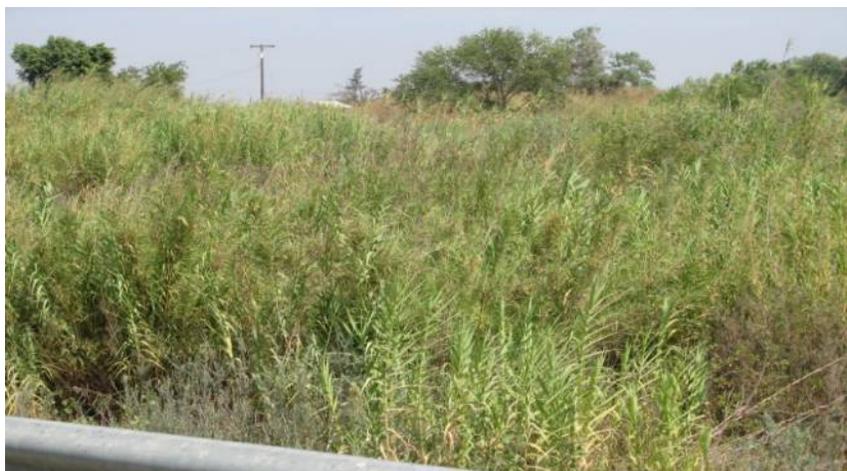
Report Line	3
Location	
Category	Rivers, Channels & Designated Floodways
Item	Vegetation & Obstructions

Upstream from Road 13. (Note heavy growth of bambo)

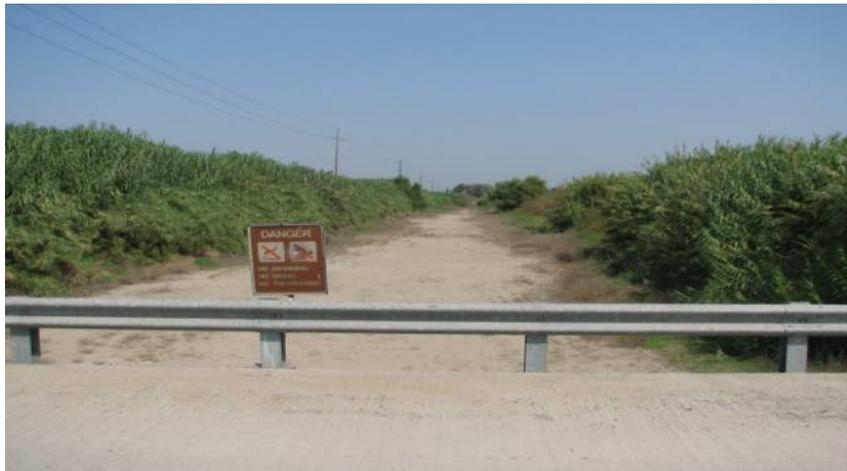
Report Line	4
Location	
Category	Rivers, Channels & Designated Floodways
Item	Vegetation & Obstructions
Downstream from Road 12.

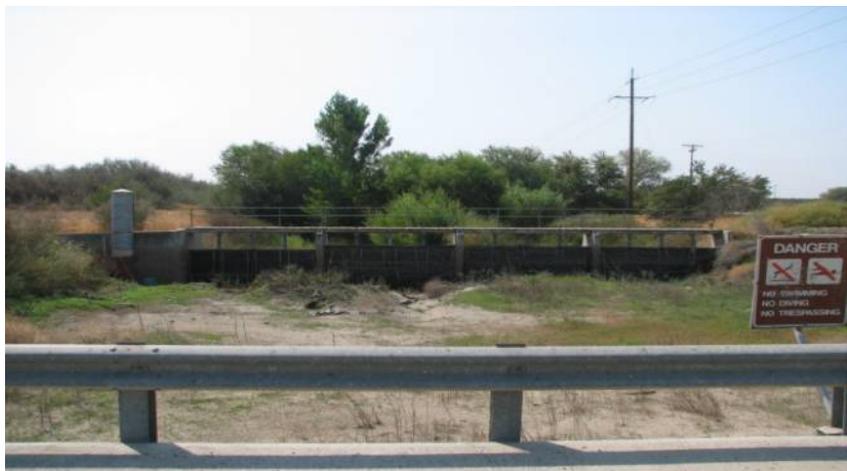
Report Line	5
Location	
Category	Rivers, Channels & Designated Floodways
Item	Vegetation & Obstructions
upstream from Road 12 bridge looking back towards the weir. Note the heavy growth just upstream from weir structure.

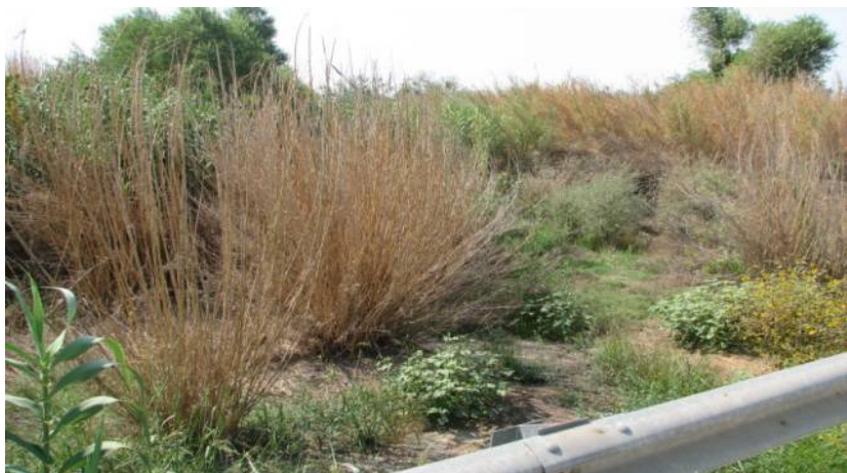
Report Line	6
Location	
Category	Rivers, Channels & Designated Floodways
Item	Vegetation & Obstructions
Upstream from Avenue 18 1/2 bridge. (Note growth in channel below bridge)

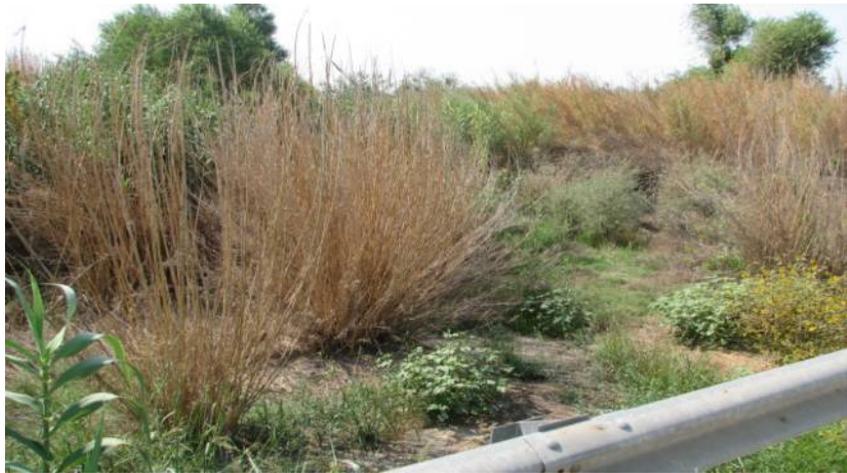
Report Line	6
Location	
Category	Rivers, Channels & Designated Floodways
Item	Vegetation & Obstructions
Downstream from Avenue 18 1/2.

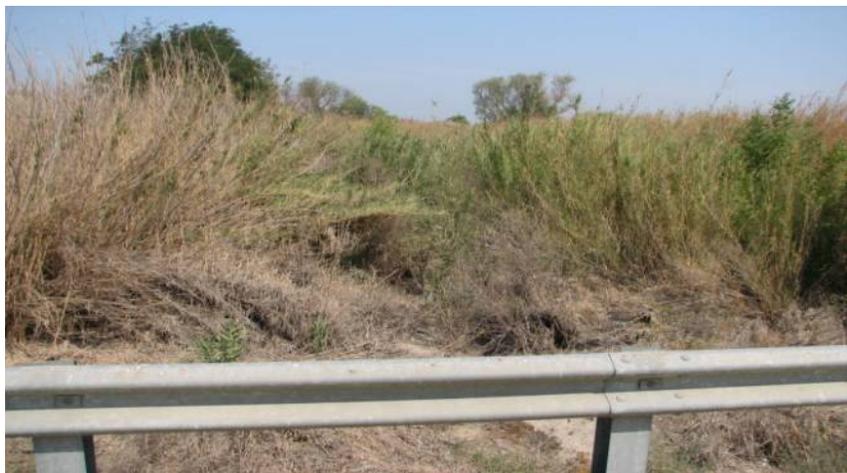
Report Line	7
Location	
Category	Rivers, Channels & Designated Floodways
Item	Vegetation & Obstructions
Upstream from Avenue 19.

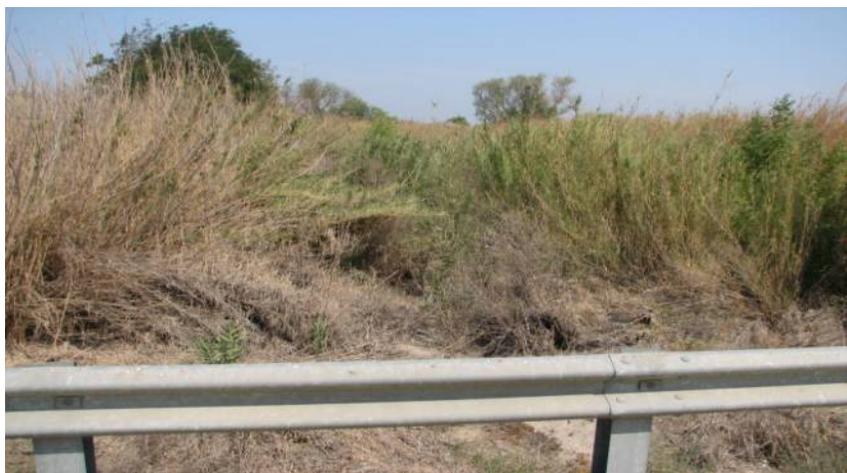
Report Line	8
Location	
Category	Rivers, Channels & Designated Floodways
Item	Vegetation & Obstructions
Down stream from Avenue 19 1/2. Note wild growth in back ground.

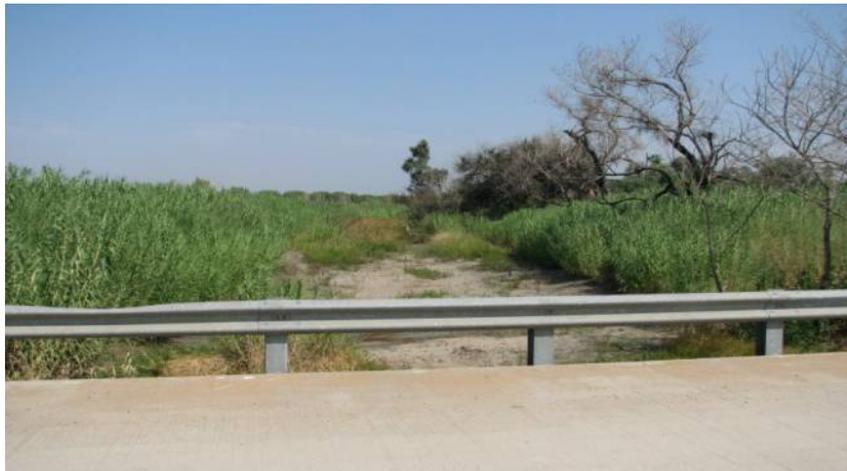
Report Line	9
Location	
Category	Rivers, Channels & Designated Floodways
Item	Vegetation & Obstructions
Downstream from Avenue 21.

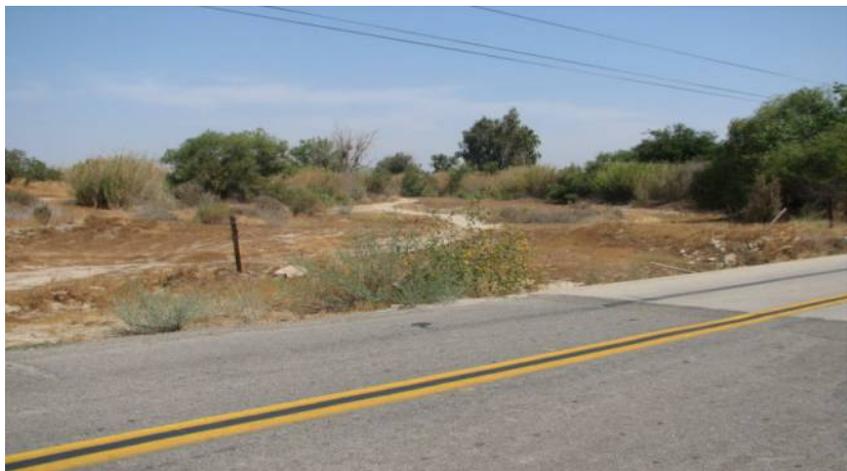
Report Line	10
Location	
Category	Rivers, Channels & Designated Floodways
Item	Vegetation & Obstructions
Upstream from Avenue 23 1/2. (Low water crossing)

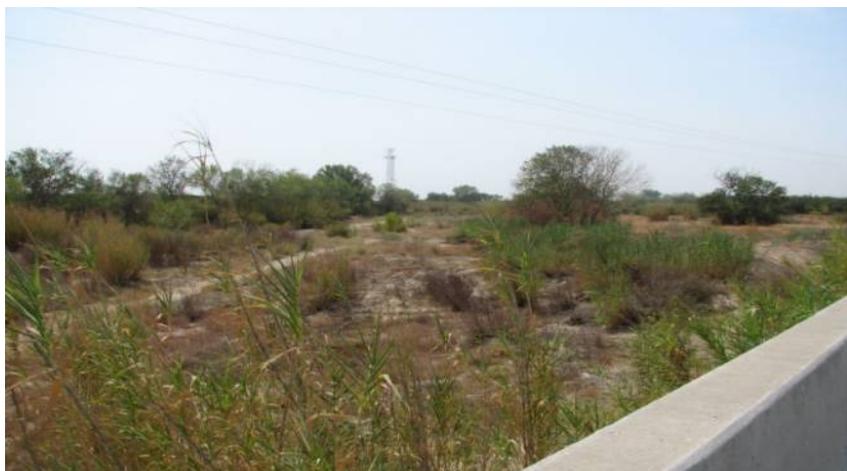
Report Line	11
Location	
Category	Rivers, Channels & Designated Floodways
Item	Vegetation & Obstructions
Down stream from road 152.

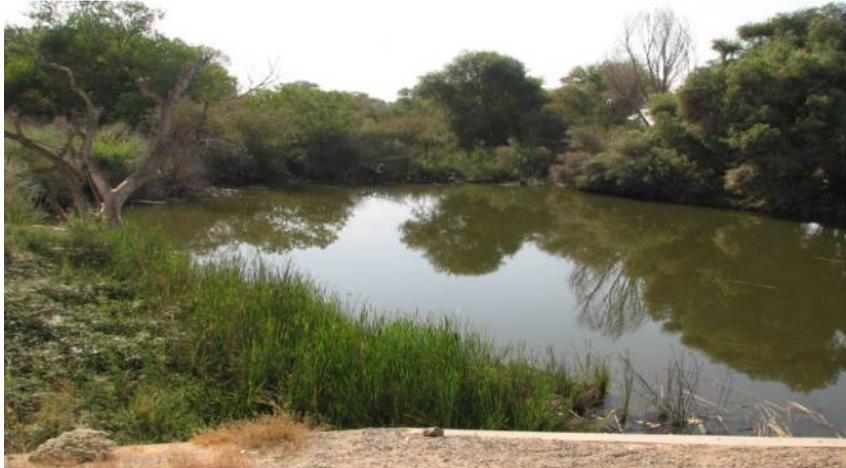
Report Line	1
Location	
Category	Rivers, Channels & Designated Floodways
Item	Vegetation & Obstructions
Downstream from the Berenda Slough bifurcation structure.

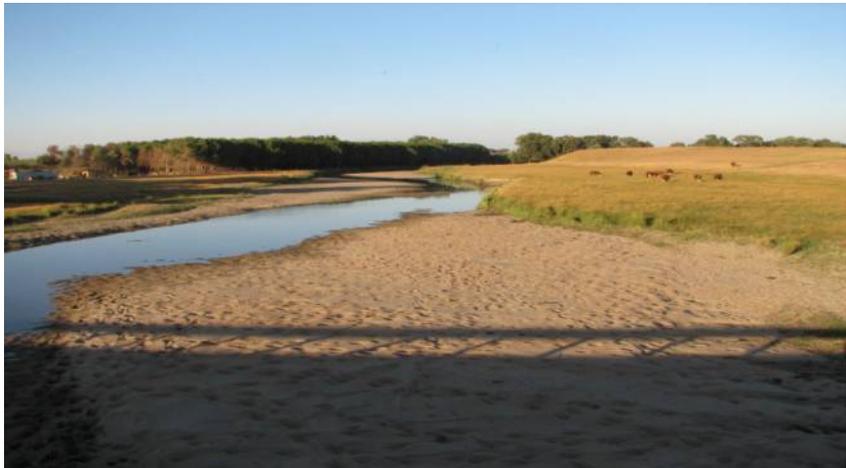
Report Line	2
Location	
Category	Rivers, Channels & Designated Floodways
Item	Vegetation & Obstructions
Upstream from Santa Fe Drive

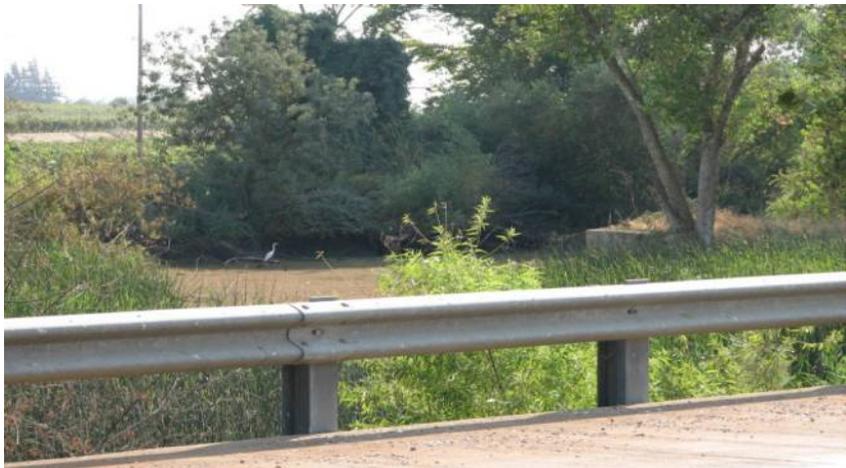
Report Line	3
Location	
Category	Rivers, Channels & Designated Floodways
Item	Vegetation & Obstructions
Downstream from Avenue 26.

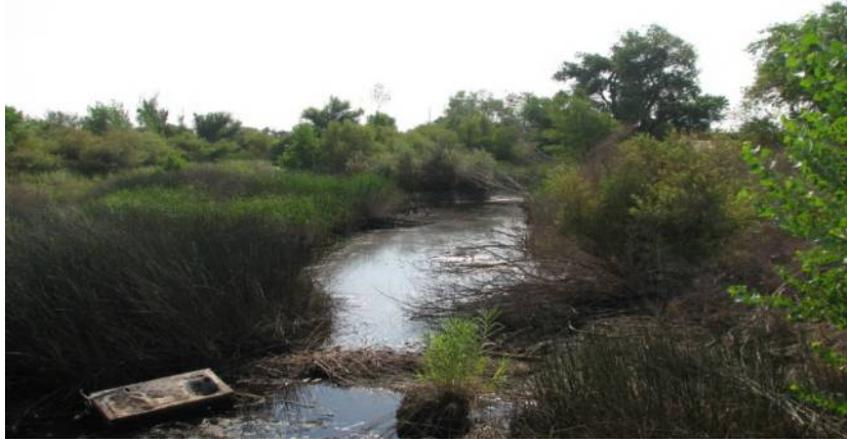
Report Line	4
Location	
Category	Rivers, Channels & Designated Floodways
Item	Vegetation & Obstructions
Downstream from Road 19.

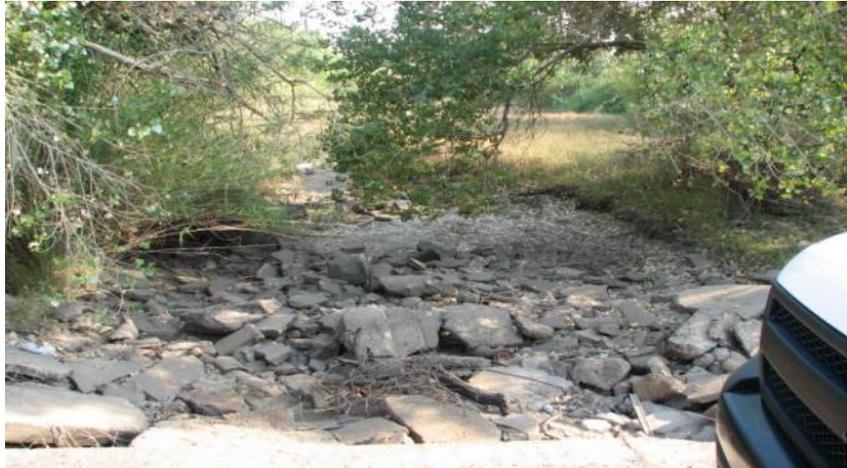
Report Line	5
Location	
Category	Rivers, Channels & Designated Floodways
Item	Vegetation & Obstructions
Downstream from Avenue 22 1/2 low water crossing.

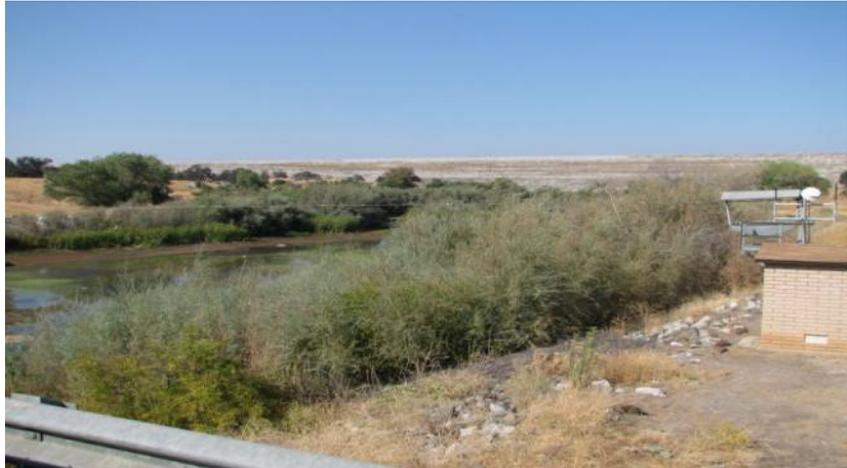
Report Line	1
Location	
Category	Rivers, Channels & Designated Floodways
Item	Vegetation & Obstructions
From bridge downstream from Buchanan Dam, vegetation on both banks does not obstruct flow.

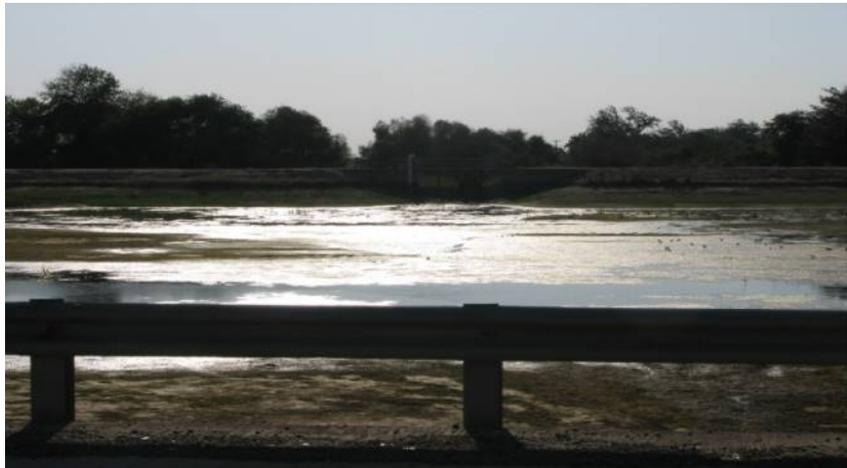
Report Line	2
Location	
Category	Rivers, Channels & Designated Floodways
Item	Vegetation & Obstructions
Downstream from Road 15 (Minturn Road).

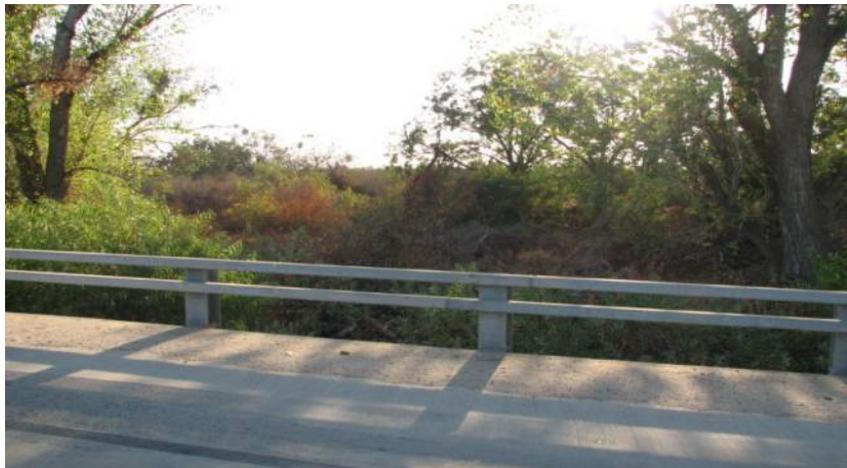
Report Line	3
Location	
Category	Rivers, Channels & Designated Floodways
Item	Vegetation & Obstructions
Downstream from Road 13 (Vista Avenue).

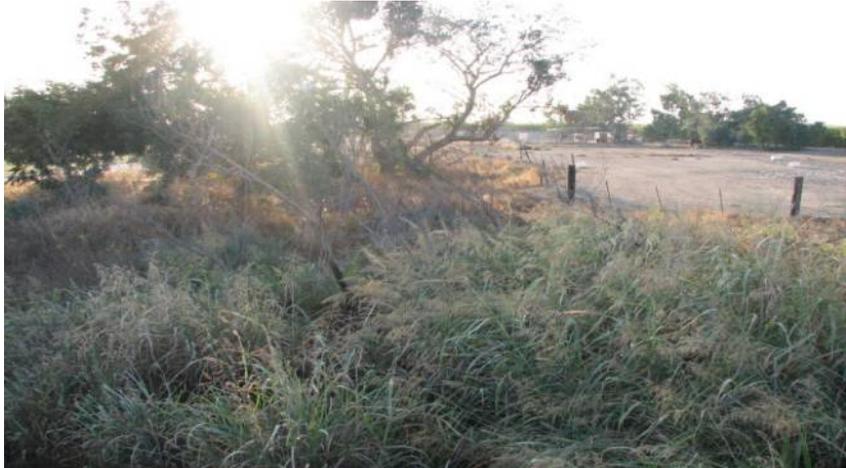
Report Line	4
Location	
Category	Rivers, Channels & Designated Floodways
Item	Vegetation & Obstructions
Downstream from Road 9 (Bliss Road).

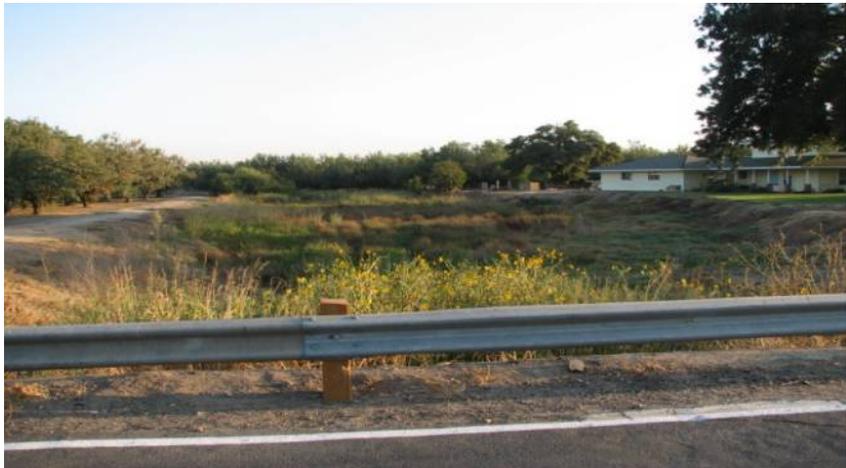
Report Line	5
Location	
Category	Rivers, Channels & Designated Floodways
Item	Vegetation & Obstructions
Upstream of Avenue 25 (Washington Road).

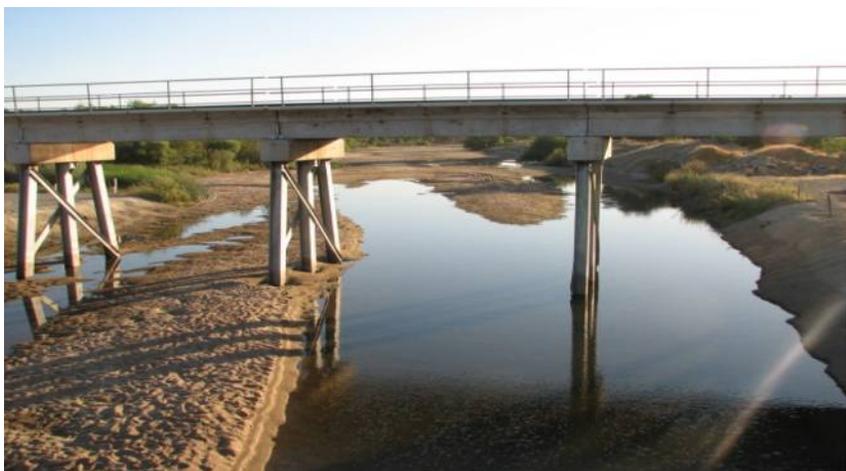
Report Line	6
Location	
Category	Rivers, Channels & Designated Floodways
Item	Encroachments
Downstream from Santa Fe Drive, this is a new Train Track Structure that was replaced 2007. The timber one burned down.

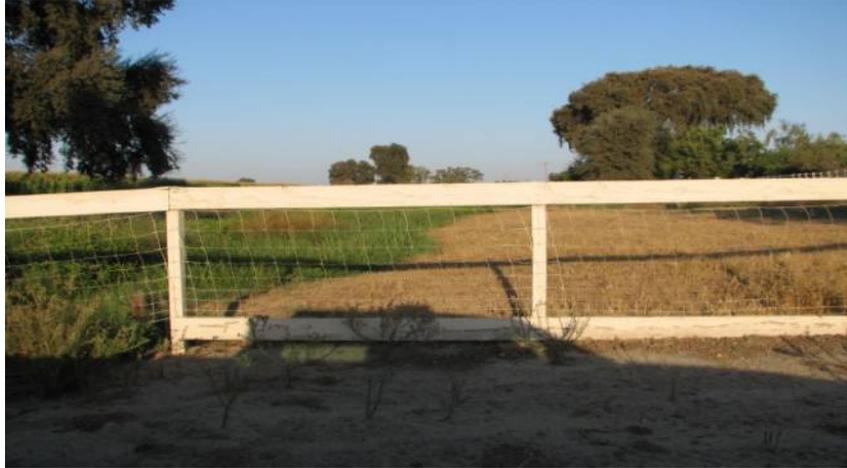
Report Line	7
Location	
Category	Rivers, Channels & Designated Floodways
Item	Encroachments

Roll Line	Category	Item	Location *	Rating **	Comment	GPS	Photo	Issue
1	Rivers, Channels & Designated Floodways	Vegetation & Obstructions		A			◦ ◦	Y 1
2	Rivers, Channels & Designated Floodways	Vegetation & Obstructions		A	This location did not have any visible problems.		◦ ◦	Y 3
3	Rivers, Channels & Designated Floodways	Vegetation & Obstructions		U			◦ ◦	Y 4
4	Rivers, Channels & Designated Floodways	Vegetation & Obstructions		M	This portion of channel is heavily over grown with wild growth.		◦ ◦	Y 6
5	Rivers, Channels & Designated Floodways	Vegetation & Obstructions		A			◦ ◦	Y 7
6	Rivers, Channels & Designated Floodways	Encroachments		A	The location where this photo was taken shows no particular problem except for minor growth along the banks.		◦ ◦	Y 2
7	Rivers, Channels & Designated Floodways	Encroachments		U	This fence is an unauthorized encroachment across the channel.		◦ ◦	Y 5

Upstream on Road 11. Fencing across the channel

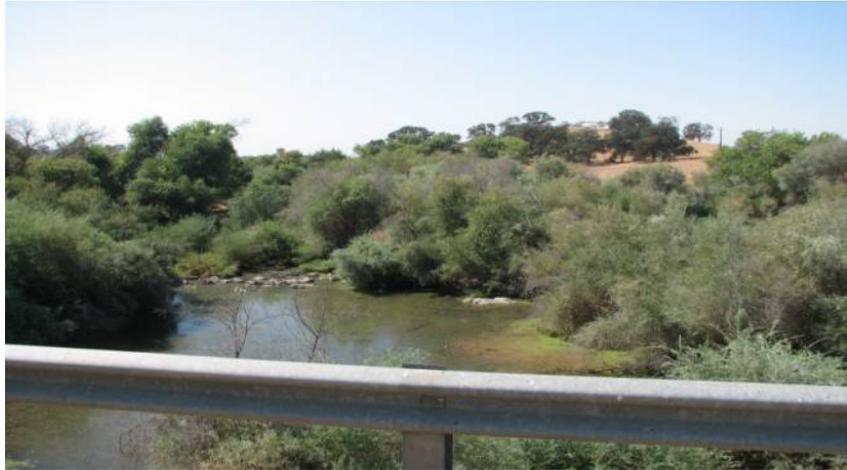
Report Line	1
Location	
Category	Rivers, Channels & Designated Floodways
Item	Vegetation & Obstructions
Downstream of Road 603.

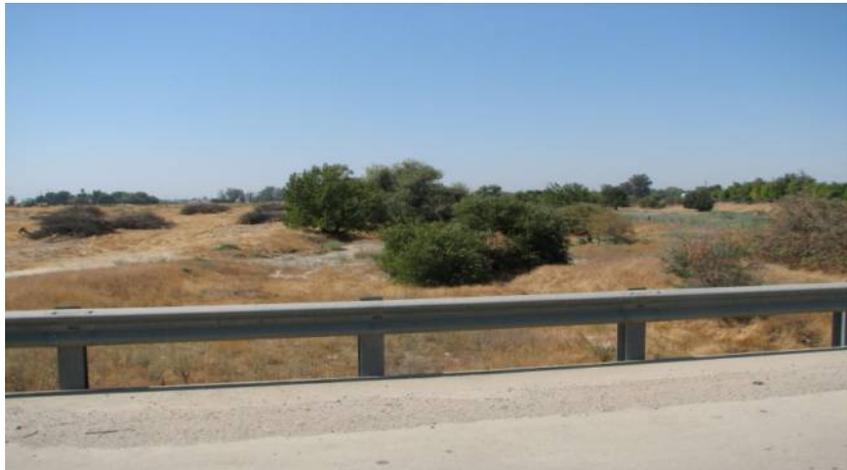
Report Line	1
Location	
Category	Rivers, Channels & Designated Floodways
Item	Vegetation & Obstructions
Upstream from Island Drive.

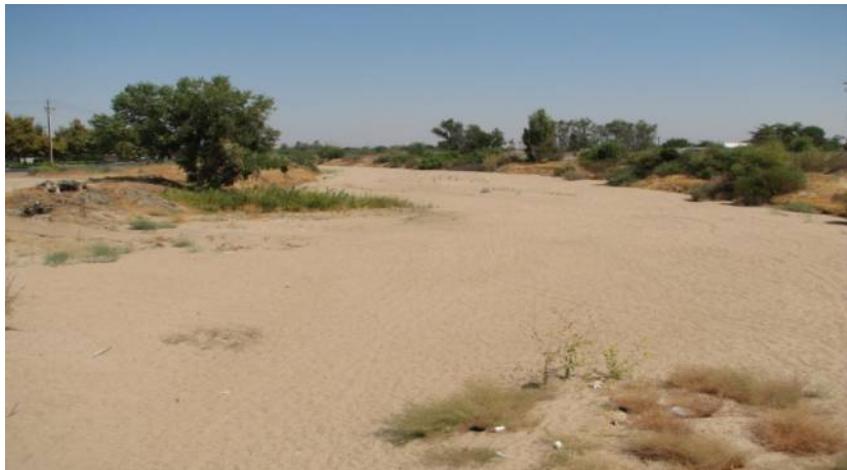
Report Line	3
Location	
Category	Rivers, Channels & Designated Floodways
Item	Vegetation & Obstructions
Downstream from Cleveland Avenue.

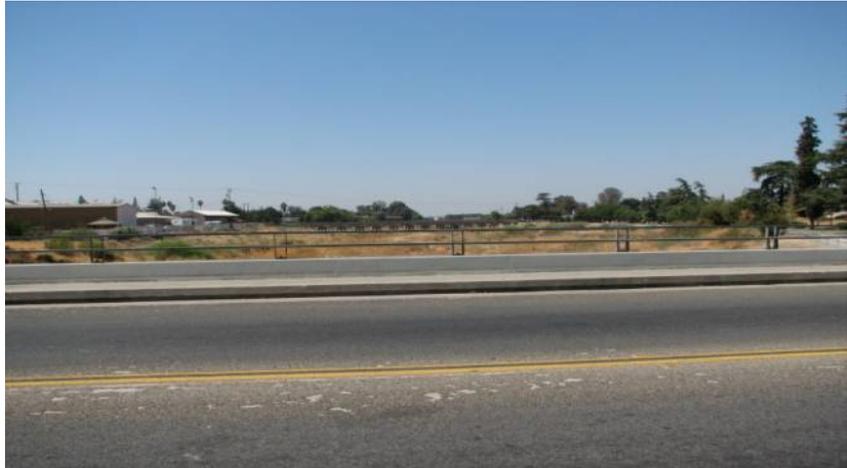
Report Line	4
Location	
Category	Rivers, Channels & Designated Floodways
Item	Vegetation & Obstructions
Downstream From "D" street looking at the Gateway bridge.

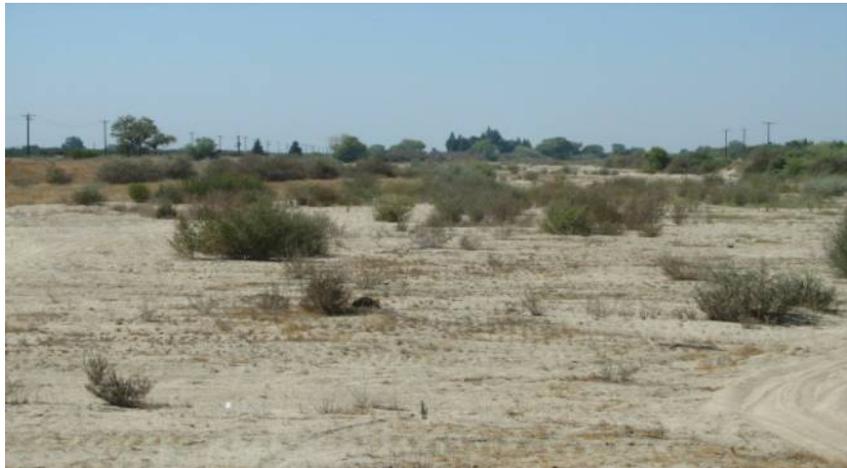
Report Line	5
Location	
Category	Rivers, Channels & Designated Floodways
Item	Vegetation & Obstructions
Downstream from Road 23.

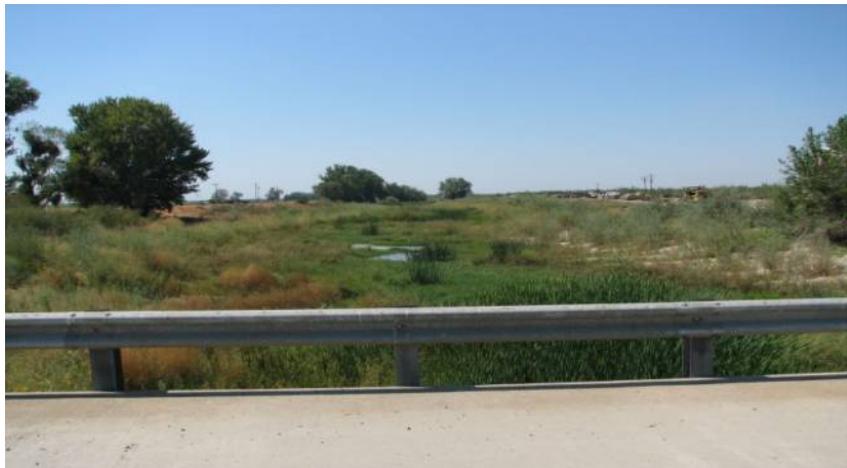
Report Line	6
Location	
Category	Rivers, Channels & Designated Floodways
Item	Vegetation & Obstructions
Downstream from Road 20. Bambo and small trees growing with in channel.

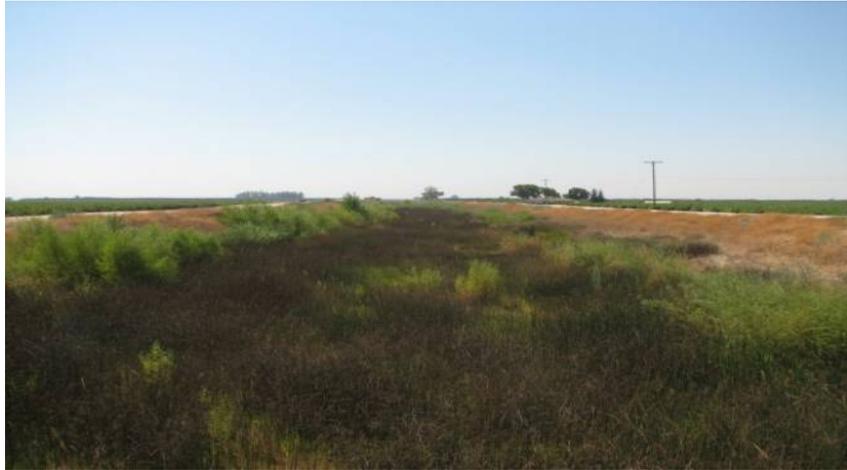
Report Line	7
Location	
Category	Rivers, Channels & Designated Floodways
Item	Vegetation & Obstructions

Upstream from the downstream boundary.
