Flood Control Project Maintenance
2008 Structure Summary Report
Overall Unit and Item Ratings

Sacramento County

American River Pumping Plant No. 1 Howe Avenue Storm Drain D - 05

American River Pumping Plant No. 2 Willhaggin Storm Drain D - 43

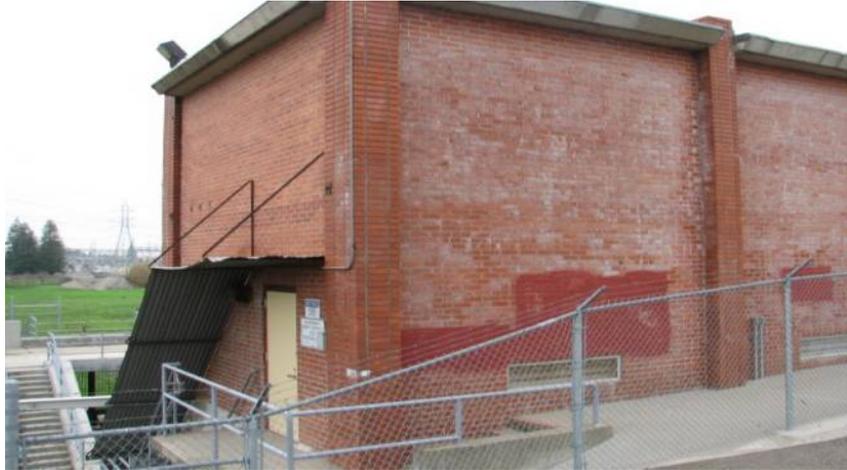
Report Line	3
Location	
Category	Pump Stations
Item	Plant Building
Plant building is brick. No deterioration or cracking is visible.

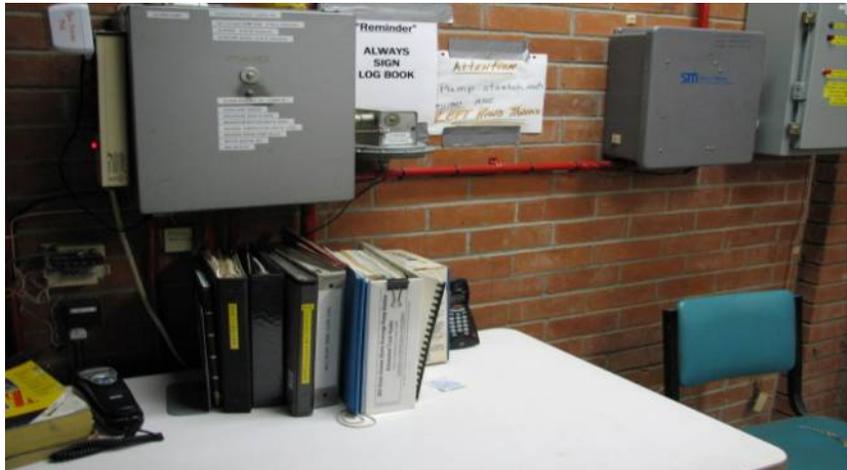
Report Line	4
Location	
Category	Pump Stations
Item	Communications
Communications area within the station.

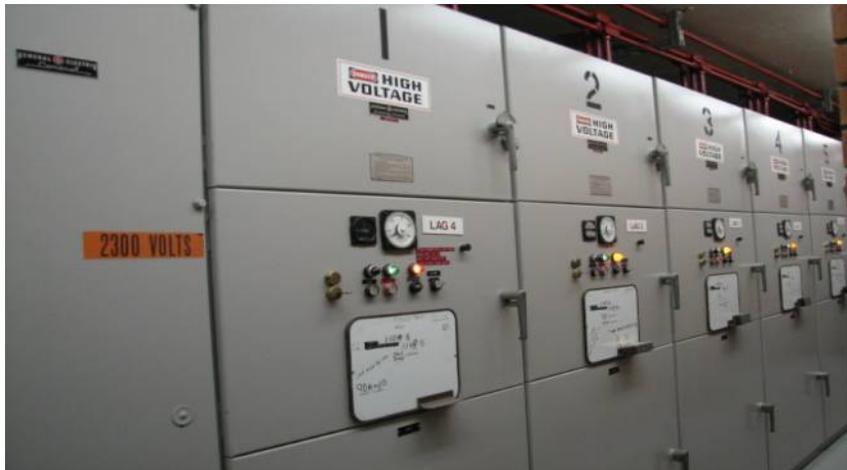
Report Line	10
Location	
Category	Pump Stations
Item	Pump Control Systems
Pump control/power.

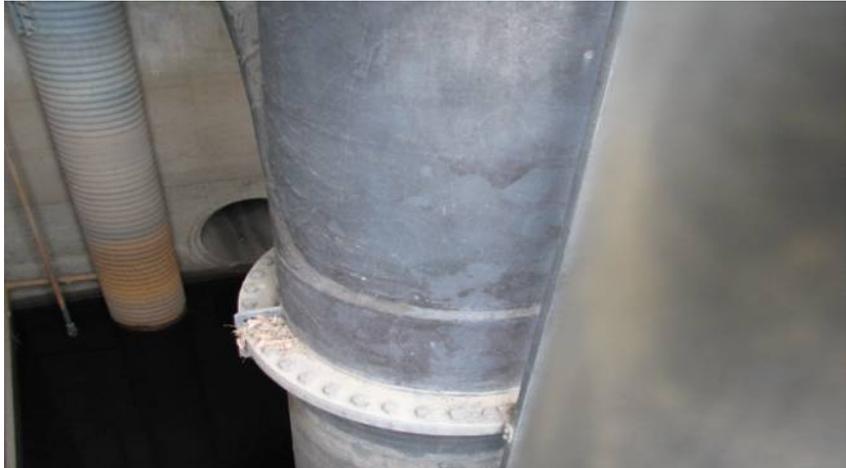
Report Line	11
Location	
Category	Pump Stations
Item	Sumps/Wet Well

View down wet-well. Clear of debris.

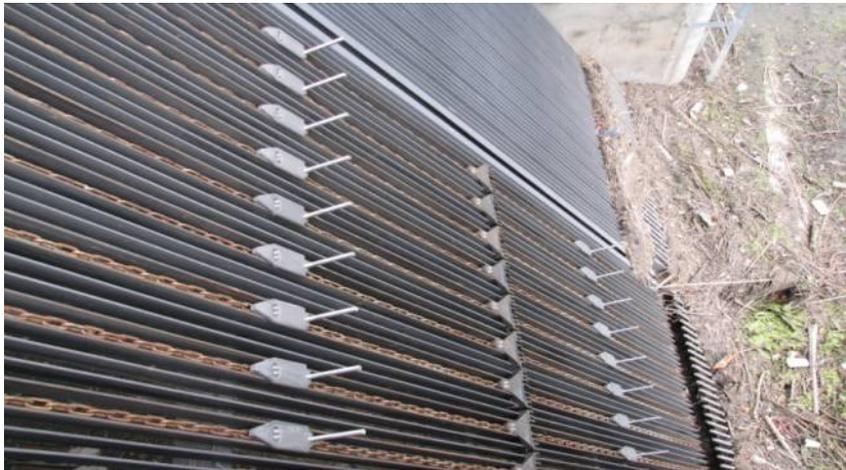
Report Line	12
Location	
Category	Pump Stations
Item	Trash Racks

View of trash racks. Chain driven trash rakes can also be seen.

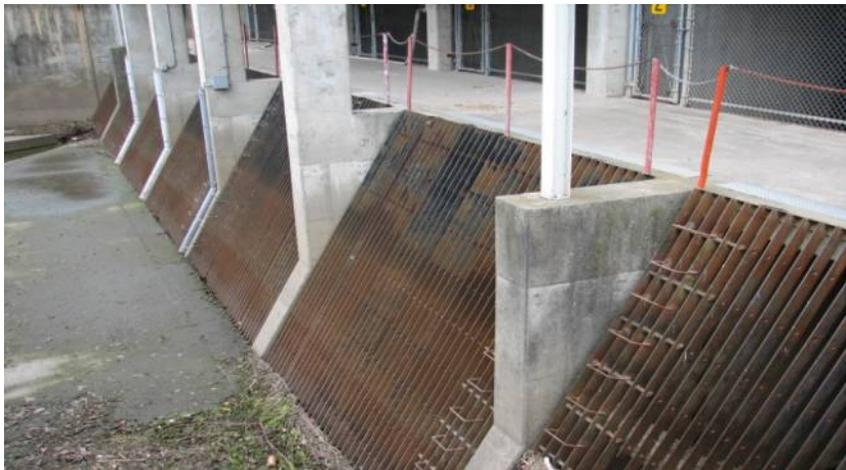
Report Line	12
Location	
Category	Pump Stations
Item	Trash Racks

View of original trash racks which are situated behind the chain driven trash rack installation. These now function as a secondary system.

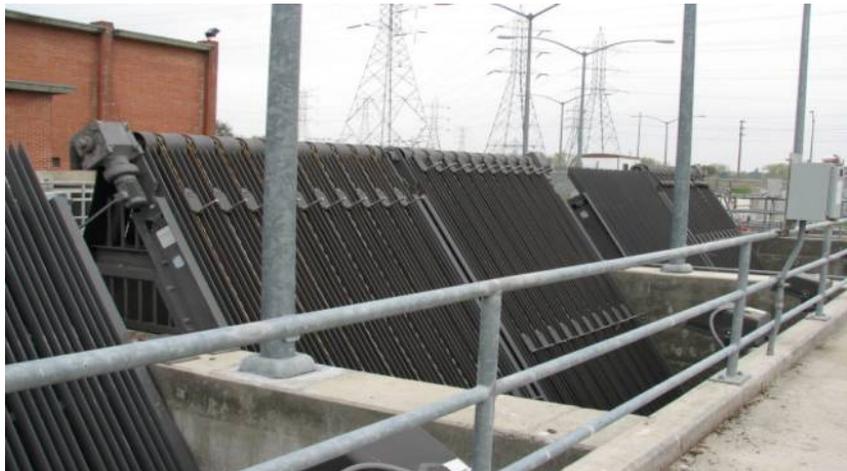
Report Line	13
Location	
Category	Pump Stations
Item	Trash Rakes
Top of trash racks where chain driven rakes are controlled.

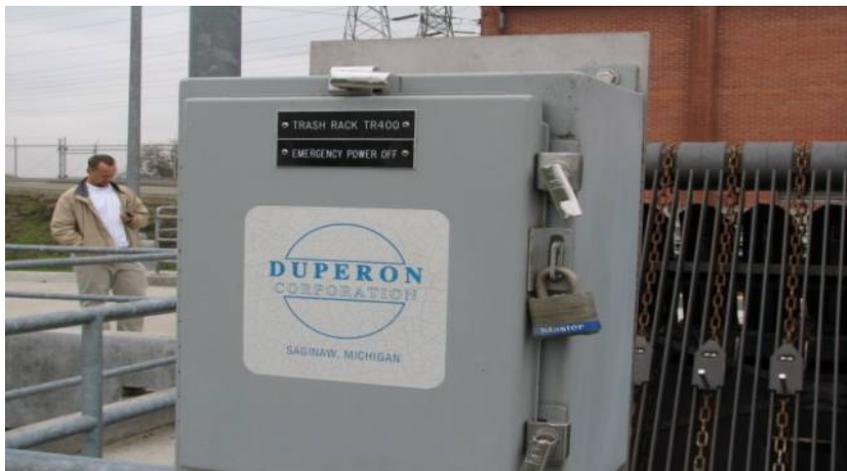
Report Line	13
Location	
Category	Pump Stations
Item	Trash Rakes
Power for the chain drive.

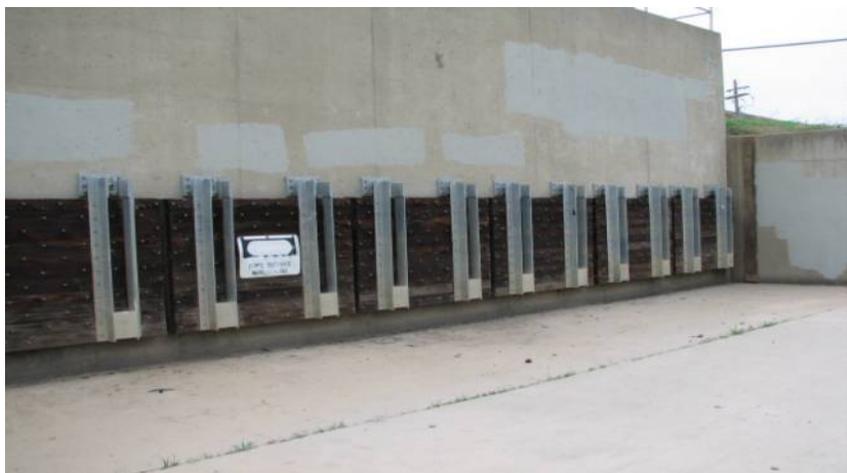
Report Line	18
Location	
Category	Pump Stations
Item	Flap Gates
Flap gates.

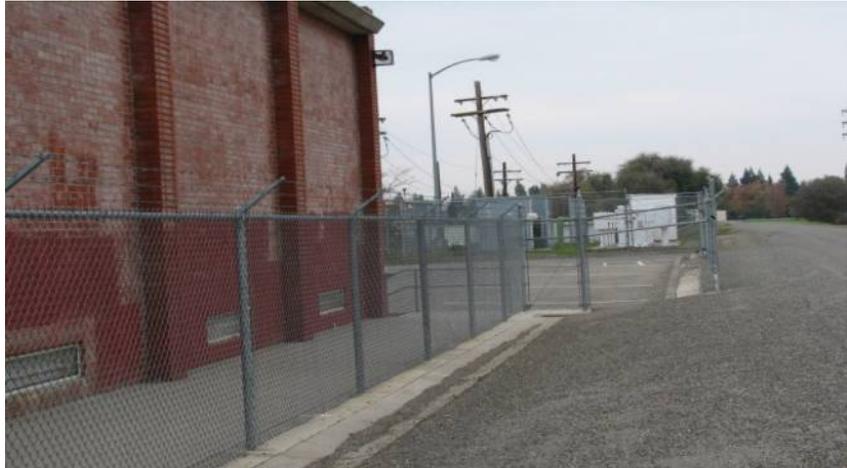
Report Line	20
Location	
Category	Pump Stations
Item	Security Fencing

Security fencing completely encloses the station and is topped with barbed wire.

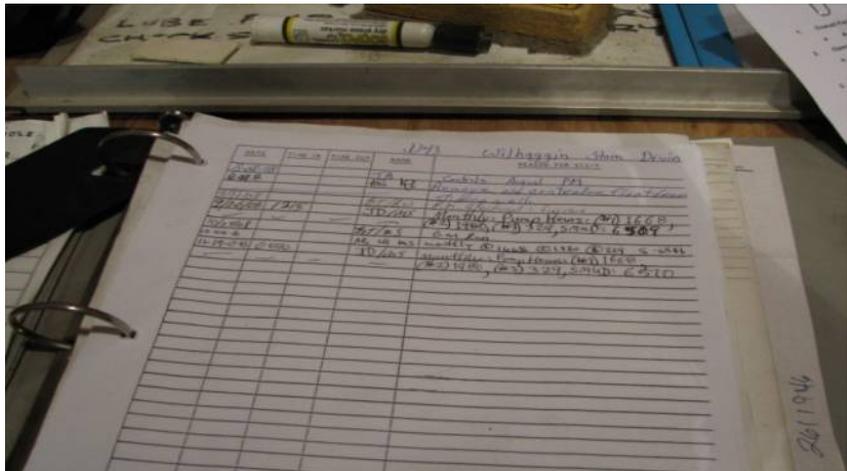
Report Line	1
Location	
Category	Pump Stations
Item	Operating Log
Maintenance and operations log indicates regular care is taken.

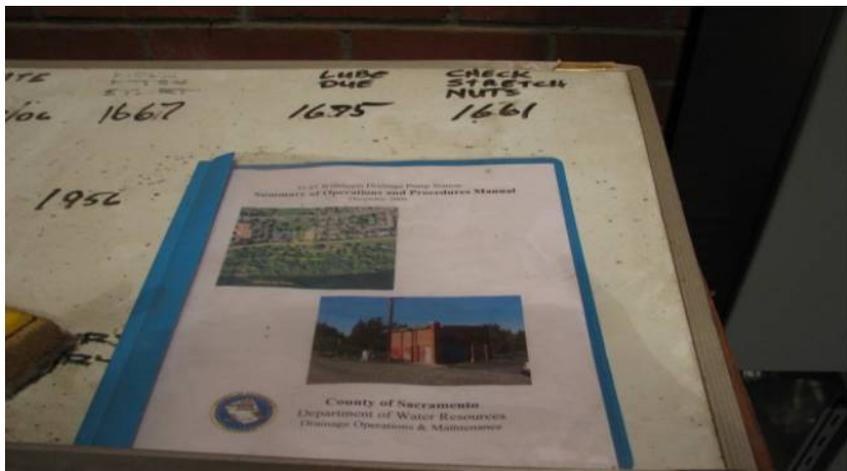
Report Line	2
Location	
Category	Pump Stations
Item	Operation & Maintenance Manual
County O&M manual present.

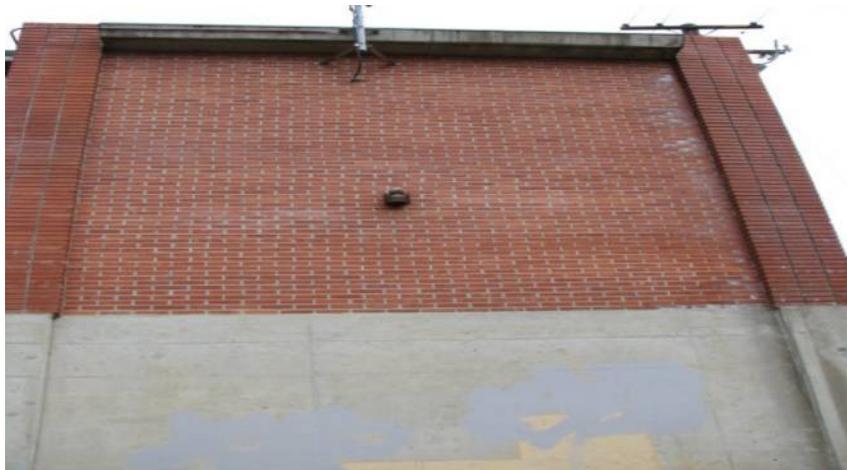
Report Line	3
Location	
Category	Pump Stations
Item	Plant Building
Pump station exterior has no visible cracking, appears structurally sound.

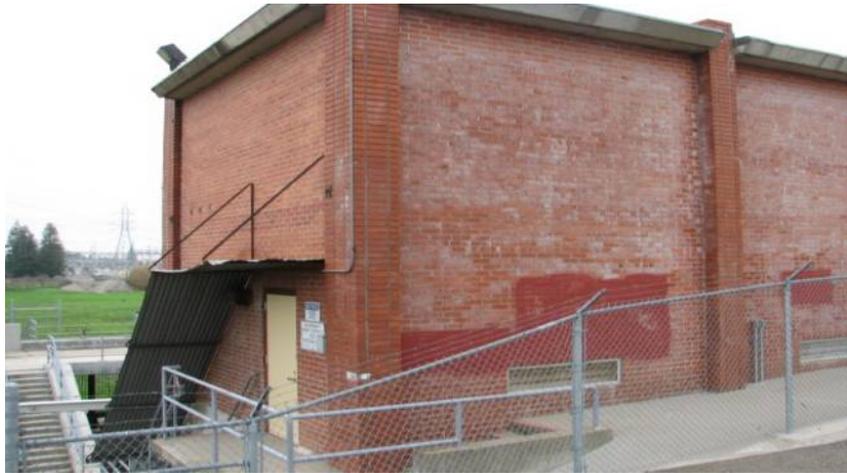
Report Line	3
Location	
Category	Pump Stations
Item	Plant Building

Another view.

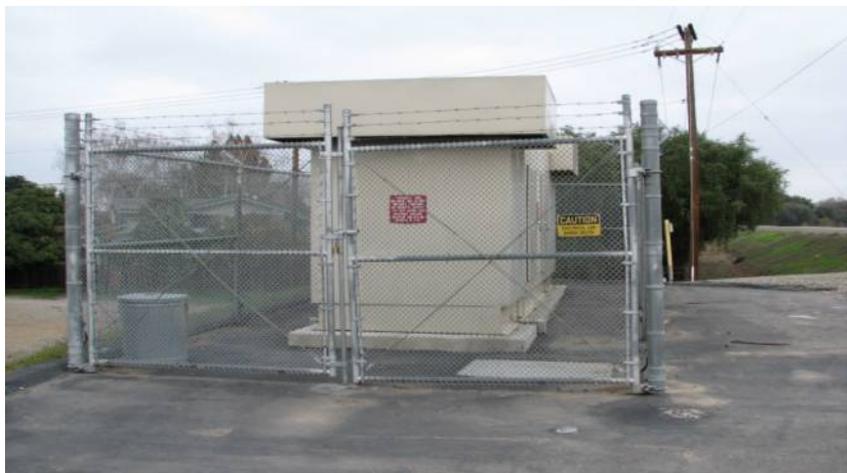
Report Line	8
Location	
Category	Pump Stations
Item	Power

Generators are housed within this fencing approximately 20' from the pump station.

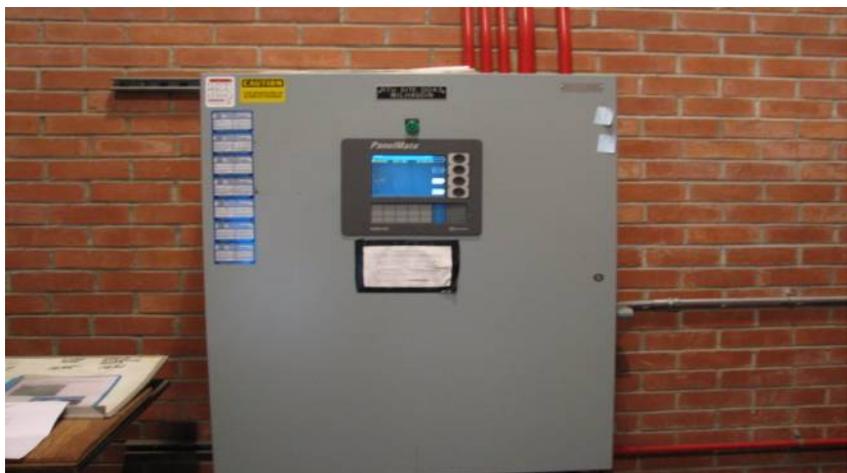
Report Line	10
Location	
Category	Pump Stations
Item	Pump Control Systems

Pump control system.

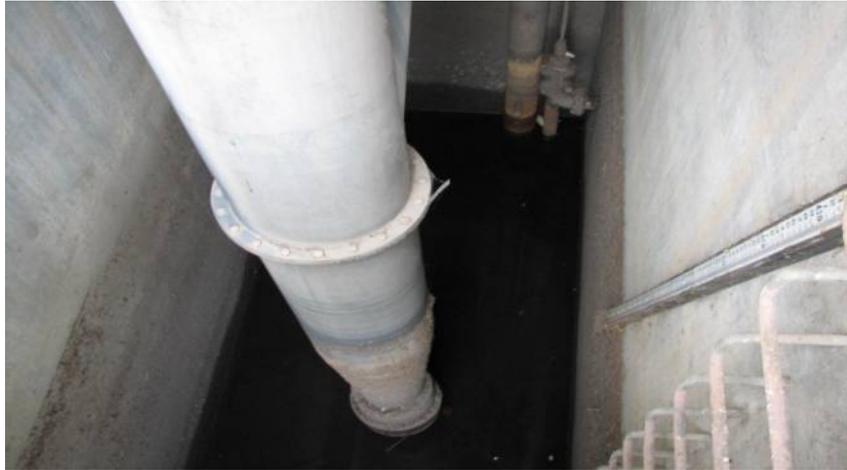
Report Line	11
Location	
Category	Pump Stations
Item	Sumps/Wet Well

View down to the wet well. Very clean.

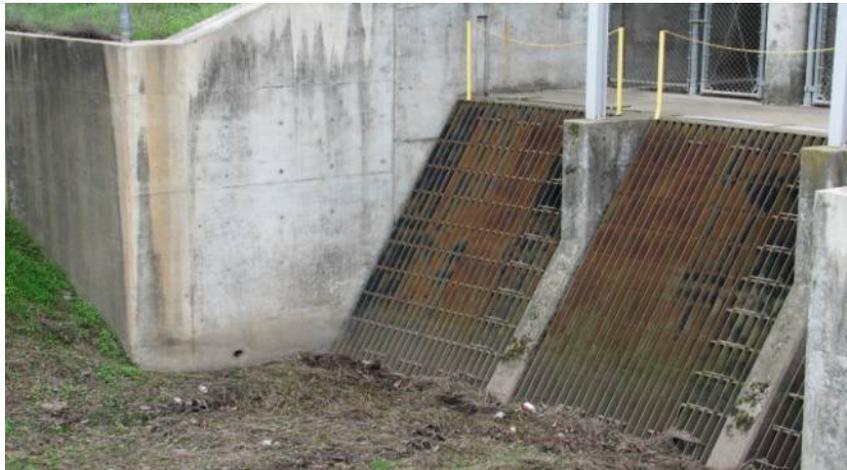
Report Line	12
Location	
Category	Pump Stations
Item	Trash Racks

Some rust is present on the racks but clear of debris.

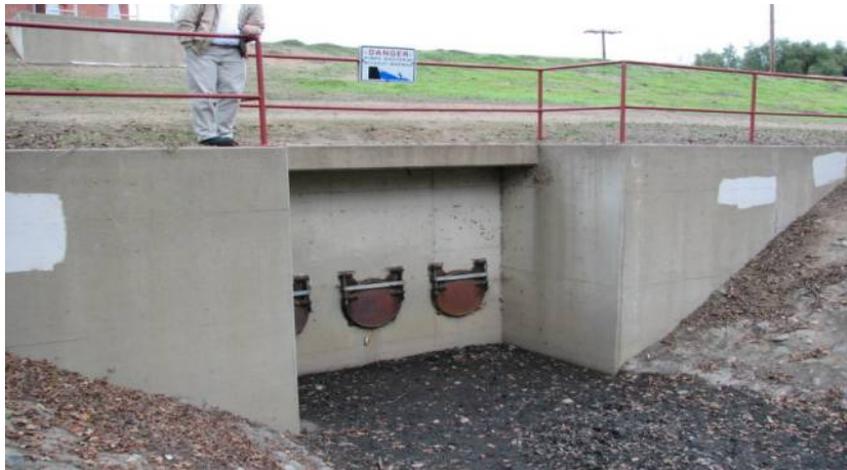
Report Line	14
Location	
Category	Pump Stations
Item	Sluice / Slide Gates

View of flap gates. No visible rust or damage.

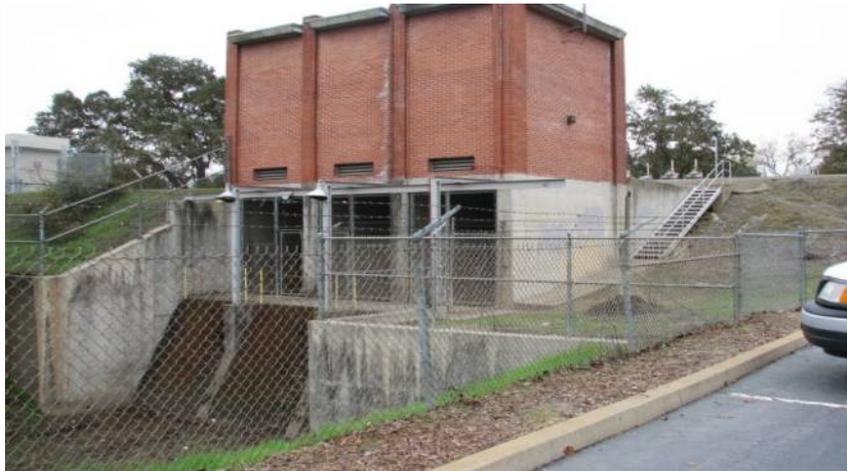
Report Line	20
Location	
Category	Pump Stations
Item	Security Fencing
View of security fencing.

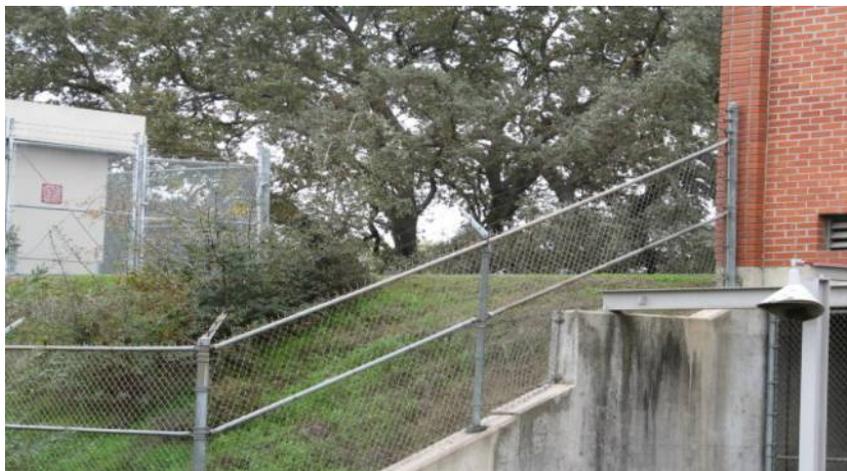
Report Line	20
Location	
Category	Pump Stations
Item	Security Fencing
Another view. Barbed wire is present at the top of the fencing but is not very visible here.
