State of California
The Natural Resources Agency
Department of Water Resources
Division of Flood Management
Flood Project Integrity & Inspection Branch

2009
SUPPLEMENTAL
EROSION SURVEY
OF THE
SAN JOAQUIN RIVER
FLOOD CONTROL SYSTEM
April 2010

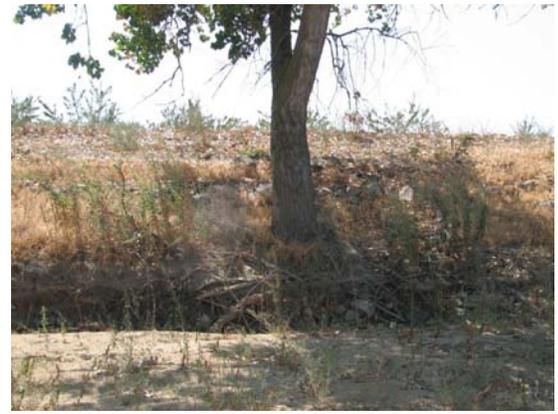
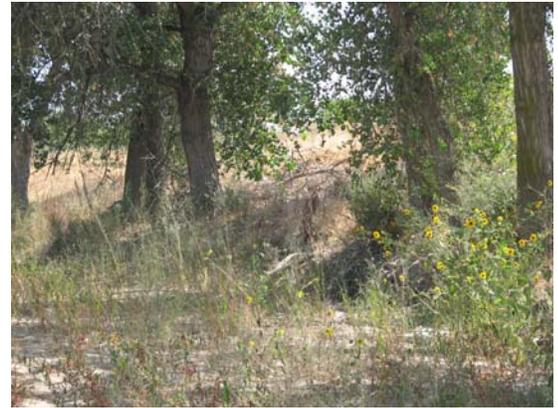
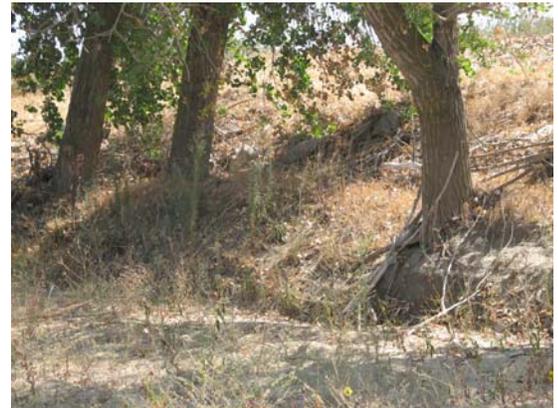
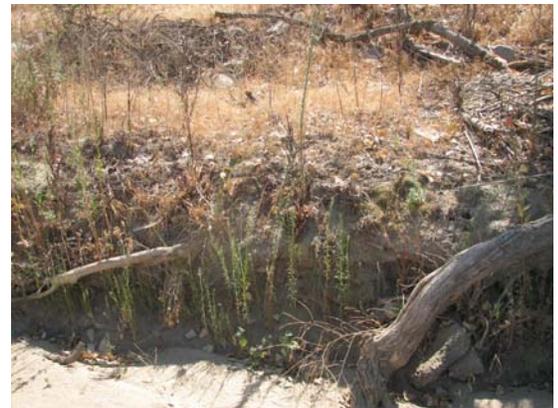
Length (ft):	460
Scarp Height (ft):	3
Location Relative to Levee:	Levee toe
Remaining Berm Width(ft):	0
Vegetation cover:	2/3 of ground covered
Burrow Holes (WS):	No Activity
Levee Slope (H:V):	2.5:1
Soil Type:	Sand (SP,SM and mixture)
Condition of surrounding tree(s)	Tree(s) within affected area and with visible roots and leaning
Crown Width (ft):	
Site Relative to Bend:	Outside of bend > 90 deg
Radius of Curvature:	8.9

Most Recent:	2009: Site recommended as local maintenance issue, per Critical Levee Repair Office, Critical Erosion Sites Evaluation 2008 Report; previously rated "M"
Previous Comments:	2007: undercutting of the toe; several trees along the slope, with roots exposed;

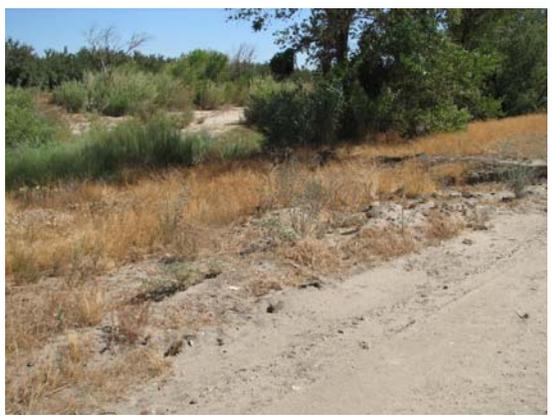
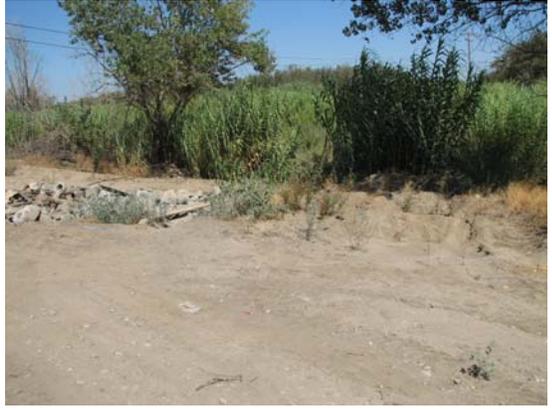
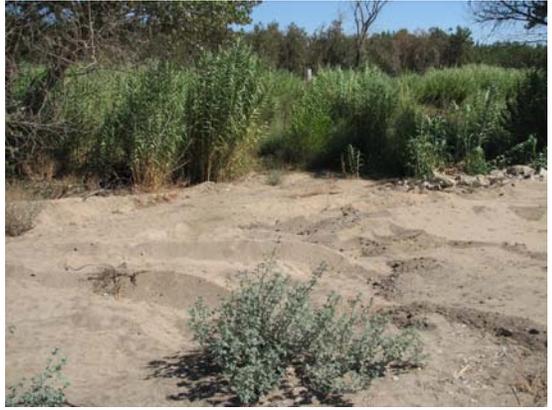
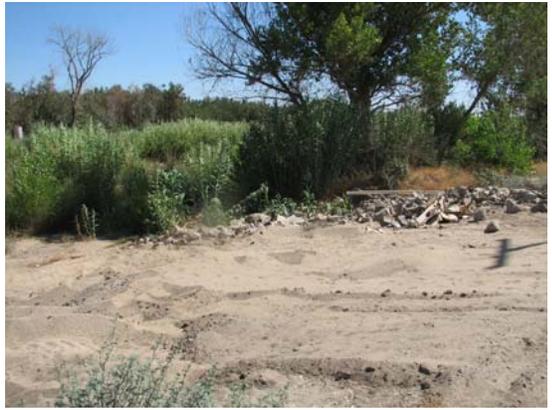
Site ID NA0011U1RM3.8

Length (ft):	<u>100</u>
Scarp Height (ft):	<u>5</u>
Location Relative to Levee:	<u>Toe & slope</u>
Remaining Berm Width(ft):	<u>10</u>
Vegetation cover:	<u>Ground surrounding site is fully covered</u>
Burrow Holes (WS):	<u>No Activity</u>
Levee Slope (H:V):	<u>3:1 or greater</u>
Soil Type:	<u>Sand (SP,SM and mixture)</u>
Condition of surrounding tree(s)	<u>Tree(s) within affected area</u>
Crown Width (ft):	
Site Relative to Bend:	<u>Immediately downstream of bend</u>
Radius of Curvature:

Most Recent:	2009: Site recommended as local maintenance issue, per CLRO CES Evaluation 2008 Report; previously rated "M"
Previous Comments:	2008: undulating waterside slope surface; vehicular damage along the waterside slope caused by farming equipment; sandy material; small area of concrete rubble found on waterside crown hinge; vehicular damage extends from levee toe to crown surface

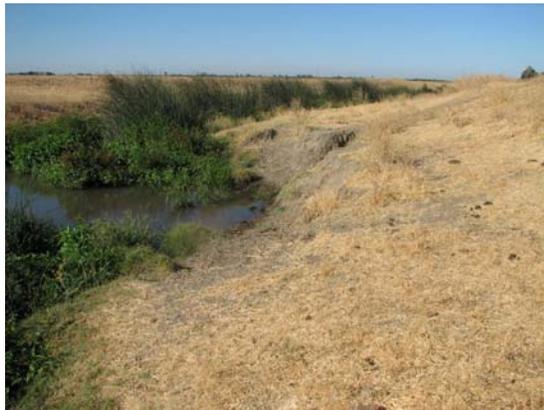
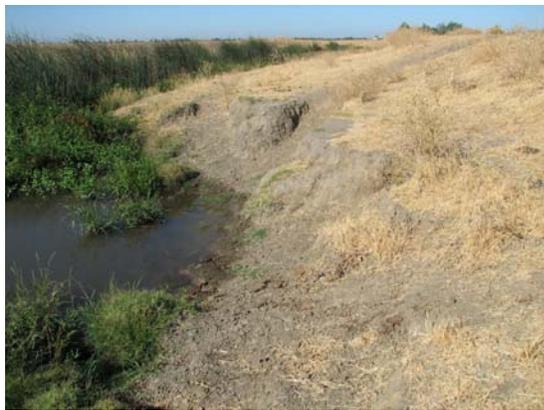
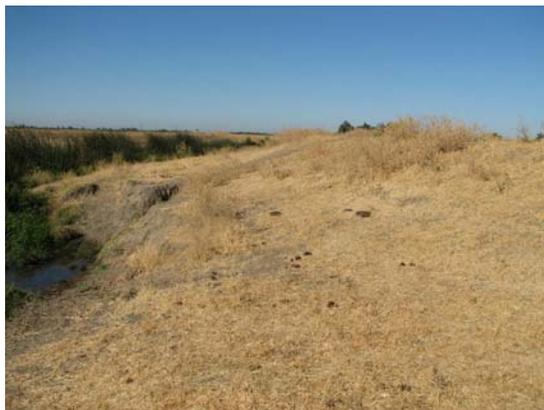
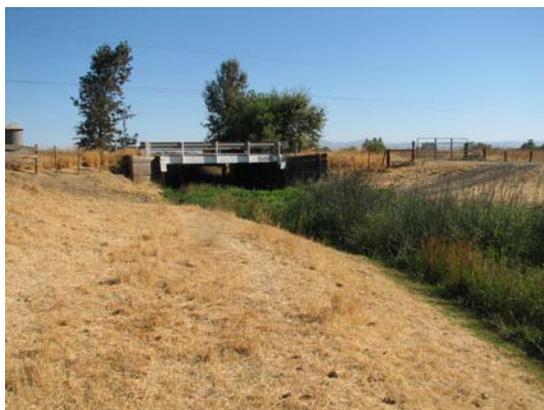
Length (ft):	10
Scarp Height (ft):	3
Location Relative to Levee:	Lower 1/2 slope
Remaining Berm Width(ft):	2
Vegetation cover:	No ground coverage
Burrow Holes (WS):	No Activity
Levee Slope (H:V):	3:1 or greater
Soil Type:	Silt (ML)
Condition of surrounding tree(s)	No tree(s) within affected area
Crown Width (ft):	
Site Relative to Bend:	Inside of bend
Radius of Curvature:	3.8

Most Recent:	2009: bank erosion scour that is immediately downstream of Mission Ave. bridge; noticeable terracing damage from livestock traversing the slope; site is recommended as local maintenance issue, per CLRO CES Evaluation 2008 Report; previously rated "M"
Previous Comments:	2008: Terracing damage from livestock; there is now a pocket developing on the levee toe; site is 100' downstream of Mission Avenue bridge

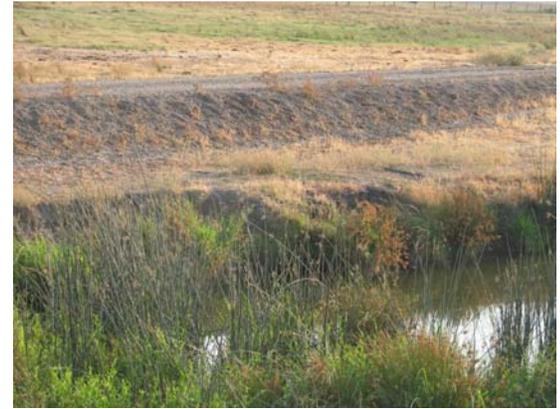
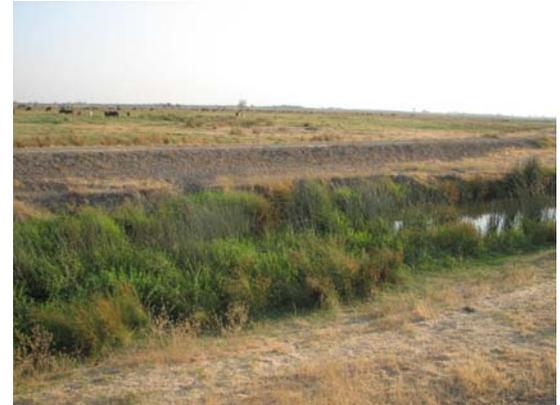
Site ID NA0013U4RM0.21

Length (ft):	<u>700</u>
Scarp Height (ft):	<u>4</u>
Location Relative to Levee:	<u>On berm</u>
Remaining Berm Width(ft):	<u>20</u>
Vegetation cover:	<u>1/3 of ground covered</u>
Burrow Holes (WS):	<u>No Activity</u>
Levee Slope (H:V):	<u>3:1 or greater</u>
Soil Type:	<u>Silt (ML)</u>
Condition of surrounding tree(s)	<u>No tree(s) within affected area</u>
Crown Width (ft):	
Site Relative to Bend:	<u>Straight reach</u>
Radius of Curvature:

Most Recent:	2009: Site recommended as local maintenance issue, per CLRO CES Evaluation 2008 Report; previously rated "U"
Previous Comments:	2007: GPS extended from opposite bank using Google Earth; signs of vehicular damage on levee

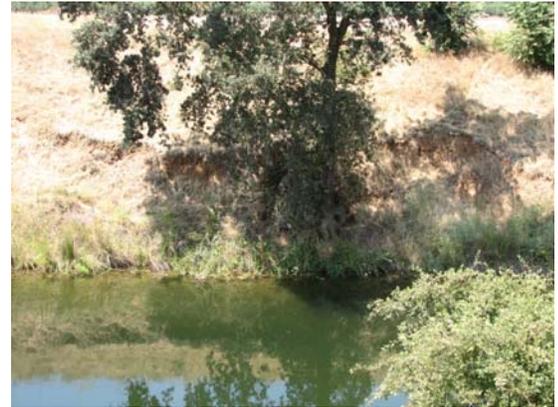
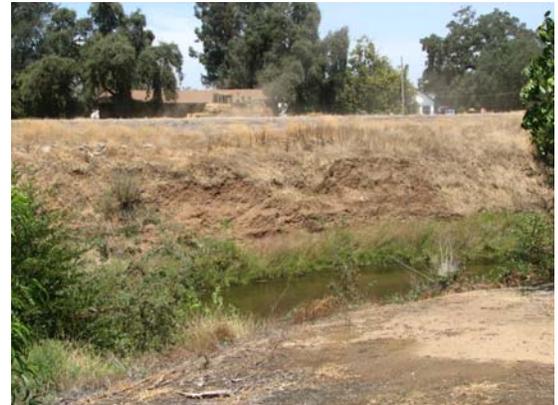
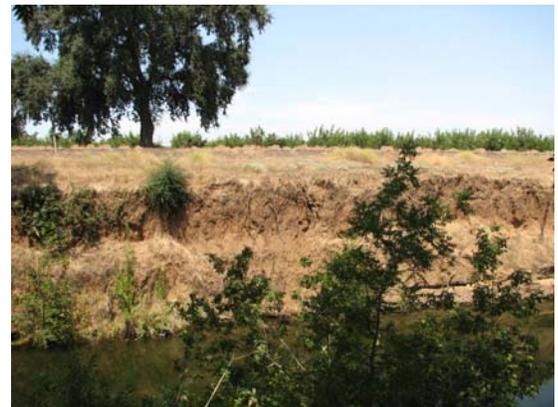
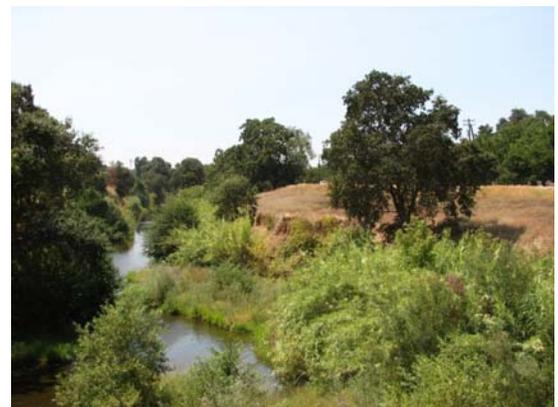
Length (ft):	4800
Scarp Height (ft):	12
Location Relative to Levee:	Toe & slope
Remaining Berm Width(ft):	11
Vegetation cover:	2/3 of ground covered
Burrow Holes (WS):	Signs of Activity
Levee Slope (H:V):	2.5:1
Soil Type:	Clay (CL,CH,SC,GC)
Condition of surrounding tree(s)	Tree(s) within affected area and visible roots
Crown Width (ft):	12
Site Relative to Bend:	Straight reach
Radius of Curvature:

Most Recent:	2009: Near-vertical bank erosion; degrading channel is incising the banks; recommend annual assessment and monitoring of critical erosion site, per CLRO CES Evaluation 2008 Report; LMA is monitoring site for changes in condition; previously rated "U"
Previous Comments:	2007: Visited site 2/6/07; possible critical site

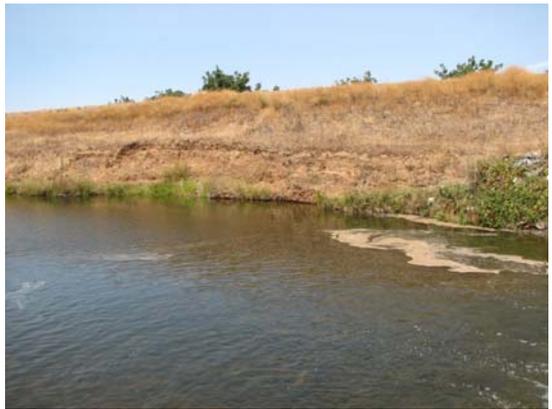
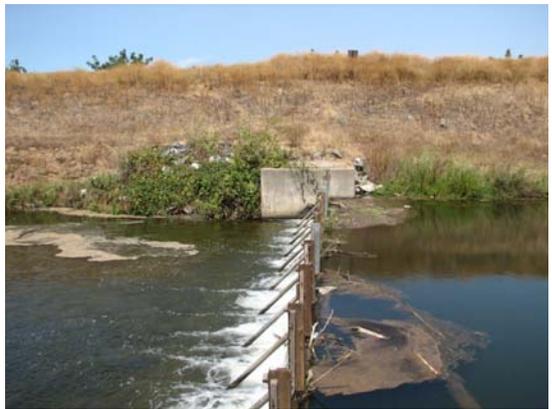
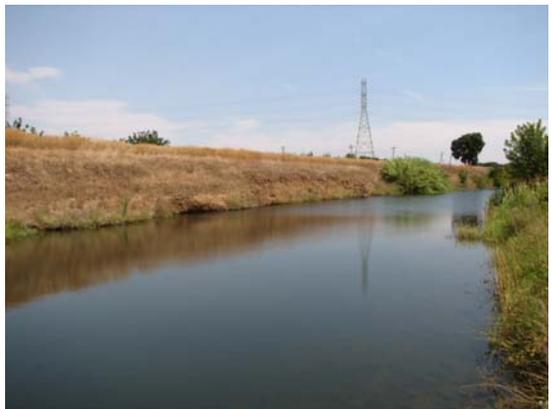
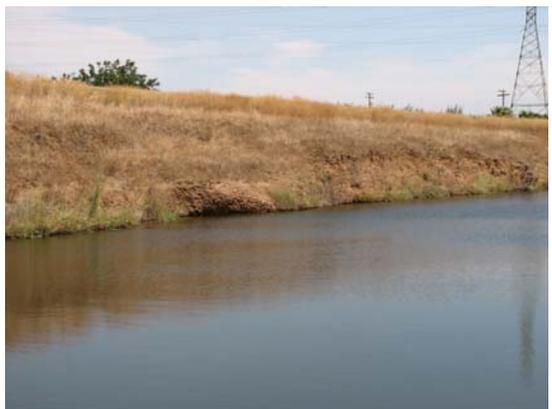
Site ID NA0017U15RM1.58

Length (ft):	350
Scarp Height (ft):	5
Location Relative to Levee:	Lower 1/2 slope
Remaining Berm Width(ft):	0
Vegetation cover:	2/3 of ground covered
Burrow Holes (WS):	Signs of Activity
Levee Slope (H:V):	1.5:1
Soil Type:	Clay (CL,CH,SC,GC)
Condition of surrounding tree(s)	No tree(s) within affected area
Crown Width (ft):	12
Site Relative to Bend:	Outside of bend > 90 deg
Radius of Curvature:	15.1

Most Recent:	2009: No change observed; erosion is upstream and downstream of drop structure; bank erosion associated with high velocities; recommend annual assessment and monitoring of critical erosion site, per CLRO CES Evaluation 2008 Report; previously rated "U"
Previous Comments:	2007: Visited site 2/6/2007

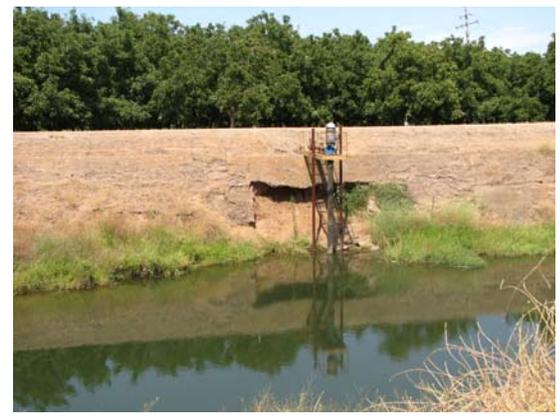
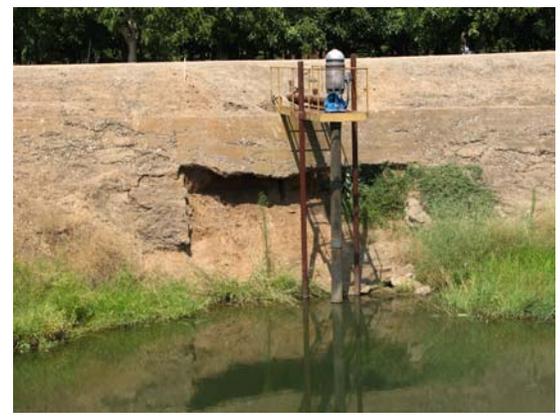
Site ID NA0017U15RM3.14

Length (ft):	<u>30</u>
Scarp Height (ft):	<u>6</u>
Location Relative to Levee:	<u>On berm</u>
Remaining Berm Width(ft):	<u>15</u>
Vegetation cover:	<u>No ground coverage</u>
Burrow Holes (WS):	<u>No Activity</u>
Levee Slope (H:V):	<u>2.5:1</u>
Soil Type:	<u>Clay (CL,CH,SC,GC)</u>
Condition of surrounding tree(s)	<u>No tree(s) within affected area</u>
Crown Width (ft):	<u>16</u>
Site Relative to Bend:	<u>Straight reach</u>
Radius of Curvature:

Most Recent:	2009: downward creep of the soil, possibly caused during pipe installation; erosion is 2-3 ft cut into the bank; vertical pump inlet is located adjacent to erosion; District personnel were made aware of this during the site survey
Previous Comments:

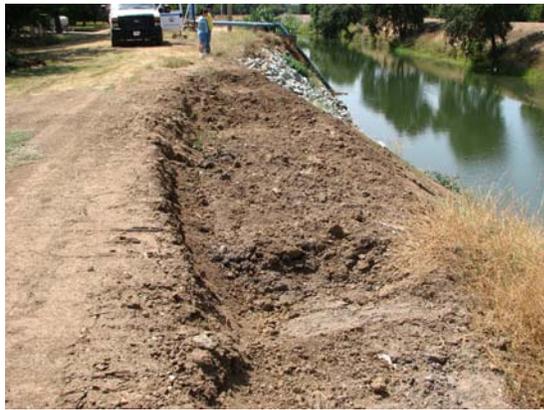
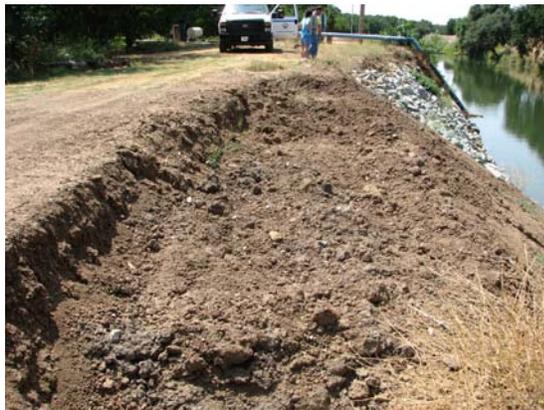
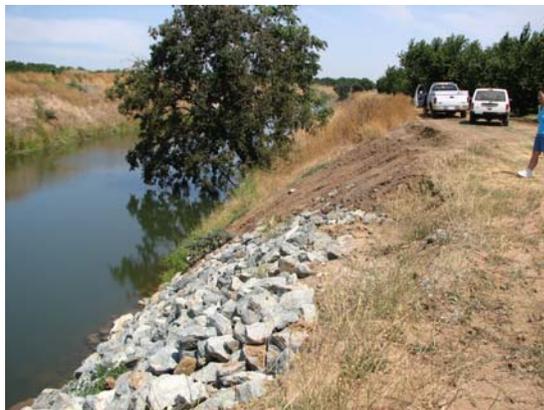
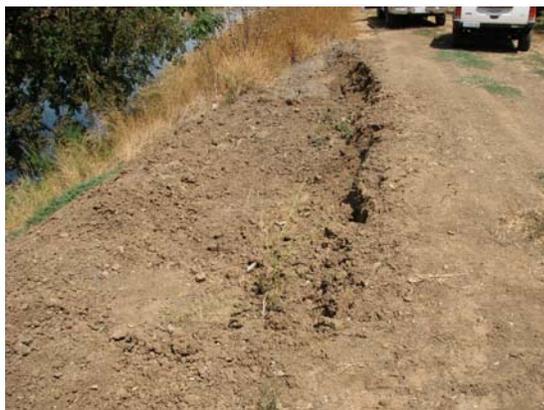
Length (ft):	80
Scarp Height (ft):	1
Location Relative to Levee:	Upper 1/2 slope
Remaining Berm Width(ft):	0
Vegetation cover:	No ground coverage
Burrow Holes (WS):	No Activity
Levee Slope (H:V):	2:1
Soil Type:	Clay (CL,CH,SC,GC)
Condition of surrounding tree(s)	No tree(s) within affected area
Crown Width (ft):	16
Site Relative to Bend:	Straight reach
Radius of Curvature:

Most Recent:	2009: Differential settlement of 1-2'; appears to be a shallow slide caused by undercutting; settlement has carved into the crown; adjacent area was recently repaired for burrow den on the lower slope; recently placed rocks on adjacent repair site
Previous Comments:

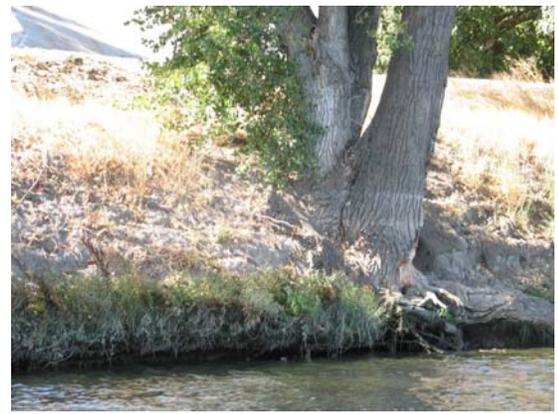
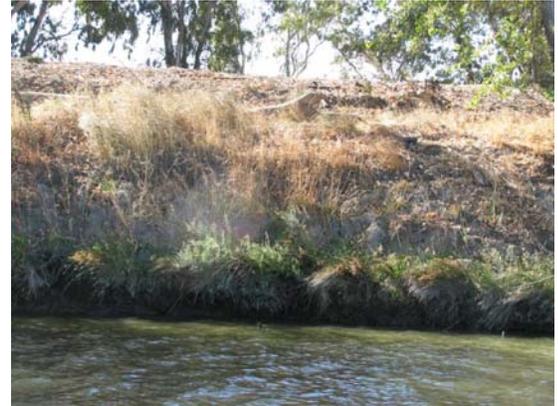
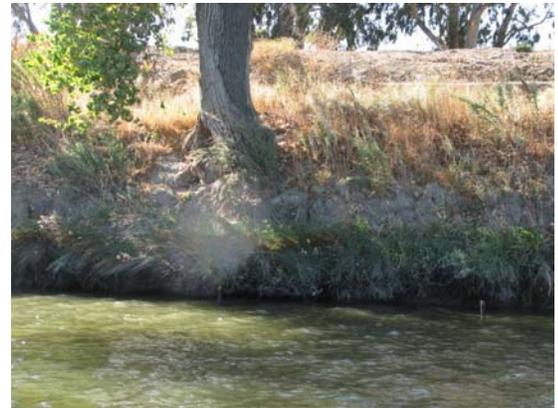
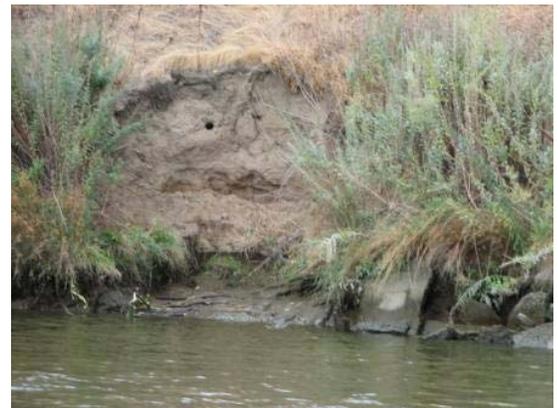
Most Recent:	2009: No major change observed; despite dense vegetation, the bank is eroding and sloughing; the levee toe is being undermined; note the tree on site; the site was previously rated "U"
Previous Comments:	2008: undermining of the toe; rodent holes in several location; trees with roots partially exposed; sloughing on slope

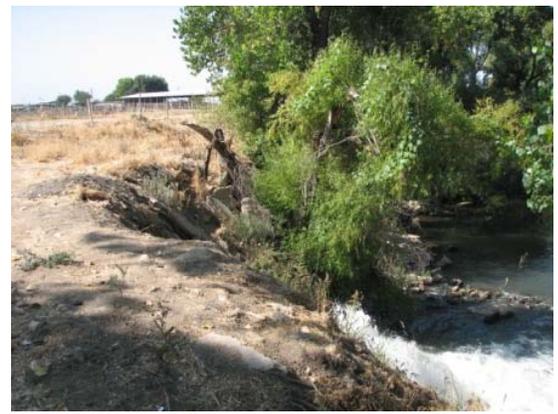
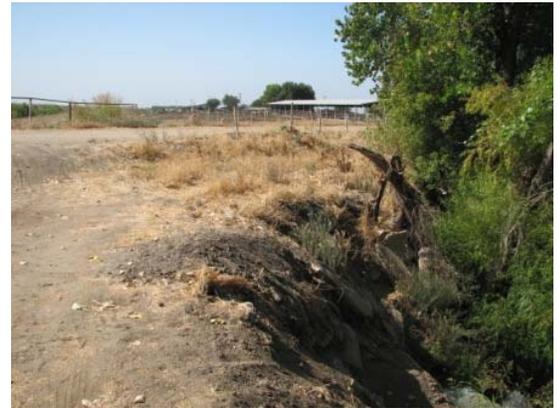
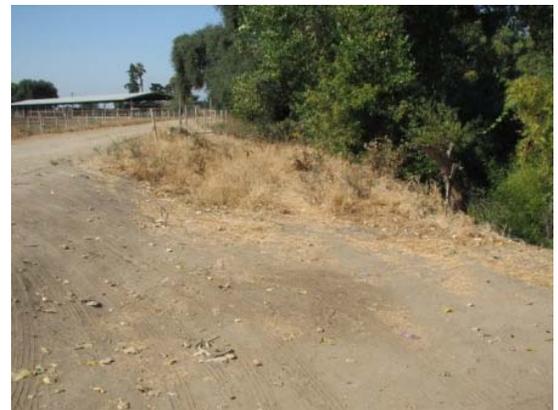
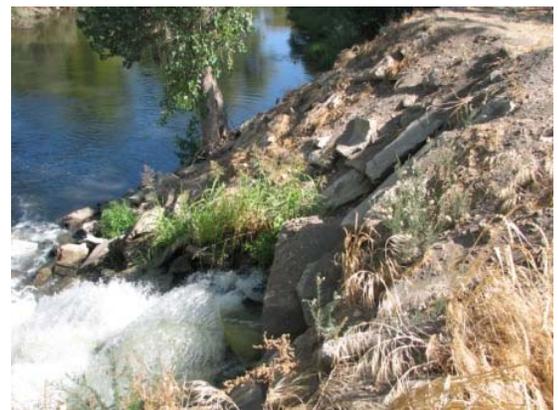
Site ID RD2031U1RM0.48

Most Recent:	2009: No major changes observed; 1" fissure cracks developing on the slope; rip rap is showing signs of sloughing; recommend as local maintenance issue, per CLRO CES Evaluation 2008 Report; site was previously rated "U"
Previous Comments:	2008: No change from previous year; irrigation outlet located on site; rock rip rap placed on river bank 2007:

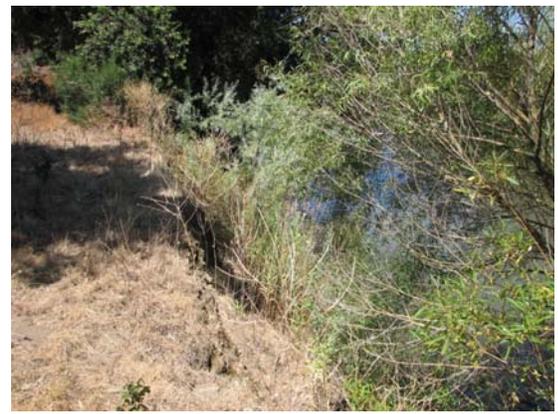
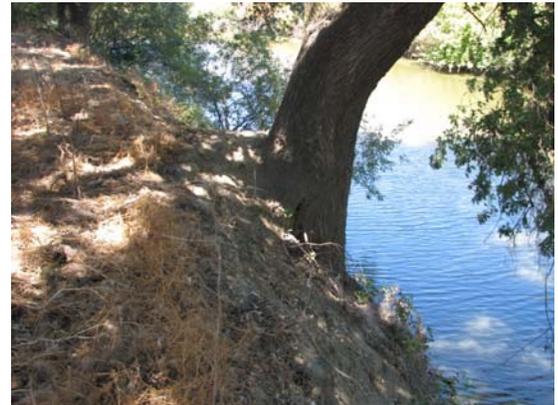
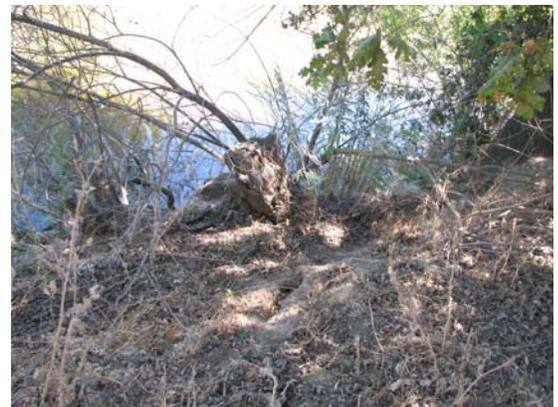
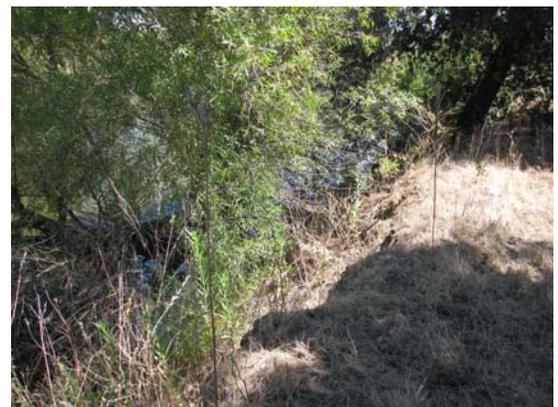
Site ID RD2058U1RM1.78

Most Recent:	2009: No major change observed; site is a 200 ft long near-vertical berm erosion; recommend annual assessment and monitoring of erosion site, per CLRO CES Evaluation 2008 Report; site # is same as RM4.0,LM4.51; previously rated "U"
Previous Comments:	2008: Two large trees (2-3' DBH) with partial roots exposed 2007: visited site 3/13/07

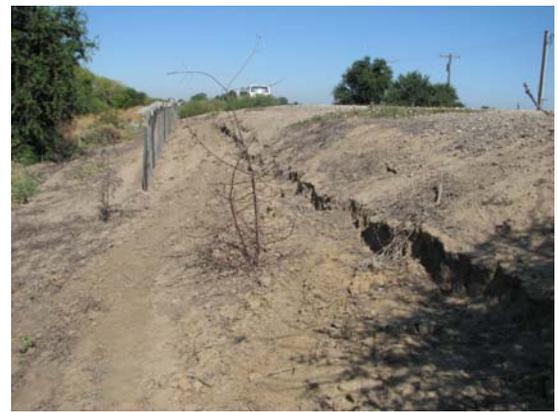
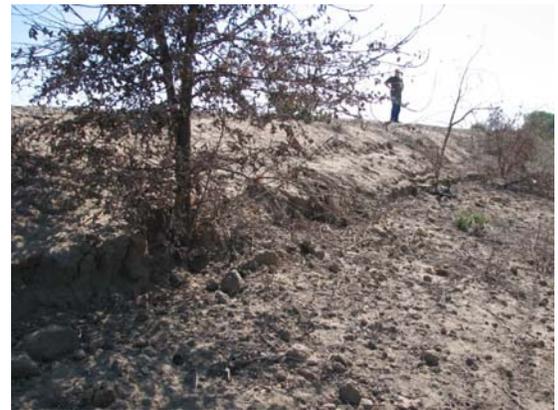
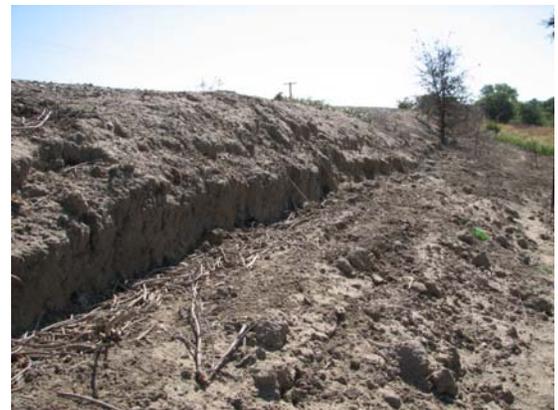
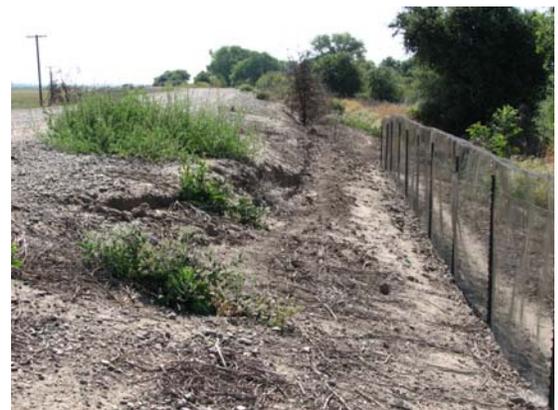
Most Recent:	2009: 1-2 ft of vertical scarp on the levee toe; damage was most likely caused by agricultural equipment during clearing operation; maintenance issue
Previous Comments:

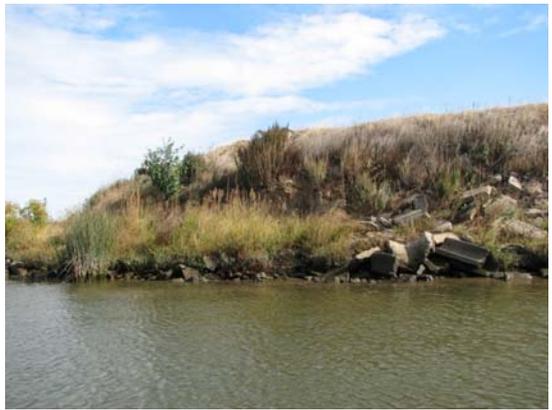
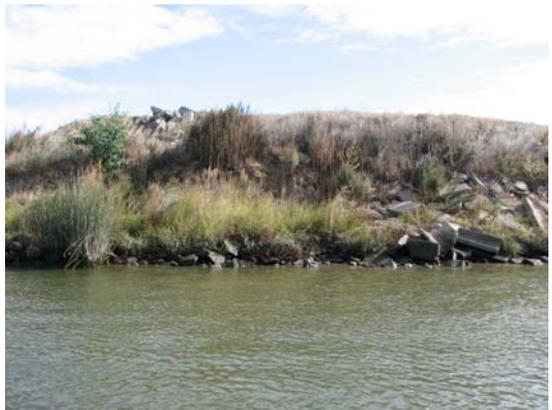
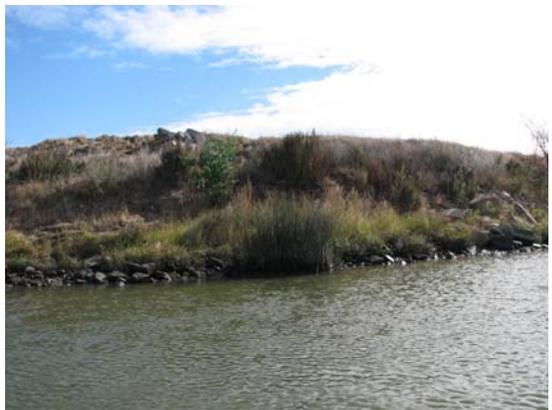
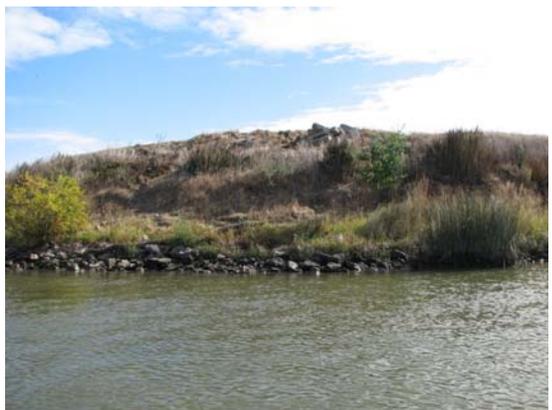
Site ID RD2062U3RM30.19

Length (ft):	475
Scarp Height (ft):	4
Location Relative to Levee:	Toe & slope
Remaining Berm Width(ft):	0
Vegetation cover:	2/3 of ground covered
Burrow Holes (WS):	Signs of Activity
Levee Slope (H:V):	2:1
Soil Type:	Silt (ML)
Condition of surrounding tree(s)	Tree(s) within affected area
Crown Width (ft):	
Site Relative to Bend:	Straight reach
Radius of Curvature:

Most Recent:	2009; no major change observed; section of the rip rap has slipped, exposing a levee section that has eroded; recommend as local maintenance issue, per CLRO CES Evaluation 2008 Report; site # same as RM30.43,LM0.63; previously rated "U"
Previous Comments:	2008: site is located inside of bend; scarp looks to be into the levee prism; piles of concrete chunks placed on the slope

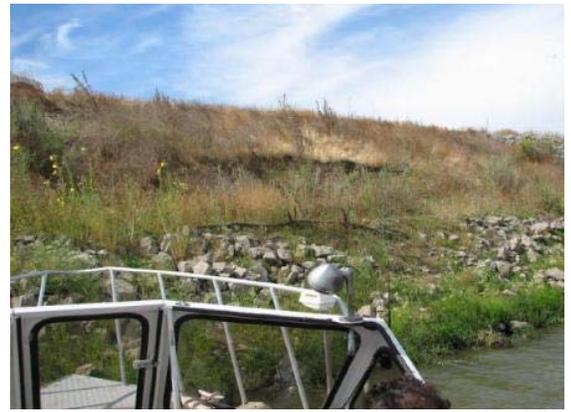
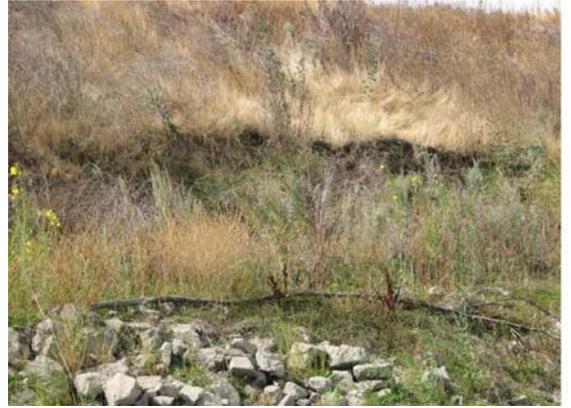
Site ID RD2062U3RM31.12

Most Recent:	2009: No major change observed; section of rip rap has slipped, creating a terraced effect; dense vegetation growth recommend as a local maintenance issue, per CLRO CES Evaluation 2008 Report; site # same as RM31.12,LM1.25; previously rated U
Previous Comments:	2006: 1-2' into prism

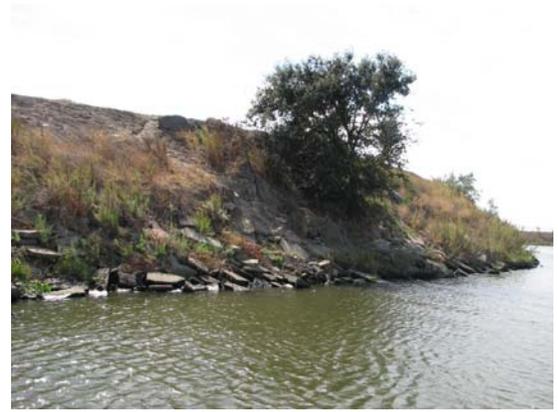
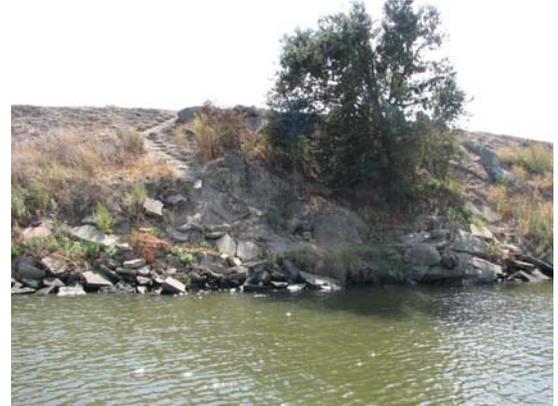
Site ID RD2062U3RM31.28

Most Recent:	2009: No major change; sliding of the rip rap at the base; there is visible man-made trail leading from crown to toe; recommend as a local maintenance issue, per CLRO CES Evaluation 2008 Report; site # same as RM31.3,LM1.45; previously rated "M"
Previous Comments:	2006: portion of rip rap along the slope has collapsed; exposed levee section is starting to erode, also exposing tree roots

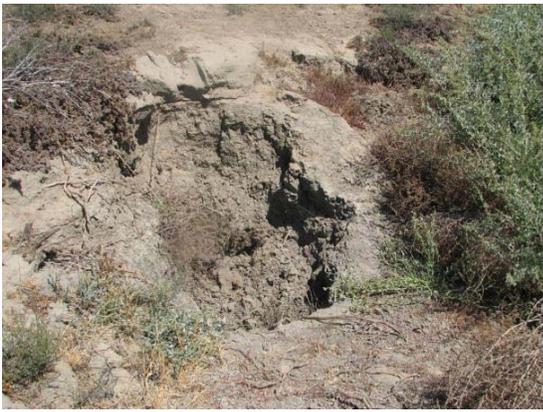
Site ID **RD2063U1RM105.5**

Most Recent:	2009: Note this site has not been reported to be repaired
Previous Comments:	2007: sinkhole approximately 7'x7'x2'; rated "M"

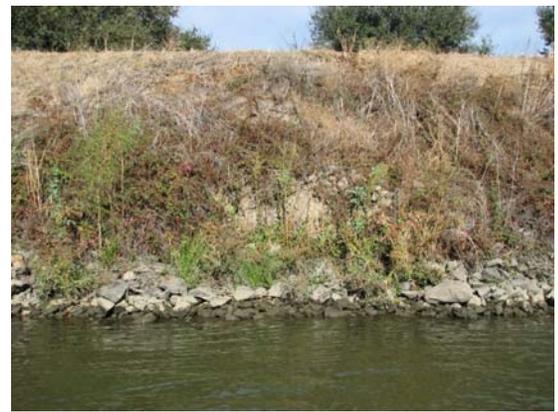
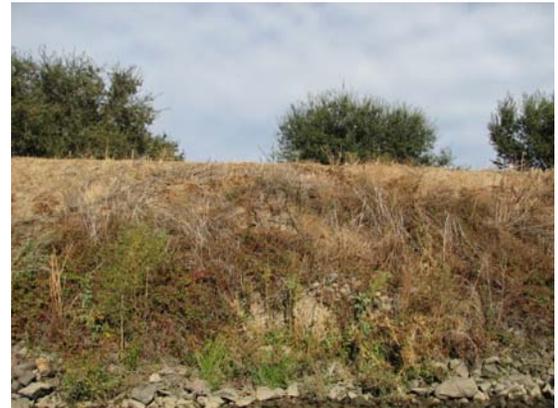
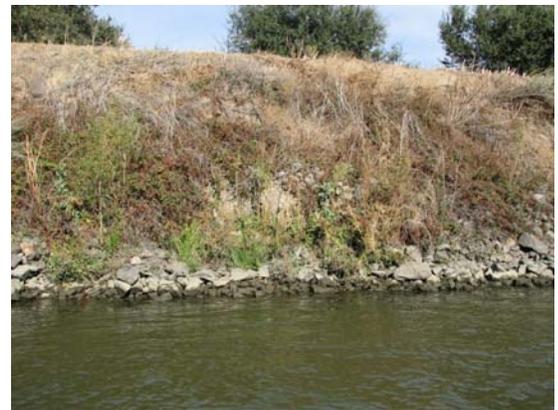
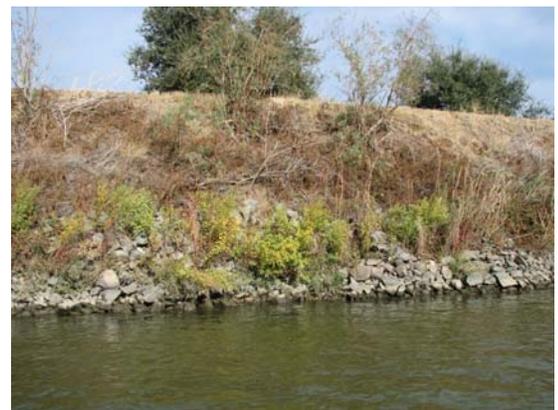
Site ID RD2075U1RM64.34

Most Recent:	2009: rock protection placed on upper slope; images need to be updated; recommend annual assessment and monitoring of erosion site, per CLRO CES Evaluation 2008 Report; site # same as RM29.84,LM0.30; previously rated "M"
Previous Comments:	2008: Two sites combined as one; steep slope; downstream of a pump. 2006: Visited site 10/20/06

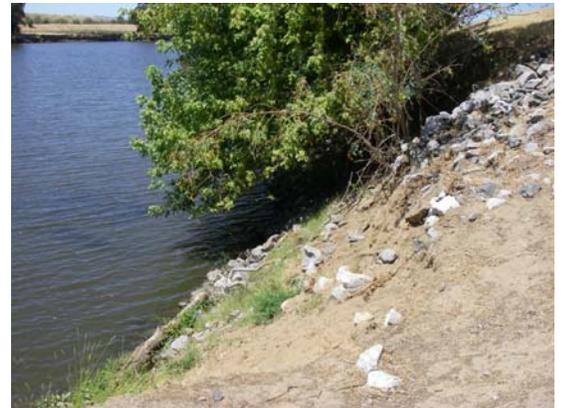
Site ID **RD2089U1RM29.95**

Length (ft):	5
Scarp Height (ft):	3
Location Relative to Levee:	Lower 1/2 slope
Remaining Berm Width(ft):	8
Vegetation cover:	2/3 of ground covered
Burrow Holes (WS):	No Activity
Levee Slope (H:V):	2:1
Soil Type:	Silt (ML)
Condition of surrounding tree(s)	Tree(s) within affected area
Crown Width (ft):	
Site Relative to Bend:	Straight reach
Radius of Curvature:

Most Recent:	2009: Pocket erosion on lower slope just above the toe rip rap; protruding rip rap upstream is creating an eddy, scouring the levee slope; site # is same as RM28.4,LM0.30; previously rated "U"; images are courtesy of the Levee Repair Office.
Previous Comments:	2008: Cut into levee profile; riprap slide; rodent holes; pictures do not match GPS and current condition

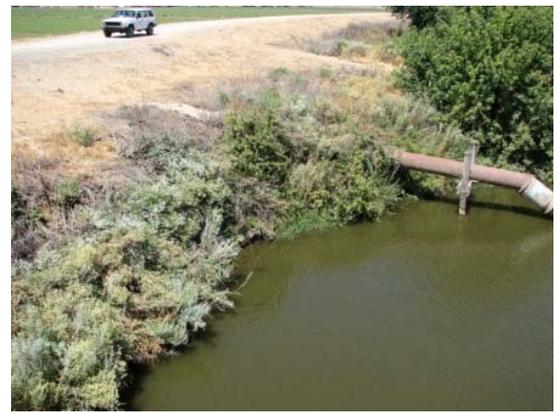
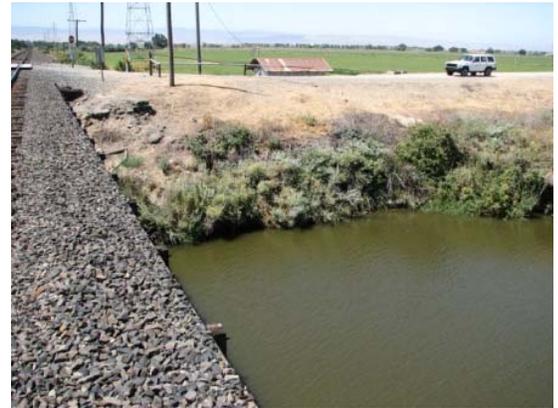
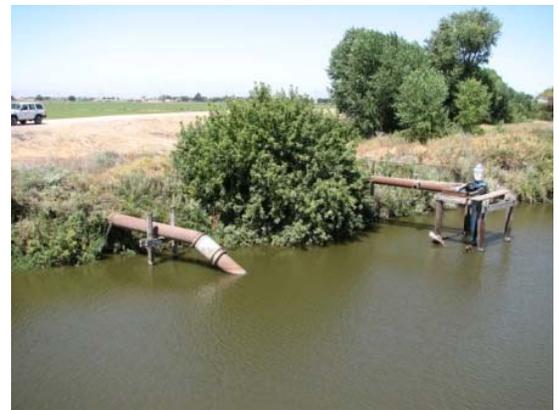
Site ID RD2092U1RM84.6

Most Recent:	2009: No major change noticeable vegetation growth; erosion is on berm, but if left untreated, it will eventually erode into levee prism; recommend annual assessment/monitoring of site, per CES 2008 Report; site # same as RM6.8, LM0.73; previously rated "U"
Previous Comments:	2008: Downstream of WPRR near siphon pipe & pump; sandy levee; visited by Jeff Van Gilder and LRO in 2008 for repair assessment; scouring downstream of RR crossing, possibly caused by eddy effects

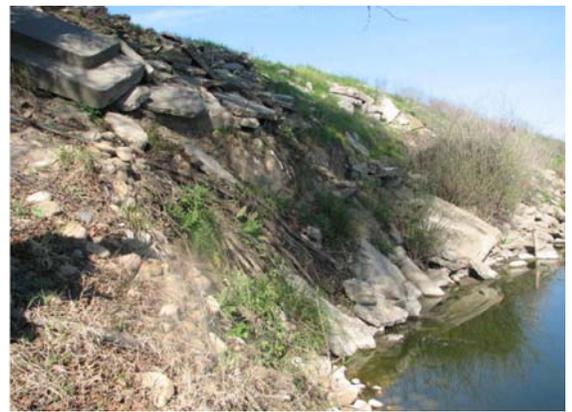
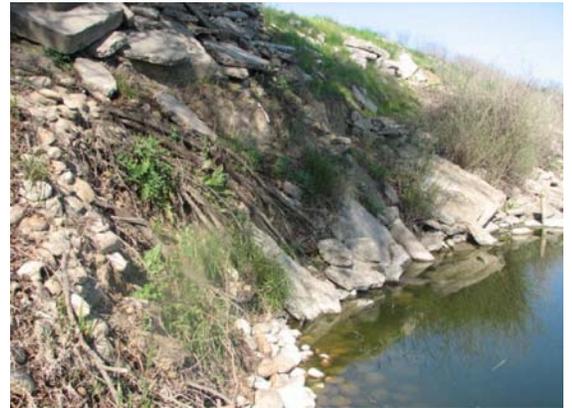
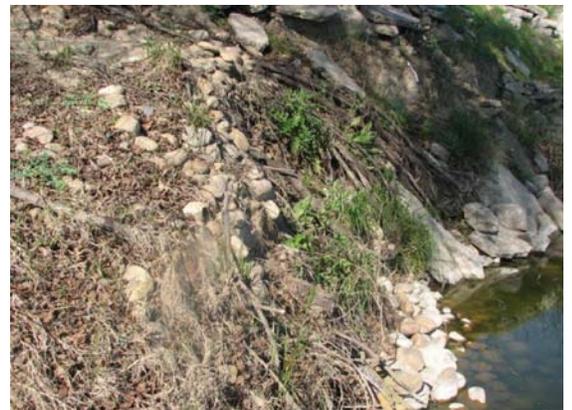
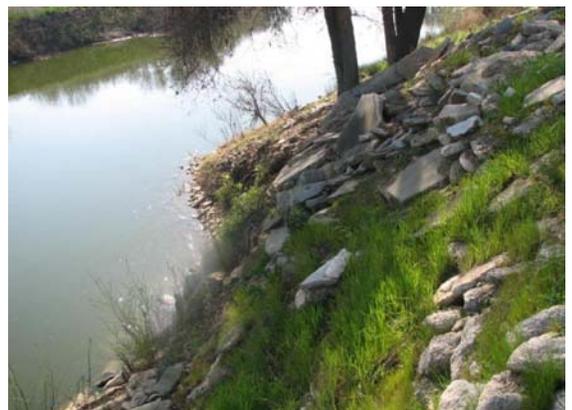
Site ID RD2095U1RM6.88

Most Recent:	2009: No major change observed; near-vertical slope that has rip rap sloughing; recommend as a local maintenance issue, per CLRO CES Evaluation 2008 Report; site# same as RM6.9,LM0.86; previously rated "U"
Previous Comments:	2008: previous erosion site that is partially protected with concrete rubble; erosion scarp is adjacent to the sloughing rip rap
