**State of California
The Resources Agency
DEPARTMENT OF WATER RESOURCES
Division of Flood Management**

**2001
OFFICE REPORT**

**INSPECTION OF FLOOD CONTROL STRUCTURES
ON THE SACRAMENTO AND SAN JOAQUIN RIVERS
AND THEIR TRIBUTARIES**

**Prepared by
FLOOD PROJECT INSPECTION SECTION**

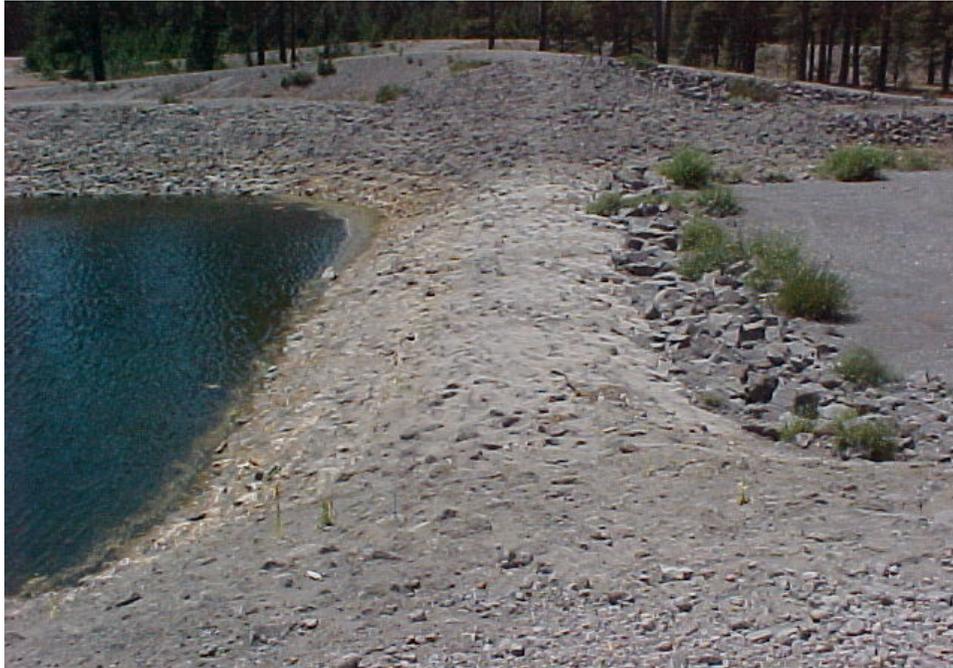
- 1. Condition of grouted rock revetment drop structure.**
 - a. Good.**
- 2. Condition of channel banks upstream and downstream of the drop structure.**
 - a. Good.**
- 3. Accumulation of trash and debris around the structure or in the channel.**
 - a. None.**
- 4. Vegetation around the structure, in the channel banks or in the channel.**
 - a. None.**
- 5. Comments:**
 - a. Good maintenance.**

Looking at the structure from the left bank.

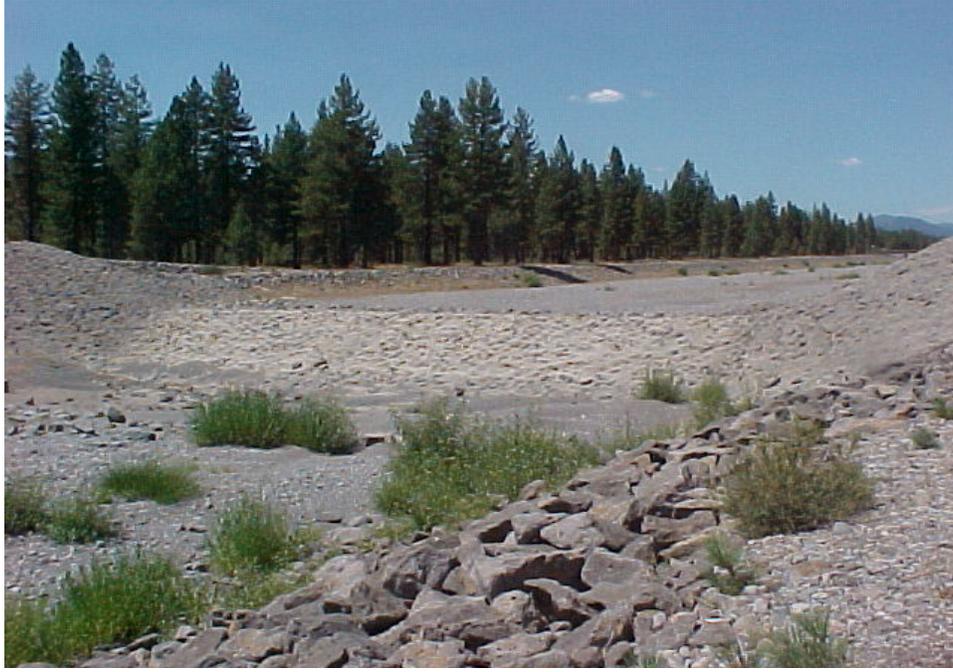
- 1. Condition of grouted rock revetment drop structure.**
 - a. Good.**

- 2. Condition of the channel banks upstream and downstream of the drop structure.**
 - a. Good.**

Looking upstream at the drop structure from the left bank.

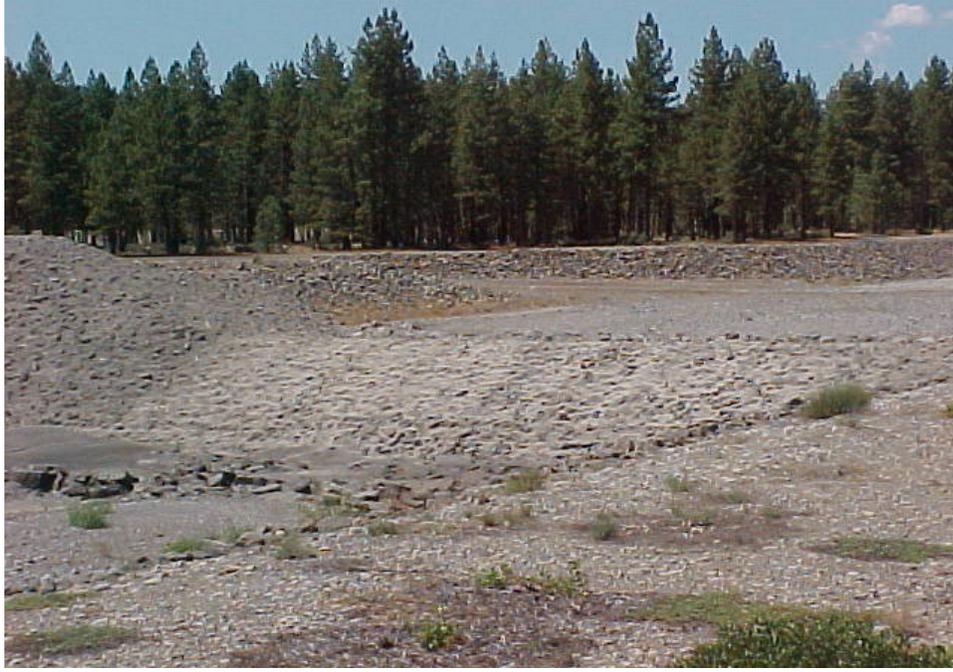
1. **Condition of grouted rock revetment drop structure.**
 - a. **Good.**
2. **Condition of channel banks upstream and downstream of the drop structure.**
 - a. **Good.**
3. **Accumulation of trash and debris around the structure or in the channel.**
 - a. **None.**
4. **Vegetation around the structure, in the channel banks or in the channel.**
 - a. **None.**
5. **Comments:**
 - a. **Good maintenance.**

Looking upstream at the drop structure from the left bank.

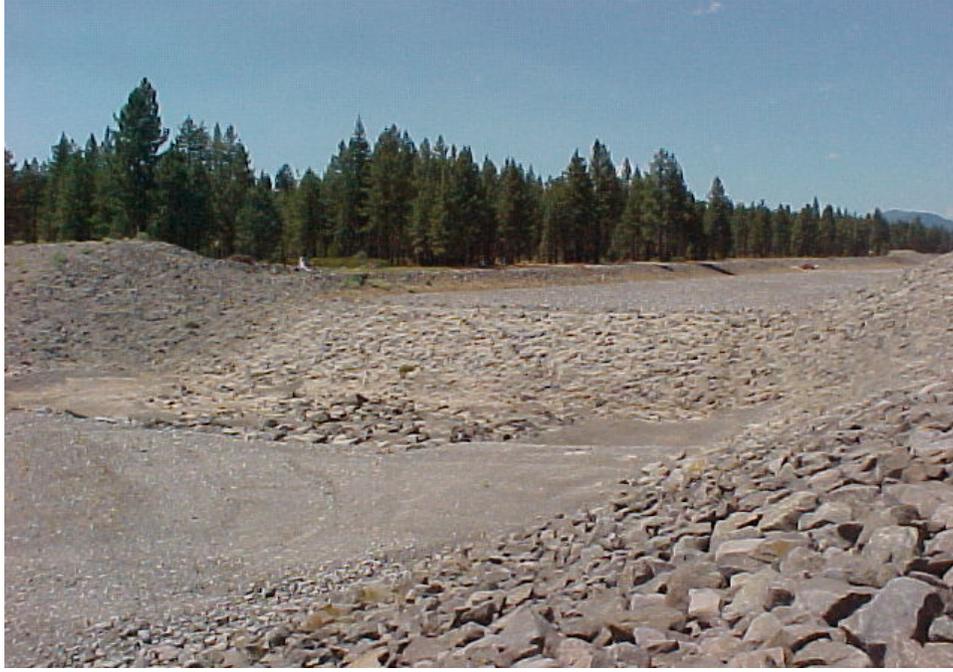
- 1. Condition of grouted rock revetment drop structure.**
 - a. Good.**
- 2. Condition of channel banks upstream and downstream of the drop structure.**
 - a. Good.**
- 3. Accumulation of trash and debris around the structure or in the channel.**
 - a. None.**
- 4. Vegetation around the structure, in the channel banks or in the channel.**
 - a. None.**
- 5. Comments:**
 - a. Good maintenance.**

Looking at upstream side of structure from the right bank.

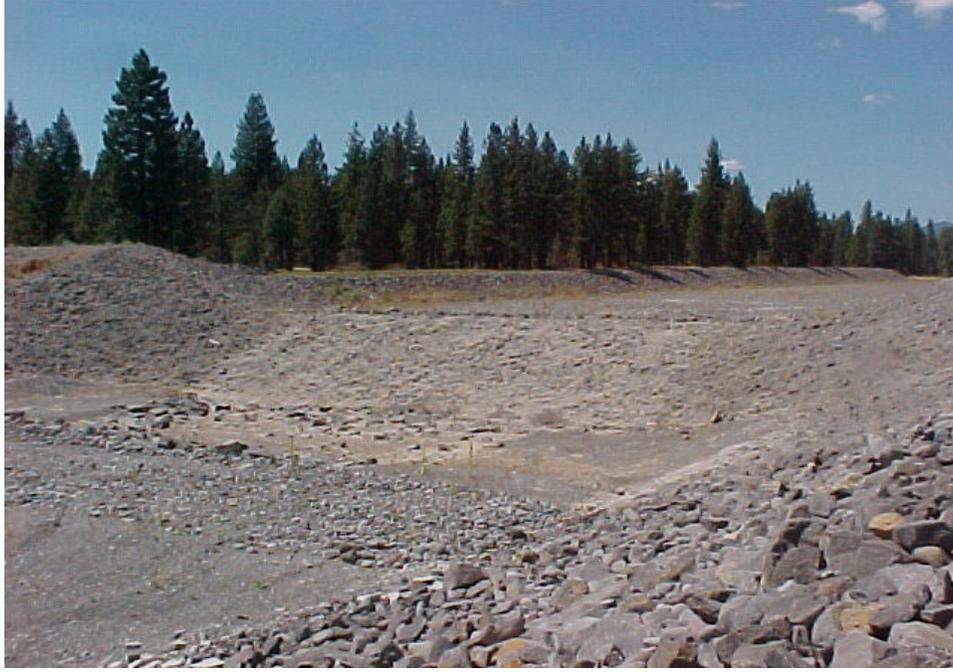
1. **Condition of grouted rock revetment drop structure.**
 - a. **Good.**
2. **Condition of channel banks upstream and downstream of the drop structure.**
 - a. **Good.**
3. **Accumulation of trash and debris around the structure or in the channel.**
 - a. **None.**
4. **Vegetation around the structure, in the channel banks or in the channel.**
 - a. **Minimal.**
5. **Comments:**
 - a. **Good maintenance.**

Looking upstream at the drop structure from the left bank.

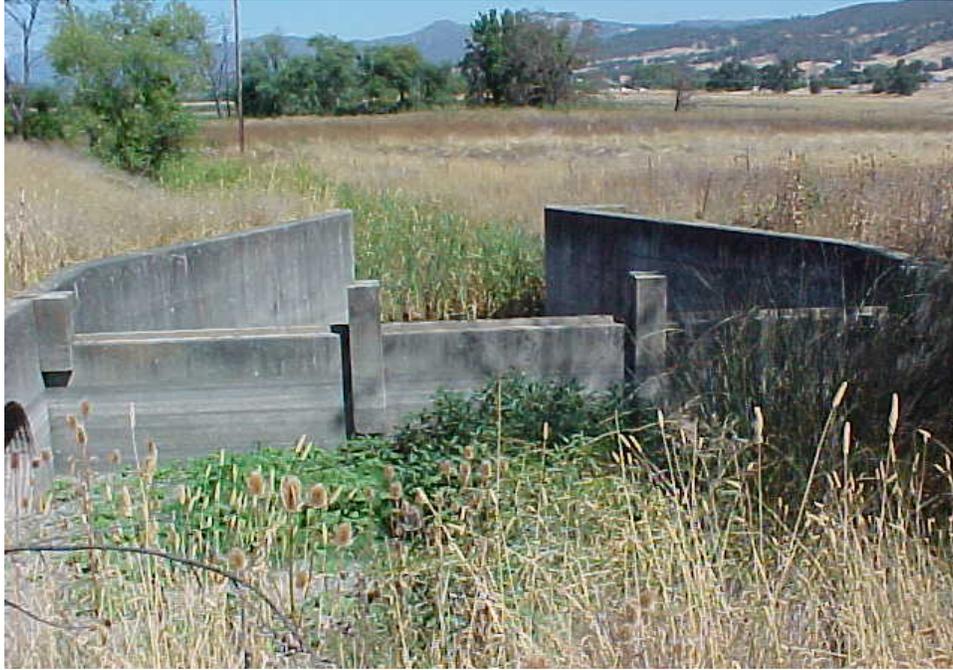
Looking downstream at the concrete weir from the left bank.

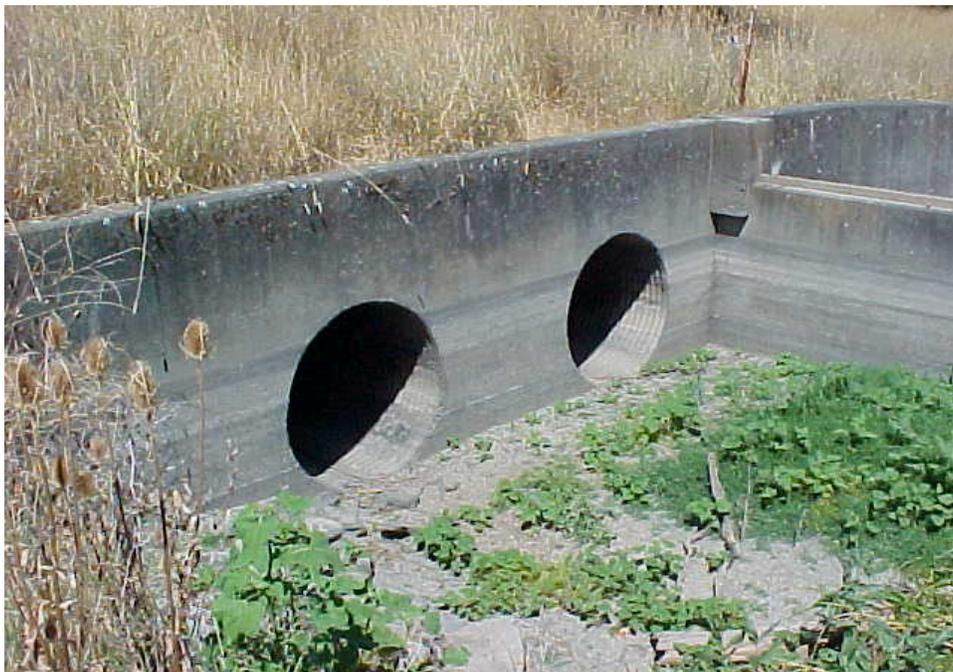
Looking at the intake of diversion pipes.

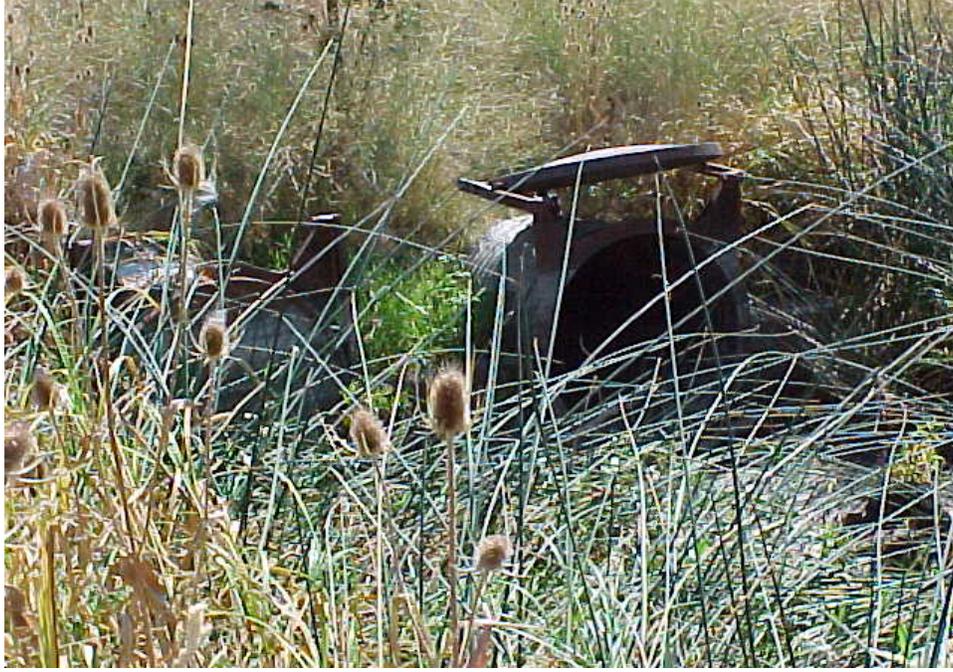
Looking upstream at the discharge pipes and flap gates.

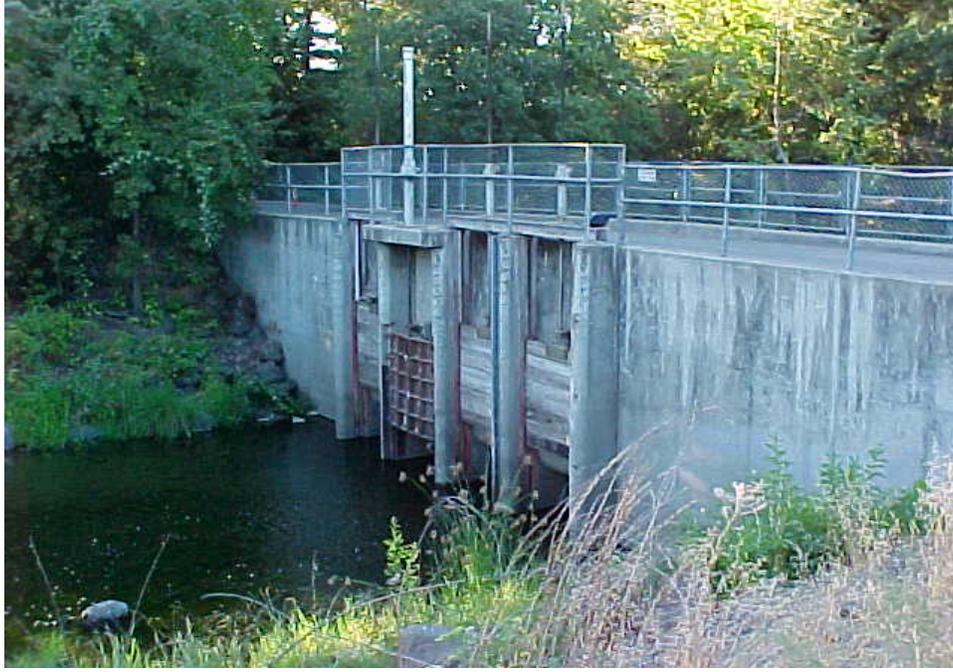
- 1. Condition of concrete control structure.**
 - a. Good.**
- 2. Condition of bulkheads.**
 - a. Good.**
- 3. Condition of gate controls and mechanisms.**
 - a. Butte Co. will test gates prior flood season.**
- 4. Condition of revetment.**
 - a. Good.**
- 5. Accumulation of trash and debris around the structure in the channel.**
 - a. None.**
- 6. Vegetation around structure and in the channel.**
 - a. There is minimal vegetation in the revetment on the upstream side of the structure.**
- 7. Comments:**
 - a. Clear growth.**
 - b. Contact DWR Inspector prior to gate test.**
 - c. Good maintenance.**

Looking downstream at inlet end of structure.

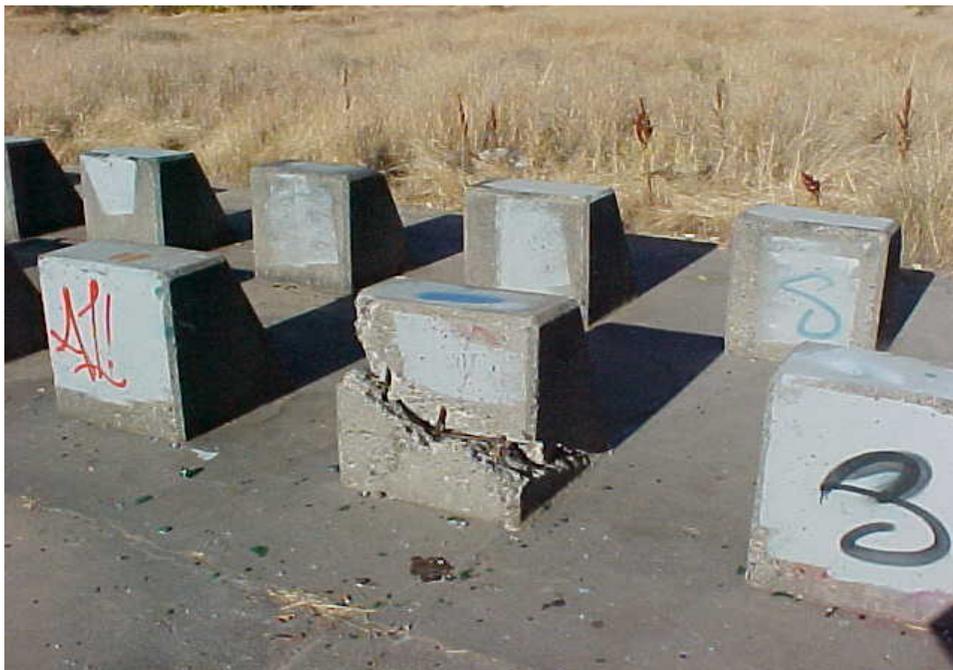
- 1. Condition of concrete weir structure and stilling basin, and velocity dissipaters.**
 - a. There are minor joint separations on the north and south ends of the weir where it contacts the abutments.**
 - b. There is minor damage to several velocity dissipaters and severe damage to one.**
- 2. Condition of concrete abutments and wingwalls.**
 - a. Good.**
- 3. Condition of revetment.**
 - a. Good.**
- 4. Accumulation of trash and debris around the structure or in the channel.**
 - a. None.**
- 5. Vegetation around structure or in the channel.**
 - a. Minimal.**
- 6. Condition of gauging house and equipment.**
 - a. Fair.**
- 7. Comments:**
 - a. Repair the severely damaged velocity dissipater.**
 - b. Remove vegetation from channel.**
 - c.**
 - d. Good maintenance.**

View of severely damaged velocity dissipater.

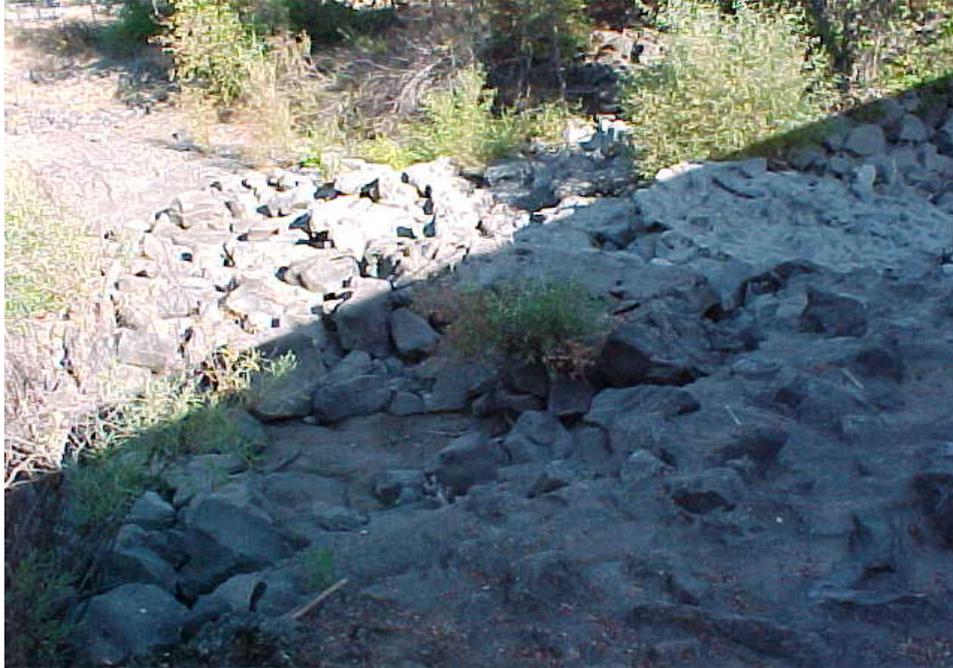
- 1. Conditions of concrete control structure.**
 - a. Good.**
- 2. Condition of bulkheads.**
 - a. There is a ½ inch separation in the joint between the south end bulkhead and the structure.**
- 3. Condition of control gates and mechanisms.**
 - a. Good.**
- 4. Condition of revetment.**
 - a. Poor. The downstream rock and gunite skirt is severely damaged.**
- 5. Accumulation of trash and debris around the structure or in the channel.**
 - a. None.**
- 6. Vegetation around the control structure or in the channel.**
 - a. None.**
- 7. Comments:**
 - a. Butte Co. will test the control gates prior to flood season.**
 - b. Repair the rock and gunite skirt downstream of structure.**
 - c. Fair maintenance.**

View of damaged rock and gunite skirt down stream of structure.

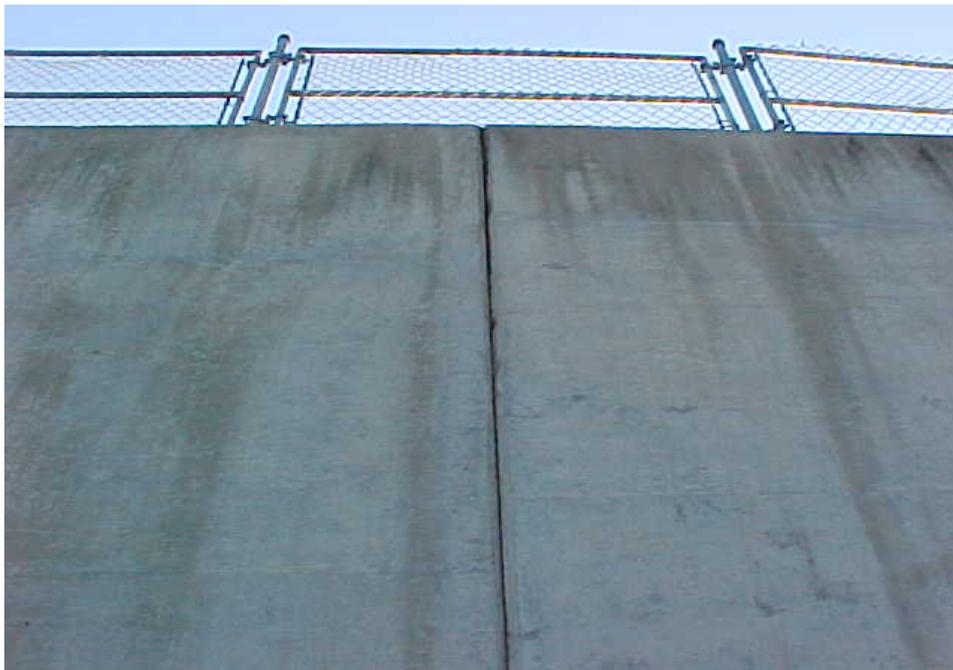
**View of the 1/2 inch separation in the joint between
the structure and the south end abutment.**

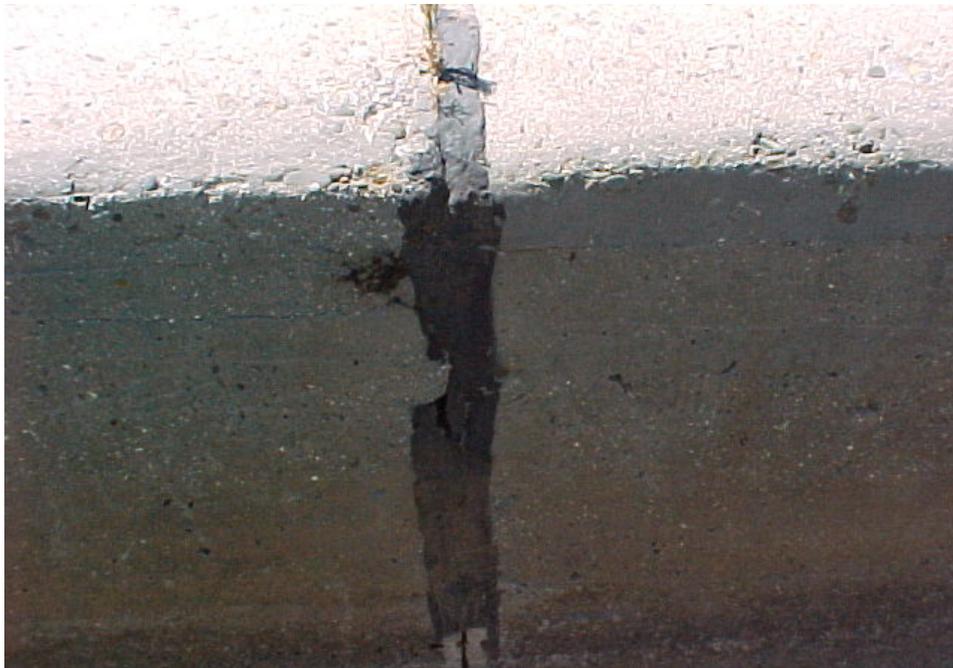
3. **Condition of concrete weir, stilling basin, and velocity dissipators.**
 - a. **Minor cracks in the weir and minor spalling of concrete on the weir invert. Repairs have been made on past reported damage.**

**Previously reported cracks and spalling
have been repaired with tar patches.**

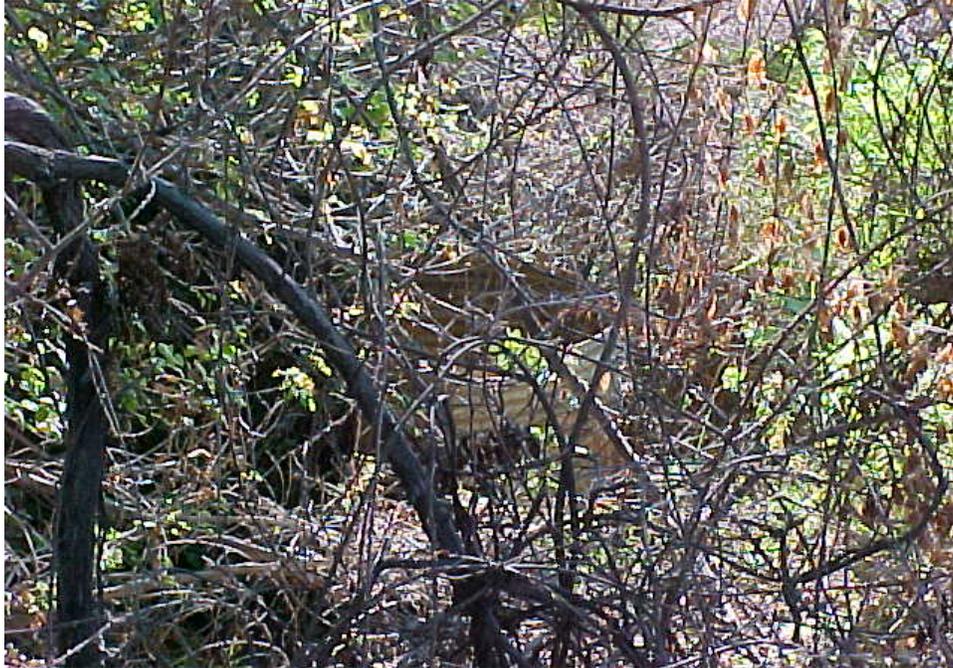
1. **Condition of the corrugated metal pipe (CMP) drainage structure.**
 - a. **Good.**
2. **Condition of the control gate, mechanisms, and flap gates.**
 - a. **Could not properly inspect due to excessive vegetation.**
3. **Condition of the revetment.**
 - a. **Good.**
4. **Accumulation of trash and debris around the inlet, in the pipe or in the channel.**
 - a. **Could not properly inspect due to excessive vegetation.**
5. **Vegetation around the structure or in the channel.**
 - a. **Heavy vegetation around structure. Growth is so dense that intake and discharge ends of structure cannot be seen.**
6. **Comments:**
 - a. **Remove vegetation from inlet and discharge ends of structure. If growth is not removed, the drainage structure could become non functional.**
 - b. **No maintenance.**

Looking at the CMP stand pipe in the center of picture, obscured by heavy growth.

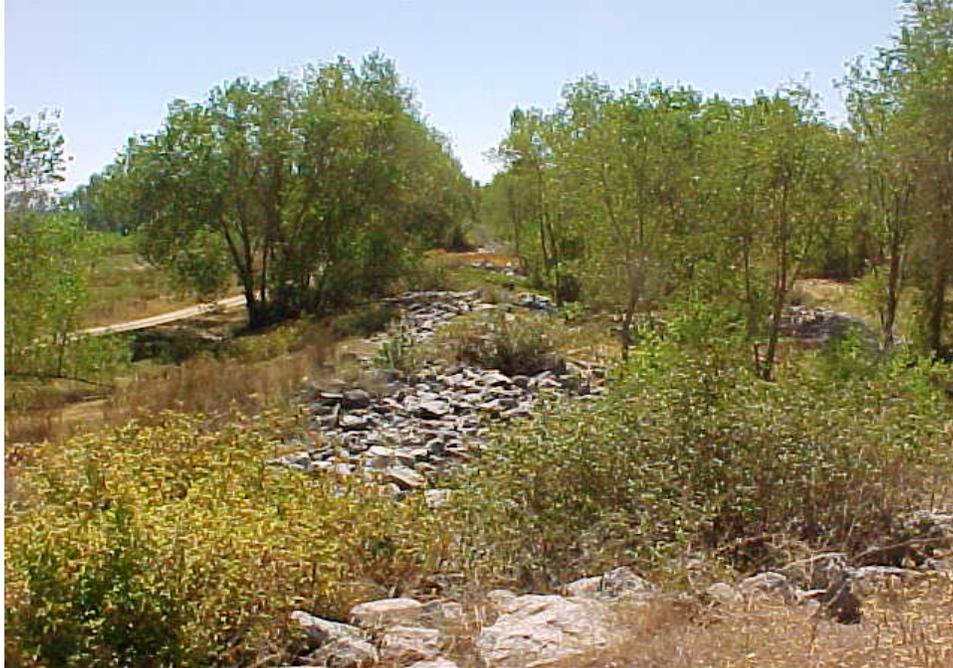
Looking southwest at the growth and debris on the rock weir.

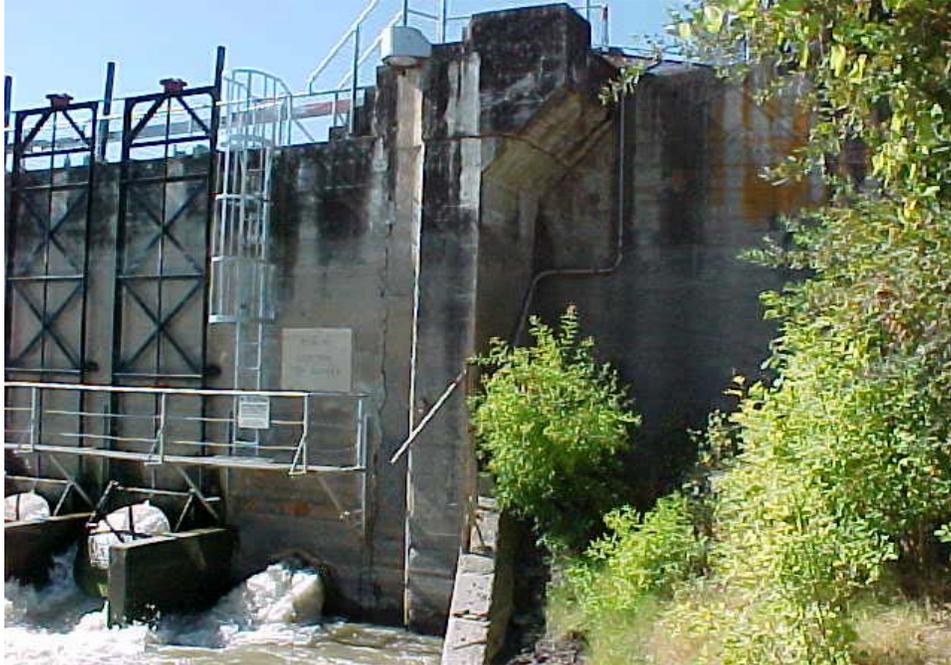
There is a large vertical crack and displacement on the downstream side of structure.

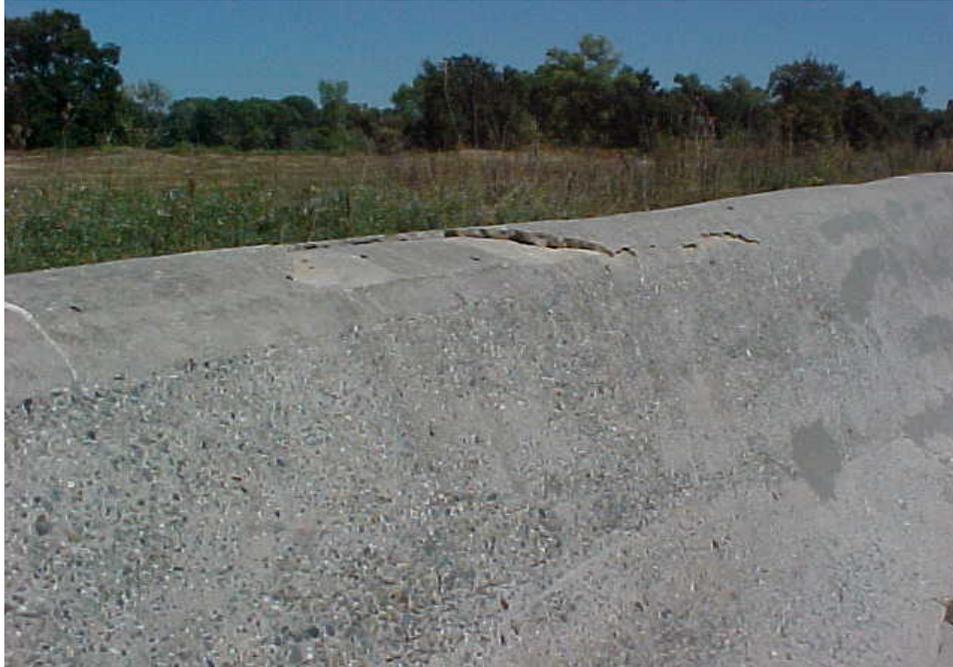
- 1. Condition of concrete weir and stilling basin.**
 - a. Some cracks and spalling exist on the weir and in the stilling basin.**
- 2. Condition of concrete abutment.**
 - a. Good.**
 - b. The crack on the downstream side of the right (west) abutment, and the two cracks on the right abutment at Rattlesnake Island, have not enlarged.**
- 3. Condition of revetment.**
 - a. Good.**
- 4. Accumulation of trash and debris around the structure or in the channel.**
 - a. Minimal.**
- 5. Vegetation around the structure or in the channel.**
 - a. Minimal.**
 - b. Minimal.**
- 6. Condition of gauging house and equipment.**
 - a. Good.**
- 7. Comments:**
 - a. Monitor the cracks and spalling and repair as needed.**
 - b. Remove debris from the stilling basin prior to flood season.**
 - c. Good maintenance.**

Looking at spalling on the crown of the weir.

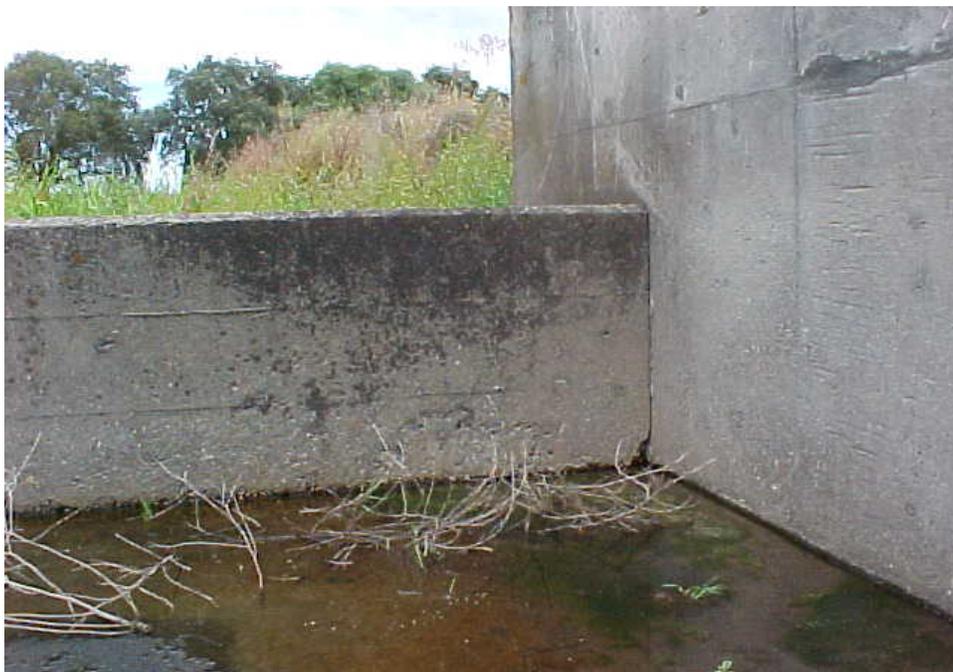
View of the crack on the downstream side of the weir at the left abutment.

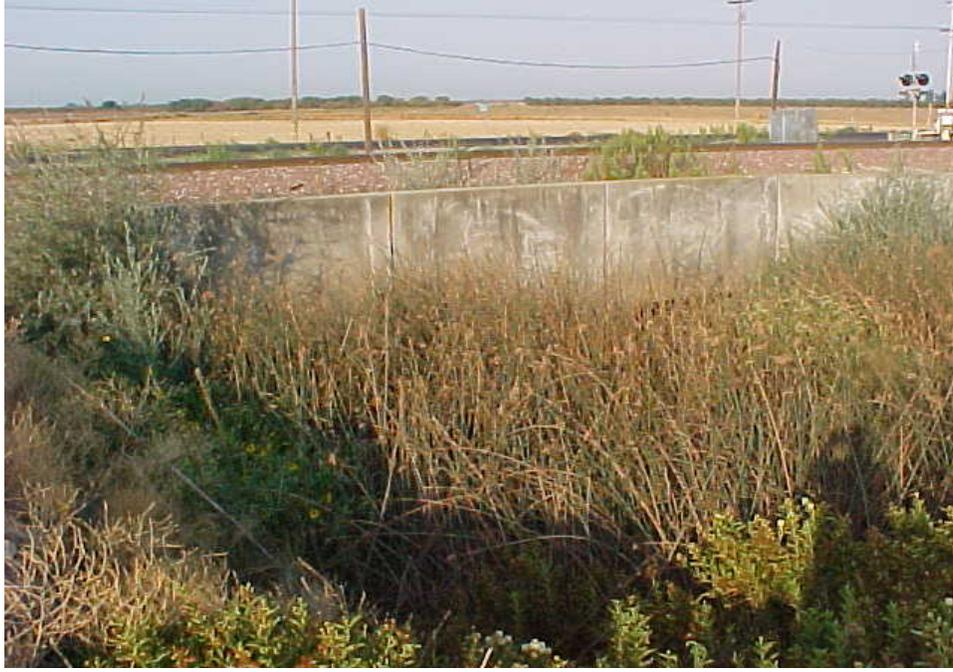
Looking at the upstream side of the structure and the heavy tule growth.

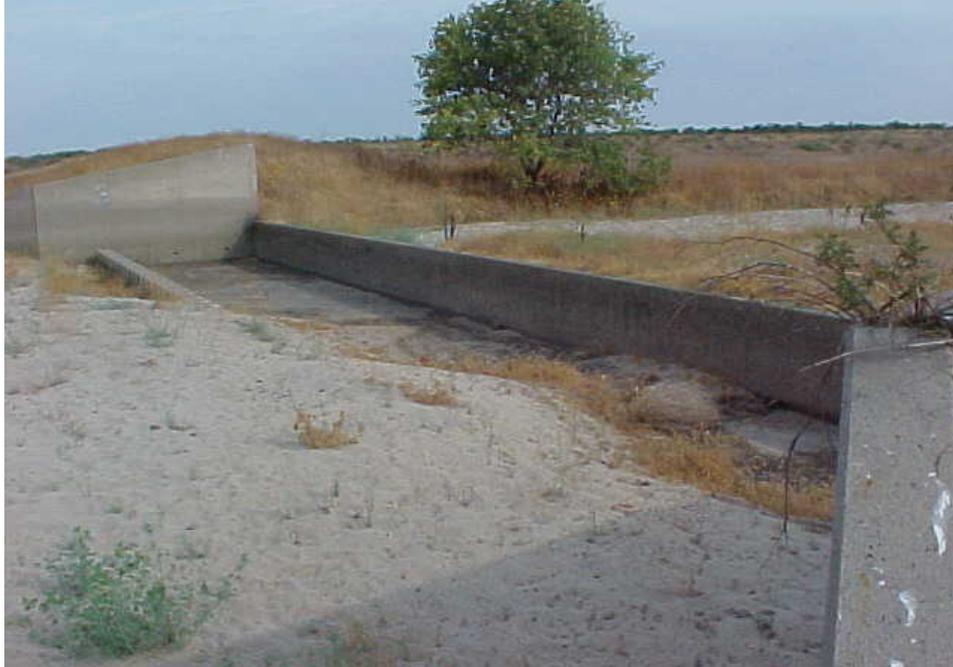
**Looking at the stilling basin and the
sand covered velocity dissipaters.**
