**State of California  
The Resources Agency  
DEPARTMENT OF WATER RESOURCES  
DIVISION OF FLOOD MANAGEMENT**

**2007  
PROJECT  
STRUCTURE REPORT**

**INSPECTION OF  
FLOOD CONTROL STRUCTURES ON THE  
SACRAMENTO AND SAN JOAQUIN RIVERS  
AND THEIR TRIBUTARIES**

**Prepared By  
The Flood Project Integrity & Inspection Branch**

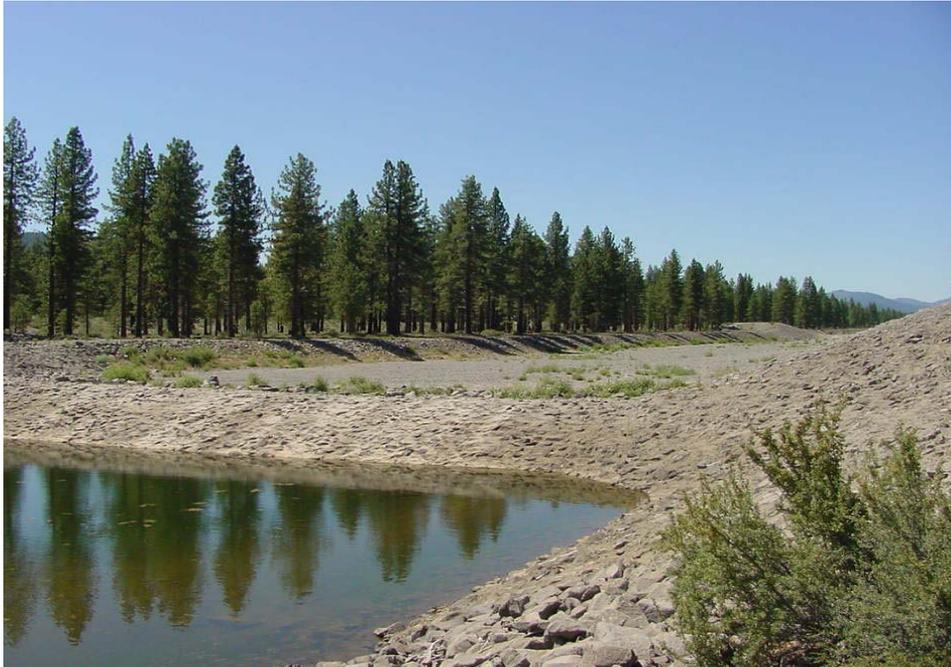
**NORTH FORK FEATHER RIVER DIVERSION CHANNEL  
DROP STRUCTURES 1 through 7  
Maintained by Plumas County**

**View of Drop Structure No. 1 from the left bank.  
Typical of all drop structures.**

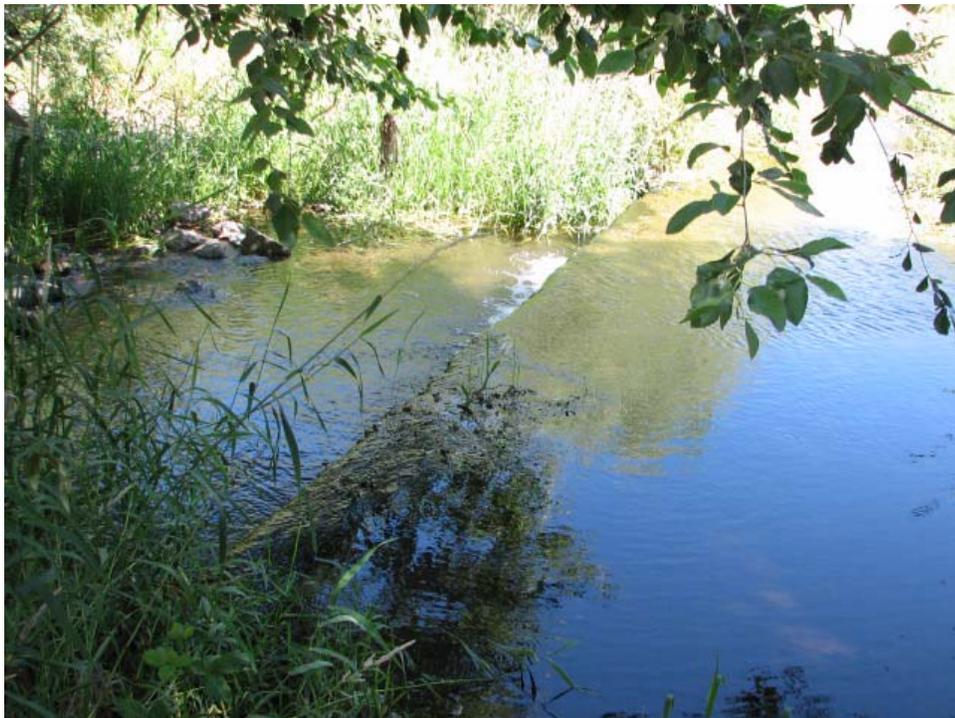
**View of the concrete weir downstream  
of the diversion structure in the bypass channel.**

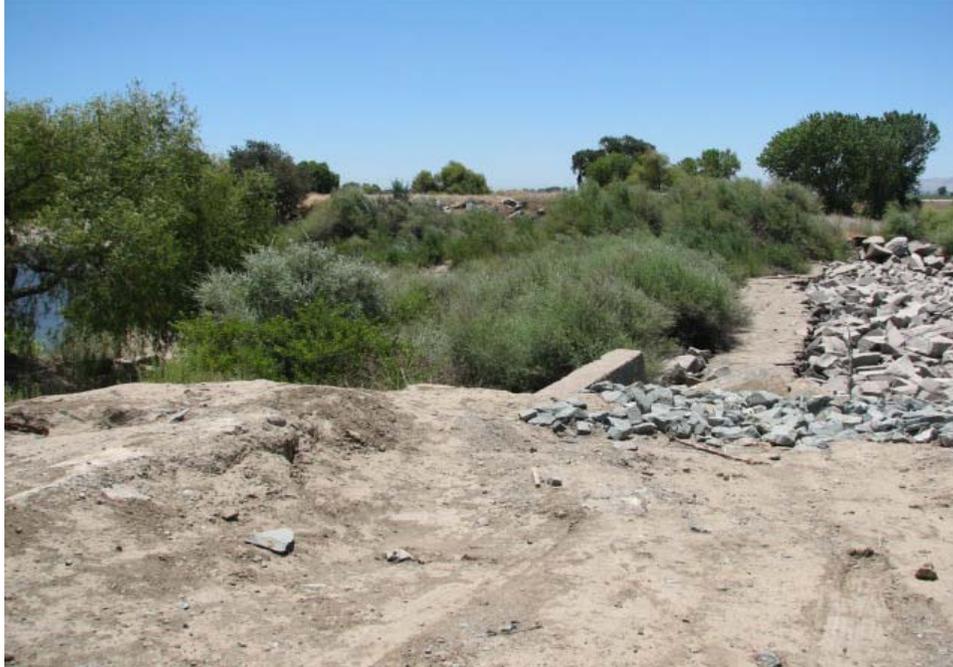
**PARADISE DAM**  
**No Maintaining Agency**

**Looking south at the upstream side of the dam.  
Note the willow growth in front of the structure.**

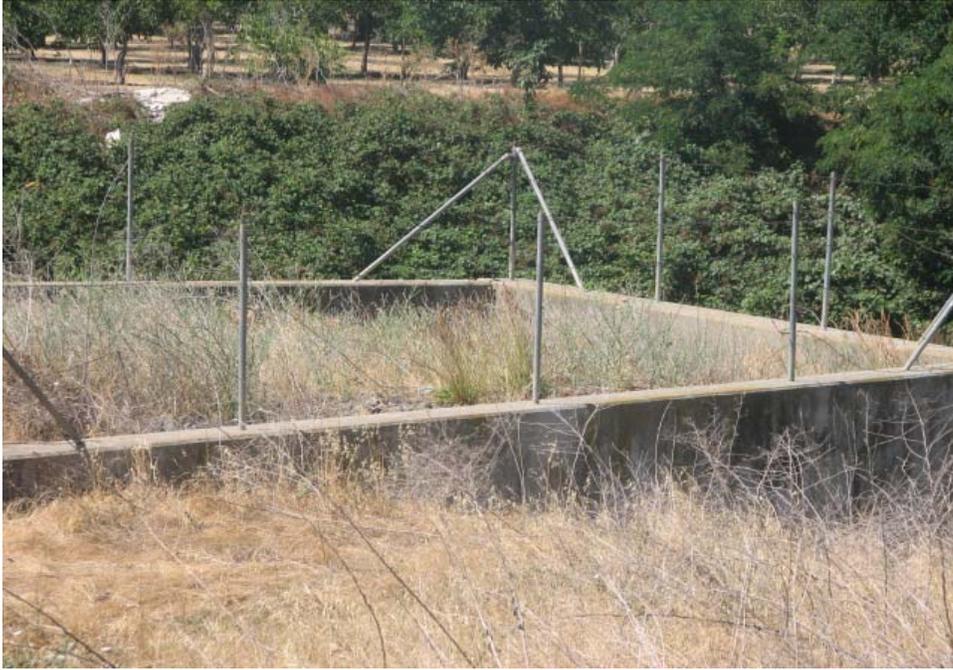
**Left bank abutment missing chain link fence**

6. Comments:
  - a. Remove vegetation upstream of the structure.
  - b. Replace the fence wire on left bank top of structure.

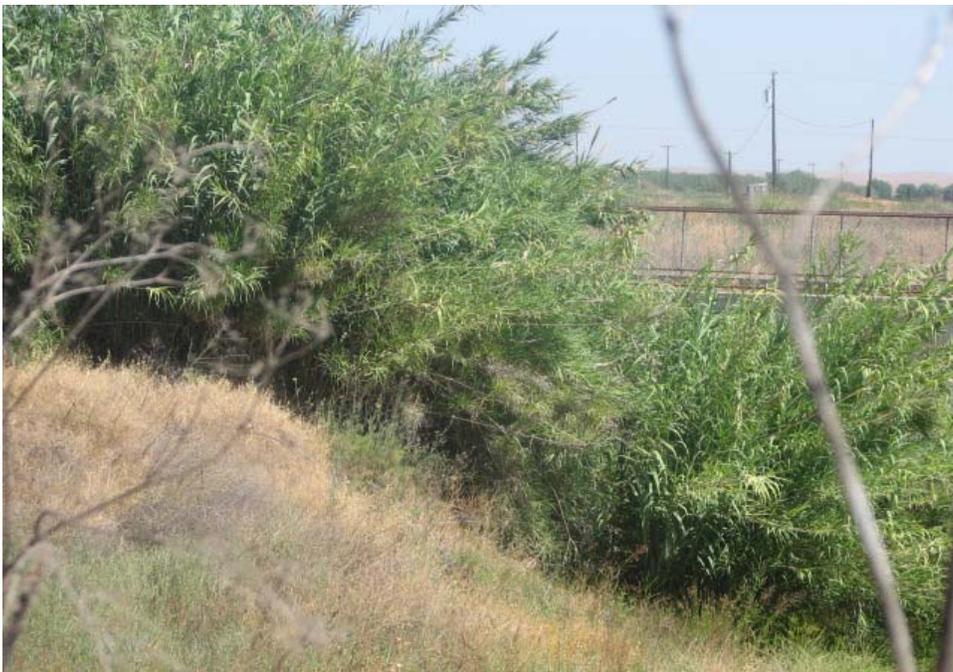
**Orondo growing around structure right bank downstream side**

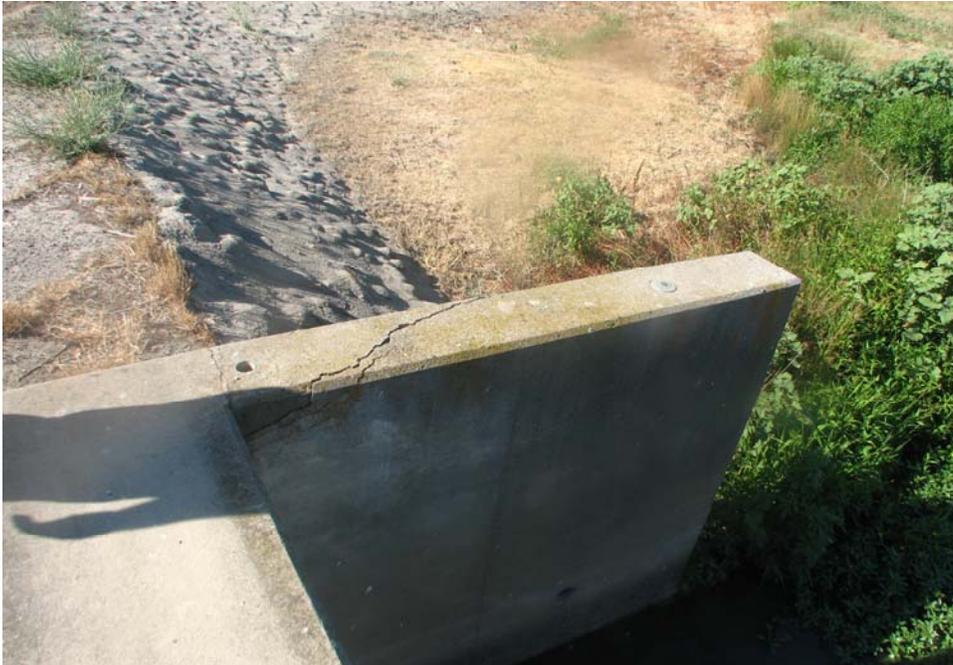
**Crack on left wing wall.**

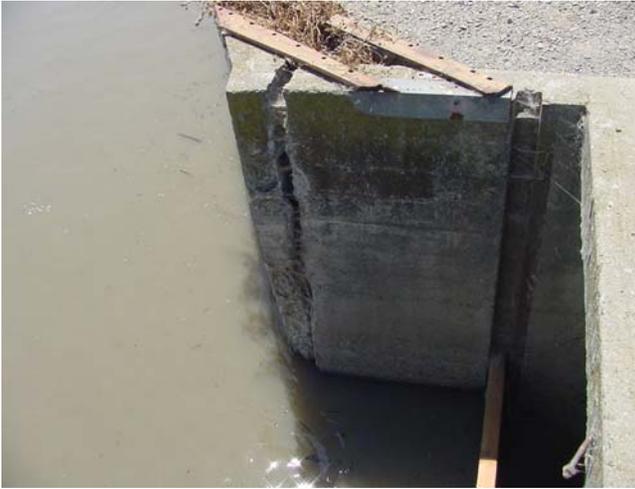
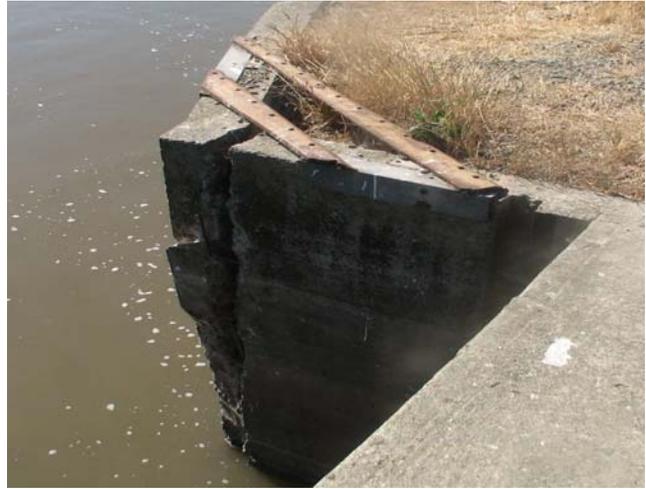
**The 2 inch crack has increased from 2" to 4" on the left bank abutment on the Upstream side and has been temporarily repaired.**

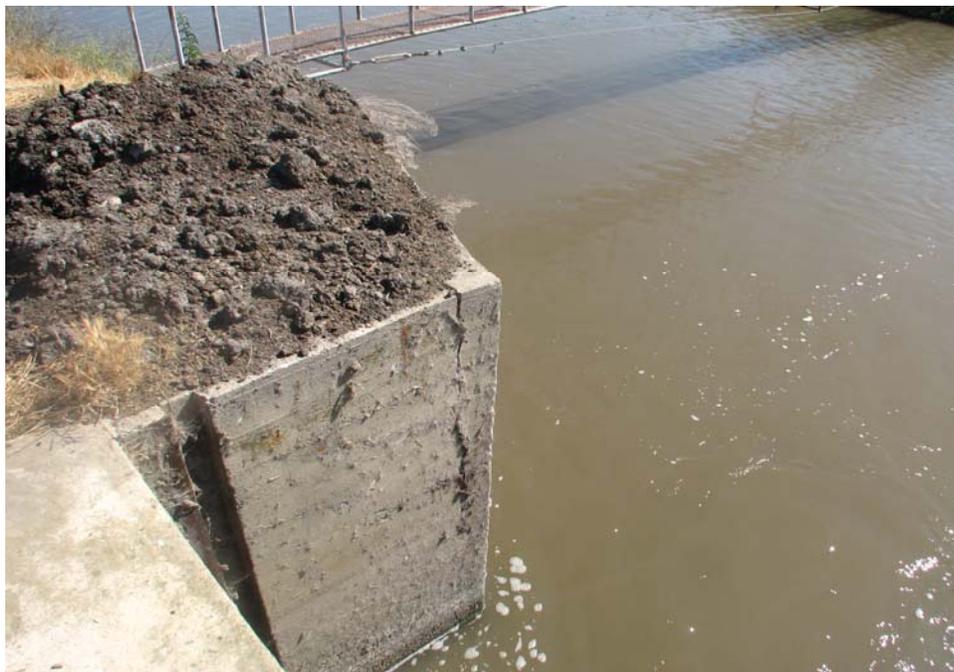
**Right wing wall showing signs of cracking**

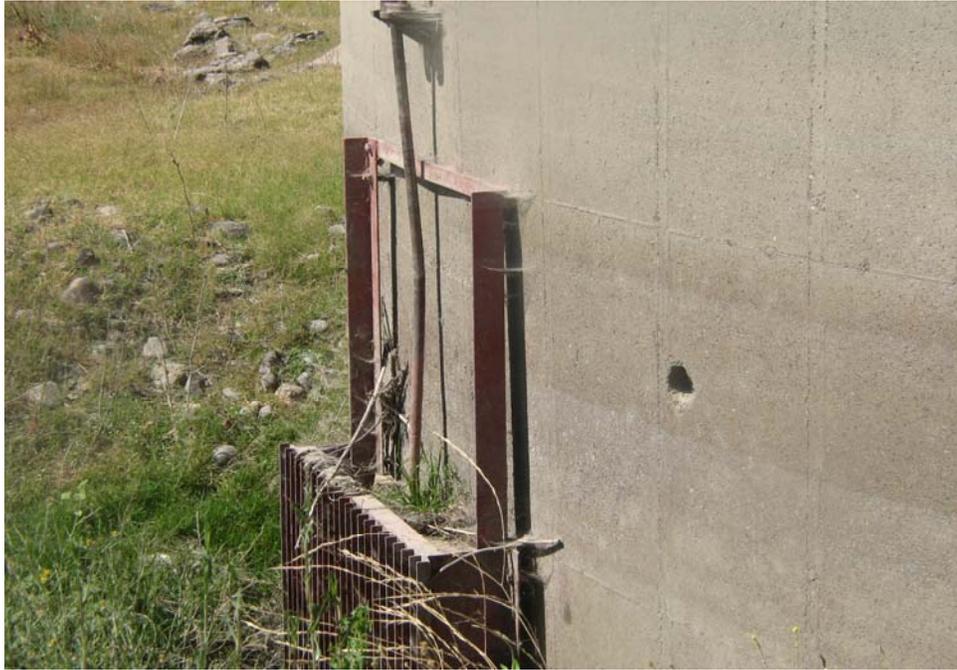
**Stem on auxiliary screw gate is bent.**

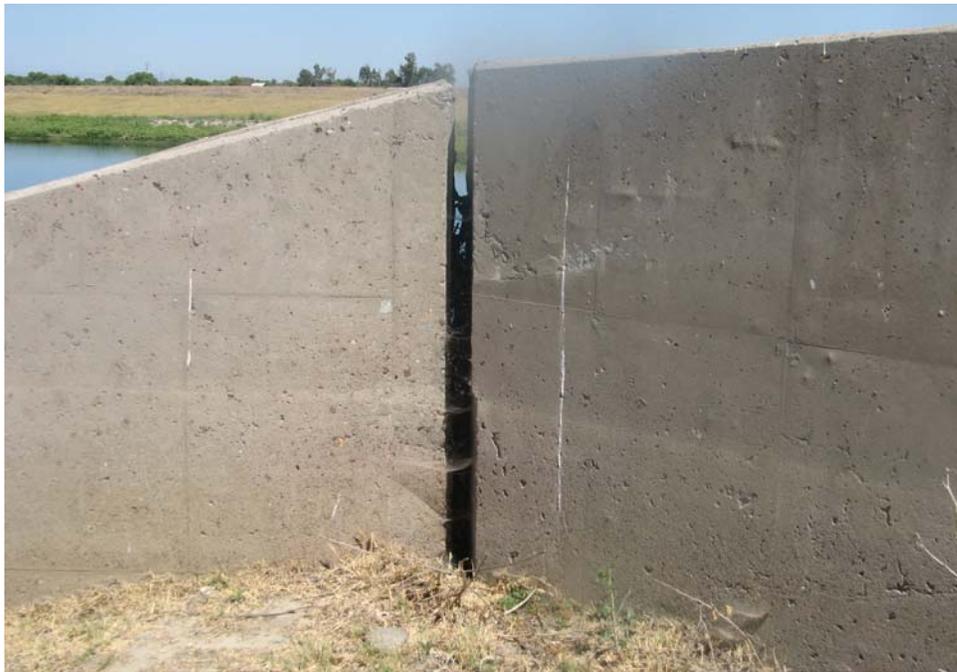
**Left wing wall has moved for  $\frac{3}{4}$ " to 2-3"**

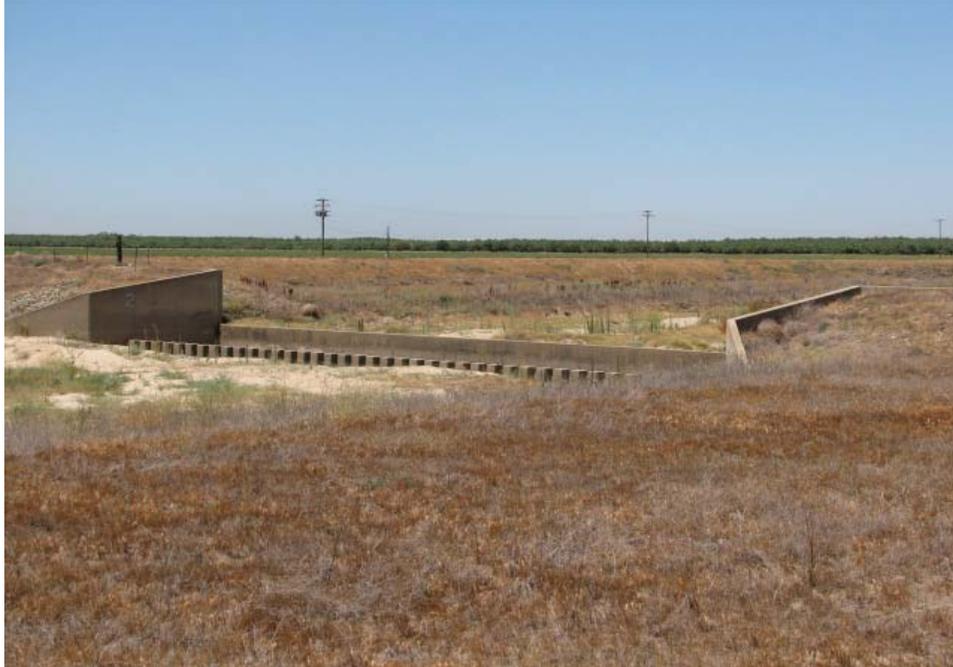
**ASH SLOUGH DROP STRUCTURE NO. 2**  
**Maintained by Lower San Joaquin Levee District**

**The downstream side of the structure.  
Sand is accumulating in the stilling basin.**

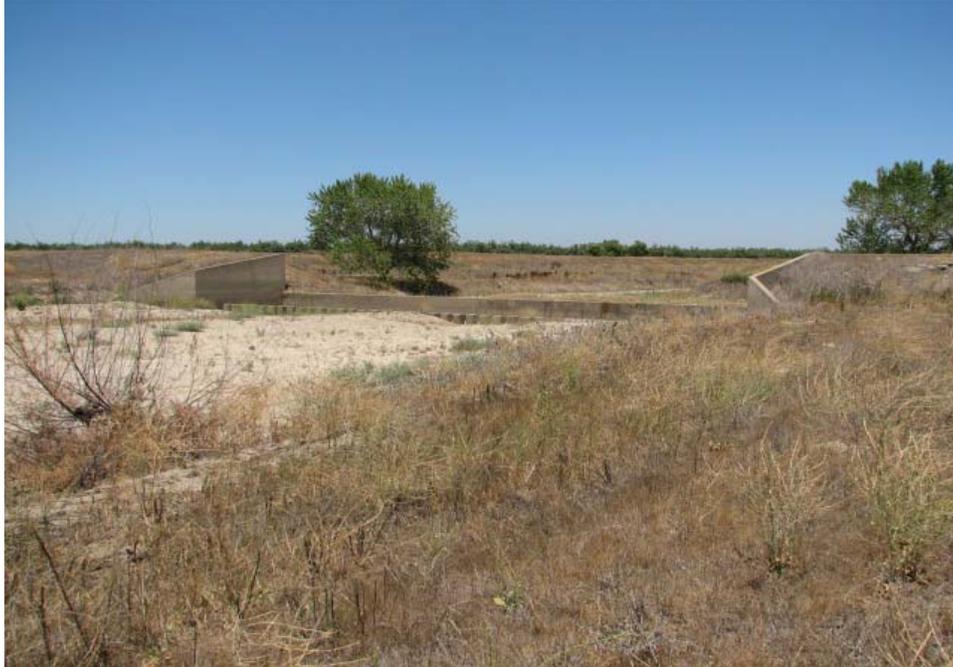
**ASH SLOUGH DROP STRUCTURE NO. 3**  
**Maintained by Lower San Joaquin Levee District**

**The partially sand filled stilling basin.  
The velocity dissipaters are covered by sand.**

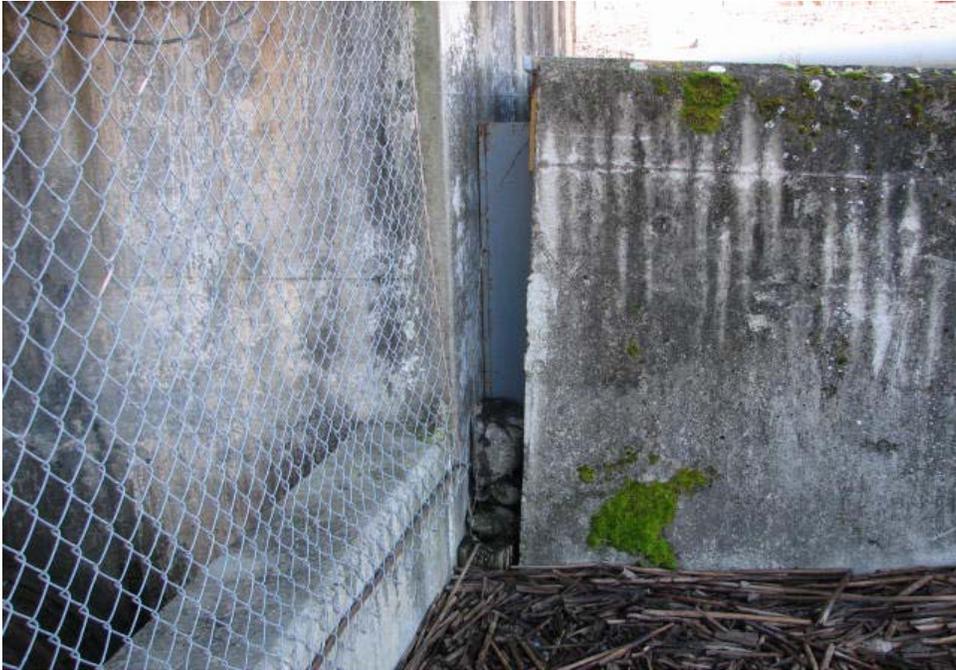
**9.5 inch side displacement between the structure and the surge chamber.**

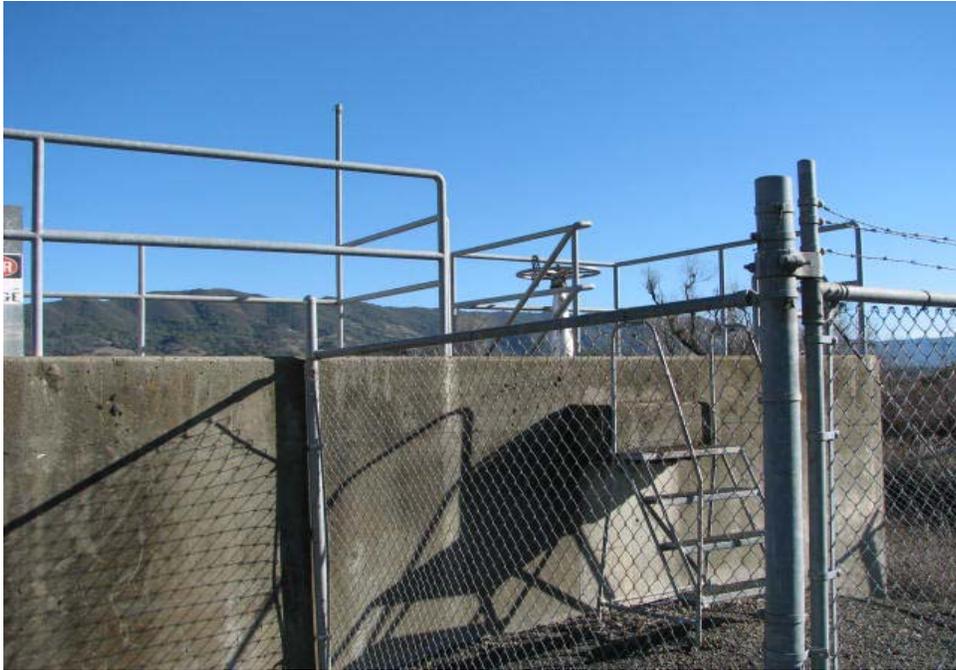
**Barb wire missing from top rail of security fence**

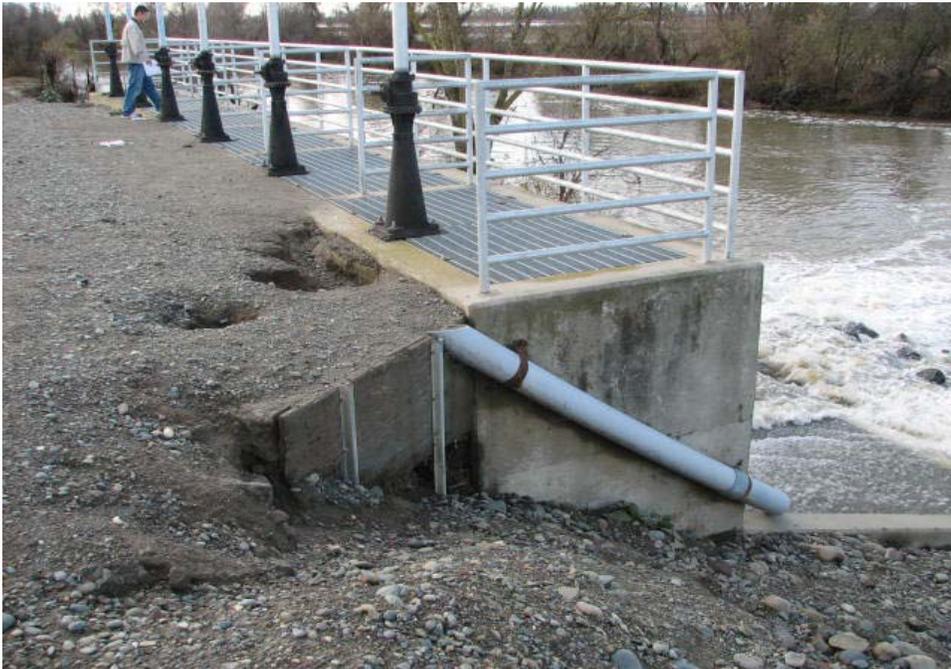
**Discharge slide gate wells and operator**  
**Note: correct erosion condition**

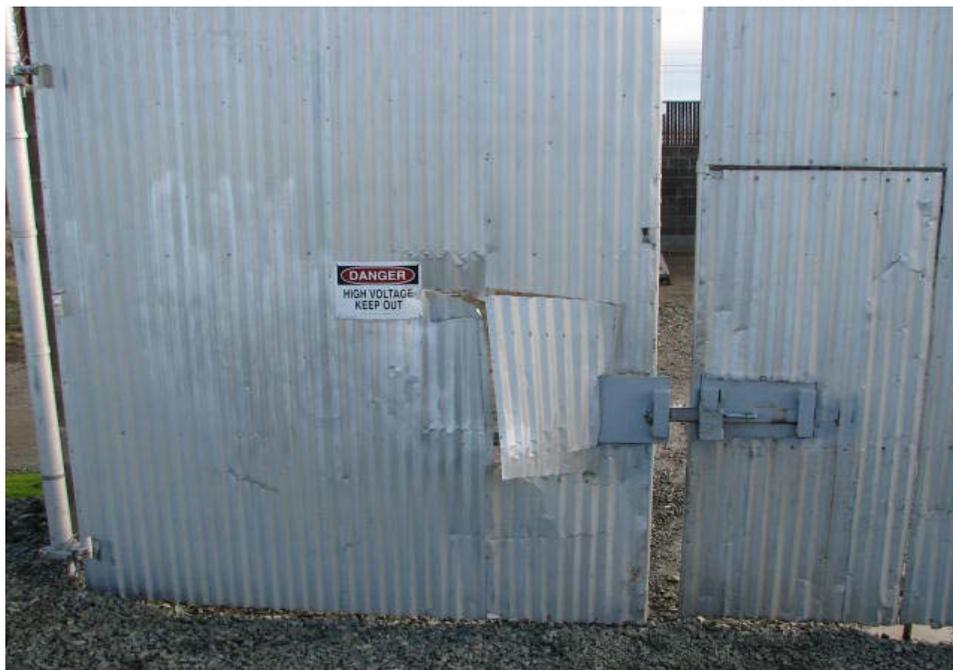
**Damaged Front Gate**

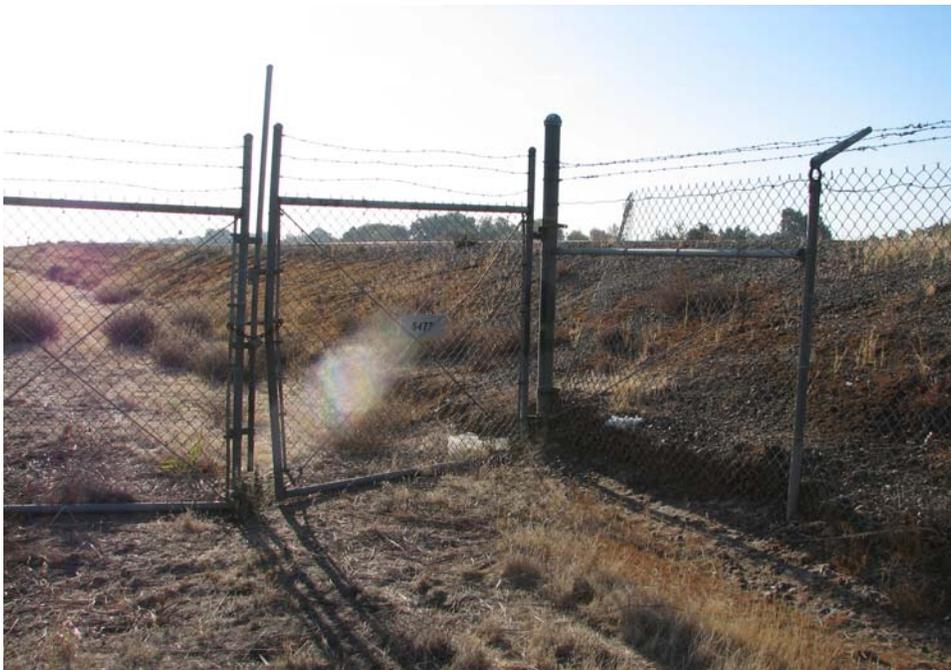
**Back security gate and fence**  
**Note: Repair gate and fence**

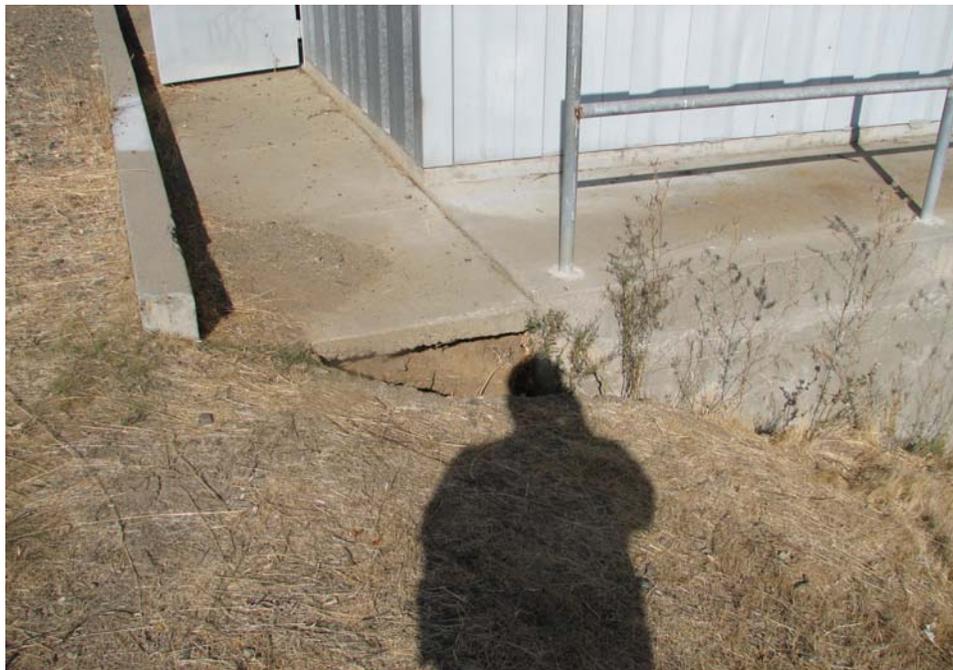
**Pump structure entry sidewalk**  
**Note: Repair sidewalk foundation and erosion path**

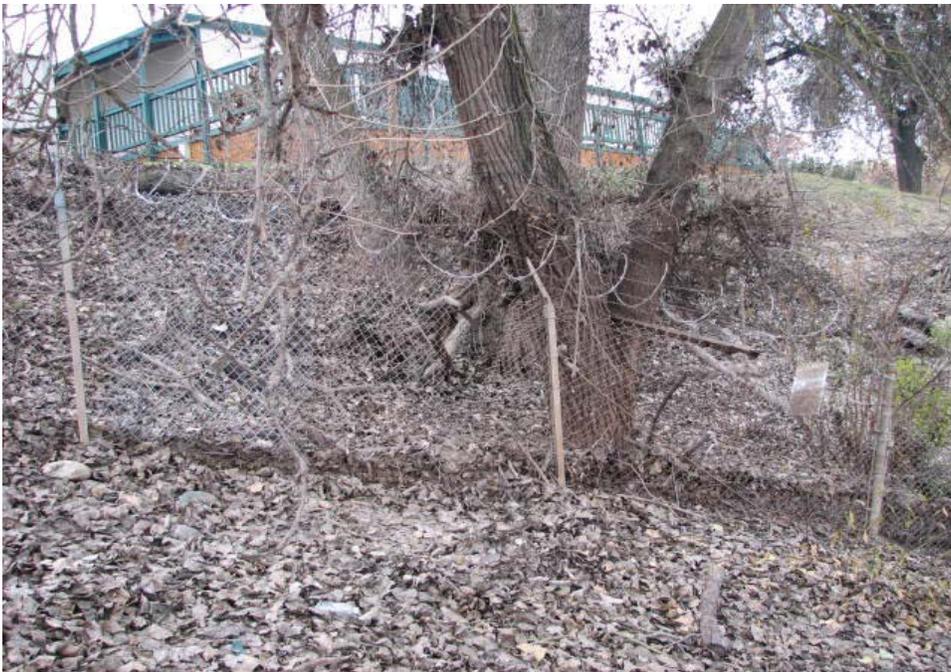
**Security fence left side of the down stream slope  
Note: Repair fence shown in middle of photo**
