**Flood Control Project Maintenance
Levee Inspections**

Maintenance Issue Types Only, Levee Inspection Report By Mile - Fall 2019

Levee District No. 0001 (Glenn County)

Waterway	Bank	Unit Miles	Inspection Start/End	Inspector
Unit No. 01 Sacramento River	Right	12.23	09/17/2019 09/17/2019	Makar Sokol

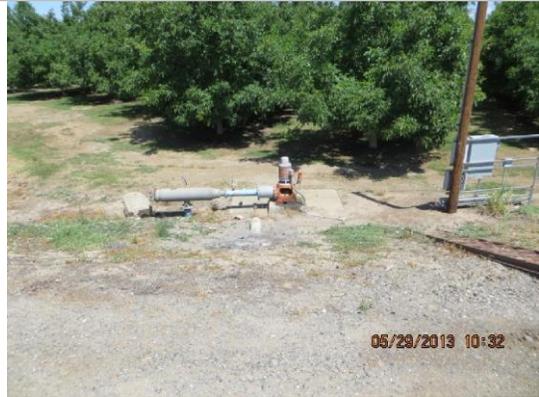
Photo 1 of 3 : UCIP_FA_2019_14332_23582.jpg

LM Start	2.22	Rating **	M	Issue No.	402
LM End	2.22	Issue Type +	Ma	Location *	
Category	Supplemental			GPS Latitude/Longitude	
				Start	End
Item	DRAFT DWR UCIP LMA Responsibility			39.501690°	39.501690°
				-122.006099°	-122.006099°
DWR ID	22944				
Comment Code					
Inspector Comment					
DS_ID:22944 FS_ID:14332 EP_NO: N/A Repair Type: Non-Urgent Crossing Status: Found UCIP Comments: Appears abandoned and should be done so properly. FIELD_STRUCT_DESC: *ABANDONED* 8-inch drainage pipe of an unknown material sleeved through a 12-inch pipe of an unknown material through the levee, 9.5 feet below the crown. Flap gate located on the waterside (WS). Pipe open on the landside (LS). [Additional Reference(s): USACE Sacramento O&M Manual 140, May 1960, (HLM 2.27)]. FS Date: 5/29/2013

Pump at location of pipe on LS toe.

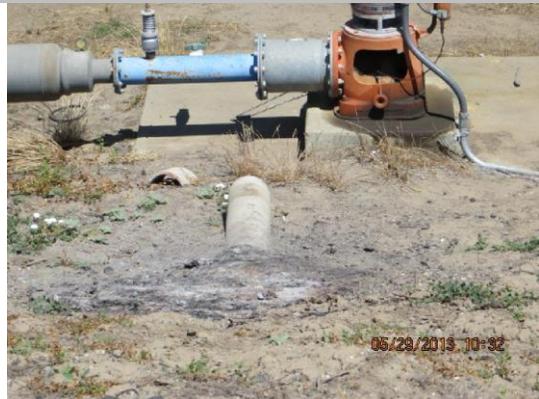
Photo 2 of 3 : UCIP_FA_2019_14332_23581.jpg

Pipe next to pump at LS toe.

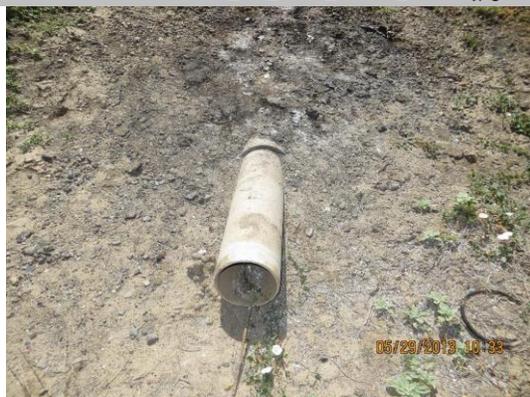
Photo 3 of 3 : UCIP_FA_2019_14332_23580.jpg

LM Start	2.22	Rating **	M	Issue No.	402 (cont)
LM End	2.22	Issue Type +	Ma	Location *	
Category	Supplemental			GPS Latitude/Longitude	
				Start	End
Item	DRAFT DWR UCIP LMA Responsibility			39.501690°	39.501690°
				-122.006099°	-122.006099°
DWR ID	22944				
Comment Code					
Inspector Comment					
DS_ID:22944 FS_ID:14332 EP_NO: N/A Repair Type: Non-Urgent Crossing Status: Found UCIP Comments: Appears abandoned and should be done so properly. FIELD_STRUCT_DESC: *ABANDONED* 8-inch drainage pipe of an unknown material sleeved through a 12-inch pipe of an unknown material through the levee, 9.5 feet below the crown. Flap gate located on the waterside (WS). Pipe open on the landside (LS). [Additional Reference(s): USACE Sacramento O&M Manual 140, May 1960, (HLM 2.27)]. FS Date: 5/29/2013

8-inch pipe sleeved through a 12-inch concrete pipe.

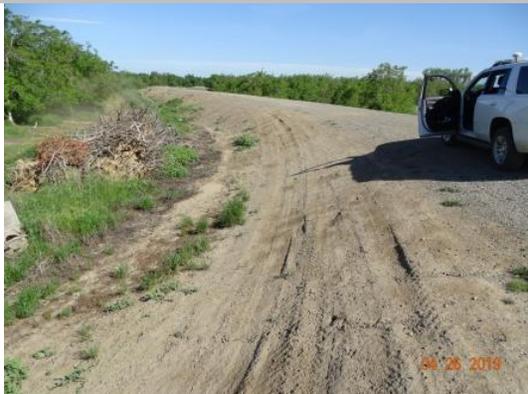
Photo 1 of 1 : FA_2019_LD0001G_432_77_20190822_00025.jpg

LM Start	3.04	Rating **	M	Issue No.	77
LM End	3.04	Issue Type +	Ma	Location *	LS
Category	Earthen Levee			GPS Latitude/Longitude	
				Start	End
Item	Slope Stability			39.512932 °	39.512932 °
				-122.009074 °	-122.009074 °
DWR ID	DWR_LD0001G_01_s_2019_77				
Comment Code					
S3 : Repair the levee slope damaged by vehicle traffic and prevent access where possible.					
Inspector Comment

View of the landside slope damaged by vehicle traffic. Spring 2019.

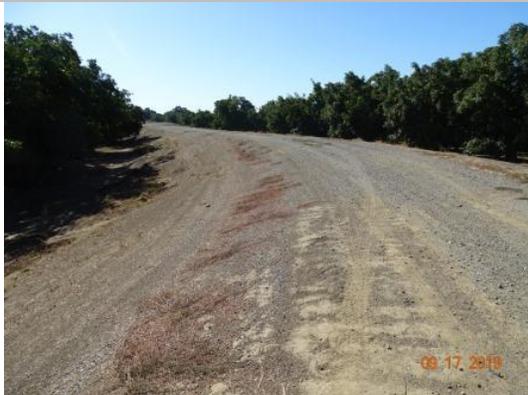
Photo 1 of 1 : FA_2019_LD0001G_432_68_20190918_00102.jpg

LM Start	3.26	Rating **	M	Issue No.	68
LM End	3.26	Issue Type +	Ma	Location *	WS
Category	Earthen Levee			GPS Latitude/Longitude	
				Start	End
Item	Slope Stability			39.515595 °	39.515595 °
				-122.011152 °	-122.011152 °
DWR ID	DWR_LD0001G_01_f_2019_68				
Comment Code					
S3 : Repair the levee slope damaged by vehicle traffic and prevent access where possible.					
Inspector Comment

View of the waterside slope damaged by vehicle traffic. Fall 2019.

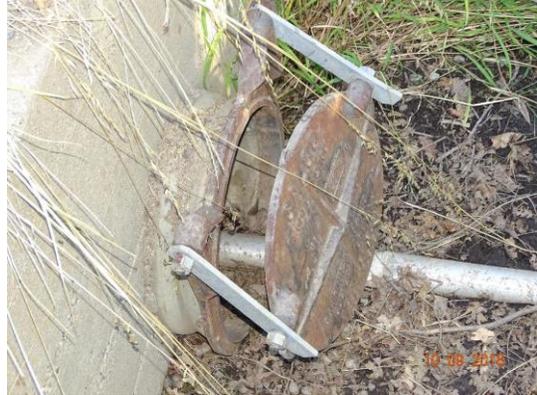
Photo 3 of 3 : UCIP_FA_2019_53006_78125.jpg

Comment Code					
Inspector Comment					
<p>DS_ID:22904 FS_ID:53006 EP_NO: 9572 Repair Type: Urgent Crossing Status: Found UCIP Comments: 10/9/2018 No change to the crossing status. Flap gate on WS cannot be fully closed due to a 3-inch pipe through drainage pipe crossing the levee. Water is supplied from a well on LS via 3-inch pipe to the WS for irrigation/drinking purposes. Owner will need to remove obstruction to allow proper flap gate closure. (O.Yakimov - DWR UCIP)12/21/2016 Flap gate on WS does not appear to be broken however, flap gate does not fully close due to a 3-inch aluminum pipe sleeve through larger pipe. Need to remove 3-inch pipe in order to have WS flap gate close and to be compliant with Title 23. (O. Magana - DWR UCIP)05/29/2013 Broken flap gate and Concrete headwall on LS toe possibly tilting. Also a 3-inch alluminum irrigation line through the pipe. (W. Wylie - DWR UCIP) FIELD_STRUCT_DESC: 18-inch steel drainage pipe through the levee, 7.3 feet below the crown. Flap gate in 6-inch by 6-inch concrete box located on the waterside (WS) end. Concrete headwall located on the landside (LS) toe. (18-inch pipe [HLM 4.05] authorized under Automatic Board Order (ABO) issued as Permit No. 9572, 1974 - Henry and Annabel B. Smith). [Additional Reference(s): DWR Levee Log, 1992. USACE Sacramento O&M Manual 140, May 1960, (HLM 4.05)]. FS Date: 10/9/2018 3:27:06 PM</p>

3-inch pipe obstructs flap gate from complete closing.

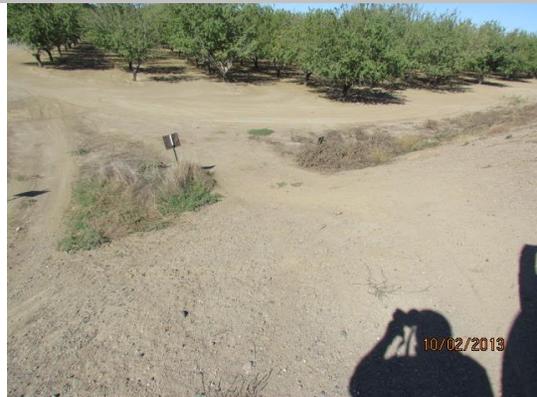
Photo 1 of 1 : FA_2019_LD0001G_432_57_20190822_00016.jpg

LM Start	5.06	Rating **	M	Issue No.	57
LM End	5.06	Issue Type +	Ma	Location *	LS
Category	Earthen Levee			GPS Latitude/Longitude	
				Start	End
Item	Slope Stability			39.534593 °	39.534593 °
				-121.995950 °	-121.995950 °
DWR ID	DWR_LD0001G_01_f_2013_57				
Comment Code					
S3 : Repair the levee slope damaged by vehicle traffic and prevent access where possible.					
Inspector Comment

View of the vehicle erosion along the slope of the levee.

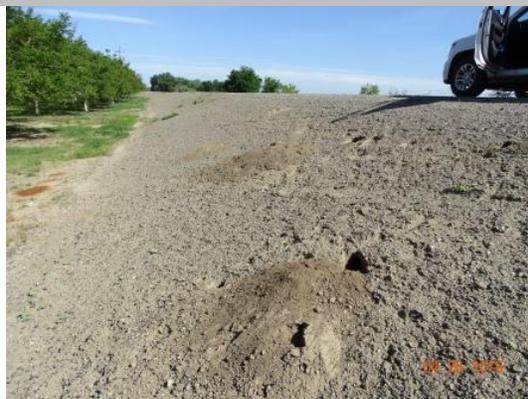
Photo 1 of 1 : FA_2019_LD0001G_432_82_20190822_00029.jpg

View of the rodent activity on the landside slope. Spring 2019.

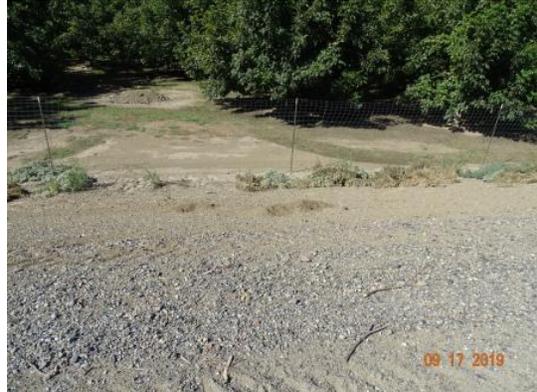
Photo 1 of 1 : FA_2019_LD0001G_432_84_20190918_00103.jpg

View of the rodent activity on the landside slope. Fall 2019.

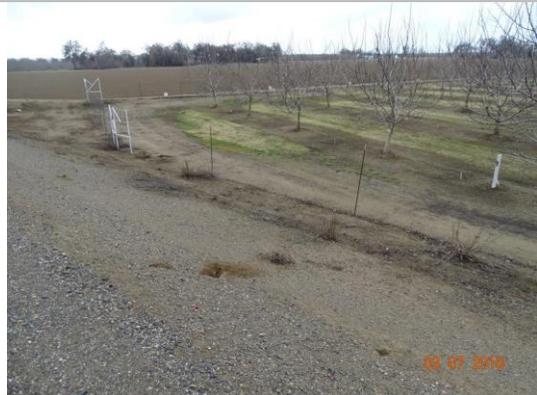
Photo 1 of 1 : FA_2019_LD0001G_432_70_20190822_00021.jpg

LM Start	5.83	Rating **	M	Issue No.	70
LM End	5.83	Issue Type +	Ma	Location *	LS
Category	Earthen Levee			GPS Latitude/Longitude	
				Start	End
Item	Animal Control			39.544894°	39.544894°
				-122.001077°	-122.001077°
DWR ID	DWR_LD0001G_01_s_2018_70				
Comment Code					
A3 : No rodents visible, but rodent burrows visible; need to backfill and compact or grout burrows.					
Inspector Comment

View of the rodent holes along the landside slope.

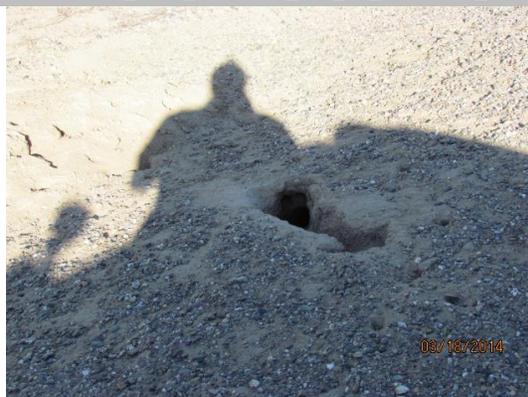
Photo 1 of 1 : FA_2019_LD0001G_432_47_20190822_00010.jpg

View of the rodent activity along the LS slope.

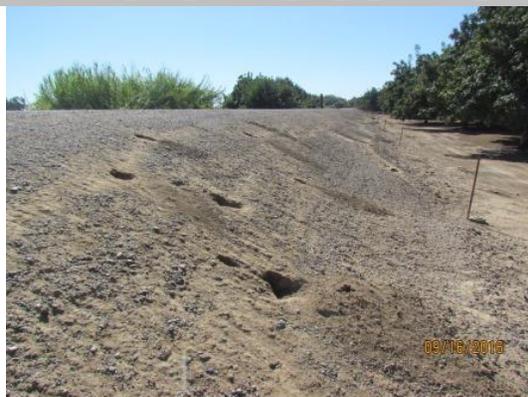
Photo 1 of 1 : FA_2019_LD0001G_432_76_20190822_00024.jpg

LM Start	6.24	Rating **	M	Issue No.	76
LM End	6.24	Issue Type +	Ma	Location *	LS
Category	Earthen Levee			GPS Latitude/Longitude	
				Start	End
Item	Animal Control			39.550725°	39.550725°
				-122.002370°	-122.002370°
DWR ID	DWR_LD0001G_01_f_2016_76				
Comment Code					
A3 : No rodents visible, but rodent burrows visible; need to backfill and compact or grout burrows.					
Inspector Comment

View of the rodent holes along the landside slope.

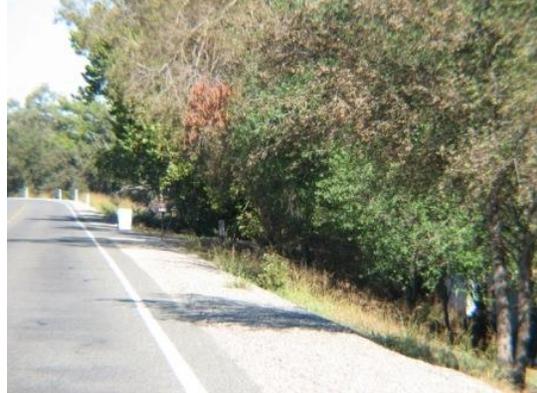
Photo 1 of 1 : FA_2019_LD0001G_432_20_20190822_00007.jpg

View of the trees and vegetation along the waterside slope of the levee.

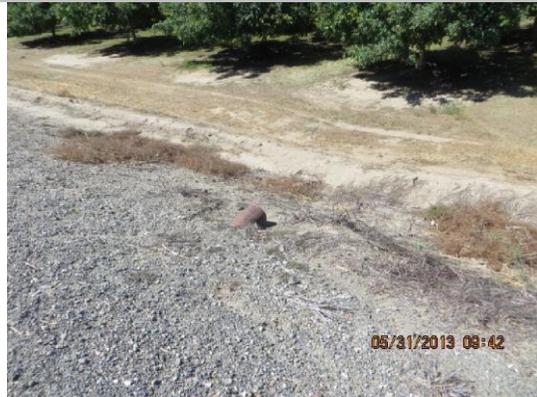
Photo 1 of 3 : UCIP_FA_2019_53341_23668.jpg

Comment Code					
Inspector Comment					
DS_ID:22918 FS_ID:53341 EP_NO: 9563 Repair Type: Non-Urgent Crossing Status: Found UCIP Comments: 10/9/2018 Pipe is open on both ends and damaged on WS. Recommended grouting in place. Crossing downgraded to "Non-Urgent" due to pipe location above floodplain. (O.Yakimov - DWR UCIP)12/21/2016 same as last inspection crossing is opened on both ends and damaged on WS slope is visible. According to LMA representative, Nick Henning, pipe appears to be abandoned. (O. Magana - DWR UCIP)05/31/2013 Pipe open on both ends and damaged on WS slope. Pipe should be abandoned properly if appropriate. (W. Wylie - DWR UCIP) FIELD_STRUCT_DESC: *ABANDONED* 12-inch steel drainage pipe through levee, 5 feet below crown. Pipe open on both waterside (WS) and landside (LS) ends. One corrugated metal cutoff wall. (12-inch pipe [HLM 8.6] authorized under Automatic Board Order (ABO) No. 9563, 1974 - County of Glenn). [Additional Reference(s): DWR Levee Log, 1992. USACE Sacramento O&M Manual Unit 140, May 1960, (HLM 8.60)]. FS Date: 10/9/2018 3:57:00 PM

Pipe on LS slope.

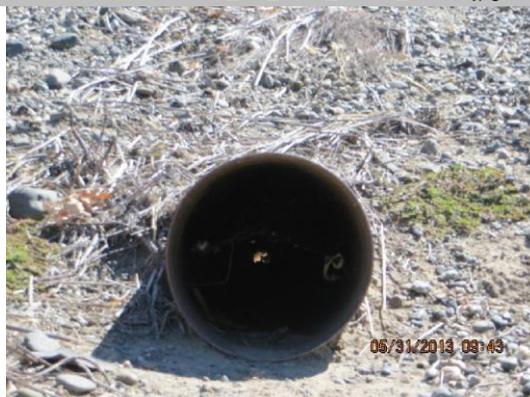
Photo 2 of 3 : UCIP_FA_2019_53341_23667.jpg

Comment Code					
Inspector Comment					
DS_ID:22918 FS_ID:53341 EP_NO: 9563 Repair Type: Non-Urgent Crossing Status: Found UCIP Comments: 10/9/2018 Pipe is open on both ends and damaged on WS. Recommended grouting in place. Crossing downgraded to "Non-Urgent" due to pipe location above floodplain. (O.Yakimov - DWR UCIP)12/21/2016 same as last inspection crossing is opened on both ends and damaged on WS slope is visible. According to LMA representative, Nick Henning, pipe appears to be abandoned. (O. Magana - DWR UCIP)05/31/2013 Pipe open on both ends and damaged on WS slope. Pipe should be abandoned properly if appropriate. (W. Wylie - DWR UCIP) FIELD_STRUCT_DESC: *ABANDONED* 12-inch steel drainage pipe through levee, 5 feet below crown. Pipe open on both waterside (WS) and landside (LS) ends. One corrugated metal cutoff wall. (12-inch pipe [HLM 8.6] authorized under Automatic Board Order (ABO) No. 9563, 1974 - County of Glenn). [Additional Reference(s): DWR Levee Log, 1992. USACE Sacramento O&M Manual Unit 140, May 1960, (HLM 8.60)]. FS Date: 10/9/2018 3:57:00 PM

Pipe on LS slope.

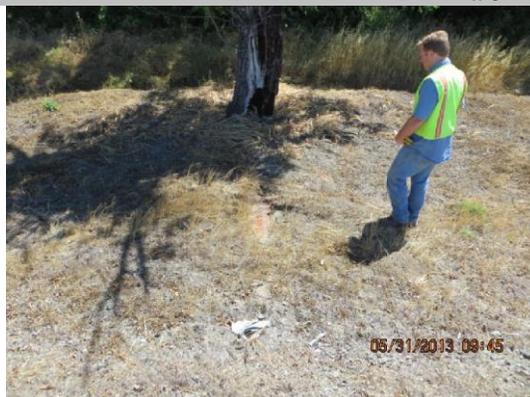
Photo 3 of 3 : UCIP_FA_2019_53341_23666.jpg

Pipe on WS slope.

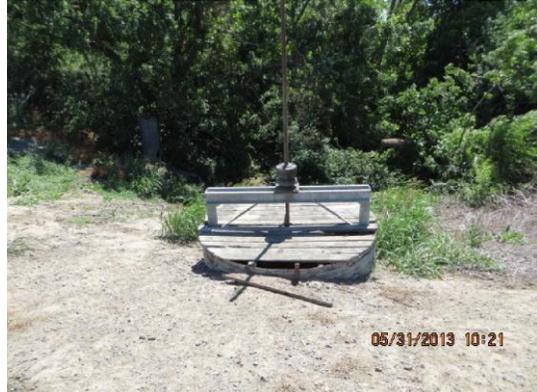
Photo 2 of 3 : UCIP_FA_2019_14389_23685.jpg

Comment Code					
Inspector Comment					
DS_ID:22920 FS_ID:14389 EP_NO: 9560 Repair Type: Non-Urgent Crossing Status: Found UCIP Comments: Heavy rust along springline of pipe. Pipe has slight deformation at centerline of levee, not noticable on crown. FIELD_STRUCT_DESC: 72-inch corrugated metal drainage pipe through the levee, 15 feet below the crown. Flap gate located on the waterside (WS) end. Slide gate in 8-inch corrugated metal riser unit on the WS slope. Concrete headwalls on both ends. Two corrugated metal cutoff walls. (72-inch pipe [HLM 9.64]authorized under Automatic Board Order (ABO) issued as Permit No. 9560, 1974 - John and Lena Friesen). [Additional Reference(s): DWR Levee Log, 1992. USACE Sacramento O&M Manual 140, May 1960, (HLM 9.64)]. FS Date: 5/31/2013

Slide gate in 8-foot diameter CMP riser on WS slope.

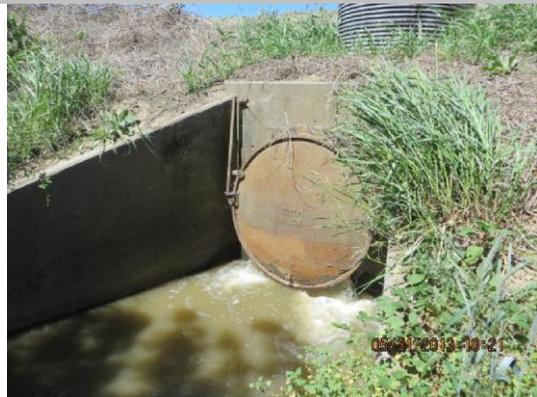
Photo 3 of 3 : UCIP_FA_2019_14389_23684.jpg

Flap gate and headwall on WS toe.

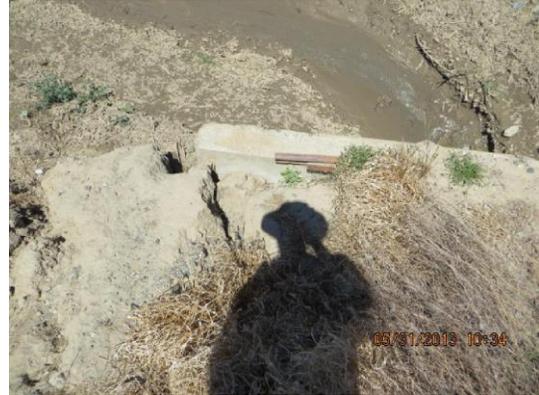
Photo 3 of 3 : UCIP_FA_2019_14390_23688.jpg

Comment Code					
Inspector Comment					
DS_ID:22921 FS_ID:14390 EP_NO: 9559 Repair Type: No Action Needed Crossing Status: Found UCIP Comments: FIELD_STRUCT_DESC: 24-inch corrugated metal drainage pipe through the levee, 11 feet below the crown. Flap gate located on the waterside (WS) end. Slide gate in 36-inch corrugated metal riser unit on the WS slope. Concrete headwalls on both ends. Two corrugated metal cutoff walls. (24-inch pipe [HLM 10.05] authorized under Automatic Board Order (ABO) issued as Permit No. 9559, 1974 - David and Mary Giesbrecht). [Additional Reference(s): DWR Levee Log, 1992. USACE Sacramento O&M Manual 140, May 1960, (HLM 10.05)]. FS Date: 5/31/2013

Erosion around headwall at LS toe.

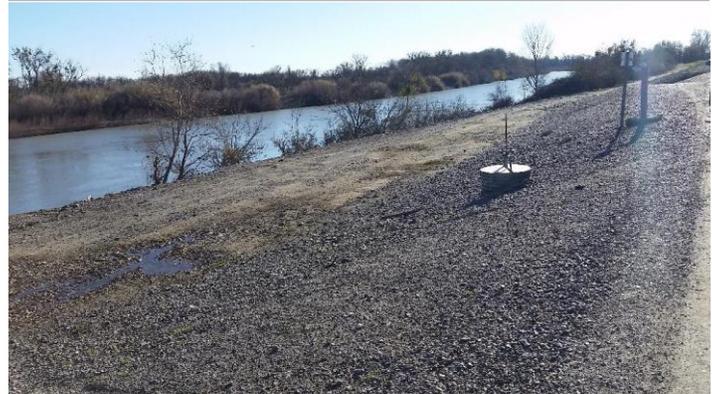
Photo 1 of 3 : UCIP_FA_2019_53340_76411.jpg

Comment Code					
Inspector Comment					
<p>DS_ID:22924 FS_ID:53340 EP_NO: 9556 Repair Type: Urgent Crossing Status: Found UCIP Comments: 10/9/2018 Large rock at the bottom of CMP riser obstructs slide gate from completely closing. Pipe is rusted through at WS end. Recommend internal inspection to determine condition of pipe through levee, and to clean the inside of CMP riser for proper slide gate function. (O.Yakimov - DWR UCIP)12/21/2016 same as last inspection flap gate disabled in open position. Surface erosion observed on LS slope. Recommend repair on WS flap gate to be able to close flap gate. (O. Magana - DWR UCIP)05/31/2013 Flap gate dissabled in open position. Pipe rusted through at WS toe upstream of Flapgate. (W. Wylie - DWR UCIP) FIELD_STRUCT_DESC: 24-inch corrugated metal drainage pipe through levee, 15 feet below crown. Flap gate is located on the waterside (WS) end. Slide gate is inside a corrugated metal pipe (CMP) riser located on the WS slope. Two CM cutoff walls. Concrete headwall is located on LS and under outlet at the WS toe. (24-inch pipe [HLM 10.59] authorized under Automatic Board Order (ABO) issued as Permit No. 9556, 1974 - E. R & M. R. Cooper). [Additional Reference(s): DWR Levee Log, 1992. USACE Sacramento O&M Manual Unit 140, May 1960, (HLM 10.59)]. FS Date: 10/9/2018 4:05:00 PM</p>

View of WS.

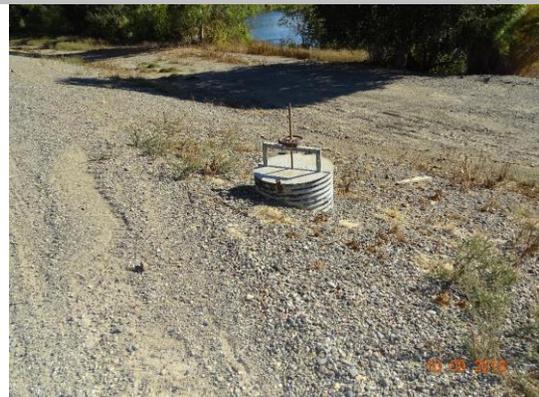
Photo 2 of 3 : UCIP_FA_2019_53340_78135.jpg

Water-Side

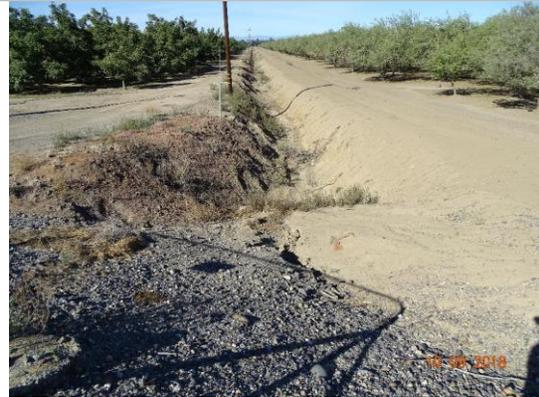
Photo 3 of 3 : UCIP_FA_2019_53340_78136.jpg

Comment Code					
Inspector Comment					
<p>DS_ID:22924 FS_ID:53340 EP_NO: 9556 Repair Type: Urgent Crossing Status: Found UCIP Comments: 10/9/2018 Large rock at the bottom of CMP riser obstructs slide gate from completely closing. Pipe is rusted through at WS end. Recommend internal inspection to determine condition of pipe through levee, and to clean the inside of CMP riser for proper slide gate function. (O.Yakimov - DWR UCIP)12/21/2016 same as last inspection flap gate disabled in open position. Surface erosion observed on LS slope. Recommend repair on WS flap gate to be able to close flap gate. (O. Magana - DWR UCIP)05/31/2013 Flap gate dissabled in open position. Pipe rusted through at WS toe upstream of Flapgate. (W. Wylie - DWR UCIP) FIELD_STRUCT_DESC: 24-inch corrugated metal drainage pipe through levee, 15 feet below crown. Flap gate is located on the waterside (WS) end. Slide gate is inside a corrugated metal pipe (CMP) riser located on the WS slope. Two CM cutoff walls. Concrete headwall is located on LS and under outlet at the WS toe. (24-inch pipe [HLM 10.59] authorized under Automatic Board Order (ABO) issued as Permit No. 9556, 1974 - E. R & M. R. Cooper). [Additional Reference(s): DWR Levee Log, 1992. USACE Sacramento O&M Manual Unit 140, May 1960, (HLM 10.59)]. FS Date: 10/9/2018 4:05:00 PM</p>

Drainage channel on LS.

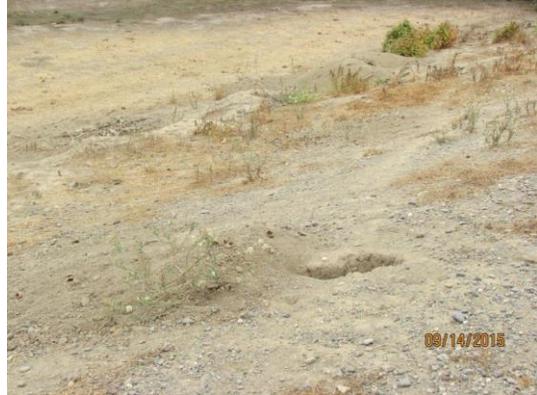
Photo 1 of 1 : FA_2019_LD0001G_432_66_20190822_00019.jpg

View of the rodent holes along the waterside slope.

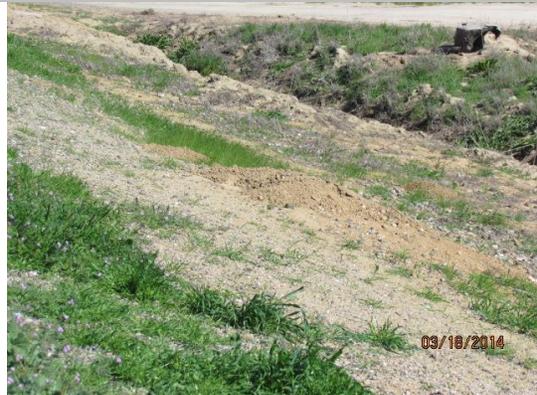
Photo 1 of 1 : FA_2019_LD0001G_432_48_20190822_00011.jpg

View of the rodent activity along the waterside slope.

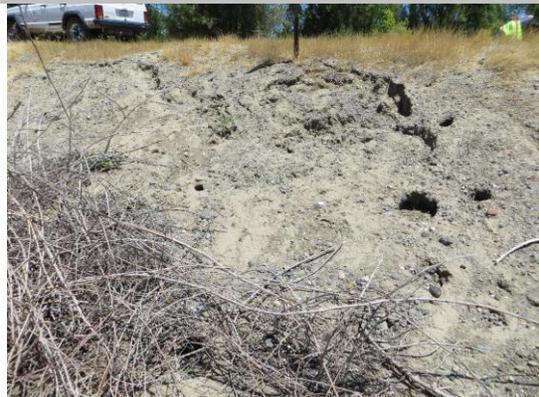
Photo 3 of 3 : UCIP_FA_2019_14567_24015.jpg

Comment Code					
Inspector Comment					
DS_ID:22927 FS_ID:14567 EP_NO: 9554 Repair Type: Non-Urgent Crossing Status: Found UCIP Comments: Erosion and sloughing on LS slope possibly due to rodent activity in area. FIELD_STRUCT_DESC: 24-inch corrugated metal drainage pipe through the levee, 11 feet below the crown. Slide gate in 36-inch corrugated metal riser unit on the waterside (WS) slope. 48-inch concrete standpipe on the landside (LS) toe. Two corrugated metal cutoff walls. (24-inch pipe [HLM 11.93] authorized under Automatic Board Order (ABO) issued as Permit No. 9554, 1974 - Thomas H. Reed). [Additional Reference(s): DWR Levee Log, 1992. USACE Sacramento O&M Manual 140, May 1960, (HLM 11.93)]. FS Date: 5/31/2013

Erosion and sloughing on LS slope possibly due to rodent activity.

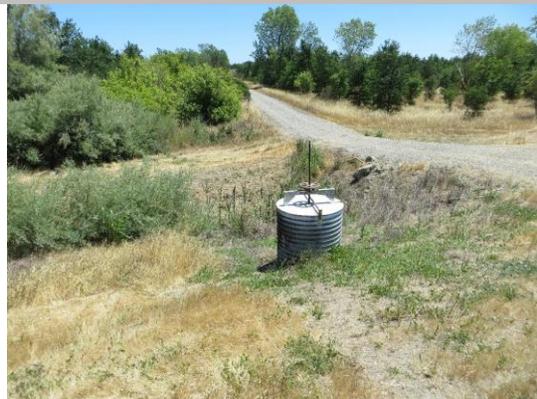
Photo 1 of 3 : UCIP_FA_2019_14569_24026.jpg

Comment Code					
Inspector Comment					
DS_ID:22928 FS_ID:14569 EP_NO: 9554 Repair Type: Non-Urgent Crossing Status: Found UCIP Comments: Flap gate heavily corroded. Good candidate for video inspection. Vegetation interfering with inlet. FIELD_STRUCT_DESC: 24-inch corrugated metal drainage pipe through the levee, 7 feet below the crown. Flap gate on the waterside (WS) end. Slide gate in 36-inch corrugated metal pipe riser unit on the WS slope. Concrete headwalls on both ends. Two corrugated metal cutoff walls. (24-inch pipe [12.04] authorized under Automatic Board Order (ABO) issued as Permit No. 9554, 1974 - Thomas H. Reed). [Additional Reference(s): DWR Levee Log, 1992. USACE Sacramento O&M Manual 140, May 1960, (HLM 12.04)]. FS Date: 5/31/2013

Slidegate in 36-inch CMP riser on WS slope.
