**Flood Control Project Maintenance  
Levee Inspections**

**Fall 2019 Levee Maintenance Deficiency Summary Report**

**Sacramento River Basin**

**Levee District No. 0001 (Sutter County)**

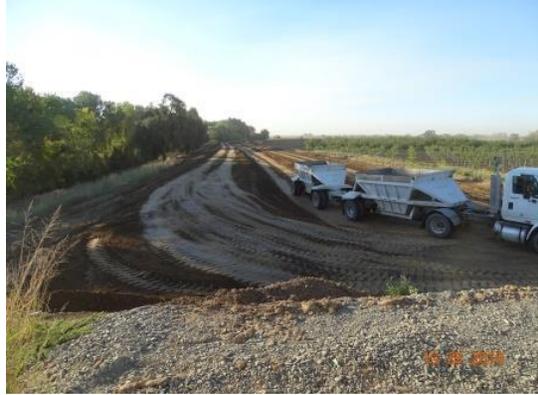
Photo 1 of 2 : FA\_2019\_LD0001S\_433\_20\_20191030\_00042.jpg

View looking south downstream at SABFCA Project; this section of levee is under construction with the install of a slurry wall. This section of the levee will not be inspected until completion of work and turned back over to the LMA, Spring 2020.

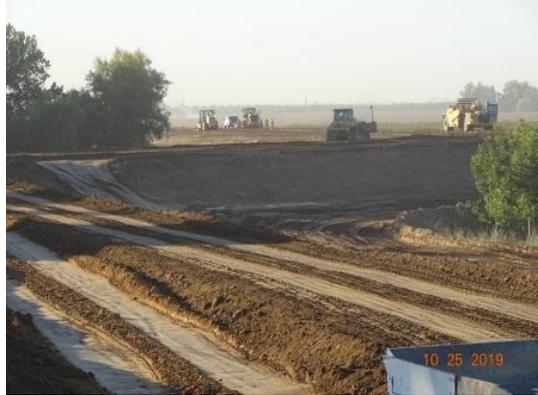
Photo 2 of 2 : FA\_2019\_LD0001S\_433\_20\_20191030\_00043.jpg

View looking south downstream at SABFCA Project; this section of levee is under construction with the install of a slurry wall. This section of the levee will not be inspected until completion of work and turned back over to the LMA, Spring 2020.

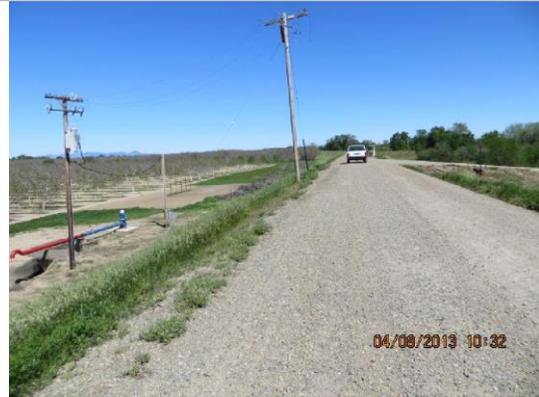
Photo 1 of 3 : UCIP\_FA\_2019\_41624\_18769.jpg

Item	DRAFT DWR UCIP Field Study		38.956192°	38.956192°	
			-121.585510°	-121.585510°	
DWR ID	18653				
Comment Code					
Inspector Comment					
DS_ID:18653 FS_ID:41624 EP_NO: 4667 Repair Type: Non-Urgent Crossing Status: Found UCIP Comments: 04/12/2013 Abandoned crossing. Concrete box on both sides found. Pipe remainings are found on WS. (DWR UCIP - P. Amatya) FIELD_STRUCT_DESC: *ABANDONED* 36-inch steel irrigation pipe through the levee, 10 feet below the crown. Concrete box found on each side. Pipe remains found on the waterside (WS) after the removal of 40 feet of 36-inch steel pipe from a spur levee and 20 feet of 36-inch steel pipe from the landside (LS) slope of the Feather River Levee. (Plans for removal of a portion and filling with concrete a portion of an abandoned 36-inch steel pipe through the levee authorized under Permit No. 4667, 1964 - Levee District No. 1 of Sutter County [LD0001S]). [Additional Reference(s): USACE Sacramento O&M Manual 144, August 1955, (Station 735+57)]. FS Date: 4/12/2013

Crown view- overview of both sides of the levee

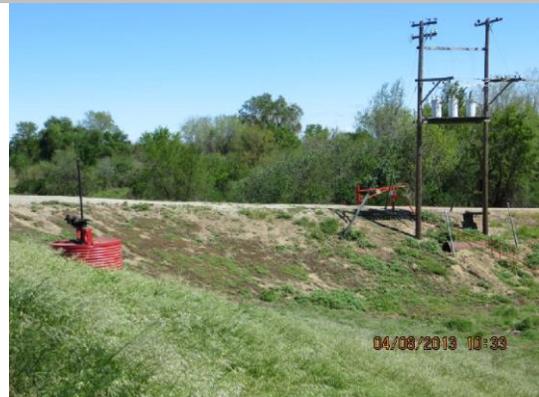
Photo 2 of 3 : UCIP\_FA\_2019\_41624\_18768.jpg

WS- abandoned pipe near power pole (right)

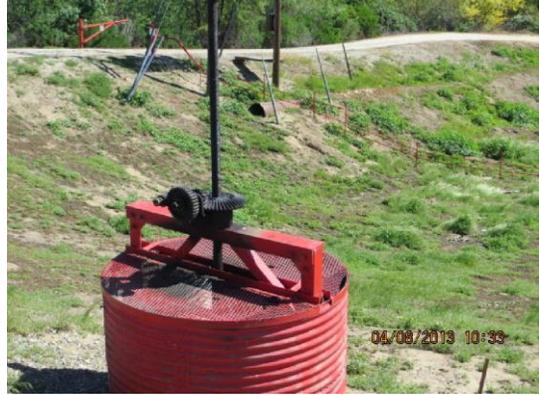
Photo 3 of 3 : UCIP\_FA\_2019\_41624\_18767.jpg

Item	DRAFT DWR UCIP Field Study			38.956192°	38.956192°
				-121.585510°	-121.585510°
DWR ID	18653				
Comment Code					
Inspector Comment					
DS_ID:18653 FS_ID:41624 EP_NO: 4667 Repair Type: Non-Urgent Crossing Status: Found UCIP Comments: 04/12/2013 Abandoned crossing. Concrete box on both sides found. Pipe remainings are found on WS. (DWR UCIP - P. Amatya) FIELD_STRUCT_DESC: *ABANDONED* 36-inch steel irrigation pipe through the levee, 10 feet below the crown. Concrete box found on each side. Pipe remains found on the waterside (WS) after the removal of 40 feet of 36-inch steel pipe from a spur levee and 20 feet of 36-inch steel pipe from the landside (LS) slope of the Feather River Levee. (Plans for removal of a portion and filling with concrete a portion of an abandoned 36-inch steel pipe through the levee authorized under Permit No. 4667, 1964 - Levee District No. 1 of Sutter County [LD0001S]). [Additional Reference(s): USACE Sacramento O&M Manual 144, August 1955, (Station 735+57)]. FS Date: 4/12/2013

WS- abandoned pipe near power pole (top)

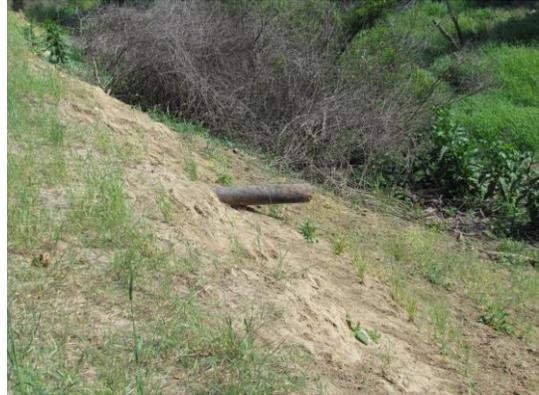
Photo 1 of 3 : UCIP\_FA\_2019\_53068\_75107.jpg

Item	DRAFT DWR UCIP Field Study			38.977002°	38.977002°
				-121.591199°	-121.591199°
DWR ID	17917				
Comment Code					
Inspector Comment					
DS_ID:17917 FS_ID:53068 EP_NO: N/A Repair Type: Non-Urgent Crossing Status: Not Found UCIP Comments: 10/15/2018 Pipe not found. Pipe removed as part of the Project Area A Feather River West Levee Project. Contacted LMA to obtain as-built drawings showing the pipe removal through the levee. Crossing has been downgraded from Urgent to Non-Urgent, waiting to receive as-built drawings pertaining to levee improvement project for this section of the levee. (O. Magana - DWR UCIP)07/20/2016 Same as previous comment, although pipe is open on the waterside (WS) and capped on the LS. Note that this section of levee will likely be reconstructed as part of Project Area A of the Feather River West Levee Project (Star Bend to Sutter Bypass). (K. Fazel - UCIP)05/23/2016 Needs proper abandonment; pipe open on both ends (courtesy of Sterling York, DWR Inspector). (K. Fazel - UCIP) FIELD_STRUCT_DESC: *REMOVED* 8-inch steel pipe of an unknown purpose through the levee, 4.6 feet below the crown. Siphon breaker in a 24-inch corrugated metal pipe (CMP) riser on the landside (LS) shoulder, not found in 2016. [Additional Reference(s): DWR Levee Log, 2005. USACE Sacramento O&M Manual 144, August 1955, (Station 657+00), As-Built Drawing No. 4-4-205-1]. FS Date: 10/16/2018

Pipe visible on WS slope. Photo courtesy of Sterling York, DWR Inspector.

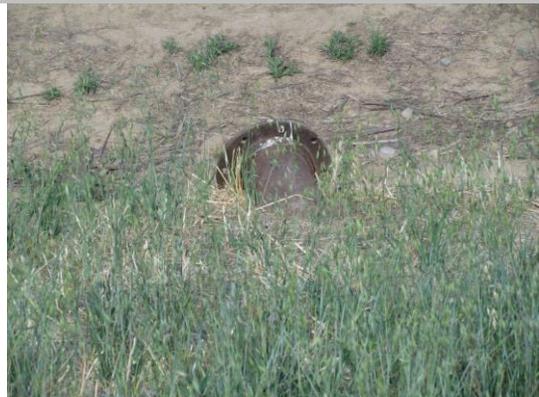
Photo 2 of 3 : UCIP\_FA\_2019\_53068\_75108.jpg

Pipe open on LS end. Photo courtesy of Sterling York, DWR Inspector.

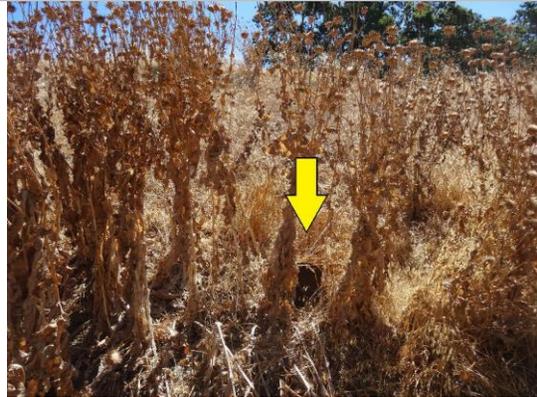
Photo 3 of 3 : UCIP\_FA\_2019\_53068\_76120.jpg

Item	DRAFT DWR UCIP Field Study			38.977002°	38.977002°
				-121.591199°	-121.591199°
DWR ID	17917				
Comment Code					
Inspector Comment					
DS_ID:17917 FS_ID:53068 EP_NO: N/A Repair Type: Non-Urgent Crossing Status: Not Found UCIP Comments: 10/15/2018 Pipe not found. Pipe removed as part of the Project Area A Feather River West Levee Project. Contacted LMA to obtain as-built drawings showing the pipe removal through the levee. Crossing has been downgraded from Urgent to Non-Urgent, waiting to receive as-built drawings pertaining to levee improvement project for this section of the levee. (O. Magana - DWR UCIP)07/20/2016 Same as previous comment, although pipe is open on the waterside (WS) and capped on the LS. Note that this section of levee will likely be reconstructed as part of Project Area A of the Feather River West Levee Project (Star Bend to Sutter Bypass). (K. Fazel - UCIP)05/23/2016 Needs proper abandonment; pipe open on both ends (courtesy of Sterling York, DWR Inspector). (K. Fazel - UCIP) FIELD_STRUCT_DESC: *REMOVED* 8-inch steel pipe of an unknown purpose through the levee, 4.6 feet below the crown. Siphon breaker in a 24-inch corrugated metal pipe (CMP) riser on the landside (LS) shoulder, not found in 2016. [Additional Reference(s): DWR Levee Log, 2005. USACE Sacramento O&M Manual 144, August 1955, (Station 657+00), As-Built Drawing No. 4-4-205-1]. FS Date: 10/16/2018

LS view: pipe appears to be capped, though in a rudimentary fashion.

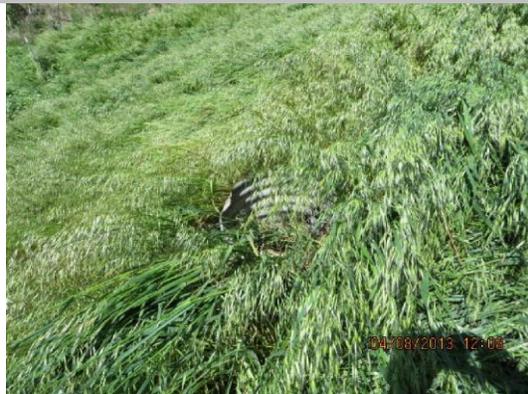
Photo 3 of 3 : UCIP\_FA\_2019\_11383\_18780.jpg

LM Start	<b>2.21</b>	Rating **	M	Issue No.	<b>29 (cont)</b>
LM End	<b>2.21</b>	Issue Type +	En	Location *	
Category	Supplemental			GPS Latitude/Longitude	
				Start	End
Item	DRAFT DWR UCIP Field Study			38.982135°	38.982135°
				-121.591974°	-121.591974°
DWR ID	17915				
Comment Code					
Inspector Comment					
DS_ID:17915 FS_ID:11383 EP_NO: N/A Repair Type: Non-Urgent Crossing Status: Found UCIP Comments: 04/12/2013 Siphon breaker cap missing. Sump pump and gate valve at landward toe not found may be due to dense vegetation. (DWR UCIP - P. Amatya) FIELD_STRUCT_DESC: 8-inch coated steel pipe of an unknown purpose through the levee, 4.6 feet below the crown. Siphon breaker in a corrugated metal pipe (CMP) riser on the landside (LS) slope. [Additional Reference(s): DWR Levee Log, 2005. USACE Sacramento O&M Manual 144, August 1955, (Station 638+07)]. FS Date: 4/12/2013

LS- CMP riser on levee slope with dense vegetation.

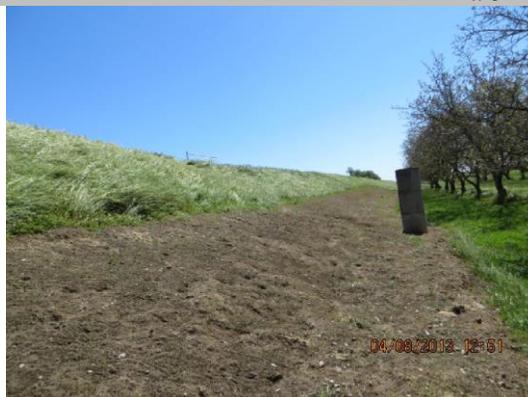
Photo 1 of 3 : UCIP\_FA\_2019\_41787\_18793.jpg

Item	DRAFT DWR UCIP Field Study			38.985223°	38.985223°
				-121.591922°	-121.591922°
DWR ID	18667				
Comment Code					
Inspector Comment					
DS_ID:18667 FS_ID:41787 EP_NO: N/A Repair Type: Non-Urgent Crossing Status: Found UCIP Comments: 04/12/2013 Pipe appears to be abandoned and should be verified as having been done so properly. - concrete standpipe with 10-inch steel pipe.- concrete wing wall- no pipe-abandoned structure- a pump found on other side of the levee (WS) but not sure whether it is associated with this crossing. (DWR UCIP - P. Amatya) FIELD_STRUCT_DESC: *ABANDONED* 24-inch gravity drainage pipe of an unknown material under the landside (LS) approach, at an unknown depth. Plans to install a 10-inch corrugated iron gravity drainage culvert under the LS approach, at an unknown depth. Crossing not found in the O&M Manual. FS Date: 4/12/2013

LS- overview of landside with concrete standpipe

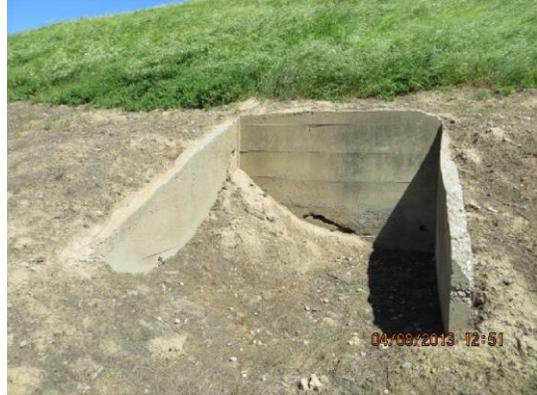
Photo 2 of 3 : UCIP\_FA\_2019\_41787\_18792.jpg

Item	DRAFT DWR UCIP Field Study			38.985223°	38.985223°
				-121.591922°	-121.591922°
DWR ID	18667				
Comment Code					
Inspector Comment					
DS_ID:18667 FS_ID:41787 EP_NO: N/A Repair Type: Non-Urgent Crossing Status: Found UCIP Comments: 04/12/2013 Pipe appears to be abandoned and should be verified as having been done so properly. - concrete standpipe with 10-inch steel pipe.- concrete wing wall- no pipe-abandoned structure- a pump found on other side of the levee (WS) but not sure whether it is associated with this crossing. (DWR UCIP - P. Amatya) FIELD_STRUCT_DESC: *ABANDONED* 24-inch gravity drainage pipe of an unknown material under the landside (LS) approach, at an unknown depth. Plans to install a 10-inch corrugated iron gravity drainage culvert under the LS approach, at an unknown depth. Crossing not found in the O&M Manual. FS Date: 4/12/2013

LS- abandoned wing wall- no pipe

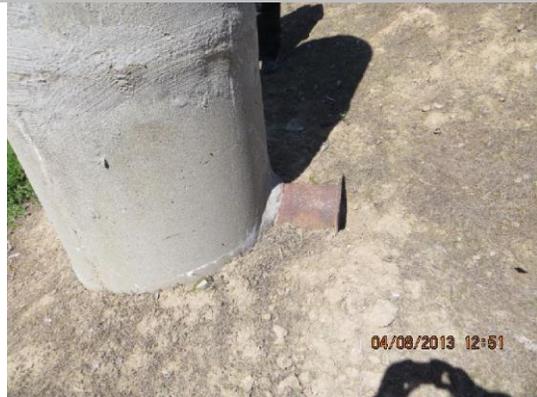
Photo 3 of 3 : UCIP\_FA\_2019\_41787\_18791.jpg

LS- concrete standpipe with disconnected steel pipe

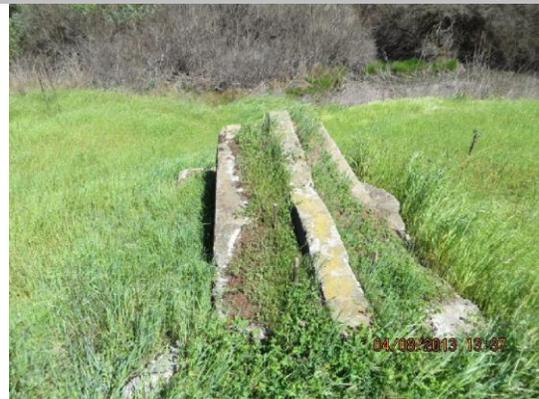
Photo 1 of 3 : UCIP\_FA\_2019\_41348\_18882.jpg

Item	DRAFT DWR UCIP Field Study		38.998858°	38.998858°	
			-121.596746°	-121.596746°	
DWR ID	17918				
Comment Code					
Inspector Comment					
DS_ID:17918 FS_ID:41348 EP_NO: N/A Repair Type: Non-Urgent Crossing Status: Indicator Found UCIP Comments: 04/08/2013 Only an abandoned steel structure on water and a concrete structure on WS Levee slope found. Need to verify pipe was properly abandoned. (DWR UCIP - P. Amatya) FIELD_STRUCT_DESC: *ABANDONED* 8-inch steel pipe of an unknown purpose through the levee, 4.1 feet below the crown. Siphon breaker on the landside (LS) slope. Butterfly shutoff valve on the LS slope. Concrete standpipe and pump at the LS toe. Pipe discharges into borrow pit on the waterside (WS). [Additional Reference(s): DWR Levee Log, 2005. USACE Sacramento O&M Manual 144, August 1955, (Station 574+20)]. FS Date: 4/8/2013

WS- abandoned concrete structure on levee slope

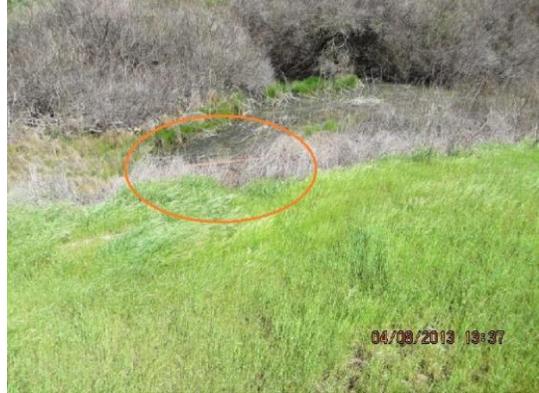
Photo 2 of 3 : UCIP\_FA\_2019\_41348\_18881.jpg

Item	DRAFT DWR UCIP Field Study			38.998858 °	38.998858 °
				-121.596746 °	-121.596746 °
DWR ID	17918				
Comment Code					
Inspector Comment					
DS_ID:17918 FS_ID:41348 EP_NO: N/A Repair Type: Non-Urgent Crossing Status: Indicator Found UCIP Comments: 04/08/2013 Only an abandoned steel structure on water and a concrete structure on WS Levee slope found. Need to verify pipe was properly abandoned. (DWR UCIP - P. Amatya) FIELD_STRUCT_DESC: *ABANDONED* 8-inch steel pipe of an unknown purpose through the levee, 4.1 feet below the crown. Siphon breaker on the landside (LS) slope. Butterfly shutoff valve on the LS slope. Concrete standpipe and pump at the LS toe. Pipe discharges into borrow pit on the waterside (WS). [Additional Reference(s): DWR Levee Log, 2005. USACE Sacramento O&M Manual 144, August 1955, (Station 574+20)]. FS Date: 4/8/2013

WS- abandoned steel structure on waterway

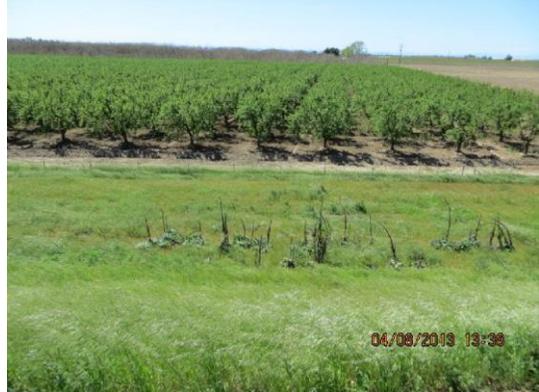
Photo 3 of 3 : UCIP\_FA\_2019\_41348\_18880.jpg

Overview of landside of the levee- no pipes visible. Dense vegetation.

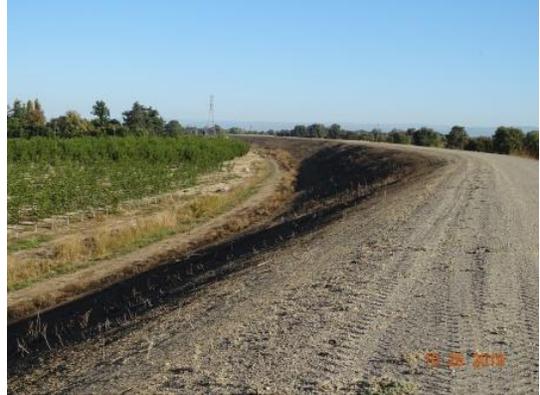
Photo 1 of 1 : FA\_2019\_LD0001S\_433\_15\_20191030\_00044.jpg

View looking upstream landside at the well maintained annual vegetation, Fall 2019.

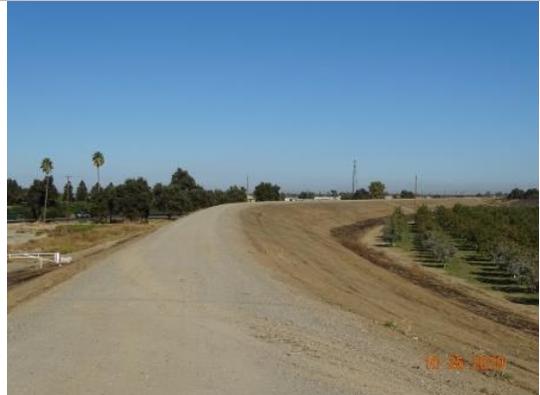
Photo 1 of 1 : FA\_2019\_LD0001S\_433\_16\_20191030\_00046.jpg

LM Start	<b>4.41</b>	Rating **	A	Issue No.	<b>16</b>
LM End	<b>16.11</b>	Issue Type +	Ma	Location *	WS
Category	Earthen Levee		GPS Latitude/Longitude		
			Start	End	
Item	Vegetation		39.011497°	39.169221°	
			-121.603630°	-121.622951°	
DWR ID	DWR_LD0001S_01_f_2019_16				
Comment Code					
V1 : Control annual grass and weeds on the levee slopes and easements.					
Inspector Comment					
The annual vegetation is well maintained, Fall 2019.

View looking upstream waterside at the well maintained annual vegetation, Fall 2019.

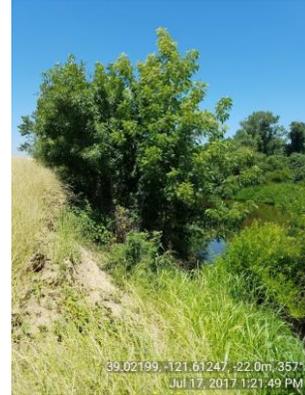
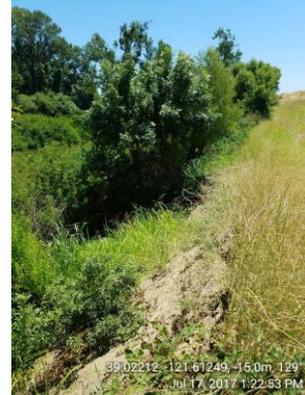
LM Start	<b>5.02</b>	Rating **	A/W	Issue No.	<b>25</b>
LM End	<b>5.02</b>	Issue Type +	Ma	Location *	
Category	Supplemental			GPS Latitude/Longitude	
				Start	End
Item	2017 Storm Damage			39.018322°	39.018322°
				-121.610275°	-121.610275°
DWR ID	LD1-S-02				
Comment Code					
Inspector Comment					
Levee Evaluation Comments					
Description:					
Site ID No:145					
Site Designation:LD1-S-02					
Repair Type: Erosion					
Rating:Critical					
Field Date:7/17/2017					
Notes:

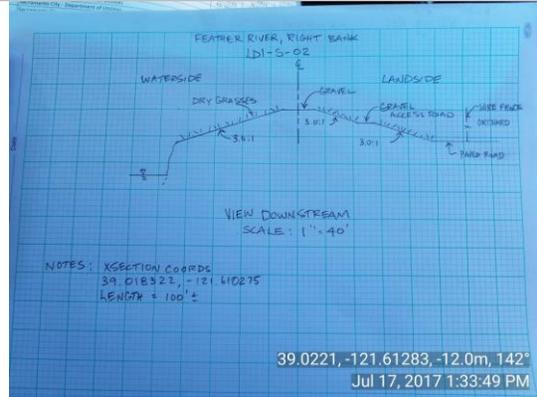
Photo 3 of 3 : LEVAL\_FA\_2019\_145\_1769.jpg

LM Start	<b>5.02</b>	Rating **	A/W	Issue No.	<b>25 (cont)</b>
LM End	<b>5.02</b>	Issue Type +	Ma	Location *	
Category	Supplemental		GPS Latitude/Longitude		
			Start	End	
Item	2017 Storm Damage		39.018322°	39.018322°	
			-121.610275°	-121.610275°	
DWR ID	LD1-S-02				
Comment Code					
Inspector Comment					
Levee Evaluation Comments					
Description:					
Site ID No:145					
Site Designation:LD1-S-02					
Repair Type: Erosion					
Rating:Critical					
Field Date:7/17/2017					
Notes:

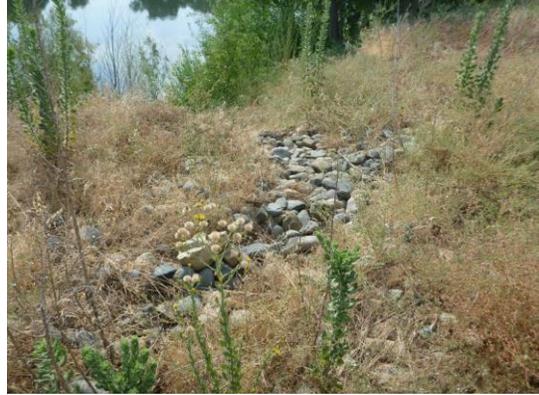
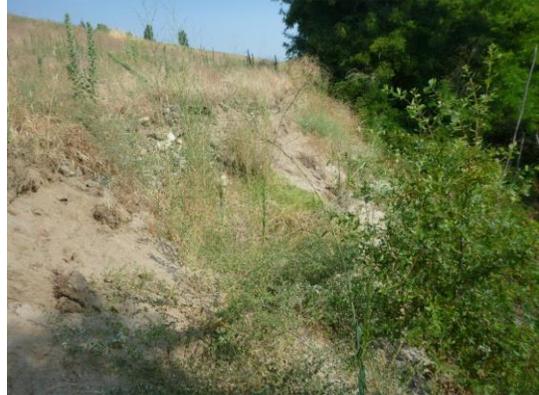
LM Start	<b>7.69</b>	Rating **	A/W	Issue No.	<b>19</b>
LM End	<b>7.74</b>	Issue Type +	Ma	Location *	
Category	Supplemental		GPS Latitude/Longitude		
			Start	End	
Item	2017 Storm Damage		39.055986°	39.056710°	
			-121.611301°	-121.611331°	
DWR ID	LD1-S-03				
Comment Code					
Inspector Comment					
Levee Evaluation Comments					
Description:					
Site ID No:146					
Site Designation:LD1-S-03					
Repair Type: Erosion					
Rating:Area of Concern					
Field Date:8/3/2017					
Notes:

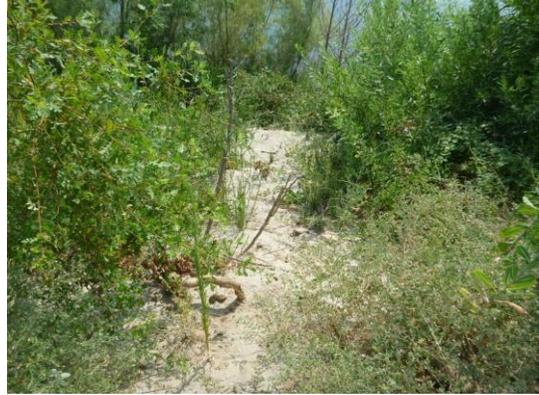
Photo 3 of 3 : LEVAL\_FA\_2019\_146\_4054.jpg

LM Start	<b>7.69</b>	Rating **	A/W	Issue No.	<b>19 (cont)</b>
LM End	<b>7.74</b>	Issue Type +	Ma	Location *	
Category	Supplemental			GPS Latitude/Longitude	
				Start	End
Item	2017 Storm Damage			39.055986°	39.056710°
				-121.611301°	-121.611331°
DWR ID	LD1-S-03				
Comment Code					
Inspector Comment					
Levee Evaluation Comments					
Description:					
Site ID No:146					
Site Designation:LD1-S-03					
Repair Type: Erosion					
Rating:Area of Concern					
Field Date:8/3/2017					
Notes:

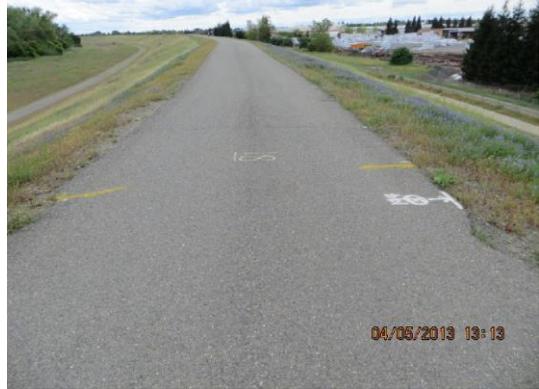
Photo 1 of 3 : UCIP\_FA\_2019\_41841\_19538.jpg

LM Start	<b>11.99</b>	Rating **	M	Issue No.	<b>32</b>
LM End	<b>11.99</b>	Issue Type +	En	Location *	
Category	Supplemental			GPS Latitude/Longitude	
				Start	End
Item	DRAFT DWR UCIP Field Study			39.114856°	39.114856°
				-121.605821°	-121.605821°
DWR ID	17932				
Comment Code					
Inspector Comment					
DS_ID:17932 FS_ID:41841 EP_NO: N/A Repair Type: Non-Urgent Crossing Status: Indicator Found UCIP Comments: 04/05/2013 Need to install Gasline Markers.Fenced control station.Indicator on LS across concrete ditch.Found road markings.(DWR UCIP - P. Amatya) FIELD_STRUCT_DESC: 1 of 2: 16-inch natural gas pipeline of an unknown material through the levee, 3 feet below the crown. PG&E gas line crossing sign on the waterside (WS) shoulder. [Additional Reference(s): DWR Levee Log, 2005]. FS Date: 4/5/2013

Levee Crown: gasline indicator/markings on crown road.

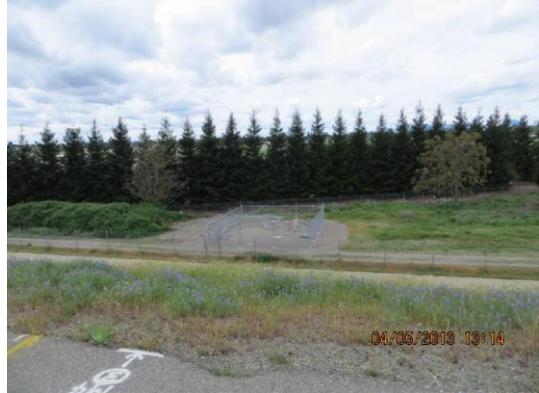
Photo 2 of 3 : UCIP\_FA\_2019\_41841\_19537.jpg

LS- fenced control station across concrete ditch

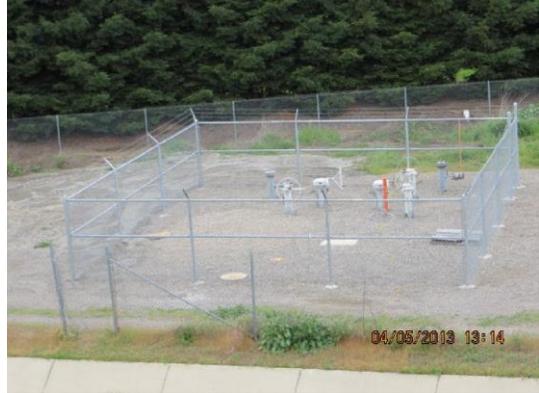
Photo 3 of 3 : UCIP\_FA\_2019\_41841\_19534.jpg

LM Start	<b>11.99</b>	Rating **	M	Issue No.	<b>32 (cont)</b>
LM End	<b>11.99</b>	Issue Type +	En	Location *	
Category	Supplemental			GPS Latitude/Longitude	
				Start	End
Item	DRAFT DWR UCIP Field Study			39.114856°	39.114856°
				-121.605821°	-121.605821°
DWR ID	17932				
Comment Code					
Inspector Comment					
DS_ID:17932 FS_ID:41841 EP_NO: N/A Repair Type: Non-Urgent Crossing Status: Indicator Found UCIP Comments: 04/05/2013 Need to install Gasline Markers.Fenced control station.Indicator on LS across concrete ditch.Found road markings.(DWR UCIP - P. Amatya) FIELD_STRUCT_DESC: 1 of 2: 16-inch natural gas pipeline of an unknown material through the levee, 3 feet below the crown. PG&E gas line crossing sign on the waterside (WS) shoulder. [Additional Reference(s): DWR Levee Log, 2005]. FS Date: 4/5/2013

LS- fenced control station with indicators

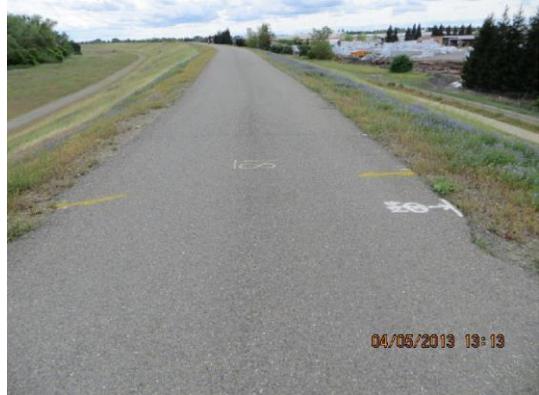
Photo 1 of 3 : UCIP\_FA\_2019\_41889\_19566.jpg

LM Start	<b>12.00</b>	Rating **	M	Issue No.	<b>33</b>
LM End	<b>12.00</b>	Issue Type +	En	Location *	
Category	Supplemental			GPS Latitude/Longitude	
				Start	End
Item	DRAFT DWR UCIP Field Study			39.114856°	39.114856°
				-121.605821°	-121.605821°
DWR ID	18880				
Comment Code					
Inspector Comment					
DS_ID:18880 FS_ID:41889 EP_NO: N/A Repair Type: Non-Urgent Crossing Status: Indicator Found UCIP Comments: 04/05/2013 Need to contact owner to install gasline markers.Fenced control station on LS.Indicator on LS across concrete channel.Road markings. (DWR UCIP - P. Amatya) FIELD_STRUCT_DESC: 2 of 2: 16-inch natural gas pipeline of an unknown material through the levee, 3 feet below the crown. PG&E gas line crossing sign on the waterside (WS) shoulder. [Additional Reference(s): DWR Levee Log, 2005]. FS Date: 4/5/2013

Levee Crown: road markings on road pavement

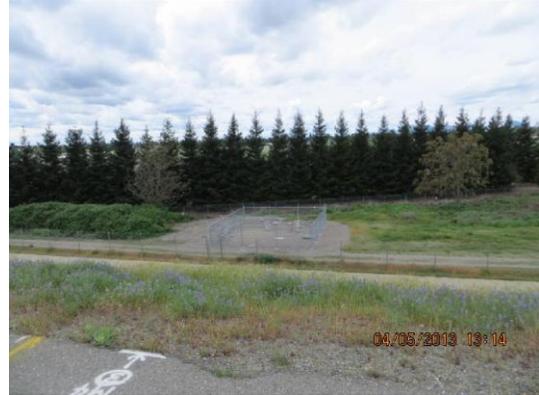
Photo 2 of 3 : UCIP\_FA\_2019\_41889\_19565.jpg

LM Start	<b>12.00</b>	Rating **	M	Issue No.	<b>33 (cont)</b>
LM End	<b>12.00</b>	Issue Type +	En	Location *	
Category	Supplemental			GPS Latitude/Longitude	
				Start	End
Item	DRAFT DWR UCIP Field Study			39.114856°	39.114856°
				-121.605821°	-121.605821°
DWR ID	18880				
Comment Code					
Inspector Comment					
DS_ID:18880 FS_ID:41889 EP_NO: N/A Repair Type: Non-Urgent Crossing Status: Indicator Found UCIP Comments: 04/05/2013 Need to contact owner to install gasoline markers. Fenced control station on LS. Indicator on LS across concrete channel. Road markings. (DWR UCIP - P. Amatya) FIELD_STRUCT_DESC: 2 of 2: 16-inch natural gas pipeline of an unknown material through the levee, 3 feet below the crown. PG&E gas line crossing sign on the waterside (WS) shoulder. [Additional Reference(s): DWR Levee Log, 2005]. FS Date: 4/5/2013

LS- fenced control station across concrete ditch.

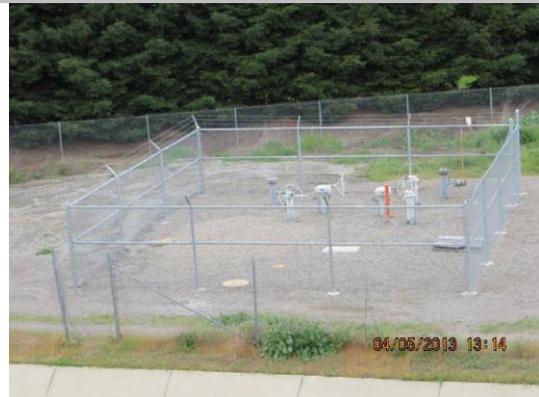
Photo 3 of 3 : UCIP\_FA\_2019\_41889\_19564.jpg

LS- fenced control station with gasoline indicator across concrete ditch.

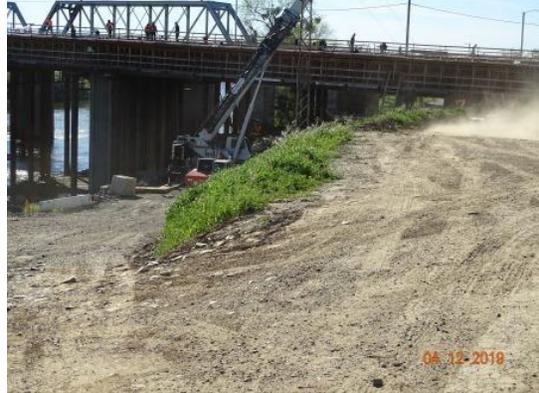
Photo 1 of 2 : FA\_2019\_LD0001S\_433\_26\_20190904\_00009.jpg

LM Start	<b>13.87</b>	Rating **	A/W	Issue No.	<b>26</b>
LM End	<b>13.87</b>	Issue Type +	Ma	Location *	CR
Category	Earthen Levee			GPS Latitude/Longitude	
				Start	End
Item	Crown Surface / Depressions / Rutting			39.139734 °	39.139734 °
				-121.608477 °	-121.608477 °
DWR ID	DWR_LD0001S_01_f_2018_26				
Comment Code					
C2 : Repair depressions or ruts in the crown or slope.					
Inspector Comment					
There is ongoing construction at the 5th Street Bridge, Fall 2019.

View looking downstream waterside of the 5th Street bridge construction, Spring 2019.

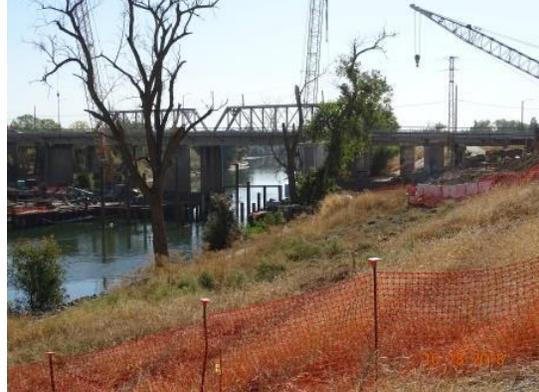
Photo 2 of 2 : FA\_2019\_LD0001S\_433\_26\_20190904\_00010.jpg

View looking downstream waterside of the 5th Street bridge construction, Fall 2018.

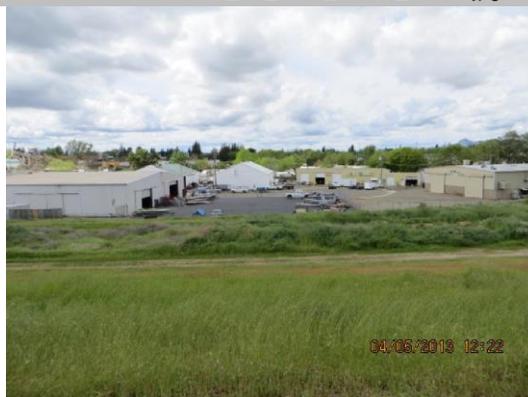
Photo 3 of 3 : UCIP\_FA\_2019\_41887\_19569.jpg

LM Start	<b>14.35</b>	Rating **	M	Issue No.	<b>34 (cont)</b>
LM End	<b>14.35</b>	Issue Type +	En	Location *	
Category	Supplemental			GPS Latitude/Longitude	
				Start	End
Item	DRAFT DWR UCIP Field Study			39.146494 °	39.146494 °
				-121.609715 °	-121.609715 °
DWR ID	18640				
Comment Code					
Inspector Comment					
DS_ID:18640 FS_ID:41887 EP_NO: N/A Repair Type: Non-Urgent Crossing Status: Indicator Found UCIP Comments: 04/05/2013 Need to contact owner to determine status of crossing and install signs if appropriate. (DWR UCIP - P. Amatya) FIELD_STRUCT_DESC: 18-inch steel natural gas pipeline through the levee, at an unknown depth. [Additional Reference(s): Sutter-Butte Flood Control Agency, Volume 3, As-Built Drawing No. GC-120, Sheet 58, no reference to any crossings at this location. USACE Sacramento O&M Manual 144, August 1955, (Station 1473+60)]. FS Date: 4/5/2013

LS- overview. No sign post or indicator found.

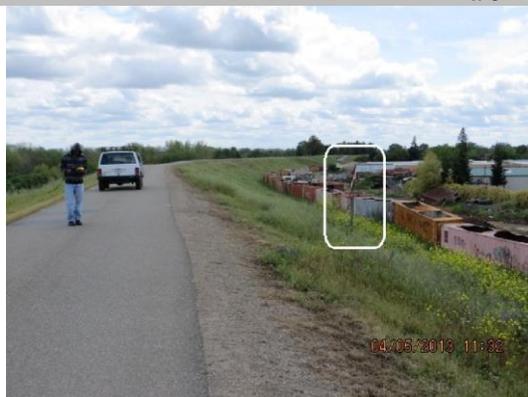
Photo 1 of 2 : UCIP\_FA\_2019\_12092\_19624.jpg

Item	DRAFT DWR UCIP Field Study			39.154970 °	39.154970 °
				-121.615617 °	-121.615617 °
DWR ID	17923				
Comment Code					
Inspector Comment					
DS_ID:17923 FS_ID:12092 EP_NO: N/A Repair Type: Non-Urgent Crossing Status: Indicator Found UCIP Comments: 04/05/2013 Only a gasoline indicator found on LS. Needs gasoline marker also on WS. (DWR UCIP - P. Amatya) FIELD_STRUCT_DESC: 16-inch natural gas pipeline of an unknown material through the levee, 3.5 feet below the crown. Pipeline protected in place as part of the Feather River West Levee Reconstruction Project. Marker installed on the landside (LS). [Additional Reference(s): DWR Levee Log, 2005. Sutter-Butte Flood Control Agency, Volume 3, As-Built Drawing No. C-124, Sheet 62, (Station 1073+41)]. FS Date: 4/5/2013

LS- overview of gasline marker on levee slope

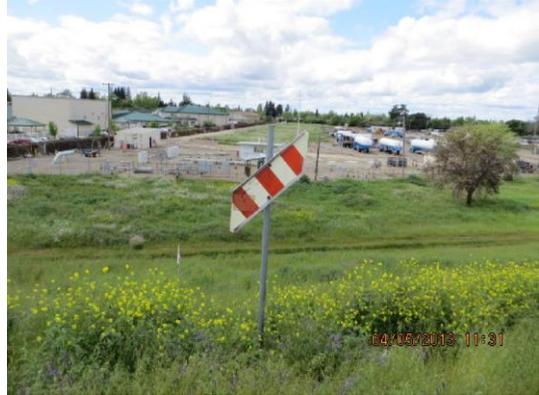
Photo 2 of 2 : UCIP\_FA\_2019\_12092\_19623.jpg

Item	DRAFT DWR UCIP Field Study			39.154970°	39.154970°
				-121.615617°	-121.615617°
DWR ID	17923				
Comment Code					
Inspector Comment					
DS_ID:17923 FS_ID:12092 EP_NO: N/A Repair Type: Non-Urgent Crossing Status: Indicator Found UCIP Comments: 04/05/2013 Only a gasoline indicator found on LS. Needs gasoline marker also on WS. (DWR UCIP - P. Amatya) FIELD_STRUCT_DESC: 16-inch natural gas pipeline of an unknown material through the levee, 3.5 feet below the crown. Pipeline protected in place as part of the Feather River West Levee Reconstruction Project. Marker installed on the landside (LS). [Additional Reference(s): DWR Levee Log, 2005. Sutter-Butte Flood Control Agency, Volume 3, As-Built Drawing No. C-124, Sheet 62, (Station 1073+41)]. FS Date: 4/5/2013

LS- gasoline marker on levee slope

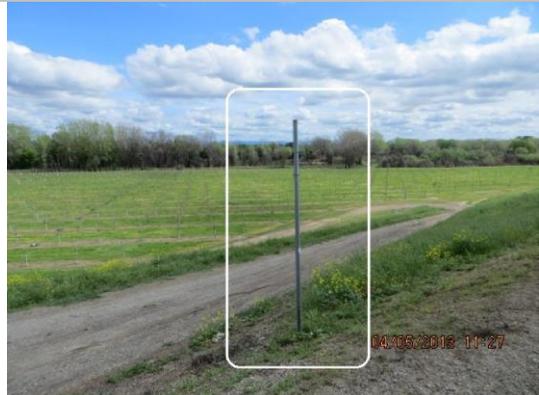
Photo 1 of 3 : UCIP\_FA\_2019\_12104\_19642.jpg

Item	DRAFT DWR UCIP Field Study			39.156241°	39.156241°
				-121.617210°	-121.617210°
DWR ID	18644				
Comment Code					
Inspector Comment					
DS_ID:18644 FS_ID:12104 EP_NO: 17259 Repair Type: Non-Urgent Crossing Status: Indicator Found UCIP Comments: 04/05/2013 Found an indicator only on LS. Needs an indicator also on WS. (DWR UCIP - P. Amatya) FIELD_STRUCT_DESC: *REMOVED* 8.375-inch-wide electrolysis test station (ETS) at a depth of 4 feet was connected to the existing 8-inch steel natural gas pipeline within the waterside (WS) levee toe. Pipeline has been removed as part of the Feather River West Levee Reconstruction Project. [Additional Reference(s): Sutter-Butte Flood Control Agency, Volume 3, As-Built Drawing No. C-124, Sheet 62, (Station 1079+91), no replacement pipe mentioned]. FS Date: 4/5/2013

WS- needs a gasoline indicator.

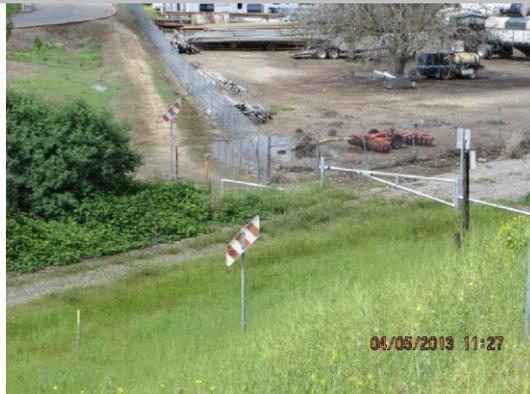
Photo 2 of 3 : UCIP\_FA\_2019\_12104\_19641.jpg

Item	DRAFT DWR UCIP Field Study			39.156241°	39.156241°
				-121.617210°	-121.617210°
DWR ID	18644				
Comment Code					
Inspector Comment					
DS_ID:18644 FS_ID:12104 EP_NO: 17259 Repair Type: Non-Urgent Crossing Status: Indicator Found UCIP Comments: 04/05/2013 Found an indicator only on LS. Needs an indicator also on WS.(DWR UCIP - P. Amatya) FIELD_STRUCT_DESC: *REMOVED* 8.375-inch-wide electrolysis test station (ETS) at a depth of 4 feet was connected to the existing 8-inch steel natural gas pipeline within the waterside (WS) levee toe. Pipeline has been removed as part of the Feather River West Levee Reconstruction Project. [Additional Reference(s): Sutter-Butte Flood Control Agency, Volume 3, As-Built Drawing No. C-124, Sheet 62, (Station 1079+91), no replacement pipe mentioned]. FS Date: 4/5/2013

LS- gasline indicators on levee slope and across.

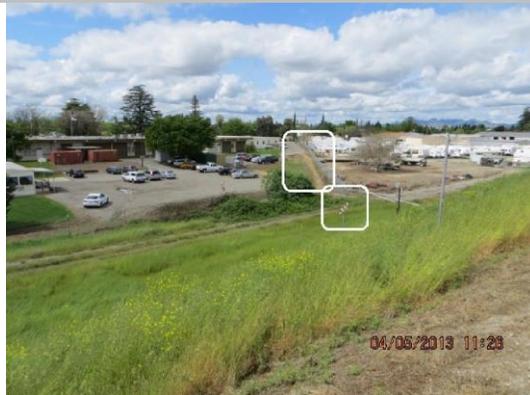
Photo 3 of 3 : UCIP\_FA\_2019\_12104\_19640.jpg

LS- overview of gasline indicators on levee slope and across.

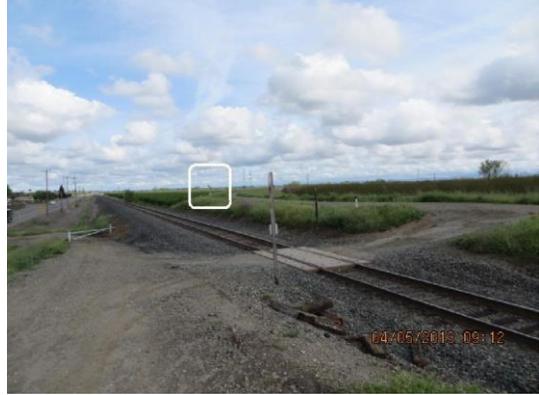
Photo 1 of 2 : UCIP\_FA\_2019\_41888\_19709.jpg

Railway and levee crossing and gasline sign across the railway

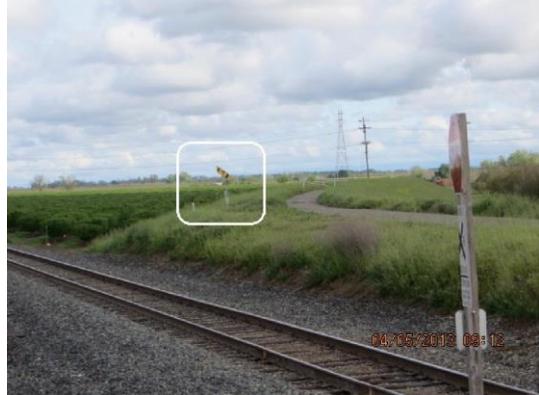
Photo 2 of 2 : UCIP\_FA\_2019\_41888\_19708.jpg

Gasline sign across the railway
