**Flood Control Project Maintenance  
Levee Inspections**  
**LMA District Cover Sheet**  
**Spring 2020 Levee Inspection Results**

**Levee District No. 0001 (Sutter County)**

**Levee Inspection Report By Mile - Spring 2020**

Waterway	Bank	Unit Miles	Inspection Start/End	Inspector
Unit No. 01 Feather River	Right	16.11	03/17/2020 03/17/2020	Sterling York

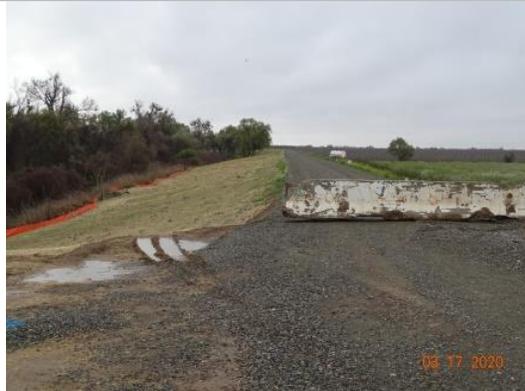
Photo 1 of 1 : SP\_2020\_LD0001S\_433\_15\_20200324\_00040.jpg

LM Start	<b>0.00</b>	Rating **	A/W	Issue No.	<b>15</b>
LM End	<b>4.34</b>	Issue Type +	Ma	Location *	CR
Category	Earthen Levee		GPS Latitude/Longitude		
			Start	End	
Item	Crown Surface / Depressions / Rutting		38.950976 °	39.010657 °	
			-121.585753 °	-121.602887 °	
DWR ID	DWR_LD0001S_01_s_2020_15				
Comment Code					
C1 : Add appropriate material and re-grade the levee to bring the crown above the design elevation.					
Inspector Comment					
USACE Project still under construction with pipe installation, Spring 2020.

View looking downstream at the section of levee that is still under construction with the pipe installation, Spring 2020.

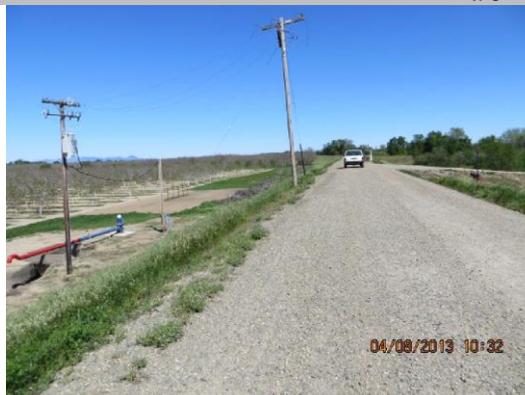
Photo 1 of 3 : UCIP\_SP\_2020\_41624\_18769.jpg

Item	DWR UCIP Field Study		38.956192 °	38.956192 °	
			-121.585510 °	-121.585510 °	
DWR ID	18653				
Comment Code					
Inspector Comment					
DS_ID:18653 FS_ID:41624 EP_NO: 4667 Repair Type: Non-Urgent Crossing Status: Found UCIP Comments: 04/12/2013 Abandoned crossing. Concrete box on both sides found. Pipe remainings are found on WS. (DWR UCIP - P. Amatya) FIELD_STRUCT_DESC: *ABANDONED* 36-inch steel irrigation pipe through the levee, 10 feet below the crown. Concrete box found on each side. Pipe remains found on the waterside (WS) after the removal of 40 feet of 36-inch steel pipe from a spur levee and 20 feet of 36-inch steel pipe from the landside (LS) slope of the Feather River Levee. (Plans for removal of a portion and filling with concrete a portion of an abandoned 36-inch steel pipe through the levee authorized under Permit No. 4667, 1964 - Levee District No. 1 of Sutter County [LD0001S]). [Additional Reference(s): USACE Sacramento O&M Manual 144, August 1955, (Station 735+57)]. FS Date: 4/12/2013

Crown view- overview of both sides of the levee

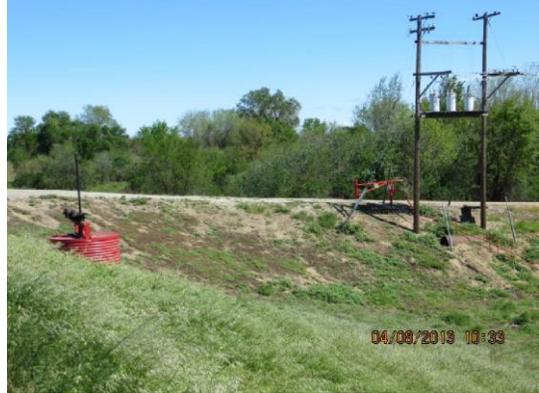
Photo 2 of 3 : UCIP\_SP\_2020\_41624\_18768.jpg

WS- abandoned pipe near power pole (right)

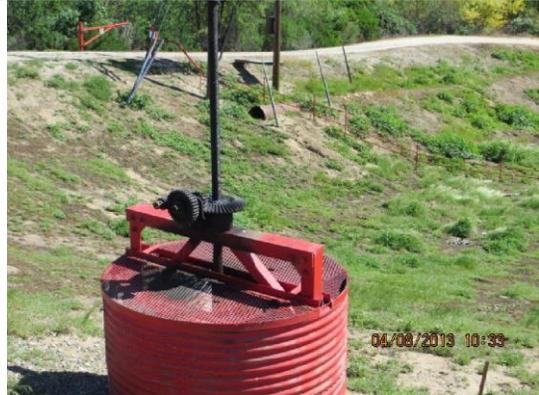
Photo 3 of 3 : UCIP\_SP\_2020\_41624\_18767.jpg

WS- abandoned pipe near power pole (top)

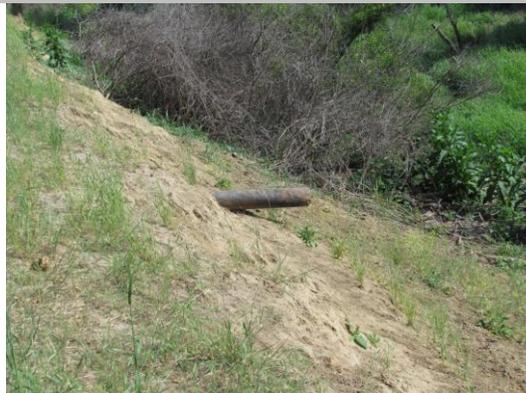
Photo 1 of 3 : UCIP\_SP\_2020\_53068\_75107.jpg

Item	DWR UCIP Field Study		38.977002 °	38.977002 °	
			-121.591199 °	-121.591199 °	
DWR ID	17917				
Comment Code					
Inspector Comment					
DS_ID:17917 FS_ID:53068 EP_NO: N/A Repair Type: Non-Urgent Crossing Status: Not Found UCIP Comments: 10/15/2018 Pipe not found. Pipe removed as part of the Project Area A Feather River West Levee Project. Contacted LMA to obtain as-built drawings showing the pipe removal through the levee. Crossing has been downgraded from Urgent to Non-Urgent, waiting to receive as-built drawings pertaining to levee improvement project for this section of the levee. (O. Magana - DWR UCIP)07/20/2016 Same as previous comment, although pipe is open on the waterside (WS) and capped on the LS. Note that this section of levee will likely be reconstructed as part of Project Area A of the Feather River West Levee Project (Star Bend to Sutter Bypass). (K. Fazel - UCIP)05/23/2016 Needs proper abandonment; pipe open on both ends (courtesy of Sterling York, DWR Inspector). (K. Fazel - UCIP) FIELD_STRUCT_DESC: *REMOVED* 8-inch steel pipe of an unknown purpose through the levee, 4.6 feet below the crown. Siphon breaker in a 24-inch corrugated metal pipe (CMP) riser on the landside (LS) shoulder, not found in 2016. [Additional Reference(s): DWR Levee Log, 2005. USACE Sacramento O&M Manual 144, August 1955, (Station 657+00), As-Built Drawing No. 4-4-205-1]. FS Date: 10/16/2018

Pipe visible on WS slope. Photo courtesy of Sterling York, DWR Inspector.

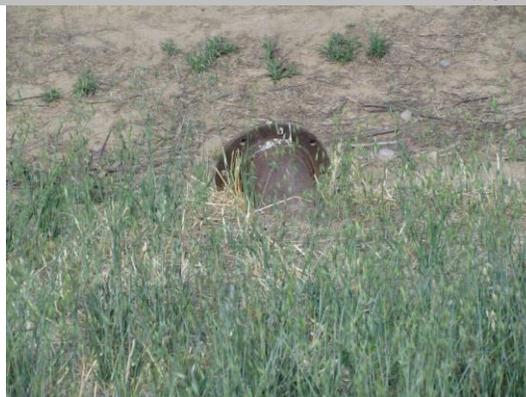
Photo 2 of 3 : UCIP\_SP\_2020\_53068\_75108.jpg

Pipe open on LS end. Photo courtesy of Sterling York, DWR Inspector.

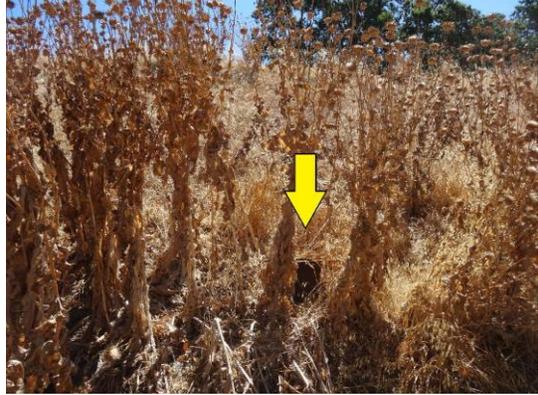
Photo 3 of 3 : UCIP\_SP\_2020\_53068\_76120.jpg

LS view: pipe appears to be capped, though in a rudimentary fashion.

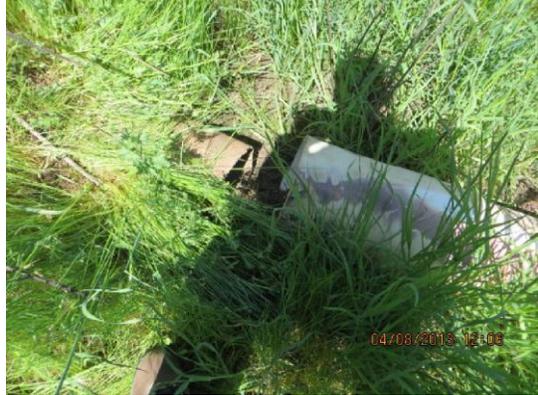
Photo 1 of 3 : UCIP\_SP\_2020\_11383\_18782.jpg

DS\_ID:17915  
 FS\_ID:11383  
 EP\_NO: N/A  
 Repair Type: Non-Urgent  
 Crossing Status: Found  
 UCIP Comments: 04/12/2013 Siphon breaker cap missing. Sump pump and gate valve at landward toe not found may be due to dense vegetation. (DWR UCIP - P. Amatya)  
 FIELD\_STRUCT\_DESC: 8-inch coated steel pipe of an unknown purpose through the levee, 4.6 feet below the crown. Siphon breaker in a corrugated metal pipe (CMP) riser on the landside (LS) slope.  
 [Additional Reference(s): DWR Levee Log, 2005. USACE Sacramento O&M Manual 144, August 1955, (Station 638+07)].  
 FS Date: 4/12/2013

WS- 8-inch steel pipe and disconnected pvc pipe on levee slope

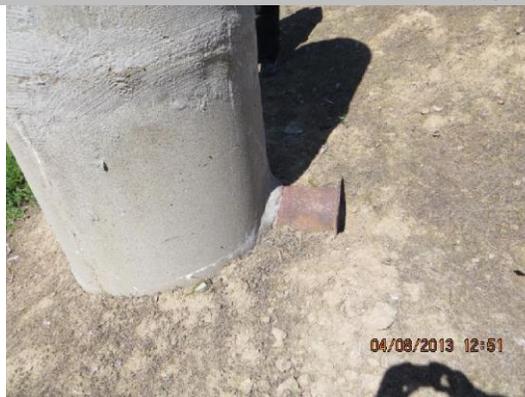
Photo 3 of 3 : UCIP\_SP\_2020\_41787\_18791.jpg

LS- concrete standpipe with disconnected steel pipe

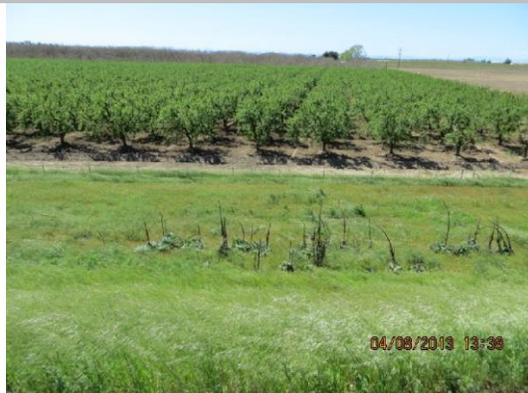
Photo 3 of 3 : UCIP\_SP\_2020\_41348\_18880.jpg

Overview of landside of the levee- no pipes visible. Dense vegetation.

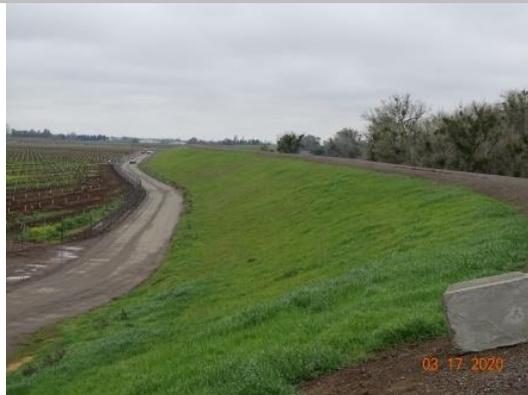
Photo 1 of 1 : SP\_2020\_LD0001S\_433\_16\_20200324\_00041.jpg

LM Start	<b>4.40</b>	Rating **	A	Issue No.	<b>16</b>
LM End	<b>16.09</b>	Issue Type +	Ma	Location *	LS
Category	Earthen Levee			GPS Latitude/Longitude	
				Start	End
Item	Vegetation			39.011370 °	39.168533 °
				-121.603526 °	-121.622706 °
DWR ID	DWR_LD0001S_01_s_2020_16				
Comment Code					
V1 : Control annual grass and weeds on the levee slopes and easements.					
Inspector Comment					
The annual vegetation is well maintained, Spring 2020.

View looking upstream landside at the well maintained annual vegetation, Spring 2020.

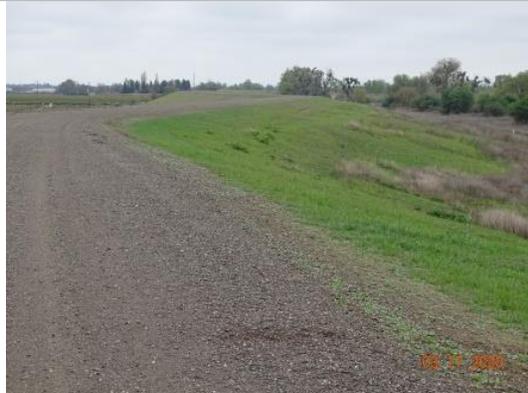
Photo 1 of 1 : SP\_2020\_LD0001S\_433\_17\_20200324\_00042.jpg

LM Start	<b>4.40</b>	Rating **	A	Issue No.	<b>17</b>
LM End	<b>16.09</b>	Issue Type +	Ma	Location *	WS
Category	Earthen Levee		GPS Latitude/Longitude		
			Start	End	
Item	Vegetation		39.011370 °	39.168533 °	
			-121.603527 °	-121.622706 °	
DWR ID	DWR_LD0001S_01_s_2020_17				
Comment Code					
V1 : Control annual grass and weeds on the levee slopes and easements.					
Inspector Comment					
The annual vegetation is well maintained, Spring 2020.

View looking upstream waterside at the well maintained annual vegetation, Spring 2020.

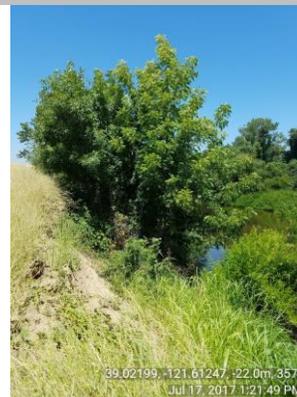
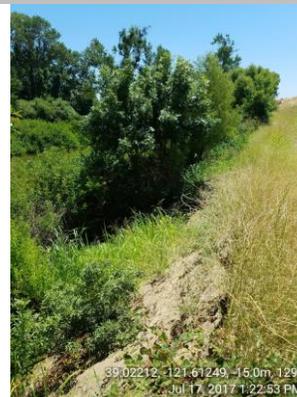
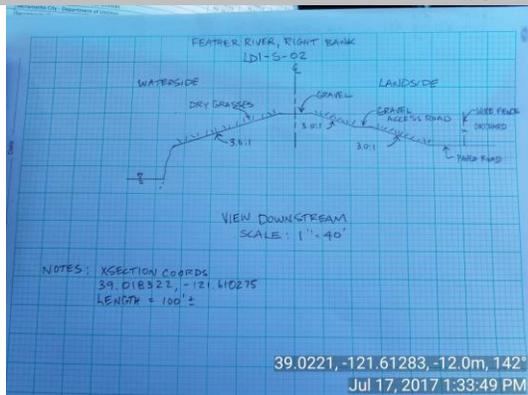
LM Start	<b>5.02</b>	Rating **	A/W	Issue No.	<b>25</b>
LM End	<b>5.43</b>	Issue Type +	Ma	Location *	
Category	Supplemental		GPS Latitude/Longitude		
			Start	End	
Item	2017 Storm Damage		39.018322 °	39.023753 °	
			-121.610275 °	-121.613171 °	
DWR ID	LD1-S-02				
Comment Code					
Inspector Comment					
The erosion site is planned for PL 84-99 Repair in 2020. Site ID No:145 Site Designation:LD1-S-02 Rating: Critical

The erosion site is planned for PL 84-99 Repair in 2020.

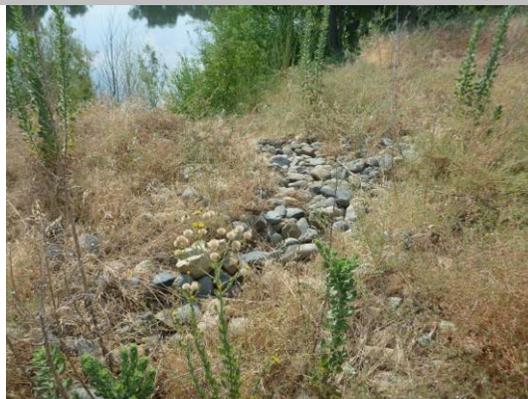
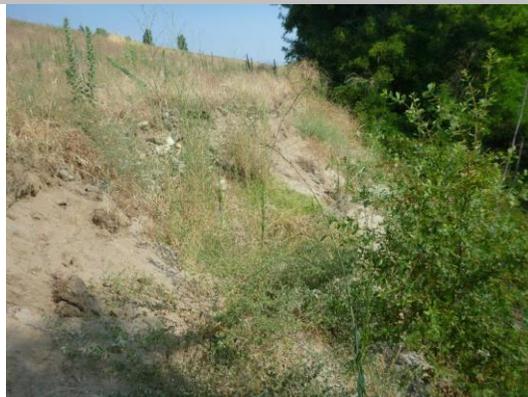
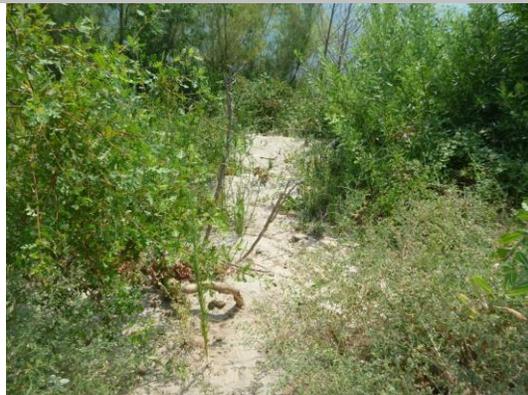
LM Start	<b>7.69</b>	Rating **	A/W	Issue No.	<b>19</b>
LM End	<b>7.74</b>	Issue Type +	Ma	Location *	WS
Category	Earthen Levee		GPS Latitude/Longitude		
			Start	End	
Item	Erosion / Bank Caving		39.055986 °	39.056710 °	
			-121.611301 °	-121.611331 °	
DWR ID	LD1-S-03				
Comment Code					
E1 : Note and monitor erosion site.					
Inspector Comment					
This was a 2017 Storm Damage site for erosion. Site ID No:146 Site Designation:LD1-S-03

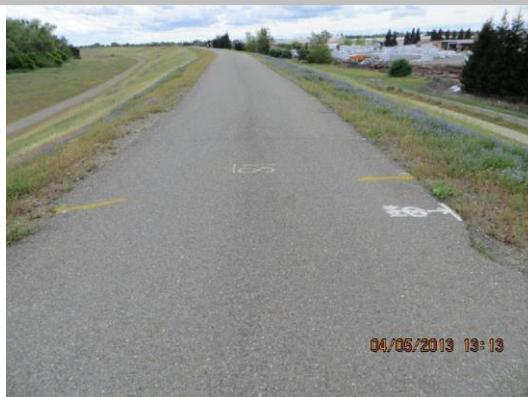
Photo 1 of 3 : UCIP\_SP\_2020\_41841\_19538.jpg

Levee Crown: gasoline indicator/markings on crown road.

DS\_ID:17932  
 FS\_ID:41841  
 EP\_NO: N/A  
 Repair Type: Non-Urgent  
 Crossing Status: Indicator Found  
 UCIP Comments: 04/05/2013 Need to install Gasline Markers.Fenced control station.Indicator on LS across concrete ditch.Found road markings.(DWR UCIP - P. Amatya)  
 FIELD\_STRUCT\_DESC: 1 of 2: 16-inch natural gas pipeline of an unknown material through the levee, 3 feet below the crown. PG&E gas line crossing sign on the waterside (WS) shoulder. [Additional Reference(s): DWR Levee Log, 2005].  
 FS Date: 4/5/2013

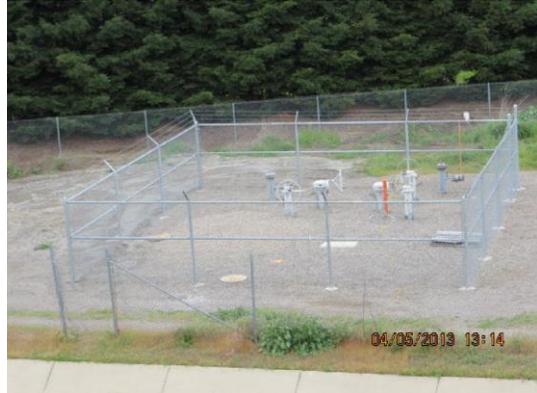
Photo 3 of 3 : UCIP\_SP\_2020\_41889\_19564.jpg

LS- fenced control station with gasoline indicator across concrete ditch.

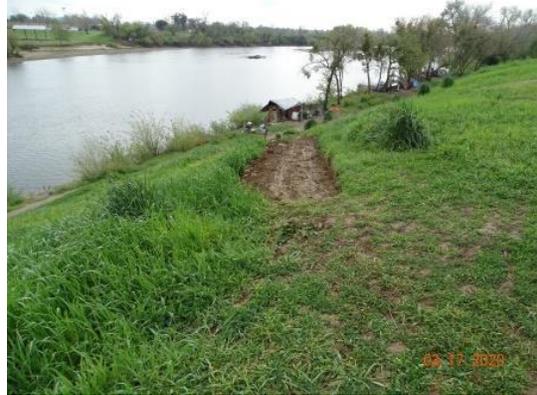
Photo 1 of 1 : SP\_2020\_LD0001S\_433\_18\_20200324\_00043.jpg

LM Start	<b>13.51</b>	Rating **	U	Issue No.	<b>18</b>
LM End	<b>13.69</b>	Issue Type +	Ma	Location *	WS
Category	Earthen Levee			GPS Latitude/Longitude	
				Start	End
Item	Slope Stability			39.135376 °	39.137718 °
				-121.604841 °	-121.606288 °
DWR ID	DWR_LD0001S_01_s_2020_18				
Comment Code					
S2 : Repair the levee slope damaged by foot traffic and prevent access where possible.					
Inspector Comment					
Repair the damage of the dug in foot ramp on the levee slope, Spring 2020.

View looking downstream waterside of a hand dug foot path, Spring 2020.

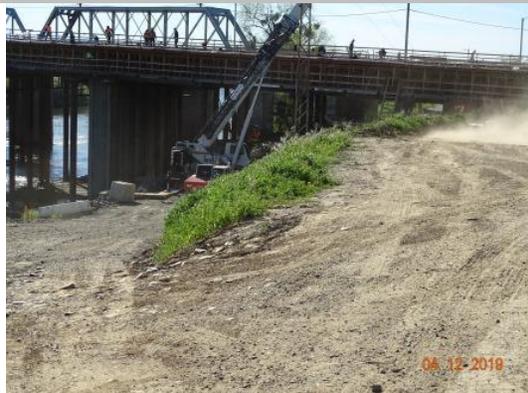
Photo 1 of 1 : SP\_2020\_LD0001S\_433\_26\_20200227\_00007.jpg

LM Start	<b>13.87</b>	Rating **	A/W	Issue No.	<b>26</b>
LM End	<b>13.87</b>	Issue Type +	Ma	Location *	CR
Category	Earthen Levee			GPS Latitude/Longitude	
				Start	End
Item	Crown Surface / Depressions / Rutting			39.139734 °	39.139734 °
				-121.608477 °	-121.608477 °
DWR ID	DWR_LD0001S_01_f_2018_26				
Comment Code					
C2 : Repair depressions or ruts in the crown or slope.					
Inspector Comment					
There is ongoing construction at the 5th Street Bridge, Spring 2020.

View looking downstream waterside of the on going 5th Street bridge construction.

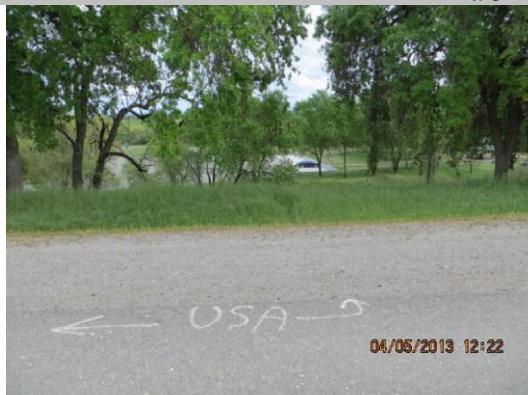
Photo 1 of 3 : UCIP\_SP\_2020\_41887\_19571.jpg

LM Start	<b>14.35</b>	Rating **	M	Issue No.	<b>34</b>
LM End	<b>14.35</b>	Issue Type +	En	Location *	
Category	Supplemental			GPS Latitude/Longitude	
				Start	End
Item	DWR UCIP Field Study			39.146494 °	39.146494 °
				-121.609715 °	-121.609715 °
DWR ID	18640				
Comment Code					
Inspector Comment					
DS_ID:18640 FS_ID:41887 EP_NO: N/A Repair Type: Non-Urgent Crossing Status: Indicator Found UCIP Comments: 04/05/2013 Need to contact ownder to determin status of crossing and install signs if appropriate. (DWR UCIP - P. Amatya) FIELD_STRUCT_DESC: 18-inch steel natural gas pipeline through the levee, at an unknown depth. [Additional Reference(s): Sutter-Butte Flood Control Agency, Volume 3, As-Built Drawing No. GC-120, Sheet 58, no reference to any crossings at this location. USACE Sacramento O&M Manual 144, August 1955, (Station 1473+60)]. FS Date: 4/5/2013

WS- USA road marking and floodway area

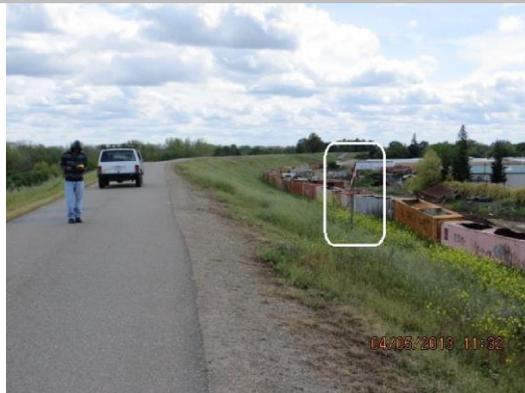
Photo 1 of 2 : UCIP\_SP\_2020\_12092\_19624.jpg

Item	DWR UCIP Field Study		39.154970 °	39.154970 °	
			-121.615617 °	-121.615617 °	
DWR ID	17923				
Comment Code					
Inspector Comment					
DS_ID:17923 FS_ID:12092 EP_NO: N/A Repair Type: Non-Urgent Crossing Status: Indicator Found UCIP Comments: 04/05/2013 Only a gasoline indicator found on LS.Needs gasoline marker also on WS.(DWR UCIP - P. Amatya) FIELD_STRUCT_DESC: 16-inch natural gas pipeline of an unknown material through the levee, 3.5 feet below the crown. Pipeline protected in place as part of the Feather River West Levee Reconstruction Project. Marker installed on the landside (LS). [Additional Reference(s): DWR Levee Log, 2005. Sutter-Butte Flood Control Agency, Volume 3, As-Built Drawing No. C-124, Sheet 62, (Station 1073+41)]. FS Date: 4/5/2013

LS- overview of gasoline marker on levee slope

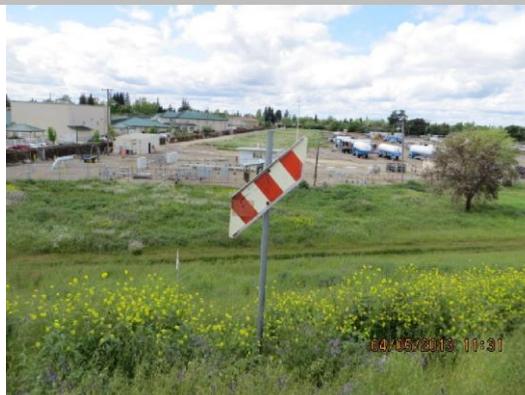
Photo 2 of 2 : UCIP\_SP\_2020\_12092\_19623.jpg

LS- gasoline marker on levee slope

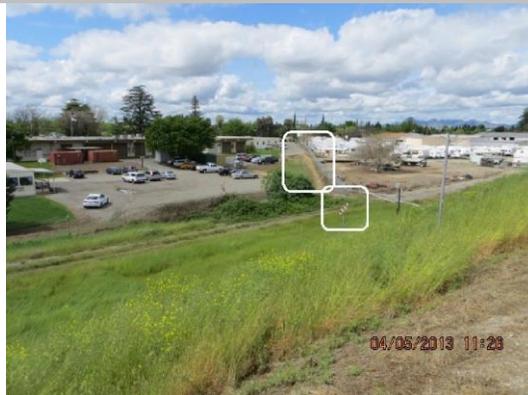
Photo 3 of 3 : UCIP\_SP\_2020\_12104\_19640.jpg

LS- overview of gasline indicators on levee slope and across.

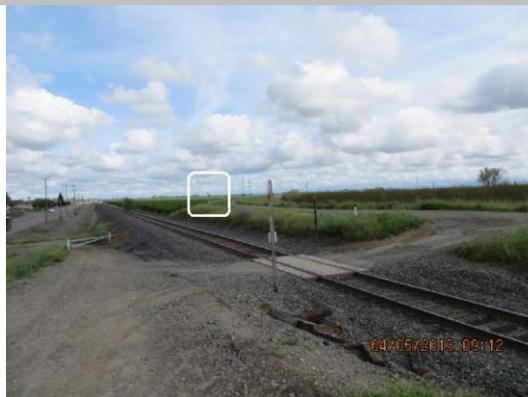
Photo 1 of 2 : UCIP\_SP\_2020\_41888\_19709.jpg

Railway and levee crossing and gasline sign across the railway

Comment Code					
Inspector Comment					
DS_ID:18645 FS_ID:41888 EP_NO: 3823 Repair Type: Non-Urgent Crossing Status: Indicator Found UCIP Comments: 04/05/2013 Need to contact owner to determine status of crossing and install markers if appropriate. Several lines in area. (DWR UCIP - P. Amatya) FIELD_STRUCT_DESC: 8-inch steel natural gas pipeline through the levee and overflow area, 3.3 feet below the crown. (Plans for installation of a steel pipeline through the levee authorized under Permit No. 3823, 1961 - Southern Pacific Pipe Lines, Inc.). FS Date: 4/5/2013
