**Flood Control Project Maintenance  
Levee Inspections**  
**LMA District Cover Sheet**  
**Spring 2020 Levee Inspection Results**

**Levee District No. 0002 (Glenn County)**

**Spring 2020 Levee Inspection Results**

**Levee Inspection Report By Mile - Spring 2020**

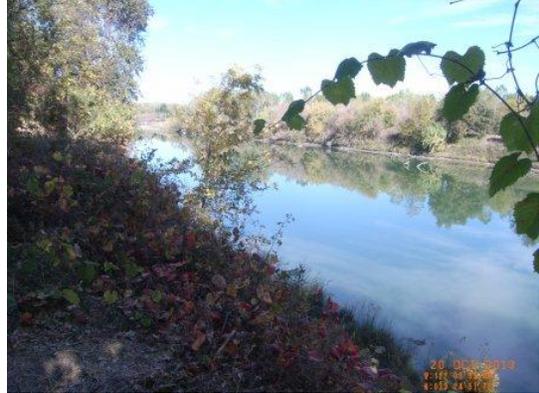
Photo 1 of 2 : SP\_2020\_LD0002\_28\_6\_20200226\_00003.jpg

LM Start	<b>0.07</b>	Rating **	M	Issue No.	<b>6</b>
LM End	<b>0.28</b>	Issue Type +	Ma	Location *	WS
Category	Supplemental		GPS Latitude/Longitude		
			Start	End	
Item	2017 USACE Erosion Survey		39.414649 °	39.417689 °	
			-122.009853 °	-122.010369 °	
DWR ID	DWR_ST0010_02_f_2022_4				
Comment Code					
Inspector Comment					
2017 Site ID: SAC 164.7 R Status: Eroding 2017 Field Notes: New erosion along entire site. Site History: 2009 - Very slow retreat, hard toe, encroaching into the levee projection. 2010 - Slowly eroding. 2011 - Site extended downstream.

USACE 2013 Photo #1

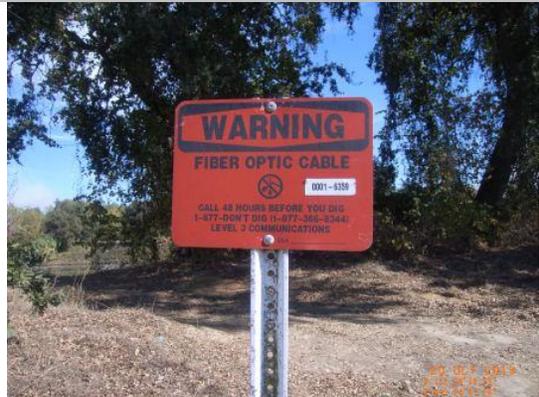
Photo 2 of 2 : SP\_2020\_LD0002\_28\_6\_20200226\_00004.jpg

USACE 2013 Photo #2

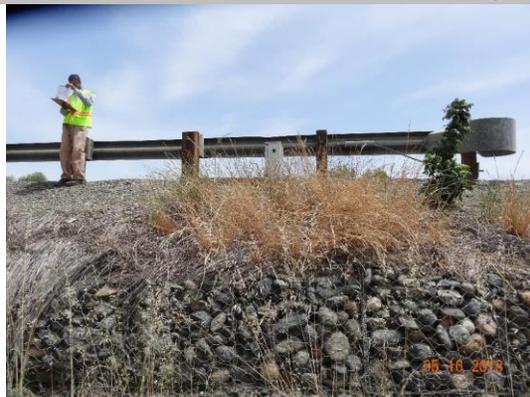
Photo 1 of 3 : UCIP\_SP\_2020\_42083\_72882.jpg

LM Start	<b>0.59</b>	Rating **	M	Issue No.	<b>58</b>
LM End	<b>0.59</b>	Issue Type +	En	Location *	
Category	Supplemental		GPS Latitude/Longitude		
			Start	End	
Item	DWR UCIP Field Study		39.422088 °	39.422088 °	
			-122.011615 °	-122.011615 °	
DWR ID	24877				
Comment Code					
Inspector Comment					
DS_ID:24877 FS_ID:42083 EP_NO: N/A Repair Type: Non-Urgent Crossing Status: Indicator Found UCIP Comments: Need to contact owner to determine if conduit goes through levee crown. If it does, will need to obtain permit number issued for encroachment. FIELD_STRUCT_DESC: Caltrans traffic control box located on the landside (LS) shoulder. FS Date: 5/16/2013

View of landward slope.

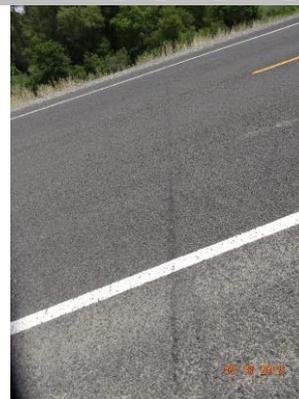
Photo 2 of 3 : UCIP\_SP\_2020\_42083\_72881.jpg

View of levee crown at crossing.

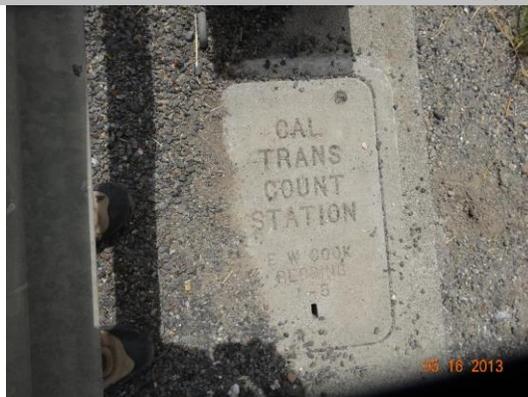
Photo 3 of 3 : UCIP\_SP\_2020\_42083\_72880.jpg

Service box located on landward shoulder.

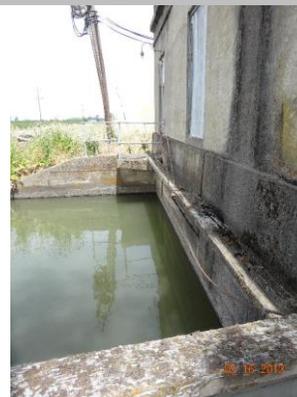
Photo 3 of 3 : UCIP\_SP\_2020\_38166\_69477.jpg

View of landward side-outlet.

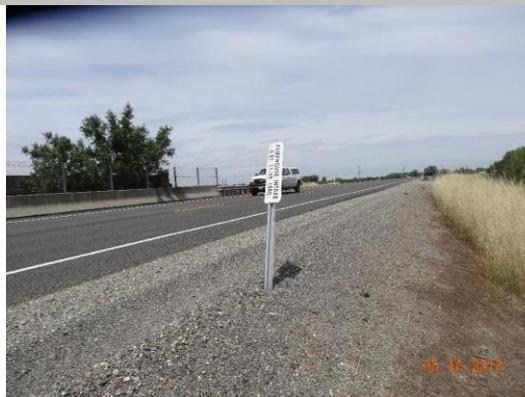
Photo 1 of 3 : UCIP\_SP\_2020\_38167\_69483.jpg

DS\_ID:21171  
 FS\_ID:38167  
 EP\_NO: N/A  
 Repair Type: Non-Urgent  
 Crossing Status: Found  
 UCIP Comments: Three pipes found in the pump house on landward side. Pump house appears to be no longer in use. Unable to locate pipes on waterward side. Will need to contact owner to determine status. Owner will need to coordinate with CVFPB regarding proper removal per Title 23 requirements.  
 FIELD\_STRUCT\_DESC: [Princeton-Cordora-Glenn Irrigation District: Schaad Pumping Plant] 3 of 3: 34-inch steel pipe sleeved through 36-inch steel pipe through the levee, 20 feet below the crown. Annular gap is grouted. Flap gate on landside (LS) end. Pump in pump house on LS slope. Rock revetment around outlet on waterside (WS) slope. (28- and 34-inch pipes sleeved through existing 30- and 36-inch pipes, permit shows three 36-inch pipes as part of Schaad Pumping Plant p. 17 of 19, authorized under Permit No. 2356, 1956, Princeton-Cordora-Glenn Irrigation District) [Additional Reference(s): DWR Levee Logs, 2005. USACE Sacramento O&M Manual Unit No. 151, November 1953, (Station 41+47), two 36-inch pipes]

View of levee crown with marker on waterward side.

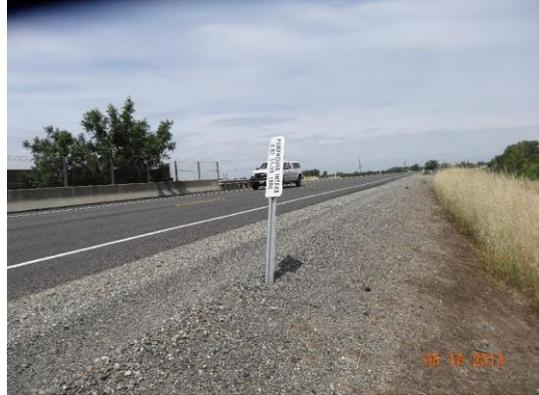
Photo 1 of 3 : UCIP\_SP\_2020\_38168\_69491.jpg

Item	DWR UCIP Field Study		39.422350 °	39.422350 °	
			-122.011637 °	-122.011637 °	
DWR ID	21182				
Comment Code					
Inspector Comment					
DS_ID:21182 FS_ID:38168 EP_NO: N/A Repair Type: Non-Urgent Crossing Status: Indicator Found UCIP Comments: Unable to verify if the pipes inside the existing pump house correlate to 24-inch installed in 1955. Three pipes found in the pump house on landward side. Pump house appears to be no longer in use. Unable to locate pipes on waterward side. Will need to contact owner to determine status. FIELD_STRUCT_DESC: [Pumping Plant] 24-inch steel pipe through the levee, 27.3 feet below the crown. Flap gate on landside (LS). Pump in pump house on LS. [Additional Reference(s): DWR Levee Logs, 2005. USACE Sacramento O&M Manual Unit No. 151, November 1953, (Station 41+47), 24-inch pipe] FS Date: 5/16/2013

View of levee crown with marker on waterward side.

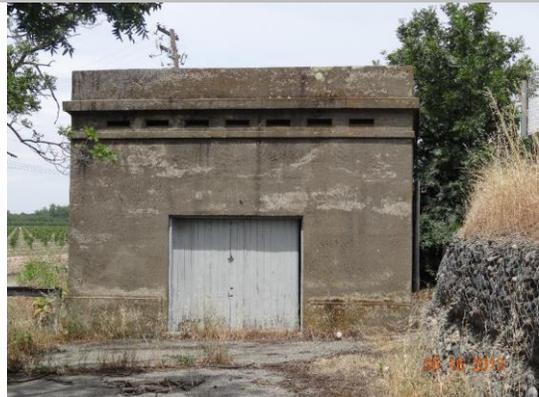
Photo 2 of 3 : UCIP\_SP\_2020\_38168\_69493.jpg

View of Princeton-Cordora-Glenn Irrigation District-Schaad Pumping Plant.

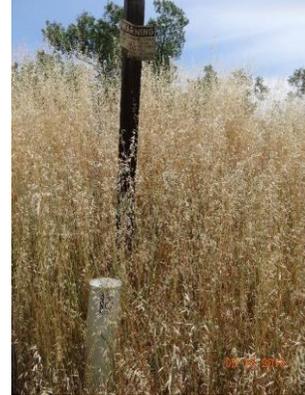
Photo 1 of 3 : UCIP\_SP\_2020\_44170\_72602.jpg

Item	DWR UCIP Field Study		39.428441 °	39.428441 °	
			-122.011032 °	-122.011032 °	
DWR ID	21177				
Comment Code					
Inspector Comment					
DS_ID:21177 FS_ID:44170 EP_NO: 9723 Repair Type: Non-Urgent Crossing Status: Indicator Found UCIP Comments: Owner is listed as Pacific Bell however sign lists AT&T as owner, need to contact owner to determine if permit was updated or if this crossing is listed under new permit. Unable to confirm if 2 crossings are present at this site. FIELD_STRUCT_DESC: Buried telephone cable through the levee at unknown depth. Telephone pole and junction box on landside (LS) toe. (telephone cable authorized under Automatic Board Order (ABO) issued as Permit No. 9723-1974, Pacific Telephone Company). FS Date: 5/16/2013

Indicators of existing line visible on slope.

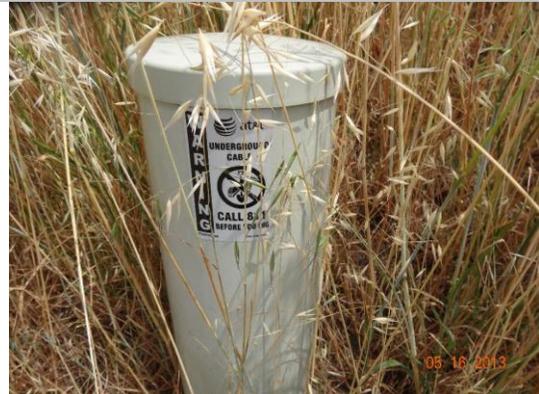
Photo 2 of 3 : UCIP\_SP\_2020\_44170\_72601.jpg

AT&T underground cable line.

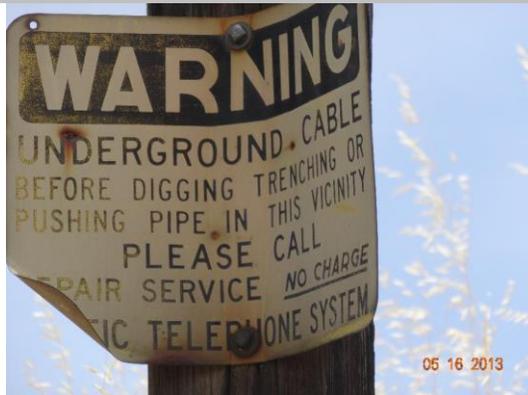
Photo 3 of 3 : UCIP\_SP\_2020\_44170\_72600.jpg

Sign lists Pacific Telephone system.

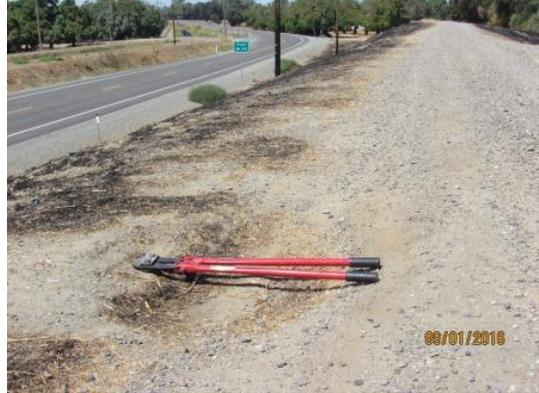
Photo 1 of 1 : SP\_2020\_LD0002\_28\_34\_20200226\_00015.jpg

LM Start	<b>1.40</b>	Rating **	M	Issue No.	<b>34</b>
LM End	<b>1.40</b>	Issue Type +	Ma	Location *	CR
Category	Earthen Levee		GPS Latitude/Longitude		
			Start	End	
Item	Crown Surface / Depressions / Rutting		39.433809 °	39.433809 °	
			-122.010814 °	-122.010814 °	
DWR ID	DWR_LD0002_01_f_2016_34				
Comment Code					
C2 : Repair depressions or ruts in the crown or slope.					
Inspector Comment

View of a depression on the levee crown looking upstream.

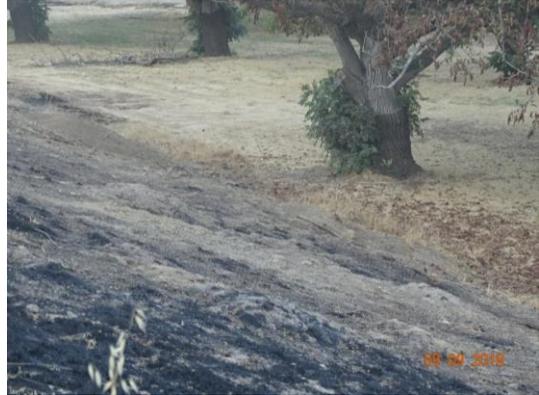
Photo 1 of 1 : SP\_2020\_LD0002\_28\_15\_20200226\_00008.jpg

View of the rodent holes along the landside slope.

LM Start	<b>1.52</b>	Rating **	U	Issue No.	<b>15</b>
LM End	<b>1.60</b>	Issue Type +	Ma	Location *	LS
Category	Earthen Levee		GPS Latitude/Longitude		
			Start	End	
Item	Animal Control		39.435485 °	39.436643 °	
			-122.010640 °	-122.010498 °	
DWR ID	DWR_LD0002_01_f_2012_15				
Comment Code					
A3 : No rodents visible, but rodent burrows visible; need to backfill and compact or grout burrows.					
Inspector Comment

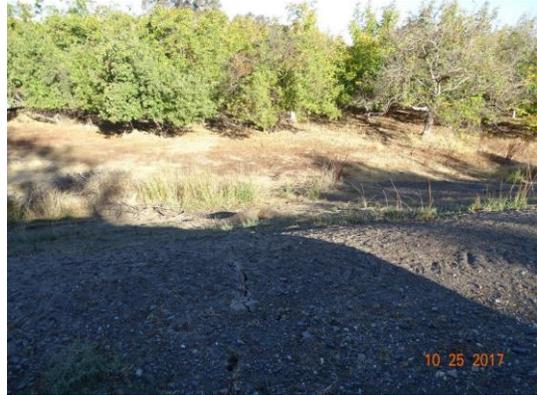
Photo 1 of 1 : SP\_2020\_LD0002\_28\_2\_20200226\_00001.jpg

View of the rodent holes along the landside slope.

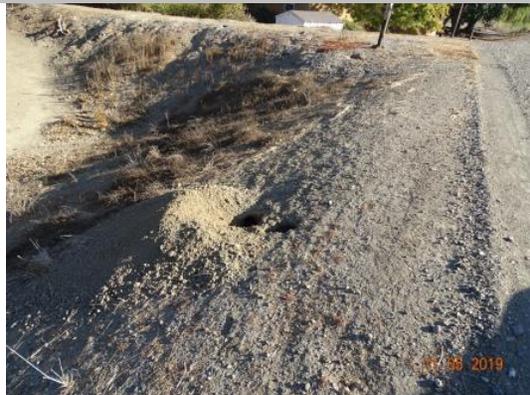
Photo 1 of 1 : SP\_2020\_LD0002\_28\_12\_20200226\_00005.jpg

View of rodent activity on the landside slope. Fall 2019.

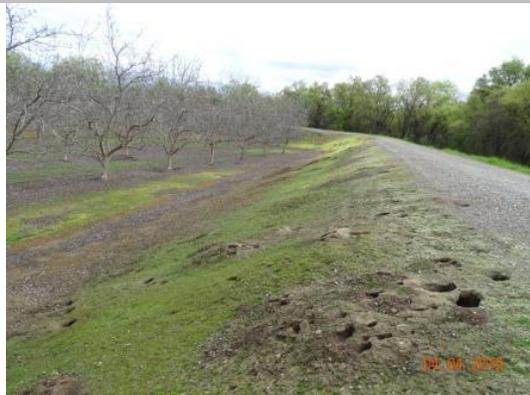
Photo 1 of 2 : SP\_2020\_LD0002\_28\_16\_20200226\_00009.jpg

View of the rodent holes along the landside slope. Spring 2019.

LM Start	<b>3.24</b>	Rating **	<b>U</b>	Issue No.	<b>16</b>
LM End	<b>3.30</b>	Issue Type +	<b>Ma</b>	Location *	<b>LS</b>
Category	Earthen Levee		GPS Latitude/Longitude		
			Start	End	
Item	Animal Control		39.456222 °	39.456272 °	
			-122.011266 °	-122.010163 °	
DWR ID	DWR_LD0002_01_f_2012_16				
Comment Code					
A3 : No rodents visible, but rodent burrows visible; need to backfill and compact or grout burrows.					
Inspector Comment

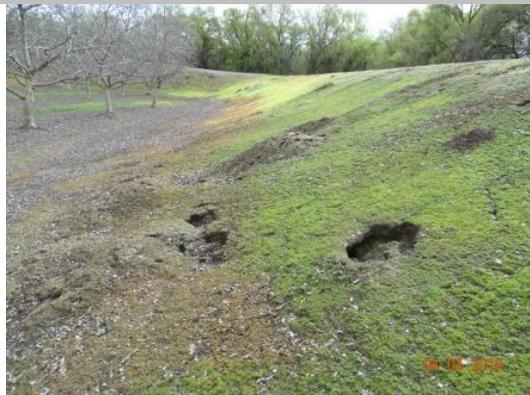
Photo 2 of 2 : SP\_2020\_LD0002\_28\_16\_20200226\_00010.jpg

Another view of the rodent holes along the landside slope. Spring 2019.

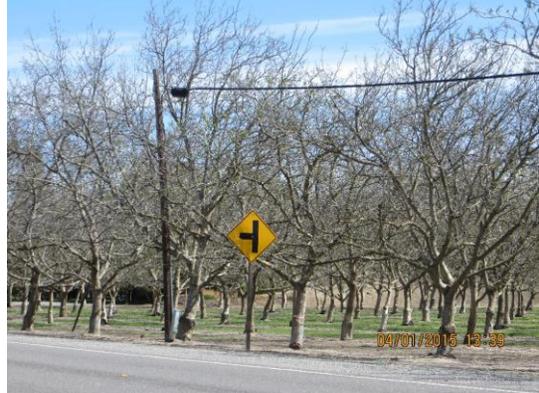
Photo 1 of 2 : UCIP\_SP\_2020\_44186\_73606.jpg

Item	DWR UCIP Field Study		39.456704 °	39.456704 °	
			-122.009621 °	-122.009621 °	
DWR ID	21188				
Comment Code					
Inspector Comment					
DS_ID:21188 FS_ID:44186 EP_NO: 12444 Repair Type: Non-Urgent Crossing Status: Indicator Found UCIP Comments: Needs markers 10-feet off both levee toes. FIELD_STRUCT_DESC: Buried cable steel conduit through the levee, 2.5 feet below the crown. Conduit extends to pole on waterside (WS). Cut in pavement visible at levee crown (aerial communication cable across left bank levee and channel of the Sacramento River and buried cable across the right bank overflow and through the right bank levee authorized under Permit No. 12444, 1978-Pacific Telephone and Telegraph Company) [Additional Reference(s): DWR Levee Logs, 2005] FS Date: 4/1/2015

Conduit may be visible on pole about 1000-feet west of levee crown.

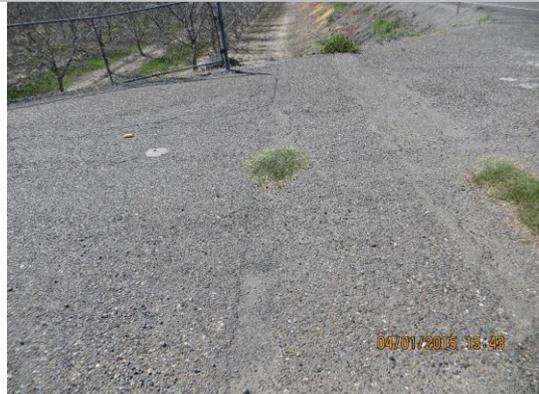
Photo 2 of 2 : UCIP\_SP\_2020\_44186\_73605.jpg

Cut in pavement at levee crown good indicator of crossing.

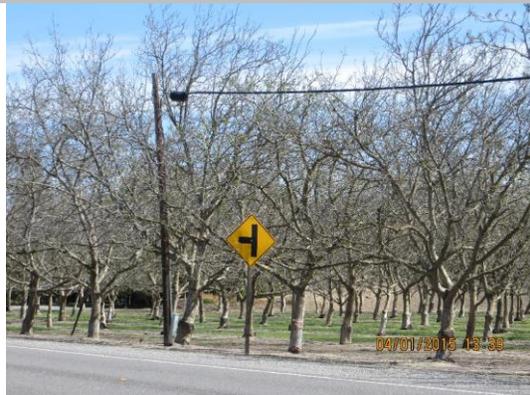
Photo 1 of 2 : UCIP\_SP\_2020\_44185\_73608.jpg

Item	DWR UCIP Field Study		39.456720 °	39.456720 °	
			-122.009630 °	-122.009630 °	
DWR ID	21175				
Comment Code					
Inspector Comment					
DS_ID:21175 FS_ID:44185 EP_NO: 5376 Repair Type: Non-Urgent Crossing Status: Indicator Found UCIP Comments: Conduit needs markers ten feet off both levee toes. FIELD_STRUCT_DESC: Three 3.5-inch steel cables sleeved through conduit through the levee, 3 feet below the crown. Metal cutoff wall around conduits near center of levee. Conduits are welded to the cutoff wall, extending only between the levee shoulders under the crown. Cut in pavement visible at crown. Cables extend to pole on waterside (WS). (replace existing aerial telephone cables with two buried cables authorized under Permit No. 5376, 1967-Pacific Telephone & Telegraph Co.) [Additional Reference(s): DWR Levee Logs, 2005] FS Date: 4/1/2015

Conduit may be visible at pole about 1000-feet west of crown.

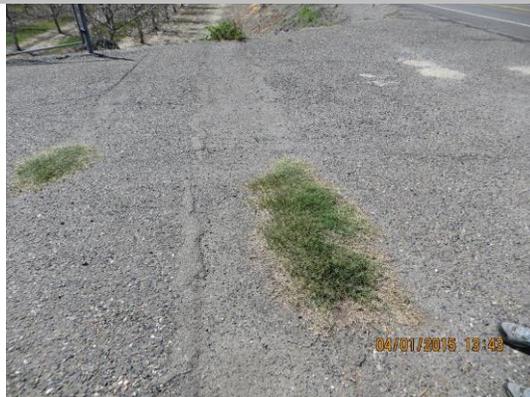
Photo 2 of 2 : UCIP\_SP\_2020\_44185\_73607.jpg

Cut in pavement visible at crown good indicator of crossing location.

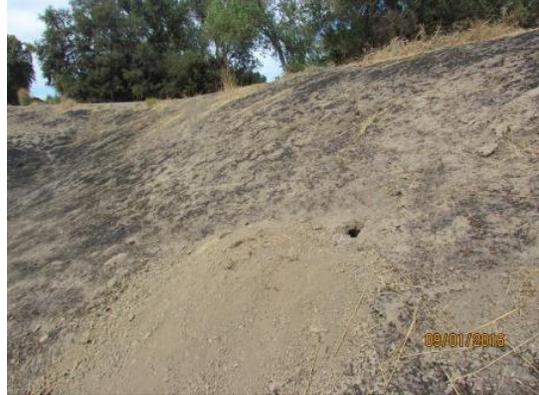
Photo 1 of 2 : SP\_2020\_LD0002\_28\_27\_20200226\_00011.jpg

View of the rodent holes along the landside slope.

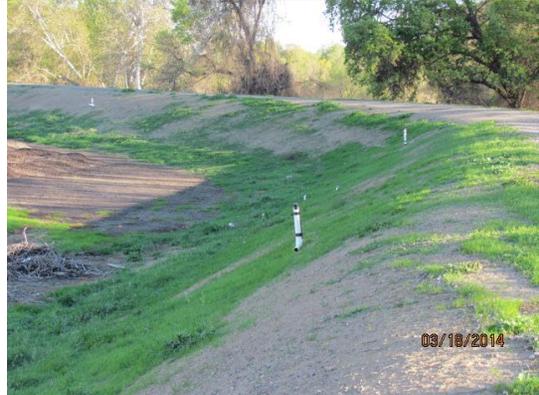
Photo 2 of 2 : SP\_2020\_LD0002\_28\_27\_20200226\_00012.jpg

View of the rodent activity along the landside slope.

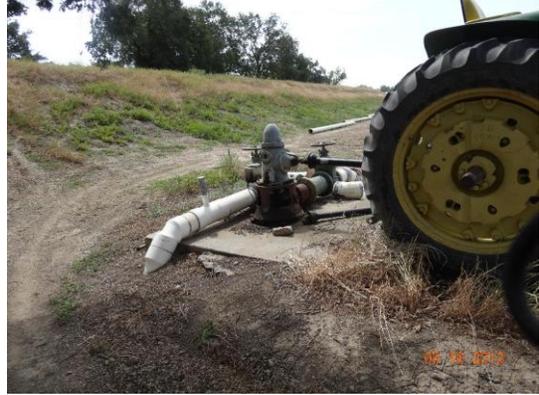
Photo 2 of 3 : UCIP\_SP\_2020\_38178\_69501.jpg

Pump system located near landward toe.

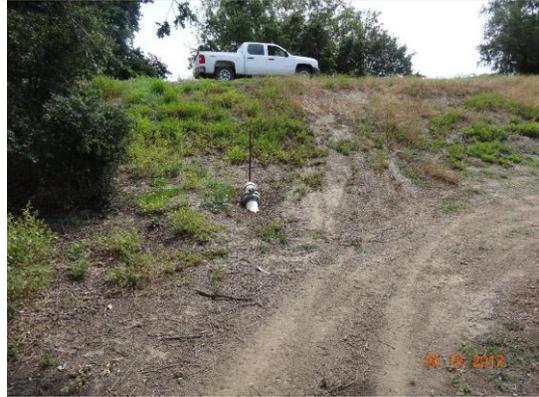
Photo 3 of 3 : UCIP\_SP\_2020\_38178\_69500.jpg

Pipe connection capped with control valve located on landward toe.

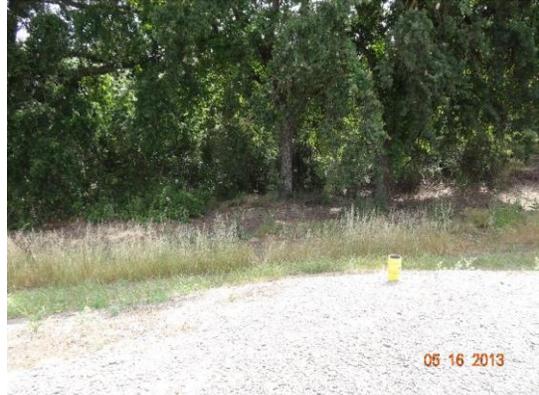
Photo 1 of 3 : UCIP\_SP\_2020\_38182\_69537.jpg

LM Start	<b>3.74</b>	Rating **	M	Issue No.	<b>69</b>
LM End	<b>3.74</b>	Issue Type +	En	Location *	
Category	Supplemental		GPS Latitude/Longitude		
			Start	End	
Item	DWR UCIP Field Study		39.461674 °	39.461674 °	
			-122.011507 °	-122.011507 °	
DWR ID	24659				
Comment Code					
Inspector Comment					
DS_ID:24659 FS_ID:38182 EP_NO: N/A Repair Type: Non-Urgent Crossing Status: Found UCIP Comments: Need to contact owner to determine status of crossing. FIELD_STRUCT_DESC: 24-inch steel drainage pipe through levee, 2-feet below the crown. Pipe is exposed on waterside (WS) with air vent on the WS levee shoulder. Open pump is approximately 550 feet on the landside (LS) of the levee toe and concrete distribution pipe. (electronic permit not available - Permit No. 16280-1995, Mathew J. Southam/McGowan) FS Date: 5/16/2013

View of waterward side.

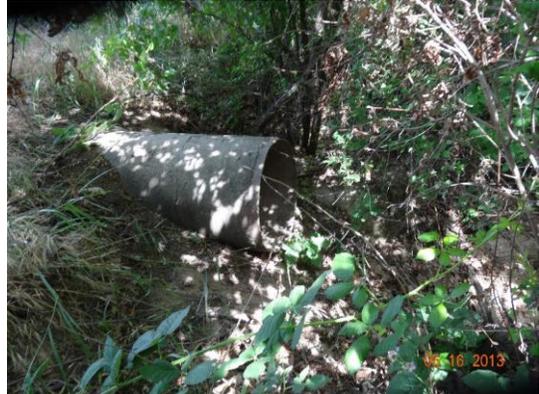
Photo 2 of 3 : UCIP\_SP\_2020\_38182\_69533.jpg

Pipe visible on waterward side.

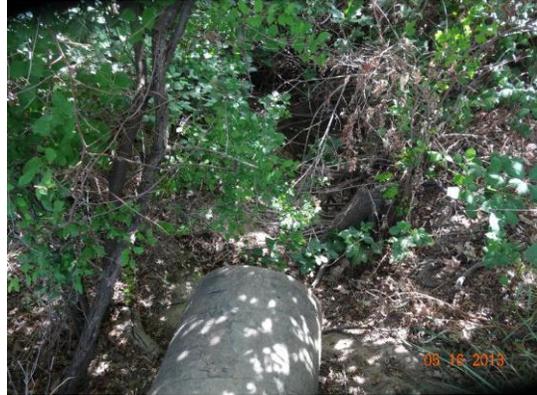
Photo 3 of 3 : UCIP\_SP\_2020\_38182\_69541.jpg

View of channel on waterward side.

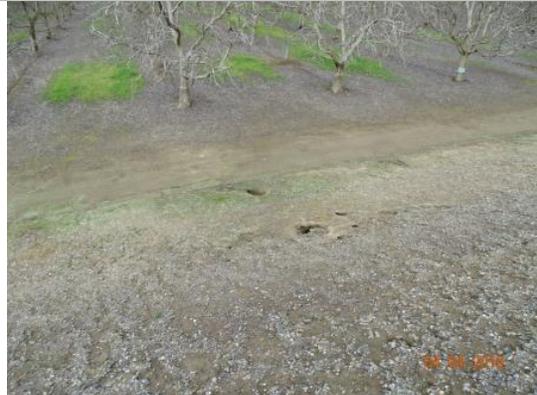
Photo 1 of 1 : SP\_2020\_LD0002\_28\_50\_20200226\_00017.jpg

View of the rodent holes on the landside slope. Spring 2019.

LM Start	<b>3.79</b>	Rating **	M	Issue No.	<b>50</b>
LM End	<b>3.79</b>	Issue Type +	Ma	Location *	LS
Category	Earthen Levee			GPS Latitude/Longitude	
				Start	End
Item	Animal Control			39.462358 °	39.462358 °
				-122.011623 °	-122.011623 °
DWR ID	DWR_LD0002_01_s_2019_50				
Comment Code					
A3 : No rodents visible, but rodent burrows visible; need to backfill and compact or grout burrows.					
Inspector Comment

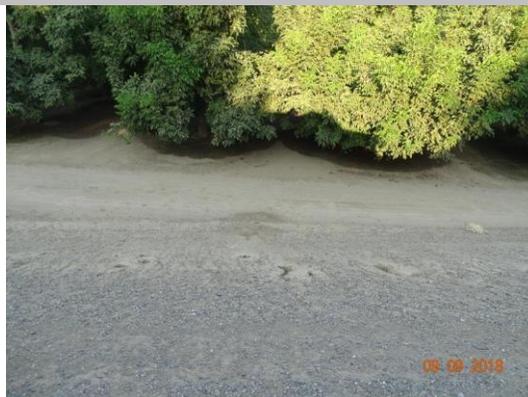
Photo 1 of 1 : SP\_2020\_LD0002\_28\_28\_20200226\_00013.jpg

View of the rodent holes along the landside slope.

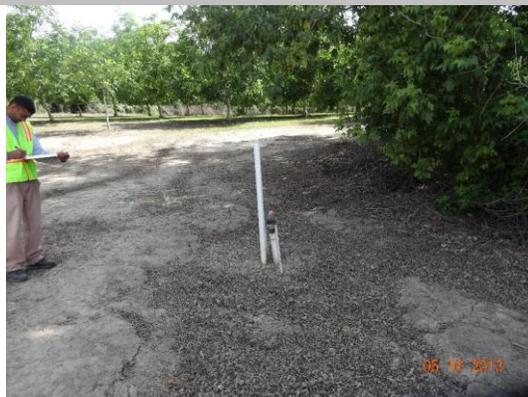
Photo 1 of 3 : UCIP\_SP\_2020\_44188\_69544.jpg

LM Start	<b>4.32</b>	Rating **	M	Issue No.	<b>70</b>
LM End	<b>4.32</b>	Issue Type +	En	Location *	
Category	Supplemental		GPS Latitude/Longitude		
			Start	End	
Item	DWR UCIP Field Study		39.469908 °	39.469908 °	
			-122.012117 °	-122.012117 °	
DWR ID	21181				
Comment Code					
Inspector Comment					
DS_ID:21181 FS_ID:44188 EP_NO: 18072 Repair Type: Non-Urgent Crossing Status: Indicator Found UCIP Comments: Pipe needs better markers at pipe crossing. FIELD_STRUCT_DESC: 6-inch steel irrigation pipe through the levee, 2 feet below the levee. Well, pump, and vent visible on landside (LS) toe. Vent visible just off waterside (WS) toe. (6-inch pipe authorized under Permit No. 18072, 2006-McCowan & Southam) FS Date: 4/1/2015

3-inch PVC pipe and vent exposed on waterward toe, likely in alignment with this crossing.

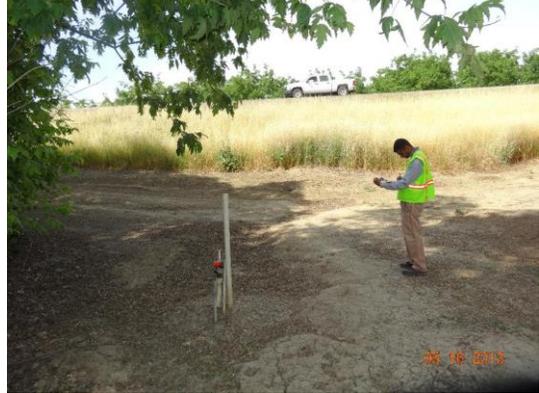
Photo 2 of 3 : UCIP\_SP\_2020\_44188\_69543.jpg

3-inch PVC pipe and vent exposed on waterward toe, likely in alignment with this crossing.

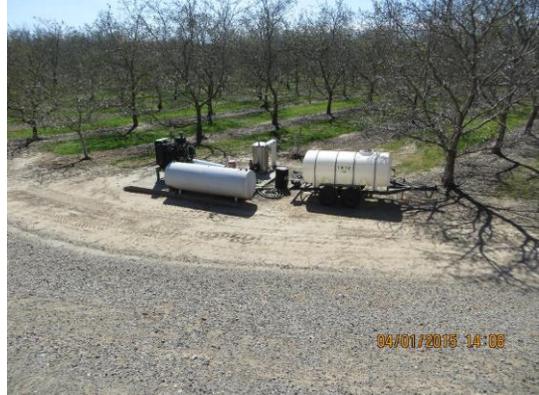
Photo 3 of 3 : UCIP\_SP\_2020\_44188\_73609.jpg

Well and pump visible on LS toe.

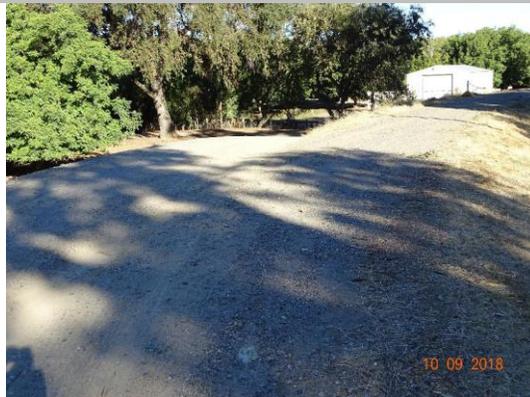
Photo 1 of 3 : UCIP\_SP\_2020\_53005\_78119.jpg

Item	DWR UCIP Field Study		39.476781 °	39.476781 °	
			-122.017494 °	-122.017494 °	
DWR ID	21176				
Comment Code					
Inspector Comment					
DS_ID:21176 FS_ID:53005 EP_NO: 15198 Repair Type: Non-Urgent Crossing Status: Not Found UCIP Comments: 10/9/2018 No markers found. Crossing downgraded to "Non-Urgent" due to reclassification of gas lines. (O.Yakimov - DWR UCIP)07/07/2016 same as previous inspection: No markers found. Unable to confirm crossing status. (DWR UCIP - omagana)05/16/2013 No markers found. Need to contact owner to determine if crossing is still active and to determine last inspection date. Will need copy of letter showing crossings passed inspection. (DWR UCIP - omagana) FIELD_STRUCT_DESC: 2-inch steel gas line through the levee, 2.5 feet below the crown. (2-inch gas line authorized under Permit No. 15198, 1989-Northern Michigan Exploration Company) FS Date: 10/9/2018 2:50:03 PM

View of levee crown at the crossing.

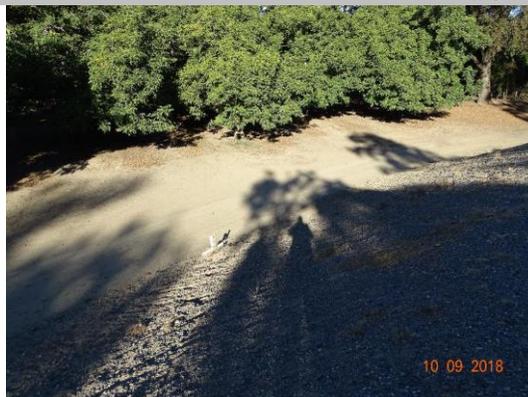
Photo 2 of 3 : UCIP\_SP\_2020\_53005\_78120.jpg

View of landside at crossing.

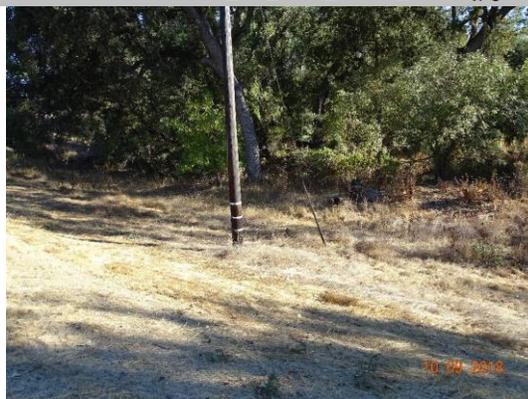
Photo 3 of 3 : UCIP\_SP\_2020\_53005\_78121.jpg

View of waterside at crossing.

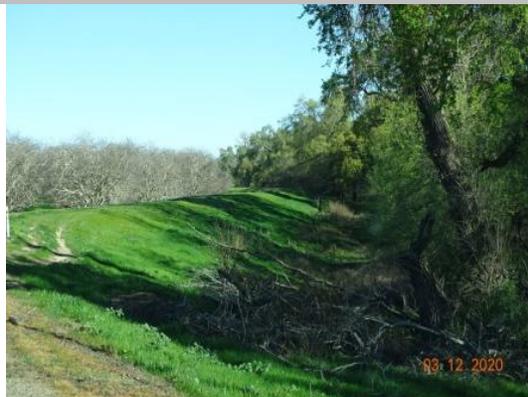
Photo 1 of 1 : SP\_2020\_LD0002\_28\_57\_20200312\_00053.jpg

View of the tree and branches on the waterside slope. Spring 2020.
