**Flood Control Project Maintenance
Levee Inspections**

Maintenance Issue Types Only, Levee Inspection Report By Mile - Fall 2019

Levee District No. 0009 (Sutter County)

Waterway	Bank	Unit Miles	Inspection Start/End	Inspector
Unit No. 01 Sutter County, Feather River	Right	6.25	10/25/2019 10/25/2019	Sterling York

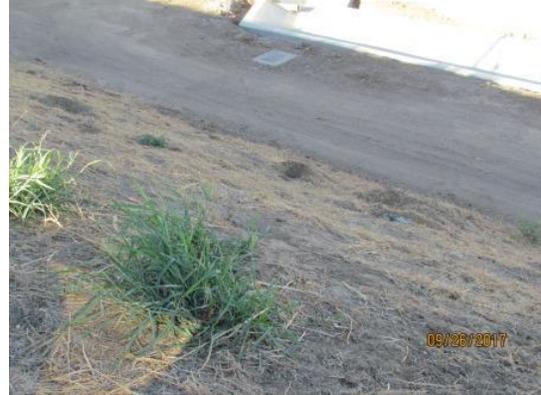
Photo 1 of 1 : FA_2019_LD0009_202_18_20190904_00001.jpg

LM Start	0.09	Rating **	M	Issue No.	18
LM End	0.09	Issue Type +	Ma	Location *	LS
Category	Earthen Levee		GPS Latitude/Longitude		
			Start	End	
Item	Animal Control		39.170064 °	39.170064 °	
			-121.622563 °	-121.622563 °	
DWR ID	DWR_LD0009_01_f_2016_18				
Comment Code					
A3 : No rodents visible, but rodent burrows visible; need to backfill and compact or grout burrows.					
Inspector Comment					
No rodent activity was observed, holes need to be backfilled. Fall 2019

View on landside of rodent activity and holes.

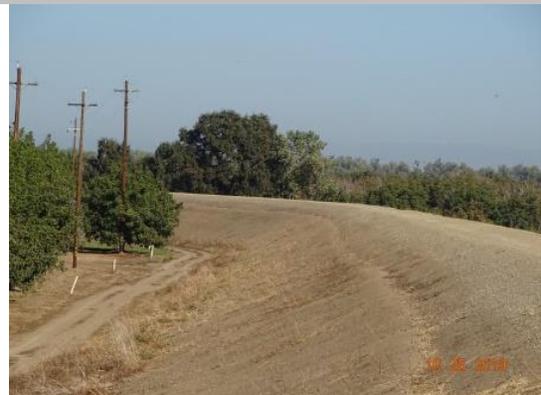
Photo 1 of 1 : FA_2019_LD0009_202_1_20191030_00005.jpg

LM Start	0.09	Rating **	A	Issue No.	1
LM End	6.23	Issue Type +	Ma	Location *	LS
Category	Earthen Levee		GPS Latitude/Longitude		
			Start	End	
Item	Vegetation		39.170114 °	39.255621 °	
			-121.622565 °	-121.636368 °	
DWR ID	DWR_LD0009_01_f_2019_1				
Comment Code					
V1 : Control annual grass and weeds on the levee slopes and easements.					
Inspector Comment					
The annual vegetation is well maintained, Fall 2019.

View looking upstream landside at the well maintained annual vegetation, Fall 2019.

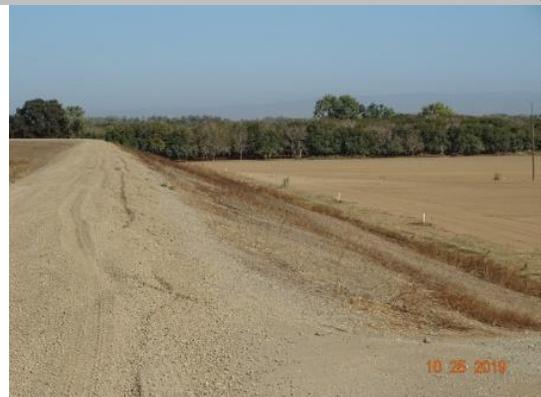
Photo 1 of 1 : FA_2019_LD0009_202_2_20191030_00004.jpg

LM Start	0.09	Rating **	A	Issue No.	2
LM End	6.23	Issue Type +	Ma	Location *	WS
Category	Earthen Levee		GPS Latitude/Longitude		
			Start	End	
Item	Vegetation		39.170114 °	39.255621 °	
			-121.622565 °	-121.636368 °	
DWR ID	DWR_LD0009_01_f_2019_2				
Comment Code					
V1 : Control annual grass and weeds on the levee slopes and easements.					
Inspector Comment					
The annual vegetation is well maintained, Fall 2019.

View looking upstream waterside at the well maintained annual vegetation, Fall 2019.
