**Flood Control Project Maintenance  
Levee Inspections**

**Fall 2019 Levee Maintenance Deficiency Summary Report**

**Sutter Maintenance Yard Maintenance Area 0001**

Waterway		Bank	Unit Miles	
Unit No. 01 Sacramento River		Right	16.76	
	Spring (March - May)	Summer (June - August)	(September - November) Fall	Winter (December - February)
Unit Maintenance Rating (Fall Only)			<b>A</b>	
Date of Inspection	4/17/2019 - 4/17/2019		10/15/2019 - 10/15/2019	
DWR Inspector	Makar Sokol		Makar Sokol	
Accompanied By	Bryan Reniff Sutter Maintenance Yard		Lincoln Carey Sutter Maintenance Yard

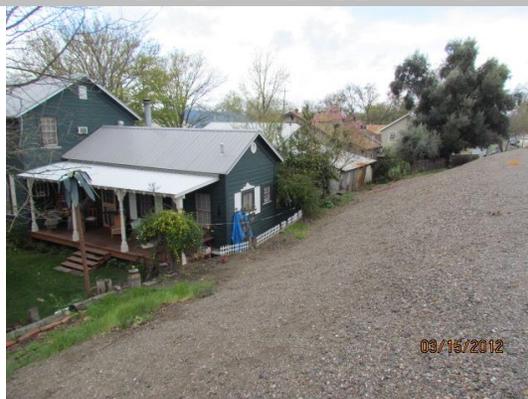
Photo 1 of 1 : FA\_2019\_MA0001\_297\_2\_20190822\_00001.jpg

View of the building along the landside toe.

LM Start	<b>0.06</b>	Rating **	C	Issue No.	<b>67</b>
LM End	<b>0.06</b>	Issue Type +	Ma	Location *	LS
Category	Earthen Levee			GPS Latitude/Longitude	
				Start	End
Item	Vegetation			39.214091 °	39.214091 °
				-122.001899 °	-122.001899 °
DWR ID	DWR_MA0001_01_s_2019_67				
Comment Code					
V2 : Remove the wild growth other than native grasses from the levee slopes.					
Inspector Comment					
The wild growth should be removed from the landside toe.

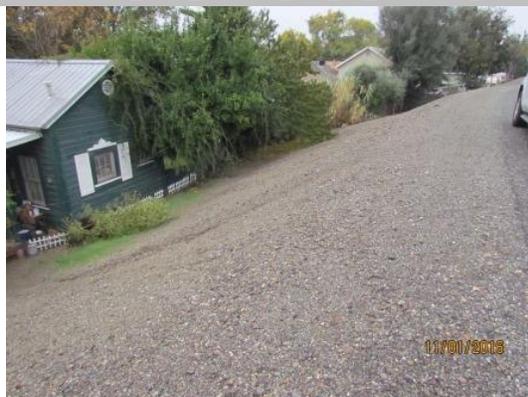
Photo 1 of 1 : FA\_2019\_MA0001\_297\_94\_20190822\_00026.jpg

LM Start	<b>0.09</b>	Rating **	A/W	Issue No.	<b>94</b>
LM End	<b>0.09</b>	Issue Type +	Ma	Location *	LS
Category	Earthen Levee			GPS Latitude/Longitude	
				Start	End
Item	Slope Stability			39.214217°	39.214217°
				-122.002378°	-122.002378°
DWR ID	DWR_MA0001_01_f_2016_94				
Comment Code					
S2 : Repair the levee slope damaged by foot traffic and prevent access where possible.					
Inspector Comment

View of the slope instability along the landside slope.

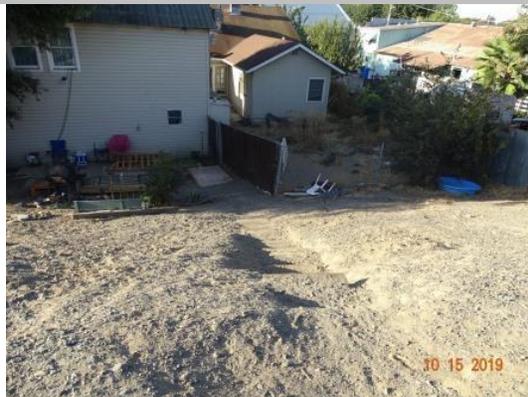
Photo 1 of 1 : FA\_2019\_MA0001\_297\_63\_20191017\_00149.jpg

LM Start	<b>0.11</b>	Rating **	U	Issue No.	<b>63</b>
LM End	<b>0.11</b>	Issue Type +	En	Location *	LS
Category	Earthen Levee			GPS Latitude/Longitude	
				Start	End
Item	Encroachments			39.214379°	39.214379°
				-122.002791°	-122.002791°
DWR ID	DWR_MA0001_01_f_2019_63				
Comment Code					
ST : Stairway					
Inspector Comment

View of the wooden stairs cut into the landside slope. Fall 2019.

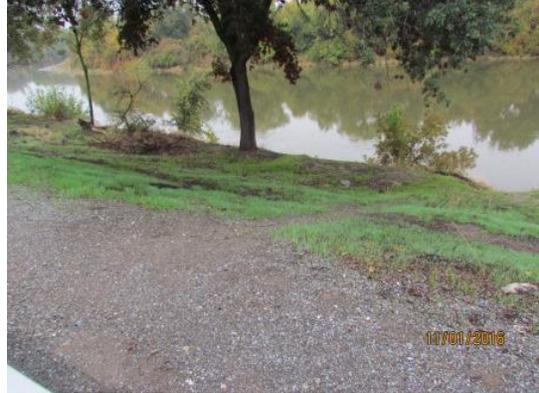
Photo 1 of 1 : FA\_2019\_MA0001\_297\_98\_20190822\_00028.jpg

LM Start	<b>0.38</b>	Rating **	A/W	Issue No.	<b>98</b>
LM End	<b>0.38</b>	Issue Type +	Ma	Location *	WS
Category	Earthen Levee			GPS Latitude/Longitude	
				Start	End
Item	Slope Stability			39.215878°	39.215878°
				-122.007278°	-122.007278°
DWR ID	DWR_MA0001_01_f_2016_98				
Comment Code					
S2 : Repair the levee slope damaged by foot traffic and prevent access where possible.					
Inspector Comment

View of the slope instability along the waterside slope.

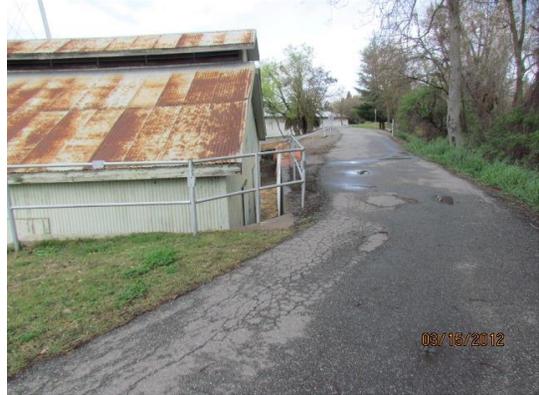
Photo 1 of 1 : FA\_2019\_MA0001\_297\_7\_20190822\_00004.jpg

View of the buildings along the landside toe.

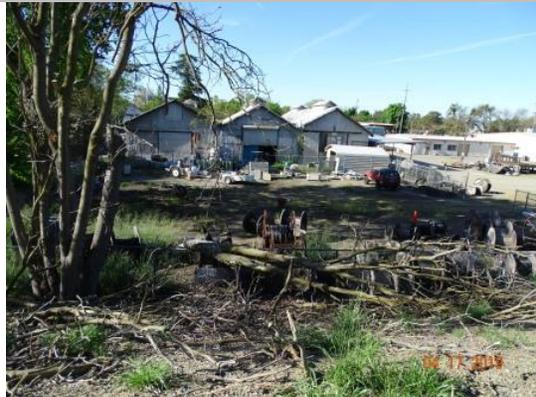
Photo 1 of 1 : FA\_2019\_MA0001\_297\_79\_20190822\_00017.jpg

View of the tree branches and limbs at the landside toe. Spring 2019.

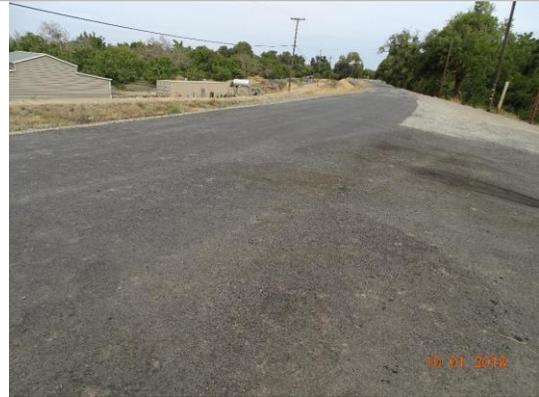
Photo 1 of 3 : UCIP\_FA\_2019\_53078\_78328.jpg

Item	DRAFT DWR UCIP Field Study		39.221685°	39.221685°	
			-122.015720°	-122.015720°	
DWR ID	25564				
Comment Code					
Inspector Comment					
DS_ID:25564 FS_ID:53078 EP_NO: N/A Repair Type: Non-Urgent Crossing Status: Found UCIP Comments: 10/1/2018 Pipe installed according to emergency work authorization dated 07/31/2017 under existing permit No. 9481. Owner Roberts Ditch Company needs to submit as-builts. (O.Yakimov - DWR UCIP) FIELD_STRUCT_DESC: 36-inch smooth steel epoxy coated interior/exterior irrigation pipe with positive closure device on the water side of the levee. Crossing penetrates the levee at an angle. Other appurtenances located at this crossing include 2 slant pumps connected to a concrete distribution box, and shed structure located 100 feet northeast from levee crossing. Flow is carried from concrete distribution box to slide gate via concrete lined ditch. pipe is open to an irrigation ditch on LS. (Installed according to the board emergency work authorization dated 07/31/2017 under existing permit No. 9481. Owner Roberts Ditch Company). Replaces pipe with DSID 16431. FS Date: 10/1/2018 10:51:57 AM

View of levee crown at crossing.

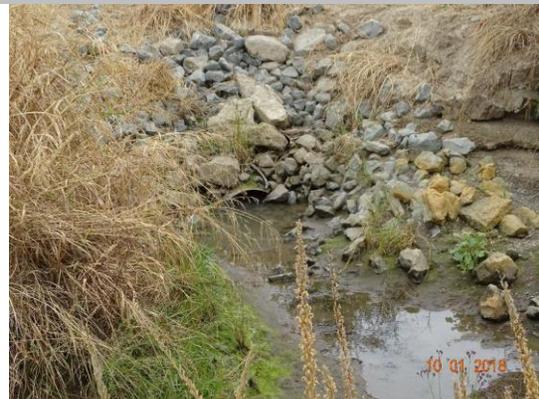
Photo 2 of 3 : UCIP\_FA\_2019\_53078\_78329.jpg

View of pipe end in irrigation ditch on LS.

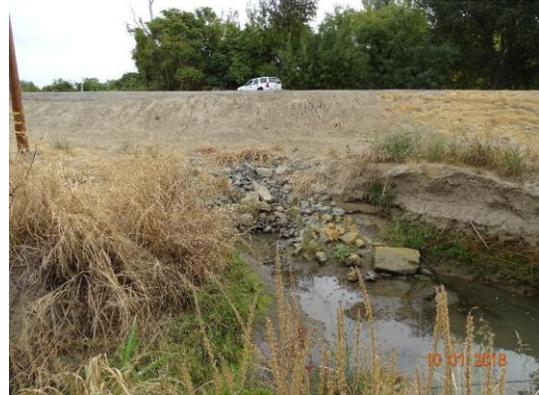
Photo 3 of 3 : UCIP\_FA\_2019\_53078\_78330.jpg

Item	DRAFT DWR UCIP Field Study			39.221685 °	39.221685 °
				-122.015720 °	-122.015720 °
DWR ID	25564				
Comment Code					
Inspector Comment					
DS_ID:25564 FS_ID:53078 EP_NO: N/A Repair Type: Non-Urgent Crossing Status: Found UCIP Comments: 10/1/2018 Pipe installed according to emergency work authorization dated 07/31/2017 under existing permit No. 9481. Owner Roberts Ditch Company needs to submit as-builts. (O.Yakimov - DWR UCIP) FIELD_STRUCT_DESC: 36-inch smooth steel epoxy coated interior/exterior irrigation pipe with positive closure device on the water side of the levee. Crossing penetrates the levee at an angle. Other appurtenances located at this crossing include 2 slant pumps connected to a concrete distribution box, and shed structure located 100 feet northeast from levee crossing. Flow is carried from concrete distribution box to slide gate via concrete lined ditch. pipe is open to an irrigation ditch on LS. (Installed according to the board emergency work authorization dated 07/31/2017 under existing permit No. 9481. Owner Roberts Ditch Company). Replaces pipe with DSID 16431. FS Date: 10/1/2018 10:51:57 AM

View of LS levee slope and irrigation ditch at levee toe.

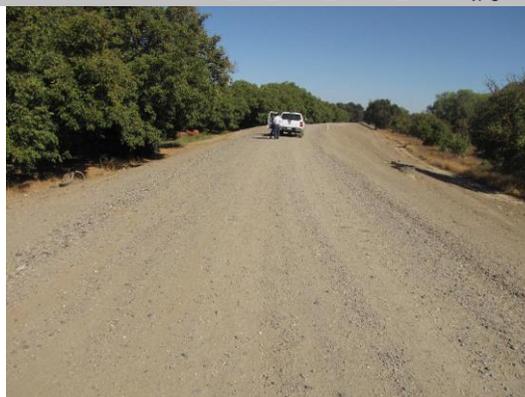
Photo 1 of 3 : UCIP\_FA\_2019\_51852\_70064.jpg

Item	DRAFT DWR UCIP LMA Responsibility			39.231866°	39.231866°
				-122.015442°	-122.015442°
DWR ID	16430				
Comment Code					
Inspector Comment					
DS_ID:16430 FS_ID:51852 EP_NO: 9487 Repair Type: Non-Urgent Crossing Status: Found UCIP Comments: 5/3/2017 WS end still partially plugged. (DWR Sutter Yard- AFreitag)10/24/2016 Ws end is till partially plugged.(DWR Sutter Yard- AFreitag)4/25/2016 WS pipe end is still plugged with soil. Rest of the pipe appeared to be in good condition.4/20/2015 WS pipe end is plugged about 50% by soil.6/18/2014 Same as last inspection.12/17/2013 Same as last inspection.7/18/2013 WS pipe end has been reformed but is still clogged about 50% by sediment.10/18/2012 Remove dirt and debris in riser. Outlet deformed and blocked over 50%. Debris-round concrete section on landward side. This crossing was listed in the USACE Periodic Inspections as ID# USACE_CESPK_MA1C_2010_p_0116 for crossing outlet deformed and clogged with dirt. FIELD_STRUCT_DESC: 1 of 2: 36-inch corrugated metal drainage pipe through the levee, approximately 12-15 feet below the crown. Slide gates in corrugated metal pipe (CMP) riser located on the waterside (WS) slope. Pipe daylights on the landside (LS). (36-inch pipe [HLM 1.97] authorized under Automatic Board Order (ABO) issued as Permit No. 9487, 1974 - Jimeno Rancho) [Additional Reference(s): DWR Levee Log, 1992. USACE Sacramento O&M Manual 137, August 1955, (Station 103+18)]. FS Date: 5/19/2017 1:20:29 PM

Overview of levee crown and slopes looking upstream towards crossing.

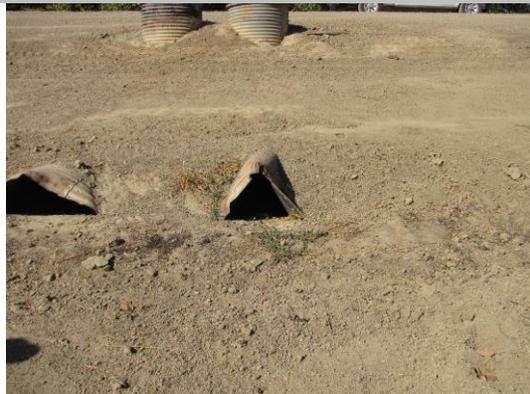
Photo 3 of 3 : UCIP\_FA\_2019\_51853\_70073.jpg

Item	DRAFT DWR UCIP LMA Responsibility			39.231880 °	39.231880 °
				-122.015432 °	-122.015432 °
DWR ID	17565				
Comment Code					
Inspector Comment					
<p>DS_ID:17565                  FS_ID:51853                  EP_NO: 9487                  Repair Type: Non-Urgent                  Crossing Status: Found                  UCIP Comments: 5/3/2017 Ws end still partially plugged. (DWR Sutter Yard- AFreitag)10/24/2016 Ws pipe end still plugged.(DWR Sutter Yard- AFreitag)4/25/2016 WS pipe end still plugged with soil. rest of pipe appears in good condition.4/20/2015 WS pipe end plugged about 50% by soil.6/18/2014 Same as last inspection.12/17/2013 Same as last inspection.7/18/2013 WS pipe end has been reformed but is still partially blocked with dirt and debris.10/18/2012 WS-remove dirt and debris in riser. Outlet deformed and blocked over 50%. Burrow activity near outlet on waterward slope. Debris around concrete section on landward side. This crossing was listed in the USACE Periodic Inspections as ID# USACE_CESPK_MA1C_2010_p_0116 for crossing outlet deformed and clogged with dirt.                  FIELD_STRUCT_DESC: 2 of 2: 36-inch corrugated metal drainage pipe through the levee, approximately 12-15 feet below the crown. Slide gates in corrugated metal pipe (CMP) riser on the waterside (WS) slope. Pipe daylights on the landside (LS). (36-inch pipe [HLM 1.97] authorized under Automatic Board Order (ABO) issued as Permit No. 9487, 1974 - Jimeno Rancho) [Additional Reference(s): DWR Levee Log, 1992. USACE Sacramento O&amp;M Manual 137, August 1955, (Station 103+18)].                  FS Date: 5/19/2017 1:21:31 PM</p>

CMP pipe outlet deformed with over 50 percent blockage.

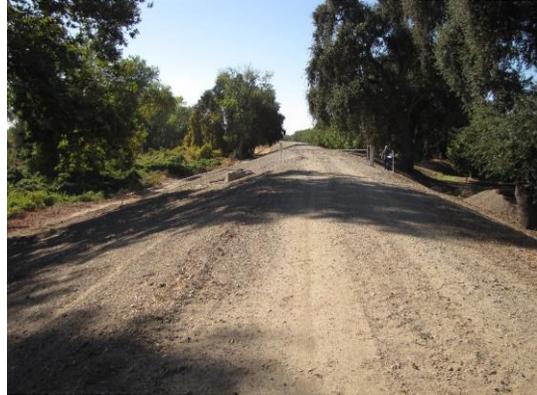
Photo 1 of 3 : UCIP\_FA\_2019\_51854\_70078.jpg

Item	DRAFT DWR UCIP LMA Responsibility			39.235993 °	39.235993 °
				-122.012970 °	-122.012970 °
DWR ID	16429				
Comment Code					
Inspector Comment					
DS_ID:16429 FS_ID:51854 EP_NO: 9472 Repair Type: Non-Urgent Crossing Status: Found UCIP Comments: 5/3/2017 LS inlet partially plugged with soil. Some debris still present inside riser. (DWR Sutter Yard-AFreitag)10/24/2016 Debris still inside of riser.(DWR Sutter Yard-AFreitag)4/25/2016 Pipe still inside of riser and LS end plugged about 50% by soil.4/20/2015 Same as last inspection.6/18/2014 Same as last inspection.12/17/2013 Same as last inspection.7/18/2013 Same as last inspection.10/18/12 Remove debris from riser. Landward inlet is blocked by over 50%. This crossing was listed in the USACE Periodic Inspections as ID# USACE_CESPK_MA1C_2010_p_0128 for sediment build up at inlet (landward side) and debris inside riser. FIELD_STRUCT_DESC: 54-inch corrugated metal drainage pipe through the levee, approximately 12-15 feet below the crown. Slide gate in corrugated metal pipe (CMP) riser on the waterside (WS) slope. 48-inch CMP at landside (LS) slope. This crossing crosses the levee at an angle. (54-inch pipe [HLM 2.29] authorized under Automatic Board Order (ABO) issued as Permit No. 9472, 1974 - Ballard ) [Additional Reference(s): DWR Levee Log, 1992. USACE Sacramento O&M Manual 137, August 1955, (Station 120+00)]. FS Date: 5/19/2017 1:23:34 PM

View of levee crown looking downstream at crossing. CMP riser located on WS shoulder.

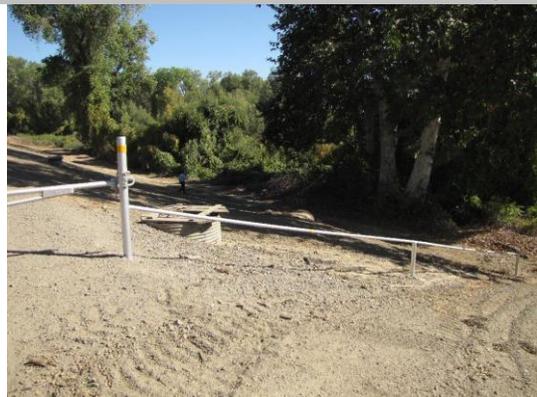
Photo 2 of 3 : UCIP\_FA\_2019\_51854\_70079.jpg

View of WS looking at slope and channel.

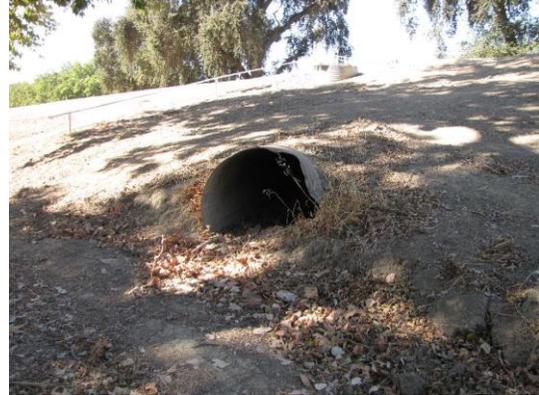
Photo 3 of 3 : UCIP\_FA\_2019\_51854\_70077.jpg

Item	DRAFT DWR UCIP LMA Responsibility			39.235993 °	39.235993 °
				-122.012970 °	-122.012970 °
DWR ID	16429				
Comment Code					
Inspector Comment					
<p>DS_ID:16429                  FS_ID:51854                  EP_NO: 9472                  Repair Type: Non-Urgent                  Crossing Status: Found                  UCIP Comments: 5/3/2017 LS inlet partially plugged with soil. Some debris still present inside riser. (DWR Sutter Yard-AFreitag)10/24/2016 Debris still inside of riser.(DWR Sutter Yard-AFreitag)4/25/2016 Pipe still inside of riser and LS end plugged about 50% by soil.4/20/2015 Same as last inspection.6/18/2014 Same as last inspection.12/17/2013 Same as last inspection.7/18/2013 Same as last inspection.10/18/12 Remove debris from riser. Landward inlet is blocked by over 50%. This crossing was listed in the USACE Periodic Inspections as ID# USACE_CESPK_MA1C_2010_p_0128 for sediment build up at inlet (landward side) and debris inside riser.                  FIELD_STRUCT_DESC: 54-inch corrugated metal drainage pipe through the levee, approximately 12-15 feet below the crown. Slide gate in corrugated metal pipe (CMP) riser on the waterside (WS) slope. 48-inch CMP at landside (LS) slope. This crossing crosses the levee at an angle. (54-inch pipe [HLM 2.29] authorized under Automatic Board Order (ABO) issued as Permit No. 9472, 1974 - Ballard ) [Additional Reference(s): DWR Levee Log, 1992. USACE Sacramento O&amp;M Manual 137, August 1955, (Station 120+00)].                  FS Date: 5/19/2017 1:23:34 PM</p>

View of outlet located at WS toe.

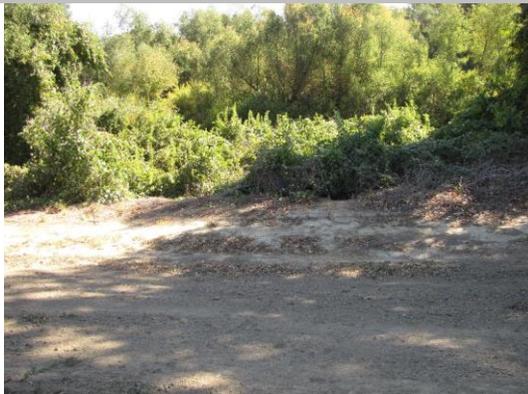
Photo 3 of 3 : UCIP\_FA\_2019\_51855\_70083.jpg

Item	DRAFT DWR UCIP LMA Responsibility			39.236178°	39.236178°
				-122.012812°	-122.012812°
DWR ID	16428				
Comment Code					
Inspector Comment					
<p>DS_ID:16428                  FS_ID:51855                  EP_NO: 9467                  Repair Type: Non-Urgent                  Crossing Status: Found                  UCIP Comments: 5/3/2017 Abandoned- needs to be done so properly. (DWR Sutter Yard- AFreitag)10/24/2016 Abandoned.(DWR Sutter Yard- AFreitag)4/25/2016 Abandoned crossing. Unable to locate any WS and LS pipe ends.4/20/2015 Same as last inspection.6/18/2014 Same as last inspection.12/17/2013 Same as last inspection.7/18/2013 Same as last inspection.10/18/2012 Only riser visible. Debris and sediment blocking gate. Gate inside riser is buried and non-functional. If crossing is abandoned, owner needs to properly abandon. This crossing was listed in the USACE Periodic Inspections as ID# USACE_CESPK_MA1C_2010_p_0132 no culvert through the levee is visible here.                  FIELD_STRUCT_DESC: *ABANDONED* 24-inch corrugated metal drainage pipe through the levee, approximately 12-15 feet below the crown. Slide gate in CM pipe riser on the waterside (WS) slope. No signs of inlet visible on the landside (LS). (24-inch pipe [HLM 2.31] authorized under Automatic Board Order (ABO) issued as Permit No. 9467, 1974 - Lovell E. Spurgeon) [Additional Reference(s): DWR Levee Log, 1992. USACE Sacramento O&amp;M Manual 137, August 1955, (Station 120+60)].                  FS Date: 5/19/2017 1:48:04 PM</p>

Unable to locate WS outlet.

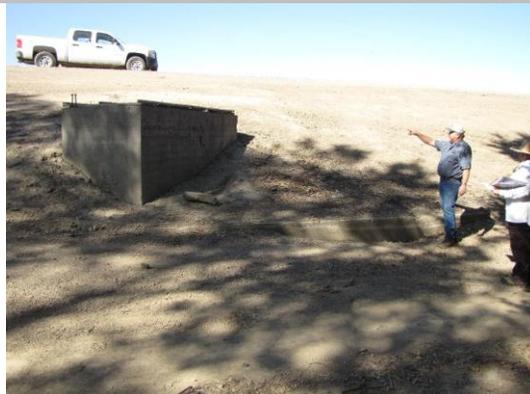
Photo 2 of 3 : UCIP\_FA\_2019\_51856\_70094.jpg

Item	DRAFT DWR UCIP Field Study			39.243410°	39.243410°
				-122.008393°	-122.008393°
DWR ID	16416				
Comment Code					
Inspector Comment					
<p>DS_ID:16416                  FS_ID:51856                  EP_NO: 9474                  Repair Type: Non-Urgent                  Crossing Status: Found                  UCIP Comments: 5/3/2017 Appears abandoned- WS vault full of soil. Needs to be abandoned properly. (DWR Sutter Yard- AFreitag)10/24/2016 Appears to be abandoned. WS vault full of soil to help prevent water from flowing through during high water season.(DWR Sutter Yard- AFreitag)4/25/2016 Concrete box was filled with dirt to help prevent water from through during high water times.4/20/2015 Positive closure device is missing and water cannot be prevented from flowing through pipe during high water. 6/18/2014 Same as last inspection.12/17/2013 Same as last inspection.7/18/2013 Same as last inspection.10/18/12 During high water flow goes through levee. Missing positive closure device on waterward side. This structure appears abandoned-slide gates have been removed. Crossing needs to be properly abandoned. This crossing was listed in the USACE Periodic Inspection as ID# USACE_CESPK_MA1C_2010_p_0169 for concrete box partially filled with dirt.                  FIELD_STRUCT_DESC: 1 of 2: 60-inch reinforced concrete irrigation pipe through the levee, approximately 12-15 feet below the crown. This crossing penetrates the levee at an angle. Slide gates in concrete well at the waterside (WS) toe. Slide gates missing. (Automatic Board Order (ABO) issued as Permit No. 9774, 1974 - George R. Zumwalt) O&amp;M manual description is for two 5-foot by 5-foot concrete culverts with two hand-operated slide gates. Culvert constructed with wing walls and gates. [Additional Reference(s): DWR Levee Log, 1992. USACE Sacramento O&amp;M Manual 137, August 1955, (Station 150+06)].                  FS Date: 5/19/2017 1:48:47 PM</p>

View of concrete distribution box and headwall located on WS.

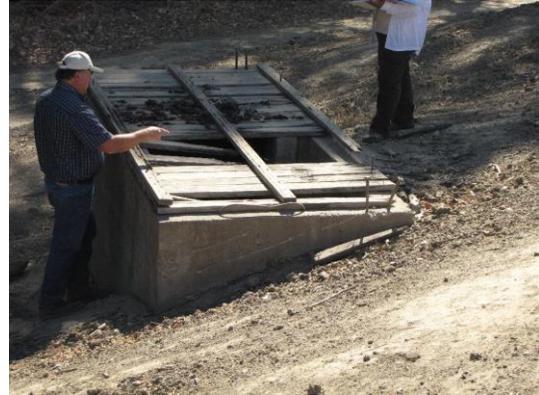
Photo 3 of 3 : UCIP\_FA\_2019\_51856\_70090.jpg

Item	DRAFT DWR UCIP Field Study			39.243410°	39.243410°
				-122.008393°	-122.008393°
DWR ID	16416				
Comment Code					
Inspector Comment					
<p>DS_ID:16416                  FS_ID:51856                  EP_NO: 9474                  Repair Type: Non-Urgent                  Crossing Status: Found                  UCIP Comments: 5/3/2017 Appears abandoned- WS vault full of soil. Needs to be abandoned properly. (DWR Sutter Yard- AFreitag)10/24/2016 Appears to be abandoned. WS vault full of soil to help prevent water from flowing through during high water season.(DWR Sutter Yard- AFreitag)4/25/2016 Concrete box was filled with dirt to help prevent water from through during high water times.4/20/2015 Positive closure device is missing and water cannot be prevented from flowing through pipe during high water. 6/18/2014 Same as last inspection.12/17/2013 Same as last inspection.7/18/2013 Same as last inspection.10/18/12 During high water flow goes through levee. Missing positive closure device on waterward side. This structure appears abandoned-slide gates have been removed. Crossing needs to be properly abandoned. This crossing was listed in the USACE Periodic Inspection as ID# USACE_CESPK_MA1C_2010_p_0169 for concrete box partially filled with dirt.                  FIELD_STRUCT_DESC: 1 of 2: 60-inch reinforced concrete irrigation pipe through the levee, approximately 12-15 feet below the crown. This crossing penetrates the levee at an angle. Slide gates in concrete well at the waterside (WS) toe. Slide gates missing. (Automatic Board Order (ABO) issued as Permit No. 9774, 1974 - George R. Zumwalt) O&amp;M manual description is for two 5-foot by 5-foot concrete culverts with two hand-operated slide gates. Culvert constructed with wing walls and gates. [Additional Reference(s): DWR Levee Log, 1992. USACE Sacramento O&amp;M Manual 137, August 1955, (Station 150+06)].                  FS Date: 5/19/2017 1:48:47 PM</p>

Concrete distribution box located on WS shoulder.

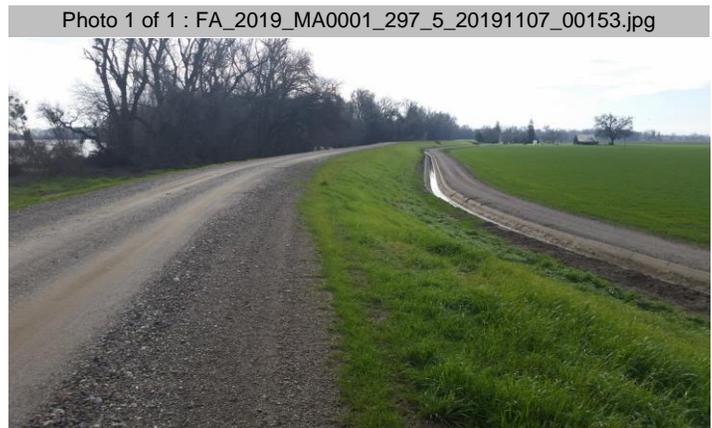
LM Start	<b>3.05</b>	Rating **	U	Issue No.	<b>5</b>
LM End	<b>3.70</b>	Issue Type +	En	Location *	LS
Category	Earthen Levee			GPS Latitude/Longitude	
				Start	End
Item	Encroachments			39.246813°	39.255976°
				-122.008155°	-122.009794°
DWR ID	DWR_MA0001_01_s_2012_5				
Comment Code					
DT : Ditch					
Inspector Comment

View of the concrete lined ditch along the landside toe.

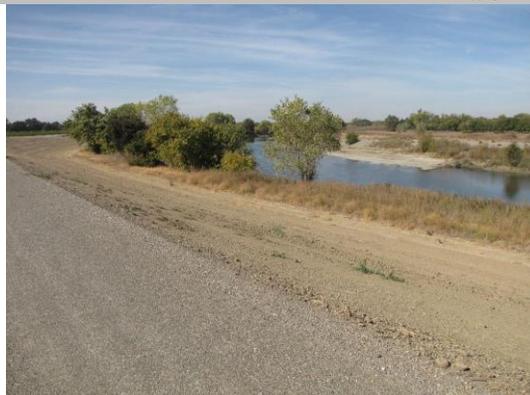
Photo 3 of 3 : UCIP\_FA\_2019\_51868\_70148.jpg

View of WS-no visible appurtenances associated with structure.

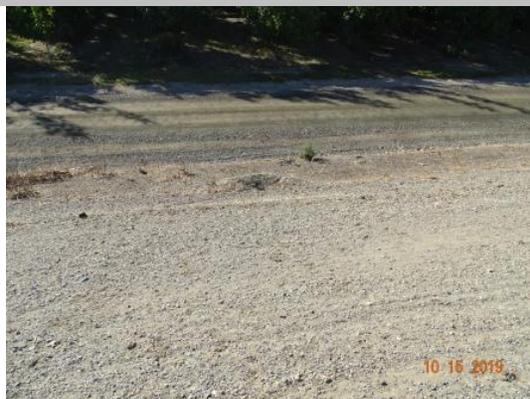
Photo 1 of 1 : FA\_2019\_MA0001\_297\_80\_20191017\_00150.jpg

View of the rodent activity at the landside toe. Fall 2019.

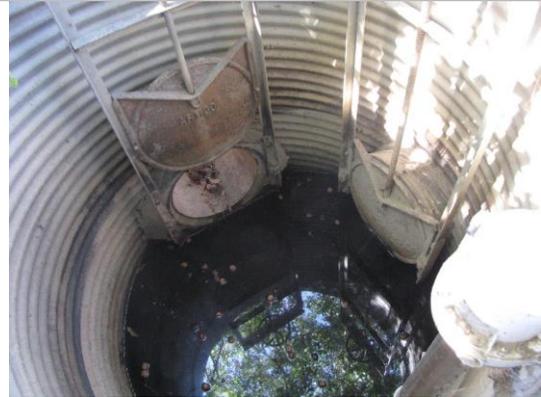
Photo 3 of 3 : UCIP\_FA\_2019\_51872\_70171.jpg

Photo 1 of 2 inside view of CMP riser located on LS toe.

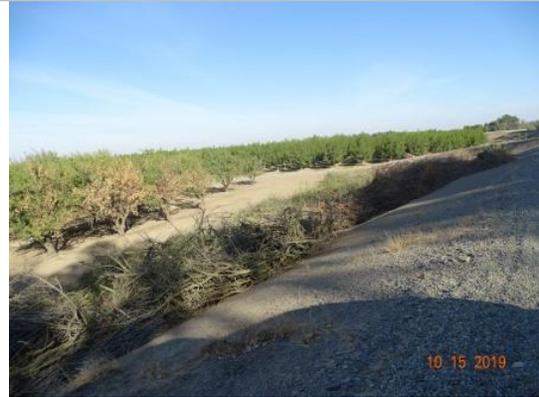
Photo 1 of 1 : FA\_2019\_MA0001\_297\_115\_20191017\_00151.jpg

View of the prunings along the landside slope and toe. Fall 2019.

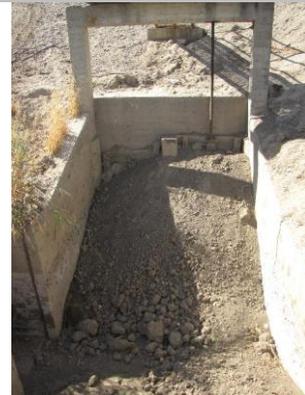
Photo 3 of 3 : UCIP\_FA\_2019\_51875\_70190.jpg

View of crossing from WS side. WS blocked by sediment. 2 slide gates part of structure design.

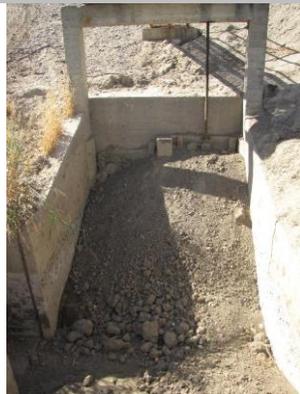
Photo 3 of 3 : UCIP\_FA\_2019\_51876\_70196.jpg

View of crossing from WS. WS blocked by sediment. 2 slide gates part of structure design.

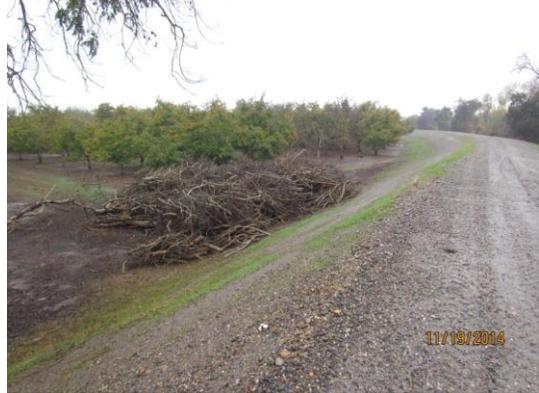
Photo 1 of 2 : FA\_2019\_MA0001\_297\_636\_20190822\_00039.jpg

View of the pruning along the landside toe.

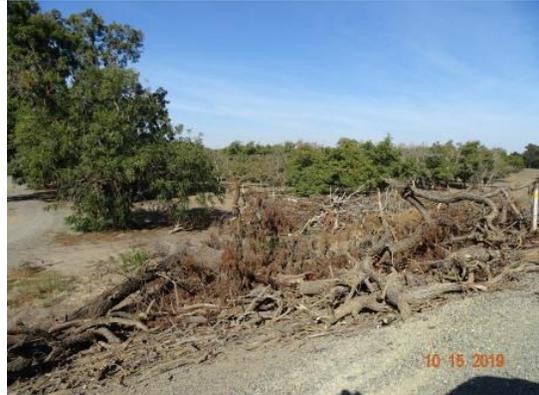
Photo 2 of 2 : FA\_2019\_MA0001\_297\_636\_20191017\_00152.jpg

View of a large fallen tree and prunings on the landside slope. Fall 2019.

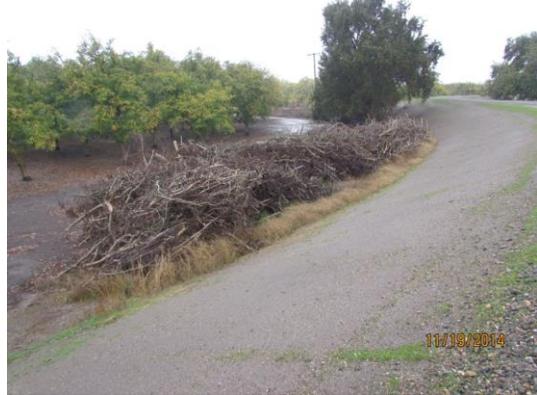
Photo 1 of 1 : FA\_2019\_MA0001\_297\_638\_20190822\_00041.jpg

View of the pruning along the landside toe.

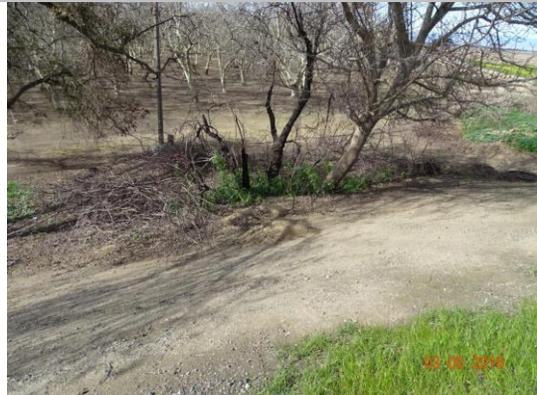
Photo 1 of 1 : FA\_2019\_MA0001\_297\_69\_20190822\_00014.jpg

View of the rodent holes along the landside slope.

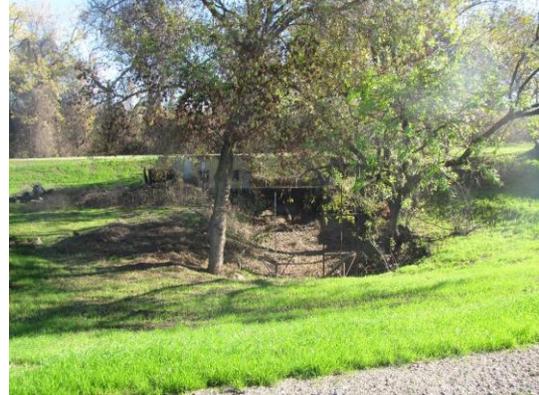
Photo 2 of 3 : UCIP\_FA\_2019\_53053\_70265.jpg

View of abandoned structure located on WS (inside ring levee).

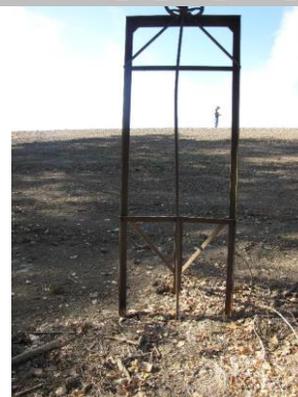
Photo 2 of 2 : UCIP\_FA\_2019\_51910\_70380.jpg

WS-Slide gate buried-non-functional.

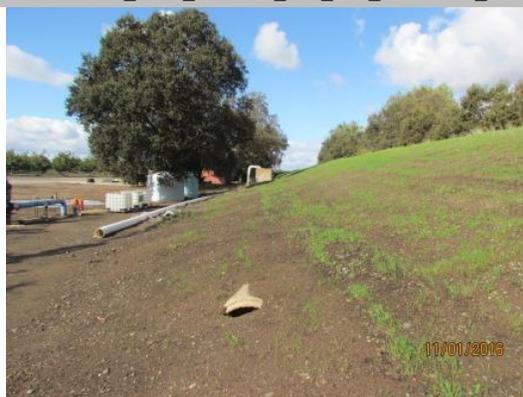
Photo 1 of 1 : FA\_2019\_MA0001\_297\_128\_20190822\_00035.jpg

View of a concrete pipe that runs along the levee toe.

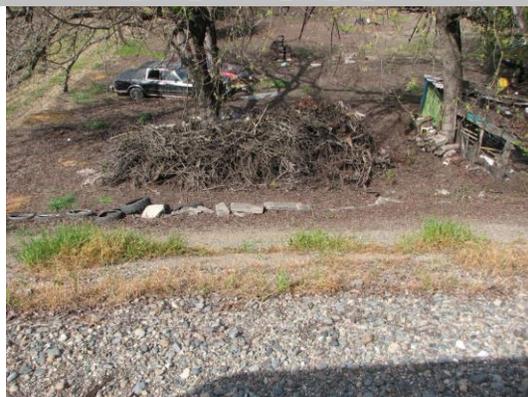
Photo 1 of 1 : FA\_2019\_MA0001\_297\_85\_20190822\_00020.jpg

View of prunings, concrete, and tires along the toe.

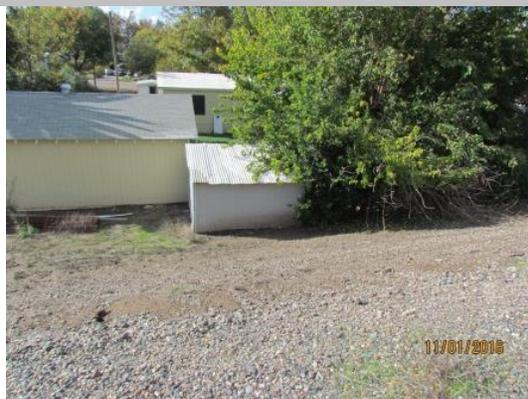
Photo 1 of 1 : FA\_2019\_MA0001\_297\_87\_20190822\_00022.jpg

View of a shed along the landside toe.

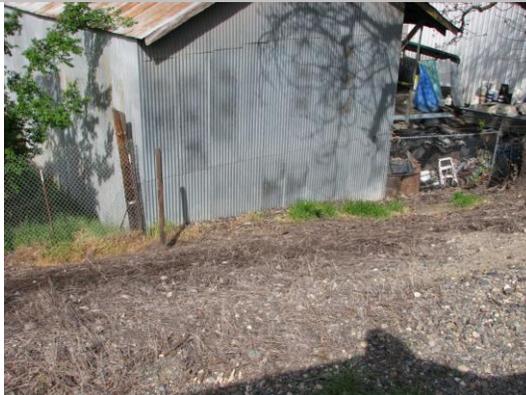
Photo 1 of 1 : FA\_2019\_MA0001\_297\_90\_20190822\_00024.jpg

View of a corrugated metal building obstructing visibility and access.

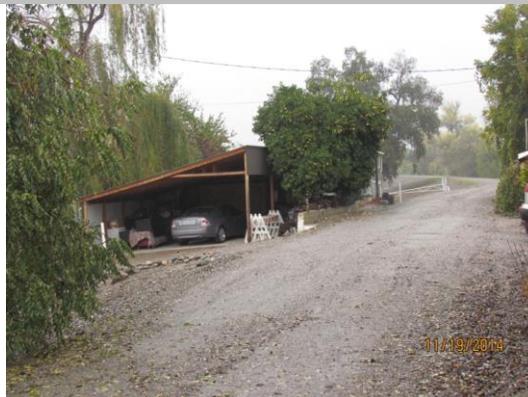
Photo 1 of 1 : FA\_2019\_MA0001\_297\_26\_20190822\_00010.jpg

View of the building on the landside slope.

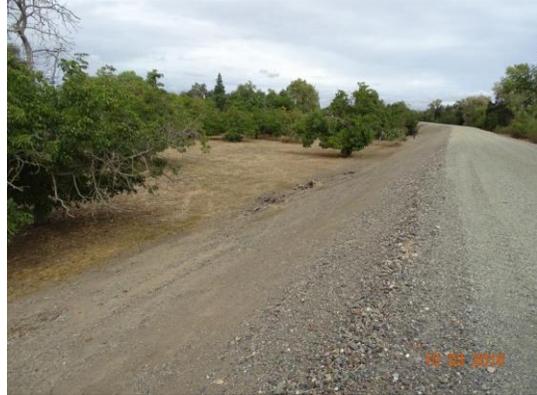
Photo 1 of 1 : FA\_2019\_MA0001\_297\_71\_20190822\_00015.jpg

View of the rodent holes along the landside slope.

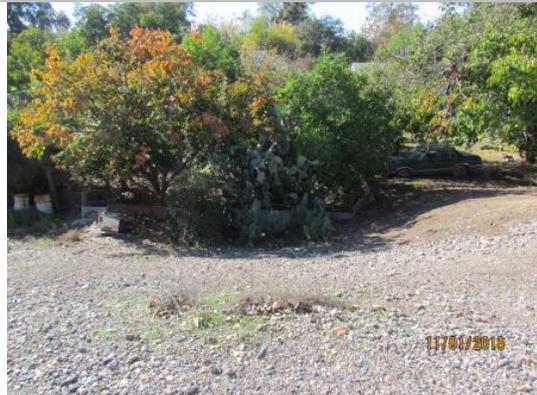
Photo 1 of 1 : FA\_2019\_MA0001\_297\_134\_20190822\_00037.jpg

View of cactus and fruit trees along the landside toe blocking visibility.

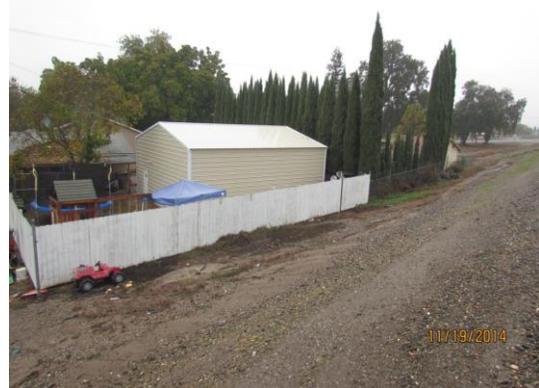
Photo 1 of 1 : FA\_2019\_MA0001\_297\_47\_20190822\_00012.jpg

View of the fence along the landside toe.

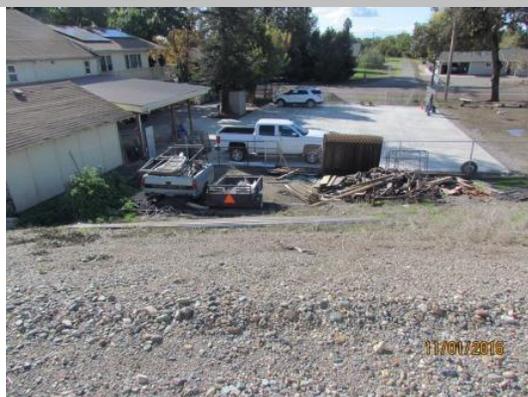
Photo 1 of 1 : FA\_2019\_MA0001\_297\_135\_20190822\_00038.jpg

View of metal sheets along the levee slope and debris and firewood along the landside toe.
