**Flood Control Project Maintenance  
Levee Inspections**

**Fall 2019 Levee Maintenance Deficiency Summary Report**

**Sutter Maintenance Yard Maintenance Area 0003**

**Levee Inspection Report By Mile - Fall 2019**

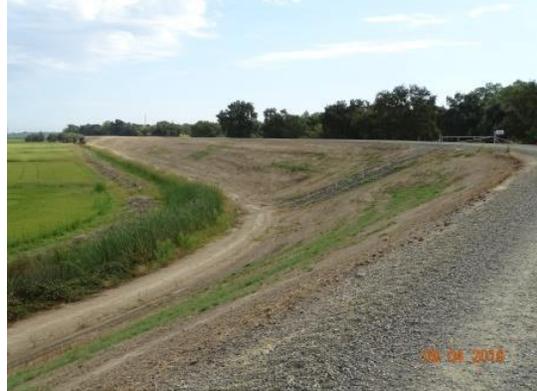
Photo 1 of 1 : FA\_2019\_MA0003\_195\_11\_20190912\_00020.jpg

LM Start	<b>0.01</b>	Rating **	A	Issue No.	<b>11</b>
LM End	<b>4.11</b>	Issue Type +	Ma	Location *	LS
Category	Earthen Levee			GPS Latitude/Longitude	
				Start	End
Item	Vegetation			38.897889°	38.936840°
				-121.617985°	-121.589000°
DWR ID	DWR_MA0003_01_f_2019_11				
Comment Code					
V1 : Control annual grass and weeds on the levee slopes and easements.					
Inspector Comment					
The annual vegetation is well maintained, Fall 2019.

View looking upstream landside at the well maintained vegetation, Fall 2019.

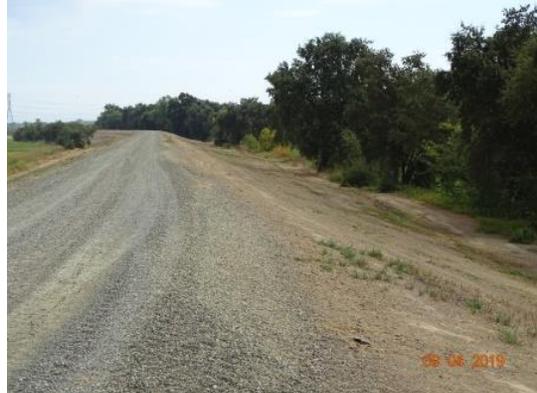
Photo 1 of 1 : FA\_2019\_MA0003\_195\_12\_20190912\_00021.jpg

LM Start	<b>0.01</b>	Rating **	A	Issue No.	<b>12</b>
LM End	<b>4.11</b>	Issue Type +	Ma	Location *	WS
Category	Earthen Levee			GPS Latitude/Longitude	
				Start	End
Item	Vegetation			38.897889°	38.936840°
				-121.617985°	-121.589000°
DWR ID	DWR_MA0003_01_f_2019_12				
Comment Code					
V1 : Control annual grass and weeds on the levee slopes and easements.					
Inspector Comment					
The annual vegetation is well maintained, Fall 2019.

View looking upstream waterside at the well maintained vegetation, Fall 2019.

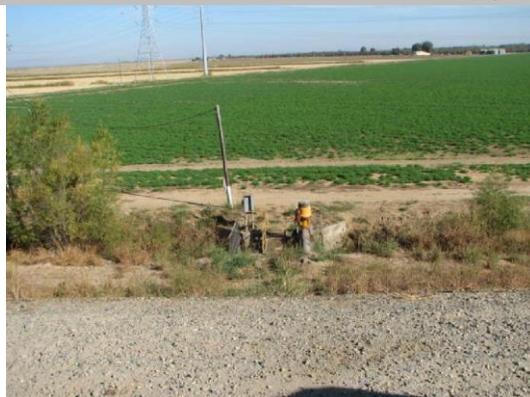
Photo 1 of 3 : UCIP\_FA\_2019\_54171\_64649.jpg

DS\_ID:17092  
 FS\_ID:54171  
 EP\_NO: N/A  
 Repair Type: Urgent  
 Crossing Status: Found  
 UCIP Comments: 05/01/2019 Same as last inspection, record remains Urgent due to the potential of levee integrity issues on the LS. Dense vegetation on both the WS and LS limits the inspection to determine if sink hole or erosion behind headwall on LS has progressed. No permit has been identified for this structure. Structure has been abandoned. (O. Magana - DWR UCIP)10/04/2018 Sink hole observed between the dual 18-inch pipes located on the LS near the concrete headwall. Erosion was also observed behind the concrete headwall located on the LS. Inlet of dual 18-inch pipes was still covered by filled sandbags. Crossing remains Urgent due to the sink hole and erosion visible on the LS. These crossings were recommended for replacement under the SBFCA project; however, no work has been done to date. Recommend monitoring site and coordinating with SBFCA to determine the status of the project. (O. Magana - DWR UCIP)

04/11/2017 Water levels were high on WS during inspection so pipe ends could not be inspected. Believe that the sandbags are still in place and condition of flap gates is unknown. (DWR Sutter Yard - AFreitag)10/10/2016 WS pipe end was underwater for inspection but the sandbags still appear to be in place. (DWR Sutter Yard - afreitag)04/18/2016 No repairs have been made to the pipe yet. (DWR Sutter Yard - afreitag)05/12/2015 Water level high in WS ditch so could not see WS end of crossing. Do not believe that repairs have been made yet. (DWR Sutter Yard - afreitag)11/17/2014 Same as last inspection. (DWR Sutter Yard - afreitag)05/14/2014 Same as last inspection. (DWR Sutter Yard - afreitag)10/30/2013 Same as last inspection. (DWR Sutter Yard - afreitag)05/21/2013 SBFCA project recommends replacing in accordance with title 23. High water levels in WS ditch have pipe ends underwater but repairs have not yet been completed but are planned for when water levels drop. (DWR Sutter Yard - afreitag)10/10/2012 Flap gates not visible on waterward headwall and it appears as though they have been replaced by sandbags. Slide gates on LS appear to be closed yet water leaks excessively from the WS at the sandbagged headwall. (DWR UCIP - W. Wylie)

FIELD\_STRUCT\_DESC: 1 of 2: 18-inch steel drainage pipe through the levee, 32 feet below the crown. Flap gate on the waterside (WS) end. Slide gate on the landside (LS) end at concrete headwall. Concrete "U" shaped headwall at the WS toe. [Additional Reference(s): DWR Levee Log, 2005. USACE Sacramento O&M Manual 143, August 1955, (Station 982+00)].  
 FS Date: 5/1/2019 2:50:00 PM

Concrete headwall with walkway and slide gates at LS toe.

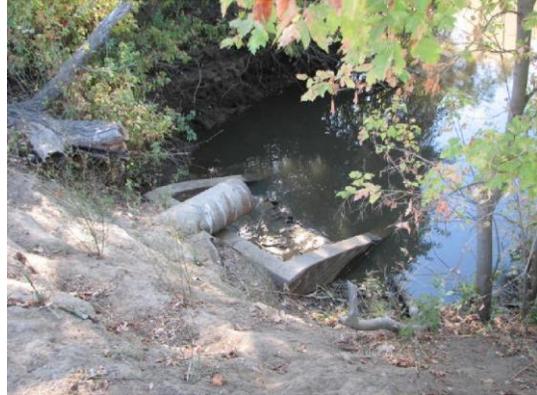
Photo 2 of 3 : UCIP\_FA\_2019\_54171\_64648.jpg

Comment Code					
Inspector Comment					
<p>DS_ID:17092 FS_ID:54171 EP_NO: N/A Repair Type: Urgent Crossing Status: Found UCIP Comments: 05/01/2019 Same as last inspection, record remains Urgent due to the potential of levee integrity issues on the LS. Dense vegetation on both the WS and LS limits the inspection to determine if sink hole or erosion behind headwall on LS has progressed. No permit has been identified for this structure. Structure has been abandoned. (O. Magana - DWR UCIP)10/04/2018 Sink hole observed between the dual 18-inch pipes located on the LS near the concrete headwall. Erosion was also observed behind the concrete headwall located on the LS. Inlet of dual 18-inch pipes was still covered by filled sandbags. Crossing remains Urgent due to the sink hole and erosion visible on the LS. These crossings were recommended for replacement under the SBFCA project; however, no work has been done to date. Recommend monitoring site and coordinating with SBFCA to determine the status of the project. (O. Magana - DWR UCIP) 04/11/2017 Water levels were high on WS during inspection so pipe ends could not be inspected. Believe that the sandbags are still in place and condition of flap gates is unknown. (DWR Sutter Yard - AFreitag)10/10/2016 WS pipe end was underwater for inspection but the sandbags still appear to be in place. (DWR Sutter Yard - afreitag)04/18/2016 No repairs have been made to the pipe yet. (DWR Sutter Yard - afreitag)05/12/2015 Water level high in WS ditch so could not see WS end of crossing. Do not believe that repairs have been made yet. (DWR Sutter Yard - afreitag)11/17/2014 Same as last inspection. (DWR Sutter Yard - afreitag)05/14/2014 Same as last inspection. (DWR Sutter Yard - afreitag)10/30/2013 Same as last inspection. (DWR Sutter Yard - afreitag)05/21/2013 SBFCA project recommends replacing in accordance with title 23. High water levels in WS ditch have pipe ends underwater but repairs have not yet been completed but are planned for when water levels drop. (DWR Sutter Yard - afreitag)10/10/2012 Flap gates not visible on waterward headwall and it appears as though they have been replaced by sandbags. Slide gates on LS appear to be closed yet water leaks excessively from the WS at the sandbagged headwall. (DWR UCIP - W. Wylie) FIELD_STRUCT_DESC: 1 of 2: 18-inch steel drainage pipe through the levee, 32 feet below the crown. Flap gate on the waterside (WS) end. Slide gate on the landside (LS) end at concrete headwall. Concrete "U" shaped headwall at the WS toe. [Additional Reference(s): DWR Levee Log, 2005. USACE Sacramento O&amp;M Manual 143, August 1955, (Station 982+00)]. FS Date: 5/1/2019 2:50:00 PM</p>

Concrete U shaped headwall on WS toe filled in with Sandbags. 16-inch pipe shown over top of headwall.

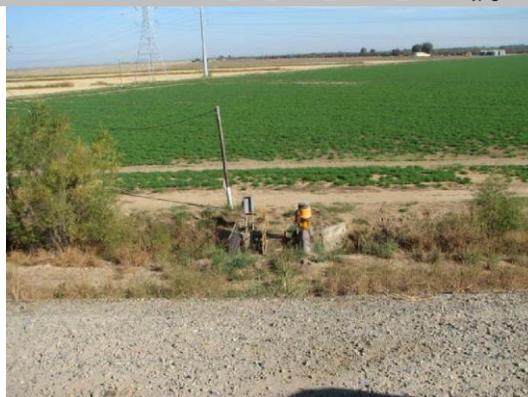
Photo 1 of 3 : UCIP\_FA\_2019\_56067\_64662.jpg

DS\_ID:17136  
FS\_ID:56067  
EP\_NO: N/A  
Repair Type: Urgent  
Crossing Status: Found  
UCIP Comments: 05/01/2019 Same as last inspection, record remains Urgent due to the potential of levee integrity issues on the LS. Dense vegetation on both the WS and LS limits the inspection to determine if sink hole or erosion behind headwall on LS has progressed. No permit has been identified for this structure. Structure has been abandoned. (O. Magana - DWR UCIP)10/04/2018 Sink hole observed between the dual 18-inch pipes located on the LS near the concrete headwall. Erosion was also observed behind the concrete headwall located on the LS. Inlet of dual 18-inch pipes was still covered by filled sandbags. Crossing remains Urgent due to the sink hole and erosion visible on the LS. These crossings were recommended for replacement under the SBFCA project; however, no work has been done to date. Recommend monitoring site and coordinating with SBFCA to determine the status of the project. (O. Magana - DWR UCIP)

04/11/2017 Water levels were high on WS during inspection so pipe ends could not be inspected. Believe that the sandbags are still in place and condition of flap gates is unknown. (DWR Sutter Yard - AFreitag)10/10/2016 WS pipe end was underwater for the inspection but the sandbags appear to still be in place. (DWR Sutter Yard - afreitag)04/18/2016 No repairs have been made to the pipe yet. (DWR Sutter Yard - afreitag)05/12/2015 Water level high in WS ditch so could not see WS end of crossing. Do not believe that repairs have been made yet. (DWR Sutter Yard - afreitag)11/17/2014 Same as last inspection. (DWR Sutter Yard - afreitag)05/14/2014 Same as last inspection. (DWR Sutter Yard - afreitag)10/30/2013 Same as last inspection. (DWR Sutter Yard - afreitag)05/21/2013 SBFCA project recommends replacing in accordance with title 23. High water levels in WS ditch have pipe ends underwater but repairs have not yet been completed but are planned for when water levels drop. (DWR Sutter Yard - afreitag)10/10/2012 Flap gates not visible on waterward headwall and it appears as though they have been replaced by sandbags. Slide gates on LS appear to be closed yet water leaks excessively from the WS at the sandbagged headwall. (DWR UCIP - W. Wylie)

FIELD\_STRUCT\_DESC: 2 of 2: 18-inch steel drainage pipe through the levee, 32 feet below the crown. Flap gate on the waterside (WS) end. Slide gate on the landside (LS) end at concrete headwall. Concrete "U" headwall at the WS toe. [Additional Reference(s): DWR Levee Log, 2005. USACE Sacramento O&M Manual 143, August 1955, (Station 982+00)].  
FS Date: 5/1/2019 2:51:00 PM

Concrete headwall, slidegates, and metal walkway on LS toe.

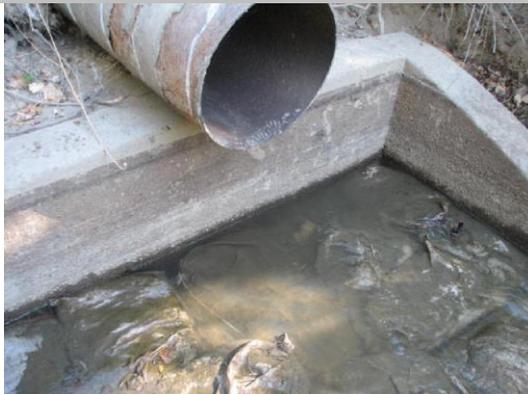
Photo 3 of 3 : UCIP\_FA\_2019\_56067\_64660.jpg

Item	DRAFT DWR UCIP LMA Responsibility			38.903264 °	38.903264 °
				-121.605698 °	-121.605698 °
DWR ID	17136				
Comment Code					
Inspector Comment					
<p>DS_ID:17136                  FS_ID:56067                  EP_NO: N/A                  Repair Type: Urgent                  Crossing Status: Found                  UCIP Comments: 05/01/2019 Same as last inspection, record remains Urgent due to the potential of levee integrity issues on the LS. Dense vegetation on both the WS and LS limits the inspection to determine if sink hole or erosion behind headwall on LS has progressed. No permit has been identified for this structure. Structure has been abandoned. (O. Magana - DWR UCIP)10/04/2018 Sink hole observed between the dual 18-inch pipes located on the LS near the concrete headwall. Erosion was also observed behind the concrete headwall located on the LS. Inlet of dual 18-inch pipes was still covered by filled sandbags. Crossing remains Urgent due to the sink hole and erosion visible on the LS. These crossings were recommended for replacement under the SBFCA project; however, no work has been done to date. Recommend monitoring site and coordinating with SBFCA to determine the status of the project. (O. Magana - DWR UCIP)                  04/11/2017 Water levels were high on WS during inspection so pipe ends could not be inspected. Believe that the sandbags are still in place and condition of flap gates is unknown. (DWR Sutter Yard - AFreitag)10/10/2016 WS pipe end was underwater for the inspection but the sandbags appear to still be in place. (DWR Sutter Yard - afreitag)04/18/2016 No repairs have been made to the pipe yet. (DWR Sutter Yard - afreitag)05/12/2015 Water level high in WS ditch so could not see WS end of crossing. Do not believe that repairs have been made yet. (DWR Sutter Yard - afreitag)11/17/2014 Same as last inspection. (DWR Sutter Yard - afreitag)05/14/2014 Same as last inspection. (DWR Sutter Yard - afreitag)10/30/2013 Same as last inspection. (DWR Sutter Yard - afreitag)05/21/2013 SBFCA project recommends replacing in accordance with title 23. High water levels in WS ditch have pipe ends underwater but repairs have not yet been completed but are planned for when water levels drop. (DWR Sutter Yard - afreitag)10/10/2012 Flap gates not visible on waterward headwall and it appears as though they have been replaced by sandbags. Slide gates on LS appear to be closed yet water leaks excessively from the WS at the sandbagged headwall. (DWR UCIP - W. Wylie)                  FIELD_STRUCT_DESC: 2 of 2: 18-inch steel drainage pipe through the levee, 32 feet below the crown. Flap gate on the waterside (WS) end. Slide gate on the landside (LS) end at concrete headwall. Concrete "U" headwall at the WS toe. [Additional Reference(s): DWR Levee Log, 2005. USACE Sacramento O&amp;M Manual 143, August 1955, (Station 982+00)].                  FS Date: 5/1/2019 2:51:00 PM</p>

Flap gates appear to be missing from U shaped headwall. Sandbags fill headwall but water flows heavily from LS.

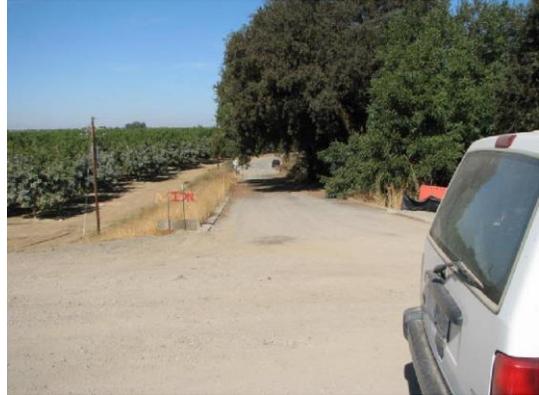
Photo 1 of 3 : UCIP\_FA\_2019\_54174\_64665.jpg

Item	DRAFT DWR UCIP Field Study			38.907744 °	38.907744 °
				-121.589344 °	-121.589344 °
DWR ID	17090				
Comment Code					
Inspector Comment					
<p>DS_ID:17090                  FS_ID:54174                  EP_NO: 3511                  Repair Type: Non-Urgent                  Crossing Status: Not Found                  UCIP Comments: 05/01/2019 Record has been updated from No Action Needed to Non-Urgent due to the unknown status of the crossing through the levee. Permit recordation indicates line was not abandoned as of 5-30-1974 (page 3 of 98) notes indicated the following: "App #3511 Comm Cable is in use and not abandoned". However, page 4 of 98, permit records indicate the Board approved abandonment of line and asked the owner to meet certain conditions to properly abandon line. (O. Magana - DWR UCIP)04/11/2017 Unable to locate. (DWR Sutter Yard- AFreitag)10/10/2016 Unable to locate.(DWR Sutter Yard - afreitag)04/18/2016 Unable to locate.05/12/2015 Unable to locate.11/17/2014 Same as last inspection.05/14/2014 Same as last inspection.05/21/2013 SBFCA report claims cable may meet title 23 requirements but will need to be removed for cutoff wall construction and replaced in accordance of title 23. Could not find any signs of crossing.10/30/2013 Same as last inspection.10/10/2012 Unable to locate any indication that crossing exists at old Nicolaus bridge. (DWR UCIP - W. Wylie)                  FIELD_STRUCT_DESC: USA communication cable of an unknown size or material through the levee, 3 feet below the crown. (underground cable authorized under Permit No. 3511, 1961 - U.S. Army Engineer District; ). [Additional Reference(s): DWR Levee Log, 2005].                  FS Date: 5/1/2019 2:52:00 PM</p>

Old nicolaus bridge location. No indication of crossing.

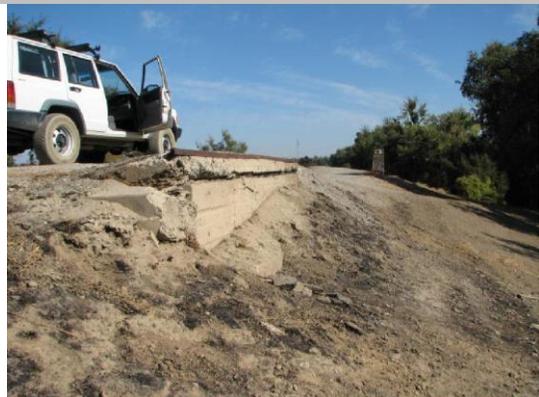
Photo 2 of 3 : UCIP\_FA\_2019\_54174\_64664.jpg

Old nicolaus bridge location. No indication of crossing.

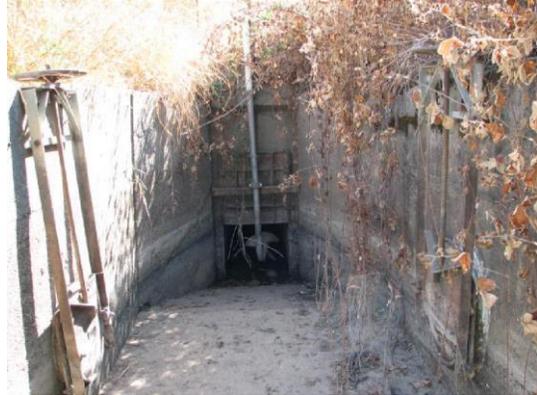
Photo 1 of 3 : UCIP\_FA\_2019\_54185\_64668.jpg

DS\_ID:17088  
FS\_ID:54185  
EP\_NO: 3284  
Repair Type: Urgent  
Crossing Status: Found  
UCIP Comments: 06/14/2019 Record remains Urgent due to the integrity issues identified during the Aug 2018 internal inspection completed by Odysseus Farms Hamatani. Received PL 84-99 Emergency Levee Repairs Site 0521-41 Plans, from J. Peterson with the CVFPB Enforcement Section, documenting proposed culvert removal and new pipe installation system through levee. Emergency Levee Repairs at this location are expected to start 2020. LMA should be monitoring this site until emergency levee repairs are completed. If any issues arise please contact J. Peterson (Jenna.Peterson@cvflood.ca.gov) with the CVFPB Enforcement Section. Pipe is being tracked under CVFPB Enforcement Case No. 14794. (O. Magana - DWR UCIP)  
05/01/2019 Same as October 2018 inspection. LS ditch filled with water and unable to access LS outlet. As of March 2019, this crossing is under investigation by the CVFPB under CVFPB Enforcement Case No. 14794. (O. Magana - DWR UCIP)01/16/2019 The following DSIDs, 17089 and 17134, are considered duplicate entries for DSID 17088. DWR Levee Log and USACE O&M manual reference 24-inch concrete culvert through levee, permit records indicate 32-inch concrete culvert through levee. Need to measure concrete box through levee to confirm culvert size. Concrete culvert through the levee was referenced in permit records as existing structure (32-inch culvert) back in 1960 under Permit No. 3284. (O. Magana - DWR UCIP)

10/04/2018 Cavity filled with rock is still intact. Unable to determine cause of cavity collapse. Photos taken from LS show some sediment buildup inside concrete culvert. The pipe is a straight through culvert that goes through a tall levee (about 25 feet tall). Recommend internal inspection to determine integrity condition of culvert through the levee. Crossing remains Urgent due to the cavity collapse observed during 2017 (unknown cause of failure) and the unknown condition of the culvert through the levee. Erosion and potential sink holes visible behind concrete box on the WS toe. (O. Magana - DWR UCIP)  
4/11/2017 There was a cavity collapse above the pipe alignment on the WS slope during January 2017 high water event. Cavity was filled with rock to prevent further levee damage during the high water season. Further inspection will be needed on this crossing to determine the cause of the collapse. Recommend having an internal camera inspection done. Erosion happening around the WS concrete vault. (DWR Sutter Yard- AFreitag)10/10/2016 LS pipe end was mostly submerged so could not verify the connectivity between the LS headwall and WS vault. Blackberries and still overgrown on WS.(DWR Sutter Yard - afreitag)4/18/2016 WS vault is being overgrown with

32X32 box culvert on LS toe in Concrete U shaped channel with slide gate.

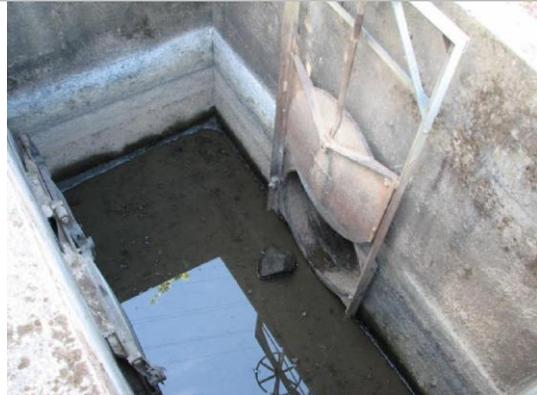
Photo 2 of 3 : UCIP\_FA\_2019\_54185\_64667.jpg

blackberries. They should be sprayed and cleared back. No other problems were noticeable with this crossing.05/12/2015 Only the right flap gate appeared to be abandoned. The left and middle flap gates were flowing water during the last inspection.11/17/2014 Same as last inspection.05/14/2014 Same as last inspection.10/30/2013 Same as last inspection.05/21/2013 Pumping plant was running and filling concrete vault on WS toe through the left flap gate and then flowing through levee pipe and filling irrigation ditch on LS. Left and middle flap gates appear to be connected to pumps and right gate appears abandoned. Recommend contacting owner to get more details.10/10/2012 Pumping plant has been disconnected from levee. Need to determine if abandonment is appropriate or if this is now a gravity drain with flap gate. (DWR UCIP - W. Wylie)  
FIELD\_STRUCT\_DESC: 32-inch by 32-inch reinforced concrete irrigation culvert through the levee, approximately 28 feet below the crown. Transition between vault on the waterside (WS) and box culvert within levee section is made with a 41-inch corrugated metal pipe (CMP). Slide gate located on the landside (LS) at concrete h

8-foot X 14-foot concrete box on WS toe with slide gate and 3 abandoned flap gates.

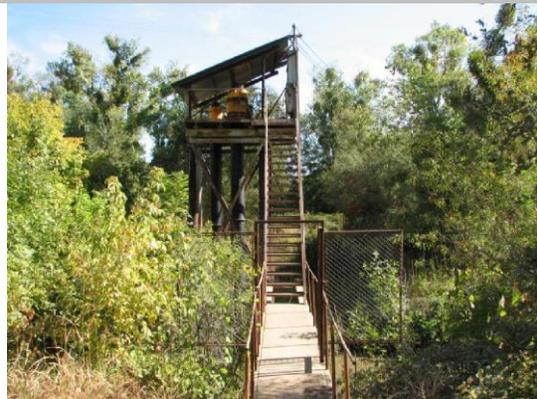
Photo 3 of 3 : UCIP\_FA\_2019\_54185\_64666.jpg

Pumping plant on WS toe at small slough. Pipes no longer connected to concrete box on WS toe.

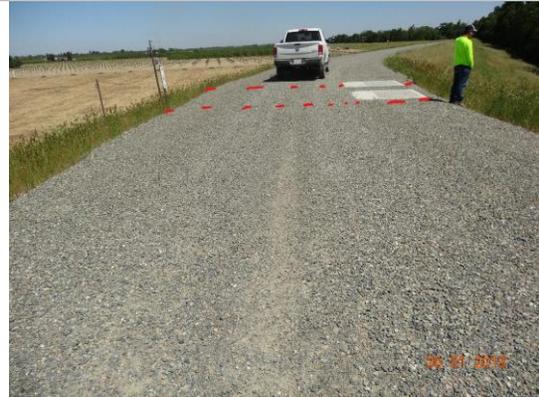
Photo 1 of 3 : UCIP\_FA\_2019\_54191\_79824.jpg

Item	DRAFT DWR UCIP Field Study			38.932512°	38.932512°
				-121.590987°	-121.590987°
DWR ID	17086				
Comment Code					
Inspector Comment					
<p>DS_ID:17086                  FS_ID:54191                  EP_NO: 769                  Repair Type: Non-Urgent                  Crossing Status: Not Found                  UCIP Comments: 05/01/2019 Record has been updated from No Action Needed to Non-Urgent due to the modifications made to this crossing. This section of the levee has been upgraded under a levee improvement project however, no records have been received to confirm project or extent of project. Need to contact owner to determine extent of work done through this section of the levee. No records were found to authorize the work through this section of the levee. Need to confirm if this crossing is a new encroachment or if crossing is the existing 10-inch pipe. Levee Mile and coordinates were updated from CLM 3.785 (38.932602, -121.590933) to 3.778 (38.932512, -121.590987). If crossing is not abandoned record will need to be updated to show active line. (O. Magana - DWR UCIP)04/11/2017 Unable to locate. (DWR Sutter Yard- AFreitag)10/10/2016 Unable to locate.(DWR Sutter Yard - afreitag)04/18/2016 Unable to locate.05/12/2015 Unable to locate.11/17/2014 Same as last inspection.05/14/2014 Same as last inspection.10/30/2013 Same as last inspection.05/21/2013 Could not locate any signs of crossing.10/10/2012 Unable to locate. (DWR UCIP - W. Wylie) FIELD_STRUCT_DESC: *ABANDONED* 10-inch steel pipe through the levee, 5.4 feet below the crown. Siphon breaker located on the landside (LS). Pipe appears to be abandoned (recorded in 2005 or earlier). (10-inch pipe authorized under Permit No. 769, 1938 - Garden Highway Mutual Water Co.) [Additional Reference(s): DWR Levee Log, 2005].                  FS Date: 5/1/2019 2:56:00 PM</p>

Overview of levee crown looking upstream at pipe crossings.

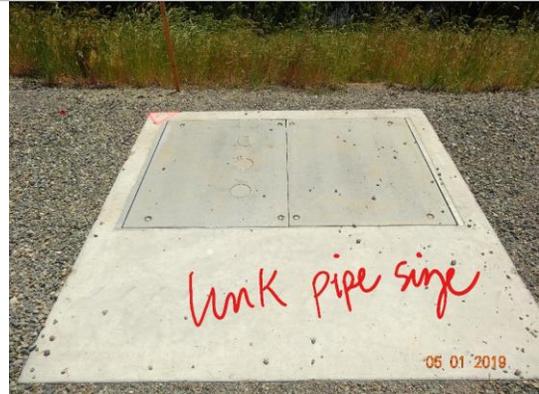
Photo 2 of 3 : UCIP\_FA\_2019\_54191\_79825.jpg

Item	DRAFT DWR UCIP Field Study			38.932512°	38.932512°
				-121.590987°	-121.590987°
DWR ID	17086				
Comment Code					
Inspector Comment					
DS_ID:17086 FS_ID:54191 EP_NO: 769 Repair Type: Non-Urgent Crossing Status: Not Found UCIP Comments: 05/01/2019 Record has been updated from No Action Needed to Non-Urgent due to the modifications made to this crossing. This section of the levee has been upgraded under a levee improvement project however, no records have been received to confirm project or extent of project. Need to contact owner to determine extent of work done through this section of the levee. No records were found to authorize the work through this section of the levee. Need to confirm if this crossing is a new encroachment or if crossing is the existing 10-inch pipe. Levee Mile and coordinates were updated from CLM 3.785 (38.932602, -121.590933) to 3.778 (38.932512, -121.590987). If crossing is not abandoned record will need to be updated to show active line. (O. Magana - DWR UCIP)04/11/2017 Unable to locate. (DWR Sutter Yard- AFreitag)10/10/2016 Unable to locate.(DWR Sutter Yard - afreitag)04/18/2016 Unable to locate.05/12/2015 Unable to locate.11/17/2014 Same as last inspection.05/14/2014 Same as last inspection.10/30/2013 Same as last inspection.05/21/2013 Could not locate any signs of crossing.10/10/2012 Unable to locate. (DWR UCIP - W. Wylie) FIELD_STRUCT_DESC: *ABANDONED* 10-inch steel pipe through the levee, 5.4 feet below the crown. Siphon breaker located on the landside (LS). Pipe appears to be abandoned (recorded in 2005 or earlier). (10-inch pipe authorized under Permit No. 769, 1938 - Garden Highway Mutual Water Co.) [Additional Reference(s): DWR Levee Log, 2005]. FS Date: 5/1/2019 2:56:00 PM

WS view: concrete vault located on levee crown. Unknown pipe size or purpose.

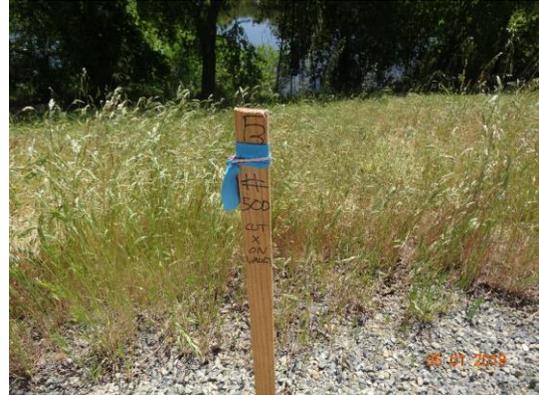
Photo 3 of 3 : UCIP\_FA\_2019\_54191\_79826.jpg

Item	DRAFT DWR UCIP Field Study			38.932512°	38.932512°
				-121.590987°	-121.590987°
DWR ID	17086				
Comment Code					
Inspector Comment					
DS_ID:17086 FS_ID:54191 EP_NO: 769 Repair Type: Non-Urgent Crossing Status: Not Found UCIP Comments: 05/01/2019 Record has been updated from No Action Needed to Non-Urgent due to the modifications made to this crossing. This section of the levee has been upgraded under a levee improvement project however, no records have been received to confirm project or extent of project. Need to contact owner to determine extent of work done through this section of the levee. No records were found to authorize the work through this section of the levee. Need to confirm if this crossing is a new encroachment or if crossing is the existing 10-inch pipe. Levee Mile and coordinates were updated from CLM 3.785 (38.932602, -121.590933) to 3.778 (38.932512, -121.590987). If crossing is not abandoned record will need to be updated to show active line. (O. Magana - DWR UCIP)04/11/2017 Unable to locate. (DWR Sutter Yard- AFreitag)10/10/2016 Unable to locate.(DWR Sutter Yard - afreitag)04/18/2016 Unable to locate.05/12/2015 Unable to locate.11/17/2014 Same as last inspection.05/14/2014 Same as last inspection.10/30/2013 Same as last inspection.05/21/2013 Could not locate any signs of crossing.10/10/2012 Unable to locate. (DWR UCIP - W. Wylie) FIELD_STRUCT_DESC: *ABANDONED* 10-inch steel pipe through the levee, 5.4 feet below the crown. Siphon breaker located on the landside (LS). Pipe appears to be abandoned (recorded in 2005 or earlier). (10-inch pipe authorized under Permit No. 769, 1938 - Garden Highway Mutual Water Co.) [Additional Reference(s): DWR Levee Log, 2005]. FS Date: 5/1/2019 2:56:00 PM

WS view: stake located on WS shoulder. Unable to determine if work is still pending.

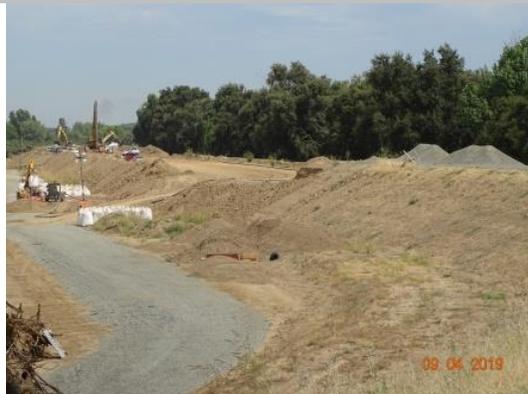
Photo 1 of 1 : FA\_2019\_MA0003\_195\_15\_20190912\_00024.jpg

LM Start	<b>4.11</b>	Rating **	A/W	Issue No.	<b>15</b>
LM End	<b>5.10</b>	Issue Type +	Ma	Location *	CR
Category	Earthen Levee			GPS Latitude/Longitude	
				Start	End
Item	Crown Surface / Depressions / Rutting			38.936840 °	38.950762 °
				-121.589000 °	-121.585810 °
DWR ID	DWR_MA0003_01_f_2019_15				
Comment Code					
C1 : Add appropriate material and re-grade the levee to bring the crown above the design elevation.					
Inspector Comment					
Under construction on this portion of levee, Fall 2019.

View looking upstream at the portion of levee that is under construction, Fall 2019.
