**Flood Control Project Maintenance
Levee Inspections**
LMA District Cover Sheet
Spring 2020 Levee Inspection Results

Sutter Maintenance Yard Maintenance Area 0003

Levee Inspection Report By Mile - Spring 2020

Waterway	Bank	Unit Miles	Inspection Start/End	Inspector
Unit No. 01 Feather River	Right	5.11	03/18/2020 03/18/2020	Sterling York

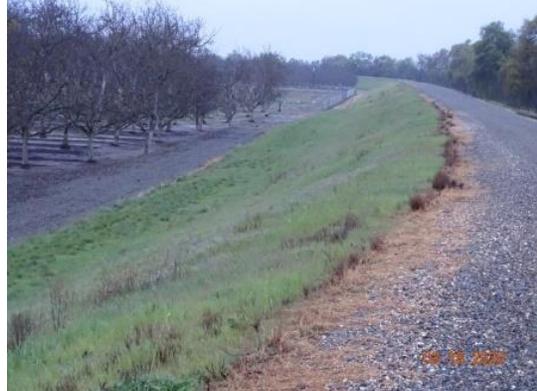
Photo 1 of 1 : SP_2020_MA0003_195_12_20200327_00024.jpg

LM Start	0.01	Rating **	A	Issue No.	12
LM End	3.99	Issue Type +	Ma	Location *	LS
Category	Earthen Levee		GPS Latitude/Longitude		
			Start	End	
Item	Vegetation		38.898005 °	38.935226 °	
			-121.617932 °	-121.589146 °	
DWR ID	DWR_MA0003_01_s_2020_12				
Comment Code					
V1 : Control annual grass and weeds on the levee slopes and easements.					
Inspector Comment					
The annual vegetation is well maintained, Spring 2020.

View looking upstream landside at the well maintained annual vegetation, Spring 2020.

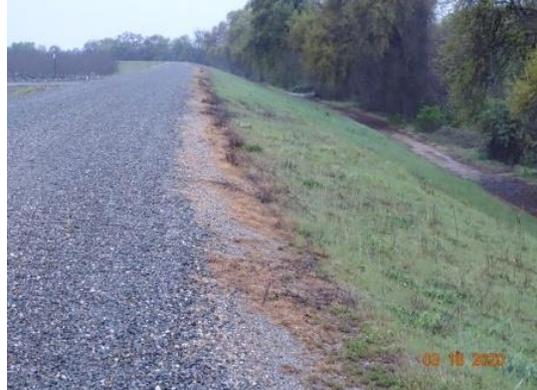
Photo 1 of 1 : SP_2020_MA0003_195_17_20200327_00025.jpg

LM Start	0.01	Rating **	A	Issue No.	17
LM End	3.99	Issue Type +	Ma	Location *	WS
Category	Earthen Levee		GPS Latitude/Longitude		
			Start	End	
Item	Vegetation		38.898006 °	38.935226 °	
			-121.617932 °	-121.589146 °	
DWR ID	DWR_MA0003_01_s_2020_17				
Comment Code					
V1 : Control annual grass and weeds on the levee slopes and easements.					
Inspector Comment

View looking upstream waterside at the well maintained annual vegetation, Spring 2020.

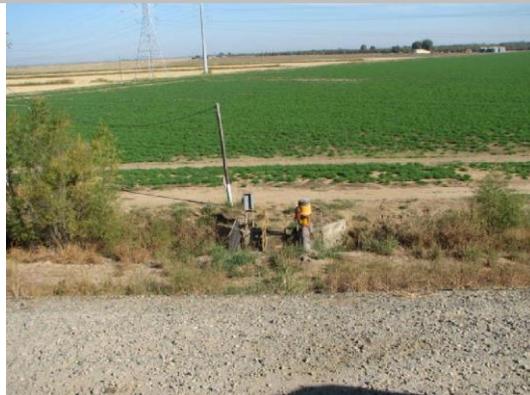
Photo 1 of 3 : UCIP_SP_2020_54171_64649.jpg

LM Start	0.81	Rating **	U	Issue No.	19
LM End	0.81	Issue Type +	Ma	Location *	
Category	Supplemental		GPS Latitude/Longitude		
			Start	End	
Item	DWR UCIP LMA Responsibility		38.903264 °	38.903264 °	
			-121.605698 °	-121.605698 °	
DWR ID	17092

DS_ID:17092
 FS_ID:54171
 EP_NO: N/A
 Repair Type: Urgent
 Crossing Status: Found
 UCIP Comments: 05/01/2019 Same as last inspection, record remains Urgent due to the potential of levee integrity issues on the LS. Dense vegetation on both the WS and LS limits the inspection to determine if sink hole or erosion behind headwall on LS has progressed. No permit has been identified for this structure. Structure has been abandoned. (O. Magana - DWR UCIP)10/04/2018 Sink hole observed between the dual 18-inch pipes located on the LS near the concrete headwall. Erosion was also observed behind the concrete headwall located on the LS. Inlet of dual 18-inch pipes was still covered by filled sandbags. Crossing remains Urgent due to the sink hole and erosion visible on the LS. These crossings were recommended for replacement under the SBFCA project; however, no work has been done to date. Recommend monitoring site and coordinating with SBFCA to determine the status of the project. (O. Magana - DWR UCIP)

04/11/2017 Water levels were high on WS during inspection so pipe ends could not be inspected. Believe that the sandbags are still in place and condition of flap gates is unknown. (DWR Sutter Yard - AFreitag)10/10/2016 WS pipe end was underwater for inspection but the sandbags still appear to be in place. (DWR Sutter Yard - afreitag)04/18/2016 No repairs have been made to the pipe yet. (DWR Sutter Yard - afreitag)05/12/2015 Water level high in WS ditch so could not see WS end of crossing. Do not believe that repairs have been made yet. (DWR Sutter Yard - afreitag)11/17/2014 Same as last inspection. (DWR Sutter Yard - afreitag)05/14/2014 Same as last inspection. (DWR Sutter Yard - afreitag)10/30/2013 Same as last inspection. (DWR Sutter Yard - afreitag)05/21/2013 SBFCA project recommends replacing in accordance with title 23. High water levels in WS ditch have pipe ends underwater but repairs have not yet been completed but are planned for when water levels drop. (DWR Sutter Yard - afreitag)10/10/2012 Flap gates not visible on waterward headwall and it appears as though they have been replaced by sandbags. Slide gates on LS appear to be closed yet water leaks excessively from the WS at the sandbagged headwall. (DWR UCIP - W. Wylie)

Concrete headwall with walkway and slide gates at LS toe.

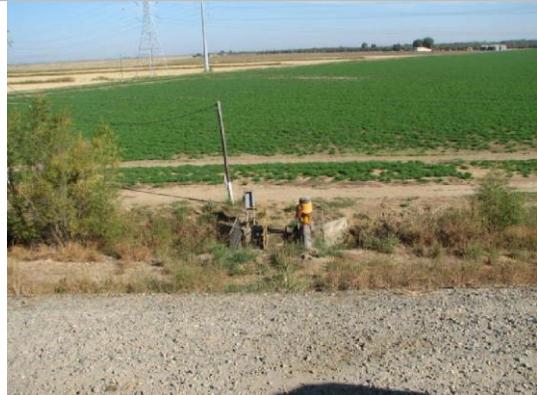
Photo 1 of 3 : UCIP_SP_2020_56067_64662.jpg

LM Start	0.81	Rating **	U	Issue No.	20
LM End	0.81	Issue Type +	Ma	Location *	
Category	Supplemental		GPS Latitude/Longitude		
			Start	End	
Item	DWR UCIP LMA Responsibility		38.903264 °	38.903264 °	
			-121.605698 °	-121.605698 °	
DWR ID	17136

DS_ID:17136
 FS_ID:56067
 EP_NO: N/A
 Repair Type: Urgent
 Crossing Status: Found
 UCIP Comments: 05/01/2019 Same as last inspection, record remains Urgent due to the potential of levee integrity issues on the LS. Dense vegetation on both the WS and LS limits the inspection to determine if sink hole or erosion behind headwall on LS has progressed. No permit has been identified for this structure. Structure has been abandoned. (O. Magana - DWR UCIP)10/04/2018 Sink hole observed between the dual 18-inch pipes located on the LS near the concrete headwall. Erosion was also observed behind the concrete headwall located on the LS. Inlet of dual 18-inch pipes was still covered by filled sandbags. Crossing remains Urgent due to the sink hole and erosion visible on the LS. These crossings were recommended for replacement under the SBFCA project; however, no work has been done to date. Recommend monitoring site and coordinating with SBFCA to determine the status of the project. (O. Magana - DWR UCIP)

04/11/2017 Water levels were high on WS during inspection so pipe ends could not be inspected. Believe that the sandbags are still in place and condition of flap gates is unknown. (DWR Sutter Yard - AFreitag)10/10/2016 WS pipe end was underwater for the inspection but the sandbags appear to still be in place. (DWR Sutter Yard - afreitag)04/18/2016 No repairs have been made to the pipe yet. (DWR Sutter Yard - afreitag)05/12/2015 Water level high in WS ditch so could not see WS end of crossing. Do not believe that repairs have been made yet. (DWR Sutter Yard - afreitag)11/17/2014 Same as last inspection. (DWR Sutter Yard - afreitag)05/14/2014 Same as last inspection. (DWR Sutter Yard - afreitag)10/30/2013 Same as last inspection. (DWR Sutter Yard - afreitag)05/21/2013 SBFCA project recommends replacing in accordance with title 23. High water levels in WS ditch have pipe ends underwater but repairs have not yet been completed but are planned for when water levels drop. (DWR Sutter Yard - afreitag)10/10/2012 Flap gates not visible on waterward headwall and it appears as though they have been replaced by sandbags. Slide gates on LS appear to be closed yet water leaks excessively from the WS at the sandbagged headwall. (DWR UCIP - W. Wylie)

Concrete headwall, slidegates, and metal walkway on LS toe.

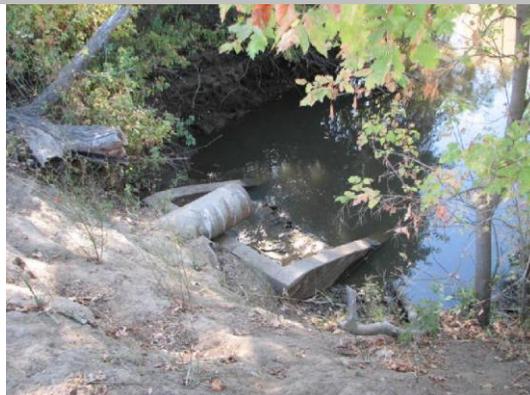
Photo 2 of 3 : UCIP_SP_2020_56067_64661.jpg

Concrete U shaped headwall on WS toe filled with sandbags.

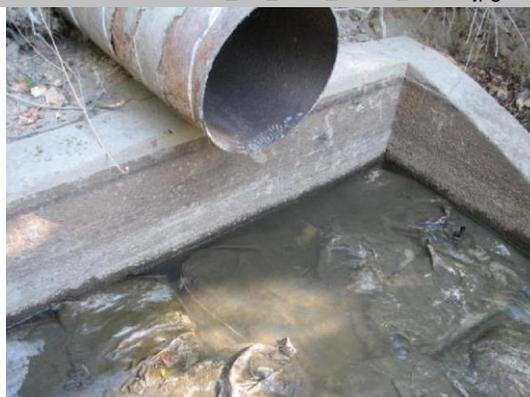
Photo 3 of 3 : UCIP_SP_2020_56067_64660.jpg

Flap gates appear to be missing from U shaped headwall. Sandbags fill headwall but water flows heavily from LS.

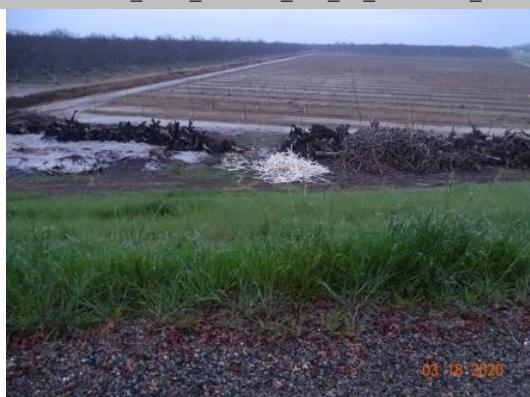
Photo 1 of 1 : SP_2020_MA0003_195_13_20200327_00022.jpg

LM Start	1.13	Rating **	M	Issue No.	13
LM End	1.13	Issue Type +	En	Location *	LS
Category	Earthen Levee			GPS Latitude/Longitude	
				Start	End
Item	Encroachments			38.901931 °	38.901931 °
				-121.599893 °	-121.599893 °
DWR ID	DWR_MA0003_01_f_2019_13				
Comment Code					
PR : Prunings					
Inspector Comment					
Remove prunings and irrigation pipe at the levee toe, Spring 2020.

View looking at landside of prunings and irrigation piping piled at the levee toe, Spring 2020.

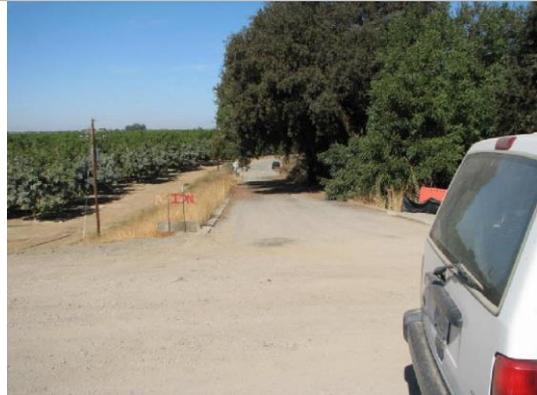
Photo 1 of 3 : UCIP_SP_2020_54174_64665.jpg

Comment Code					
Inspector Comment					
DS_ID:17090 FS_ID:54174 EP_NO: 3511 Repair Type: Non-Urgent Crossing Status: Not Found UCIP Comments: 05/01/2019 Record has been updated from No Action Needed to Non-Urgent due to the unknown status of the crossing through the levee. Permit recordation indicates line was not abandoned as of 5-30-1974 (page 3 of 98) notes indicated the following: "App #3511 Comm Cable is in use and not abandoned". However, page 4 of 98, permit records indicate the Board approved abandonment of line and asked the owner to meet certain conditions to properly abandon line. (O. Magana - DWR UCIP)04/11/2017 Unable to locate. (DWR Sutter Yard- AFreitag)10/10/2016 Unable to locate.(DWR Sutter Yard - afreitag)04/18/2016 Unable to locate.05/12/2015 Unable to locate.11/17/2014 Same as last inspection.05/14/2014 Same as last inspection.05/21/2013 SBFCA report claims cable may meet title 23 requirements but will need to be removed for cutoff wall construction and replaced in accordance of title 23. Could not find any signs of crossing.10/30/2013 Same as last inspection.10/10/2012 Unable to locate any indication that crossing exists at old Nicolaus bridge. (DWR UCIP - W. Wylie) FIELD_STRUCT_DESC: USA communication cable of an unknown size or material through the levee, 3 feet below the crown. (underground cable authorized under Permit No. 3511, 1961 - U.S. Army Engineer District). [Additional Reference(s): DWR Levee Log, 2005 (HLM 1.70)]. FS Date: 5/1/2019 2:52:00 PM

Old nicolaus bridge location. No indication of crossing.

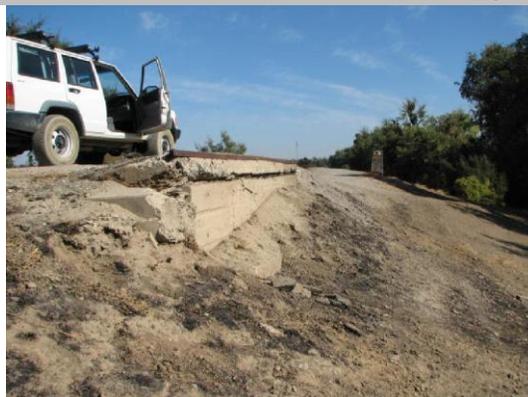
Photo 2 of 3 : UCIP_SP_2020_54174_64664.jpg

Old nicolaus bridge location. No indication of crossing.

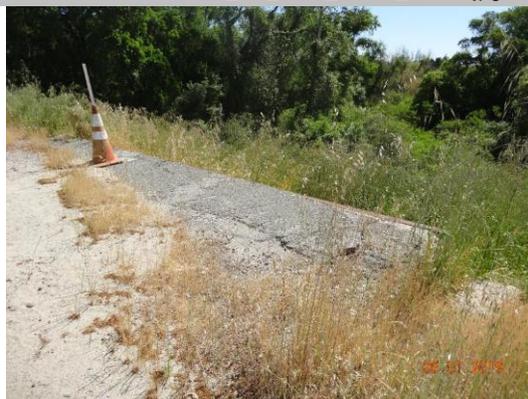
Photo 3 of 3 : UCIP_SP_2020_54174_79804.jpg

WS view: Old Nicolaus bridge location only concrete section remains. No evidence of communication line.

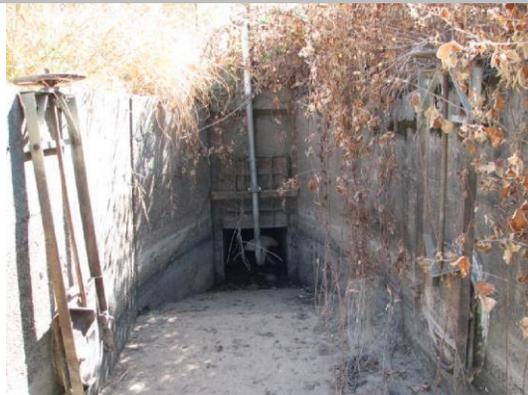
Photo 1 of 3 : UCIP_SP_2020_54185_64668.jpg

DS_ID:17088
 FS_ID:54185
 EP_NO: 3284
 Repair Type: Urgent
 Crossing Status: Found
 UCIP Comments: 06/14/2019 Record remains Urgent due to the integrity issues identified during the Aug 2018 internal inspection completed by Odysseus Farms Hamatani. Received PL 84-99 Emergency Levee Repairs Site 0521-41 Plans, from J. Peterson with the CVFPB Enforcement Section, documenting proposed culvert removal and new pipe installation system through levee. Emergency Levee Repairs at this location are expected to start 2020. LMA should be monitoring this site until emergency levee repairs are completed. If any issues arise please contact J. Peterson (Jenna.Peterson@cvflood.ca.gov) with the CVFPB Enforcement Section. Pipe is being tracked under CVFPB Enforcement Case No. 14794. (O. Magana - DWR UCIP)
 05/01/2019 Same as October 2018 inspection. LS ditch filled with water and unable to access LS outlet. As of March 2019, this crossing is under investigation by the CVFPB under CVFPB Enforcement Case No. 14794. (O. Magana - DWR UCIP)01/16/2019 The following DSIDs, 17089 and 17134, are considered duplicate entries for DSID 17088. DWR Levee Log and USACE O&M manual reference 24-inch concrete culvert through levee, permit records indicate 32-inch concrete culvert through levee. Need to measure concrete box through levee to confirm culvert size. Concrete culvert through the levee was referenced in permit records as existing structure (32-inch culvert) back in 1960 under Permit No. 3284. (O. Magana - DWR UCIP)

10/04/2018 Cavity filled with rock is still intact. Unable to determine cause of cavity collapse. Photos taken from LS show some sediment buildup inside concrete culvert. The pipe is a straight through culvert that goes through a tall levee (about 25 feet tall). Recommend internal inspection to determine integrity condition of culvert through the levee. Crossing remains Urgent due to the cavity collapse observed during 2017 (unknown cause of failure) and the unknown condition of the culvert through the levee. Erosion and potential sink holes visible behind concrete box on the WS toe. (O. Magana - DWR UCIP)
 4/11/2017 There was a cavity collapse above the pipe alignment on the WS slope during January 2017 high water event. Cavity was filled with rock to prevent further levee damage during the high water season. Further inspection will be needed on this crossing to determine the cause of the collapse. Recommend having an internal camera inspection done. Erosion happening around the WS concrete vault. (DWR Sutter Yard- A Freitag)10/10/2016 LS pipe end was mostly submerged so could not verify the connectivity between the LS headwall and WS vault. Blackberries and still overgrown on WS.(DWR Sutter Yard - a Freitag)4/18/2016 WS vault is being overgrown with

32X32 box culvert on LS toe in Concrete U shaped channel with slide gate.

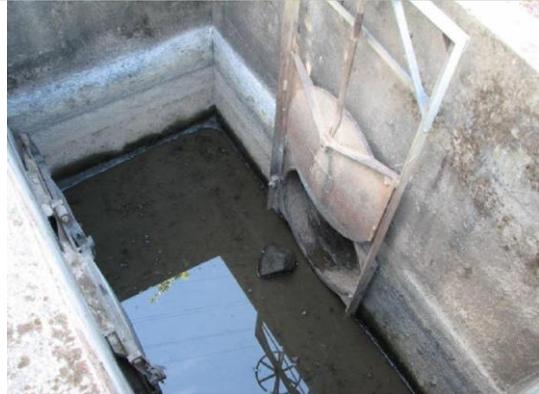
Photo 2 of 3 : UCIP_SP_2020_54185_64667.jpg

8-foot X 14-foot concrete box on WS toe with slide gate and 3 abandoned flap gates.

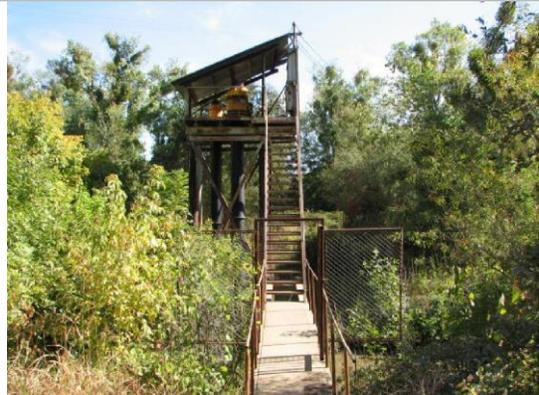
Photo 3 of 3 : UCIP_SP_2020_54185_64666.jpg

Pumping plant on WS toe at small slough. Pipes no longer connected to concrete box on WS toe.

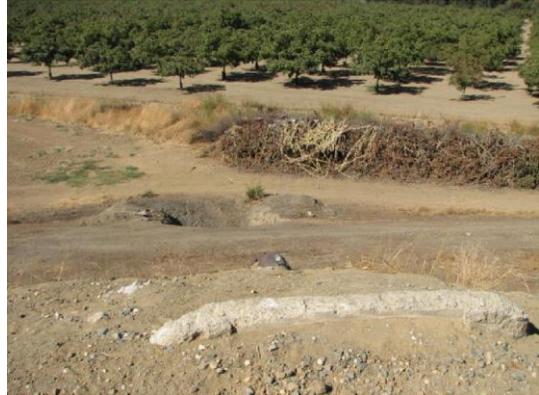
Photo 2 of 3 : UCIP_SP_2020_54190_64671.jpg

Pipe at LS shoulder showing exposed concrete cutoff wall.

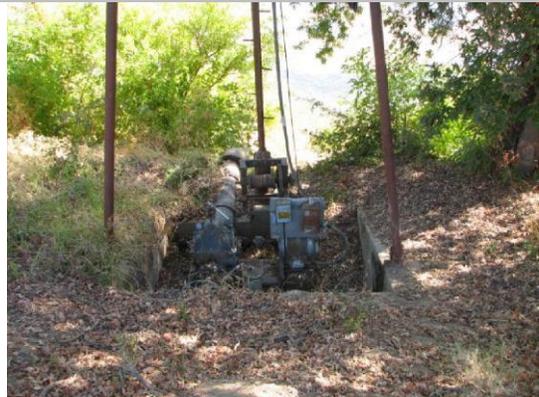
Photo 3 of 3 : UCIP_SP_2020_54190_64670.jpg

Pump at WS toe with tower over top and concrete U shaped headwall.

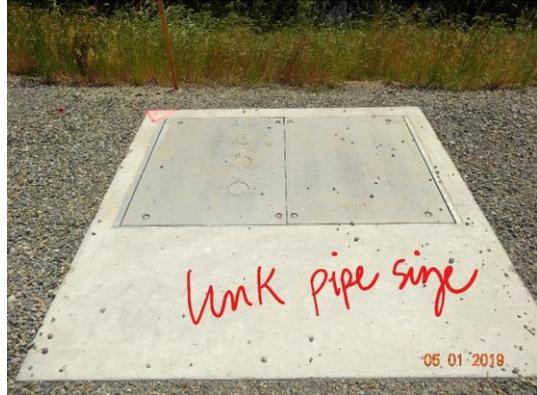
Photo 2 of 3 : UCIP_SP_2020_54191_79825.jpg

WS view: concrete vault located on levee crown. Unknown pipe size or purpose.

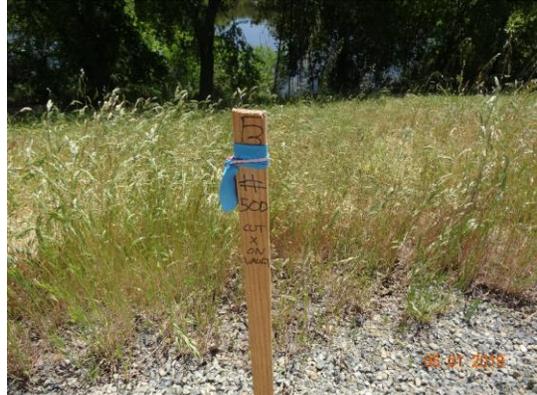
Photo 3 of 3 : UCIP_SP_2020_54191_79826.jpg

WS view: stake located on WS shoulder. Unable to determine if work is still pending.

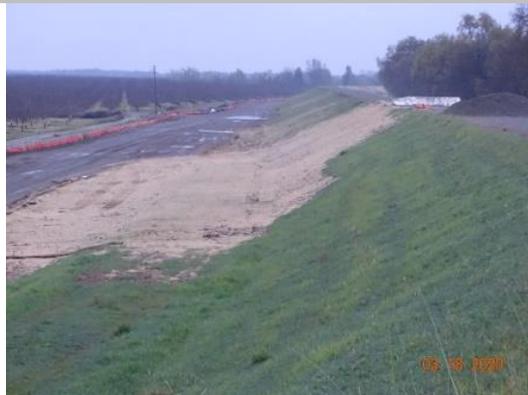
Photo 1 of 2 : SP_2020_MA0003_195_15_20200327_00026.jpg

LM Start	3.99	Rating **	A/W	Issue No.	15
LM End	5.10	Issue Type +	Ma	Location *	CR
Category	Earthen Levee		GPS Latitude/Longitude		
			Start	End	
Item	Crown Surface / Depressions / Rutting		38.935226 °	38.950762 °	
			-121.589146 °	-121.585810 °	
DWR ID	DWR_MA0003_01_f_2019_15				
Comment Code					
C1 : Add appropriate material and re-grade the levee to bring the crown above the design elevation.					
Inspector Comment					
Still under USACE construction on this portion of levee, Spring 2020.

View looking upstream at the portion of levee that is still under construction, Spring 2020.

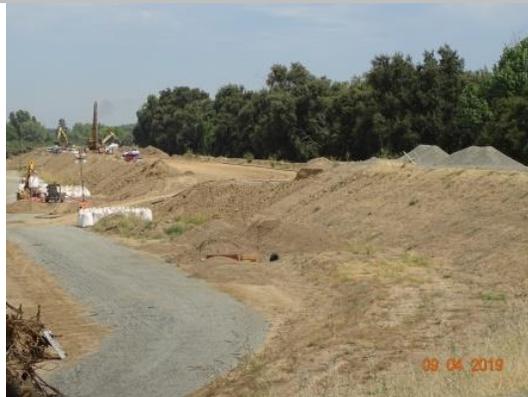
Photo 2 of 2 : SP_2020_MA0003_195_15_20200227_00003.jpg

View looking upstream at the portion of levee that is under construction, Fall 2019.
