**Flood Control Project Maintenance
Levee Inspections**

Maintenance Issue Types Only, Levee Inspection Report By Mile - Fall 2019

Sutter Maintenance Yard Maintenance Area 0003

Waterway	Bank	Unit Miles	Inspection Start/End	Inspector
Unit No. 01 Feather River	Right	5.11	09/04/2019 09/04/2019	Sterling York

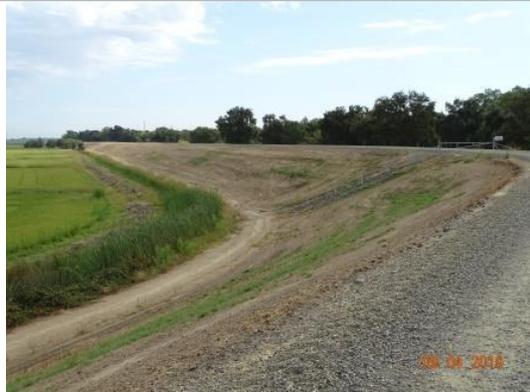
Photo 1 of 1 : FA_2019_MA0003_195_11_20190912_00020.jpg

LM Start	0.01	Rating **	A	Issue No.	11
LM End	4.11	Issue Type +	Ma	Location *	LS
Category	Earthen Levee			GPS Latitude/Longitude	
				Start	End
Item	Vegetation			38.897889°	38.936840°
				-121.617985°	-121.589000°
DWR ID	DWR_MA0003_01_f_2019_11				
Comment Code					
V1 : Control annual grass and weeds on the levee slopes and easements.					
Inspector Comment					
The annual vegetation is well maintained, Fall 2019.

View looking upstream landside at the well maintained vegetation, Fall 2019.

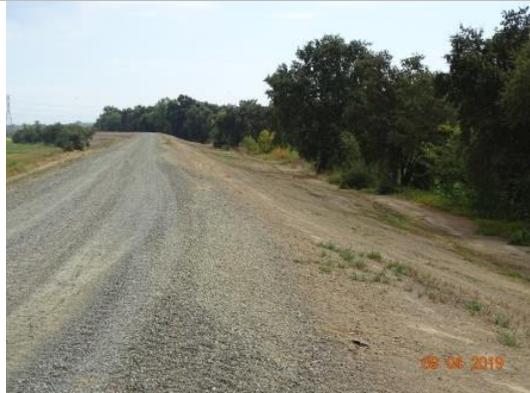
Photo 1 of 1 : FA_2019_MA0003_195_12_20190912_00021.jpg

LM Start	0.01	Rating **	A	Issue No.	12
LM End	4.11	Issue Type +	Ma	Location *	WS
Category	Earthen Levee			GPS Latitude/Longitude	
				Start	End
Item	Vegetation			38.897889°	38.936840°
				-121.617985°	-121.589000°
DWR ID	DWR_MA0003_01_f_2019_12				
Comment Code					
V1 : Control annual grass and weeds on the levee slopes and easements.					
Inspector Comment					
The annual vegetation is well maintained, Fall 2019.

View looking upstream waterside at the well maintained vegetation, Fall 2019.

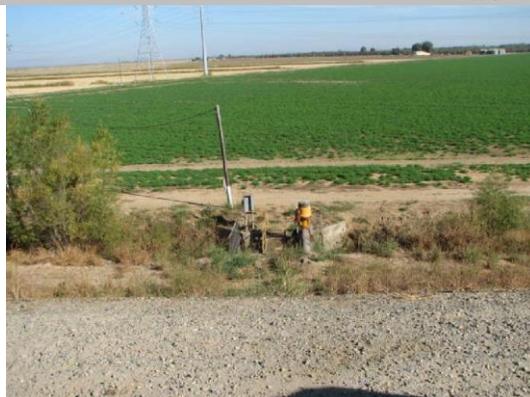
Photo 1 of 3 : UCIP_FA_2019_54171_64649.jpg

DS_ID:17092
 FS_ID:54171
 EP_NO: N/A
 Repair Type: Urgent
 Crossing Status: Found
 UCIP Comments: 05/01/2019 Same as last inspection, record remains Urgent due to the potential of levee integrity issues on the LS. Dense vegetation on both the WS and LS limits the inspection to determine if sink hole or erosion behind headwall on LS has progressed. No permit has been identified for this structure. Structure has been abandoned. (O. Magana - DWR UCIP)10/04/2018 Sink hole observed between the dual 18-inch pipes located on the LS near the concrete headwall. Erosion was also observed behind the concrete headwall located on the LS. Inlet of dual 18-inch pipes was still covered by filled sandbags. Crossing remains Urgent due to the sink hole and erosion visible on the LS. These crossings were recommended for replacement under the SBFCA project; however, no work has been done to date. Recommend monitoring site and coordinating with SBFCA to determine the status of the project. (O. Magana - DWR UCIP)

04/11/2017 Water levels were high on WS during inspection so pipe ends could not be inspected. Believe that the sandbags are still in place and condition of flap gates is unknown. (DWR Sutter Yard - AFreitag)10/10/2016 WS pipe end was underwater for inspection but the sandbags still appear to be in place. (DWR Sutter Yard - afreitag)04/18/2016 No repairs have been made to the pipe yet. (DWR Sutter Yard - afreitag)05/12/2015 Water level high in WS ditch so could not see WS end of crossing. Do not believe that repairs have been made yet. (DWR Sutter Yard - afreitag)11/17/2014 Same as last inspection. (DWR Sutter Yard - afreitag)05/14/2014 Same as last inspection. (DWR Sutter Yard - afreitag)10/30/2013 Same as last inspection. (DWR Sutter Yard - afreitag)05/21/2013 SBFCA project recommends replacing in accordance with title 23. High water levels in WS ditch have pipe ends underwater but repairs have not yet been completed but are planned for when water levels drop. (DWR Sutter Yard - afreitag)10/10/2012 Flap gates not visible on waterward headwall and it appears as though they have been replaced by sandbags. Slide gates on LS appear to be closed yet water leaks excessively from the WS at the sandbagged headwall. (DWR UCIP - W. Wylie)

Concrete headwall with walkway and slide gates at LS toe.

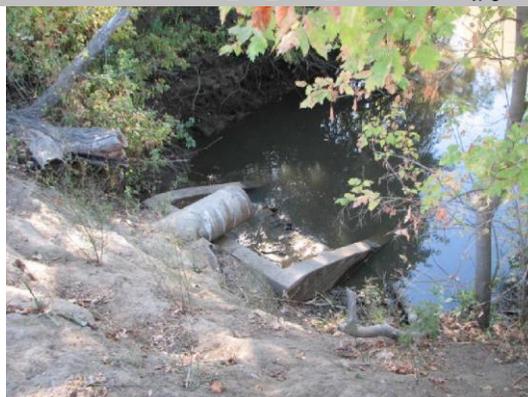
Photo 2 of 3 : UCIP_FA_2019_54171_64648.jpg

Concrete U shaped headwall on WS toe filled in with Sandbags. 16-inch pipe shown over top of headwall.

DS_ID:17092
 FS_ID:54171
 EP_NO: N/A
 Repair Type: Urgent
 Crossing Status: Found
 UCIP Comments: 05/01/2019 Same as last inspection, record remains Urgent due to the potential of levee integrity issues on the LS. Dense vegetation on both the WS and LS limits the inspection to determine if sink hole or erosion behind headwall on LS has progressed. No permit has been identified for this structure. Structure has been abandoned. (O. Magana - DWR UCIP)10/04/2018 Sink hole observed between the dual 18-inch pipes located on the LS near the concrete headwall. Erosion was also observed behind the concrete headwall located on the LS. Inlet of dual 18-inch pipes was still covered by filled sandbags. Crossing remains Urgent due to the sink hole and erosion visible on the LS. These crossings were recommended for replacement under the SBFCA project; however, no work has been done to date. Recommend monitoring site and coordinating with SBFCA to determine the status of the project. (O. Magana - DWR UCIP)

04/11/2017 Water levels were high on WS during inspection so pipe ends could not be inspected. Believe that the sandbags are still in place and condition of flap gates is unknown. (DWR Sutter Yard - AFreitag)10/10/2016 WS pipe end was underwater for inspection but the sandbags still appear to be in place. (DWR Sutter Yard - afreitag)04/18/2016 No repairs have been made to the pipe yet. (DWR Sutter Yard - afreitag)05/12/2015 Water level high in WS ditch so could not see WS end of crossing. Do not believe that repairs have been made yet. (DWR Sutter Yard - afreitag)11/17/2014 Same as last inspection. (DWR Sutter Yard - afreitag)05/14/2014 Same as last inspection. (DWR Sutter Yard - afreitag)10/30/2013 Same as last inspection. (DWR Sutter Yard - afreitag)05/21/2013 SBFCA project recommends replacing in accordance with title 23. High water levels in WS ditch have pipe ends underwater but repairs have not yet been completed but are planned for when water levels drop. (DWR Sutter Yard - afreitag)10/10/2012 Flap gates not visible on waterward headwall and it appears as though they have been replaced by sandbags. Slide gates on LS appear to be closed yet water leaks excessively from the WS at the sandbagged headwall. (DWR UCIP - W. Wylie)

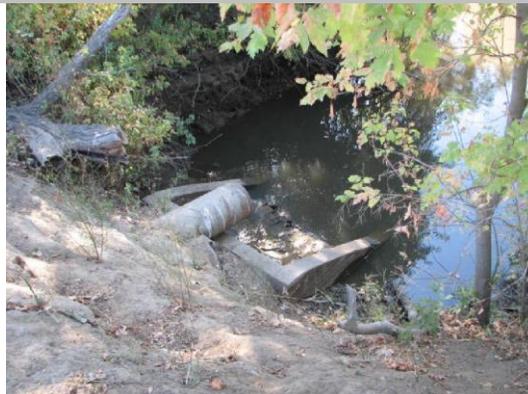
Photo 2 of 3 : UCIP_FA_2019_56067_64661.jpg

Concrete U shaped headwall on WS toe filled with sandbags.

DS_ID:17136
 FS_ID:56067
 EP_NO: N/A
 Repair Type: Urgent
 Crossing Status: Found
 UCIP Comments: 05/01/2019 Same as last inspection, record remains Urgent due to the potential of levee integrity issues on the LS. Dense vegetation on both the WS and LS limits the inspection to determine if sink hole or erosion behind headwall on LS has progressed. No permit has been identified for this structure. Structure has been abandoned. (O. Magana - DWR UCIP)10/04/2018 Sink hole observed between the dual 18-inch pipes located on the LS near the concrete headwall. Erosion was also observed behind the concrete headwall located on the LS. Inlet of dual 18-inch pipes was still covered by filled sandbags. Crossing remains Urgent due to the sink hole and erosion visible on the LS. These crossings were recommended for replacement under the SBFCA project; however, no work has been done to date. Recommend monitoring site and coordinating with SBFCA to determine the status of the project. (O. Magana - DWR UCIP)

04/11/2017 Water levels were high on WS during inspection so pipe ends could not be inspected. Believe that the sandbags are still in place and condition of flap gates is unknown. (DWR Sutter Yard - AFreitag)10/10/2016 WS pipe end was underwater for the inspection but the sandbags appear to still be in place. (DWR Sutter Yard - afreitag)04/18/2016 No repairs have been made to the pipe yet. (DWR Sutter Yard - afreitag)05/12/2015 Water level high in WS ditch so could not see WS end of crossing. Do not believe that repairs have been made yet. (DWR Sutter Yard - afreitag)11/17/2014 Same as last inspection. (DWR Sutter Yard - afreitag)05/14/2014 Same as last inspection. (DWR Sutter Yard - afreitag)10/30/2013 Same as last inspection. (DWR Sutter Yard - afreitag)05/21/2013 SBFCA project recommends replacing in accordance with title 23. High water levels in WS ditch have pipe ends underwater but repairs have not yet been completed but are planned for when water levels drop. (DWR Sutter Yard - afreitag)10/10/2012 Flap gates not visible on waterward headwall and it appears as though they have been replaced by sandbags. Slide gates on LS appear to be closed yet water leaks excessively from the WS at the sandbagged headwall. (DWR UCIP - W. Wylie)

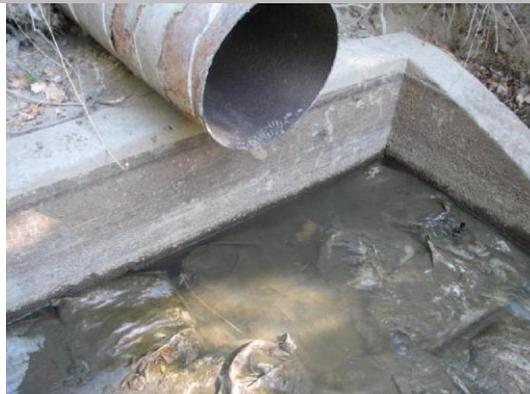
Photo 3 of 3 : UCIP_FA_2019_56067_64660.jpg

Comment Code					
Inspector Comment					
<p>DS_ID:17136 FS_ID:56067 EP_NO: N/A Repair Type: Urgent Crossing Status: Found UCIP Comments: 05/01/2019 Same as last inspection, record remains Urgent due to the potential of levee integrity issues on the LS. Dense vegetation on both the WS and LS limits the inspection to determine if sink hole or erosion behind headwall on LS has progressed. No permit has been identified for this structure. Structure has been abandoned. (O. Magana - DWR UCIP)10/04/2018 Sink hole observed between the dual 18-inch pipes located on the LS near the concrete headwall. Erosion was also observed behind the concrete headwall located on the LS. Inlet of dual 18-inch pipes was still covered by filled sandbags. Crossing remains Urgent due to the sink hole and erosion visible on the LS. These crossings were recommended for replacement under the SBFCA project; however, no work has been done to date. Recommend monitoring site and coordinating with SBFCA to determine the status of the project. (O. Magana - DWR UCIP) 04/11/2017 Water levels were high on WS during inspection so pipe ends could not be inspected. Believe that the sandbags are still in place and condition of flap gates is unknown. (DWR Sutter Yard - AFreitag)10/10/2016 WS pipe end was underwater for the inspection but the sandbags appear to still be in place. (DWR Sutter Yard - afreitag)04/18/2016 No repairs have been made to the pipe yet. (DWR Sutter Yard - afreitag)05/12/2015 Water level high in WS ditch so could not see WS end of crossing. Do not believe that repairs have been made yet. (DWR Sutter Yard - afreitag)11/17/2014 Same as last inspection. (DWR Sutter Yard - afreitag)05/14/2014 Same as last inspection. (DWR Sutter Yard - afreitag)10/30/2013 Same as last inspection. (DWR Sutter Yard - afreitag)05/21/2013 SBFCA project recommends replacing in accordance with title 23. High water levels in WS ditch have pipe ends underwater but repairs have not yet been completed but are planned for when water levels drop. (DWR Sutter Yard - afreitag)10/10/2012 Flap gates not visible on waterward headwall and it appears as though they have been replaced by sandbags. Slide gates on LS appear to be closed yet water leaks excessively from the WS at the sandbagged headwall. (DWR UCIP - W. Wylie) FIELD_STRUCT_DESC: 2 of 2: 18-inch steel drainage pipe through the levee, 32 feet below the crown. Flap gate on the waterside (WS) end. Slide gate on the landside (LS) end at concrete headwall. Concrete "U" headwall at the WS toe. [Additional Reference(s): DWR Levee Log, 2005. USACE Sacramento O&M Manual 143, August 1955, (Station 982+00)]. FS Date: 5/1/2019 2:51:00 PM</p>

Flap gates appear to be missing from U shaped headwall. Sandbags fill headwall but water flows heavily from LS.

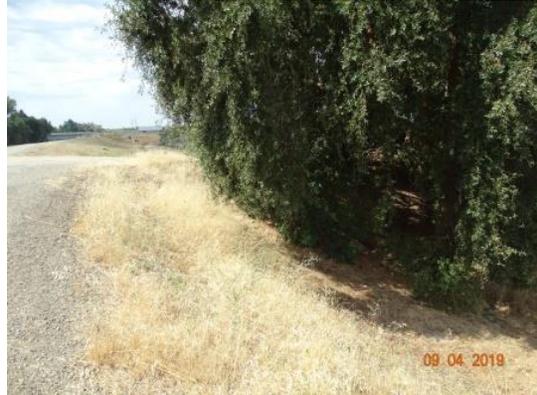
Photo 1 of 1 : FA_2019_MA0003_195_14_20190912_00023.jpg

LM Start	1.86	Rating **	M	Issue No.	14
LM End	1.86	Issue Type +	Ma	Location *	LS
Category	Earthen Levee		GPS Latitude/Longitude		
			Start	End	
Item	Trim / Thin Trees		38.907820°	38.907820°	
			-121.589000°	-121.589000°	
DWR ID	DWR_MA0003_01_f_2019_14				
Comment Code					
T1 : Trim trees to at least five feet above ground level.					
Inspector Comment					
Tree limbs need to be trimmed, Fall 2019.

View looking downstream landside of tree limbs that need to be trimmed, Fall 2019.

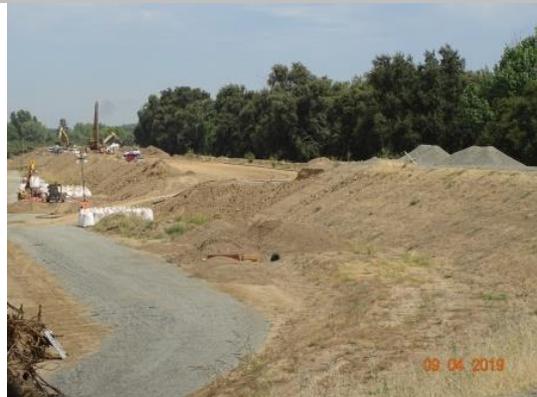
Photo 1 of 1 : FA_2019_MA0003_195_15_20190912_00024.jpg

LM Start	4.11	Rating **	A/W	Issue No.	15
LM End	5.10	Issue Type +	Ma	Location *	CR
Category	Earthen Levee		GPS Latitude/Longitude		
			Start	End	
Item	Crown Surface / Depressions / Rutting		38.936840°	38.950762°	
			-121.589000°	-121.585810°	
DWR ID	DWR_MA0003_01_f_2019_15				
Comment Code					
C1 : Add appropriate material and re-grade the levee to bring the crown above the design elevation.					
Inspector Comment					
Under construction on this portion of levee, Fall 2019.

View looking upstream at the portion of levee that is under construction, Fall 2019.
