**Flood Control Project Maintenance
Levee Inspections**

Fall 2019 Levee Maintenance Deficiency Summary Report

**Flood Control Project Maintenance
Levee Inspections
LMA District Cover Sheet
Fall 2019 Levee Inspection Results**

Sutter Maintenance Yard Maintenance Area 0005

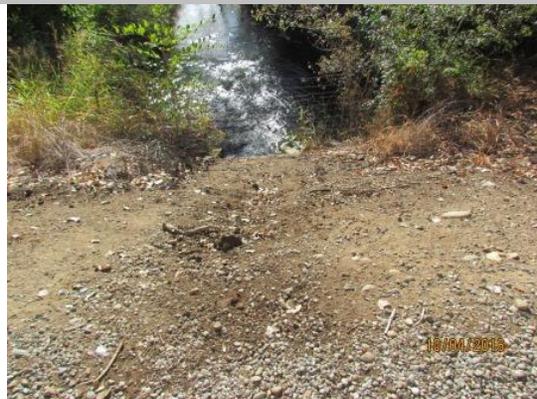
Photo 1 of 1 : FA_2019_MA0005_196_46_20190822_00022.jpg

LM Start	0.07	Rating **	M	Issue No.	46
LM End	0.07	Issue Type +	Ma	Location *	LS
Category	Earthen Levee		GPS Latitude/Longitude		
			Start	End	
Item	Slope Stability		39.696611°	39.696611°	
			-121.774349°	-121.774349°	
DWR ID	DWR_MA0005_01_f_2016_46				
Comment Code					
S2 : Repair the levee slope damaged by foot traffic and prevent access where possible.					
Inspector Comment

View of the damaged slope by foot traffic.

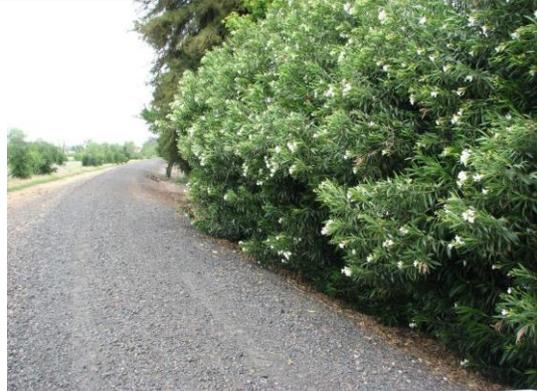
Photo 1 of 1 : FA_2019_MA0005_196_44_20190822_00020.jpg

View of oleanders along the landside toe.

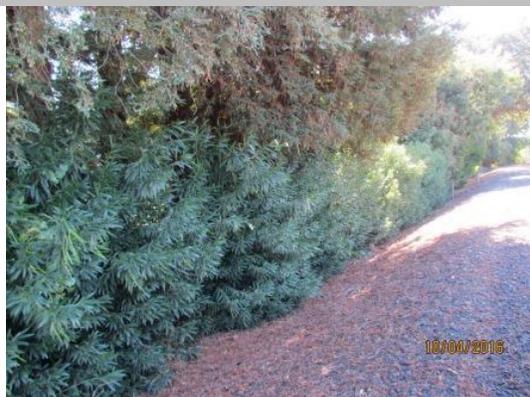
Photo 1 of 1 : FA_2019_MA0005_196_50_20190822_00024.jpg

View of the oleanders along the landside toe.

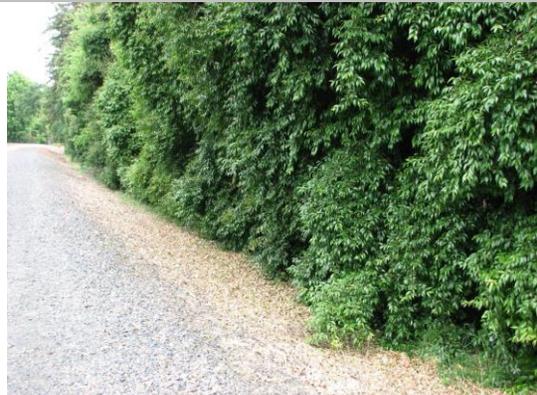
Photo 1 of 1 : FA_2019_MA0005_196_43_20190822_00019.jpg

View of the overgrown vegetation at the landside toe.

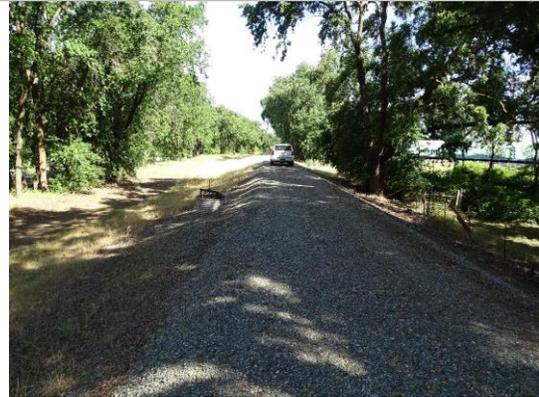
Photo 1 of 3 : UCIP_FA_2019_54140_79693.jpg

Comment Code					
Inspector Comment					
<p>DS_ID:1615 FS_ID:54140 EP_NO: N/A Repair Type: Non-Urgent Crossing Status: Found UCIP Comments: 06/05/2019 Durham Mutual Water Company fixed broken slide gate by replacing a stem. Operating wheel is missing. Crossing downgraded to non-urgent. (O.Yakimov - DWR UCIP)10/5/2018 Observed pipe running during inspection. Pipe is used to drain water from LS concrete box to WS. Field structure description was updated to show structure type as drainage pipe. Confirmed that the concrete box on LS receives water from a pipe running along the LS toe from orchards upstream and distributes water between 3 pipes, one of which crosses levee at an angle. Missing closure device on WS. Screw gate stuck in open position inside CMP riser located on WS shoulder and is not operable. (O.Yakimov - DWR)5/15/2017 WS slide gate stem bent and gate is stuck in the open position. Outlet in the the concrete box on the WS berm is opened and allowed water to free flow through the pipe during the Jan/Feb 2017 high water events. Either the screw gate needs to be repaired or a flap gate added to the outlet in the concrete box to not allow high water flows though the levee. Pipe is believed to be owned and operated by Duhram Mutual Water Company at 1807 Duhram Dayton HWY, PO Box 612, Duhram CA 95938 (530)342-9324. (DWR Sutter Yard- AFreitag)</p> <p>11/15/2016 Abandoned- slide gate is opened and inoperable. Needs to be properly abandoned. (DWR Sutter Yard- AFreitag)5/9/2016 Abandoned crossing. Slide gate stem bent and wheel is missing.8/5/2015 Abandoned crossing. Slide gate stem is bent and gate is inoperable. Needs to be properly abandoned.12/8/2014 Same as last inspection.6/11/2014 Same as last inspection.11/20/2013 Same as last inspection.5/29/2013 Same as last inspection.10/30/2012 Pipe appears to be abandoned. Slide gate open and inoperable. Pipe should be properly abandoned. FIELD_STRUCT_DESC: 30-inch corrugated metal drainage pipe through the levee, 10.5 feet below the crown. Slide gate in a corrugated metal riser on the waterside (WS) slope. Concrete distribution box on the landside (LS) toe and concrete overflow and siphon box at the edge of berm. [Additional Reference(s): DWR Levee Log, 1990 (HLM 3.69). USACE Sacramento O&M Manual, Unit 516 - Upper Butte Creek - Part No. 2, April 1960 (Station 368+17)]. FS Date: 6/5/2019 1:45:26 PM</p>

View of levee crown at crossing

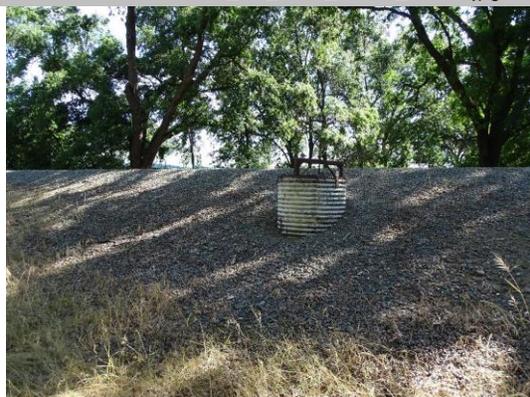
Photo 3 of 3 : UCIP_FA_2019_54140_79690.jpg

11/15/2016 Abandoned- slide gate is opened and inoperable. Needs to be properly abandoned. (DWR Sutter Yard- AFreitag)5/9/2016 Abandoned crossing. Slide gate stem bent and wheel is missing.8/5/2015 Abandoned crossing. Slide gate stem is bent and gate is inoperable. Needs to be properly abandoned.12/8/2014 Same as last inspection.6/11/2014 Same as last inspection.11/20/2013 Same as last inspection.5/29/2013 Same as last inspection.10/30/2012 Pipe appears to be abandoned. Slide gate open and inoperable. Pipe should be properly abandoned.

CMP riser WS shoulder

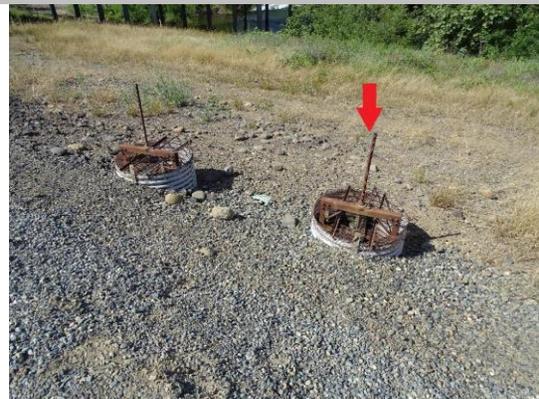
Photo 1 of 3 : UCIP_FA_2019_54141_79700.jpg

CMP riser and slide gate on WS shoulder

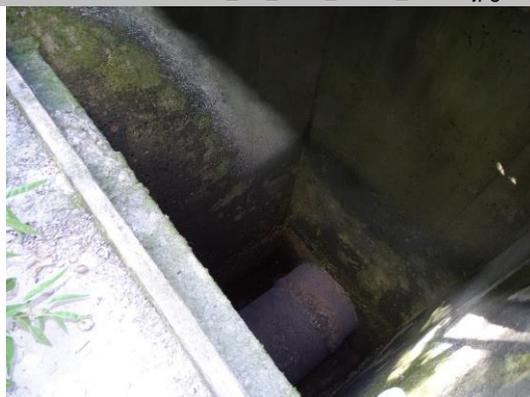
Photo 3 of 3 : UCIP_FA_2019_54141_79699.jpg

Steel welded pipe inside of concrete distribution box on LS goes toward the levee

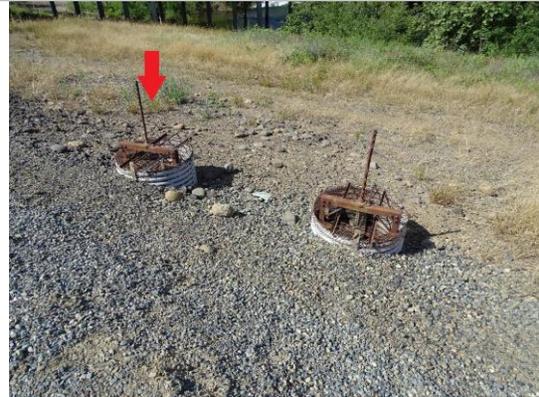
Photo 1 of 3 : UCIP_FA_2019_54142_79701.jpg

CMP riser and slide gate on WS shoulder

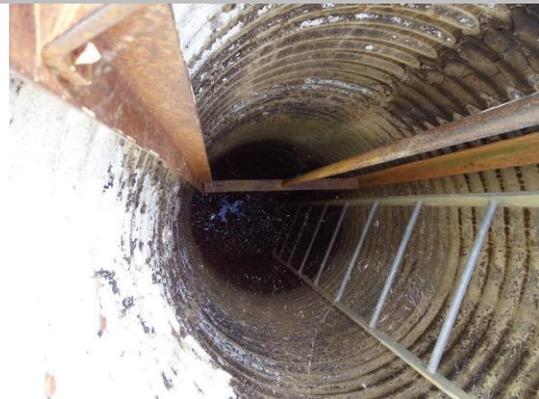
Photo 2 of 3 : UCIP_FA_2019_54142_79703.jpg

Inside view of CMP riser on WS shoulder

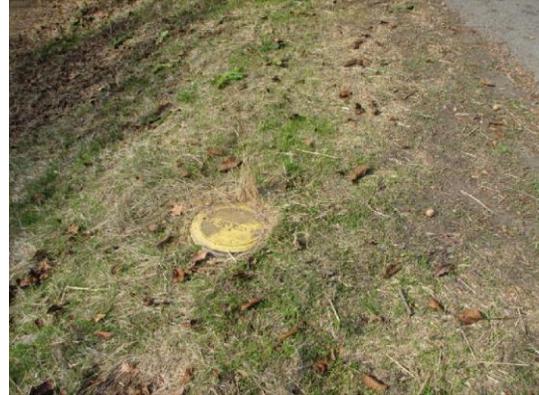
Photo 1 of 2 : UCIP_FA_2019_51952_67936.jpg

PG&E access lid on south edge of roadway.

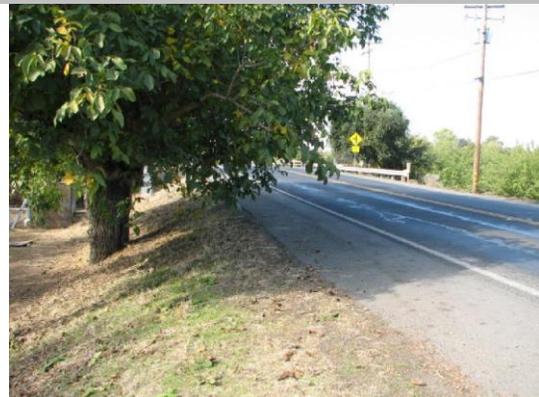
Photo 2 of 2 : UCIP_FA_2019_51952_67935.jpg

Location of PG&E access lid 250-feet east of levee crown on south side of roadway.

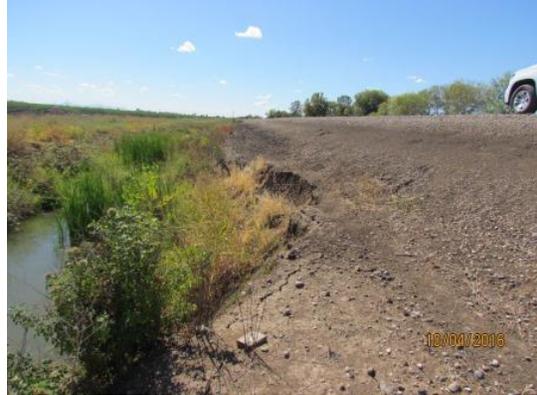
Photo 1 of 2 : FA_2019_MA0005_196_56_20190822_00027.jpg

View of the landside toe erosion.

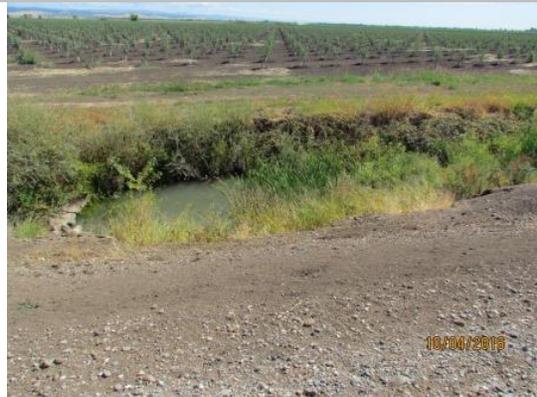
Photo 2 of 2 : FA_2019_MA0005_196_56_20190822_00028.jpg

Another view of the landside toe erosion.

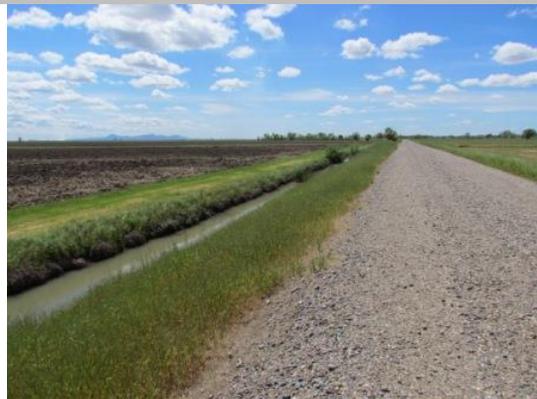
Photo 1 of 1 : FA_2019_MA0005_196_6_20190822_00003.jpg

View of the agricultural ditch along the landside toe.

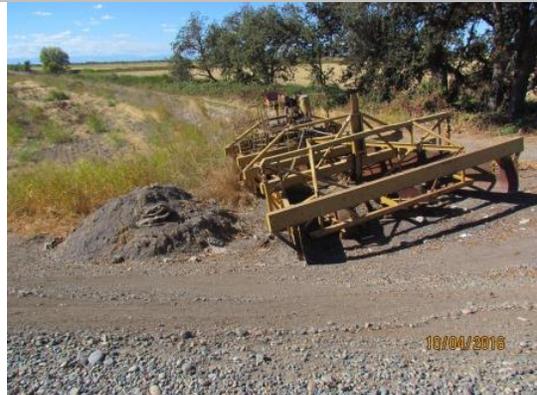
Photo 1 of 1 : FA_2019_MA0005_197_48_20190822_00023.jpg

View of soil pile, rocks, and ag equipment.

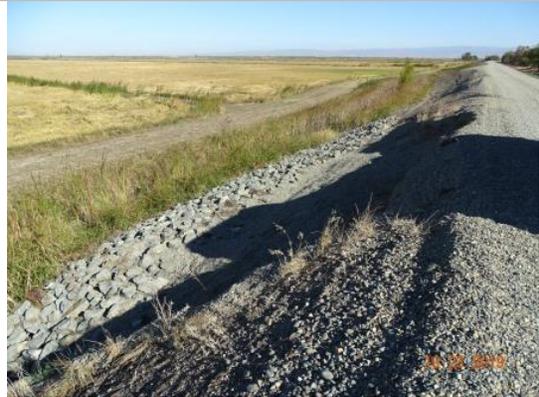
Photo 1 of 1 : FA_2019_MA0005_197_55_20191028_00099.jpg

View of sloughing on the landside slope. Fall 2019.

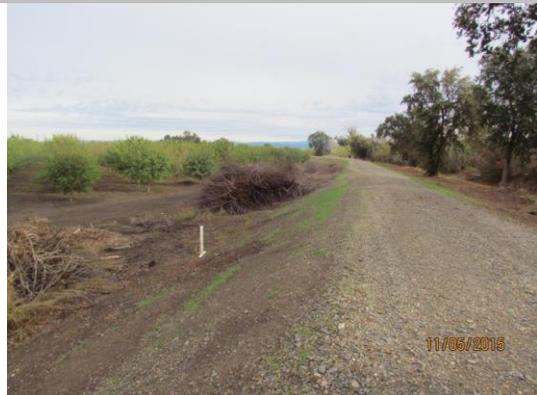
Photo 1 of 1 : FA_2019_MA0005_197_35_20190822_00012.jpg

View of the prunings along the landside slope.

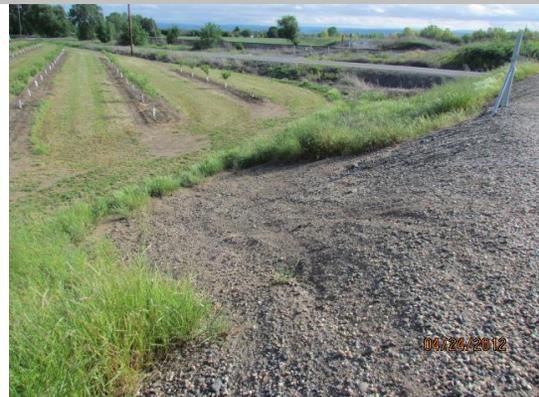
Photo 1 of 2 : FA_2019_MA0005_197_13_20190822_00006.jpg

View of the vehicle erosion along the slope.

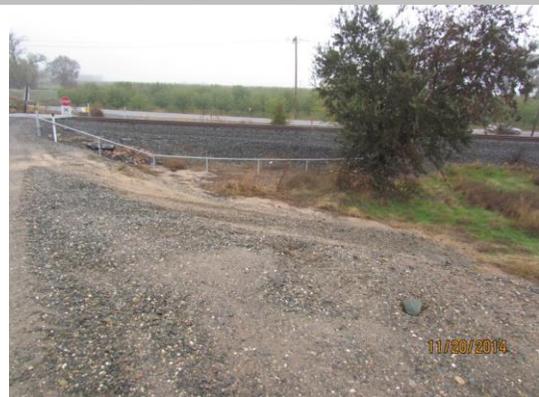
Photo 1 of 1 : FA_2019_MA0005_197_40_20190822_00016.jpg

View of the vehicle slope instability along the landside slope.

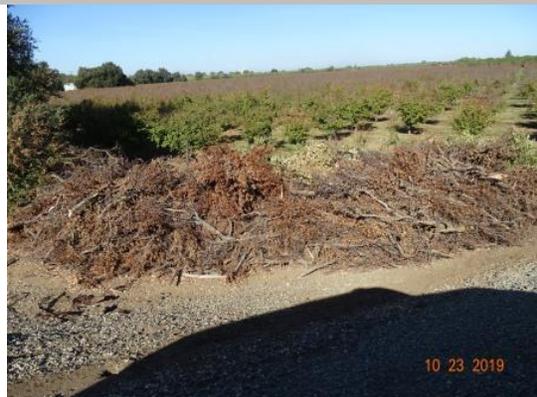
Photo 1 of 1 : FA_2019_MA0005_197_64_20191028_00100.jpg

View of a large pruning pile at the landside toe. Fall 2019.

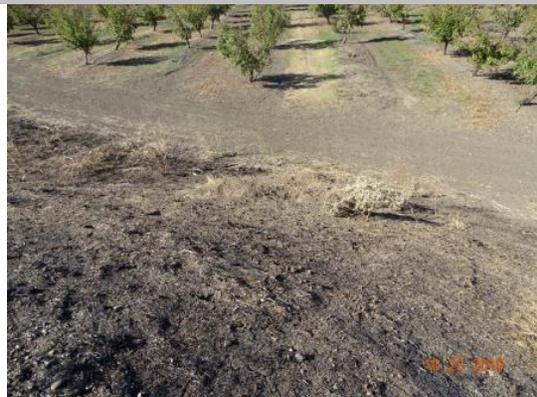
Photo 1 of 1 : FA_2019_MA0005_197_73_20191028_00101.jpg

View of two large rodent burrows on the landside slope and toe. Fall 2019.

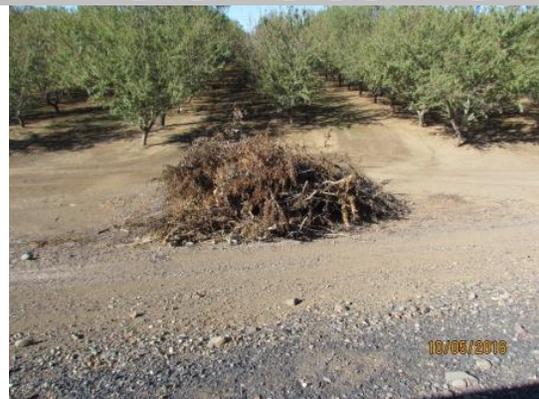
Photo 1 of 1 : FA_2019_MA0005_197_56_20190822_00027.jpg

View of the prunings along the landside toe.

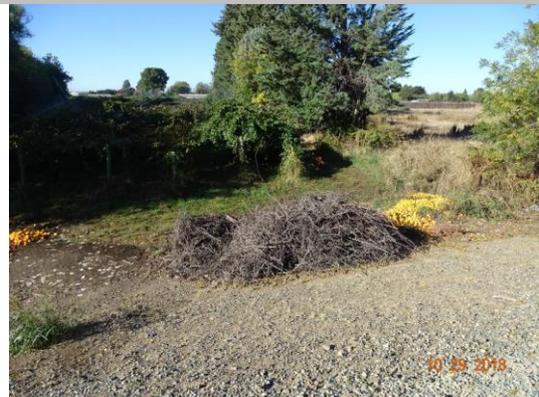
Photo 1 of 1 : FA_2019_MA0005_197_67_20190822_00032.jpg

View of the prunings along the landside toe.

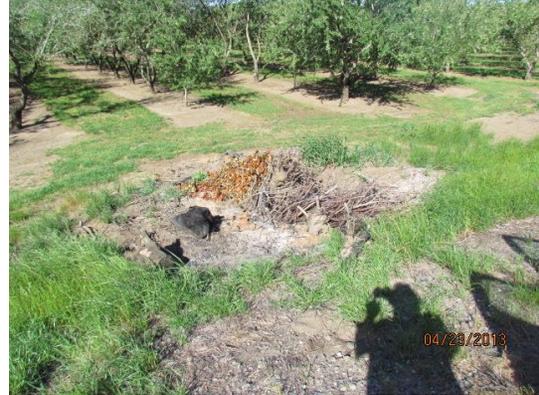
Photo 1 of 1 : FA_2019_MA0005_197_3_20190822_00002.jpg

View of the prunings along the landside toe.

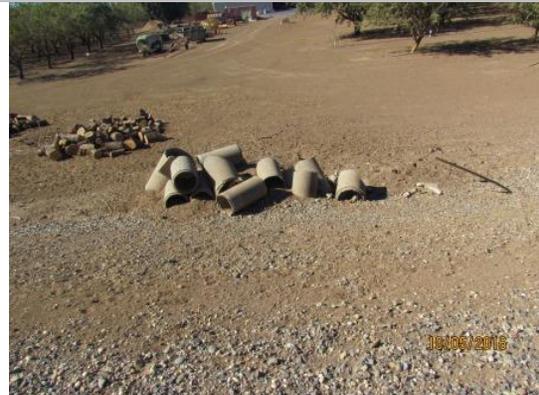
Photo 1 of 1 : FA_2019_MA0005_197_57_20190822_00028.jpg

View of the broken concrete pipes and firewood along the landside toe.

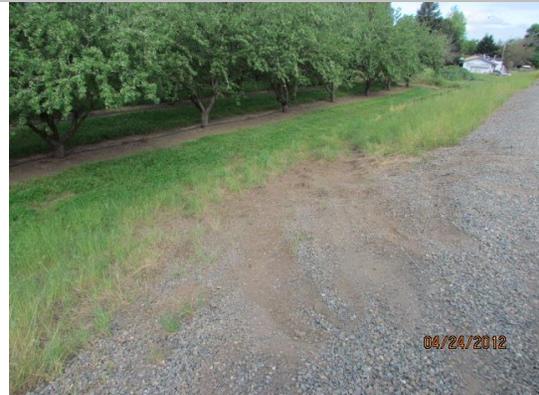
Photo 1 of 1 : FA_2019_MA0005_197_18_20190822_00008.jpg

View of the vehicle erosion along the slope of the levee.

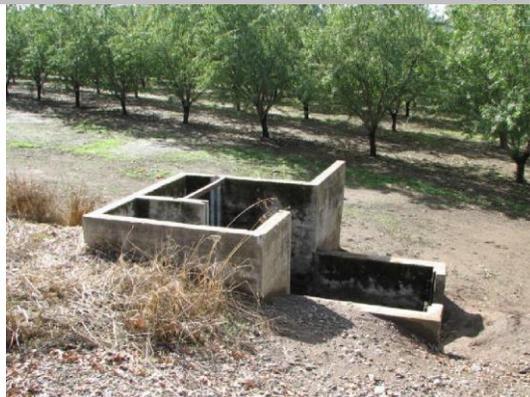
Photo 2 of 3 : UCIP_FA_2019_52069_68433.jpg

Distribution box on LS toe. Missing slide gate at pipe entrance.

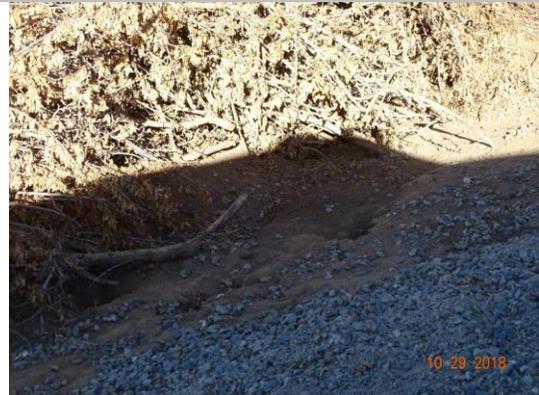
Photo 1 of 1 : FA_2019_MA0005_197_71_20190822_00036.jpg

View of the rodent holes along the landside slope.

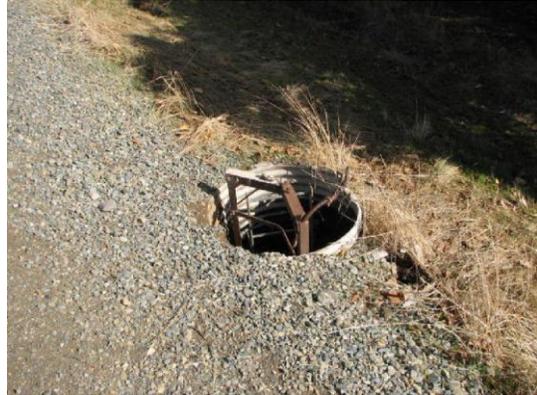
Photo 1 of 3 : UCIP_FA_2019_54048_68465.jpg

Broken slide gate in CM riser on WS slope.

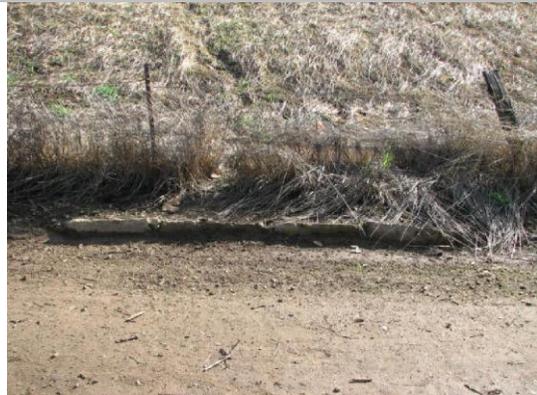
Photo 2 of 3 : UCIP_FA_2019_54048_68464.jpg

Abandoned headwall on LS toe.

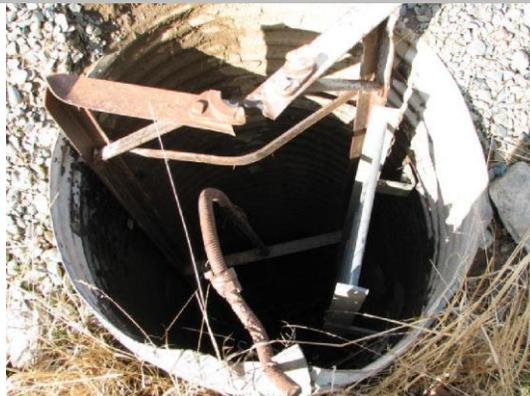
Photo 3 of 3 : UCIP_FA_2019_54048_68463.jpg

Broken slide gate in CM riser on WS slope.

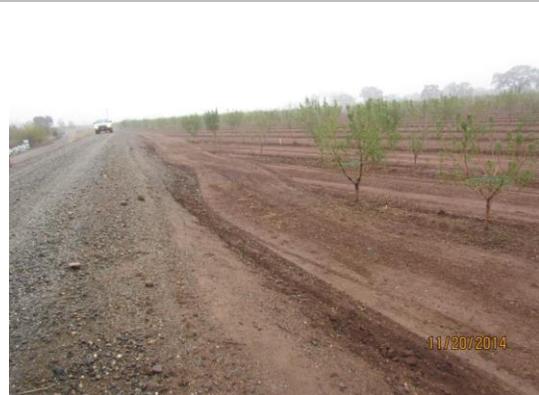
Photo 1 of 1 : FA_2019_MA0005_197_43_20190822_00019.jpg

View of the tilling into the landside slope.

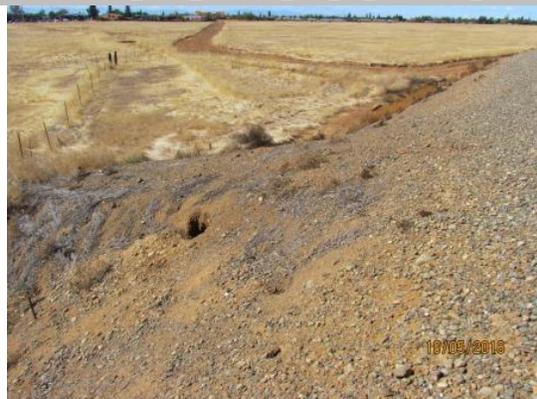
Photo 1 of 1 : FA_2019_MA0005_197_39_20190822_00015.jpg

View of the rodent holes along the landside slope.
