**Flood Control Project Maintenance
Levee Inspections**

Fall 2019 Levee Maintenance Deficiency Summary Report

Sacramento River Basin

Sutter Maintenance Yard Maintenance Area 0007

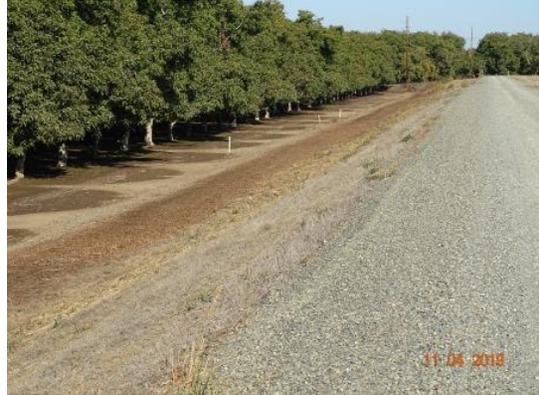
Photo 1 of 1 : FA_2019_MA0007_200_10_20191112_00024.jpg

View looking upstream landside at the well maintained annual vegetation, Fall 2019.

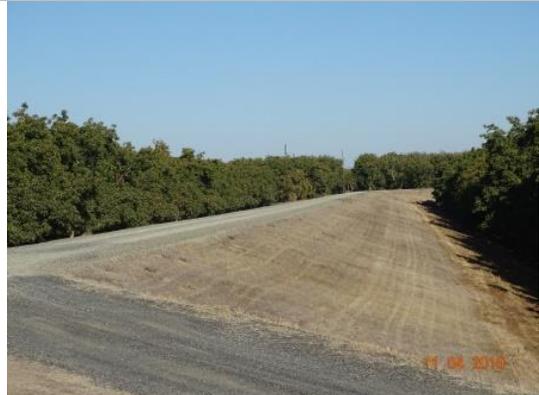
Photo 1 of 1 : FA_2019_MA0007_200_11_20191112_00026.jpg

LM Start	0.02	Rating **	A	Issue No.	11
LM End	11.64	Issue Type +	Ma	Location *	WS
Category	Earthen Levee		GPS Latitude/Longitude		
			Start	End	
Item	Vegetation		39.311187°	39.439540°	
			-121.637590°	-121.646135°	
DWR ID	DWR_MA0007_01_f_2019_11				
Comment Code					
V1 : Control annual grass and weeds on the levee slopes and easements.					
Inspector Comment					
The annual vegetation is well maintained, Fall 2019.

View looking upstream waterside at the well maintained annual vegetation, Fall 2019.

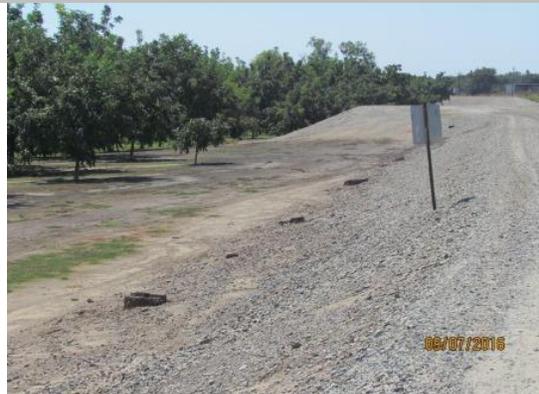
Photo 1 of 1 : FA_2019_MA0007_200_69_20190904_00007.jpg

LM Start	0.31	Rating **	N	Issue No.	69
LM End	0.37	Issue Type +	Ma	Location *	WS
Category	Earthen Levee		GPS Latitude/Longitude		
			Start	End	
Item	Trim / Thin Trees		39.314991°	39.315693°	
			-121.635038°	-121.634459°	
DWR ID	DWR_MA0007_01_s_2016_69				
Comment Code					
T5 : Tree stumps.					
Inspector Comment					
Several tree stumps at WS levee toe.

View looking downstream at several tree stumps on the WS levee toe.

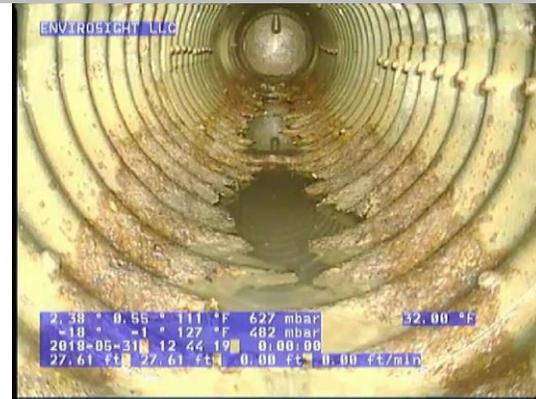
Photo 1 of 3 : UCIP_FA_2019_55847_79201.jpg

DS_ID:16928
 FS_ID:55847
 EP_NO: N/A
 Repair Type: Urgent
 Crossing Status: Found
 UCIP Comments: 09/04/2019 Photos provided by M. Bellomy with Flood Maintenance Office have been uploaded to record. Photos highlight the extent of damage on LS slope. (O. Magana - DWR UCIP)05/08/2019 LMA Supervisor, Shawn Freitag, has completed a temporary repair to prevent water from flowing from LS irrigation ditch to WS. Burrow hole on LS has been plugged and concrete bags have been placed to prevent water from entering the pipe and causing further damage to the pipe section through levee. Crossing will continued to be monitored by LMA. Need to coordinate with DWR DMP to address permanent solution for abandoned crossing. (O. Magana - DWR UCIP)

05/07/2019 Record has been updated from Non-Urgent to Urgent due to pipe integrity issues found. DWR UCIP was notified by LMA Supervisor, Shawn Freitag, of pipe leak observed on LS and causing flooding to WS. Burrow hole is allowing flow to enter pipe. Hole present on pipe section near the concrete headwall. Erosion (sloughing) observed on LS slope. Pipe section tied to WS concrete box that runs parallel to levee was flooding Kiwi Orchard. Section of concrete distribution box was removed to allow for proper drainage and prevent flooding to Kiwi Orchard. Measures by LMA Supervisor are being pursued to stop flow through pipe to prevent further erosion damage through the levee (damage identified during DWR DMP Phase 1 internal video inspection). Record has been updated to reflect the DMP Phase 1 inspection report, crossing has been upgraded from Non-Urgent to Urgent based on the condition of the pipe through the levee. (O. Magana - DWR UCIP)12/07/2018 Encroachment owner information: Sukhraj Singh Pamma, 9850 Sheldon Avenue, Live Oak, CA 95953-9784, 1-530-695-2490. The CVFPB sent an encroachment violation notice on August 16, 2011 to Mr. and Ms. Ratana. Information obtained from the Levee_Encroachment_listing_11288.pdf which was received from SBFCA. Need to coordinate with CVFPB to determine status of permit. (O. Magana - DWR UCIP)

LS view: Internal view of pipe condition during DMP Phase 1 Inspection.

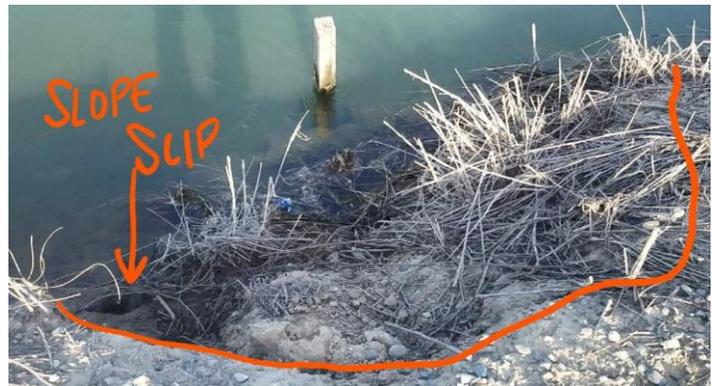
Photo 2 of 3 : UCIP_FA_2019_55847_79230.jpg

LS view: section of levee has slipped at pipe crossing.

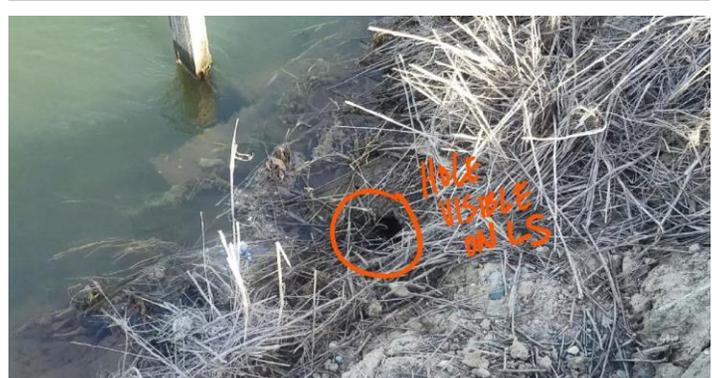
Photo 3 of 3 : UCIP_FA_2019_55847_79229.jpg

LS view: hole visible on LS, appears to be linked to burrow hole that is allowing flow to go into pipe.

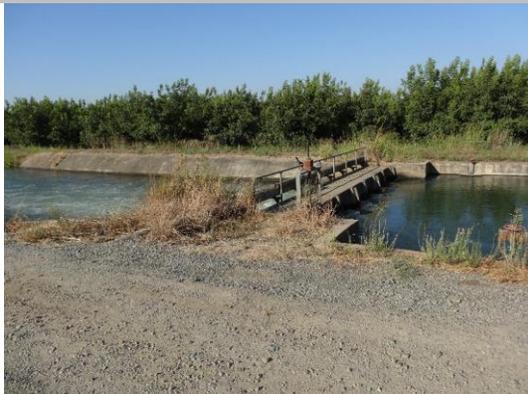
Photo 1 of 3 : UCIP_FA_2019_56069_77330.jpg

DS_ID:20816
 FS_ID:56069
 EP_NO: 11987
 Repair Type: Non-Urgent
 Crossing Status: Found
 UCIP Comments: 05/07/2019 Crossing has been modified. Need to contact owner to determine permit authorizing new modifications on both WS and LS. (O. Magana - DWR UCIP)12/07/2018 New encroachment owner information: Sukhraj Singh Pamma, 9850 Sheldon Avenue, Live Oak, CA 95953-9784, 1-530-695-2490. Information obtained from the Levee_Encroachment_listing_11288.pdf received from SBFCA. The permit listed in the pdf file is 11987. This permit was issued to the Cox Brothers in 1977. Need to have new owner apply for Permit Name Change with the CVFPB. (O. Magana - DWR UCIP) 08/09/2017 It appears that this pipe is used to water the orchard located on the WS. Dense vegetation present along the WS slope, recommend clearing vegetation to allow for proper inspection of levee slope. No permit has been identified since 2012. (DWR UCIP - O. Magana)08/02/2017 After reviewing record drawings it appears this crossing has remained. This pipe was not part of the Feather River West Levee Improvements, Project D. Pipe is located outside the project limits. Project Improvements began at Station (Sta) 1765+00 (MA0007 about LM 1.73) to Sta 2303+50 (ST0005 about LM 1.23), refer to record drawings for the Feather River West Levee Improvement Plans Station 1765+00 to 2368+26, Project D details. (DWR UCIP - O. Magana)

LS view: pipe visible along LS canal.

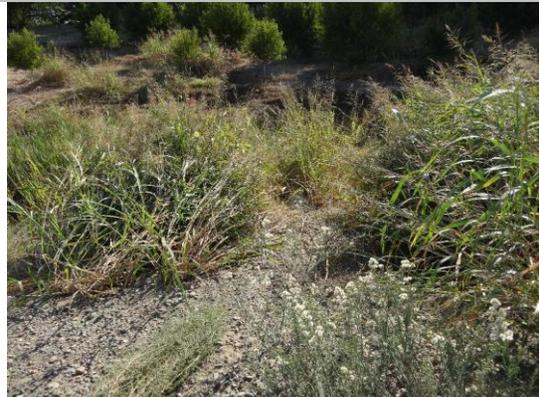
Photo 3 of 3 : UCIP_FA_2019_56069_77332.jpg

WS view: dense vegetation along WS slope.

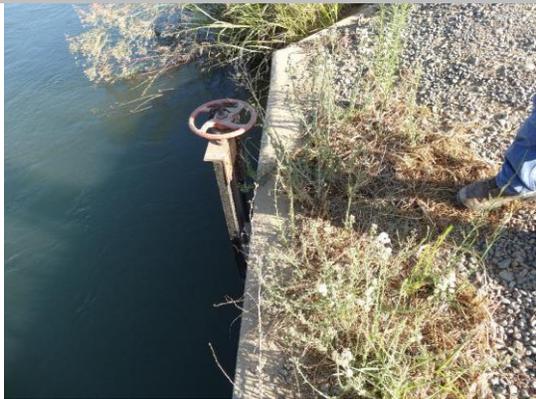
Photo 1 of 3 : UCIP_FA_2019_55062_77335.jpg

DS_ID:16927
 FS_ID:55062
 EP_NO: N/A
 Repair Type: Non-Urgent
 Crossing Status: Found
 UCIP Comments: 05/07/2019 Record remains Non-Urgent, no permit has been identified for this crossing. Internal inspection has been completed but no pipe evaluation by DMP is available yet. Need to determine if pipe is mainly used for drainage or irrigation. (O. Magana - DWR UCIP)12/07/2018 Encroachment owner information: Sukhraj Singh Pamma, 9850 Sheldon Avenue, Live Oak, CA 95953-9784, 1-530-695-2490. Information obtained from the Levee_Encroachment_listing_11288.pdf which was received from SBFCA. Need to coordinate with CVFPB to determine status of permit. (O. Magana - DWR UCIP)
 08/09/2017 Crossing is still present, unable to confirm is crossing is still in use. Recommend contacting owner to determine status, remove dense vegetation blocking outlet, and to obtain permit authorizing crossing. (DWR UCIP - O. Magana)08/02/2017 After reviewing record drawings it appears this crossing has remained. This pipe was not part of the Feather River West Levee Improvements, Project D. Pipe is located outside the project limits. Project Improvements began at Station (Sta) 1765+00 (MA0007 about LM 1.73) to Sta 2303+50 (ST0005 about LM 1.23), refer to record drawings for the Feather River West Levee Improvement Plans Station 1765+00 to 2368+26, Project D details. (DWR UCIP - O. Magana)

05/16/2016 Feather River West Levee Improvement Project--Levee currently under construction.06/10/2015 WS headwall is still damaged and no repairs were made to this pipe. Looks like the SBFCA project skipped over this area so pipe was not replaced as it was listed to be.12/29/2014 Same as last inspection.05/19/2014 Same as last inspection.11/06/2013 Same as last inspection.05/13/2013 SBFCA project recommends replacing with accordance to title 23.05/07/2013 Same as last inspection, however exposed rebar on WS headwall does not impede structure performance.10/31/2012 WS headwall rebar exposed. This crossing was listed in the USACE Periodic Inspections as ID# USACE_CESPK_MA07_2010_a_0051 however, no issue listed. (DWR UCIP - O. Magana)
 FIELD_STRUCT_DESC: 10-inch polyvinyl chloride (PVC) pipe encased in a 12-inch corrugated metal irrigation pipe through the levee, 7 feet below the crown. Concrete U-shaped headwall at the waterside (WS) toe. Concrete headwall and slide gate on the landside (LS). Concrete weir in the canal. (Existing 10-inch PVC pipe and 12-inch corrugated metal [concrete indicated in record drawings] irrigation pipe crossing remained during the Feather River West Levee Improvements, Project D). [Additional Reference(s): DWR Levee Log, 2005. Sutter Butte Flood Control Agency (SBFCA) Feather River West Levee Project, Volume 4

LS view: screw gate and concrete headwall visible on LS.

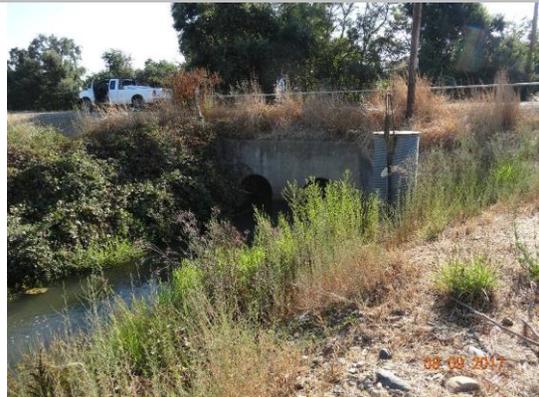
Photo 2 of 3 : UCIP_FA_2019_55067_77351.jpg

DS_ID:16926
 FS_ID:55067
 EP_NO: N/A
 Repair Type: Non-Urgent
 Crossing Status: Found
 UCIP Comments: 05/07/2019 Record remains Non-Urgent, no permit has been identified for the structure. Recommend adding covers to the CMP risers located on the WS as a safety measure. DMP internal inspection is still pending. It is unclear who the owner and maintainer is for this structure. LMA will need to coordinate with CVFPB to determine true owner. (O. Magana - DWR UCIP)12/07/2018 Encroachment Owner is Butte Water District c/o Mark Orme, District Manager, 735 Virginia Street, Gridley, CA 95948, 1-530-846-3100. Information obtained from the Levee_Encroachment_listing_11288.pdf obtained from SBFCA which also indicates CVFPB Permit Process - New Permit. Need to coordinate with CVFPB to determine status of permit. (O. Magana - DWR UCIP)
 08/09/2017 Dual 60-inch pipes are still present--no modifications appear to have been made to this structure. No permit or owner has been identified. Need to contact owner to notify of safety issue regarding the missing covers for CMP riser. (DWR UCIP - O. Magana)08/02/2017 After reviewing record drawings it appears this crossing has remained. Project Improvements begin at Station (Sta) 1765+00 (MA0007 about LM 1.73) to Sta 2303+50 (ST0005 about LM 1.23), refer to record drawings for the Feather River West Levee Improvement Plans Station 1765+00 to 2368+26, Project D details. MA0007 project details include NO CUTOFF WALL from Sta 1765+00 (MA0007 about LM 1.73) to 1815+00 (MA0007 about LM 2.64) and LEVEE DEGRADE AND RECONSTRUCTION WITH CUT OFF WALL from Sta 1817+00 (MA0007 about LM 2.69) to Sta 2289+00, Sta 2287+00 to Sta 2290+00 (MA0007 about LM 11.60). (DWR UCIP - O. Magana)

LS view: concrete headwall with dual 60-inch crossings visible from LS.

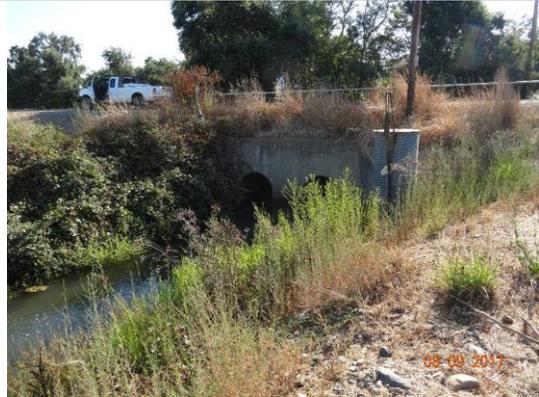
Photo 2 of 3 : UCIP_FA_2019_55066_77357.jpg

DS_ID:17011
 FS_ID:55066
 EP_NO: N/A
 Repair Type: Non-Urgent
 Crossing Status: Found
 UCIP Comments: 05/07/2019 Record remains Non-Urgent, no permit has been identified for the structure. Recommend adding covers to the CMP risers located on the WS as a safety measure. DMP internal inspection is still pending. It is unclear who the owner and maintainer is for this structure. LMA will need to coordinate with CVFPB to determine true owner. (O. Magana - DWR UCIP)12/07/2018 Encroachment Owner is Butte Water District c/o Mark Orme, District Manager, 735 Virginia Street, Gridley, CA 95948, 1-530-846-3100. Information obtained from the Levee_Encroachment_listing_11288.pdf obtained from SBFCa which also indicates CVFPB Permit Process - New Permit. Need to coordinate with CVFPB to determine status of permit. (O. Magana - DWR UCIP)
 08/09/2017 Dual 60-inch pipes are still present--no modifications appear to have been made to this structure. No permit or owner has been identified. Need to contact owner to notify of safety issue regarding the missing covers for CMP riser. (DWR UCIP - O. Magana)08/02/2017 After reviewing record drawings it appears this crossing has remained. Project Improvements begin at Station (Sta) 1765+00 (MA0007 about LM 1.73) to Sta 2303+50 (ST0005 about LM 1.23), refer to record drawings for the Feather River West Levee Improvement Plans Station 1765+00 to 2368+26, Project D details. MA0007 project details include NO CUTOFF WALL from Sta 1765+00 (MA0007 about LM 1.73) to 1815+00 (MA0007 about LM 2.64) and LEVEE DEGRADE AND RECONSTRUCTION WITH CUT OFF WALL from Sta 1817+00 (MA0007 about LM 2.69) to Sta 2289+00, Sta 2287+00 to Sta 2290+00 (MA0007 about LM 11.60). (DWR UCIP - O. Magana)

LS view: concrete headwall with dual 60-inch crossings.

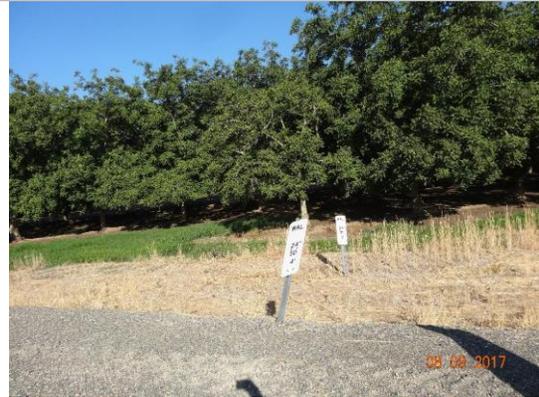
Photo 3 of 3 : UCIP_FA_2019_55068_77118.jpg

Overview of LS at crossing. Markers along pipe alignment indicating pipe depth of 4-feet (near levee shoulder) and 3-feet near toe.

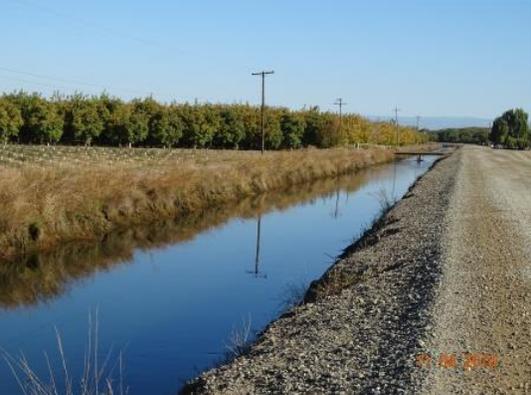
Photo 1 of 1 : FA_2019_MA0007_200_39_20191112_00028.jpg

View looking upstream landside at an irrigation ditch at the levee toe, Fall 2019.

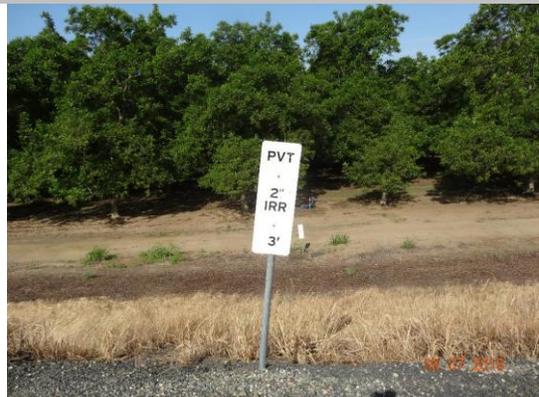
Photo 2 of 3 : UCIP_FA_2019_55084_80716.jpg

LS view: paddle marker along pipe alignment.

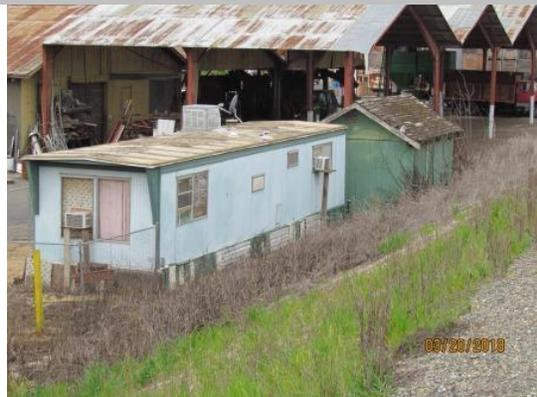
Photo 1 of 1 : FA_2019_MA0007_200_45_20190904_00004.jpg

LM Start	9.65	Rating **	U	Issue No.	45
LM End	9.65	Issue Type +	En	Location *	LS
Category	Earthen Levee			GPS Latitude/Longitude	
				Start	End
Item	Encroachments			39.416384 °	39.416384 °
				-121.634503 °	-121.634503 °
DWR ID	DWR_MA0007_01_s_2012_45				
Comment Code					
BU : Building					
Inspector Comment					
A trailer is still located at the landside levee toe, no permit found.

Building at the landside toe, no permit identified.

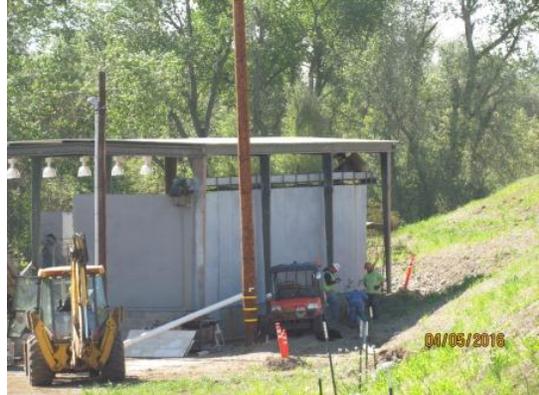
Photo 1 of 1 : FA_2019_MA0007_200_40_20190904_00003.jpg

View showing structure on the waterside looking downstream.
