**Flood Control Project Maintenance  
Levee Inspections**

**Fall 2019 Levee Maintenance Deficiency Summary Report**

**Sutter Maintenance Yard Maintenance Area 0012**

Waterway	Bank	Unit Miles
Unit No. 01 Colusa Drain	Left	11.06

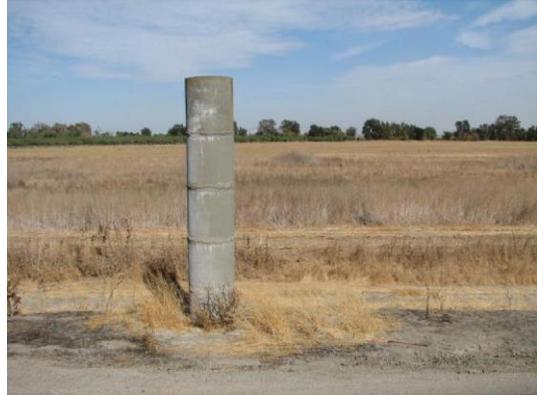
Photo 1 of 1 : UCIP\_FA\_2019\_51778\_68970.jpg

Item	DRAFT DWR UCIP Field Study			39.035889°	39.035889°
				-121.996882°	-121.996882°
DWR ID	17145				
Comment Code					
Inspector Comment					
DS_ID:17145 FS_ID:51778 EP_NO: 9381 Repair Type: Non-Urgent Crossing Status: Indicator Found UCIP Comments: 5/2/2017 Abandoned- needs to be done so properly. Only the LS standpipe was found. (DWR Sutter Yard-AFreitag)10/17/2016 Abandoned (DWR Sutter Yard-AFreitag)5/31/2016 Abandoned- only the LS concrete standpipe was found.5/4/2015 Abandoned crossing.6/17/2014 Same as last inspection.12/16/2013 Same as last inspection.7/16/2013 Same as last inspection.10/11/2012 Need to verify proper abandonment of pipe. FIELD_STRUCT_DESC: *ABANDONED* 14-inch steel irrigation pipe through the levee, 3 feet below the crown. Open on the waterside (WS) end. 3-foot by 6-foot concrete well on the WS berm. Siphon breaker in 24-inch riser located on the landside (LS) shoulder. 36-inch concrete standpipe on the LS toe. The only item identified is the 36-inch standpipe on the LS toe. (Automatic Board Order (ABO) issued as Permit No. 9381, 1974 - F. L. Tribble). [Additional Reference(s): DWR Levee Log, 2005. USACE Sacramento O&M Manual 132, October 1959, (HLM 0.22, Drawing No. 50-4-3081)]. FS Date: 5/2/2017 1:37:36 PM

36-inch concrete riser on LS toe.

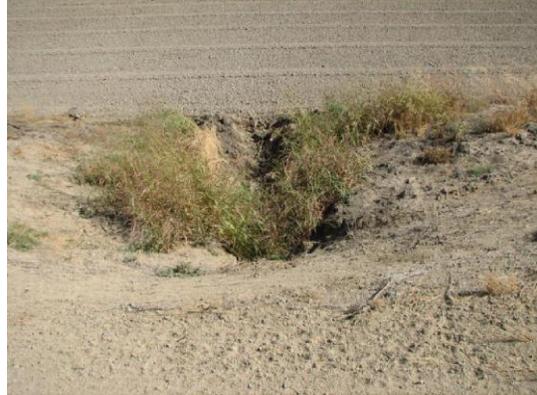
Photo 1 of 3 : UCIP\_FA\_2019\_51780\_68977.jpg

Item	DRAFT DWR UCIP LMA Responsibility		39.051280 °	39.051280 °	
			-122.002981 °	-122.002981 °	
DWR ID	17147				
Comment Code					
Inspector Comment					
<p>DS_ID:17147                      FS_ID:51780                      EP_NO: 9382                      Repair Type: No Action Needed                      Crossing Status: Found                      UCIP Comments: 5/2/2017 Crossing appears to be in good condition. (DWR Sutter Yard- AFreitag)10/17/2016 Crossing appears to be in good condition. This is a gravity for the LS.(DWR Sutter Yard- AFreitag)5/31/2016 Crossing appears to be in good condition.5/4/2015 Crossing is in good condition. No issues.6/17/2014 Same as last inspection.12/16/2013 Same as last inspection.7/16/2013 Same as last inspection.                      FIELD_STRUCT_DESC: 24-inch corrugated metal drainage pipe through the levee, 13 feet below the crown. Flap gate, concrete headwall, and grouted cobble spillway on the waterside (WS). Concrete headwall on the landside (LS). (24-inch pipe [HLM 1.40] authorized under Automatic Board Order (ABO) issued as Permit No. 9382, 1974 - Olen C. Bober). [Additional Reference(s): DWR Levee Log, 2005. USACE Sacramento O&amp;M Manual 132, October 1959, (HLM 1.4)].                      FS Date: 5/2/2017 1:40:20 PM</p>

Intake on LS toe.

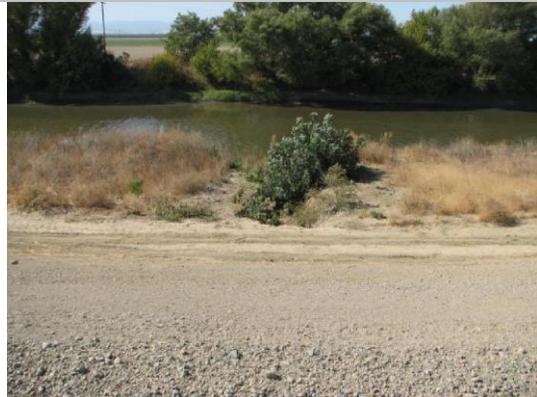
Photo 2 of 3 : UCIP\_FA\_2019\_51780\_68976.jpg

Outlet at WS toe.

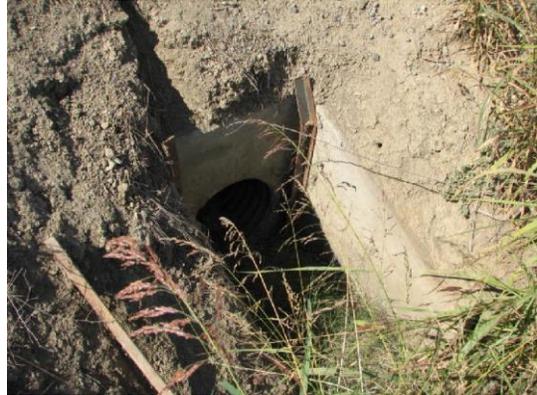
Photo 3 of 3 : UCIP\_FA\_2019\_51780\_68975.jpg

Item	DRAFT DWR UCIP LMA Responsibility		39.051280 °	39.051280 °	
			-122.002981 °	-122.002981 °	
DWR ID	17147				
Comment Code					
Inspector Comment					
DS_ID:17147 FS_ID:51780 EP_NO: 9382 Repair Type: No Action Needed Crossing Status: Found UCIP Comments: 5/2/2017 Crossing appears to be in good condition. (DWR Sutter Yard- AFreitag)10/17/2016 Crossing appears to be in good condition. This is a gravity for the LS.(DWR Sutter Yard- AFreitag)5/31/2016 Crossing appears to be in good condition.5/4/2015 Crossing is in good condition. No issues.6/17/2014 Same as last inspection.12/16/2013 Same as last inspection.7/16/2013 Same as last inspection. FIELD_STRUCT_DESC: 24-inch corrugated metal drainage pipe through the levee, 13 feet below the crown. Flap gate, concrete headwall, and grouted cobble spillway on the waterside (WS). Concrete headwall on the landside (LS). (24-inch pipe [HLM 1.40] authorized under Automatic Board Order (ABO) issued as Permit No. 9382, 1974 - Olen C. Bober). [Additional Reference(s): DWR Levee Log, 2005. USACE Sacramento O&M Manual 132, October 1959, (HLM 1.4)]. FS Date: 5/2/2017 1:40:20 PM

Concrete U shaped headwall on LS toe.

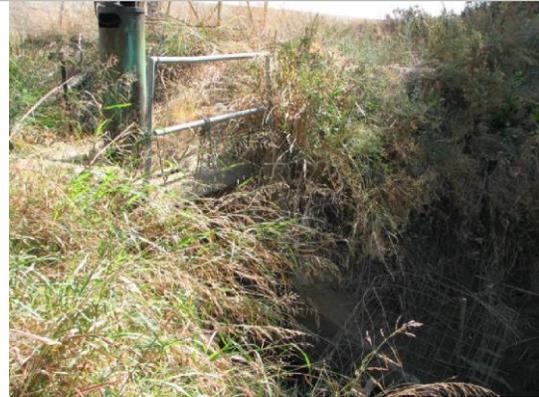
Photo 3 of 3 : UCIP\_FA\_2019\_51781\_68979.jpg

Comment Code						
Inspector Comment						
<p>DS_ID:17148                  FS_ID:51781                  EP_NO: 9382                  Repair Type: Non-Urgent                  Crossing Status: Found                  UCIP Comments: 5/2/2017 WS is being overgrown with vegetation. The rest of the crossing appears to be in good condition. (DWR Sutter Yard- AFreitag)10/17/2016 Vegetation is overgrowing the WS head wall near the pump. The rest of the crossing appears to be in good condition. (DWR Sutter Yard- AFreitag)5/31/2016 Crossing appears to be in good condition.5/4/2015 Crossing appears in good condition. No noticeable issues to report.6/17/2014 Same as last inspection.12/16/2013 Same as last inspection.7/16/2013 Same as last inspection.                  FIELD_STRUCT_DESC: 18-inch steel irrigation pipe through the levee, 3 feet below the crown. Pump, butterfly valve, and concrete headwall at the edge of the bank. Bank cobble revetted 10 feet on both the waterside (WS) and the landside (LS) of installation. 18-inch polyvinyl chloride (PVC) standpipe on the LS berm. Siphon breaker in 18-inch concrete riser on the LS shoulder. Service pole at the edge of the bank. (24-inch [HLM 1.53] authorized under Automatic Board Order (ABO) issued as Permit No. 9382, 1974 - Olen C. Bober) [Additional Reference(s): DWR Levee Log, 2005. USACE Sacramento O&amp;M Manual 132, October 1959, (HLM 1.53)].                  FS Date: 5/2/2017 1:47:19 PM</p>

Pump and concrete headwall at WS toe.

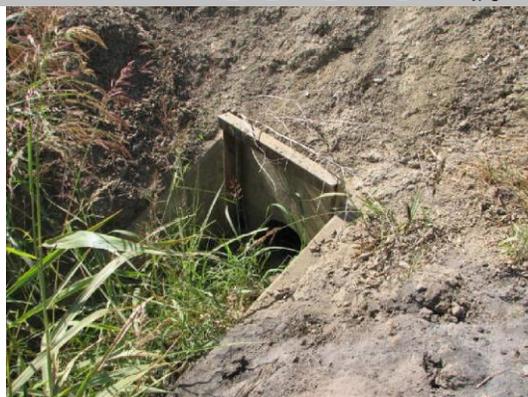
Photo 3 of 3 : UCIP\_FA\_2019\_51782\_68982.jpg

Item	DRAFT DWR UCIP LMA Responsibility			39.055711 °	39.055711 °
				-122.003252 °	-122.003252 °
DWR ID	17149				
Comment Code					
Inspector Comment					
<p>DS_ID:17149                  FS_ID:51782                  EP_NO: 9382                  Repair Type: Non-Urgent                  Crossing Status: Found                  UCIP Comments: 5/2/2017 WS flapgate buried by sediment. Needs to be dug out. (DWR Sutter Yard- AFreitag)10/17/2016 Crossing appears to be in good condition. This is a gravity drain for the LS. (DWR Sutter Yard- AFreitag)5/31/2016 LS inlets was partially plugged. WS flapgate was clear of sediment and abale to operate properly.5/4/2015 WS flapgate is blocked by sediment and unable to open. LS inlet is plugged by silt and wood chippings. Needs to be cleaned.6/17/2014 Flap gate was cleaned out and is fully closed. LS inlet still partially full of soil.12/16/2013 Same as last inspection. WS flapgate still needs to be cleaned out and shut.7/16/2013 Same as last inspection. Make sure flapgate is closed before highwater season.10/11/2012 Inlet on LS filled partially with soil. Outlet blocked with soil and the flap gate wont close.                  FIELD_STRUCT_DESC: 24-inch corrugated metal drainage pipe through the levee, 13 feet below the crown. Flap gate, concrete headwall, and grouted cobble spillway on the waterside (WS). Concrete headwall on the landside (LS). (24-inch pipe [HLM 1.72] authorized under Automatic Board Order (ABO) issued as Permit No. 9382, 1974 - Olen C. Bober). [Additional Reference(s): DWR Levee Log, 2005. USACE Sacramento O&amp;M Manual 132, October 1959, (HLM 1.72)].                  FS Date: 5/2/2017 1:50:52 PM</p>

Concrete U shaped headwall at LS inlet.

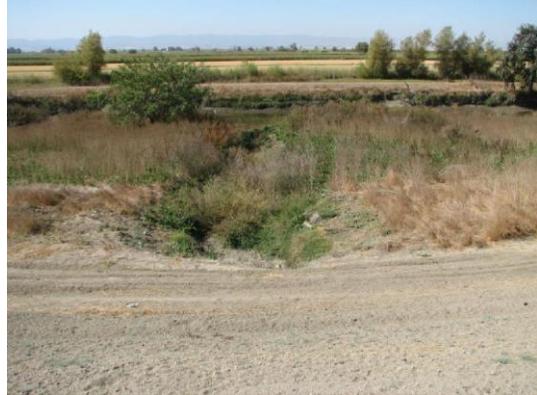
Photo 2 of 3 : UCIP\_FA\_2019\_51788\_69001.jpg

Item	DRAFT DWR UCIP LMA Responsibility			39.074151 °	39.074151 °
				-122.014960 °	-122.014960 °
DWR ID	17153				
Comment Code					
Inspector Comment					
<p>DS_ID:17153                  FS_ID:51788                  EP_NO: 9384                  Repair Type: No Action Needed                  Crossing Status: Found                  UCIP Comments: 5/2/2017 Crossing appears to be in good condition. (DWR Sutter Yard- AFreitag)10/17/2016 Crossing appears to be in good condition. (DWR Sutter Yard- AFreitag)5/31/2016 Crossing appears to be in good condition.5/4/2015 Crossing appears in good condition. No noticeable issues.6/17/2014 Same as last inspection.12/16/2013 Same as last inspection.7/16/2013 Same as last inspection.                  FIELD_STRUCT_DESC: 24-inch corrugated metal drainage pipe through the levee, 16 feet below the crown. Flap gate, concrete headwall, and grouted cobble spillway on the waterside (WS). Concrete headwall on the landside (LS). (24-inch pipe [HLM 3.22] authorized under Automatic Board Order (ABO) issued as Permit No. 9384, 1974 - William D. Struckmeyer) [Additional Reference(s): DWR Levee Log, 2005. USACE Sacramento O&amp;M Manual 132, October 1959, (HLM 3.22)].                  FS Date: 5/2/2017 2:04:40 PM</p>

Drainage Swale on WS toe.

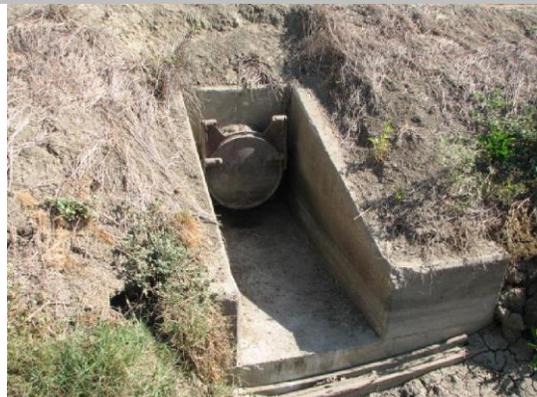
Photo 3 of 3 : UCIP\_FA\_2019\_51788\_69000.jpg

Concrete headwall and flap gate at WS toe.

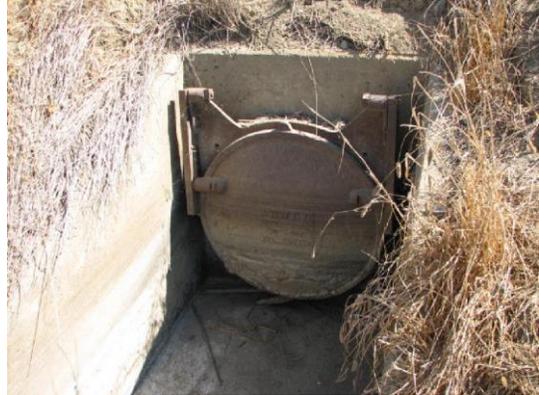
Photo 3 of 3 : UCIP\_FA\_2019\_51791\_69012.jpg

Item	DRAFT DWR UCIP LMA Responsibility			39.088561 °	39.088561 °
				-122.015179 °	-122.015179 °
DWR ID	17168				
Comment Code					
Inspector Comment					
DS_ID:17168 FS_ID:51791 EP_NO: 9388 Repair Type: No Action Needed Crossing Status: Found UCIP Comments: 5/2/2017 Crossing appears to be in good condition. (DWR Sutter Yard- AFreitag)10/17/2016 Crossing appears to be in good condition. (DWR Sutter Yard- AFreitag)5/31/2016 Crossing appears to be in good condition.5/4/2015 Corssing appears to be in good condition. No noticeable issues to report.6/17/2014 Same as last inspection.12/16/2013 Same as last inspection.7/16/2013 Same as last inspection. FIELD_STRUCT_DESC: 36-inch corrugated metal drainage pipe through the levee, 27.5 feet below the crown. Flap gate, concrete headwall, and grouted cobble spillway located on the waterside (WS). Concrete headwall located on the landside (LS). (24-inch pipe [HLM 4.25] authorized under Automatic Board Order (ABO) issued as Permit No. 9388, 1974 - Pauline A. Wallace). [Additional Reference(s): DWR Levee Log, 2005. USACE Sacramento O&M Manual 132, October 1959, (HLM 4.25)]. FS Date: 5/2/2017 2:08:40 PM

Concrete U shaped headwall and flap gate on WS toe.

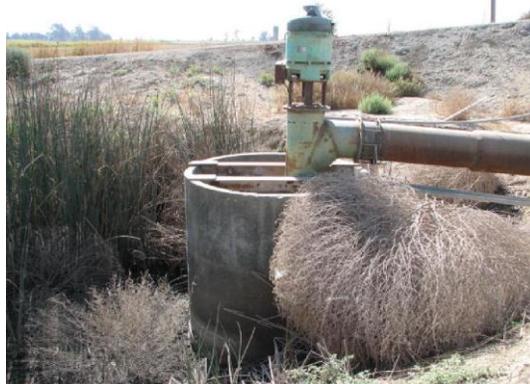
Photo 1 of 3 : UCIP\_FA\_2019\_51792\_69017.jpg

Item	DRAFT DWR UCIP LMA Responsibility		39.089551 °	39.089551 °	
			-122.015241 °	-122.015241 °	
DWR ID	17156				
Comment Code					
Inspector Comment					
DS_ID:17156 FS_ID:51792 EP_NO: 9388 Repair Type: No Action Needed Crossing Status: Found UCIP Comments: 5/2/2017 Crossing appears to be in good condition. (DWR Sutter Yard- AFreitag)10/17/2016 Crossing appears to be in good condition. (DWR Sutter Yard- AFreitag)5/31/2016 Crossing appears to be in good condition. 5/4/2015 Corssing appears to be in good condition. No noticeable issues to report. 6/17/2014 Same as last inspection. 12/16/2013 Same as last inspection. 7/16/2013 Same as last inspection. FIELD_STRUCT_DESC: 24-inch corrugated metal drainage pipe through the levee, 9.2 feet below the crown. Slide gate in a 36-inch corrugated metal pipe (CMP) riser on the waterside (WS) slope. Pump on a 60-inch concrete standpipe at the landside (LS) toe. (24-inch pipe [HLM 4.32] authorized under Automatic Board Order (ABO) issued as Permit No. 9388, 1974 - Pauline A. Wallace). [Additional Reference(s): DWR Levee Log, 2005. USACE Sacramento O&M Manual 132, October 1959, (HLM 4.32)]. FS Date: 5/2/2017 2:20:21 PM

Pump on Concrete riser at LS toe.

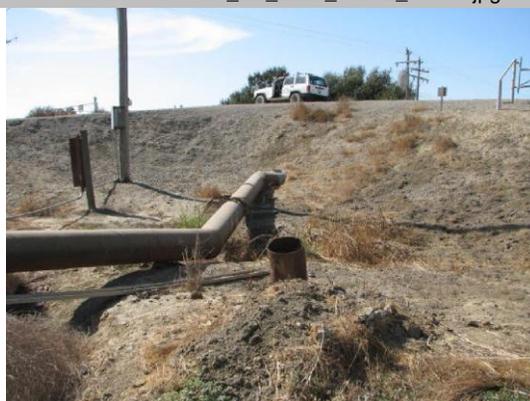
Photo 2 of 3 : UCIP\_FA\_2019\_51792\_69016.jpg

Pipe through levee at LS slope.

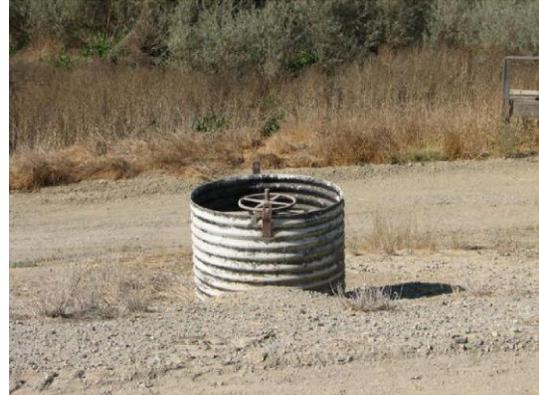
Photo 3 of 3 : UCIP\_FA\_2019\_51792\_69015.jpg

Item	DRAFT DWR UCIP LMA Responsibility			39.089551 °	39.089551 °
				-122.015241 °	-122.015241 °
DWR ID	17156				
Comment Code					
Inspector Comment					
<p>DS_ID:17156                  FS_ID:51792                  EP_NO: 9388                  Repair Type: No Action Needed                  Crossing Status: Found                  UCIP Comments: 5/2/2017 Crossing appears to be in good condition. (DWR Sutter Yard- A Freitag)10/17/2016 Crossing appears to be in good condition. (DWR Sutter Yard- A Freitag)5/31/2016 Crossing appears to be in good condition.5/4/2015 Corssing appears to be in good condition. No noticeable issues to report.6/17/2014 Same as last inspection.12/16/2013 Same as last inspection.7/16/2013 Same as last inspection.                  FIELD_STRUCT_DESC: 24-inch corrugated metal drainage pipe through the levee, 9.2 feet below the crown. Slide gate in a 36-inch corrugated metal pipe (CMP) riser on the waterside (WS) slope. Pump on a 60-inch concrete standpipe at the landside (LS) toe. (24-inch pipe [HLM 4.32] authorized under Automatic Board Order (ABO) issued as Permit No. 9388, 1974 - Pauline A. Wallace). [Additional Reference(s): DWR Levee Log, 2005. USACE Sacramento O&amp;M Manual 132, October 1959, (HLM 4.32)].                  FS Date: 5/2/2017 2:20:21 PM</p>

36-inch CMP riser with Slide gate on WS shoulder.

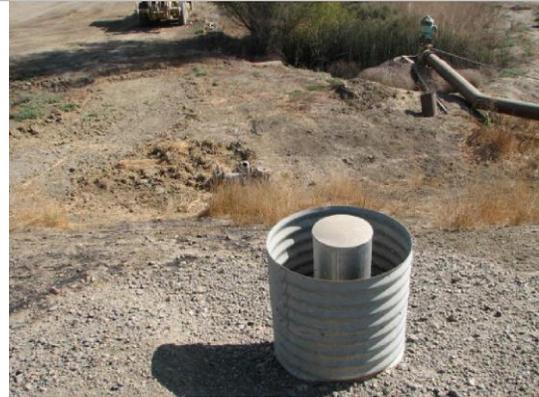
Photo 1 of 3 : UCIP\_FA\_2019\_51794\_69023.jpg

Item	DRAFT DWR UCIP Field Study		39.089666°	39.089666°	
			-122.015248°	-122.015248°	
DWR ID	20717				
Comment Code					
Inspector Comment					
DS_ID:20717 FS_ID:51794 EP_NO: N/A Repair Type: Non-Urgent Crossing Status: Found UCIP Comments: 5/2/2017 Crossing appears to be in good condition. (DWR Sutter Yard- AFreitag)10/17/2016 Crossing appears to be in good condition. (DWR Sutter Yard- AFreitag)5/31/2016 Crossing appears to be in good condition.5/4/2015 Corssing appears to be in good condition. No noticeable issues to report.6/17/2014 Same as last inspection. Pump reinstalled on pier.12/16/2013 Pump has been removed for winter.7/16/2013 Same as last inspection.10/11/2012 No permit identified for this crossing. FIELD_STRUCT_DESC: 24-inch asphalt coated steel irrigation pipe though the levee, 4.5 feet below the crown. Pump in pump house located on the waterside (WS) bank. Siphon breaker valve installed on the landside (LS) shoulder. No permit has been identified since crossing was field discovered in 2012. FS Date: 5/2/2017 2:29:42 PM

Possible siphon breaker for pipe on LS shoulder.

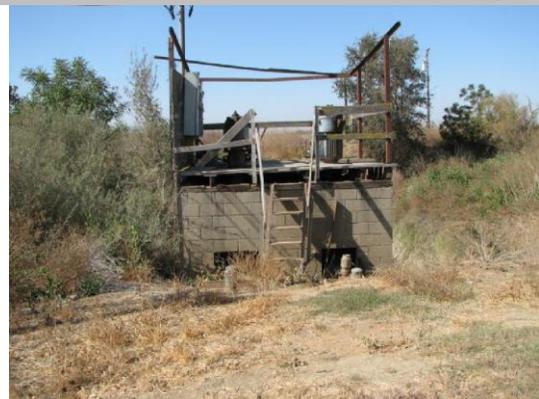
Photo 2 of 3 : UCIP\_FA\_2019\_51794\_69022.jpg

Pumping plant on WS toe.

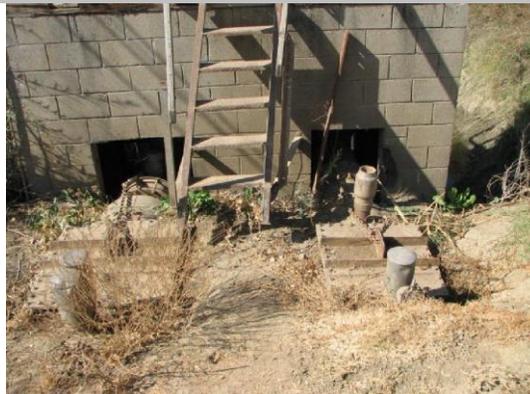
Photo 3 of 3 : UCIP\_FA\_2019\_51794\_69021.jpg

Item	DRAFT DWR UCIP Field Study			39.089666°	39.089666°
				-122.015248°	-122.015248°
DWR ID	20717				
Comment Code					
Inspector Comment					
DS_ID:20717 FS_ID:51794 EP_NO: N/A Repair Type: Non-Urgent Crossing Status: Found UCIP Comments: 5/2/2017 Crossing appears to be in good condition. (DWR Sutter Yard- AFreitag)10/17/2016 Crossing appears to be in good condition. (DWR Sutter Yard- AFreitag)5/31/2016 Crossing appears to be in good condition. 5/4/2015 Corssing appears to be in good condition. 6/17/2014 Same as last inspection. No noticeable issues to report. 12/16/2013 Pump has been removed for winter. 7/16/2013 Same as last inspection. 10/11/2012 No permit identified for this crossing. FIELD_STRUCT_DESC: 24-inch asphalt coated steel irrigation pipe though the levee, 4.5 feet below the crown. Pump in pump house located on the waterside (WS) bank. Siphon breaker valve installed on the landside (LS) shoulder. No permit has been identified since crossing was field discovered in 2012. FS Date: 5/2/2017 2:29:42 PM

Pipe on seft side of photo.

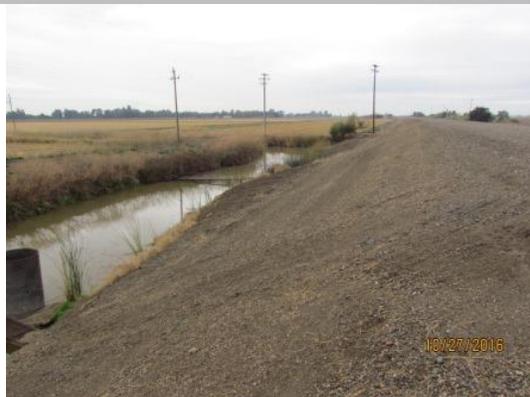
Photo 1 of 1 : FA\_2019\_MA0012\_299\_4\_20190829\_00003.jpg

LM Start	<b>4.72</b>	Rating **	M	Issue No.	<b>4</b>
LM End	<b>4.77</b>	Issue Type +	En	Location *	LS
Category	Earthen Levee			GPS Latitude/Longitude	
				Start	End
Item	Encroachments			39.096839°	39.097455°
				-122.015568°	-122.015581°
DWR ID	DWR_MA0012_01_s_2012_4				
Comment Code					
DT : Ditch					
Inspector Comment

View of a ditch along the landside toe.

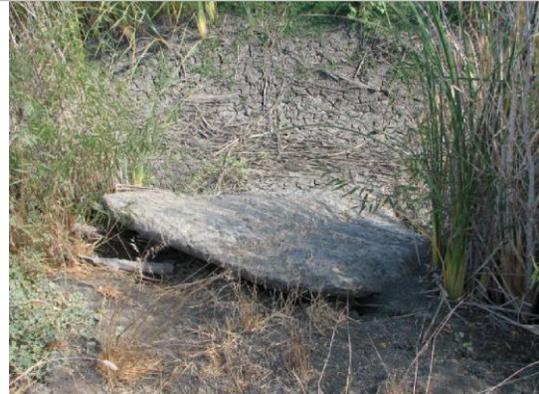
Photo 1 of 3 : UCIP\_FA\_2019\_51796\_69030.jpg

Item	DRAFT DWR UCIP LMA Responsibility			39.100898°	39.100898°
				-122.016078°	-122.016078°
DWR ID	17191				
Comment Code					
Inspector Comment					
<p>DS_ID:17191                  FS_ID:51796                  EP_NO: N/A                  Repair Type: Non-Urgent                  Crossing Status: Found                  UCIP Comments: 5/2/2017 WS headwall and flapgate almost completely buried with only a small portion of the head wall visible. LS end is buried and unable to be located. (DWR Sutter Yard- AFreitag)10/17/2016 WS flap gate is still silted over and LS inlet is heavily vegetated and unable to be inspected. (DWR Sutter Yard- AFreitag)9/29/2016 Crosssing has been downgraded from Urgent to Non-Urgent WS flap gate is closed shut due to sediment build up. For flood season flap gate is required to be closed. Need to coordinate with owner to remove sediment from WS to have WS flap gate be operable after flood season. (DWR UCIP - omagana)5/31/2016 WS pipe end was mostly underwater but it appears to still be silted over. (DWR Sutter Yard - afreitag)5/4/2015 WS flapgate is blocked by sediment and unable to open. LS inlet is hidden by sediment and heavy vegetation and unable to be located. Needs to be cleared. (DWR Sutter Yard - afreitag)6/17/2014 Same as last inspection. (DWR Sutter Yard - afreitag)12/16/2013 Same as last inspection. (DWR Sutter Yard - afreitag)7/16/2013 Same as last inspection. (DWR Sutter Yard - afreitag)10/11/2012 Pipe is clogged at both the inlet and outlet. Good candidate for video inspection. (DWR UCIP - wwyllie)                  FIELD_STRUCT_DESC: 48-inch corrugated metal drainage pipe through the levee, approximately 15 feet below the crown. Concrete headwalls on both the waterside (WS) and the landside (LS) ends with an automatic drainage gate on the WS. [Additional Reference(s): USACE Sacramento O&amp;M Manual 132, October 1959, (HLM 5.12)].                  FS Date: 5/2/2017 2:31:39 PM</p>

Apparent inlet clogged with concrete or grout on LS toe in drainage swale.

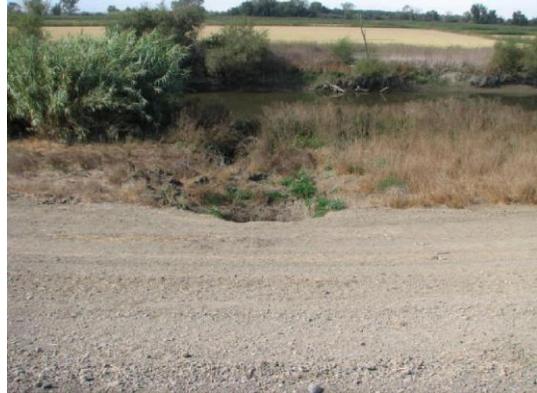
Photo 2 of 3 : UCIP\_FA\_2019\_51796\_69029.jpg

Item	DRAFT DWR UCIP LMA Responsibility			39.100898°	39.100898°	
				-122.016078°	-122.016078°	
DWR ID	17191					
Comment Code						
Inspector Comment						
DS_ID:17191 FS_ID:51796 EP_NO: N/A Repair Type: Non-Urgent Crossing Status: Found UCIP Comments: 5/2/2017 WS headwall and flapgate almost completely buried with only a small portion of the head wall visible. LS end is buried and unable to be located. (DWR Sutter Yard- AFreitag)10/17/2016 WS flap gate is still silted over and LS inlet is heavily vegetated and unable to be inspected. (DWR Sutter Yard- AFreitag)9/29/2016 Crosssing has been downgraded from Urgent to Non-Urgent WS flap gate is closed shut due to sediment build up. For flood season flap gate is required to be closed. Need to coordinate with owner to remove sediment from WS to have WS flap gate be operable after flood season. (DWR UCIP - omagana)5/31/2016 WS pipe end was mostly underwater but it appears to still be silted over. (DWR Sutter Yard - afreitag)5/4/2015 WS flapgate is blocked by sediment and unable to open. LS inlet is hidden by sediment and heavy vegetation and unable to be located. Needs to be cleared. (DWR Sutter Yard - afreitag)6/17/2014 Same as last inspection. (DWR Sutter Yard - afreitag)12/16/2013 Same as last inspection. (DWR Sutter Yard - afreitag)7/16/2013 Same as last inspection. (DWR Sutter Yard - afreitag)10/11/2012 Pipe is clogged at both the inlet and outlet. Good candidate for video inspection. (DWR UCIP - wwyllie) FIELD_STRUCT_DESC: 48-inch corrugated metal drainage pipe through the levee, approximately 15 feet below the crown. Concrete headwalls on both the waterside (WS) and the landside (LS) ends with an automatic drainage gate on the WS. [Additional Reference(s): USACE Sacramento O&M Manual 132, October 1959, (HLM 5.12)]. FS Date: 5/2/2017 2:31:39 PM

Outlet on WS toe.

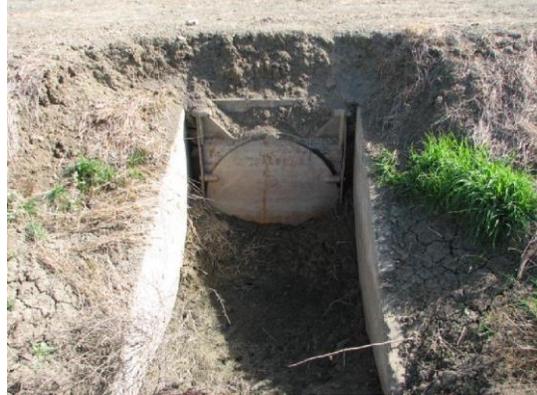
Photo 3 of 3 : UCIP\_FA\_2019\_51796\_69028.jpg

Item	DRAFT DWR UCIP LMA Responsibility			39.100898°	39.100898°
				-122.016078°	-122.016078°
DWR ID	17191				
Comment Code					
Inspector Comment					
<p>DS_ID:17191                      FS_ID:51796                      EP_NO: N/A                      Repair Type: Non-Urgent                      Crossing Status: Found                      UCIP Comments: 5/2/2017 WS headwall and flapgate almost completely buried with only a small portion of the head wall visible. LS end is buried and unable to be located. (DWR Sutter Yard- AFreitag)10/17/2016 WS flap gate is still silted over and LS inlet is heavily vegetated and unable to be inspected. (DWR Sutter Yard- AFreitag)9/29/2016 Crosssing has been downgraded from Urgent to Non-Urgent WS flap gate is closed shut due to sediment build up. For flood season flap gate is required to be closed. Need to coordinate with owner to remove sediment from WS to have WS flap gate be operable after flood season. (DWR UCIP - omagana)5/31/2016 WS pipe end was mostly underwater but it appears to still be silted over. (DWR Sutter Yard - afreitag)5/4/2015 WS flapgate is blocked by sediment and unable to open. LS inlet is hidden by sediment and heavy vegetation and unable to be located. Needs to be cleared. (DWR Sutter Yard - afreitag)6/17/2014 Same as last inspection. (DWR Sutter Yard - afreitag)12/16/2013 Same as last inspection. (DWR Sutter Yard - afreitag)7/16/2013 Same as last inspection. (DWR Sutter Yard - afreitag)10/11/2012 Pipe is clogged at both the inlet and outlet. Good candidate for video inspection. (DWR UCIP - wwyllie)                      FIELD_STRUCT_DESC: 48-inch corrugated metal drainage pipe through the levee, approximately 15 feet below the crown. Concrete headwalls on both the waterside (WS) and the landside (LS) ends with an automatic drainage gate on the WS. [Additional Reference(s): USACE Sacramento O&amp;M Manual 132, October 1959, (HLM 5.12)].                      FS Date: 5/2/2017 2:31:39 PM</p>

Concrete U shaped headwall and flap gate on WS toe.

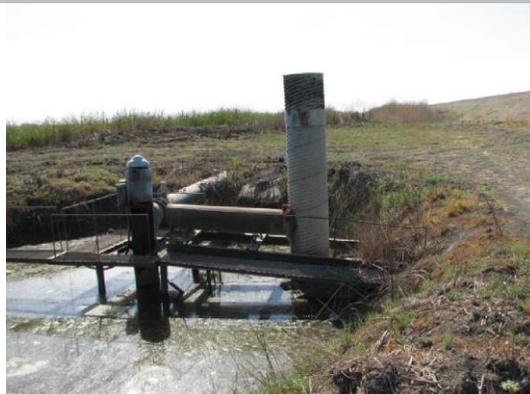
Photo 1 of 3 : UCIP\_FA\_2019\_51797\_69034.jpg

Item	DRAFT DWR UCIP LMA Responsibility			39.113840°	39.113840°
				-122.017736°	-122.017736°
DWR ID	17190				
Comment Code					
Inspector Comment					
DS_ID:17190 FS_ID:51797 EP_NO: N/A Repair Type: No Action Needed Crossing Status: Found UCIP Comments: 5/2/2017 Crossing appears to be in good condition. (DWR Sutter Yard- AFreitag)10/17/2016 Crossing appears to be in good condition. Pipe was field verified to be 48inch cmp. (DWR Sutter Yard- AFreitag)5/31/2016 Crossing appears to be in good condition.5/4/2015 Corssing appears to be in good condition. No noticeable issues to report.6/17/2014 Same as last inspection.12/16/2013 Same as last inspection.7/16/2013 Same as last inspection. FIELD_STRUCT_DESC: 48-inch corrugated metal drainage pipe through the levee, approximately 22 feet below the crown. Concrete headwalls at both the waterside (WS) and the landside (LS) ends with flap gate on the WS. 36-inch corrugated metal pipe (CMP) riser on the LS toe with steel pipe extension for overflow weir of LS ditch. Walkway and pump not associated with this crossing. (Automatic board order (ABO) issued as Permit No. 8234, 1972 - Glenn Irrigation District, for 36-inch, not 48-inch). [Additional Reference(s): USACE Sacramento O&M Manual 132, October 1959, (HLM 6.04, Drawing No. 50-4-3081, Sheet 16)]. FS Date: 5/2/2017 2:33:13 PM

36-inch CM standpipe with steel pipe extension for weir on LS toe. pump not associated with storm drain crossing.

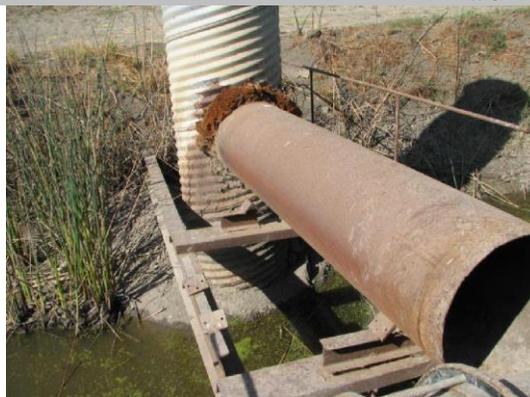
Photo 2 of 3 : UCIP\_FA\_2019\_51797\_69033.jpg

36-inch CM standpipe with steel pipe extension for weir on LS toe.

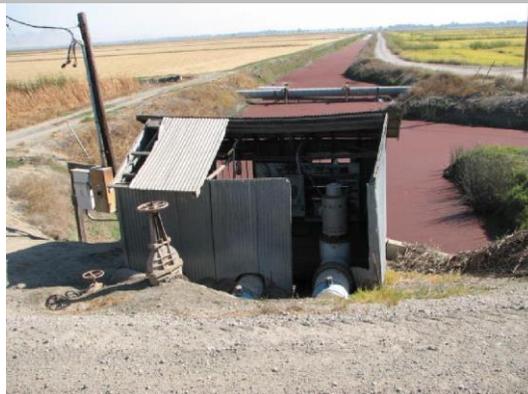
Photo 1 of 3 : UCIP\_FA\_2019\_51800\_69061.jpg

Item	DRAFT DWR UCIP Field Study		39.114949°	39.114949°	
			-122.017946°	-122.017946°	
DWR ID	20715				
Comment Code					
Inspector Comment					
<p>DS_ID:20715                  FS_ID:51800                  EP_NO: 13699                  Repair Type: Non-Urgent                  Crossing Status: Found                  UCIP Comments: 5/2/2017 Pipe appears to be in good condition. Minor erosion above the LS pump house. (DWR Sutter Yard-AFreitag)10/17/2016 Crossing appears to be in good condition.</p> <p>5/31/2016 Crossing appears to be in good condition.5/4/2015 Corssing appears to be in good condition. No noticeable issues to report.6/17/2014 Same as last inspection.12/16/2013 Same as last inspection.7/16/2013 Same as last inspection.10/11/2012 Oil leakage around pump.</p> <p>FIELD_STRUCT_DESC: 1 of 2: 20-inch soil proofed steel drainage pipe through the levee, 4.4 feet below the crown. Cobble revetted sump located on the waterside (WS). Siphon breaker in a 24-inch metal riser on the WS shoulder. Pump house at the landside (LS) toe. This crossing replaces the previous 18-inch pipe listed in the O&amp;M manual, see DS_ID 17162. (Permit No. 13699, 1984 - Davis Ranches).                  [Additional Reference(s): USACE Sacramento O&amp;M Manual 132, October 1959, (HLM 6.13)].                  FS Date: 5/2/2017 2:35:14 PM</p>

Pumping plant on LS slope

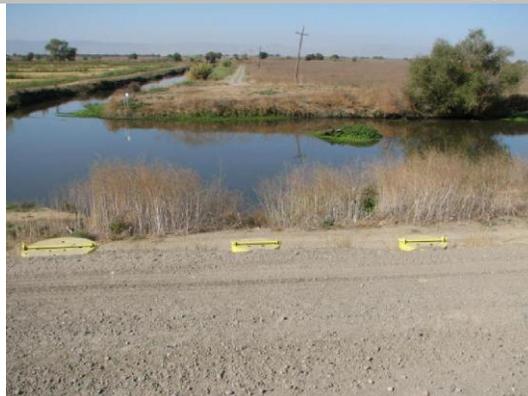
Photo 2 of 3 : UCIP\_FA\_2019\_51800\_69060.jpg

Siphon Breaker on WS shoulder.

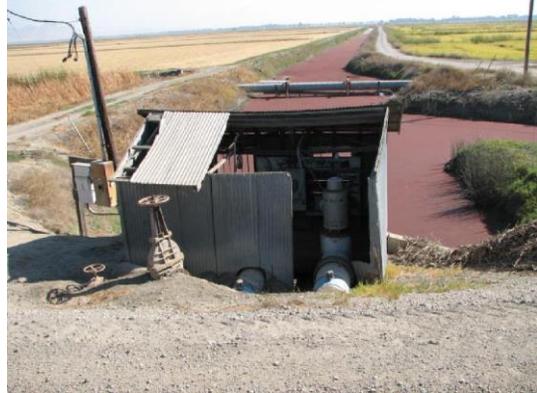
Photo 1 of 3 : UCIP\_FA\_2019\_51803\_69081.jpg

Item	DRAFT DWR UCIP LMA Responsibility		39.114977°	39.114977°	
			-122.017947°	-122.017947°	
DWR ID	17199				
Comment Code					
Inspector Comment					
<p>DS_ID:17199                  FS_ID:51803                  EP_NO: 9390                  Repair Type: Non-Urgent                  Crossing Status: Found                  UCIP Comments: 5/2/2017 Pipe appears to be in good condition. Minor erosion above the LS pump house. (DWR Sutter Yard- AFreitag)10/17/2016 Crossing appears to be in good condition. (DWR Sutter Yard- AFreitag)5/31/2016 Crossing appears to be in good condition.5/4/2015 Corssing appears to be in good condition. No noticeable issues to report.6/17/2014 Same as last inspection.12/16/2013 Same as last inspection.7/16/2013 Same as last inspection.10/11/2012 Minor oil leak on pump.                  FIELD_STRUCT_DESC: 3 of 3: 18-inch steel drainage pipe through the levee, 4.4 feet below the crown. Cobble revetted sump located on the waterside (WS). Siphon breaker in a 16-inch metal riser on the WS shoulder. Pump house at the landside (LS) toe. (18-inch pipe authorized under Automatic Board Order (ABO) issued as Permit No. 9390, 1974 - Annie D. Propfe). [Additional Reference(s): DWR Levee Log, 2005. USACE Sacramento O&amp;M Manual 132, October 1959, (HLM 6.13)].                  FS Date: 5/2/2017 2:37:23 PM</p>

Pump house on LS slope.

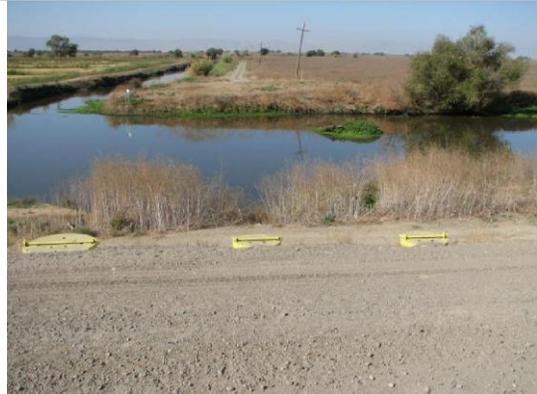
Photo 2 of 3 : UCIP\_FA\_2019\_51803\_69080.jpg

Siphon breaker on WS shoulder.

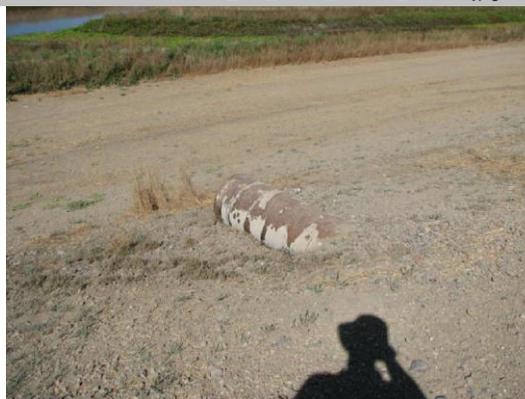
Photo 1 of 3 : UCIP\_FA\_2019\_51804\_69089.jpg

Item	DRAFT DWR UCIP Field Study			39.137187°	39.137187°
				-122.022793°	-122.022793°
DWR ID	17163				
Comment Code					
Inspector Comment					
DS_ID:17163 FS_ID:51804 EP_NO: 9390 Repair Type: Non-Urgent Crossing Status: Found UCIP Comments: 5/2/2017 Appears abandoned- pipe capped on both ends. Should be removed. (DWR Sutter Yard- AFreitag)10/17/2016 Appears abandoned and should be removed. (DWR Sutter Yard- AFreitag)5/31/2016 Appears to be abandoned. Pipe is capped on both WS and LS ends.5/4/2015 Corssing appears to be in good condition. No noticeable issues to report.6/17/2014 Same as last inspection.12/16/2013 Same as last inspection.7/16/2013 Same as last inspection.10/11/2012 Rodent burrowing along sides of pipe on LS. FIELD_STRUCT_DESC: 24-inch steel irrigation pipe through the levee, 3 feet below the crown. Both ends capped, terminating on levee slopes. (Automatic Board Order (ABO) issued as Permit No. 9390, 1974 - Annie D. Propfe). [Additional Reference(s): DWR Levee Log, 2005. USACE Sacramento O&M Manual 132, October 1959, (HLM 7.76)]. FS Date: 5/2/2017 2:45:44 PM

Pipe on WS.

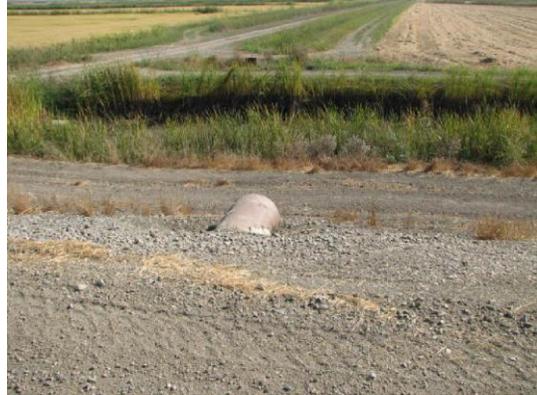
Photo 2 of 3 : UCIP\_FA\_2019\_51804\_69088.jpg

Item	DRAFT DWR UCIP Field Study			39.137187°	39.137187°
				-122.022793°	-122.022793°
DWR ID	17163				
Comment Code					
Inspector Comment					
DS_ID:17163 FS_ID:51804 EP_NO: 9390 Repair Type: Non-Urgent Crossing Status: Found UCIP Comments: 5/2/2017 Appears abandoned- pipe capped on both ends. Should be removed. (DWR Sutter Yard- AFreitag)10/17/2016 Appears abandoned and should be removed. (DWR Sutter Yard- AFreitag)5/31/2016 Appears to be abandoned. Pipe is capped on both WS and LS ends.5/4/2015 Corssing appears to be in good condition. No noticeable issues to report.6/17/2014 Same as last inspection.12/16/2013 Same as last inspection.7/16/2013 Same as last inspection.10/11/2012 Rodent burrowing along sides of pipe on LS. FIELD_STRUCT_DESC: 24-inch steel irrigation pipe through the levee, 3 feet below the crown. Both ends capped, terminating on levee slopes. (Automatic Board Order (ABO) issued as Permit No. 9390, 1974 - Annie D. Propfe). [Additional Reference(s): DWR Levee Log, 2005. USACE Sacramento O&M Manual 132, October 1959, (HLM 7.76)]. FS Date: 5/2/2017 2:45:44 PM

Pipe on LS.

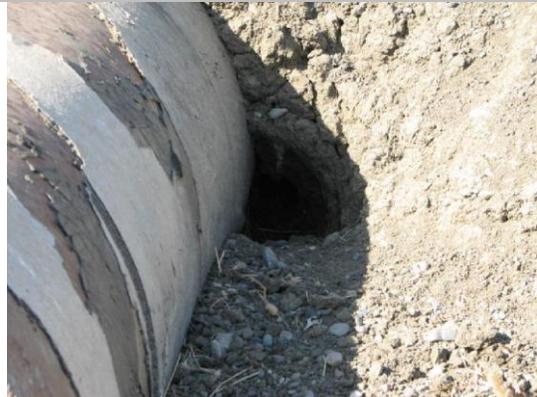
Photo 3 of 3 : UCIP\_FA\_2019\_51804\_69087.jpg

Animal burrows along side of pipe LS.

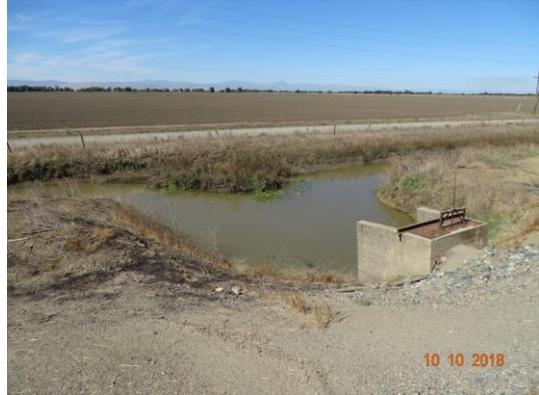
Photo 1 of 2 : FA\_2019\_MA0012\_299\_35\_20190829\_00005.jpg

View of diversion structure. Fall 2018.

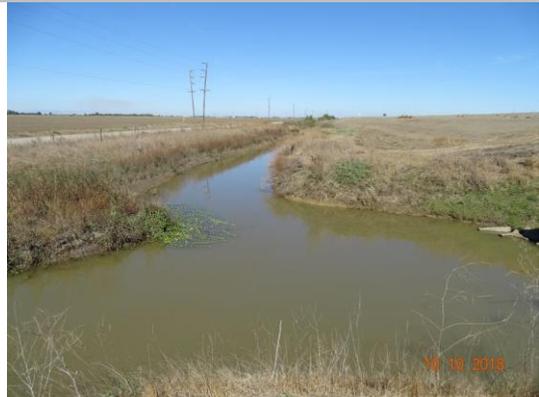
Photo 2 of 2 : FA\_2019\_MA0012\_299\_35\_20190829\_00006.jpg

Upstream view of Colusa Basin from the diversion structure. Fall 2018.

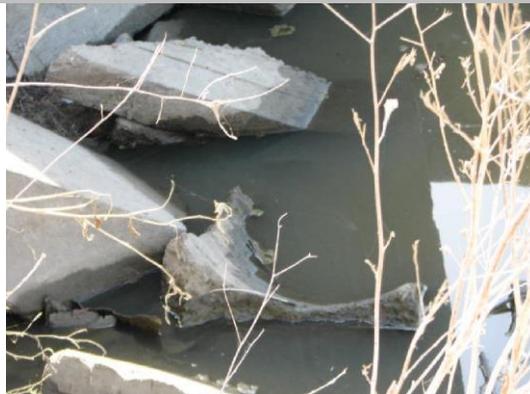
Photo 3 of 3 : UCIP\_FA\_2019\_51807\_69107.jpg

Item	DRAFT DWR UCIP Field Study			39.158124 °	39.158124 °
				-122.021701 °	-122.021701 °
DWR ID	17165				
Comment Code					
Inspector Comment					
DS_ID:17165 FS_ID:51807 EP_NO: 9390 Repair Type: Non-Urgent Crossing Status: Indicator Found UCIP Comments: 5/2/2017 Abandoned- only LS steel walkway is visible. (DWR Sutter Yard- AFreitag)10/17/2016 Abandoned. (DWR Sutter Yard- AFreitag)5/31/2016 Abandoned crossing.5/4/2015 Abandoned crossing.6/17/2014 Same as last inspection.12/16/2013 Same as last inspection.7/16/2013 Same as last inspection.10/11/2012 Pipe abandoned. Steel pump platform remains on LS slope, but all appurtenances have been removed. FIELD_STRUCT_DESC: *ABANDONED* 18-inch steel drainage pipe through the levee, 3 feet below the crown. Waterside (WS) end open into concrete spill box. Pump located on the landside (LS) on steel pier. (18-inch pipe authorized under Automatic Board Order (ABO) issued as Permit No. 9390, 1974 - Annie D. Propfe). [Additional Reference(s): DWR Levee Log, 2005. USACE Sacramento O&M Manual 132, October 1959, (HLM 9.24)]. FS Date: 5/2/2017 2:47:45 PM

headwall debris on LS toe showing evidence of 18-inch cmp.

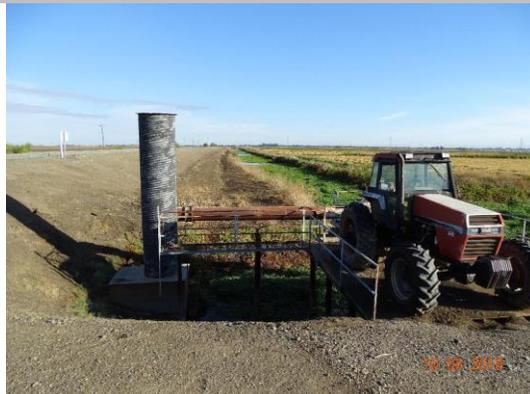
Photo 1 of 3 : UCIP\_FA\_2019\_53013\_78165.jpg

DS\_ID:17167  
 FS\_ID:53013  
 EP\_NO: 9389  
 Repair Type: Urgent  
 Crossing Status: Found  
 UCIP Comments: 10/5/2018 Flap gate was installed at WS end of the pipe. Pipe is excessively corroded looking inside from WS end. Video inspection is recommended. Cracks more than 1-inch wide were observed on WS slope around pipe alignment that may be a sign of slope instability. (O.Yakimov - DWR UCIP)5/2/2017 No repairs have been made to this crossing yet. WS flap gate is still disconnected from end of pipe and pipe is showing heavy signs of rust and deterioration as far in as i can see from the WS end. Pipe should be internally camera inspected and repaired/replaced. (DWR Sutter Yard-AFreitag)01/31/2017 Informal Notice of Violation (NOV) was sent out January 31, 2017 by DWR Flood Maintenance Office--owner needs to re-attach flap gate to drainage pipe and coordinate with CVFPB to address additional issue(s) identified in NOV. Owner has until Monday February 27th, 2017 to repond to DWR contact: Bryan Reniff. (refer to Official Notice for details). (DWR UCIP - O. Magana) 10/17/2016 WS flapgate has seperated from the pipe end. WS pipe end is showing signs of rust and deterioration. Needs a new flapgate or other means of closing off the pipe before flood season. (DWR Sutter Yard-AFreitag)5/31/2016 Crossing appears to be in good condition.5/4/2015 Corssing appears to be in good condition. No noticeable issues to report.6/17/2014 Same as last inspection.12/16/2013 Same as last inspection.7/16/2013 Same as last inspection.

Pumping plant at LS toe.

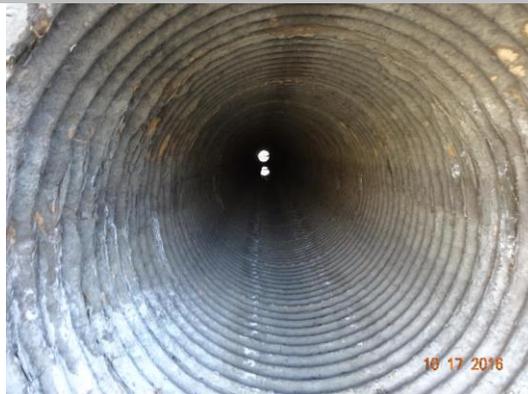
Photo 2 of 3 : UCIP\_FA\_2019\_53013\_76060.jpg

View inside of pipe from the WS

DS\_ID:17167  
 FS\_ID:53013  
 EP\_NO: 9389  
 Repair Type: Urgent  
 Crossing Status: Found  
 UCIP Comments: 10/5/2018 Flap gate was installed at WS end of the pipe. Pipe is excessively corroded looking inside from WS end. Video inspection is recommended. Cracks more than 1-inch wide were observed on WS slope around pipe alignment that may be a sign of slope instability. (O.Yakimov - DWR UCIP)5/2/2017 No repairs have been made to this crossing yet. WS flap gate is still disconnected from end of pipe and pipe is showing heavy signs of rust and deterioration as far in as i can see from the WS end. Pipe should be internally camera inspected and repaired/replaced. (DWR Sutter Yard-AFreitag)01/31/2017 Informal Notice of Violation (NOV) was sent out January 31, 2017 by DWR Flood Maintenance Office--owner needs to re-attach flap gate to drainage pipe and coordinate with CVFPB to address additional issue(s) identified in NOV. Owner has until Monday February 27th, 2017 to repond to DWR contact: Bryan Reniff. (refer to Official Notice for details). (DWR UCIP - O. Magana) 10/17/2016 WS flapgate has seperated from the pipe end. WS pipe end is showing signs of rust and deterioration. Needs a new flapgate or other means of closing off the pipe before flood season. (DWR Sutter Yard-AFreitag)5/31/2016 Crossing appears to be in good condition.5/4/2015 Corssing appears to be in good condition. No noticeable issues to report.6/17/2014 Same as last inspection.12/16/2013 Same as last inspection.7/16/2013 Same as last inspection.

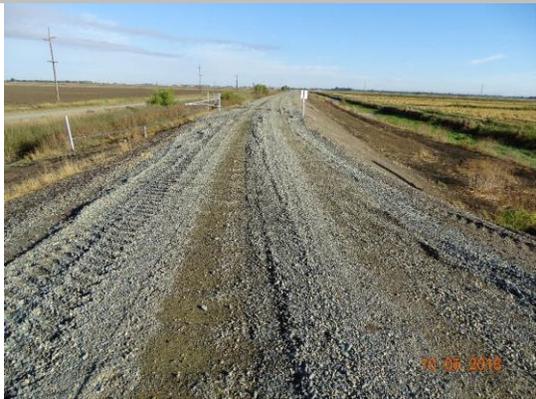
Photo 3 of 3 : UCIP\_FA\_2019\_53013\_78159.jpg

DS\_ID:17167  
 FS\_ID:53013  
 EP\_NO: 9389  
 Repair Type: Urgent  
 Crossing Status: Found  
 UCIP Comments: 10/5/2018 Flap gate was installed at WS end of the pipe. Pipe is excessively corroded looking inside from WS end. Video inspection is recommended. Cracks more than 1-inch wide were observed on WS slope around pipe alignment that may be a sign of slope instability. (O.Yakimov - DWR UCIP)5/2/2017 No repairs have been made to this crossing yet. WS flap gate is still disconnected from end of pipe and pipe is showing heavy signs of rust and deterioration as far in as i can see from the WS end. Pipe should be internally camera inspected and repaired/replaced. (DWR Sutter Yard-AFreitag)01/31/2017 Informal Notice of Violation (NOV) was sent out January 31, 2017 by DWR Flood Maintenance Office--owner needs to re-attach flap gate to drainage pipe and coordinate with CVFPB to address additional issue(s) identified in NOV. Owner has until Monday February 27th, 2017 to repond to DWR contact: Bryan Reniff. (refer to Official Notice for details). (DWR UCIP - O. Magana) 10/17/2016 WS flapgate has seperated from the pipe end. WS pipe end is showing signs of rust and deterioration. Needs a new flapgate or other means of closing off the pipe before flood season. (DWR Sutter Yard-AFreitag)5/31/2016 Crossing appears to be in good condition.5/4/2015 Corssing appears to be in good condition. No noticeable issues to report.6/17/2014 Same as last inspection.12/16/2013 Same as last inspection.7/16/2013 Same as last inspection.

View of levee crown at crossing.

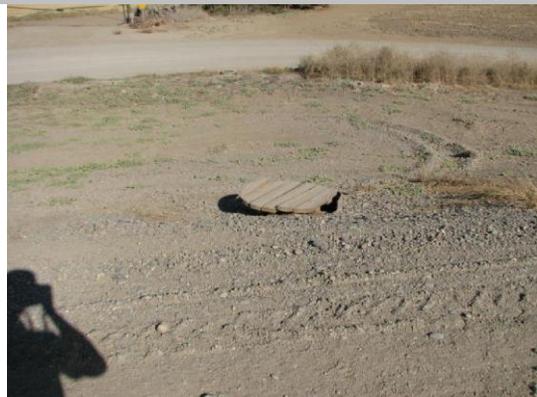
Photo 1 of 2 : UCIP\_FA\_2019\_51810\_69115.jpg

Item	DRAFT DWR UCIP LMA Responsibility			39.180039°	39.180039°
				-122.014266°	-122.014266°
DWR ID	17157				
Comment Code					
Inspector Comment					
DS_ID:17157 FS_ID:51810 EP_NO: 9386 Repair Type: Non-Urgent Crossing Status: Found UCIP Comments: 5/2/2017 Abandoned- needs to be done properly. (DWR Sutter Yard- AFreitag)10/17/2016 Abandoned crossing. (DWR Sutter Yard- AFreitag)5/31/2016 Abandoned crossing. Both pipe ends and slide gate inside of riser are buried.5/4/2015 Both pipe ends and slide gate in riser are plugged with soil. Crossing is inoperable.6/17/2014 Same as last inspection.12/16/2013 Same as last inspection.7/16/2013 Same as last inspection.10/11/2012 Pipe plugged with soil on both ends as well as at slide gate on WS slope. Slide gate inoperable. FIELD_STRUCT_DESC: *ABANDONED* 24-inch corrugated metal drainage pipe through the levee, 8 feet below the crown. Slide gate in a 36-inch riser on the waterside (WS) shoulder. Levee turns eastward. (24-inch pipe [HLM 11.17] authorized under Automatic Board Order (ABO) issued as Permit No. 9386, 1974 - C. J. Wescott Jr.). [Additional Reference(s): DWR Levee Log, 2005. USACE Sacramento O&M Manual 132, October 1959, (HLM 11.17)]. FS Date: 5/2/2017 2:51:53 PM

cover on 36-inch CMP standpipe on WS slope.

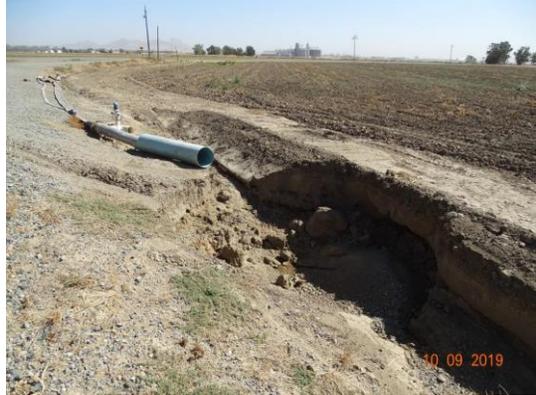
Photo 2 of 2 : FA\_2019\_MA0012\_299\_31\_20191010\_00078.jpg

View of the water source. Fall 2019.
