**Flood Control Project Maintenance  
Levee Inspections**

**Maintenance Issue Types Only, Levee Inspection Report By Mile - Fall 2019**

**Sutter Maintenance Yard Maintenance Area 0013**

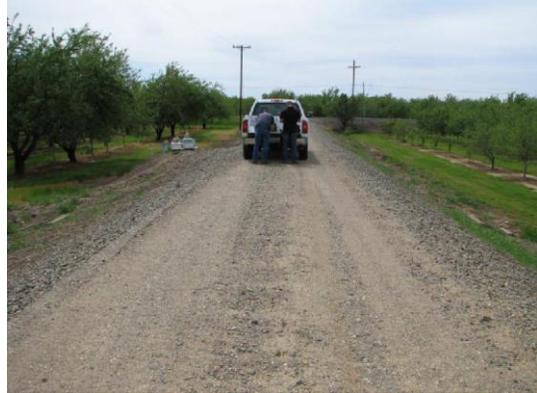
Photo 1 of 3 : UCIP\_FA\_2019\_54938\_66689.jpg

| DS_ID:16343<br>FS_ID:54938<br>EP_NO: N/A<br>Repair Type: Non-Urgent<br>Crossing Status: Found<br>UCIP Comments: 08/06/2019 Record has been updated from No Action Needed to Non-Urgent, due to unauthorized encroachment. Pipe has been lined. (O. Magana - DWR UCIP, A. Freitag - DWR Sutter Yard)06/14/2017 Crossing appears to be in good condition. Pipe has been selected to be internally cleaned and inspected as part of the DMP project. (DWR Sutter Yard- AFreitag)11/16/2016 Crossing appears to be in good condition. (DWR Sutter Yard- AFreitag)04/28/2016 Crossing appears to be in good condition.07/14/2015 Crossing appears in good condition. No noticeable issues to report.05/21/2014 Same as last inspection.12/02/2013 Same as last inspection.07/10/2013 Same as last inspection.04/17/2012 Drain is still in use. 4 inch pipe in channel near WS headwall (see photo). The pipe does not appear to impact the crossing.<br>FIELD_STRUCT_DESC: 24-inch corrugated metal drainage pipe through the levee, 8.6 feet below the crown. Concrete "U" headwalls on both the waterside (WS) and landside (LS). Flap gate on the WS end. [Additional Reference(s): DWR Levee Log, 1993. USACE Sacramento O&M Manual 519, June 1962 (HLM 1.15)]<br>FS Date: 8/6/2019 8:46:00 AM | | | | | |

Overview of levee crown at crossing looking D/S .

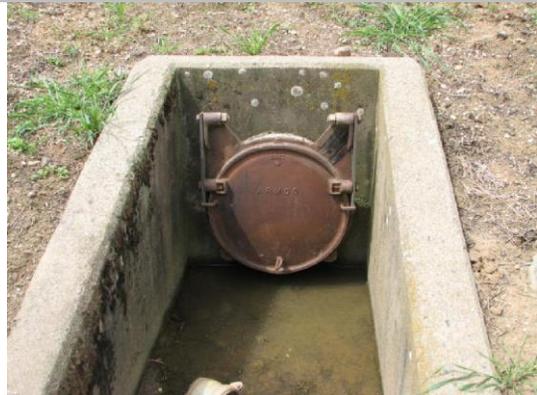
Photo 2 of 3 : UCIP\_FA\_2019\_54938\_66688.jpg

View of WS headwall and flap gate.

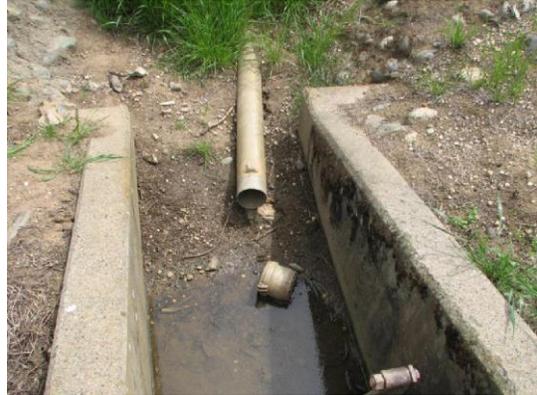
Photo 3 of 3 : UCIP\_FA\_2019\_54938\_66687.jpg

View of WS with pipe in channel.

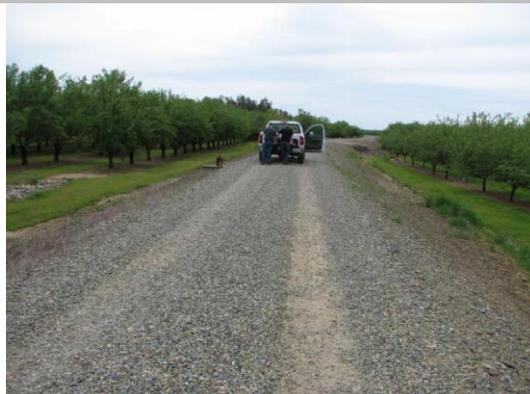
Photo 1 of 3 : UCIP\_FA\_2019\_54939\_66695.jpg

DS\_ID:16831  
 FS\_ID:54939  
 EP\_NO: N/A  
 Repair Type: Non-Urgent  
 Crossing Status: Found  
 UCIP Comments: 08/06/2019 Record remains Non-Urgent, need to clarify owner for this crossing. This pipe has been identified as an LMA responsible drainage pipe. However, adjacent property owner has modified the WS outlet by burying the concrete headwall. No permit has been found authorizing the modification to the WS. LMA and adjacent property owner will need to coordinate with the CVFPB to comply with Title 23. (O. Magana - DWR UCIP, A. Freitag - DWR Sutter Yard)08/23/2018 Same as last inspection; still no sign of WS pipe end. Unclear if this SD crossing is still in use. The WS toe has standing, mucky, water around where the pipe end should be. Downgrading to Non-Urgent from Urgent because there appears no immediate threat to levee. Recommend follow up with owner to determine pipe use, and an internal pipe inspection to determine pipe integrity and threat to levee (D. Sanoski - DWR UCIP).06/14/2017 Still no sign of WS pipe end. Pipe may need to be traced with GPR and excavated to determine if the WS end was properly capped after the Headwall and pipe sections were removed. Pipe has been selected to be internally cleaned and inspected as part of the DMP project. (DWR Sutter Yard-AFreitag)11/16/2016 WS structures still removed. (DWR Sutter Yard-AFreitag)10/17/2016 Landowner removed WS concrete headwall and pipe section through floodway to make room for orchard. The area disturbed appears to be from WS toe to where the mature trees are located within floodway, approximately 45 feet from WS toe. Crossing is classified as Urgent with potential levee integrity issues due to the disturbance of the WS without prior approval from the CVFPB. (DWR UCIP - omagana)

04/28/2016 Landowner appears to have removed the WS headwall and pipe to make room for planting more orchard trees. LS pipe end was full of water as it has no where to drain to anymore. Changing to urgent listing but it currently does not affect the levee integrity. (see photos 8, 9, & 10) (DWR Sutter Yard - afreitag)07/14/2015 Crossing appears in good condition. No noticeable issues to report. (DWR Sutter Yard - afreitag)05/21/2014 Same as last inspection. (DWR Sutter Yard - afreitag)12/02/2013 Pipe section was dug up and repaired. Crossing is now in good condition. (DWR Sutter Yard - afreitag) 04/17/2012 Pipe collapse on WS 10 feet from toe, needs repair. From WS, sediment is visible inside pipe. (DWR UCIP - omagana)  
 FIELD\_STRUCT\_DESC: 36-inch corrugated metal drainage pipe through the levee, 7.8 feet below the crown. Concrete "U" headwalls on both waterside (WS) and landside (LS) ends. Slide gate in corrugated metal pipe (CMP) riser on the WS slope. [Additional Reference(s): DWR Levee Log, 1993. USACE Sacramento O&M Manual 519, June

Overview of levee crown at crossing looking downstream.

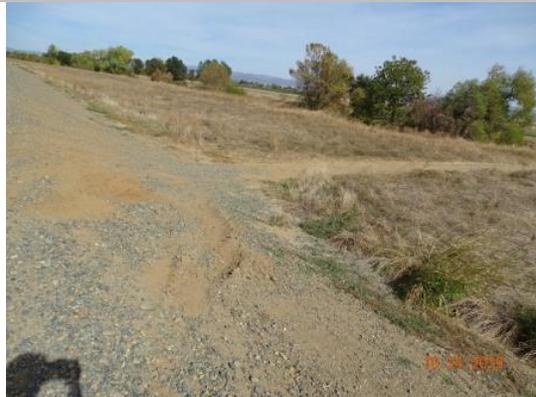
Photo 1 of 1 : FA\_2019\_MA0013\_300\_73\_20191028\_00144.jpg

View of depressions in the waterside slope due to vehicle traffic. Fall 2019.

| C2 : Repair depressions or ruts in the crown or slope. | | | | | |

| S3 : Repair the levee slope damaged by vehicle traffic and prevent access where possible. | | | | | |

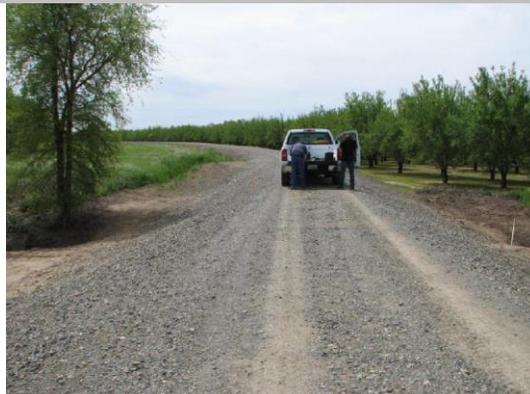
Photo 1 of 3 : UCIP\_FA\_2019\_54942\_66715.jpg

| DS_ID:16347<br>FS_ID:54942<br>EP_NO: N/A<br>Repair Type: Non-Urgent<br>Crossing Status: Found<br>UCIP Comments: 08/06/2019 Record has been updated from No Action Needed to Non-Urgent, no permit identified. Crossing is scheduled to be lined. (O. Magana - DWR UCIP, A. Freitag - DWR Sutter Yard)06/14/2017 Crossing appears to be in good condition. (DWR Sutter Yard- AFreitag)11/16/2016 Crossing appears to be in good condition. (DWR Sutter Yard- AFreitag)04/28/2016 Crossing appears to be in good condition.07/14/2015 Crossing appears in good condition. No noticeable issues to report.05/21/2014 Same as last inspection.12/02/2013 Same as last inspection.07/15/2013 Same as last inspection.04/17/2012 Vegetation/sedimentation from WS has been removed. This crossing was listed in the USACE Periodic Inspection report as Corp's inspect ID#USACE_CESPK_M13D_2011_p_0130 for WS flap gate closed and blocked by sediment.<br>FIELD_STRUCT_DESC: 24-inch corrugated metal drainage pipe through the levee, 9.4 feet below the crown. Concrete "U" headwall on both waterside (WS) and landside (LS) ends. Flap gate on the WS end. [Additional Reference(s): DWR Levee Log, 1993. USACE Sacramento O&M Manual 519, June 1962 (HLM 2.74)]<br>FS Date: 8/6/2019 9:39:00 AM | | | | | |

Overview of levee crown looking downstream at crossing.

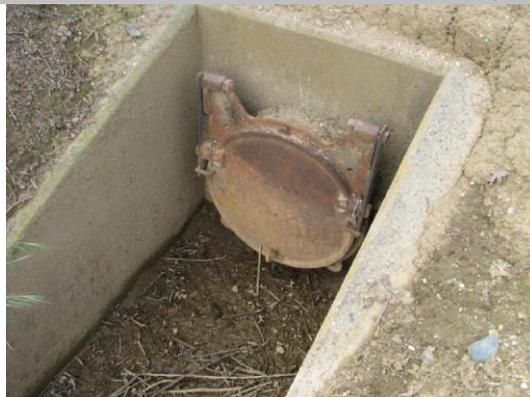
Photo 2 of 3 : UCIP\_FA\_2019\_54942\_66714.jpg

Flap gate at WS.

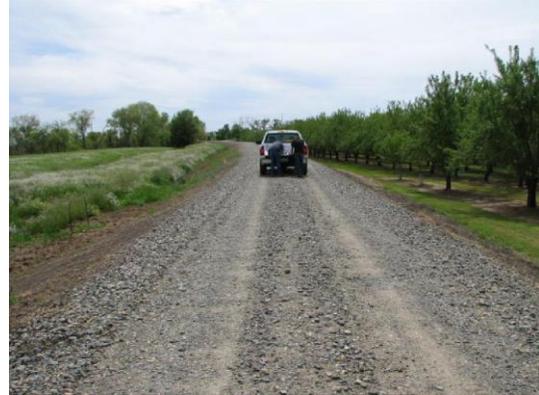
Photo 1 of 3 : UCIP\_FA\_2019\_54943\_66718.jpg

| <p>DS_ID:17372<br/> FS_ID:54943<br/> EP_NO: N/A<br/> Repair Type: Non-Urgent<br/> Crossing Status: Found<br/> UCIP Comments: 08/06/2019 Record remains Non-Urgent, no permit identified authorizing pipe. Pipe has been internally cleaned and cleared of any obstructions on the WS and LS. DMP internal inspection pending. (O. Magana - DWR UCIP, A. Freitag - DWR Sutter Yard)06/14/2017 WS flap gate is completely buried by sediment-needs to be dug out. Pipe is about 50% full of sediment inside. Pipe has been selected to be internally cleaned and inspected as part of the DMP project. (DWR Sutter Yard- AFreitag)11/16/2016 Pipe about 50% full of sediment. (DWR Sutter Yard- AFreitag)04/28/2016 Pipe on LS is about 50% full of sediment. There is now a concrete pipe that discharges into the LS inlet of this crossing. Not sure where the concrete pipe comes from.07/14/2015 Crossing appears in good condition. No noticeable issues to report.05/21/2014 Same as last inspection.12/02/2013 Pipe section was dug up and repaired. Crossing is now in good condition.07/15/2013 Pipe appears to have a possible hole in top of pipe about 10ft. in from LS headwall.04/17/2012 LS headwall blocked by sediment (50 % of opening is covered). LS floor is higher than LS pipe invert. WS headwall has been recently cleared of vegetation and sediment. This crossing was listed in the USACE Periodic Inspection report as Corp's inspect ID#USACE_CESPK_M13D_2011_p_0157 for WS and LS inlet/outlet blocked by sediment.<br/> FIELD_STRUCT_DESC: 36-inch corrugated metal drainage pipe through the levee, 11.8 feet below the crown. Flap gate is located on the waterside (WS). Concrete headwall located on the landside (LS).<br/> [Additional Reference(s): DWR Levee Log, 1993 (HLM 3.07, 24-inch). USACE Sacramento O&amp;M Manual 519, June 1962 (HLM 3.10, 36-inch)]<br/> FS Date: 8/6/2019 9:47:00 AM</p> | | | | | |

Overview of levee crown looking downstream at crossing.

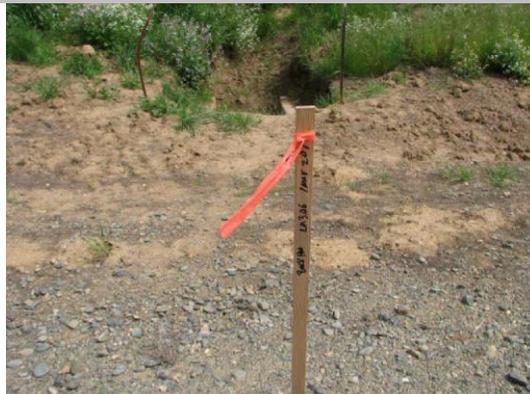
Photo 2 of 3 : UCIP\_FA\_2019\_54943\_66716.jpg

WS levee slope.

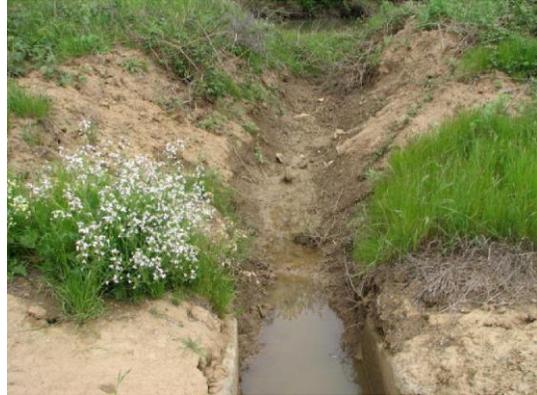
Photo 3 of 3 : UCIP\_FA\_2019\_54944\_66726.jpg

| <p>DS_ID:16349<br/> FS_ID:54944<br/> EP_NO: N/A<br/> Repair Type: Non-Urgent<br/> Crossing Status: Found<br/> UCIP Comments: 08/06/2019 Record remains Non-Urgent, no permit found authorizing pipe. Pipe has been lined. (O. Magana - DWR UCIP, A. Freitag - DWR Sutter Yard)06/14/2017 Both pipe ends and gates are mostly buried- need to be dug out. Pipe has been selected to be internally cleaned and inspected as part of the DMP project. (DWR Sutter Yard- AFreitag)11/16/2016 Both gates closed but partially buried and unable to open. (DWR Sutter Yard- AFreitag)04/28/2016 Sediment build up on both gates blocking them from operating properly.07/14/2015 Crossing appears in good condition. No noticeable issues to report.05/21/2014 Same as last inspection.12/02/2013 Same as last inspection.07/15/2013 Stem on LS screw gate has been replaced and is now full functional.04/17/2012 LS slide gate stem is bent and prevents gate from fully closing. Both WS and LS have been cleared of debris and sediment. This crossing was listed in the USACE Periodic Inspection report as Corp's inspect ID#USACE_CESPK_M13D_2011_p_0162 for inoperable gates on WS &amp; LS due to sediment and grass blocking inlet and outlet.<br/> FIELD_STRUCT_DESC: 24-inch corrugated metal drainage pipe through the levee, 8.9 feet below the crown. Concrete "U" headwalls on both the waterside (WS) and landside (LS) ends. Flap gate visible on the waterside (WS) end. [Additional Reference(s): DWR Levee Log, 1993. USACE Sacramento O&amp;M Manual 519, June 1962 (HLM 3.29)]<br/> FS Date: 8/6/2019 10:02:00 AM</p> | | | | | |

Recent sediment removal on WS.

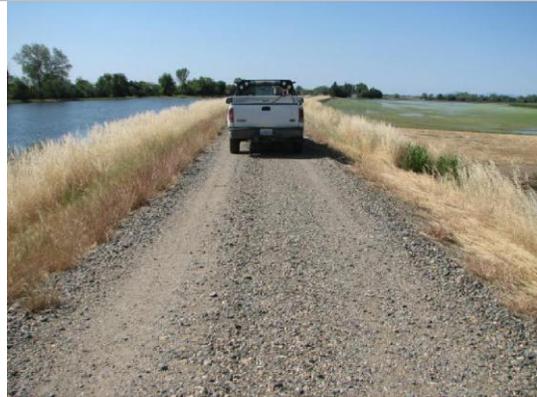
Photo 1 of 3 : UCIP\_FA\_2019\_54946\_66736.jpg

| <p>DS_ID:16351<br/> FS_ID:54946<br/> EP_NO: N/A<br/> Repair Type: Non-Urgent<br/> Crossing Status: Found<br/> UCIP Comments: 08/26/2019 Record has been updated from No Action Needed to Non-Urgent, no permit has been identified for this crossing. Crossing is scheduled to be lined. (O. Magana - DWR UCIP, A. Freitag - DWR Sutter Yard)06/14/2017 Both pipe ends were underwater during site visit. Pipe has been selected to be internally cleaned and inspected as part of the DMP project. (DWR Sutter Yard-AFreitag)11/16/2016 Crossing appears to be in good condition. (DWR Sutter Yard- AFreitag)04/28/2016 Both sides of the crossing were underwater during time of inspection.07/14/2015 Crossing appears in good condition. No noticeable issues to report.05/21/2014 Same as last inspection.12/02/2013 Same as last inspection.07/15/2013 Slopes have been cleared of vegetation and are in good condition.04/18/2012 Limited inspection on WS and LS slope due to dense vegetation. Need photos of cleared slopes.<br/> FIELD_STRUCT_DESC: 24-inch corrugate metal drainage pipe through the levee, 8.1 feet below the crown. Flap gate on the waterside (WS) end. Slide gate located on the landside (LS) end. Concrete "U" headwalls on both ends. [Additional Reference(s): DWR Levee Log, 1993. USACE Sacramento O&amp;M Manual 519, June 1962 (HLM 3.80)]<br/> FS Date: 8/26/2019 12:22:00 PM</p> | | | | | |

Overview of levee crown at crossing looking downstream.

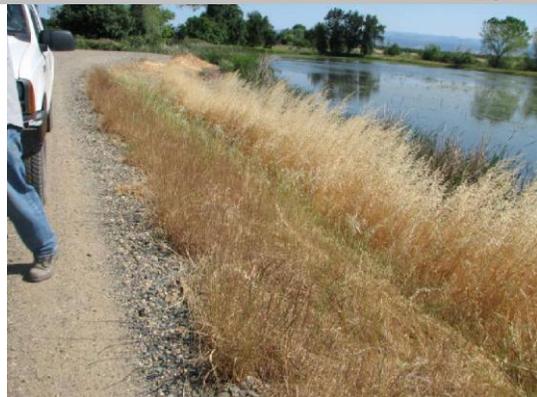
Photo 2 of 3 : UCIP\_FA\_2019\_54946\_66738.jpg

WS slope covered by dense vegetation.

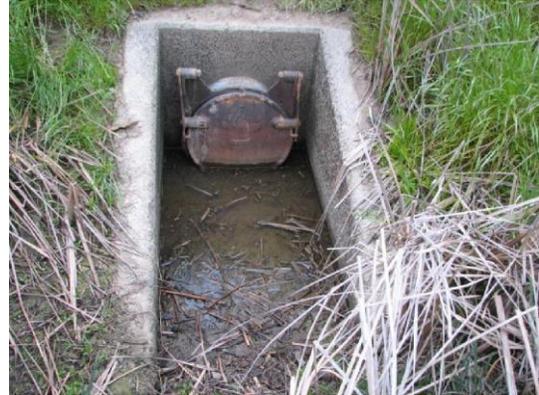
Photo 3 of 3 : UCIP\_FA\_2019\_54946\_66735.jpg

WS flap gate

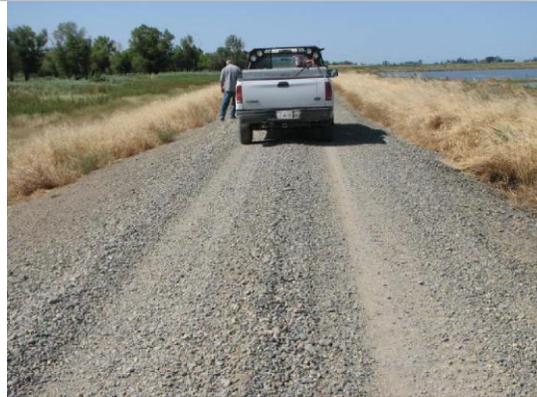
Photo 1 of 3 : UCIP\_FA\_2019\_54958\_66800.jpg

| <p>DS_ID:16360<br/> FS_ID:54958<br/> EP_NO: N/A<br/> Repair Type: Non-Urgent<br/> Crossing Status: Found<br/> UCIP Comments: 08/26/2019 Record has been updated from No Action Needed to Non-Urgent, no permit has been identified authorizing pipe. Pipe is scheduled to be lined. (O. Magana - DWR UCIP, A. Freitag - DWR Sutter Yard)06/14/2017 Crossing appears to be in good condition. LS is completely submerged in an irrigation ditch. Pipe has been selected to be internally cleaned and inspected as part of the DMP project. (DWR Sutter Yard- AFreitag)11/16/2016 Crossing appears to be in good condition. (DWR Sutter Yard- AFreitag)04/28/2016 Crossing appears to be in good condition.07/13/2015 LS screw gate was completely submerged but crossing appears to be in good condition.05/21/2014 Same as last inspection.12/02/2013 Same as last inspection.07/15/2013 Same as last inspection.04/18/2012 Burrow activity near crossing; burrow holes present on LS.<br/> FIELD_STRUCT_DESC: 24-inch corrugated metal drainage pipe through the levee, 6.2 feet below the crown. Flap gate on the waterside (WS) end. Slide gate on the landside (LS) end. Concrete "U" headwalls on both ends. [Additional Reference(s): DWR Levee Log, 1993. USACE Sacramento O&amp;M Manual 519, June 1962 (HLM 5.97)]<br/> FS Date: 8/26/2019 12:40:00 PM</p> | | | | | |

Overview of levee crown at crossing looking downstream.

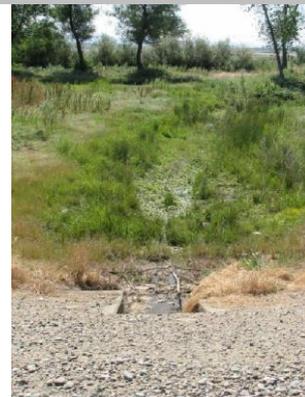
Photo 2 of 3 : UCIP\_FA\_2019\_54958\_66801.jpg

View of WS slope and toe.

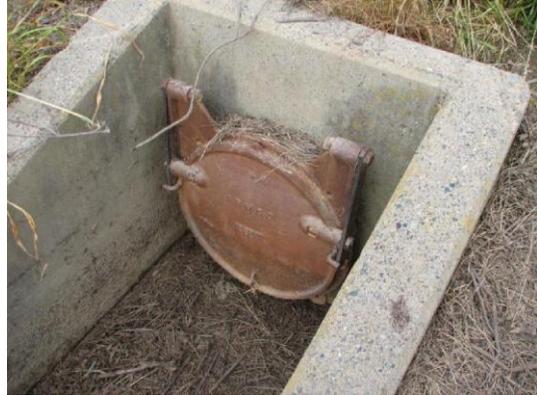
Photo 3 of 3 : UCIP\_FA\_2019\_54959\_66804.jpg

| <p>DS_ID:16361<br/> FS_ID:54959<br/> EP_NO: N/A<br/> Repair Type: Non-Urgent<br/> Crossing Status: Found<br/> UCIP Comments: 08/26/2019 Record remains Non-Urgent, no permit has been identified authorizing pipe. Pipe is scheduled to be lined. (O. Magana - DWR UCIP, A. Freitag - DWR Sutter Yard)06/14/2017 WS appears to be in good condition. LS slide gate is buried and submerged. Pipe has been selected to be internally cleaned and inspected as part of the DMP project. (DWR Sutter Yard- AFreitag)11/16/2016 LS screw gate is buried and non-operational. (DWR Sutter Yard- AFreitag)04/28/2016 LS screw gate is still completely buried. 07/13/2015 LS screw gate is completely buried.05/21/2014 Same as last inspection.07/15/2013 WS slope has been cleared of vegetation and is in good condition. LS screw gate is still buried.12/02/2013 Same as last inspection.04/18/2012 LS slide gate is buried. Pipe is not visible on LS toe. Limited inspection on WS slope due to dense vegetation.<br/> FIELD_STRUCT_DESC: 24-inch corrugated metal drainage pipe through the levee, 7.4 feet below the crown. Flap gate on the waterside (WS) end. Slide gate on the landside (LS) end. Concrete "U" headwalls on both ends. [Additional Reference(s): DWR Levee Log, 1993. USACE Sacramento O&amp;M Manual 519, June 1962 (HLM 6.34)]<br/> FS Date: 8/26/2019 12:41:00 PM</p> | | | | | |

View of WS flap gate.

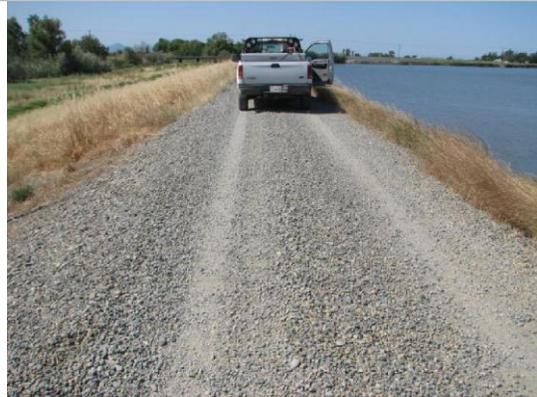
Photo 1 of 3 : UCIP\_FA\_2019\_54969\_66853.jpg

| <p>DS_ID:16352<br/> FS_ID:54969<br/> EP_NO: N/A<br/> Repair Type: Non-Urgent<br/> Crossing Status: Found<br/> UCIP Comments: 08/26/2019 Record has been updated from No Action Needed to Non-Urgent, no permit has been identified authorizing pipe. Pipe is scheduled to be lined. (O. Magana - DWR UCIP, A. Freitag - DWR Sutter Yard)06/14/2017 Crossing appears to be in good condition. Pipe has been selected to be internally cleaned and inspected as part of the DMP project. (DWR Sutter Yard-AFreitag)11/16/2016 Crossing appears to be in good condition. (DWR Sutter Yard- AFreitag)04/28/2016 Crossing appears to be in good condition.07/13/2015 WS ditch is getting to be heavily vegetated but it is not yet affecting flap gate operation. Vegetation needs to be cleared back some.05/21/2014 Same as last inspection.12/02/2013 Same as last inspection.07/15/2013 Slopes have been cleared of vegetation and are in good condition.04/18/2012 Limited inspection on WS and LS slopes due to dense vegetation. Need photos of cleared WS and LS slopes during next inspection.<br/> FIELD_STRUCT_DESC: 24-inch corrugated metal drainage pipe through the levee, 10.2 feet below the crown. Flap gate on the waterside (WS) end. Screw gate on the landside (LS) end. Concrete headwall on both ends. [Additional Reference(s): DWR Levee Log, 1993. USACE Sacramento O&amp;M Manual 519, June 1962 (HLM 7.58)]<br/> FS Date: 8/26/2019 1:03:00 PM</p> | | | | | |

View of levee crown at crossing looking D/S.

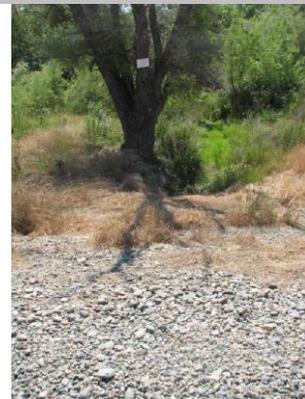
Photo 2 of 3 : UCIP\_FA\_2019\_54969\_66851.jpg

WS view of slope and channel.

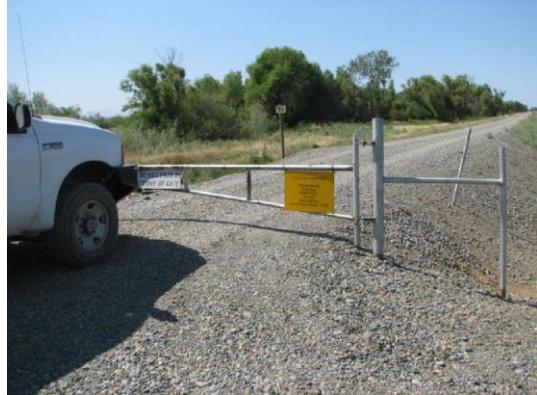
Photo 1 of 3 : UCIP\_FA\_2019\_56090\_66867.jpg

| <p>DS_ID:16320<br/> FS_ID:56090<br/> EP_NO: N/A<br/> Repair Type: Non-Urgent<br/> Crossing Status: Found<br/> UCIP Comments: 08/26/2019 Record has been updated from No Action Needed to Non-Urgent, no permit has been identified authorizing pipe. Pipe is scheduled to be lined. The following maintenance issues should be addressed: clear vegetation from LS inlet and repair CMP riser lid (safety measure). (O. Magana - DWR UCIP, A. Freitag - DWR Sutter Yard)06/14/2017 Debris down inside of WS riser. The rest of the crossing appears to be in good condition. Pipe has been selected to be internally cleaned and inspected as part of the DMP project. (DWR Sutter Yard- AFreitag)11/16/2016 Crossing appears to be in good condition. (DWR Sutter Yard- AFreitag)04/28/2016 Crossing appears to be in good condition.07/13/2015 The bottom of the entire pipe has about 8inch of sediment in it. Sediment is preventing the screw gate from fully closing. WS flap gate seems to be in good condition.05/21/2014 Same as last inspection.12/03/2013 Same as last inspection.07/15/2013 Same as last inspection.<br/> FIELD_STRUCT_DESC: 48-inch corrugated metal drainage pipe through the levee, 9.9 feet below the crown. Flap gate on the waterside (WS) end. Slide gate in corrugated metal pipe riser on the WS slope. Concrete "U" headwalls on both ends. Spillway grouted for 35 feet.<br/> [Additional Reference(s): DWR Levee Log, 1993. USACE Sacramento O&amp;M Manual 519, June 1962 (HLM 7.76)]<br/> FS Date: 8/26/2019 1:06:00 PM</p> | | | | | |

Overview of levee crown at crossing (past gate) looking D/S.

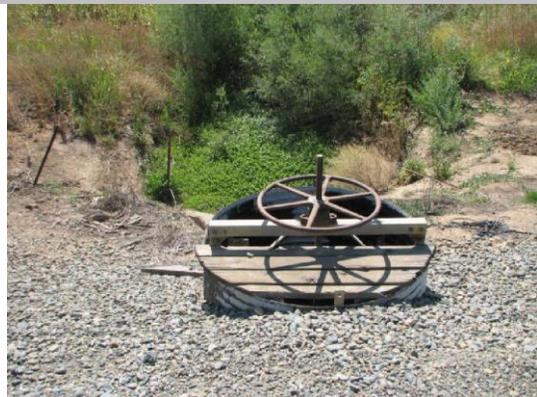
Photo 2 of 3 : UCIP\_FA\_2019\_56090\_66865.jpg

View of WS slope, corrugated metal riser with slide gate.

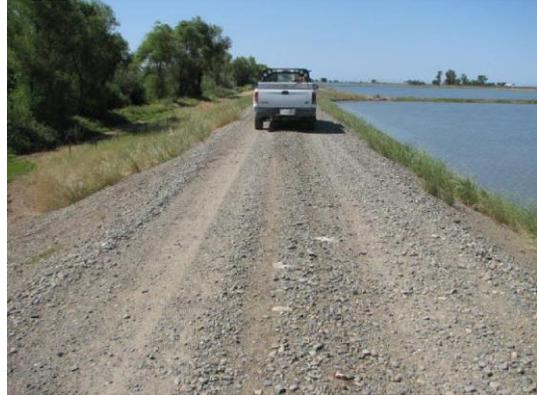
Photo 1 of 3 : UCIP\_FA\_2019\_54973\_66872.jpg

| <p>DS_ID:16321<br/> FS_ID:54973<br/> EP_NO: N/A<br/> Repair Type: Non-Urgent<br/> Crossing Status: Found<br/> UCIP Comments: 08/27/2019 Record has been updated from No Action Needed to Non-Urgent, no permit has been identified authorizing pipe. Pipe is scheduled to be lined. (O. Magana - DWR UCIP, A. Freitag - DWR Sutter Yard)06/14/2017 Crossing appears to be in good condition. Pipe has been selected to be internally cleaned and inspected as part of the DMP project. (DWR Sutter Yard- AFreitag)11/16/2016 Crossing appears to be in good condition. (DWR Sutter Yard- AFreitag)04/28/2016 Crossing appears to be in good condition.07/13/2015 Crossing appears to be in good condition.</p> <p>05/21/2014 Same as last inspection.12/03/2013 Same as last inspection.07/15/2013 Same as last inspection.04/18/2012 Sediment build up against flashboards. Flashboards are in use on landside of levee.<br/> FIELD_STRUCT_DESC: 24-inch corrugated metal drainage pipe through the levee, 8.2 feet below the crown. Flap gate on the waterside (WS) end. Concrete "U" headwalls on both ends. Flashboards should be present on the landside (LS). [Additional Reference(s): DWR Levee Log, 1993. USACE Sacramento O&amp;M Manual 519, June 1962 (HLM 8.12)]<br/> FS Date: 8/27/2019 2:07:00 PM</p> | | | | | |

Overview of levee crown at crossing looking D/S.

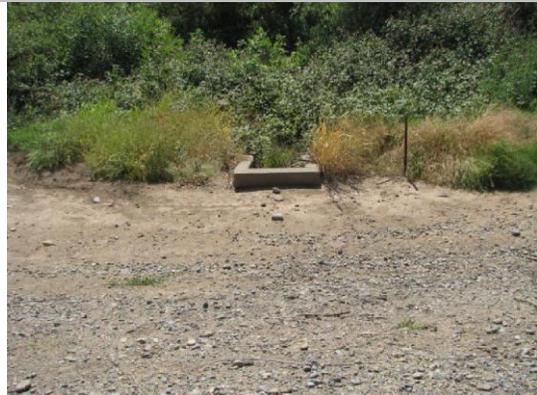
Photo 2 of 3 : UCIP\_FA\_2019\_54973\_66873.jpg

View of WS slope and toe.

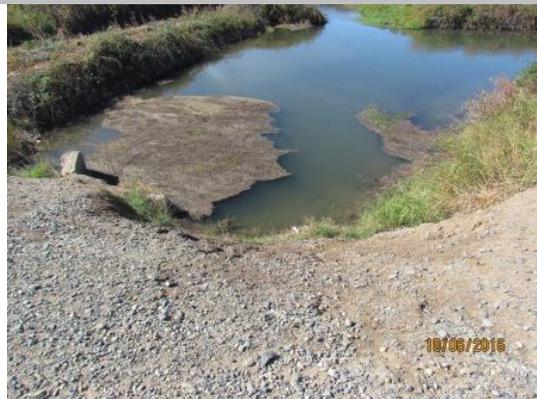
Photo 1 of 1 : FA\_2019\_MA0013\_300\_49\_20190822\_00007.jpg

View of the erosion site along the landside toe.

| E2 : Schedule repair of erosion site prior to the next inspection. | | | | | |

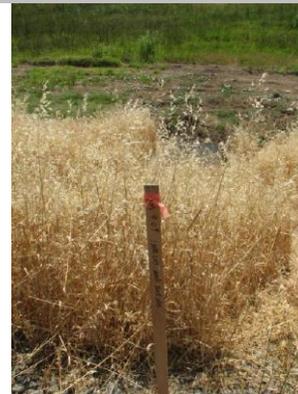
Photo 2 of 3 : UCIP\_FA\_2019\_54982\_66911.jpg

| <p>DS_ID:16317<br/> FS_ID:54982<br/> EP_NO: N/A<br/> Repair Type: Non-Urgent<br/> Crossing Status: Found<br/> UCIP Comments: 08/27/2019 Record has been updated from No Action Needed to Non-Urgent, no permit has been identified authorizing pipe. Pipe is scheduled to be lined. (O. Magana - DWR UCIP, A. Freitag - DWR Sutter Yard)06/14/2017 Crossing appears to be in good condition. Pipe has been selected to be internally cleaned and inspected as part of the DMP project. (DWR Sutter Yard- AFreitag)11/16/2016 Crossing appears to be in good condition. (DWR Sutter Yard- AFreitag)04/28/2016 Crossing appears to be in good condition.07/13/2015 LS inlet has minor vegetation still. WS appears in good condition.05/21/2014 Same as last inspection.12/03/2013 Same as last inspection.07/15/2013 Slopes have been cleared of vegetation and are in good condition.04/18/2012 Limited inspection on WS and LS slopes due to dense vegetation. Need photos of cleared WS and LS slopes. This crossing was listed in the USACE Periodic Inspections as Corp's Insect ID# USACE_CESPK_M13D_2011_p_0278 for WS outlet sedimentation and sediment/grass at LS inlet.<br/> FIELD_STRUCT_DESC: 36-inch corrugated metal drainage pipe through the levee, 10.2 feet below the crown. Flap gate on the waterside (WS) end. Concrete "U" headwalls on both ends. Flashboards should be present on the landside (LS). [Additional Reference(s): DWR Levee Log, 1993. USACE Sacramento O&amp;M Manual 519, June 1962 (HLM 9.09)]<br/> FS Date: 8/27/2019 2:13:00 PM</p> | | | | | |

View of WS slope and toe.

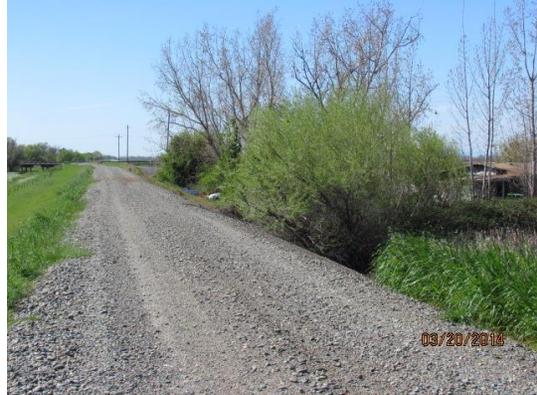
Photo 1 of 1 : FA\_2019\_MA0013\_300\_5\_20190822\_00002.jpg

View of the overgrown trees along the landside slope and toe.

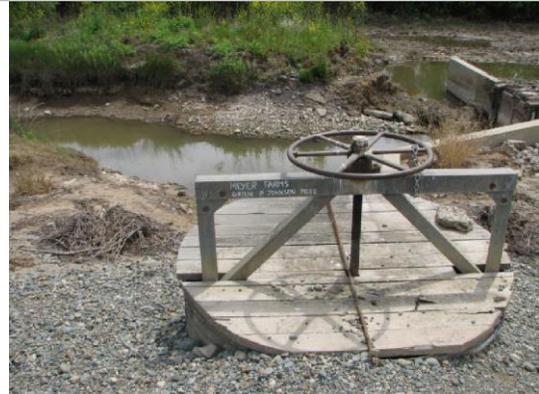
Photo 2 of 3 : UCIP\_FA\_2019\_54990\_66925.jpg

| <p>DS_ID:16332<br/> FS_ID:54990<br/> EP_NO: N/A<br/> Repair Type: Non-Urgent<br/> Crossing Status: Found<br/> UCIP Comments: 08/27/2019 Record has been updated from No Action Needed to Non-Urgent, no permit has been identified authorizing the dual purpose of this crossing. Crossing is used as an irrigation turnout. Flow from Cherokee canal is diverted about 900 feet upstream by weir and feed into an irrigation canal that runs parallel along WS levee toe for about 2.5 miles. The irrigation turnout is used to divert water from WS irrigation canal to LS. Need to update crossing type from Drainage to Other. This crossing is not maintained or operated by LMA-Sutter Yard. (O. Magana - DWR UCIP, A. Freitag - DWR Sutter Yard)06/15/2017 Crossing appears to be in good condition. Pipe has been selected to be internally cleaned and inspected as part of the DMP project. (DWR Sutter Yard- A.Freitag)11/16/2016 Crossing appears to be in good condition. (DWR Sutter Yard- A.Freitag)04/28/2016 Crossing appears to be in good condition.07/13/2015 Crossing appears in good condition. No noticeable issues to report.05/21/2014 Same as last inspection.12/03/2013 Same as last inspection.07/15/2013 Same as last inspection.<br/> FIELD_STRUCT_DESC: 60-inch corrugated metal drainage pipe through the levee, 11.5 feet below the crown. Slide gate in corrugated metal pipe riser on the waterside (WS) slope. Concrete "U" headwall on both ends and weir in channel. Crossing is used as an irrigation turnout. [Additional Reference(s): DWR Levee Log, 1993. USACE Sacramento O&amp;M Manual 519, June 1962 (HLM 11.21)]<br/> FS Date: 8/27/2019 2:16:00 PM</p> | | | | | |

Corrugated metal riser with owner information.

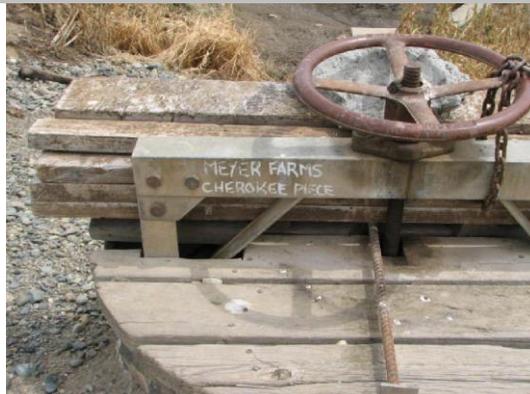
Photo 3 of 3 : UCIP\_FA\_2019\_54994\_66951.jpg

DS\_ID:16336  
 FS\_ID:54994  
 EP\_NO: N/A  
 Repair Type: Non-Urgent  
 Crossing Status: Found  
 UCIP Comments: 08/27/2019 Record remains Non-Urgent, no permit has been identified authorizing the dual purpose of this crossing and slide gate is still missing from the WS CMP riser. Crossing is used as an irrigation turnout. Flow from Cherokee Canal is diverted upstream by weir and feed into an irrigation canal that runs parallel along WS levee toe for about 2.5 miles. The irrigation turnout is used to divert water from WS irrigation canal to LS. Need to update crossing type from Drainage to Other. This crossing is not maintained or operated by LMA-Sutter Yard. (O. Magana - DWR UCIP, A. Freitag - DWR Sutter Yard)06/15/2017 Slide gate still missing from inside of WS standpipe. Pipe has been selected to be internally cleaned and inspected as part of the DMP project. (DWR Sutter Yard- AFreitag)11/17/2016 Slide gate still missing from inside the WS standpipe. (DWR Sutter Yard- AFreitag)04/28/2016 Slide gate was removed from inside the WS standpipe.07/13/2015 New screw gate installed on the WS pipe end in the irrigation ditch.05/21/2014 Same as last inspection.12/03/2013 Same as last inspection.07/15/2013 Same as last inspection.04/18/2012 Irrigation turnout. Not in use during April 2012 Inspection. During the follow up May 2012 Inspection structure was being used as irrigation turnout, reason for barcode tags. FIELD\_STRUCT\_DESC: 30-inch corrugated metal drainage pipe through the levee, 10.7 feet below the crown. Slide gate in corrugated metal pipe (CMP) riser on the waterside (WS) slope. Concrete "U" headwalls on both ends. This crossing is used as an irrigation turnout bar code plate located on the WS slide gate (identified as 141 and 142). [Additional Reference(s): DWR Levee Log, 1993. USACE Sacramento O&M Manual 519, June 1962 (HLM 12.94)]

Slide gate located on WS slope. Owner information marked on gate.

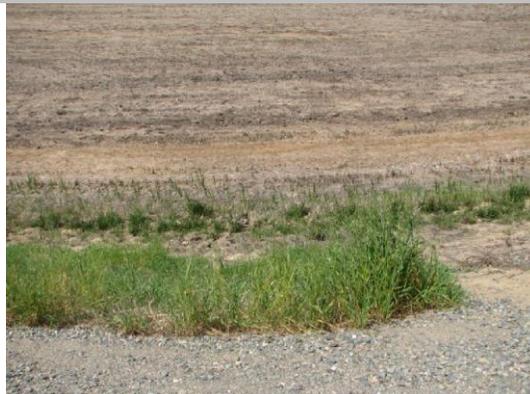
Photo 2 of 3 : UCIP\_FA\_2019\_54998\_66973.jpg

View of LS slope and toe. Unable to find welded plate on LS.

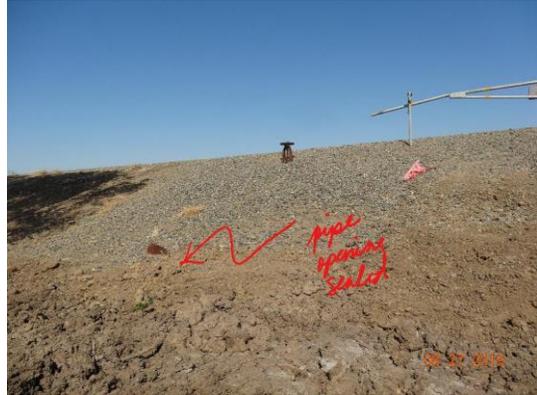
Photo 3 of 3 : UCIP\_FA\_2019\_54998\_80558.jpg

WS view: pipe section capped off on WS.

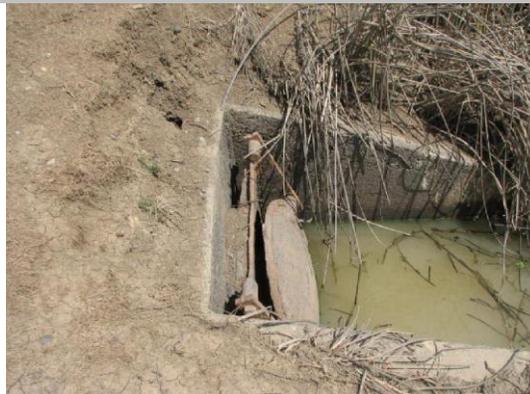
Photo 1 of 3 : UCIP\_FA\_2019\_54999\_66976.jpg

Headwall and flapgate located on water side of levee

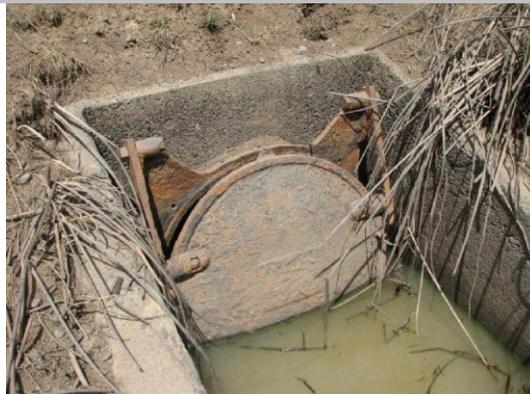
Photo 2 of 3 : UCIP\_FA\_2019\_54999\_66974.jpg

Headwall and flapgate located on water side of levee

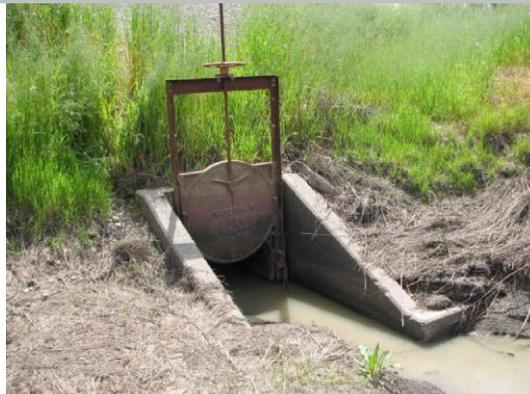
Photo 3 of 3 : UCIP\_FA\_2019\_54999\_66975.jpg

Head wall and screw gate located on land side of levee

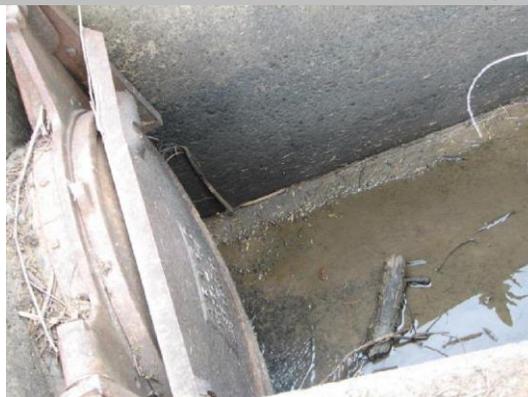
Photo 1 of 3 : UCIP\_FA\_2019\_55000\_66981.jpg

WS headwall and flapgate

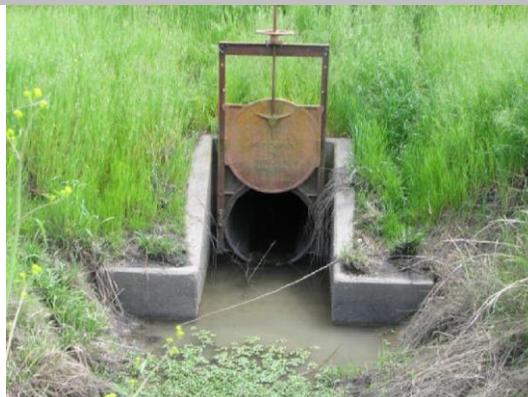
Photo 2 of 3 : UCIP\_FA\_2019\_55000\_66980.jpg

Slide gate located on LS toe. Dense vegetation present on LS slope.

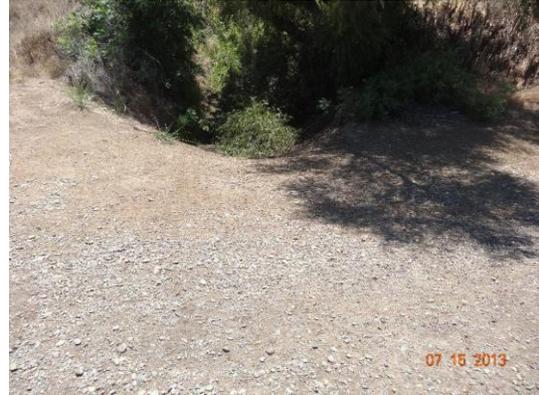
Photo 3 of 3 : UCIP\_FA\_2019\_55000\_66982.jpg

WS slope cleared of vegetation

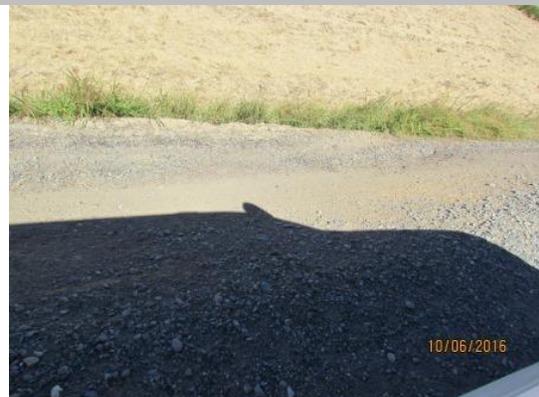
Photo 1 of 1 : FA\_2019\_MA0013\_300\_57\_20190822\_00008.jpg

View of slope instability along the landside slope.

| S1 : Repair slope instability. | | | | | |

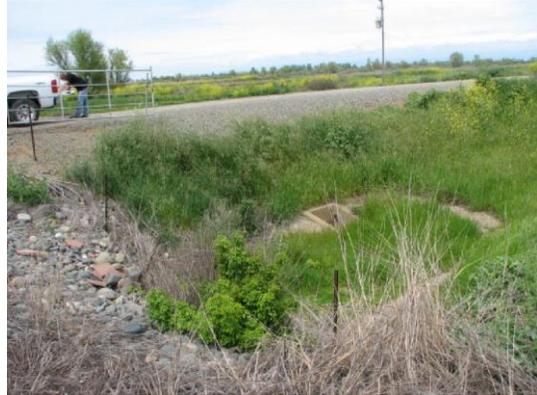
Photo 1 of 3 : UCIP\_FA\_2019\_55006\_67017.jpg

View of WS slope and toe.

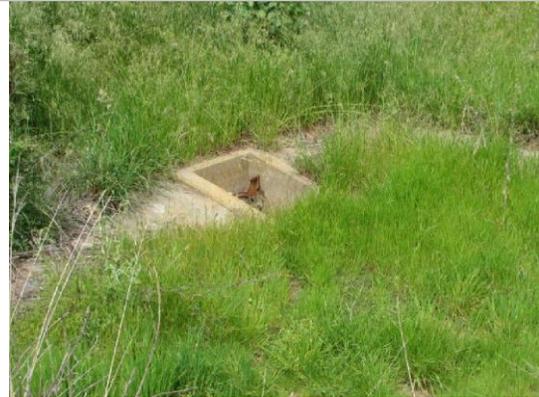
Photo 2 of 3 : UCIP\_FA\_2019\_55006\_67019.jpg

View of WS headwall and flap gate.

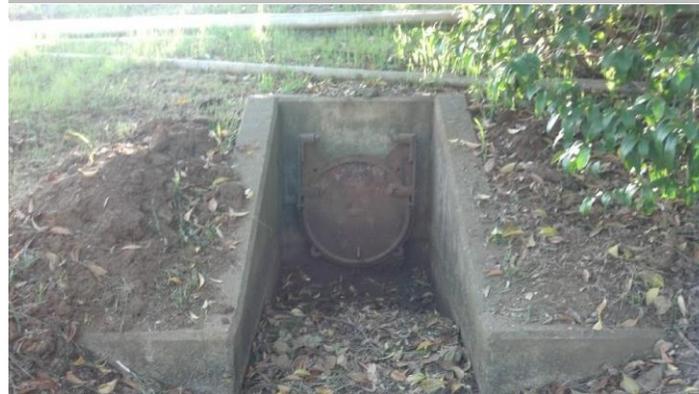
Photo 2 of 3 : UCIP\_FA\_2019\_55415\_45642.jpg

Headwall and flap gate on WS. Soil and pipes stockpiled next to headwall.

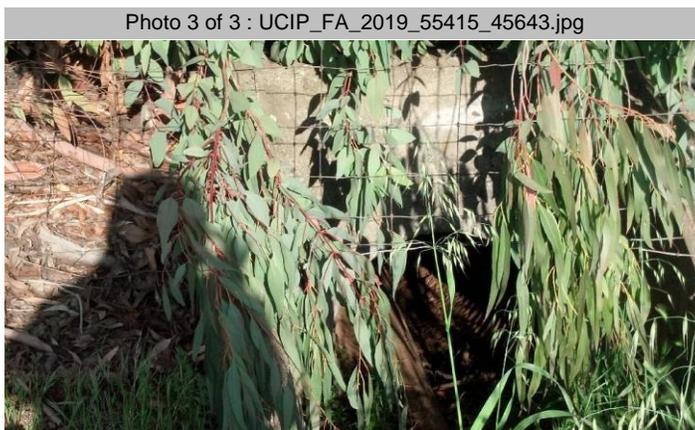
| <p>DS_ID:16397<br/> FS_ID:55415<br/> EP_NO: N/A<br/> Repair Type: Non-Urgent<br/> Crossing Status: Found<br/> UCIP Comments: 08/28/2019 Record remains Non-Urgent, no permit has been identified authorizing pipe. Pipe has been lined. (O. Magana - DWR UCIP, A. Freitag - DWR Sutter Yard)06/05/2017 Crossing appears to be in good condition. (DWR Sutter Yard- AFreitag)11/18/2016 Crossing appears to be in good condition. 4inch pipe still present on LS but it does not affect the function of the crossing. (DWR Sutter Yard- AFreitag)09/27/2016 Crossing has been downgraded from Urgent to Non-Urgent--sleeved pipe does not prevent flap gate from closing on WS. Still need to coordinate with owner to remove sleeved pipe through existing crossing per Title 23. (DWR UCIP - omagana)04/27/2016 Crossing appears to be in good condition. 4 inch pipe is still present in LS opening but does not go all the way through to the WS. (DWR Sutter Yard - afreitag)07/01/2015 Crossing appears in good condition. No noticeable issues to report. (DWR Sutter Yard - afreitag)05/29/2014 Same as last inspection. (DWR Sutter Yard - afreitag)12/09/2013 4in. Pipe was removed and flap gate is closed and ready for high water. (DWR Sutter Yard - afreitag)07/10/2013 Same as last inspection. Urgency rating carry over from last entry. (DWR Sutter Yard - afreitag)04/19/2012 4-6 inch pipe is not part of original crossing--remove pipe. WS-pipe stockpile on WS slope. LS-Overgrown branches limit inspection. This crossing was listed in the USACE Periodic Inspection report listed as Corp's Inspect ID# USACE_CESPK_M13G_2011_p_0009 for WS flap gate not functioning properly as irrigation pipe passes inside crossing. (DWR UCIP - omagana)<br/> FIELD_STRUCT_DESC: 24-inch CIPP-lined corrugated metal drainage pipe through the levee, 6 feet below the crown. Concrete "U" headwalls on both WS and landside (LS). Flap gate on the waterside (WS) end.<br/> [Additional Reference(s): DWR Levee Log, 1993. USACE Sacramento O&amp;M Manual 519, June 1962 (HLM 0.04).<br/> FS Date: 8/28/2019 12:55:00 PM</p> | | | | | |

LS headwall blocked by overgrown branches.

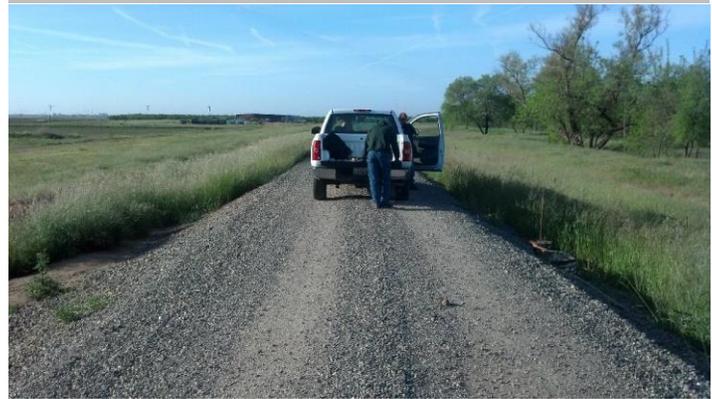
Photo 1 of 3 : UCIP\_FA\_2019\_55970\_67047.jpg

Overview looking south

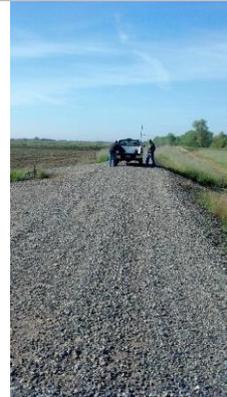
Photo 1 of 3 : UCIP\_FA\_2019\_55418\_67063.jpg

Overview of levee crown looking south

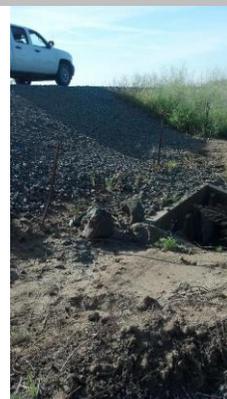
Photo 2 of 3 : UCIP\_FA\_2019\_55418\_67068.jpg

View of WS slope.

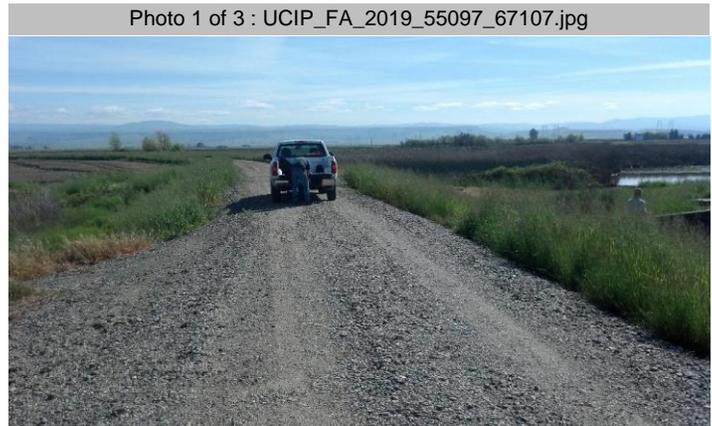
| <p>DS_ID:16847<br/> FS_ID:55097<br/> EP_NO: N/A<br/> Repair Type: Non-Urgent<br/> Crossing Status: Found<br/> UCIP Comments: 08/28/2019 Record remains Non-Urgent, no permit has been identified authorizing pipe. Pending internal inspection under DMP Phase 1 both inlet and outlet underwater. (O. Magana - DWR UCIP, A. Freitag - DWR Sutter Yard)06/05/2017 Both ends submerged but crossing appears to be in good condition. (DWR Sutter Yard- AFreitag)11/18/2016 Crossing appears to be in good condition. It appears that this crossing does not require a slide gate. (DWR Sutter Yard- AFreitag)04/27/2016 LS slide gate was still missing. Rest of crossing appears to be in good condition.07/01/2015 There appears to be a LS gate now but both pipe ends were submerged so it was hard to tell for certain.05/29/2014 Same as last inspection.12/09/2013 Pulled sticks from WS flap gate to allow it to close. Ls gate is still missing.07/10/2013 WS and LS slopes have been cleared of vegetation and are in good condition. LS gate is still missing and WS flap gate is still wedged open with sticks.04/19/2012 LS gate missing &amp; limited inspection. Need photos of WS &amp; LS cleared slopes. Description calls for slide gate on LS-slide gate missing. Debris scattered near LS headwall. This crossing was listed in the USACE Periodic Inspection report as Corp's Inspect ID# USACE_CESPK_M13J_2011_p_0010 for WS gate wedged open &amp; missing LS slide gate.<br/> FIELD_STRUCT_DESC: 36-inch corrugated metal drainage pipe through the levee, 8.8 feet below the crown. Flap gate on the waterside (WS) end. Slide gate on the landside (LS) end. Concrete "U" headwalls on both ends. [Additional Reference(s): DWR Levee Log, 1993. USACE Sacramento O&amp;M Manual 519, June 1962 (HLM 3.85)]<br/> FS Date: 8/28/2019 1:21:00 PM</p> | | | | | |

Overview looking south on left levee

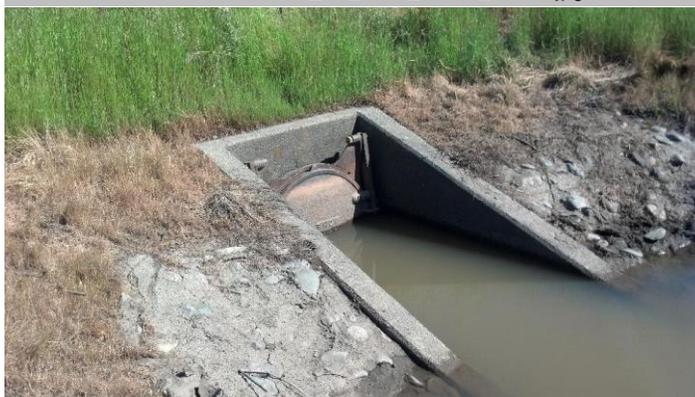
Photo 2 of 3 : UCIP\_FA\_2019\_55097\_67108.jpg

Headwall and flap gate located on WS toe.

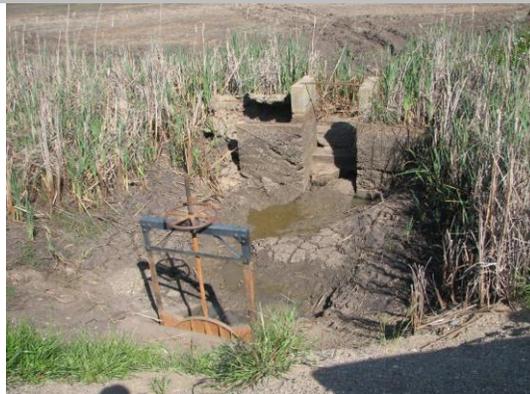
Photo 3 of 3 : UCIP\_FA\_2019\_55098\_67113.jpg

Overview of LS screw gate and concrete sump structure.

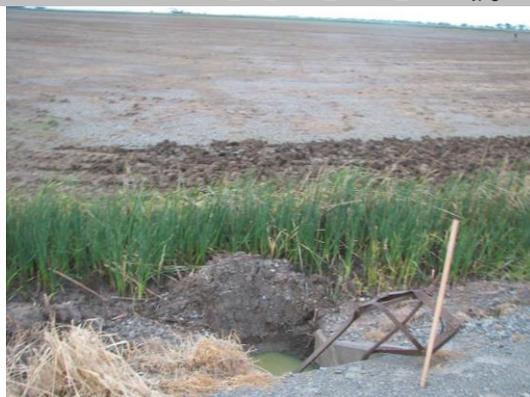
Photo 3 of 3 : UCIP\_FA\_2019\_56101\_67141.jpg

Overview of LS floor is higher in elevation than pipe invert causing build up sediment.

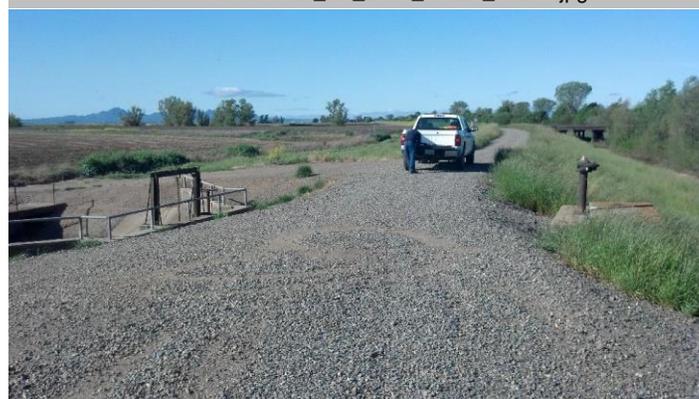
Photo 1 of 3 : UCIP\_FA\_2019\_55120\_67280.jpg

Overview of levee crown at crossing looking D/S.

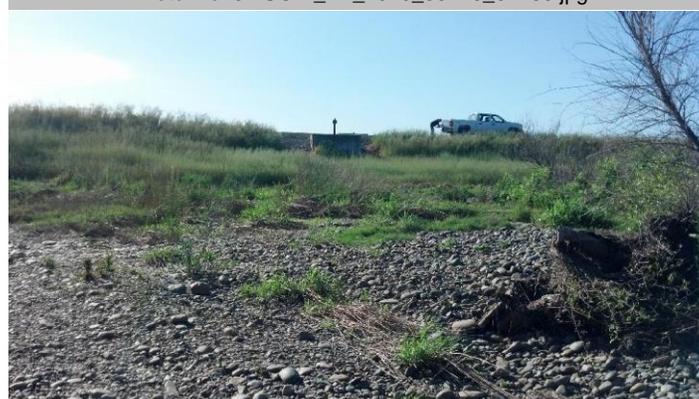
Photo 2 of 3 : UCIP\_FA\_2019\_55120\_67285.jpg

View of crossing looking from channel towards WS levee.

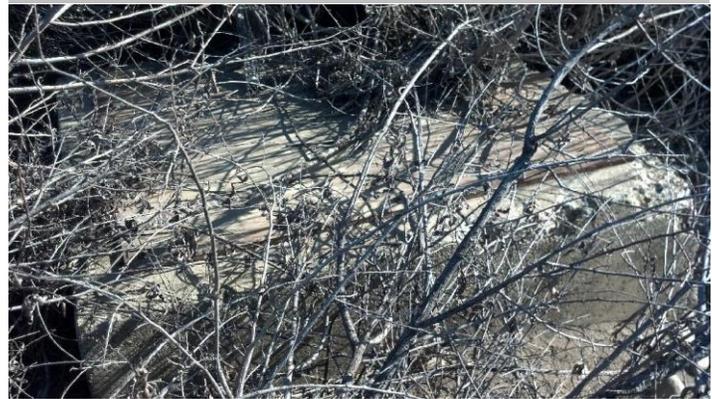
Photo 3 of 3 : UCIP\_FA\_2019\_55120\_67283.jpg

WS view-access well located 60 feet from WS toe.

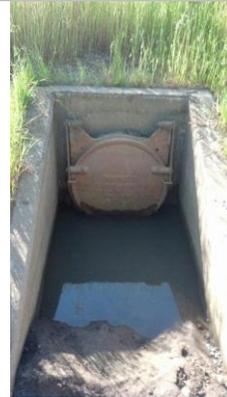
Photo 1 of 3 : UCIP\_FA\_2019\_55118\_67289.jpg

WS view of crossing. Dense vegetation along WS slope limited visual inspection. (WS Photo 1 of 2)

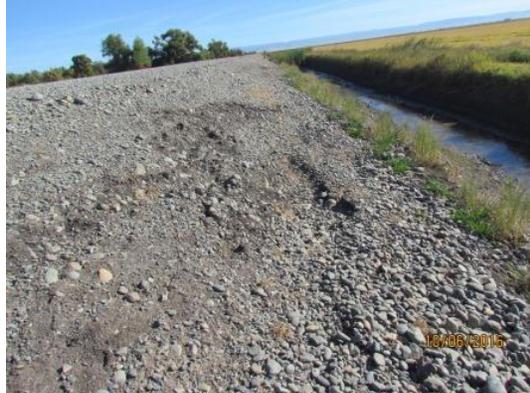
Photo 1 of 1 : FA\_2019\_MA0013\_301\_69\_20190822\_00014.jpg

View of slope instability issue along the landside slope.

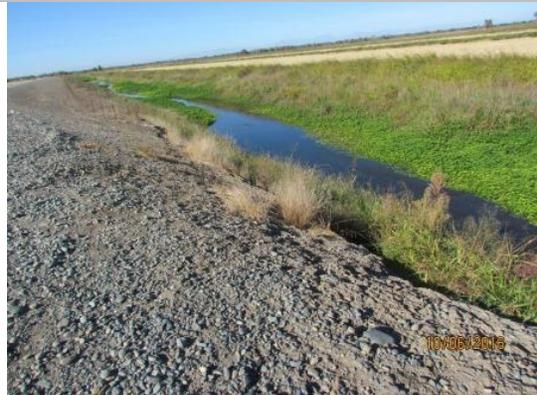
Photo 1 of 1 : FA\_2019\_MA0013\_301\_75\_20190822\_00015.jpg

View of the erosion along the waterside toe.

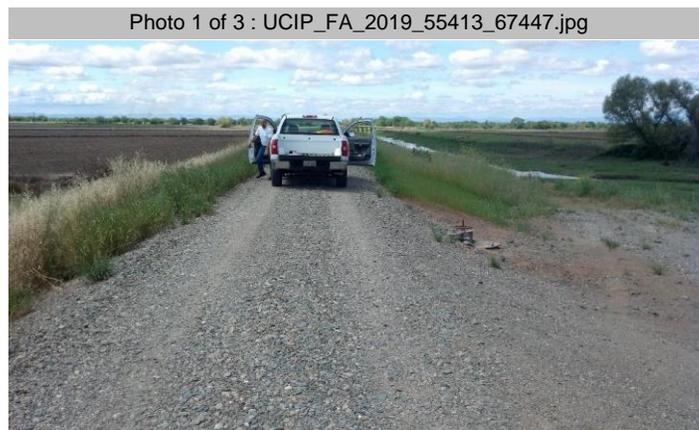
FIELD\_STRUCT\_DESC: 24-inch corrugated metal irrigation pipe through the levee, 8.2 feet below the crown. Crossing penetrates levee at angle. Slide gate in corrugated metal pipe (CMP) riser on the waterside (WS) slope. Pipe crosses the channel. Corroded section of existing pipe, 9-foot and 8-inch of an 18-inch corrugated metal pipe section, was replaced under Permit 7231 prior to 1974. (24-inch CMP authorized to match existing 24-inch CMP through left bank under Permit No. 7231, 1960 - Estate of Walter L. King) [Additional Reference(s): DWR Levee Log, 1993. USACE Sacramento O&M Manual 519, June 1962 (HLM 21.60)]  
 FS Date: 8/29/2019 7:39:00 AM

Overview of crossing looking downstream.

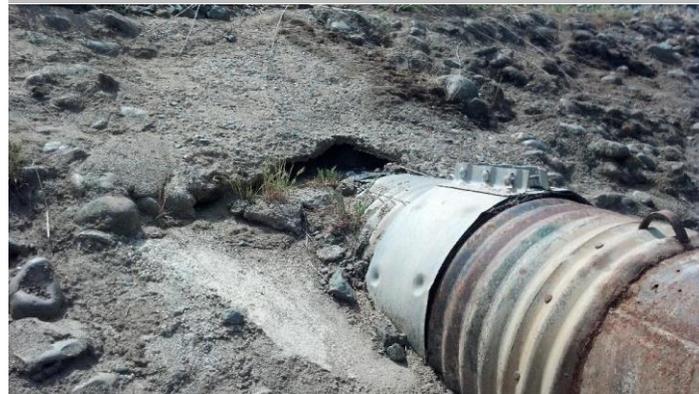
Photo 2 of 3 : UCIP\_FA\_2019\_55413\_67451.jpg

View of WS daylight. Hole present at pipe daylight.

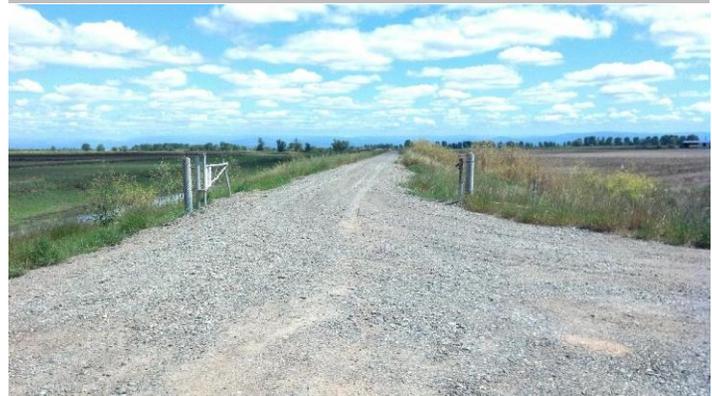
Photo 1 of 3 : UCIP\_FA\_2019\_55414\_67462.jpg

Overview of crossing looking upstream at the left bank of Cherokee Canal.

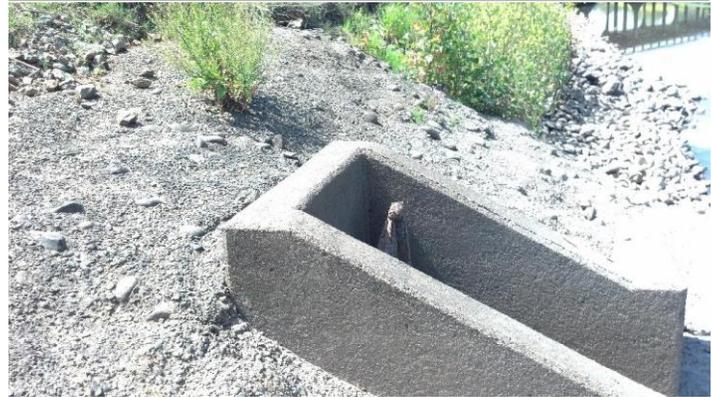
Photo 2 of 3 : UCIP\_FA\_2019\_55414\_67460.jpg

View of WS headwall.

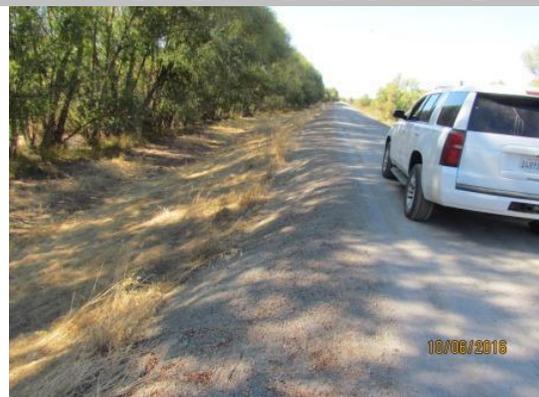
Photo 1 of 1 : FA\_2019\_MA0013\_301\_62\_20190822\_00012.jpg

View of slope instability issue along the landside slope.

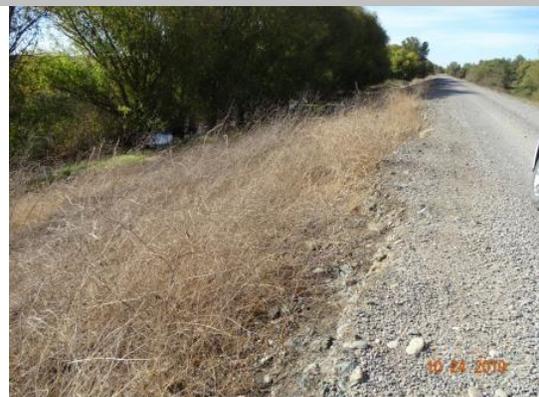
Photo 1 of 1 : FA\_2019\_MA0013\_301\_58\_20191028\_00128.jpg

View of erosion on the landside slope. Fall 2019.

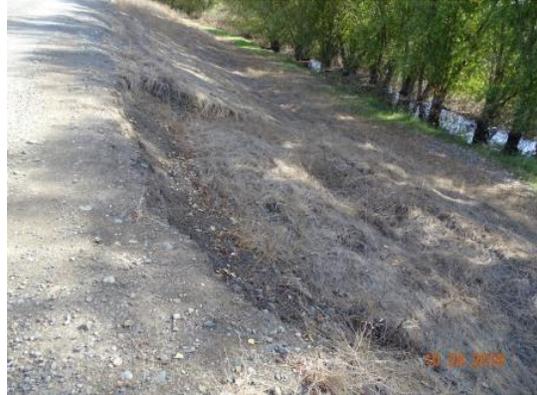
Photo 1 of 1 : FA\_2019\_MA0013\_301\_60\_20191028\_00129.jpg

View of sloughing on the landside slope. Fall 2019.

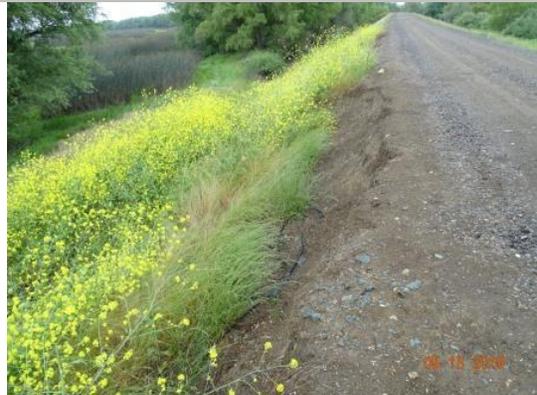
Photo 1 of 1 : FA\_2019\_MA0013\_301\_61\_20190822\_00011.jpg

View of the erosion at the landside shoulder and slope. Spring 2019.
