**Flood Control Project Maintenance  
Levee Inspections**

**Maintenance Issue Types Only, Levee Inspection Report By Mile - Fall 2019**

**Sutter Maintenance Yard Maintenance Area 0016**

Waterway	Bank	Unit Miles	Inspection Start/End	Inspector
Unit No. 01 Feather River	Right	4.06	11/04/2019 11/04/2019	Sterling York

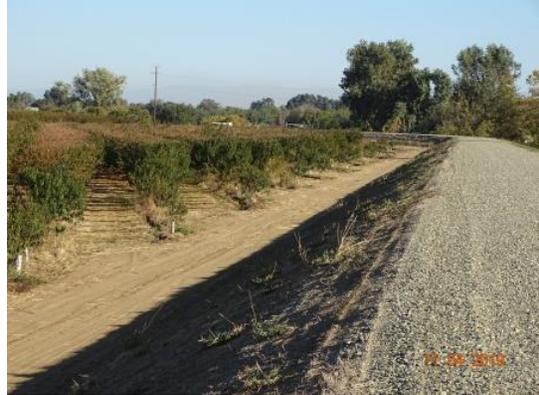
Photo 1 of 1 : FA\_2019\_MA0016\_302\_7\_20191112\_00010.jpg

LM Start	<b>0.01</b>	Rating **	A	Issue No.	<b>7</b>
LM End	<b>4.06</b>	Issue Type +	Ma	Location *	LS
Category	Earthen Levee		GPS Latitude/Longitude		
			Start	End	
Item	Vegetation		39.255899°	39.310952°	
			-121.636412°	-121.637662°	
DWR ID	DWR_MA0016_01_f_2019_7				
Comment Code					
V1 : Control annual grass and weeds on the levee slopes and easements.					
Inspector Comment					
The annual vegetation is well maintained, Fall 2019.

View looking upstream landside at the well maintained annual vegetation, Fall 2019.

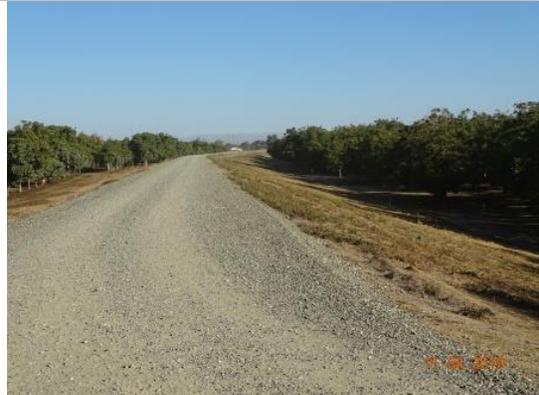
Photo 1 of 1 : FA\_2019\_MA0016\_302\_8\_20191112\_00011.jpg

LM Start	<b>0.01</b>	Rating **	A	Issue No.	<b>8</b>
LM End	<b>4.06</b>	Issue Type +	Ma	Location *	WS
Category	Earthen Levee		GPS Latitude/Longitude		
			Start	End	
Item	Vegetation		39.255899°	39.310953°	
			-121.636412°	-121.637662°	
DWR ID	DWR_MA0016_01_f_2019_8				
Comment Code					
V1 : Control annual grass and weeds on the levee slopes and easements.					
Inspector Comment					
The annual vegetation is well maintained, Fall 2019.

View looking upstream waterside at the well maintained annual vegetation, Fall 2019.

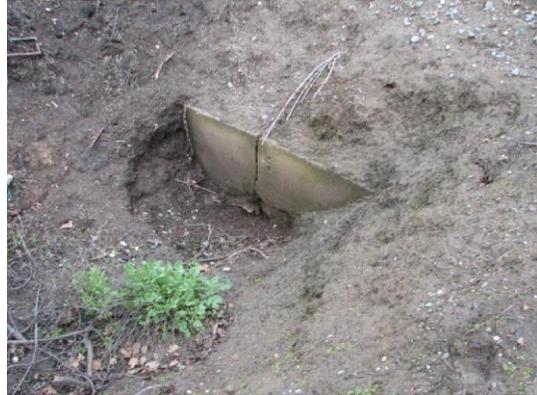
Photo 1 of 3 : UCIP\_FA\_2019\_55877\_65782.jpg

LM Start	<b>3.39</b>	Rating **	U	Issue No.	<b>17</b>
LM End	<b>3.39</b>	Issue Type +	Ma	Location *	
Category	Supplemental		GPS Latitude/Longitude		
			Start	End

Item	DRAFT DWR UCIP LMA Responsibility		39.301218°	39.301218°	
			-121.638332°	-121.638332°	
DWR ID	17125				
Comment Code					
Inspector Comment					
DS_ID:17125 FS_ID:55877 EP_NO: N/A Repair Type: Urgent Crossing Status: Found UCIP Comments: 05/22/2019 No internal inspection was completed due to the poor condition of the pipe. Pipe has been upgraded from Non-Urgent to Urgent due to the condition of the pipe. (O. Magana - DWR UCIP)05/22/2017 LS inlet buried. WS access being blocked off by over grown vegetation. Pipe has been selected for internal cleaning and inspection as part of the DMP project. (DWR Sutter Yard - AFreitag)12/01/2016 LS inlet completely buried. (DWR Sutter Yard- AFreitag)05/26/2016 LS inlet was completely buried.06/08/2015 Concrete headwall is still cracked and inlet is buried. It was said to be replaced with the SBFCA project but the project skipped over in this area.12/29/2014 Same as last inspection.05/19/2014 Same as last inspection.11/06/2013 Same as last inspection.05/14/2013 SBFCA project recommends replacing in accordance with title 23. Same as last inspection.12/11/2012 Concrete headwall on LS toe is cracked through middle and pipe is buried in soil. pipe appears corroded. (DWR UCIP - W. Wylie) FIELD_STRUCT_DESC: 1 of 2: 24-inch corrugated metal drainage pipe through the levee, 16.6 feet below the crown. Concrete headwalls on both the waterside (WS) and the landside (LS) ends. Flap gate on the WS end. [Additional Reference(s): DWR Levee Log, 2005. USACE Sacramento O&M Manual 148, August 1955, (Station 646+96)]. FS Date: 5/22/2019 3:47:00 PM

Headwall at LS toe is cracked and the inlet is buried in soil.

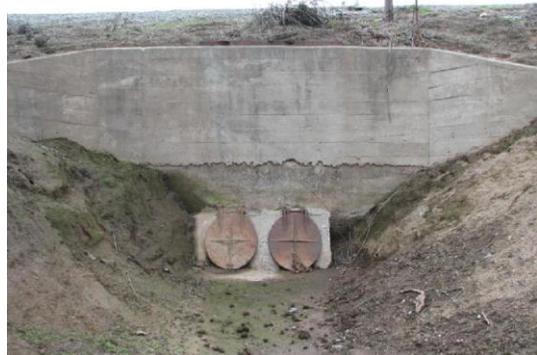
Photo 2 of 3 : UCIP\_FA\_2019\_55877\_65781.jpg

Headwall on WS toe with flap gates.

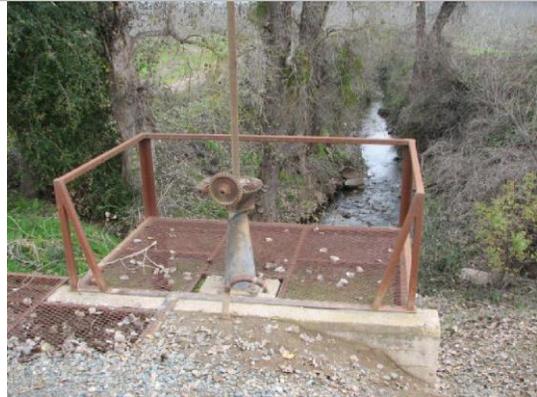
Photo 1 of 3 : UCIP\_FA\_2019\_55881\_65785.jpg

LM Start	<b>4.07</b>	Rating **	M	Issue No.	<b>19</b>
LM End	<b>4.07</b>	Issue Type +	Ma	Location *	
Category	Supplemental		GPS Latitude/Longitude		
			Start	End

Item	DRAFT DWR UCIP LMA Responsibility		39.311127°	39.311127°	
			-121.637606°	-121.637606°	
DWR ID	17123				
Comment Code					
Inspector Comment					
<p>DS_ID:17123                  FS_ID:55881                  EP_NO: N/A                  Repair Type: Non-Urgent                  Crossing Status: Found                  UCIP Comments: 05/22/2019 Record has been updated from No Action Needed to Non-Urgent, need to clarify owner. Unclear the purpose of this pipe. The pipe transfers water from LS to WS and then the flow is diverted via a WS canal that runs parallel along levee for about 0.92 miles. This crossing might be used to irrigate orchards located on the WS. Need to contact owner to clarify purpose of this structure. (O. Magana - DWR UCIP)05/22/2017 Crossing appears to be in good condition. (DWR Sutter Yard - AFreitag)12/01/2016 Crossing appears to be in good condition. (DWR Sutter Yard- AFreitag)05/26/2016 Crossing appears to be in good condition.06/08/2015 Pipe appears to be in good condition. No noticeable issues to report. Pipe was listed to be replaced with the SBFCA project but the project did not take place in this area.12/29/2014 Same as last inspection.05/19/2014 Same as last inspection.11/06/2013 Same as last inspection.05/14/2013 Slide gate opened allowing water to flow through, debris problem has been cleared and the gates seem to be functioning properly. SBFCA project recommends replacing in accordance with title 23.12/11/2012 Lock missing from concrete well access door-this should be replaced. Some debris blocking preventing flap gate from completely closing. (DWR UCIP - W. Wylie)                  FIELD_STRUCT_DESC: 48-inch by 72-inch reinforced concrete drainage culvert through the levee, 20.5 feet below the crown. Slide gate in a concrete well on the waterside (WS) slope. Siphon breaker/air vent on the WS shoulder at the concrete well. [Additional Reference(s): DWR Levee Log, 2005. USACE Sacramento O&amp;M Manual 148, August 1955, (Station 683+25)].                  FS Date: 5/22/2019 3:50:00 PM</p>

Slide gate, concrete well, siphon breaker/air vent and open channel on WS of levee.

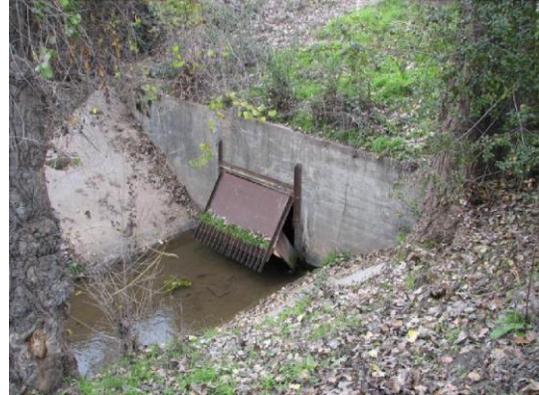
Photo 3 of 3 : UCIP\_FA\_2019\_55881\_65783.jpg

Concrete headwall and flap gate on WS toe.
