**Flood Control Project Maintenance  
Levee Inspections**

**Maintenance Issue Types Only, Levee Inspection Report By Mile - Spring 2020**

**Sutter Maintenance Yard Maintenance Area 0016**

Waterway	Bank	Unit Miles	Inspection Start/End	Inspector
Unit No. 01 Feather River	Right	4.06	03/18/2020 03/18/2020	Sterling York

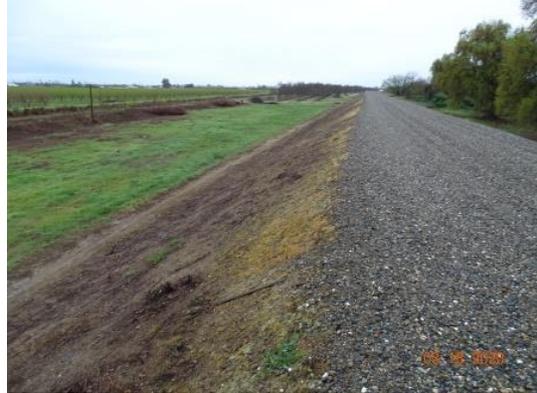
Photo 1 of 1 : SP\_2020\_MA0016\_302\_9\_20200327\_00018.jpg

LM Start	<b>0.00</b>	Rating **	A	Issue No.	<b>9</b>
LM End	<b>4.05</b>	Issue Type +	Ma	Location *	LS
Category	Earthen Levee		GPS Latitude/Longitude		
			Start	End	
Item	Vegetation		39.255854 °	39.310756 °	
			-121.636401 °	-121.637697 °	
DWR ID	DWR_MA0016_01_s_2020_9				
Comment Code					
V1 : Control annual grass and weeds on the levee slopes and easements.					
Inspector Comment					
The annual vegetation is well maintained, Spring 2020.

View looking upstream landside at the well maintained annual vegetation, Spring 2020.

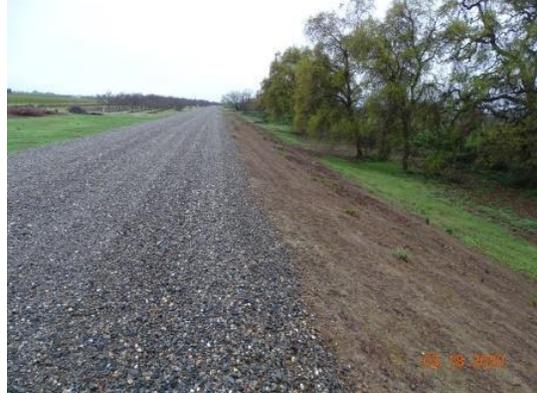
Photo 1 of 1 : SP\_2020\_MA0016\_302\_10\_20200327\_00017.jpg

LM Start	<b>0.00</b>	Rating **	A	Issue No.	<b>10</b>
LM End	<b>4.05</b>	Issue Type +	Ma	Location *	WS
Category	Earthen Levee		GPS Latitude/Longitude		
			Start	End	
Item	Vegetation		39.255854 °	39.310756 °	
			-121.636401 °	-121.637697 °	
DWR ID	DWR_MA0016_01_s_2020_10				
Comment Code					
V1 : Control annual grass and weeds on the levee slopes and easements.					
Inspector Comment					
The annual vegetation is well maintained, Spring 2020.

View looking upstream waterside at the well maintained annual vegetation, Spring 2020.

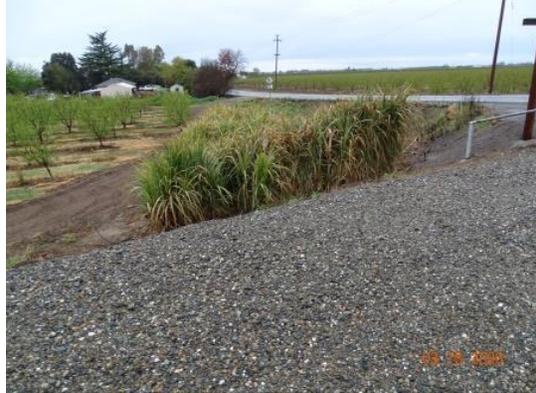
Photo 1 of 1 : SP\_2020\_MA0016\_302\_12\_20200327\_00020.jpg

LM Start	<b>1.42</b>	Rating **	M	Issue No.	<b>12</b>
LM End	<b>1.42</b>	Issue Type +	Ma	Location *	LS
Category	Earthen Levee		GPS Latitude/Longitude		
			Start	End	
Item	Vegetation		39.275979 °	39.275979 °	
			-121.632560 °	-121.632560 °	
DWR ID	DWR_MA0016_01_s_2020_12				
Comment Code					
V2 : Remove the wild growth other than native grasses from the levee slopes.					
Inspector Comment					
Remove tall weeds on levee slope, Spring 2020.

View looking upstream landside at tall weeds on levee slope, Spring 2020.

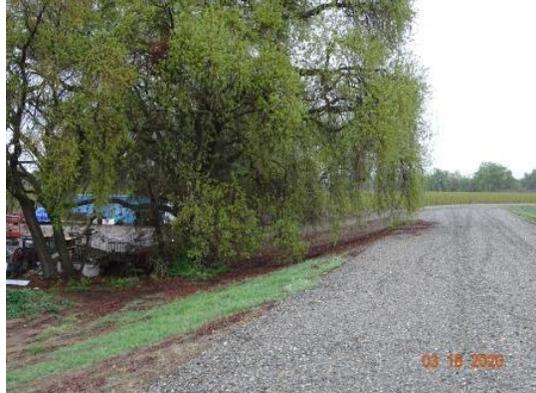
Photo 1 of 1 : SP\_2020\_MA0016\_302\_13\_20200327\_00021.jpg

LM Start	<b>1.86</b>	Rating **	M	Issue No.	<b>13</b>
LM End	<b>1.86</b>	Issue Type +	Ma	Location *	LS
Category	Earthen Levee		GPS Latitude/Longitude		
			Start	End	
Item	Trim / Thin Trees		39.282120 °	39.282120 °	
			-121.632119 °	-121.632119 °	
DWR ID	DWR_MA0016_01_s_2020_13				
Comment Code					
T1 : Trim trees to at least five feet above ground level.					
Inspector Comment					
Limbs need to be trimmed for access, Spring 2020.

View looking upstream landside at limbs that need to be trimmed for access, Spring 2020.

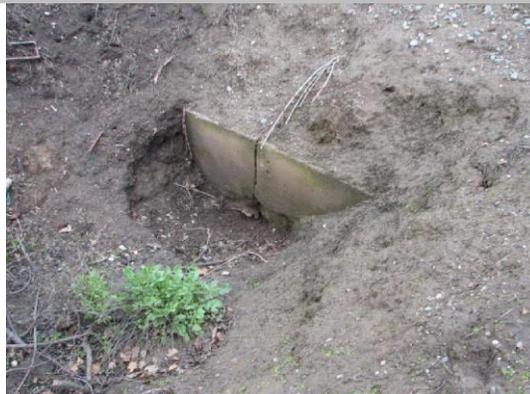
Photo 1 of 3 : UCIP\_SP\_2020\_56164\_65782.jpg

DS\_ID:17125  
 FS\_ID:56164  
 EP\_NO: N/A  
 Repair Type: Non-Urgent  
 Crossing Status: Found  
 UCIP Comments: 03/16/2020 During the fall of 2019, the two 24-inch pipes were abandoned in-place through section of the levee. A 2-foot section of the pipe ends on both the WS and LS were removed and disposed. The pipe annular void was filled with cement with aggregate as per Title 23 requirements. Both the WS and LS existing concrete headwalls were removed. Record has been downgraded from Urgent to Non-Urgent, need to coordinate with the CVFPB regarding the final documentation issued (potential permit) for the proper abandonment of these crossings. (O. Magana - DWR UCIP) 05/22/2019 No internal inspection was completed due to the poor condition of the pipe. The internal inspection was abandoned. Signs of pipe failure (holes along pipe wall, see DMP internal inspection report) found at the LS entrance. Pipe has been upgraded from Non-Urgent to Urgent due to the signs of structural failure of pipe. (O. Magana - DWR UCIP)05/22/2017 LS inlet buried. WS access being blocked off by over grown vegetation. Pipe has been selected for internal cleaning and inspection as part of the DMP project. (DWR Sutter Yard - AFreitag)12/01/2016 LS inlet completely buried. (DWR Sutter Yard - AFreitag)05/26/2016 LS inlet was completely buried.06/08/2015 Concrete headwall is still cracked and inlet is buried. It was said to be replaced with the SBFCA project but the project skipped over in this area.12/29/2014 Same as last inspection.05/19/2014 Same as last inspection.11/06/2013 Same as last inspection.05/14/2013 SBFCA project recommends replacing in accordance with title 23. Same as last inspection.12/11/2012 Concrete headwall on LS toe is cracked through middle and pipe is buried in soil. pipe appears corroded. (DWR UCIP - W. Wylie)

Headwall at LS toe is cracked and the inlet is buried in soil.

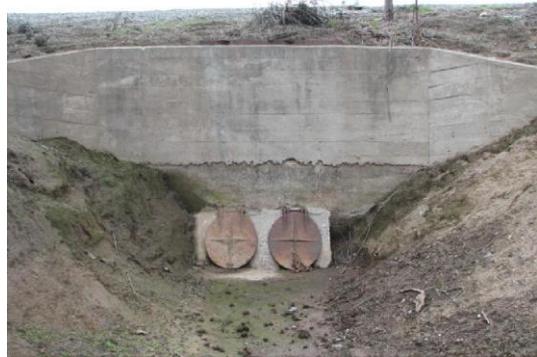
Photo 2 of 3 : UCIP\_SP\_2020\_56164\_65781.jpg

Headwall on WS toe with flap gates.

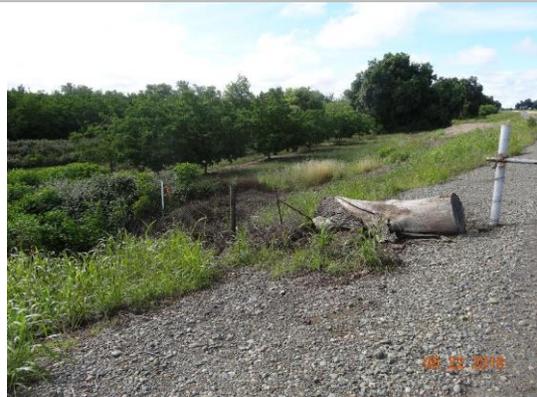
Photo 3 of 3 : UCIP\_SP\_2020\_56164\_81059.jpg

WS view: overview of WS.

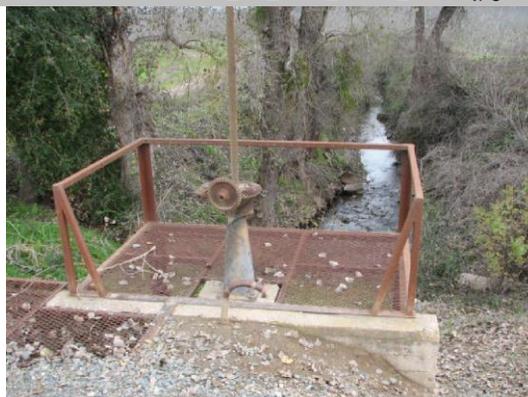
Photo 1 of 3 : UCIP\_SP\_2020\_55881\_65785.jpg

Item	DWR UCIP LMA Responsibility		39.311127 °	39.311127 °	
			-121.637606 °	-121.637606 °	
DWR ID	17123				
Comment Code					
Inspector Comment					
DS_ID:17123 FS_ID:55881 EP_NO: N/A Repair Type: Non-Urgent Crossing Status: Found UCIP Comments: 05/22/2019 Record has been updated from No Action Needed to Non-Urgent, need to clarify owner. Unclear the purpose of this pipe. The pipe transfers water from LS to WS and then the flow is diverted via a WS canal that runs parallel along levee for about 0.92 miles. This crossing might be used to irrigate orchards located on the WS. Need to contact owner to clarify purpose of this structure. (O. Magana - DWR UCIP)05/22/2017 Crossing appears to be in good condition. (DWR Sutter Yard - AFreitag)12/01/2016 Crossing appears to be in good condition. (DWR Sutter Yard - AFreitag)05/26/2016 Crossing appears to be in good condition.06/08/2015 Pipe appears to be in good condition. No noticeable issues to report. Pipe was listed to be replaced with the SBFCA project but the project did not take place in this area.12/29/2014 Same as last inspection.05/19/2014 Same as last inspection.11/06/2013 Same as last inspection.05/14/2013 Slide gate opened allowing water to flow through, debris problem has been cleared and the gates seem to be functioning properly. SBFCA project recommends replacing in accordance with title 23.12/11/2012 Lock missing from concrete well access door-this should be replaced. Some debris blocking preventing flap gate from completely closing. (DWR UCIP - W. Wylie) FIELD_STRUCT_DESC: 48-inch by 72-inch reinforced concrete drainage culvert through the levee, 20.5 feet below the crown. Slide gate in a concrete well on the waterside (WS) slope. Siphon breaker/air vent on the WS shoulder at the concrete well. [Additional Reference(s): DWR Levee Log, 2005. USACE Sacramento O&M Manual 148, August 1955, (Station 683+25)]. FS Date: 5/22/2019 3:50:00 PM

Slide gate, concrete well, siphon breaker/air vent and open channel on WS of levee.
