**Flood Control Project Maintenance
Levee Inspections**
LMA District Cover Sheet
Spring 2020 Levee Inspection Results

Butte County Department of Public Works

**Flood Control Project Maintenance
Levee Inspections**

Waterway	Bank	Unit Miles
Unit No. 01 Mud Creek	Right	6.80

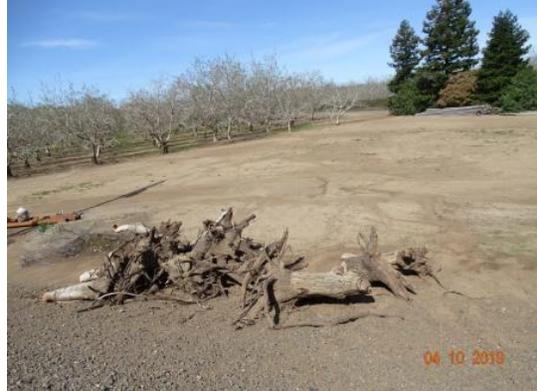
Photo 1 of 1 : SP_2020_NA0003_64_26_20200226_00006.jpg

View of an adjacent pile of tree stumps at the landside toe. Spring 2019.

LM Start	0.25	Rating **	A/W	Issue No.	64
LM End	0.25	Issue Type +	Ma	Location *	
Category	Supplemental		GPS Latitude/Longitude		
			Start	End	
Item	DWR UCIP LMA Responsibility		39.729219 °	39.729219 °	
			-121.933437 °	-121.933437 °	
DWR ID	19209				
Comment Code					
Inspector Comment					
DS_ID:19209 FS_ID:29705 EP_NO: N/A Repair Type: No Action Needed Crossing Status: Found UCIP Comments: Looks cleaned recently. FIELD_STRUCT_DESC: 24-inch corrugated metal gravity drainage pipe through the levee, 12.5 feet below the crown. Flap gate on the waterside (WS) end. Concrete U-shaped headwall on each end. Grouted riprap apron on the landside (LS) end. Grouted riprap spillway on the WS end. [Additional Reference(s): DWR Levee Log, 1992. USACE Sacramento O&M Manual 504, May 1965, (HLM 0.26)]. FS Date: 2/20/2014

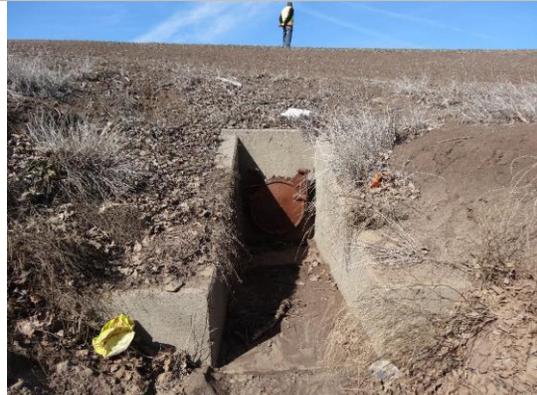
Photo 1 of 3 : UCIP_SP_2020_29705_54924.jpg

WS view: U typed concrete headwall, flapgate on levee slope.

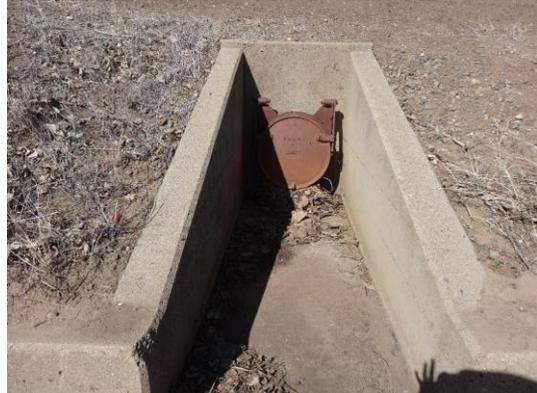
Photo 1 of 3 : UCIP_SP_2020_32044_58543.jpg

LM Start	1.00	Rating **	M	Issue No.	65
LM End	1.00	Issue Type +	Ma	Location *	
Category	Supplemental		GPS Latitude/Longitude		
			Start	End	
Item	DWR UCIP LMA Responsibility		39.739268 °	39.739268 °	
			-121.931891 °	-121.931891 °	
DWR ID	19211				
Comment Code					
Inspector Comment					
DS_ID:19211 FS_ID:32044 EP_NO: N/A Repair Type: Non-Urgent Crossing Status: Found UCIP Comments: Vegetation debris on waterside. Needs clearing and cleaning. FIELD_STRUCT_DESC: 24-inch corrugated metal gravity drainage pipe through the levee, 12 feet below the crown. Flap gate on the waterside (WS) end. Concrete U-shaped headwall on each end. Grouted riprap apron on the landside (LS) end. Grouted riprap spillway on the WS end. [Additional Reference(s): DWR Levee Log, 1992. USACE Sacramento O&M Manual 504, May 1965, (HLM 1.03)]. FS Date: 2/20/2014

WS view: U typed concrete headwall, pipe, and flapgate on levee slope.

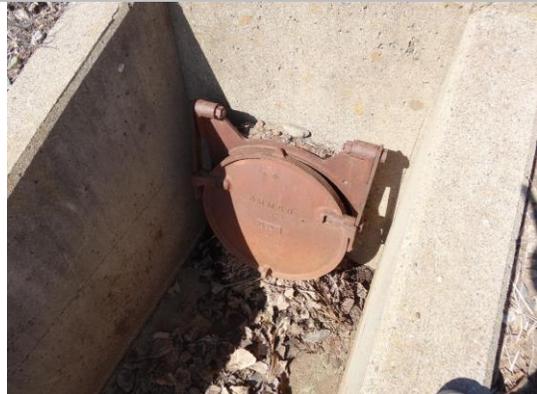
Photo 2 of 3 : UCIP_SP_2020_32044_58542.jpg

WS view: vegetation debris blocking outlet.

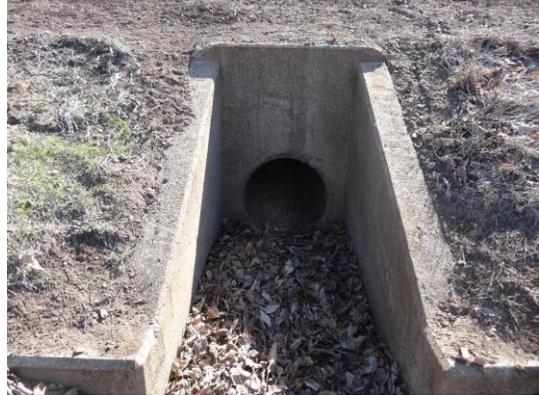
Photo 3 of 3 : UCIP_SP_2020_32044_58541.jpg

LS view: U typed concrete headwall and CMP on levee slope.

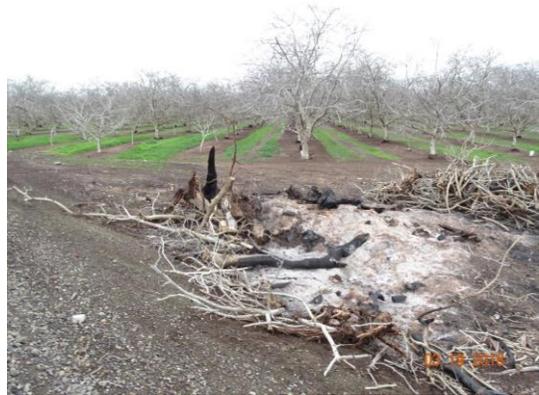
Photo 1 of 1 : SP_2020_NA0003_64_15_20200226_00002.jpg

LM Start	1.69	Rating **	M	Issue No.	15
LM End	1.69	Issue Type +	En	Location *	LS
Category	Earthen Levee			GPS Latitude/Longitude	
				Start	End
Item	Encroachments			39.745718 °	39.745718 °
				-121.923124 °	-121.923124 °
DWR ID	DWR_NA0003_01_s_2014_15				
Comment Code					
PR : Prunings					
Inspector Comment					
The prunings should be removed from the landside toe.

View of the prunings along the landside toe.

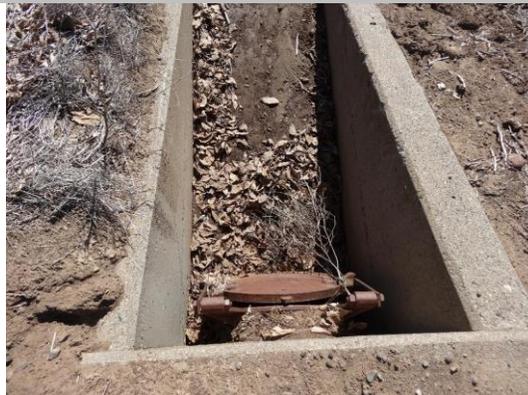
Photo 1 of 3 : UCIP_SP_2020_50142_55886.jpg

Comment Code					
Inspector Comment					
DS_ID:19212 FS_ID:50142 EP_NO: N/A Repair Type: No Action Needed Crossing Status: Found UCIP Comments: 08/29/2016: Shawn Bates of NA0003 has cleared the LS and WS of debris and blockage; WS gate functions properly now. Crossing has been downgraded from Urgent to No Action Needed. (K. Fazel - UCIP)08/11/2016: Same as last inspection. (K. Fazel - UCIP)02/20/2014:No riprap spillway on waterside. Needs cleaning and clearing of debris. Flap gate was not fully closed. (P. Amatya - UCIP) FIELD_STRUCT_DESC: 24-inch corrugated metal gravity drainage pipe through the levee, 13 feet below the crown. Flap gate on the waterside (WS) end. Concrete U-shaped headwall on each end. Grouted riprap apron on the landside (LS) end. Grouted riprap spillway on the WS end. [Additional Reference(s): DWR Levee Log, 2005. USACE Sacramento O&M Manual 504, May 1965, (HLM 1.95)]. FS Date: 8/11/2016

WS view: U type concrete headwall, flapgate on levee slope. Gate was not fully closed.

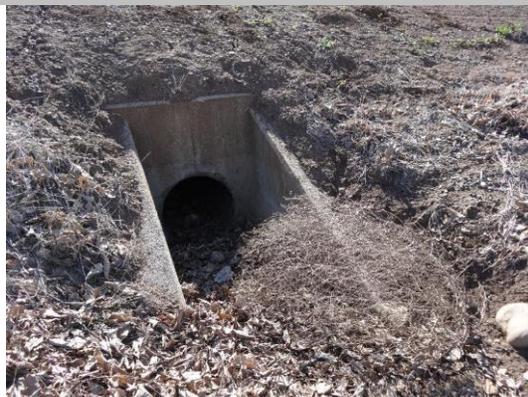
Photo 2 of 3 : UCIP_SP_2020_50142_55885.jpg

LS view: U type concrete headwall and CMP on levee slope. Vegetation debris blocking inlet.

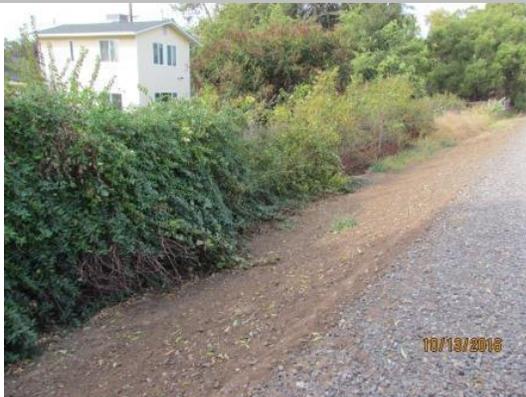
Photo 1 of 1 : SP_2020_NA0003_64_48_20200226_00014.jpg

View of landscaping vegetation blocking visibility.

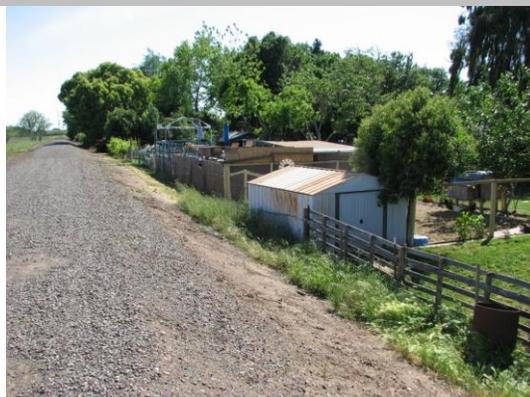
Photo 1 of 1 : SP_2020_NA0003_64_24_20200226_00004.jpg

View of a metal shed and fence along the landside toe.

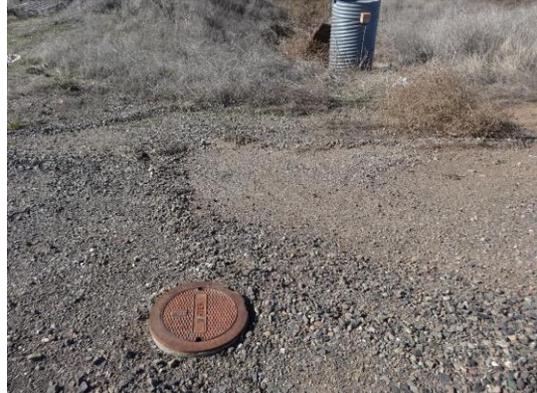
Photo 1 of 3 : UCIP_SP_2020_30291_55700.jpg

Comment Code					
Inspector Comment					
DS_ID:19230 FS_ID:30291 EP_NO: 16633 Repair Type: Non-Urgent Crossing Status: Indicator Found UCIP Comments: A concrete water control box on landside shoulder. It needs confirmation and more info from LMA and/or DWR Inspector. FIELD_STRUCT_DESC: 2-inch coated and wrapped steel storm water discharge pipeline through the right bank and landside (LS) levee toe of Mud Creek. Submerged pump in a 36-inch corrugated metal pipe (CMP) casing, approximately 10 feet from the LS toe. Drainage ditch, up to 4 feet wide, runs perpendicular to the levee alignment starting at a CMP riser and running away from the levee. (Plans to install a 2-inch storm water discharge pipe through the levee and a pump on a concrete base on the right bank LS levee toe of Mud Creek authorized under Permit No. 16633, 1996 - Jim Paiva). FS Date: 2/20/2014

LS view: CMP riser on levee toe (top) and control box on levee shoulder (bottom).

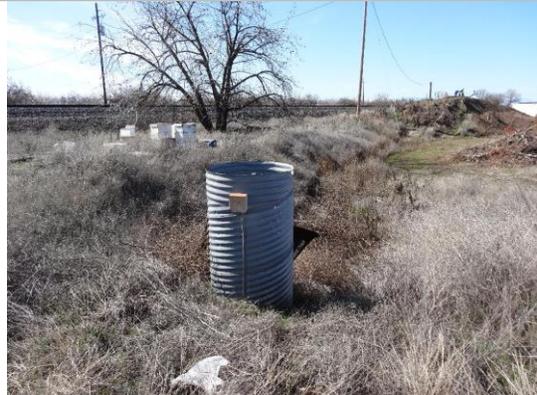
Photo 2 of 3 : UCIP_SP_2020_30291_55699.jpg

LS view: CMP riser on levee toe and drainage ditch perpendicular to the levee.

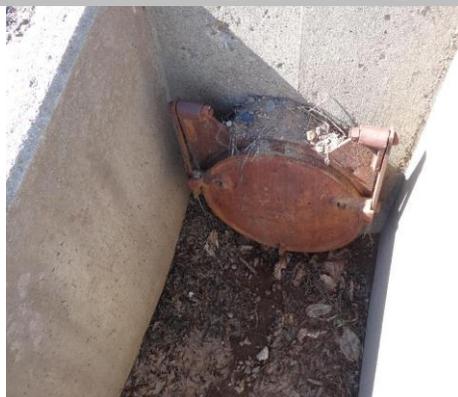
Photo 1 of 2 : UCIP_SP_2020_30294_55704.jpg

LM Start	3.03	Rating **	M	Issue No.	68
LM End	3.03	Issue Type +	Ma	Location *	
Category	Supplemental			GPS Latitude/Longitude	
				Start	End
Item	DWR UCIP LMA Responsibility			39.761224 °	39.761224 °
				-121.911108 °	-121.911108 °
DWR ID	19216				
Comment Code					
Inspector Comment					
DS_ID:19216 FS_ID:30294 EP_NO: N/A Repair Type: Non-Urgent Crossing Status: Found UCIP Comments: Inlet and outlet needs cleaning and clearing of debris. FIELD_STRUCT_DESC: 24-inch corrugated metal gravity drainage pipe through the levee, 8.5 feet below the crown. Flap gate on the waterside (WS) end. Concrete U-shaped headwall on each end. Grouted riprap apron on the landside (LS) end. Grouted riprap spillway on the WS end. [Additional Reference(s): DWR Levee Log, 1992. USACE Sacramento O&M Manual 504, May 1965, (HLM 3.11)]. FS Date: 2/20/2014

WS view: U type concrete headwall, flapgate on levee slope.

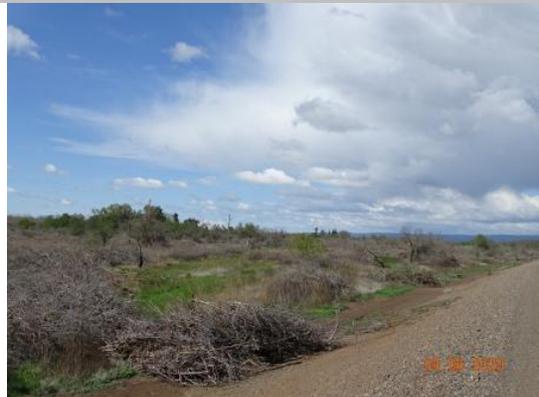
Photo 1 of 1 : SP_2020_NA0003_64_28_20200413_00049.jpg

View of the prunings at the landside toe. Spring 2020.

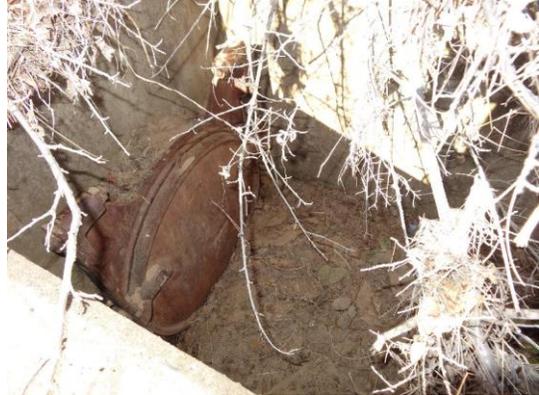
Photo 1 of 2 : UCIP_SP_2020_30388_55891.jpg

Comment Code					
Inspector Comment					
DS_ID:19221 FS_ID:30388 EP_NO: N/A Repair Type: Non-Urgent Crossing Status: Found UCIP Comments: CM Standpipe intake. Intake pipe with air vent. Steel rib-bar grit cover on the standpipe on landside levee toe. Needs cleaning and clearing on both ends of the pipe. FIELD_STRUCT_DESC: 24-inch corrugated metal gravity drainage pipe through the levee, 15 feet below the crown. Flap gate on the waterside (WS) end. Concrete U-shaped headwall on the WS end. Grouted riprap spillway on the WS end. Corrugated metal standpipe intake. Intake pipe with an air vent. Steel rib-bar grit cover on the standpipe on the landside (LS) toe. [Additional Reference(s): DWR Levee Log, 1992. USACE Sacramento O&M Manual 504, May 1965, (HLM 4.94)]. FS Date: 2/20/2014

WS view: U type concrete headwall, pipe, and flapgate on levee slope. Vegetation/soil debris blocking outlet.

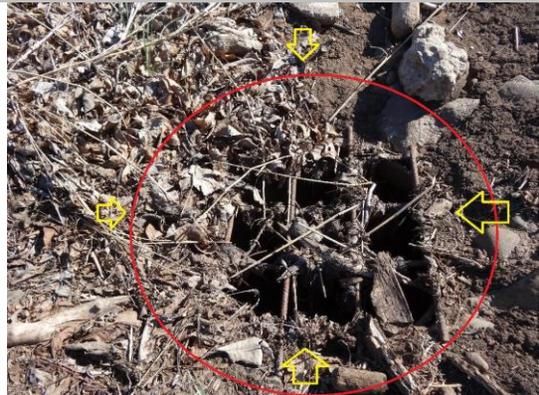
Photo 2 of 2 : UCIP_SP_2020_30388_55890.jpg

LS view: Underground CM standpipe intake with steel grit on levee toe.

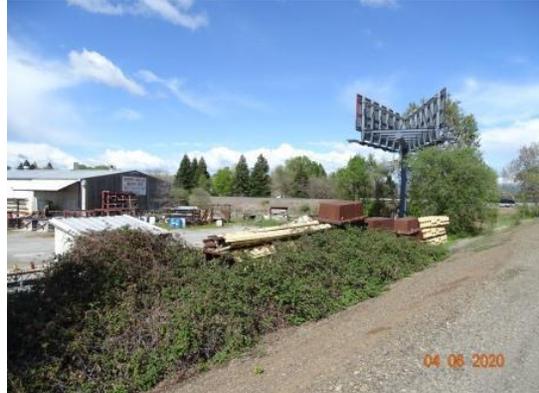
Photo 1 of 1 : SP_2020_NA0003_64_55_20200413_00050.jpg

View of the blackberry bushes along the landside toe. Spring 2020.

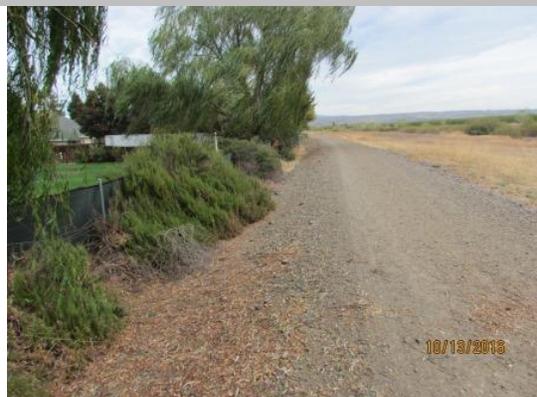
Photo 1 of 1 : SP_2020_NA0003_64_30_20200226_00009.jpg

View of the landscaping blocking visibility.

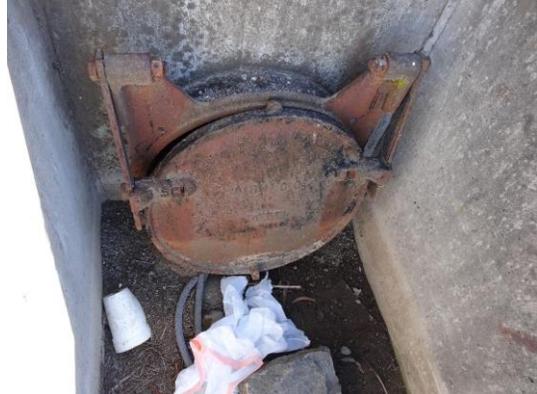
Photo 1 of 2 : UCIP_SP_2020_30743_56641.jpg

WS view: U type concrete headwall, pipe, and flapgate on levee slope. Debris in outlet box.

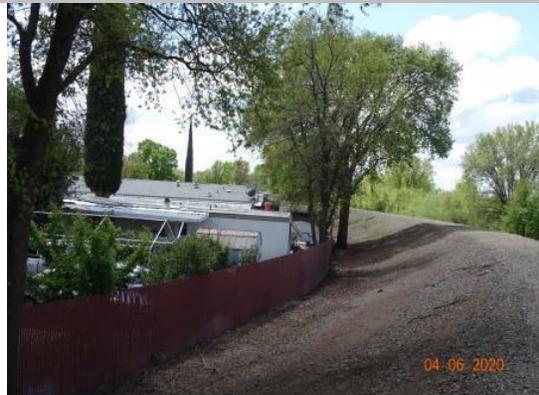
Photo 1 of 1 : SP_2020_NA0003_65_3_20200413_00059.jpg

View of the fence along the landside toe. Spring 2020.

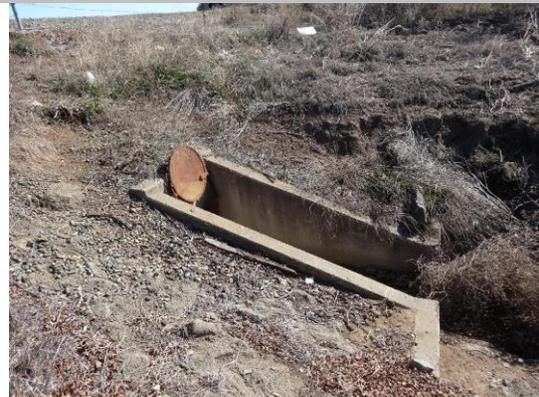
Photo 1 of 3 : UCIP_SP_2020_41375_56646.jpg

WS view: U type concrete headwall and flapgate on levee slope. Vegetation debris on spillway.

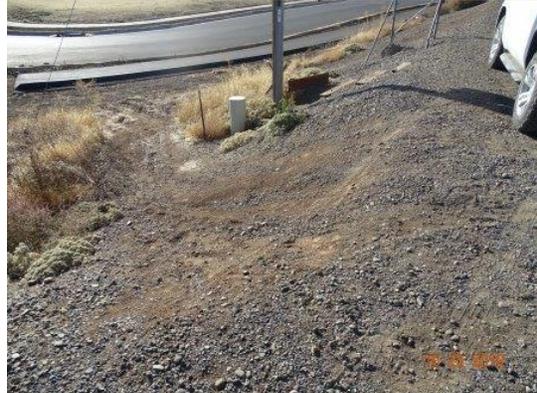
Photo 1 of 1 : SP_2020_NA0003_65_25_20200226_00004.jpg

View of the erosion on the landside slope due to vehicle traffic. Fall 2019.

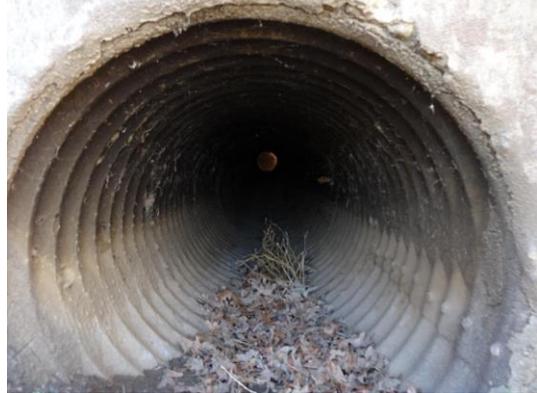
Photo 3 of 3 : UCIP_SP_2020_30783_56680.jpg

LS view: inside view of CMP on levee slope. Needs cleaning and clearing.

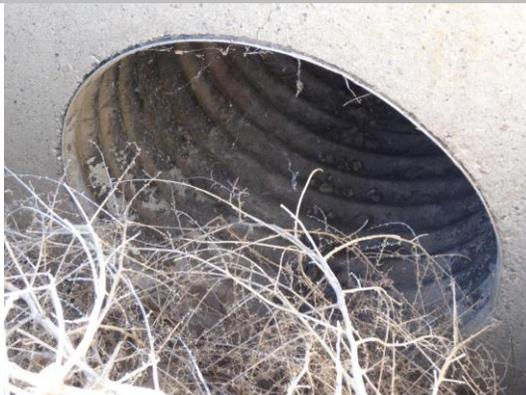
Photo 3 of 3 : UCIP_SP_2020_30803_56683.jpg

LS view: inside view of CMP on levee slope. Needs cleaning and clearing.

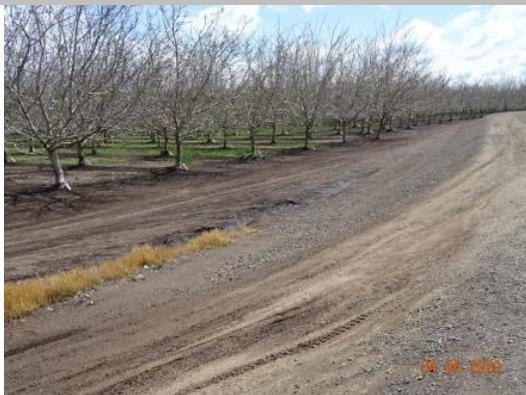
Photo 1 of 1 : SP_2020_NA0003_65_10_20200413_00060.jpg

View of the damaged landside slope due to vehicle traffic. Spring 2020.

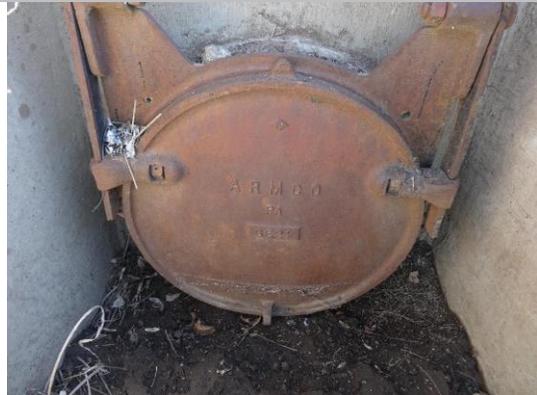
Photo 1 of 3 : UCIP_SP_2020_31028_56913.jpg

WS view: U type concrete headwall, pipe, and flapgate on levee slope. Soil/mud on outlet box.

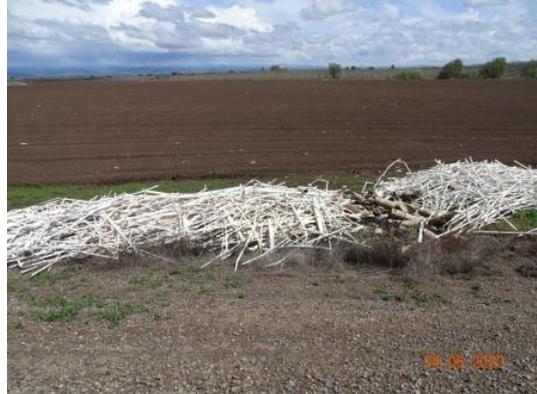
Photo 1 of 1 : SP_2020_NA0003_65_30_20200413_00061.jpg

View of the plastic piping along the landside toe. Spring 2020.

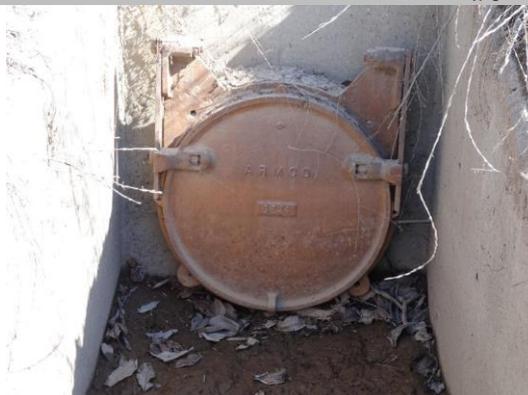
Photo 1 of 3 : UCIP_SP_2020_31085_56988.jpg

WS view: U type concrete headwall, pipe, and flapgate on levee slope. Soil/mud on outlet box.

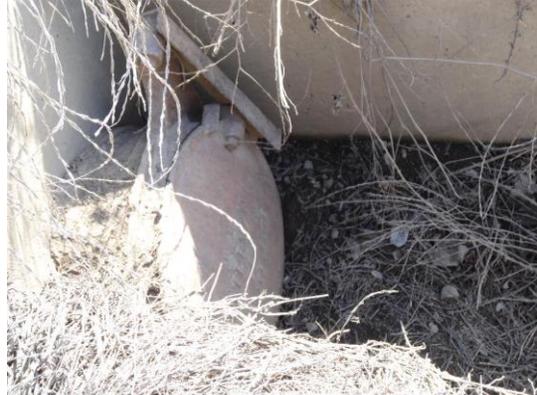
Photo 1 of 3 : UCIP_SP_2020_31103_57002.jpg

WS view: U type concrete headwall, pipe, and flapgate on levee slope. Soil/mud on outlet box. Vegetation debris blocking outlet box

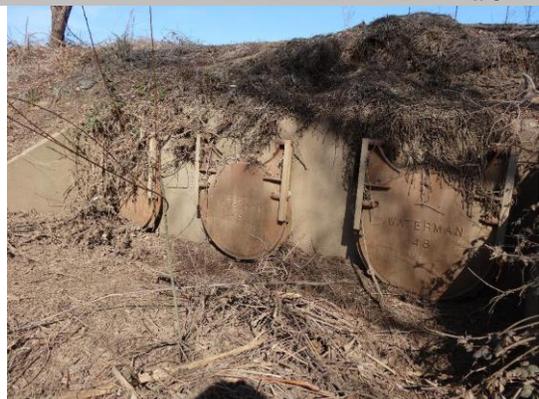
Photo 2 of 3 : UCIP_SP_2020_32085_58584.jpg

WS view: U type concrete headwall, pipes, and flapgates on levee slope. Soil/mud on outlet box. Vegetation debris blocking outlet box

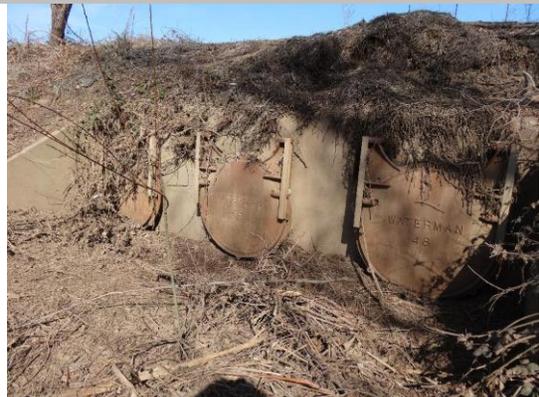
Photo 2 of 3 : UCIP_SP_2020_32086_58588.jpg

WS view: U type concrete headwall, pipes, and flapgates on levee slope. Soil/mud on outlet box. Vegetation debris on outlet box

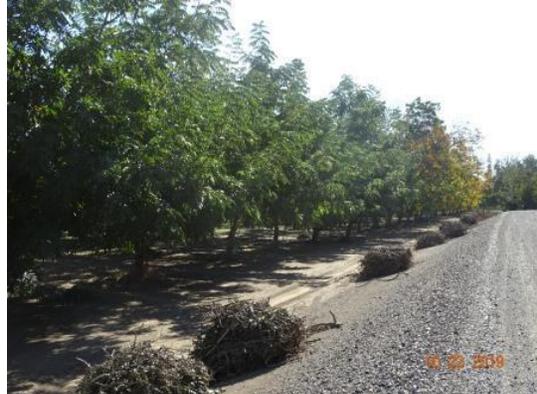
Photo 1 of 1 : SP_2020_NA0003_65_46_20200226_00005.jpg

View of the piles of prunings along the landside toe. Fall 2019.

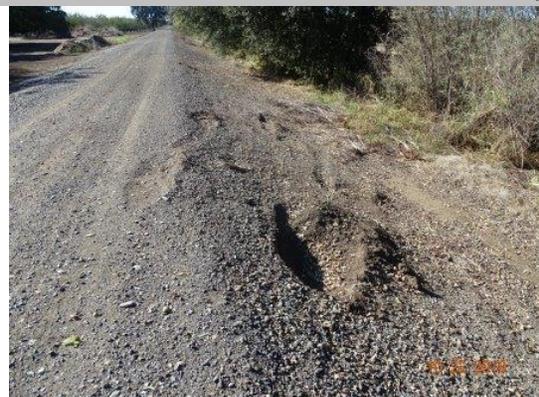
Photo 1 of 1 : SP_2020_NA0003_66_1_20200226_00001.jpg

View of depressions on the waterside slope. Fall 2019.

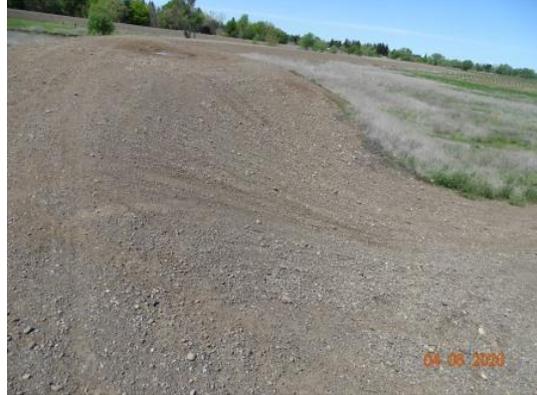
Photo 1 of 1 : SP_2020_NA0003_67_12_20200413_00041.jpg

View of the slope erosion caused by motorcycle traffic. Spring 2020.

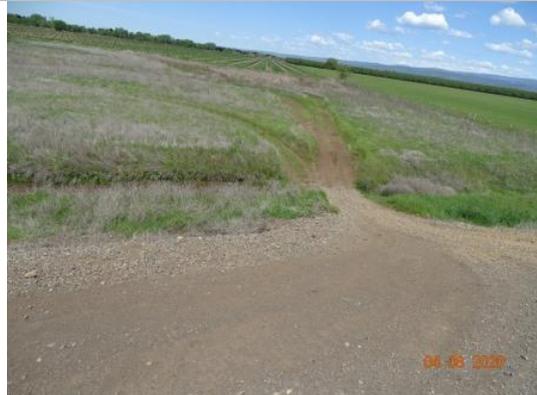
Photo 1 of 1 : SP_2020_NA0003_67_3_20200413_00042.jpg

View of the erosion caused by motorcycles on the waterside slope. Spring 2020.

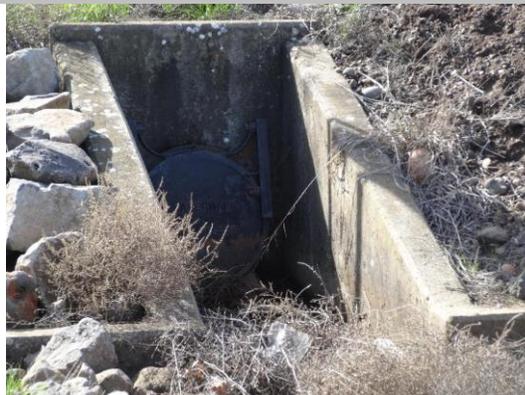
Photo 1 of 3 : UCIP_SP_2020_32124_58625.jpg

WS view: concrete headwall, pipe, and flapgate on levee slope. Vegetation and mud on outlet box.

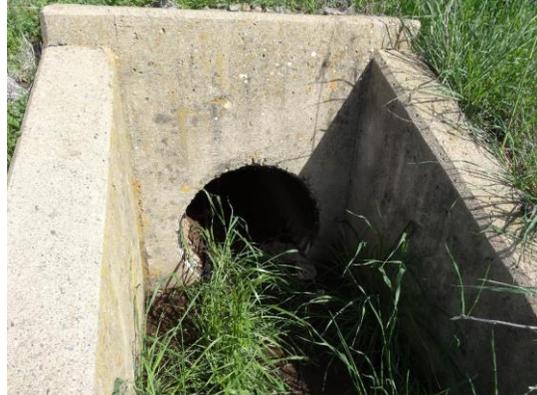
Photo 3 of 3 : UCIP_SP_2020_32124_58627.jpg

LS view: inside view of CMP on levee slope. Needs cleaning and clearing.

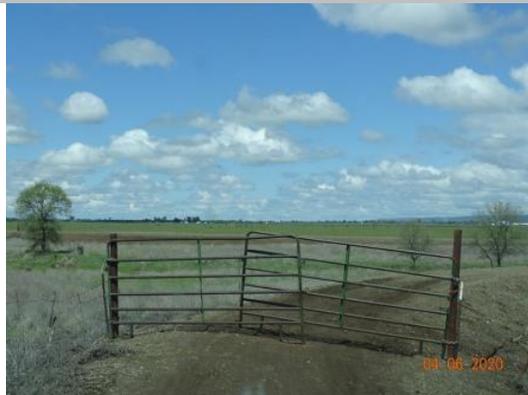
Photo 1 of 1 : SP_2020_NA0003_67_19_20200413_00039.jpg

View of the cattle gates blocking access. Spring 2020.

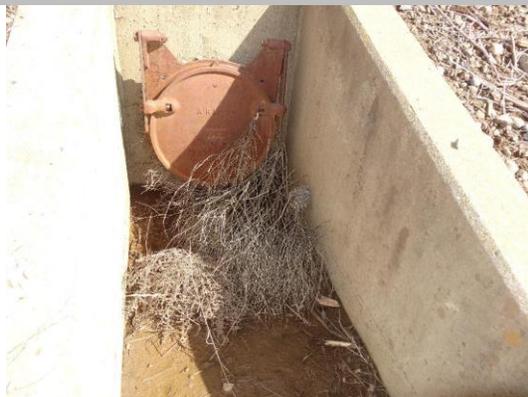
Photo 1 of 3 : UCIP_SP_2020_31901_58194.jpg

WS view: U type concrete headwall, flapgate, and CMP on levee slope. Needs cleaning and clearing.

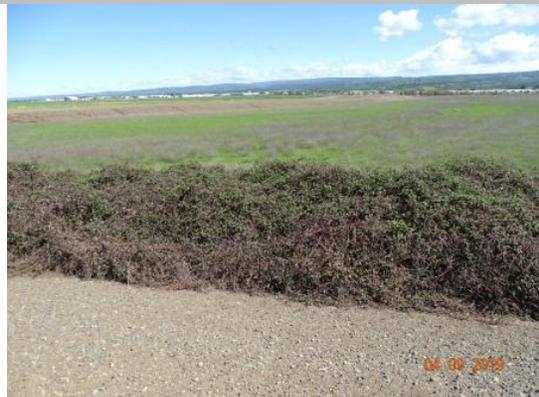
Photo 1 of 1 : SP_2020_NA0003_67_22_20200226_00005.jpg

View of the wild growth at the landside toe. Spring 2019.

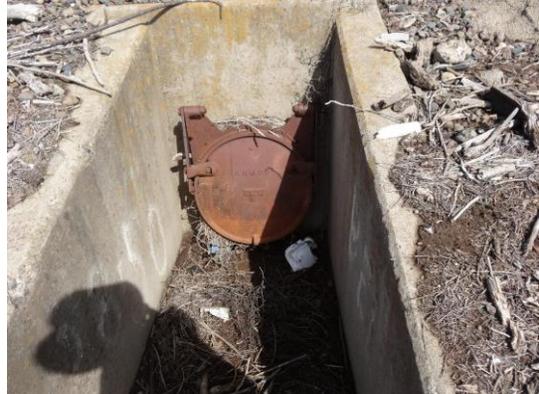
Photo 1 of 3 : UCIP_SP_2020_31864_58069.jpg

WS view: U type concrete headwall, pipe, and flapgate on levee slope. Soil/mud on outlet box. Vegetation debris blocking outlet box.

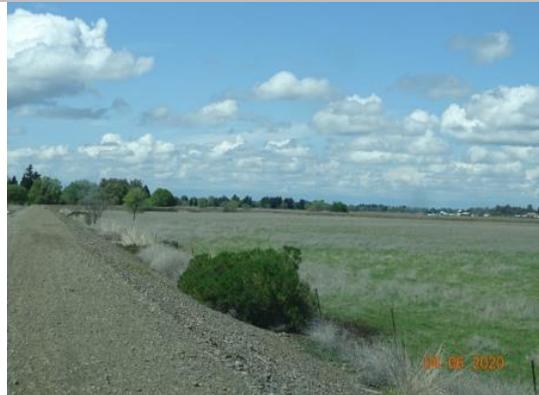
Photo 1 of 1 : SP_2020_NA0003_67_14_20200413_00040.jpg

View of a bush along the landside toe. Spring 2020.

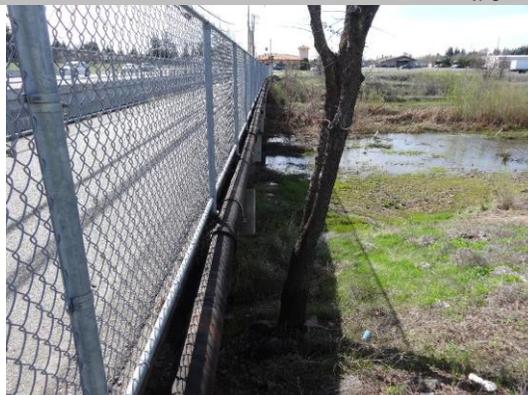
Photo 1 of 1 : UCIP_SP_2020_31851_58041.jpg

WS view: 6-inch steel pipe attached to Cohasset Road Bridge. Needs confirmation from LMA whether this is a gasline.

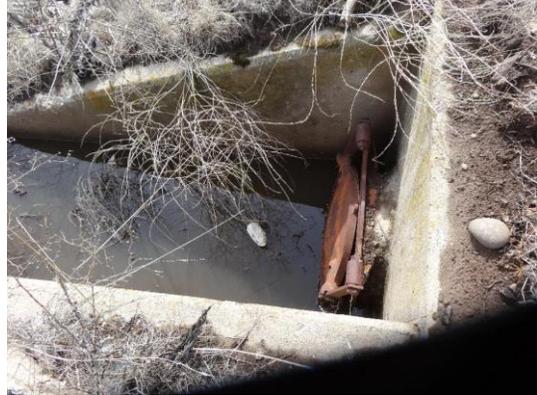
Photo 1 of 2 : UCIP_SP_2020_32125_58629.jpg

WS view: U type concrete headwall, pipe, and flapgate on levee slope. Soil/mud on outlet box. Vegetation debris blocking outlet box.

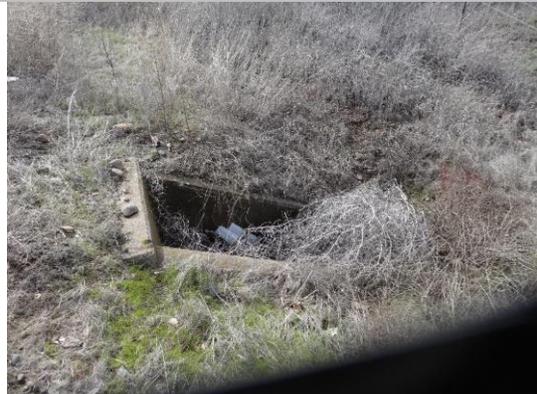
Photo 2 of 2 : UCIP_SP_2020_32125_58628.jpg

LS view: U type concrete headwall and pipe on levee slope. Soil/mud on inlet box. Vegetation debris blocking inlet box.

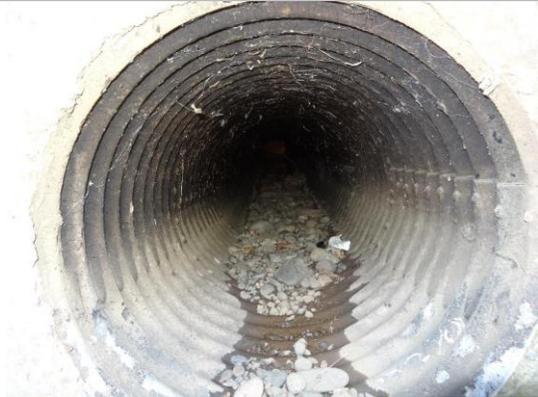
Photo 3 of 3 : UCIP_SP_2020_32023_58503.jpg

LS view: inside view of the CM pipe. Needs cleaning and clearing the pipe.

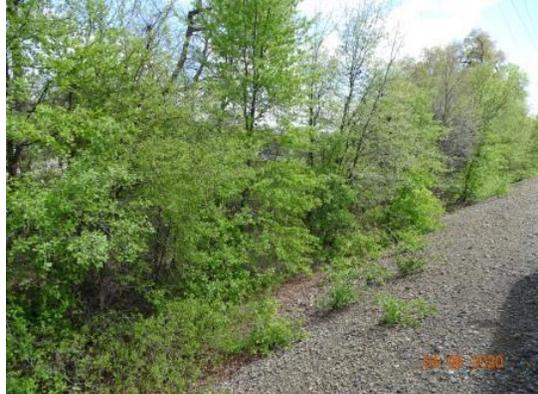
Photo 1 of 1 : SP_2020_NA0003_68_21_20200413_00035.jpg

View of the wild growth along the landside toe. Spring 2020.

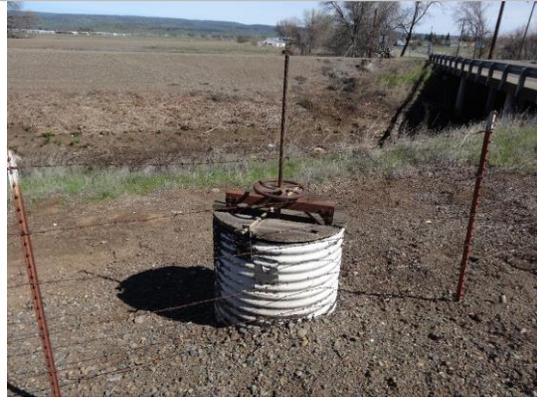
Photo 3 of 3 : UCIP_SP_2020_32144_58642.jpg

WS view: side gate in CMP riser on waterside. No access to CMP riser.

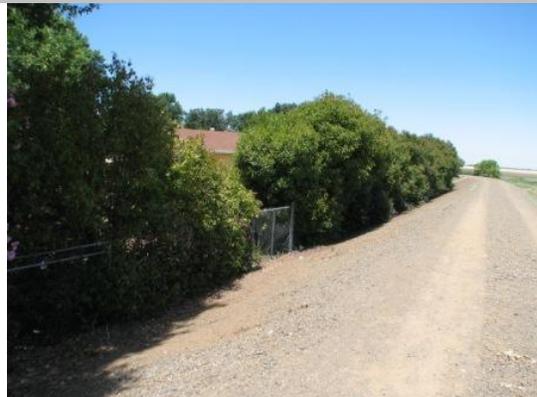
Photo 1 of 1 : SP_2020_NA0003_68_1_20200226_00001.jpg

View of the fence and trees along the landside toe of the levee.

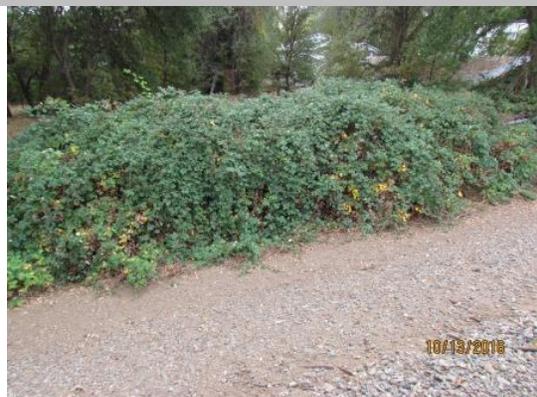
Photo 1 of 1 : SP_2020_NA0003_68_23_20200226_00007.jpg

View of the blackberries blocking visibility and access.

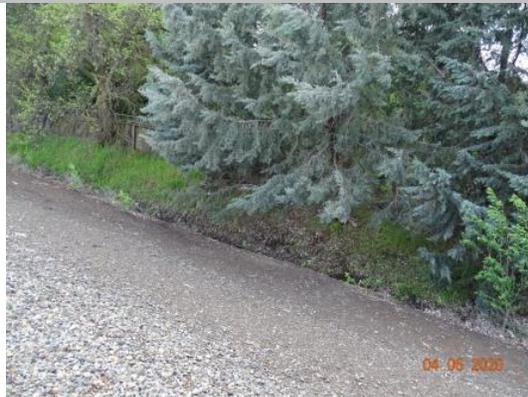
Photo 1 of 1 : SP_2020_NA0003_68_2_20200413_00037.jpg

View of the ditch at the landside toe. Spring 2020.

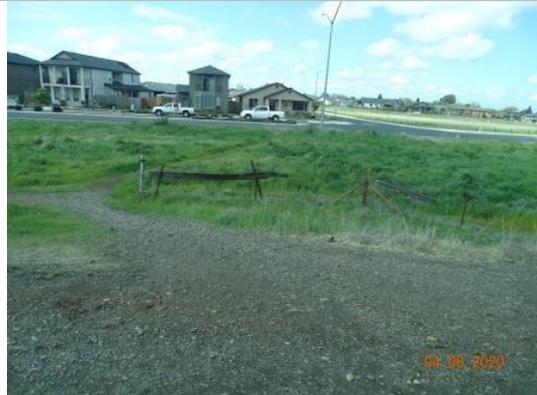
Photo 1 of 1 : SP_2020_NA0003_69_12_20200413_00007.jpg

View of the landside slope erosion caused by foot traffic. Spring 2020.

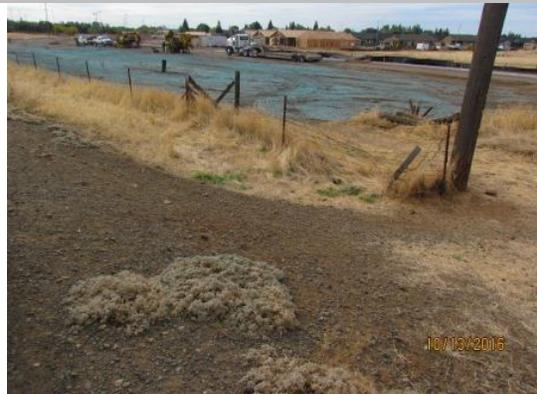
Photo 1 of 1 : SP_2020_NA0003_69_13_20200226_00004.jpg

View of the damaged slope by foot traffic.

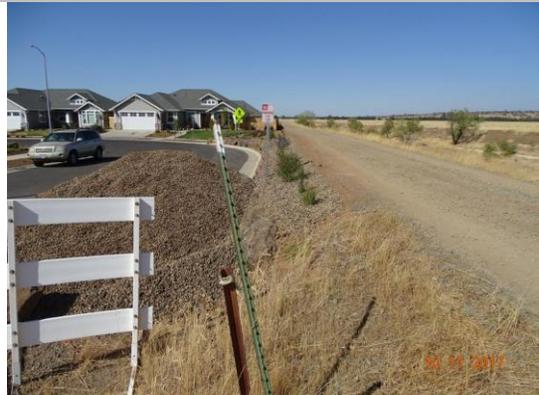
Photo 2 of 2 : SP_2020_NA0003_69_15_20200226_00006.jpg

View of the housing track road cutting into the levees slope and toe.
