**Flood Control Project Maintenance
Levee Inspections**

Maintenance Issue Types Only, Levee Inspection Report By Mile - Spring 2020

Butte County Department of Public Works

Waterway	Bank	Unit Miles	Inspection Start/End	Inspector
Unit No. 01 Mud Creek	Right	6.80	04/06/2020 04/06/2020	Makar Sokol

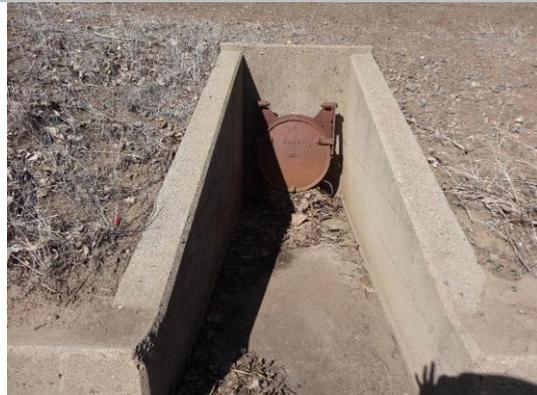
Photo 1 of 3 : UCIP_SP_2020_32044_58543.jpg

WS view: U typed concrete headwall, pipe, and flapgate on levee slope.

Comment Code					
Inspector Comment					
DS_ID:19211 FS_ID:32044 EP_NO: N/A Repair Type: Non-Urgent Crossing Status: Found UCIP Comments: Vegetation debris on waterside. Needs clearing and cleaning. FIELD_STRUCT_DESC: 24-inch corrugated metal gravity drainage pipe through the levee, 12 feet below the crown. Flap gate on the waterside (WS) end. Concrete U-shaped headwall on each end. Grouted riprap apron on the landside (LS) end. Grouted riprap spillway on the WS end. [Additional Reference(s): DWR Levee Log, 1992. USACE Sacramento O&M Manual 504, May 1965, (HLM 1.03)]. FS Date: 2/20/2014

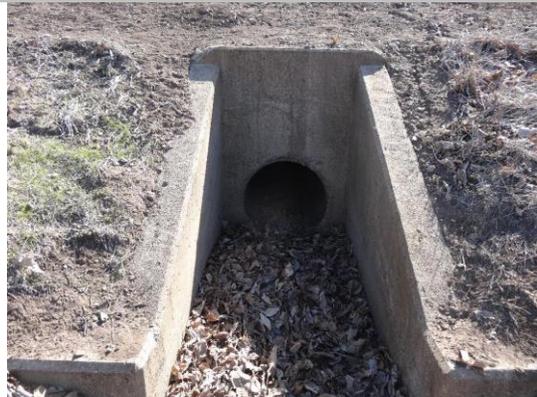
Photo 3 of 3 : UCIP_SP_2020_32044_58541.jpg

LS view: U typed concrete headwall and CMP on levee slope.

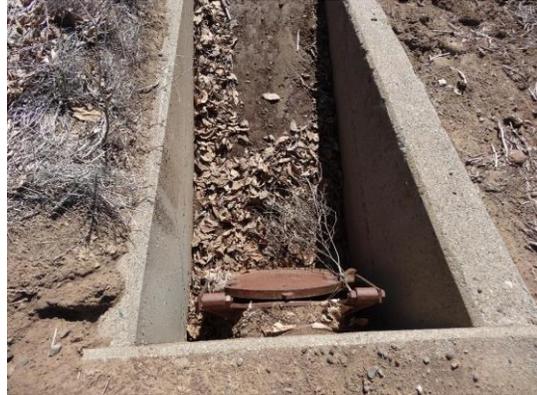
Photo 1 of 3 : UCIP_SP_2020_50142_55886.jpg

Comment Code					
Inspector Comment					
DS_ID:19212 FS_ID:50142 EP_NO: N/A Repair Type: No Action Needed Crossing Status: Found UCIP Comments: 08/29/2016: Shawn Bates of NA0003 has cleared the LS and WS of debris and blockage; WS gate functions properly now. Crossing has been downgraded from Urgent to No Action Needed. (K. Fazel - UCIP)08/11/2016: Same as last inspection. (K. Fazel - UCIP)02/20/2014:No riprap spillway on waterside. Needs cleaning and clearing of debris. Flap gate was not fully closed. (P. Amatya - UCIP) FIELD_STRUCT_DESC: 24-inch corrugated metal gravity drainage pipe through the levee, 13 feet below the crown. Flap gate on the waterside (WS) end. Concrete U-shaped headwall on each end. Grouted riprap apron on the landside (LS) end. Grouted riprap spillway on the WS end. [Additional Reference(s): DWR Levee Log, 2005. USACE Sacramento O&M Manual 504, May 1965, (HLM 1.95)]. FS Date: 8/11/2016

WS view: U type concrete headwall, flapgate on levee slope. Gate was not fully closed.

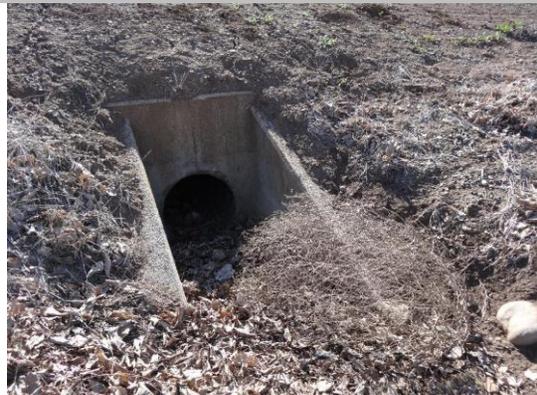
Photo 2 of 3 : UCIP_SP_2020_50142_55885.jpg

LS view: U type concrete headwall and CMP on levee slope. Vegetation debris blocking inlet.

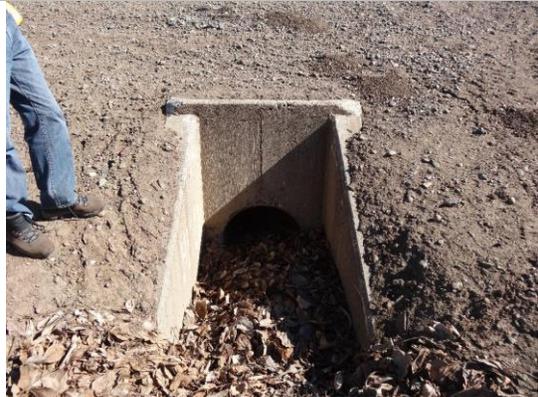
Photo 2 of 2 : UCIP_SP_2020_30295_55705.jpg

LS view: U type concrete headwall and CMP on levee slope. Vegetation debris blocking the inlet.

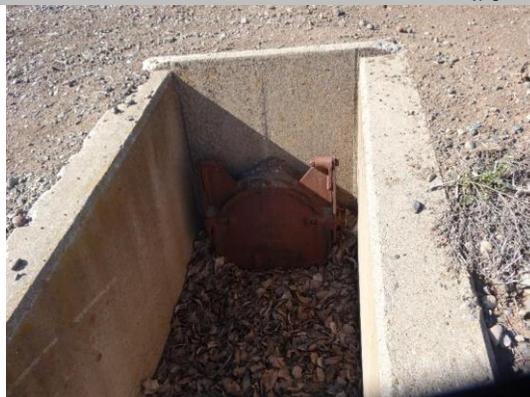
Photo 1 of 2 : UCIP_SP_2020_30311_55743.jpg

WS view: U type concrete headwall, pipe, and flapgate on levee slope. Vegetation debris blocking outlet.

Comment Code					
Inspector Comment					
DS_ID:19219 FS_ID:30311 EP_NO: N/A Repair Type: Non-Urgent Crossing Status: Found UCIP Comments: Needs cleaning and clearing of debris in both ends of the pipe. FIELD_STRUCT_DESC: 24-inch corrugated metal gravity drainage pipe through the levee, 9 feet below the crown. Flap gate on the waterside (WS) end. Concrete U-shaped headwall on each end. Grouted riprap apron on the landside (LS) end. Grouted riprap spillway on the WS end. [Additional Reference(s): DWR Levee Log, 1992. USACE Sacramento O&M Manual 504, May 1965, (HLM 4.08)]. FS Date: 2/20/2014

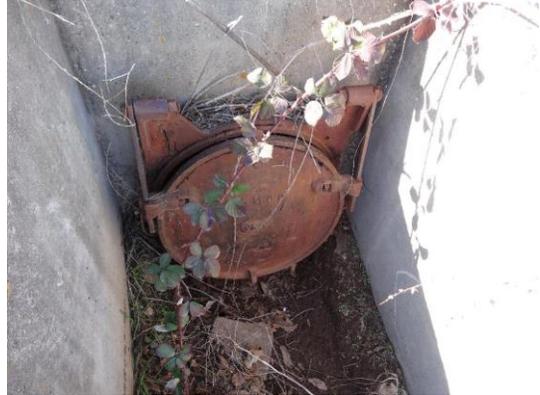
Photo 1 of 2 : UCIP_SP_2020_30312_55745.jpg

WS view: U type concrete headwall, pipe, and flapgate on levee slope. Vegetation debris blocking outlet.

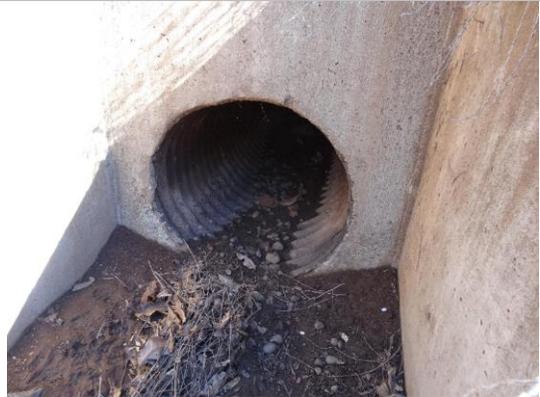
Photo 2 of 2 : UCIP_SP_2020_30312_55744.jpg

LS view: U type concrete headwall and CMP on levee slope. Needs cleaning and clearing of debris.

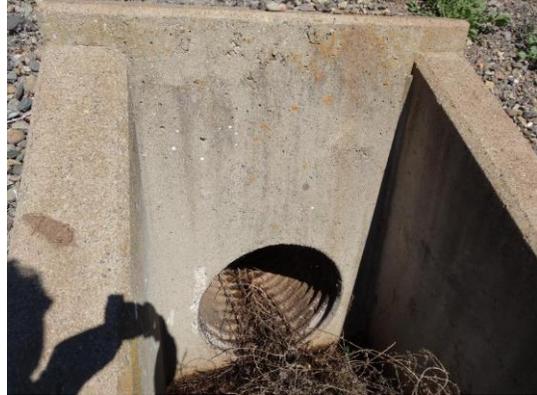
Photo 3 of 3 : UCIP_SP_2020_31667_57966.jpg

LS view: U type concrete headwall and CMP on levee slope. Vegetation debris on inlet box.

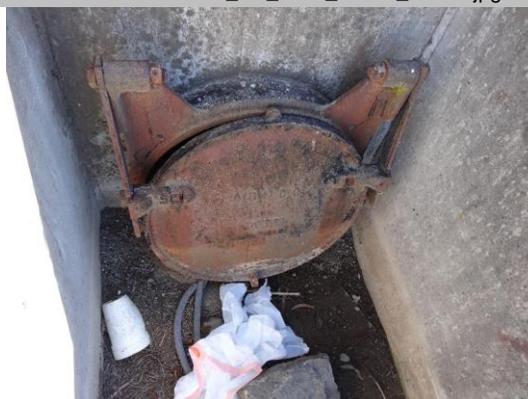
Photo 1 of 2 : UCIP_SP_2020_30743_56641.jpg

WS view: U type concrete headwall, pipe, and flapgate on levee slope. Debris in outlet box.

Comment Code					
Inspector Comment					
DS_ID:19237 FS_ID:30743 EP_NO: N/A Repair Type: Non-Urgent Crossing Status: Found UCIP Comments: Needs cleaning and clearing of debris. FIELD_STRUCT_DESC: 24-inch corrugated metal gravity drainage pipe through the levee, 11 feet below the crown. Flap gate on the waterside (WS) end. Concrete U-shaped headwall on each end. Grouted riprap apron on the landside (LS) end. Grouted riprap spillway on the WS end. [Additional Reference(s): DWR Levee Log, 1992. USACE Sacramento O&M Manual 504, May 1965, (HLM 1.55)]. FS Date: 2/24/2014

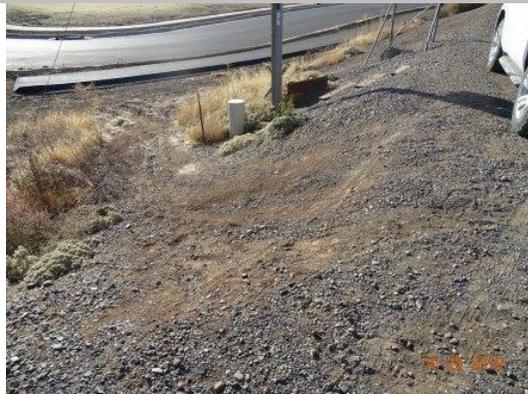
Photo 1 of 1 : SP_2020_NA0003_65_25_20200226_00004.jpg

LM Start	2.05	Rating **	M	Issue No.	25
LM End	2.05	Issue Type +	Ma	Location *	LS
Category	Earthen Levee			GPS Latitude/Longitude	
				Start	End
Item	Slope Stability			39.775748 °	39.775748 °
				-121.892958 °	-121.892958 °
DWR ID	DWR_NA0003_02_f_2019_25				
Comment Code					
S3 : Repair the levee slope damaged by vehicle traffic and prevent access where possible.					
Inspector Comment

View of the erosion on the landside slope due to vehicle traffic. Fall 2019.

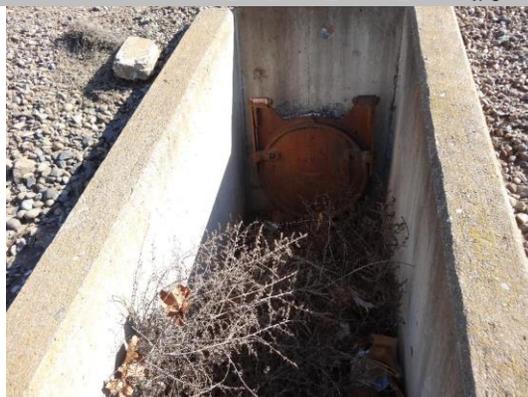
Photo 1 of 3 : UCIP_SP_2020_30763_56662.jpg

WS view: U type concrete headwall, pipe, and flapgate on levee slope. Vegetation debris blocking outlet.

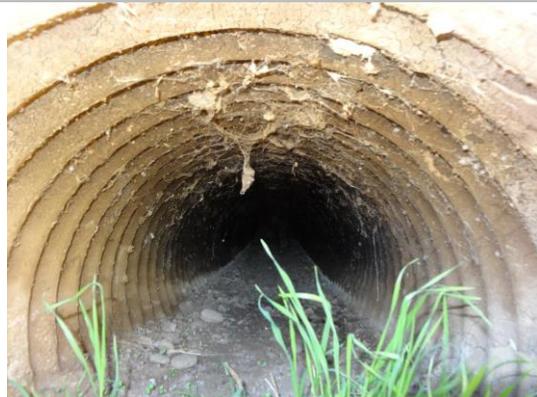
Photo 3 of 3 : UCIP_SP_2020_30763_56660.jpg

LS view: inside view of CMP on levee slope. Needs cleaning and clearing.

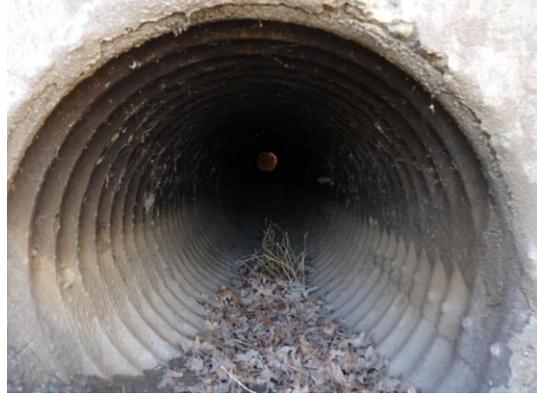
Photo 3 of 3 : UCIP_SP_2020_30783_56680.jpg

LS view: inside view of CMP on levee slope. Needs cleaning and clearing.

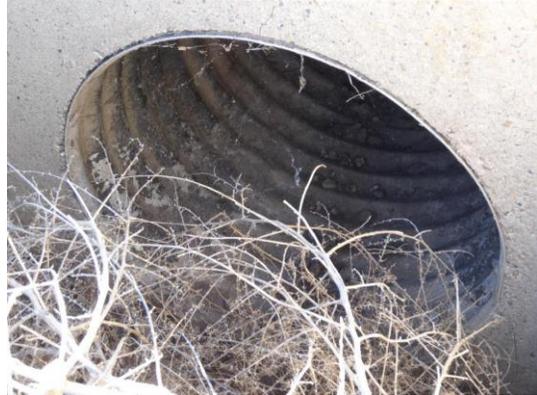
Photo 3 of 3 : UCIP_SP_2020_30803_56683.jpg

LS view: inside view of CMP on levee slope. Needs cleaning and clearing.

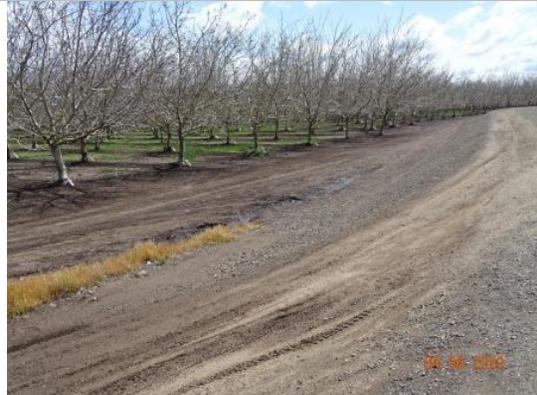
Photo 1 of 1 : SP_2020_NA0003_65_10_20200413_00060.jpg

LM Start	3.52	Rating **	M	Issue No.	10
LM End	3.52	Issue Type +	Ma	Location *	LS
Category	Earthen Levee			GPS Latitude/Longitude	
				Start	End
Item	Slope Stability			39.760582 °	39.760582 °
				-121.910303 °	-121.910303 °
DWR ID	DWR_NA0003_02_f_2015_10				
Comment Code					
S3 : Repair the levee slope damaged by vehicle traffic and prevent access where possible.					
Inspector Comment

View of the damaged landside slope due to vehicle traffic. Spring 2020.

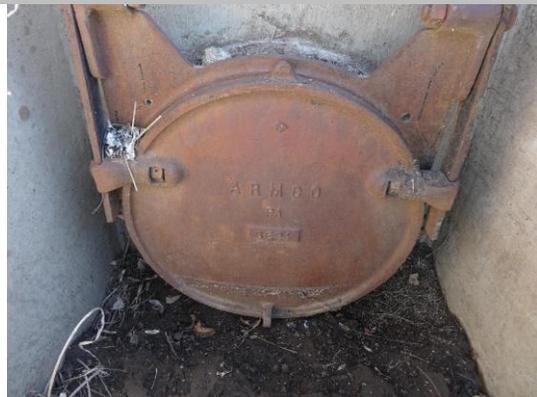
Photo 1 of 3 : UCIP_SP_2020_31028_56913.jpg

WS view: U type concrete headwall, pipe, and flapgate on levee slope. Soil/mud on outlet box.

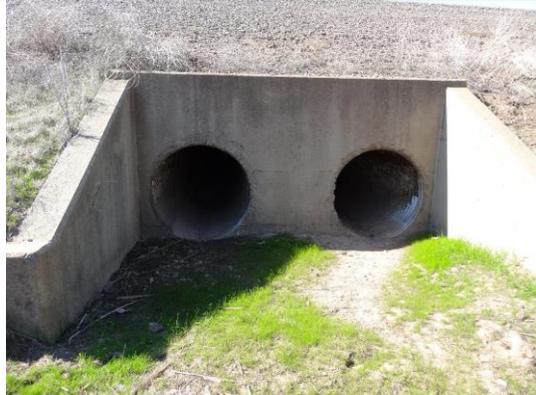
Photo 3 of 3 : UCIP_SP_2020_41376_56918.jpg

LS view: U type concrete headwall and CMPs on levee slope. Soil/mud on inlet box.

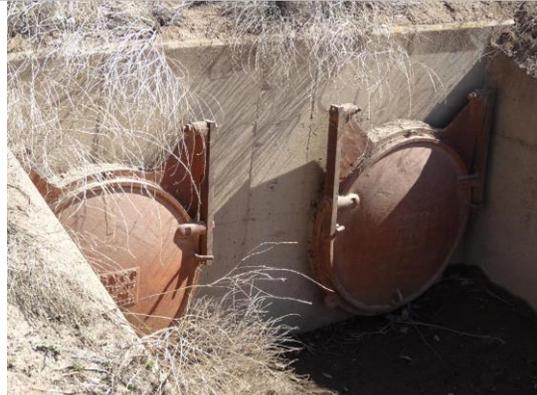
Photo 2 of 3 : UCIP_SP_2020_41377_56922.jpg

LS view: U type concrete headwall and CMPs on levee slope. Vegetation on inlet box.

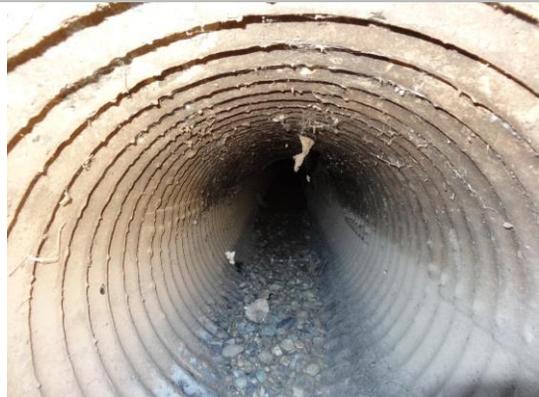
Photo 3 of 3 : UCIP_SP_2020_31034_56924.jpg

LS view: inside view of CMP on levee slope. Needs cleaning and clearing.

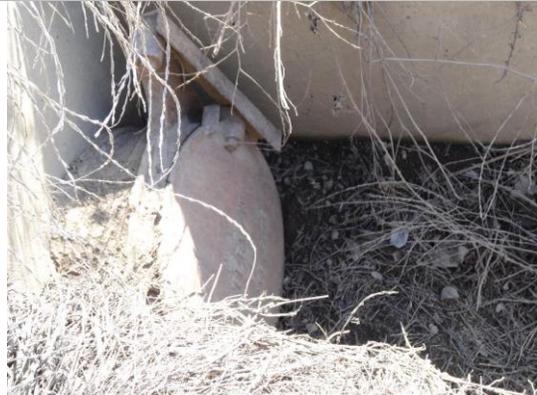
Photo 1 of 3 : UCIP_SP_2020_31103_57002.jpg

WS view: U type concrete headwall, pipe, and flapgate on levee slope. Soil/mud on outlet box. Vegetation debris blocking outlet box

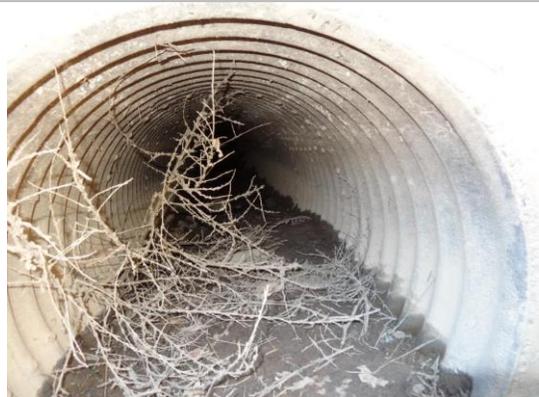
Photo 3 of 3 : UCIP_SP_2020_31103_57000.jpg

LS view: inside view of CMP on levee slope. Needs cleaning and clearing.

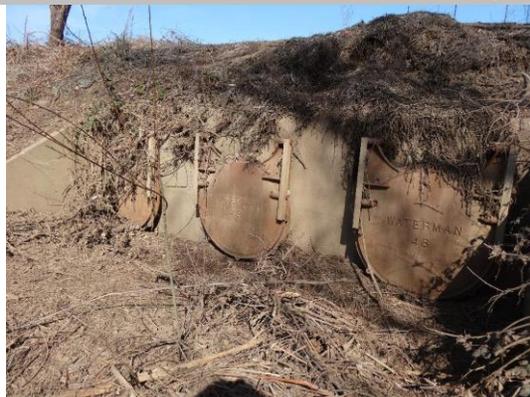
Photo 2 of 3 : UCIP_SP_2020_32085_58584.jpg

WS view: U type concrete headwall, pipes, and flapgates on levee slope. Soil/mud on outlet box. Vegetation debris blocking outlet box

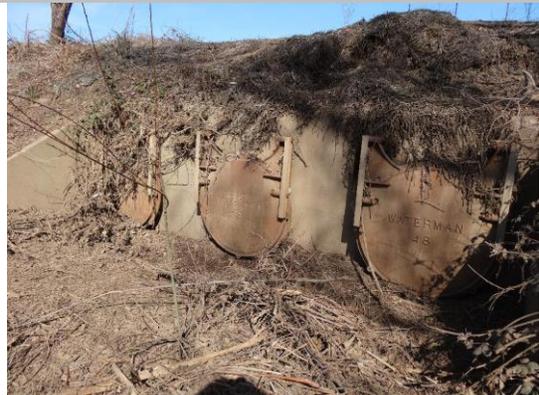
Photo 2 of 3 : UCIP_SP_2020_32086_58588.jpg

WS view: U type concrete headwall, pipes, and flapgates on levee slope. Soil/mud on outlet box. Vegetation debris on outlet box

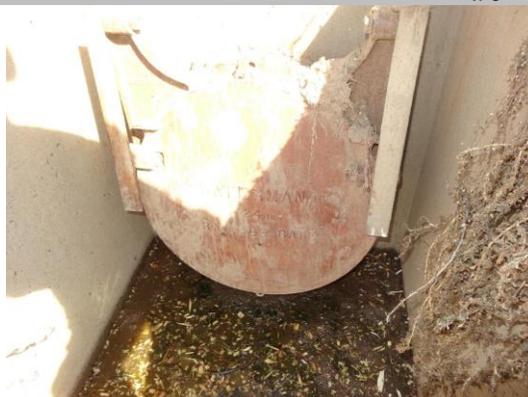
Photo 1 of 2 : UCIP_SP_2020_31129_57036.jpg

WS view: U type concrete headwall, pipe, and flapgate on levee slope. Soil/mud on outlet box.

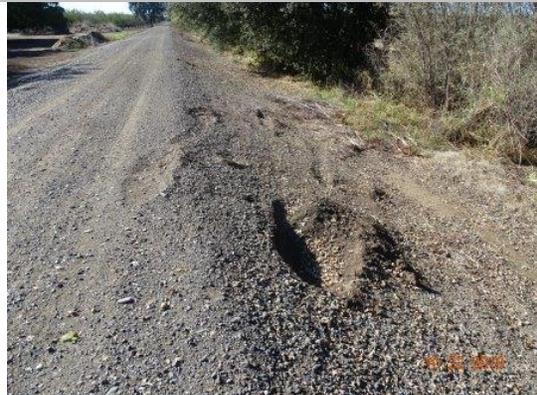
Photo 1 of 1 : SP_2020_NA0003_66_1_20200226_00001.jpg

View of depressions on the waterside slope. Fall 2019.

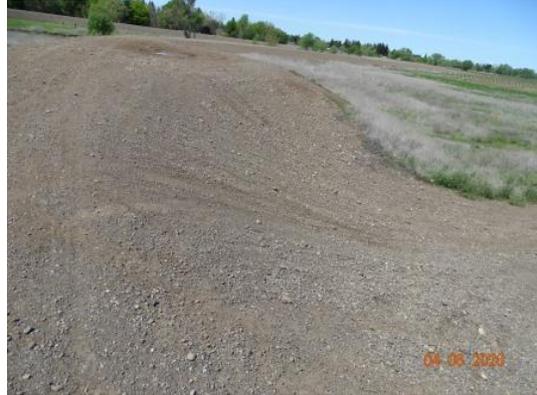
Photo 1 of 1 : SP_2020_NA0003_67_12_20200413_00041.jpg

View of the slope erosion caused by motorcycle traffic. Spring 2020.

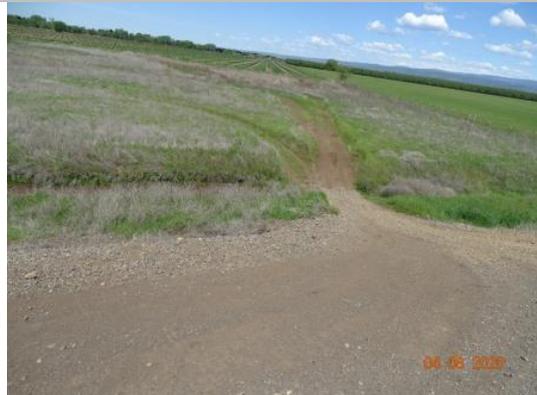
Photo 1 of 1 : SP_2020_NA0003_67_3_20200413_00042.jpg

View of the erosion caused by motorcycles on the waterside slope. Spring 2020.

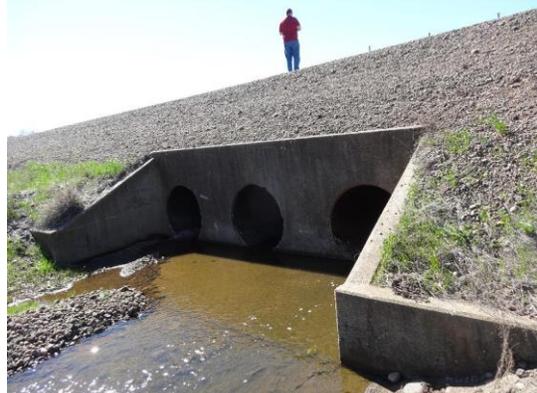
Photo 2 of 2 : UCIP_SP_2020_32104_58605.jpg

LS view: U type concrete headwall and three CMPs on levee slope. Soil/mud on inlet box.

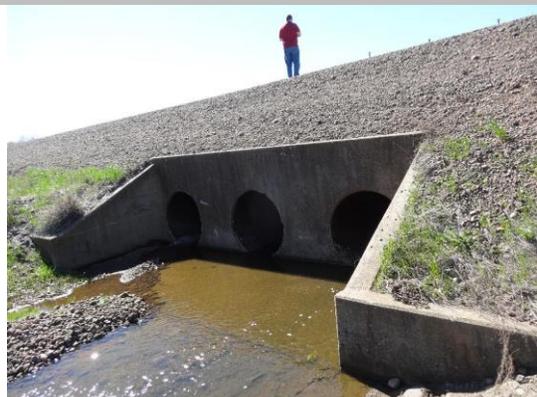
Photo 2 of 2 : UCIP_SP_2020_32106_58609.jpg

LS view: U type concrete headwall and three CMPs on levee slope. Soil/mud on inlet box.

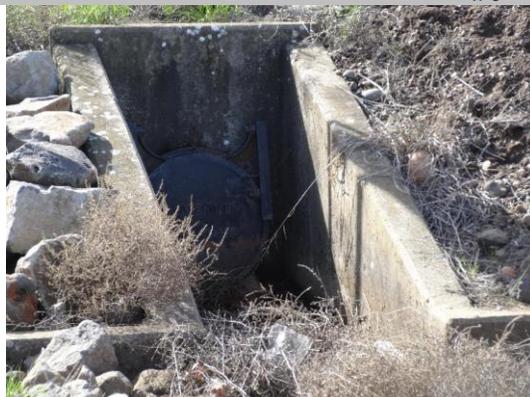
Photo 1 of 3 : UCIP_SP_2020_32124_58625.jpg

WS view: concrete headwall, pipe, and flapgate on levee slope. Vegetation and mud on outlet box.

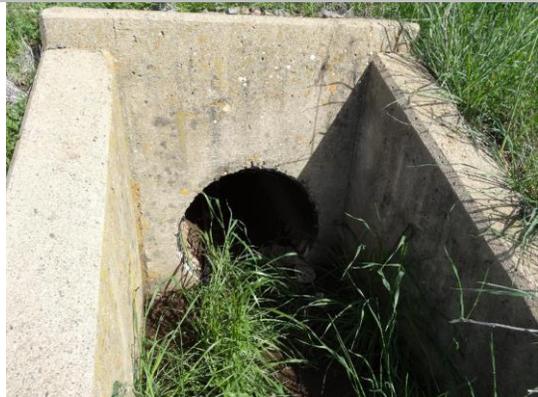
Photo 3 of 3 : UCIP_SP_2020_32124_58627.jpg

LS view: inside view of CMP on levee slope. Needs cleaning and clearing.

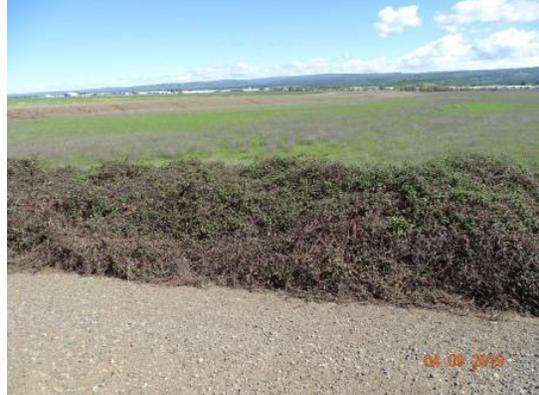
Photo 1 of 1 : SP_2020_NA0003_67_22_20200226_00005.jpg

View of the wild growth at the landside toe. Spring 2019.

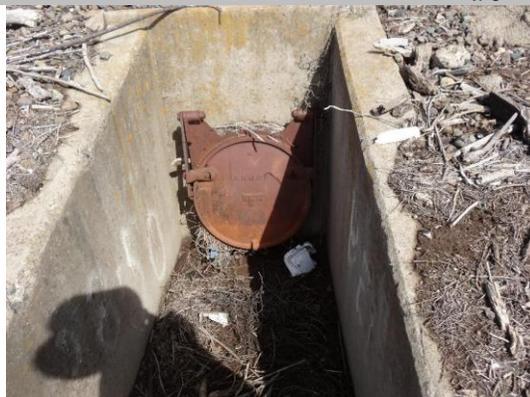
Photo 1 of 3 : UCIP_SP_2020_31864_58069.jpg

WS view: U type concrete headwall, pipe, and flapgate on levee slope. Soil/mud on outlet box. Vegetation debris blocking outlet box.

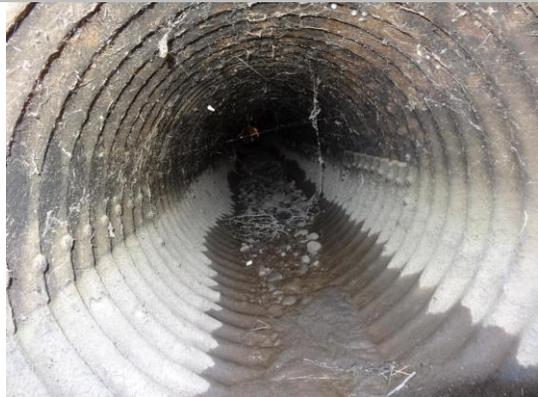
Photo 3 of 3 : UCIP_SP_2020_31864_58067.jpg

LS view: inside view of CMP on levee slope. Needs cleaning and clearing.

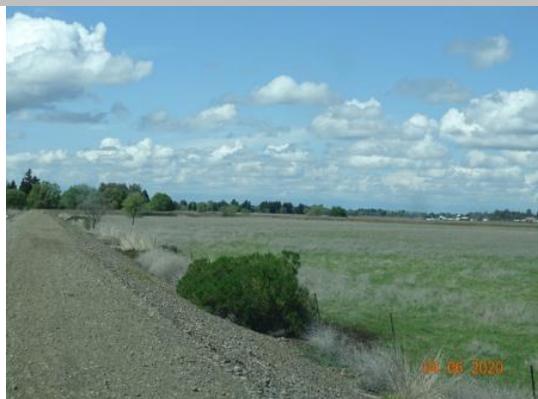
Photo 1 of 1 : SP_2020_NA0003_67_14_20200413_00040.jpg

View of a bush along the landside toe. Spring 2020.

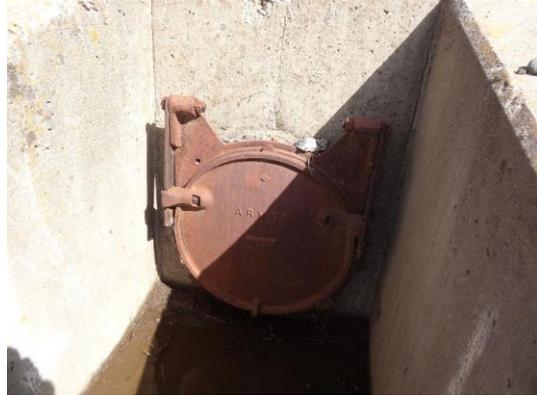
Photo 1 of 3 : UCIP_SP_2020_31856_58053.jpg

WS view: U type concrete headwall, pipe, and flapgate on levee slope. Soil/mud on outlet box.

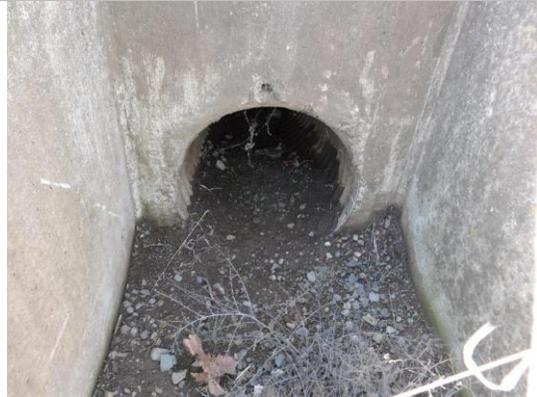
Photo 2 of 3 : UCIP_SP_2020_31856_58052.jpg

LS view: U type concrete headwall and CMP on levee slope. Soil/mud on inlet box.

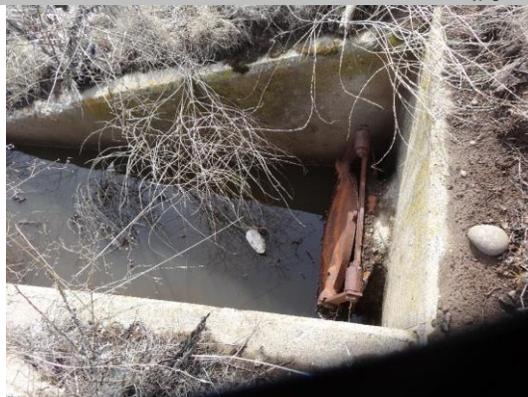
Photo 1 of 2 : UCIP_SP_2020_32125_58629.jpg

WS view: U type concrete headwall, pipe, and flapgate on levee slope. Soil/mud on outlet box. Vegetation debris blocking outlet box.

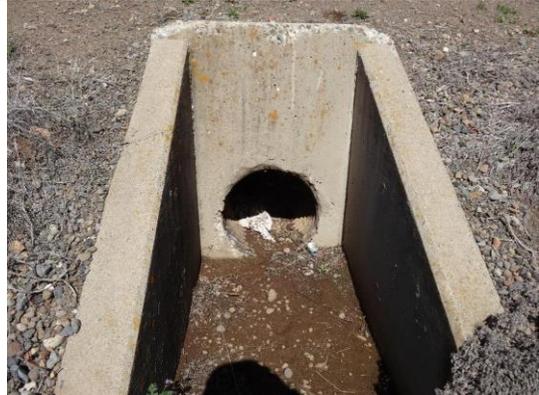
Photo 3 of 3 : UCIP_SP_2020_32026_58518.jpg

LS view: U type concrete headwall and CMP on levee slope. Mud and pebbles on inlet box.

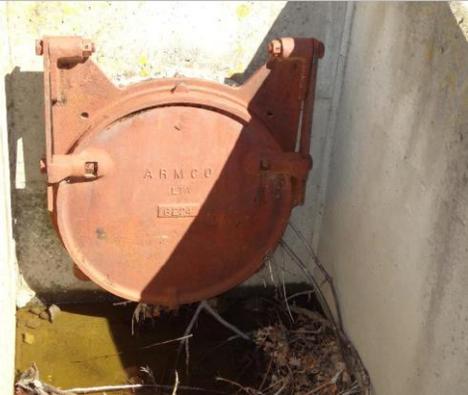
Photo 1 of 3 : UCIP_SP_2020_32023_58505.jpg

WS view: U type concrete headwall and CMP on levee slope. Vegetation debris and mud on outlet box. Needs cleaning and clearing.

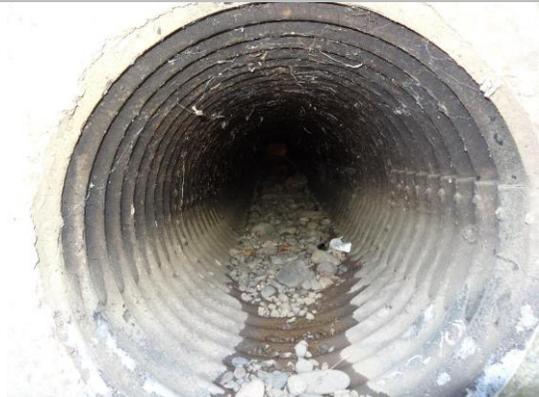
Photo 3 of 3 : UCIP_SP_2020_32023_58503.jpg

LS view: inside view of the CM pipe. Needs cleaning and clearing the pipe.

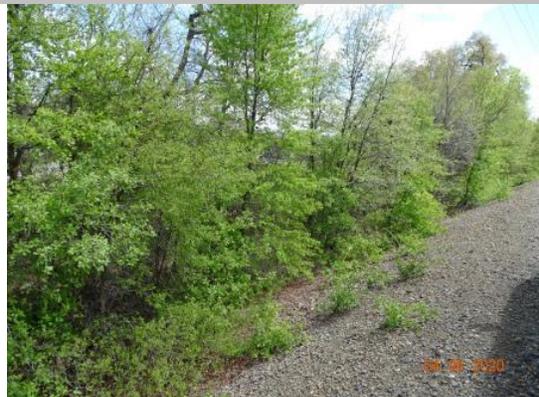
Photo 1 of 1 : SP_2020_NA0003_68_21_20200413_00035.jpg

View of the wild growth along the landside toe. Spring 2020.

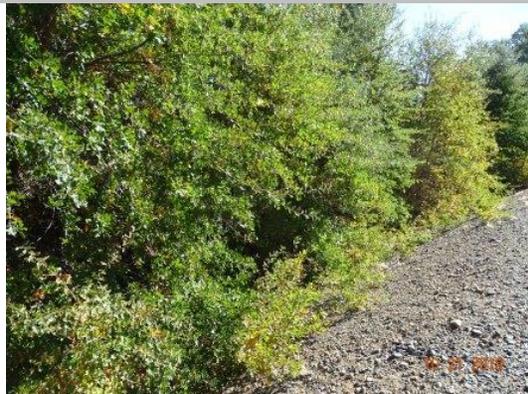
Photo 1 of 1 : SP_2020_NA0003_68_14_20200226_00004.jpg

View of trees and wild growth along the waterside slope and toe. Fall 2019.

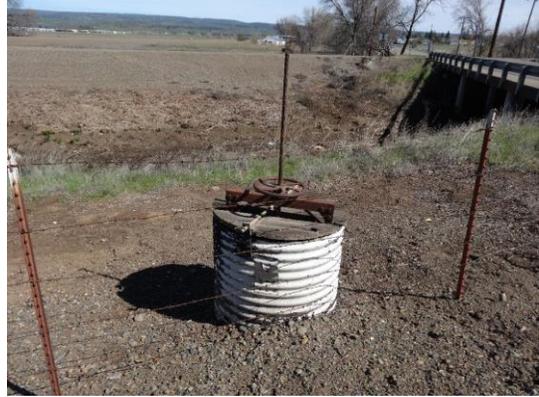
Photo 3 of 3 : UCIP_SP_2020_32144_58642.jpg

WS view: slide gate in CMP riser on waterside. No access to CMP riser.

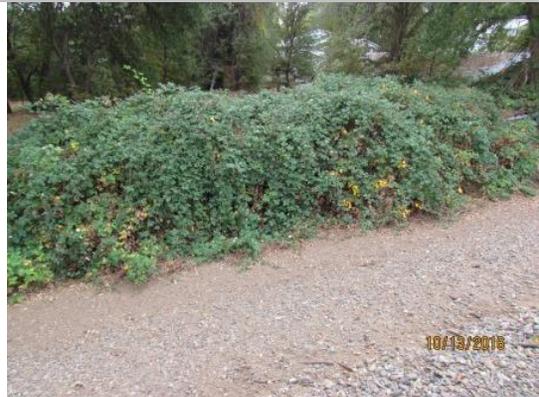
Photo 1 of 1 : SP_2020_NA0003_68_23_20200226_00007.jpg

View of the blackberries blocking visibility and access.

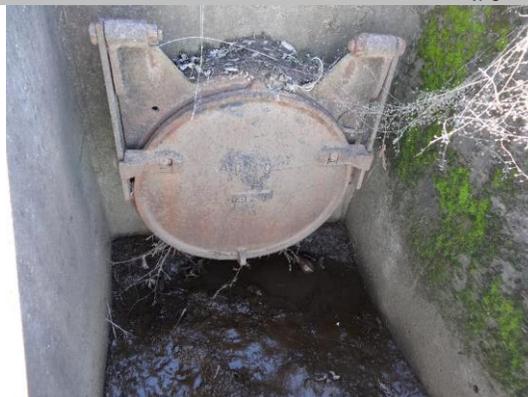
Photo 1 of 2 : UCIP_SP_2020_31964_58389.jpg

WS view: U type concrete headwall and CMP on levee slope. Vegetation debris and mud in outlet box. Needs cleaning and clearing.

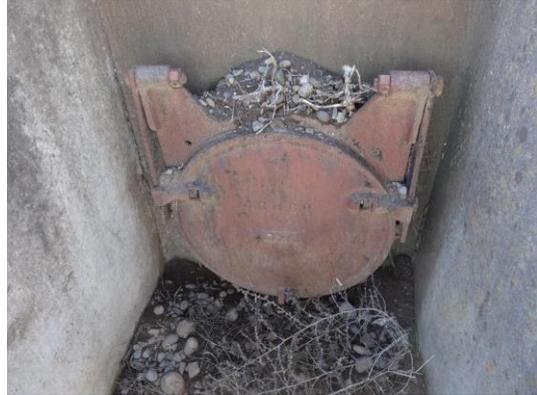
Photo 1 of 3 : UCIP_SP_2020_31965_58395.jpg

WS view: U type concrete headwall and CMP on levee slope. Vegetation debris and mud in outlet box. Needs cleaning and clearing.

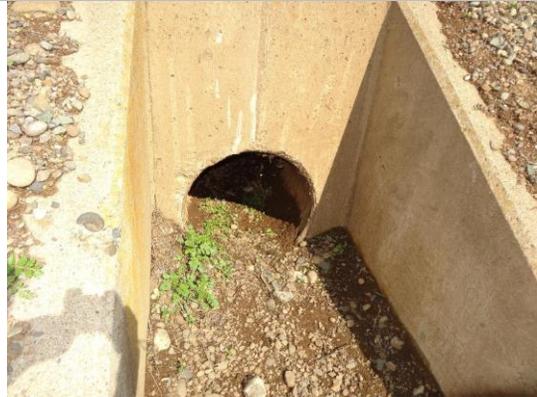
Photo 2 of 3 : UCIP_SP_2020_31965_58394.jpg

LS view: U type concrete headwall and CMP on levee slope. Vegetation debris and mud in inlet box.

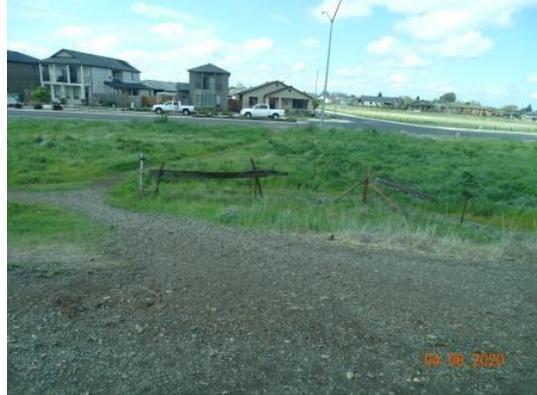
Photo 1 of 1 : SP_2020_NA0003_69_12_20200413_00007.jpg

View of the landside slope erosion caused by foot traffic. Spring 2020.

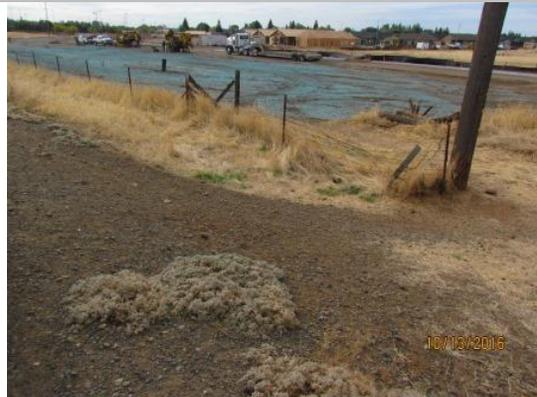
Photo 1 of 1 : SP_2020_NA0003_69_13_20200226_00004.jpg

View of the damaged slope by foot traffic.
