**Flood Control Project Maintenance  
Levee Inspections**

**Fall 2019 Levee Maintenance Deficiency Summary Report**

**Fall 2019 Levee Inspection Results**

**Marysville Levee Commission**

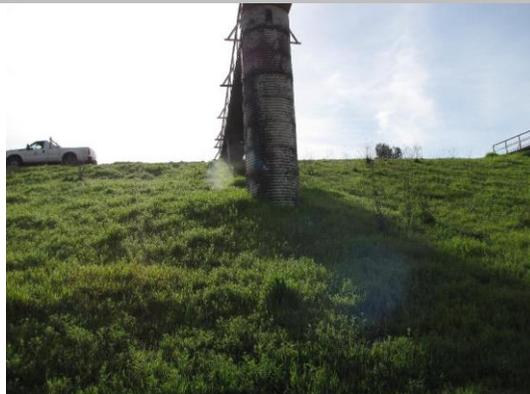
Photo 3 of 3 : UCIP\_FA\_2019\_52792\_69742.jpg

View of waterward slope.

LM Start	<b>0.72</b>	Rating **	M	Issue No.	<b>12</b>
LM End	<b>1.27</b>	Issue Type +	Ma	Location *	LS
Category	Earthen Levee			GPS Latitude/Longitude	
				Start	End
Item	Vegetation			39.156248°	39.160562°
				-121.591992°	-121.590265°
DWR ID	DWR_NA0004_01_f_2019_12				
Comment Code					
V1 : Control annual grass and weeds on the levee slopes and easements.					
Inspector Comment					
The annual vegetation in this section needs to be maintained, Fall 2019.

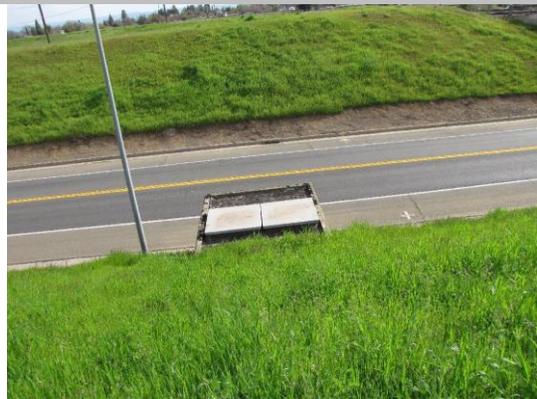
Photo 1 of 3 : UCIP\_FA\_2019\_52796\_69758.jpg

Item	DRAFT DWR UCIP Field Study			39.158946°	39.158946°
				-121.589930°	-121.589930°
DWR ID	19100				
Comment Code					
Inspector Comment					
DS_ID:19100 FS_ID:52796 EP_NO: 14518 Repair Type: Non-Urgent Crossing Status: Indicator Found UCIP Comments: 03/14/2013 Recommend having owner removing tall grass along slopes to properly inspect signs of pipe failure. (DWR UCIP - O. Magana) FIELD_STRUCT_DESC: 1 of 2: 10-inch steel drainage pipe through levee, 4 feet below crown. Flap gate on waterside (WS) end. Concrete vault on WS shoulder. Metal meter box on the landside (LS) shoulder. Pump placed on concrete footings at toe of LS slope. Drainage for underpass. Pipes approximately 2.5-feet apart. (10-inch pipe removed and replaced with new 10-inch pipe authorized under Permit No. 14518, 1987-State Department of Transportation). [Additional Reference(s): DWR Levee Logs, 1993 and 2005] FS Date: 3/14/2013

View of landward side.

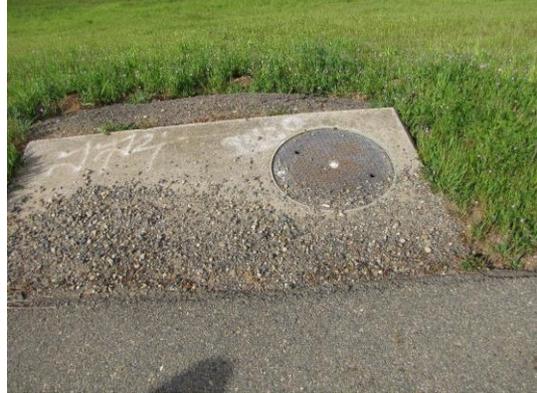
Photo 2 of 3 : UCIP\_FA\_2019\_52796\_69757.jpg

Concrete vault on waterward shoulder with manhole.

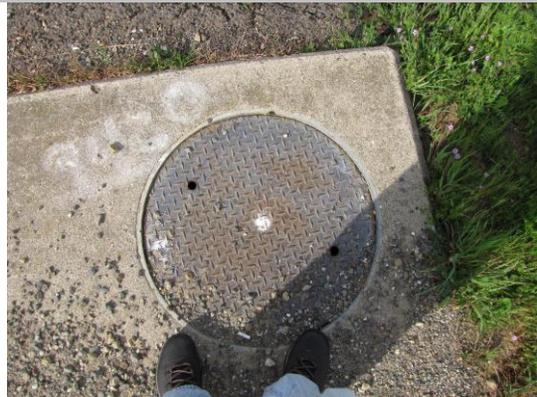
Photo 3 of 3 : UCIP\_FA\_2019\_52796\_69756.jpg

LM Start	<b>0.96</b>	Rating **	M	Issue No.	<b>38 (cont)</b>
LM End	<b>0.96</b>	Issue Type +	En	Location *

Close up view of manhole.

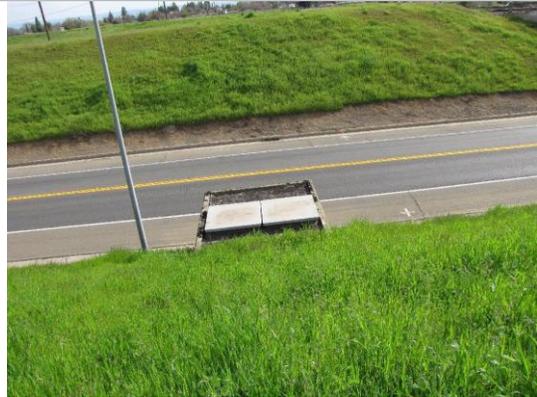
Photo 1 of 3 : UCIP\_FA\_2019\_52797\_69762.jpg

Item	DRAFT DWR UCIP Field Study			39.158951°	39.158951°
				-121.589929°	-121.589929°
DWR ID	19093				
Comment Code					
Inspector Comment					
DS_ID:19093 FS_ID:52797 EP_NO: 14518 Repair Type: Non-Urgent Crossing Status: Indicator Found UCIP Comments: 03/14/2013 Recommend having owner removing tall grass along slopes to properly inspect signs of pipe failure. (DWR UCIP - O. Magana) FIELD_STRUCT_DESC: 2 of 2: 10-inch steel drainage pipe through levee, 4 feet below crown. Flap gate on waterside (WS) end. Concrete vault on WS shoulder. Metal meter box on the landside (LS) shoulder. Pump placed on concrete footings at toe of LS slope. Drainage for underpass. Pipes approximately 2.5-feet apart. (10-inch pipe removed and replaced with new 10-inch pipe authorized under Permit No. 14518, 1987-State Department of Transportation). [Additional Reference(s): DWR Levee Logs, 1993 and 2005] FS Date: 3/14/2013

View of pump concrete building located on landward side.

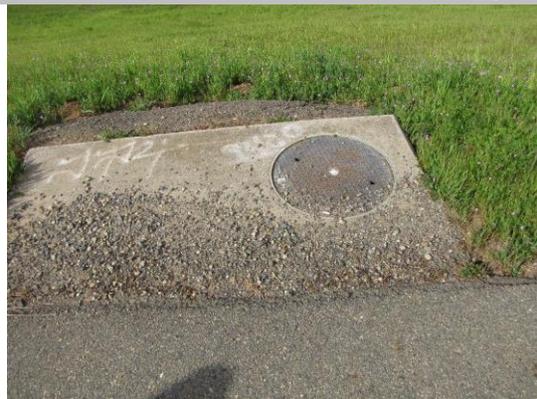
Photo 2 of 3 : UCIP\_FA\_2019\_52797\_69761.jpg

LM Start	<b>0.96</b>	Rating **	M	Issue No.	<b>39 (cont)</b>
LM End	<b>0.96</b>	Issue Type +	En	Location *

Concrete vault located on waterward shoulder.

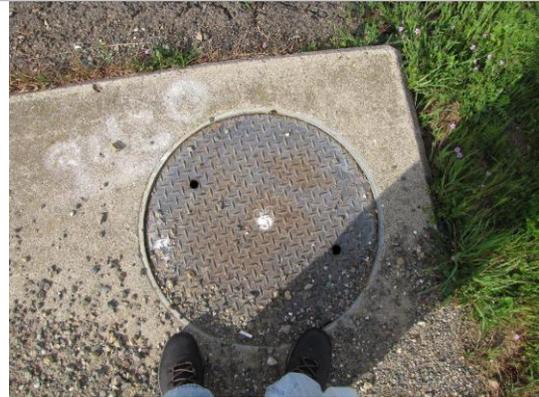
Photo 3 of 3 : UCIP\_FA\_2019\_52797\_69760.jpg

Close up of manhole.

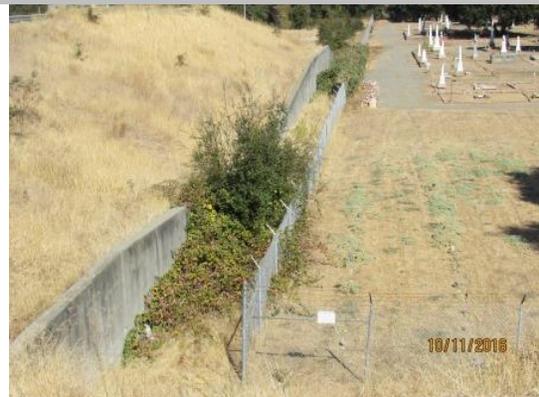
Photo 1 of 1 : FA\_2019\_NA0004\_104\_36\_20190904\_00001.jpg

LM Start	<b>0.97</b>	Rating **	M	Issue No.	<b>36</b>
LM End	<b>1.19</b>	Issue Type +	En	Location *	WS
Category	Earthen Levee			GPS Latitude/Longitude	
				Start	End
Item	Encroachments			39.159210 °	39.161576 °
				-121.590033 °	-121.590721 °
DWR ID	DWR_NA0004_01_f_2013_36				
Comment Code					
RW : Retaining Wall					
Inspector Comment					
A concrete retaining wall was cut into levee toe, no permit found.

View of the concrete retaining wall at the toe of the levee on the waterward side looking downstream.

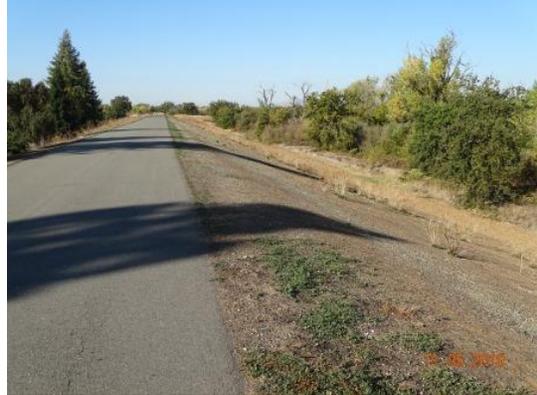
Photo 1 of 1 : FA\_2019\_NA0004\_104\_10\_20191112\_00015.jpg

View looking downstream waterside at the annual vegetation that is well maintained, Fall 2019.

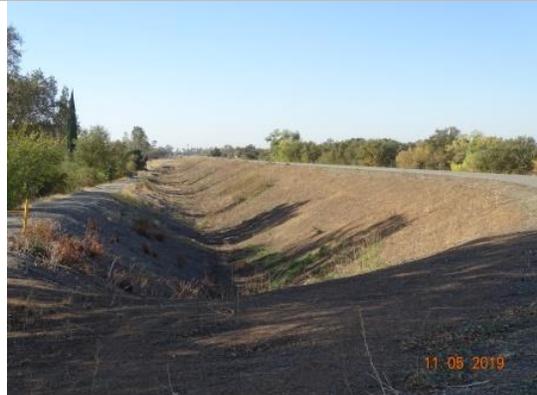
Photo 1 of 1 : FA\_2019\_NA0004\_104\_11\_20191112\_00016.jpg

LM Start	<b>1.37</b>	Rating **	A	Issue No.	<b>11</b>
LM End	<b>2.62</b>	Issue Type +	Ma	Location *	LS
Category	Earthen Levee		GPS Latitude/Longitude		
			Start	End	
Item	Vegetation		39.159271°	39.165276°	
			-121.589468°	-121.570324°	
DWR ID	DWR_NA0004_01_f_2019_11				
Comment Code					
V1 : Control annual grass and weeds on the levee slopes and easements.					
Inspector Comment					
The annual vegetation in this section is well maintained, Fall 2019.

View looking downstream landside at the annual vegetation that is well maintained, Fall 2019.

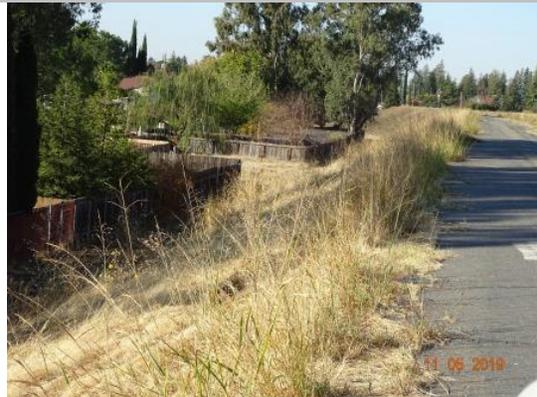
Photo 1 of 1 : FA\_2019\_NA0004\_104\_9\_20191112\_00014.jpg

View looking downstream landside at the annual vegetation that needs to be maintained, Fall 2019.

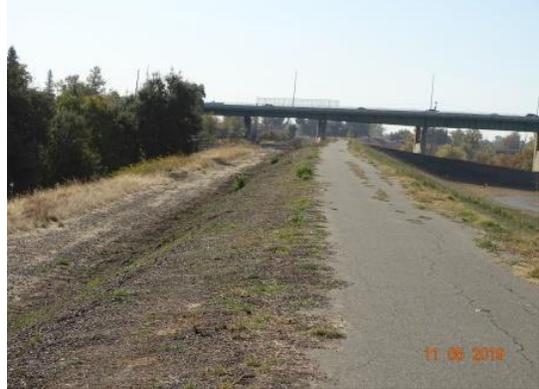
Photo 1 of 1 : FA\_2019\_NA0004\_105\_3\_20191112\_00012.jpg

View looking downstream landside at the well maintained annual vegetation, Fall 2019.

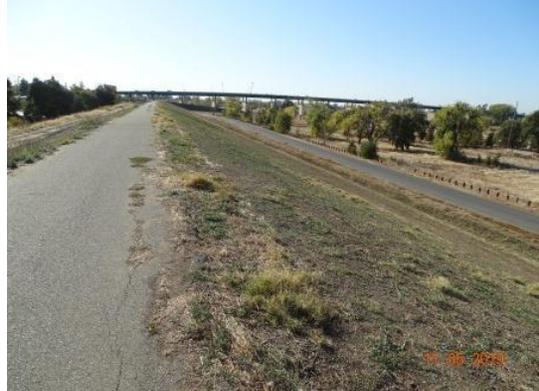
Photo 1 of 1 : FA\_2019\_NA0004\_105\_4\_20191112\_00013.jpg

LM Start	<b>0.01</b>	Rating **	A	Issue No.	<b>4</b>
LM End	<b>1.21</b>	Issue Type +	Ma	Location *	WS
Category	Earthen Levee		GPS Latitude/Longitude		
			Start	End	
Item	Vegetation		39.149379°	39.134667°	
			-121.601102°	-121.594671°	
DWR ID	DWR_NA0004_02_f_2019_4				
Comment Code					
V1 : Control annual grass and weeds on the levee slopes and easements.					
Inspector Comment					
The annual vegetation is well maintained, Fall 2019.

View looking downstream waterside at the well maintained annual vegetation, Fall 2019.

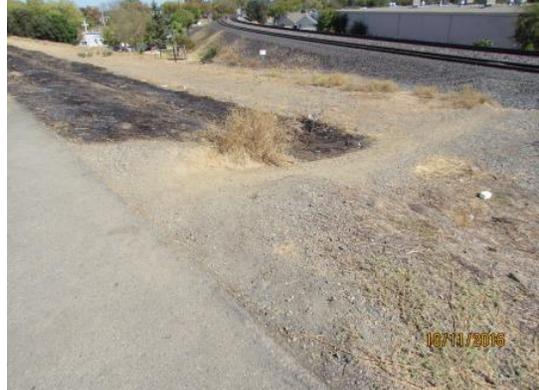
Photo 1 of 1 : FA\_2019\_NA0004\_105\_8\_20190904\_00002.jpg

LM Start	<b>0.22</b>	Rating **	A/W	Issue No.	<b>8</b>
LM End	<b>0.22</b>	Issue Type +	Ma	Location *	LS
Category	Earthen Levee		GPS Latitude/Longitude		
			Start	End	
Item	Slope Stability		39.146352°	39.146352°	
			-121.600724°	-121.600724°	
DWR ID	DWR_NA0004_02_f_2016_8				
Comment Code					
S2 : Repair the levee slope damaged by foot traffic and prevent access where possible.					
Inspector Comment					
Foot path depression in the landside levee slope shows no sign of erosion and the slope is stable, Fall 2019.

View of foot path depression in the landside levee slope.

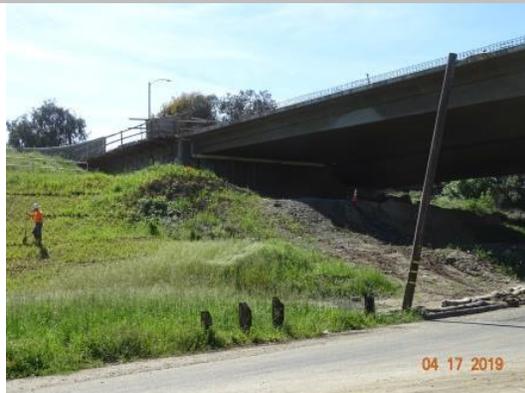
Photo 1 of 1 : FA\_2019\_NA0004\_105\_5\_20190904\_00001.jpg

View looking at the Fifth Street Bridge abutment waterside on the left bank of the Feather River, completion is estimated for the end of 2019.

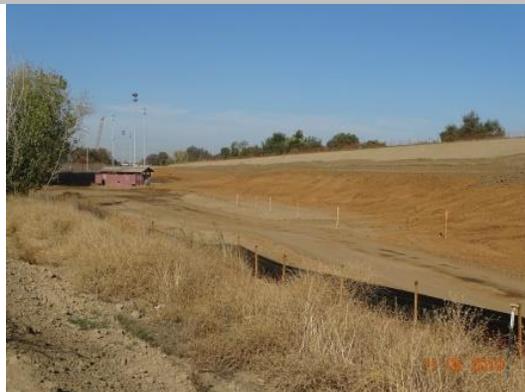
Photo 1 of 1 : FA\_2019\_NA0004\_105\_6\_20191112\_00014.jpg

LM Start	<b>0.72</b>	Rating **	A/W	Issue No.	<b>6</b>
LM End	<b>1.24</b>	Issue Type +	Ma	Location *	CR
Category	Earthen Levee			GPS Latitude/Longitude	
				Start	End
Item	Crown Surface / Depressions / Rutting			39.139958 °	39.134223 °
				-121.601648 °	-121.594079 °
DWR ID	DWR_NA0004_02_f_2019_6				
Comment Code					
C1 : Add appropriate material and re-grade the levee to bring the crown above the design elevation.					
Inspector Comment					
New levee construction in this section of levee, Fall 2019.

View looking upstream at the new construction of the levee in this section, Fall 2019.

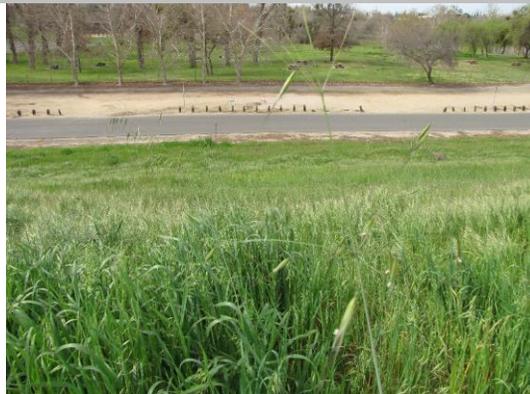
Photo 1 of 3 : UCIP\_FA\_2019\_52808\_69802.jpg

LM Start	<b>0.87</b>	Rating **	M	Issue No.	<b>15</b>
LM End	<b>0.87</b>	Issue Type +	En	Location *	
Category	Supplemental			GPS Latitude/Longitude	
				Start	End
Item	DRAFT DWR UCIP Field Study			39.138269 °	39.138269 °
				-121.599004 °	-121.599004 °
DWR ID	19123				
Comment Code					
Inspector Comment					
DS_ID:19123 FS_ID:52808 EP_NO: N/A Repair Type: Non-Urgent Crossing Status: Indicator Found UCIP Comments: 03/15/2013 Unable to tell if crossing goes through levee; according to Frank Miller crossing does not cross levee. Need to contact owner to confirm alignment. (DWR UCIP - O. Magana) FIELD_STRUCT_DESC: Fiber optics communication line of unknown material through levee at an unknown depth below the crown. Marker on waterside (WS) shoulder. [Additional Reference(s): DWR Levee Logs, 1993 and 2005] FS Date: 3/15/2013

View of waterward slope.

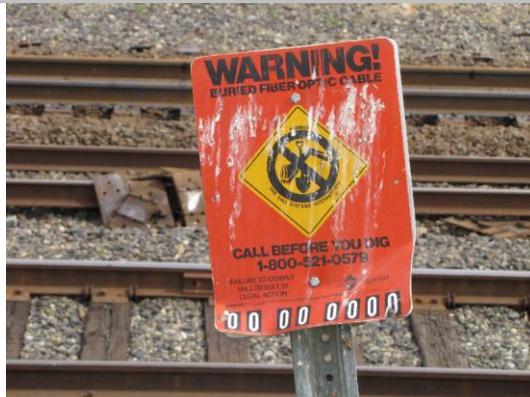
Photo 2 of 3 : UCIP\_FA\_2019\_52808\_69801.jpg

Buried fiber optical cable marker with contact information located on landward shoulder.

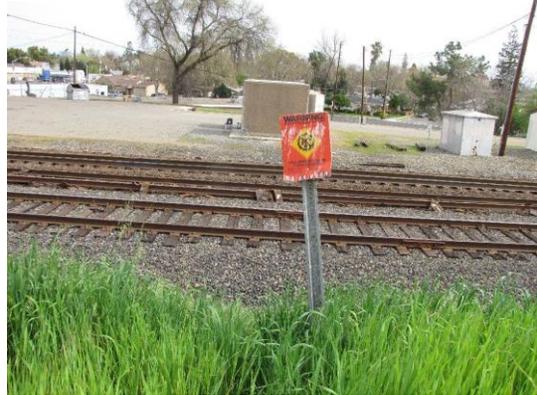
Photo 3 of 3 : UCIP\_FA\_2019\_52808\_69800.jpg

View of landward side with bldg that could be associated with cable line.

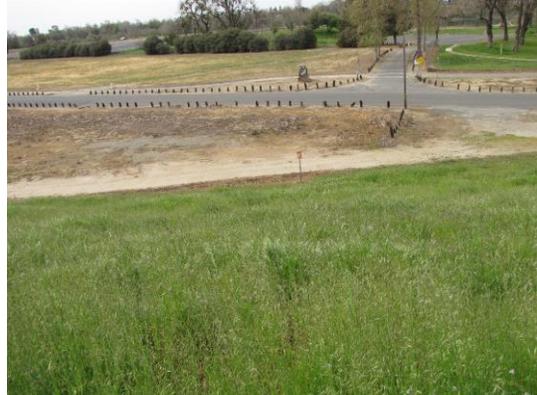
Photo 1 of 3 : UCIP\_FA\_2019\_52809\_69804.jpg

LM Start	<b>0.91</b>	Rating **	M	Issue No.	<b>16</b>
LM End	<b>0.91</b>	Issue Type +	En	Location *	
Category	Supplemental			GPS Latitude/Longitude	
				Start	End
Item	DRAFT DWR UCIP Field Study			39.137749 °	39.137749 °
				-121.598560 °	-121.598560 °
DWR ID	19104				
Comment Code					
Inspector Comment					
DS_ID:19104 FS_ID:52809 EP_NO: N/A Repair Type: Non-Urgent Crossing Status: Indicator Found UCIP Comments: 03/15/2013 Unable to tell if crossing goes through levee. Need to contact owner to confirm alignment. (DWR UCIP - O. Magana) FIELD_STRUCT_DESC: 12-inch high-density polyethylene (HDPE) conduit, with electrical lines, through the levee at an unknown depth through the levee. Extends to controller cabinet within the overflow area. FS Date: 3/15/2013

View of markers located on waterward toe.

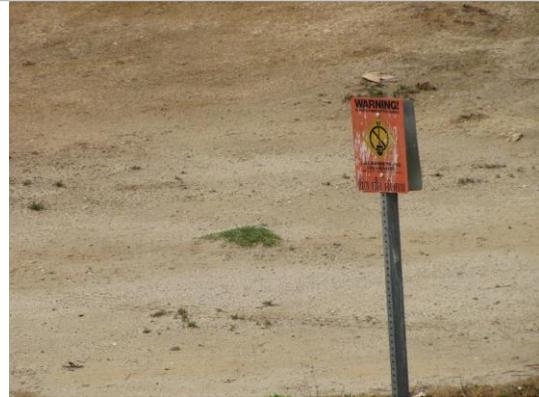
Photo 2 of 3 : UCIP\_FA\_2019\_52809\_69805.jpg

View of markers located on waterward toe.

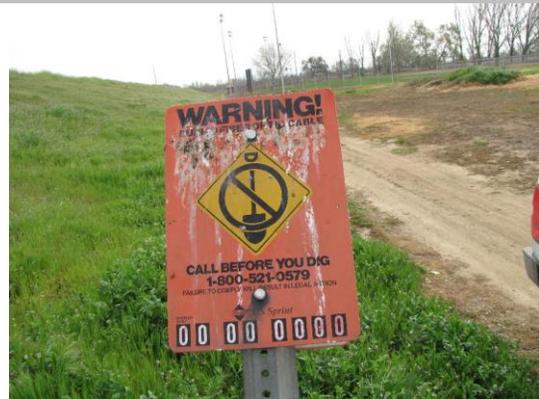
Photo 3 of 3 : UCIP\_FA\_2019\_52809\_69806.jpg

Close up of markers located at toe of waterward side.

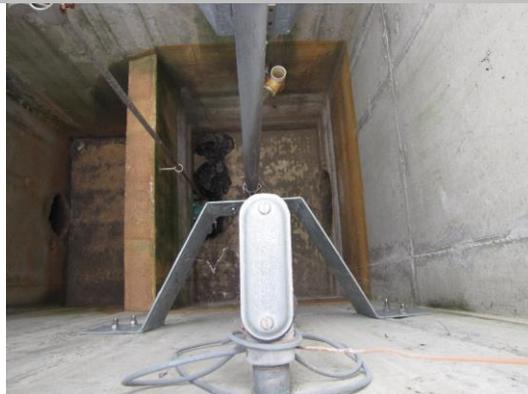
Photo 1 of 3 : UCIP\_FA\_2019\_52811\_72681.jpg

Item	DRAFT DWR UCIP Field Study			39.135010°	39.135010°
				-121.593225°	-121.593225°
DWR ID	25055				
Comment Code					
Inspector Comment					
<p>DS_ID:25055                  FS_ID:52811                  EP_NO: N/A                  Repair Type: Non-Urgent                  Crossing Status: Found                  UCIP Comments: 09/14/2018 Pipe size was changed from 10-inch to 12-inch based on drawings made available through Permit 15178 and 15178-1. (DWR UCIP - O. Magana)                  03/14/2013 Appears that crossing is currently not in use. If crossing is to be abandoned, owner will need to contact CVFPB to coordinate about proper removal. (DWR UCIP - O. Magana)                  FIELD_STRUCT_DESC: 12-inch sewer line visible on landside (LS). According to Marysville Treatment Plant Manager this crossing was installed in 1995-1996. Coordinates for box located on LS: 39.135185, -121.593254. Note coordinates used for levee crossing are projected coordinates. 12-inch gravity flow pipelines goes through levee and the 36-inch pipeline parallels with the waterside toe of the right bank levee of the Yuba River. (12-inch extending-to-36-inch-diameter chlorine contact pipe line authorized under Permit 16055, 1993-City of Marysville; related permit - existing 12-inch line connects to effluent splitter box located southwest at the City of Marysville Effluent Disposal Ponds along the right bank of the Yuba River and new 24-inch installed at existing effluent splitter box and connects to the Proposed ponds along the left bank of the Yuba River work authorized under Permit 15178, 1989 - City of Marysville Department of Public Works)                  FS Date: 3/14/2013</p>

Inside view of concrete box.

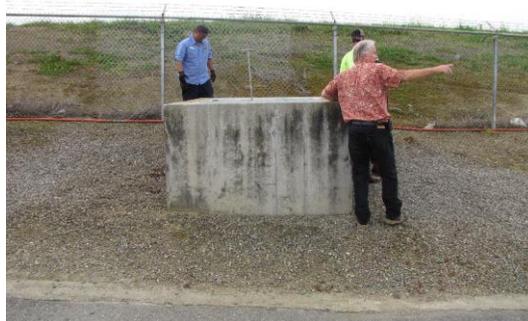
Photo 2 of 3 : UCIP\_FA\_2019\_52811\_72680.jpg

View of concrete box located on landward side--crossing not in use according to Marysville Sewage Treatment Plant Manager.

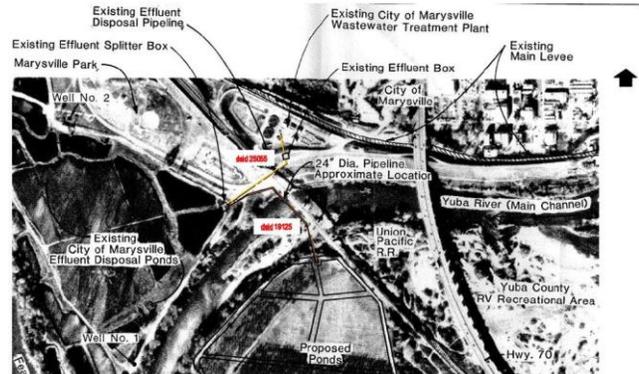
Photo 3 of 3 : UCIP\_FA\_2019\_52811\_77949.jpg

Alignment of crossing through levee per dwgs under Permit 15178 and 15178-1.

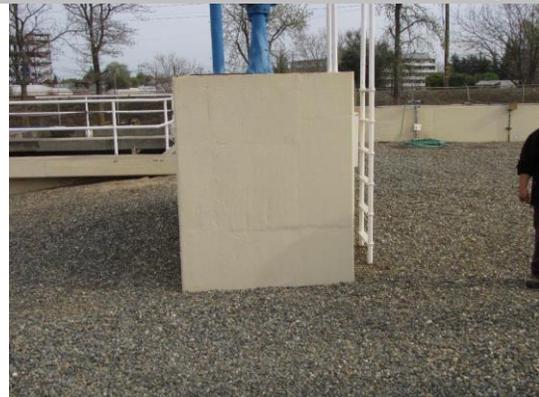
Photo 2 of 3 : UCIP\_FA\_2019\_52812\_69811.jpg

Standpipe where old line is still located.

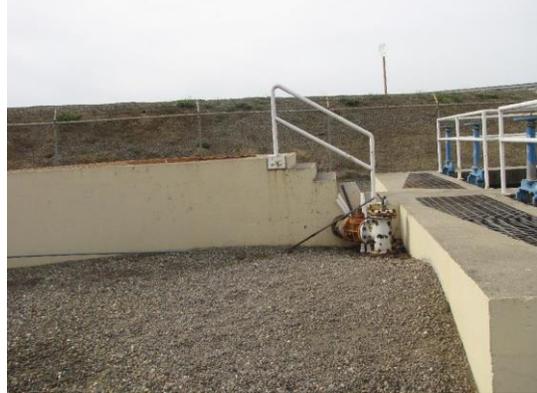
Photo 3 of 3 : UCIP\_FA\_2019\_52812\_69810.jpg

View of levee slope on waterward.

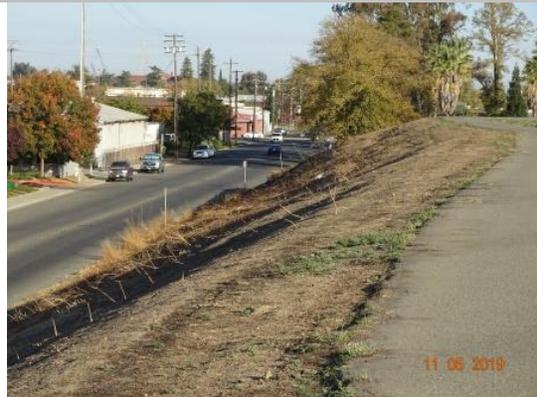
Photo 1 of 1 : FA\_2019\_NA0004\_106\_15\_20191112\_00044.jpg

View looking upstream landside at the well maintained annual vegetation in this section, Fall 2019.

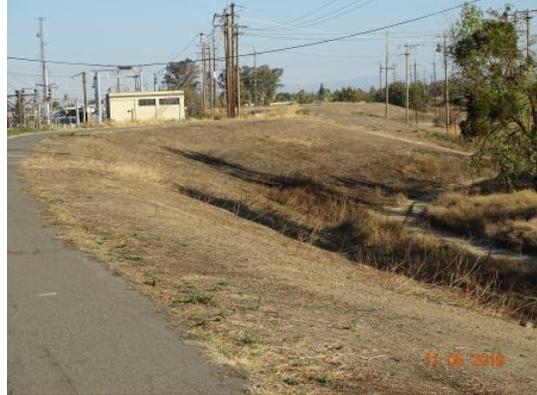
Photo 1 of 1 : FA\_2019\_NA0004\_106\_19\_20191112\_00045.jpg

View looking upstream waterside at the well maintained annual vegetation in this section, Fall 2019.

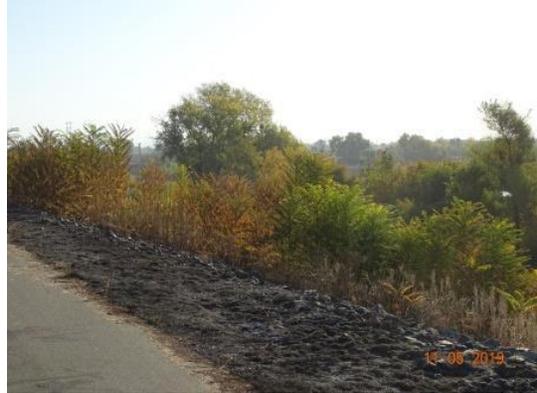
Photo 1 of 1 : FA\_2019\_NA0004\_106\_16\_20191112\_00046.jpg

View looking upstream waterside where intrusive starter trees need to be trimmed and sprayed, Fall 2019.

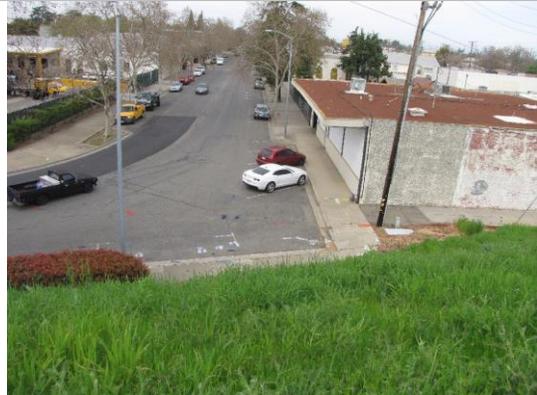
Photo 1 of 2 : UCIP\_FA\_2019\_52815\_72683.jpg

Underground service alert (USA) blue paint indicators of water line present on landward side.

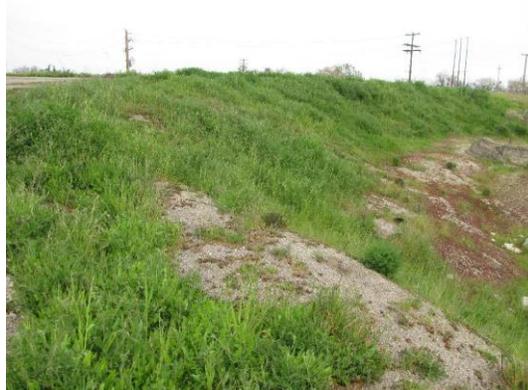
Photo 2 of 2 : UCIP\_FA\_2019\_52815\_72682.jpg

View of waterward slope--unable to confirm if crossing is active--line buried.

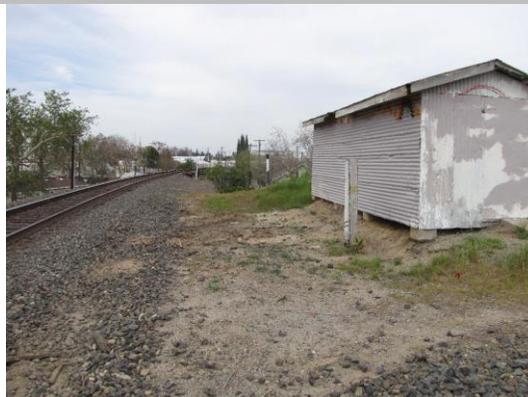
Photo 1 of 3 : UCIP\_FA\_2019\_52819\_72696.jpg

View of landward side.

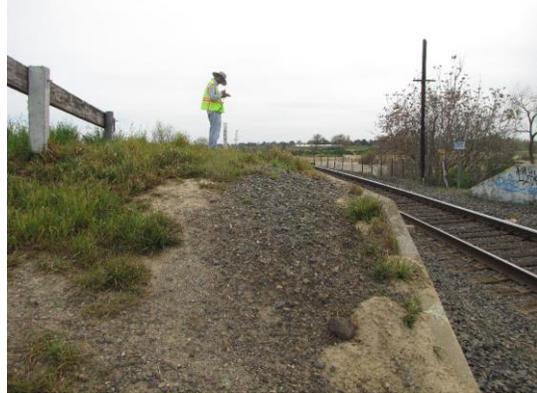
Photo 2 of 3 : UCIP\_FA\_2019\_52819\_72695.jpg

View of landward side.

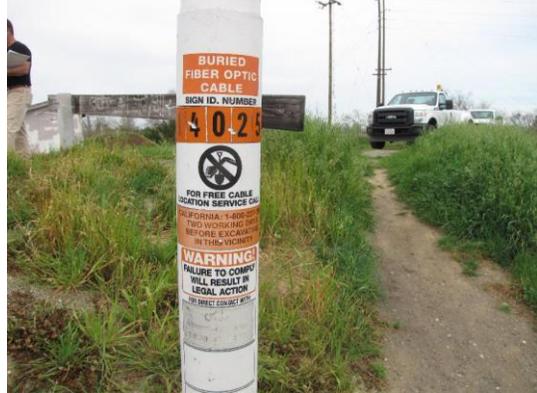
Photo 3 of 3 : UCIP\_FA\_2019\_52819\_72694.jpg

Fiber Optic Cable marker visible on landward side.

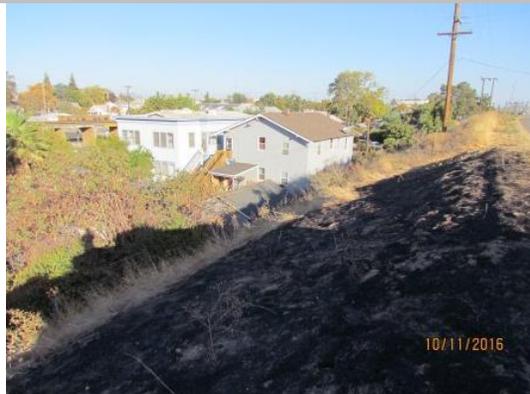
Photo 1 of 1 : FA\_2019\_NA0004\_106\_25\_20190904\_00006.jpg

View of house and shed at the landside levee toe looking upstream.

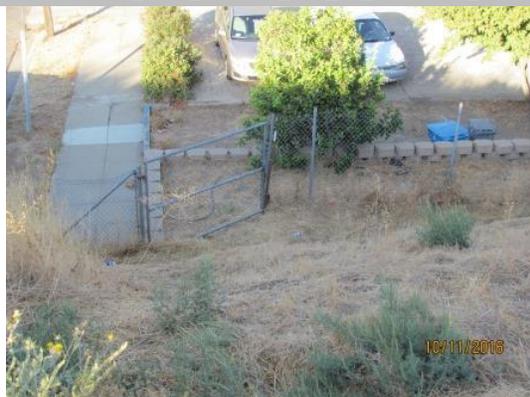
Photo 1 of 1 : FA\_2019\_NA0004\_106\_26\_20190904\_00007.jpg

View of fence that runs along landside levee toe.

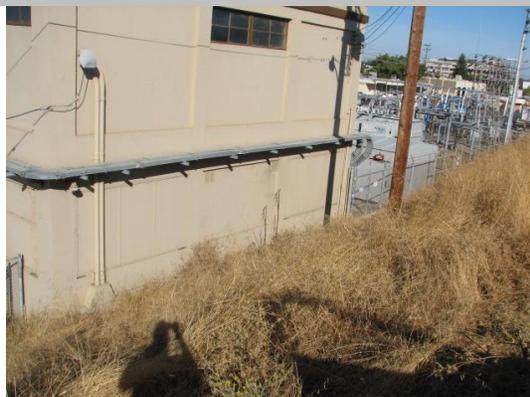
Photo 1 of 1 : FA\_2019\_NA0004\_106\_4\_20190904\_00001.jpg

Building encroaching at landside levee toe.

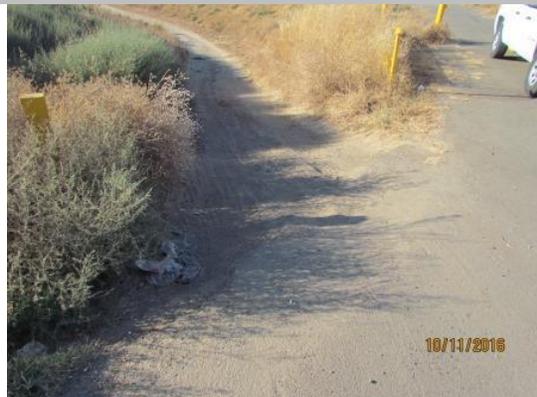
Photo 1 of 1 : FA\_2019\_NA0004\_106\_32\_20190904\_00009.jpg

View of ruts cut in by vehicle traffic on the waterside slope.

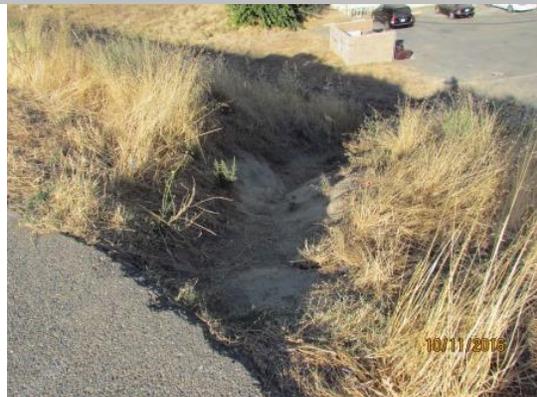
Photo 1 of 1 : FA\_2019\_NA0004\_106\_33\_20190904\_00010.jpg

View of path cut in by foot traffic on the landside slope that needs repaired.

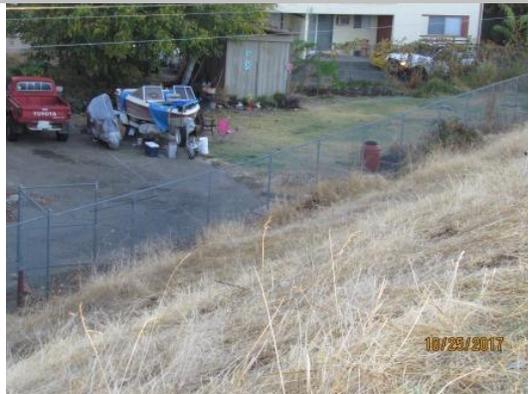
Photo 1 of 1 : FA\_2019\_NA0004\_106\_35\_20190904\_00011.jpg

View of fence on the landside toe.

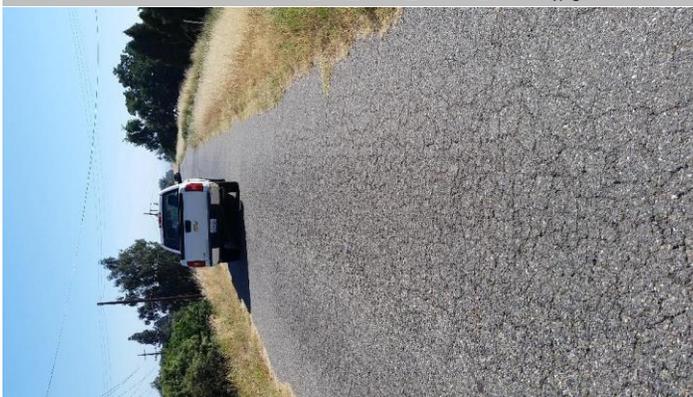
Photo 1 of 3 : UCIP\_FA\_2019\_52821\_75777.jpg

View of levee crown at crossing.

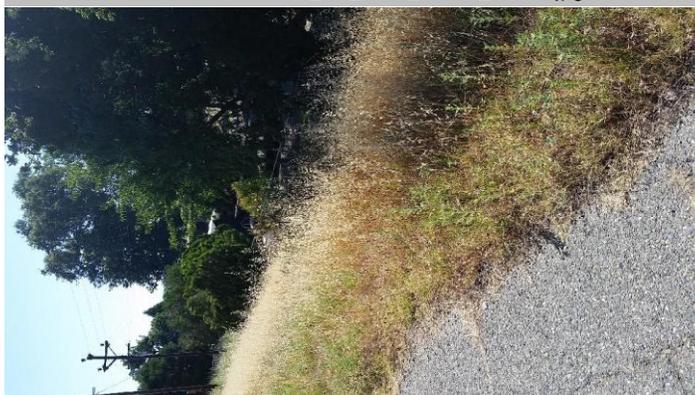
Photo 2 of 3 : UCIP\_FA\_2019\_52821\_75778.jpg

View of WS--dense vegetation on slope.

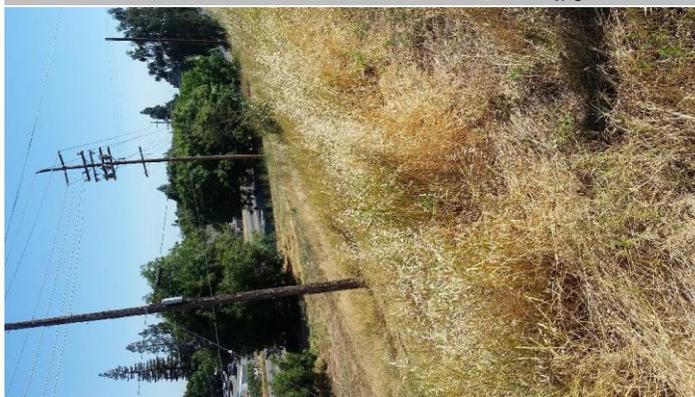
Photo 3 of 3 : UCIP\_FA\_2019\_52821\_75779.jpg

View of LS--dense vegetation on slope.

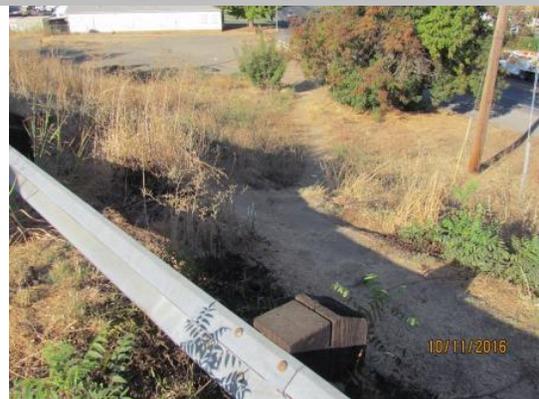
Photo 1 of 1 : FA\_2019\_NA0004\_106\_18\_20190904\_00005.jpg

View of foot path that has cut into landside levee slope.

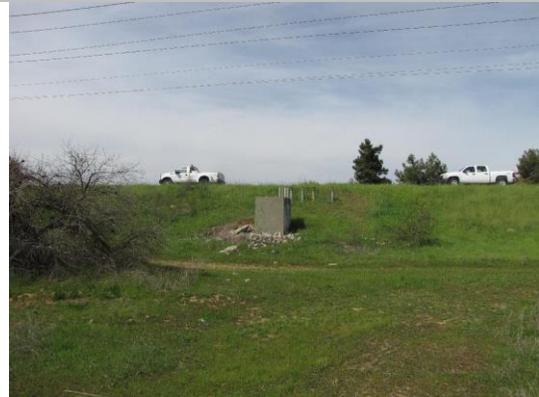
Photo 2 of 3 : UCIP\_FA\_2019\_52825\_69834.jpg

Concrete box and vent pipes located on waterward slope.

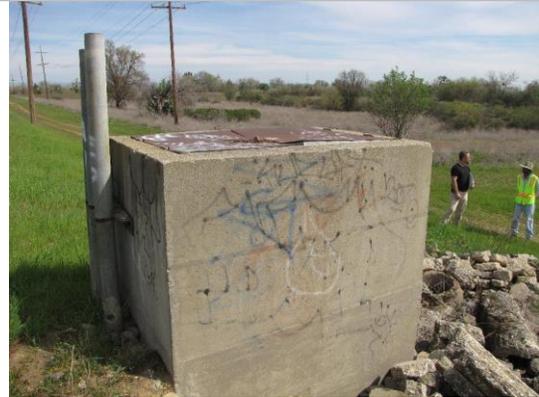
Photo 3 of 3 : UCIP\_FA\_2019\_52825\_69833.jpg

Concrete box located on waterward slope.

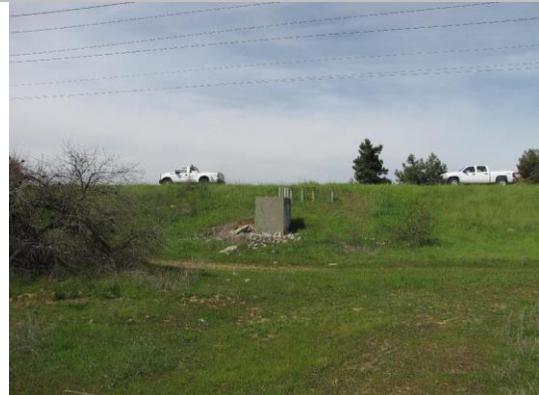
Photo 2 of 3 : UCIP\_FA\_2019\_52826\_69839.jpg

View of waterward side.

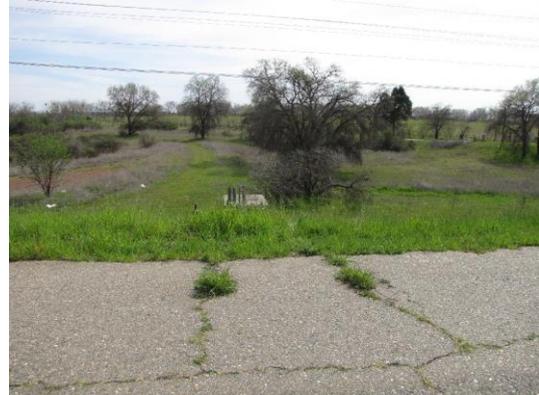
Photo 2 of 3 : UCIP\_FA\_2019\_52827\_69826.jpg

View of waterward side.

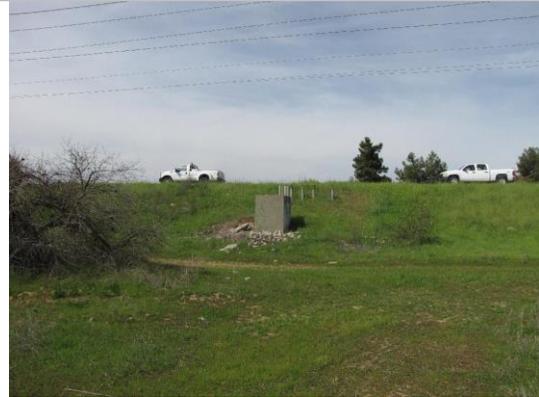
Photo 3 of 3 : UCIP\_FA\_2019\_52827\_69820.jpg

View of waterward side--concrete distribution box and gate stems located on waterward slope.

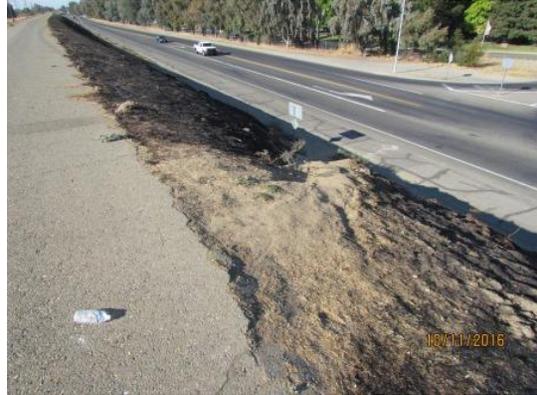
Photo 1 of 1 : FA\_2019\_NA0004\_106\_41\_20190904\_00014.jpg

View looking downstream of foot path that has cut into the landside slope.

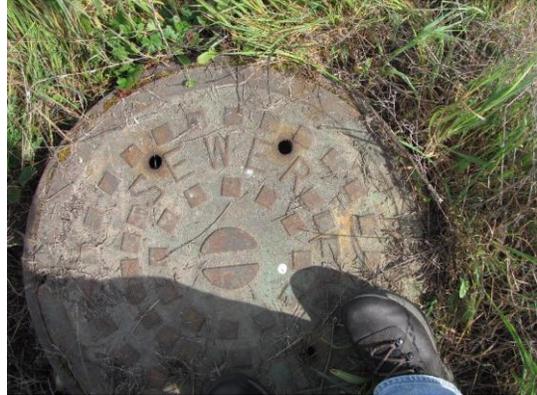
Photo 1 of 2 : UCIP\_FA\_2019\_52828\_25149.jpg

Manhole located on landward toe.

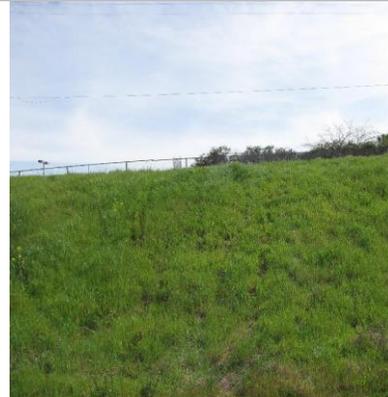
Photo 2 of 2 : UCIP\_FA\_2019\_52828\_25148.jpg

View of landward side.

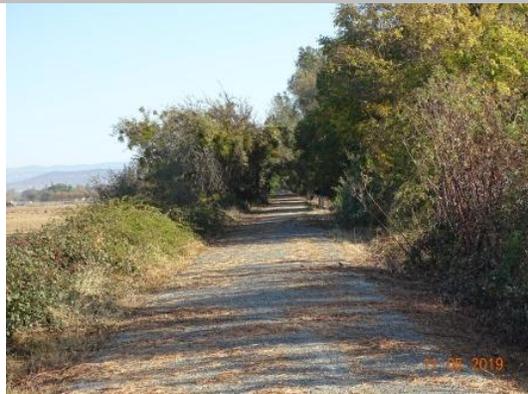
Photo 1 of 1 : FA\_2019\_NA0004\_106\_17\_20191112\_00047.jpg

View looking upstream crown of the section of levee that is only a patrol road and used in the case of emergency for evacuation access.

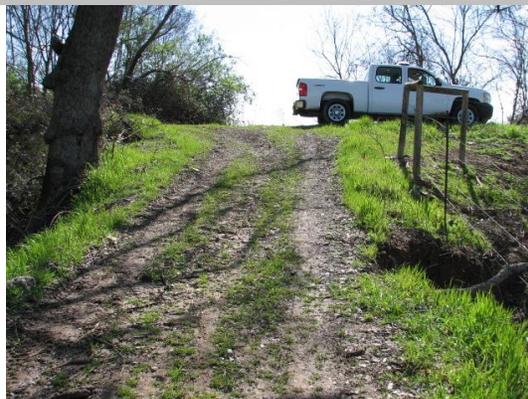
Photo 1 of 1 : FA\_2019\_NA0004\_106\_10\_20190904\_00002.jpg

This ramp is on the patrol road, no known permit.
