**Flood Control Project Maintenance
Levee Inspections**
LMA District Cover Sheet
Spring 2020 Levee Inspection Results

Knights Landing Ridge Drainage District

Spring 2020 Levee Inspection Results

Waterway	Bank	Unit Miles
Unit No. 01 Knights Landing Ridge Cut	Right	6.36

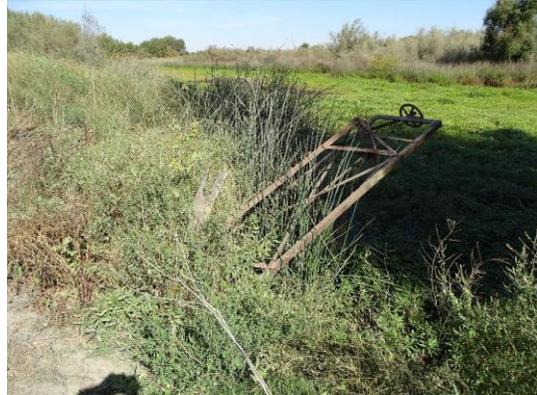
Photo 3 of 3 : UCIP_SP_2020_55381_81601.jpg

Slide gate on metal stand on WS toe needs removal

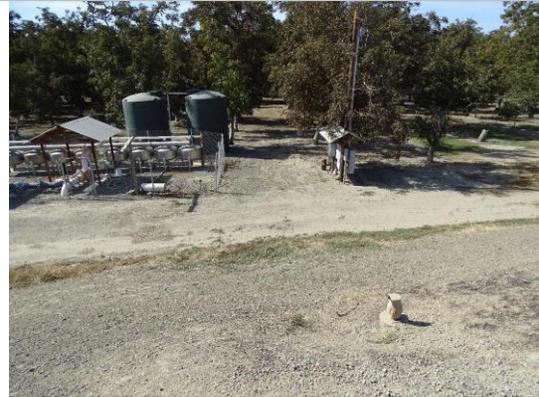
Photo 1 of 3 : UCIP_SP_2020_55685_82412.jpg

Comment Code					
Inspector Comment					
DS_ID:19361 FS_ID:55685 EP_NO: 9302 Repair Type: Urgent Crossing Status: Found UCIP Comments: 10/08/2019 Record has been updated from Non-Urgent to Urgent, excavation into WS slope and around pipe noted in USACE PI and UCIP 2013 inspection. Unable to confirm in 2019 whether excavation is still present on the WS slope due to dense vegetation on the WS. (O.Yakimov - DWR UCIP) 04/05/2013 Pipe exposed on WS slope in trench may need to be backfilled to prevent erosion under pipe. (W. Wylie - DWR UCIP) FIELD_STRUCT_DESC: 20-inch steel irrigation pipe through the levee, 8.8 feet below the crown. Pump on a steel pile structure at the waterside (WS) toe. Siphon breaker in a 12-inch steel riser on the landside (LS) slope. Possible butterfly valve at the LS toe. (36-inch pipe authorized under Automatic Board Order (ABO) issued as Permit No.9302, 1974 - Barbara Lowe Elliott). [Additional Reference(s): DWR Levee Log, 1990. USACE Sacramento O&M Manual 127, June 1953, (Station 32+94)]. FS Date: 10/8/2019

View of LS looking from levee crown

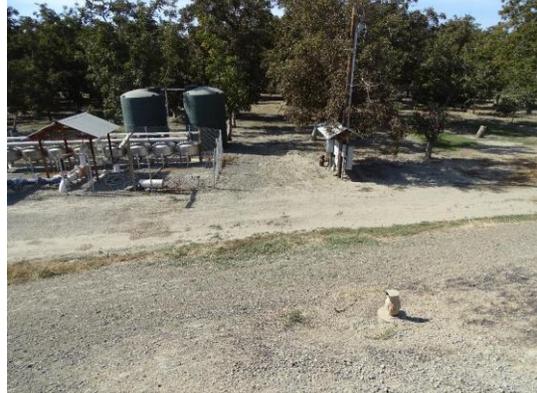
Photo 1 of 2 : UCIP_SP_2020_55686_82415.jpg

Comment Code					
Inspector Comment					
DS_ID:22967 FS_ID:55686 EP_NO: 9302 Repair Type: Non-Urgent Crossing Status: Found UCIP Comments: 10/8/2019 Record updated from No Action Needed to Non-Urgent. Vegetation on LS slope interferes complete slope inspection. Need to have CVFPB review ABO and determine current owner. (O.Yakimov - DWR UCIP) FIELD_STRUCT_DESC: 2.5-inch electrical conduit of an unknown material through the levee, 8.8 feet below the crown. Provides service for pump at the waterside (WS) toe. (36-inch pipe authorized under Permit No. 9302, 1974 - Barbara Lowe Elliott). [Additional Reference(s): USACE Sacramento O&M Manual 127, June 1953]. FS Date: 10/8/2019 3:10:34 PM

Meter and breakers at LS toe

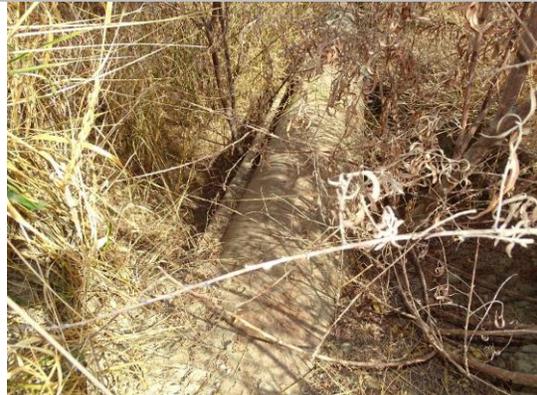
Photo 2 of 2 : UCIP_SP_2020_55686_82416.jpg

Electric conduit runs parallel toirrigation pipe along WS slope

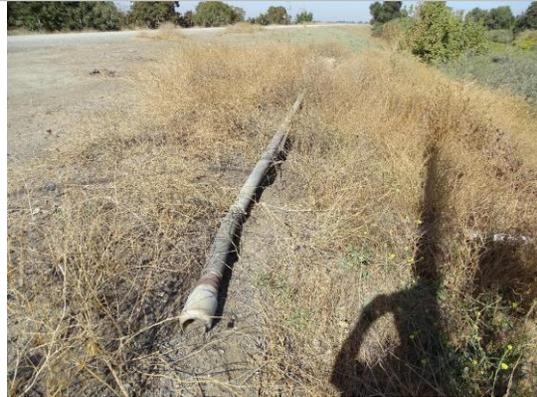
Photo 2 of 3 : UCIP_SP_2020_55687_82417.jpg

Disconnected 5-inch steel pipe on WS levee shoulder

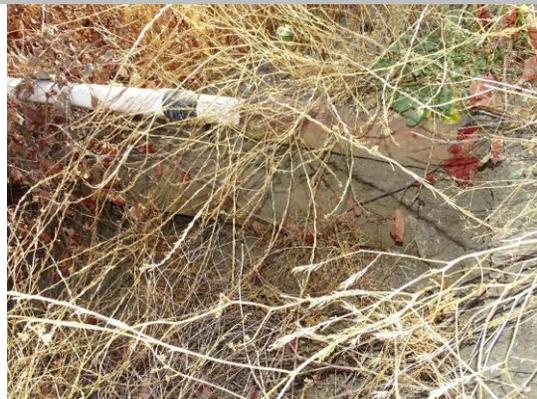
Photo 3 of 3 : UCIP_SP_2020_55687_83351.jpg

12-inch and 6-inch pipes visible

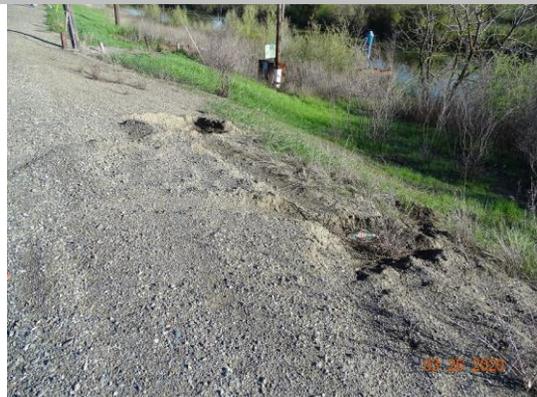
Photo 1 of 1 : SP_2020_NA0008_256_27_20200325_00047.jpg

LM Start	1.58	Rating **	M	Issue No.	27
LM End	1.58	Issue Type +	Ma	Location *	WS
Category	Earthen Levee			GPS Latitude/Longitude	
				Start	End
Item	Slope Stability			38.735245 °	38.735245 °
				-121.683928 °	-121.683928 °
DWR ID	DWR_NA0008_01_s_2020_27				
Comment Code					
S3 : Repair the levee slope damaged by vehicle traffic and prevent access where possible.					
Inspector Comment					
Ruts on the waterside slope.

View of tire ruts on the waterside shoulder. Spring 2020.

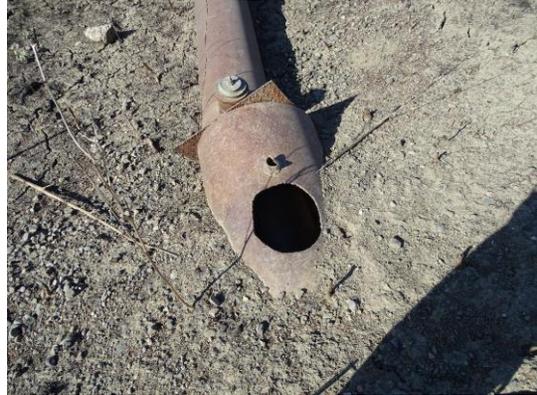
Photo 3 of 3 : UCIP_SP_2020_55692_82435.jpg

Siphon breaker and a cutout in 24-inch pipe at LS shoulder

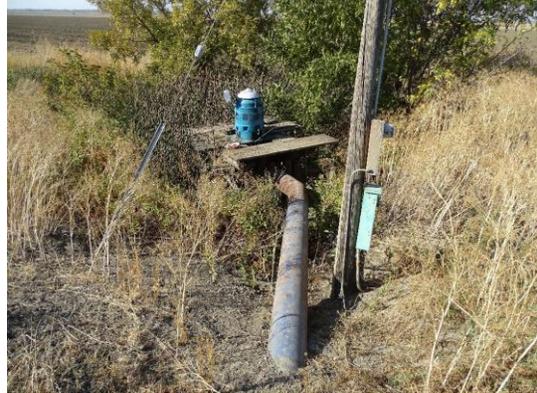
Photo 1 of 3 : UCIP_SP_2020_55698_82444.jpg

Comment Code					
Inspector Comment					
DS_ID:19364 FS_ID:55698 EP_NO: 9307 Repair Type: Non-Urgent Crossing Status: Found UCIP Comments: 0/08/2019 Record remains Non-Urgent, due to maintenance issue. Siphon breaker not found on LS slope: can be burried or broken off. Pipe outlet not found on WS. CVFPB is working with current owner to approve the removal and replacement of existing 14-inch pipe under draft Permit 9307-1. Work under permit 9307-1 not started. (O.Yakimov - DWR UCIP) 04/05/2013 Siphon breaker on LS burried or broken off and missing. (W.Wylie - DWR UCIP) FIELD_STRUCT_DESC: 14-inch steel drainage pipe through the levee, 5.4 feet below the crown. Pump house on a pile structure at the landside (LS) toe. Siphon breaker on the LS slope. Service pole and anchor at the LS toe. (14-inch pipe [HLM 2.62] authorized under Automatic Board Order (ABO) issued as Permit No. 9307, 1974 - Azalene E. Lowe; a 12-foot section of an existing 14-inch pipe on LS scheduled to be replaced and name change under DRAFT Permit No. 9307-1, 2016 - Ann Grube). [Additional Reference(s): DWR Levee Log, 1990. USACE Sacramento O&M Manual 127, June 1953, (Station 123+25)]. FS Date: 10/8/2019 8:30:25 AM

View of LS looking from levee crown

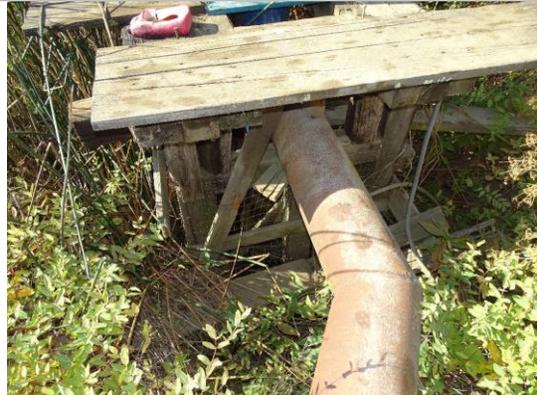
Photo 2 of 3 : UCIP_SP_2020_55698_82445.jpg

Pumping platform on pile structure

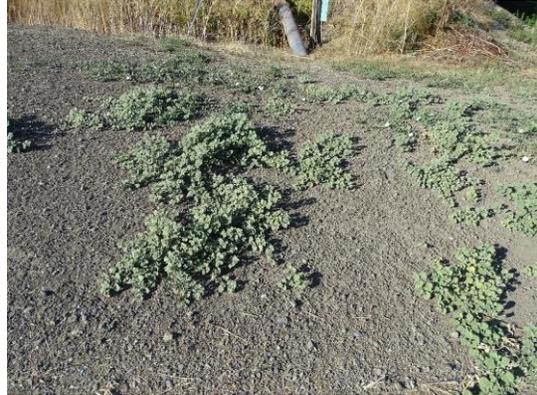
Photo 3 of 3 : UCIP_SP_2020_55698_82446.jpg

Not found siphon breaker on LS slope

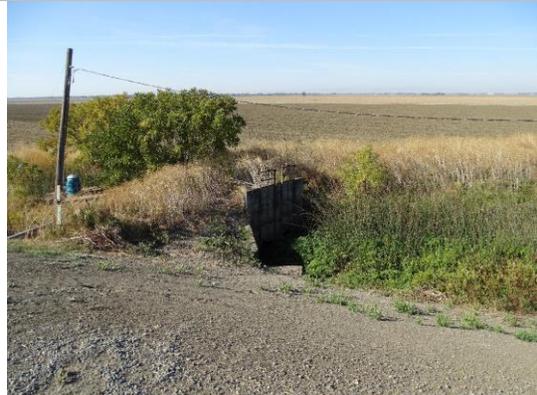
Photo 1 of 3 : UCIP_SP_2020_55708_82487.jpg

View of LS looking from levee crown

Comment Code					
Inspector Comment					
DS_ID:19391 FS_ID:55708 EP_NO: 9307 Repair Type: Non-Urgent Crossing Status: Found UCIP Comments: 10/8/2019 Record remains Non-Urgent. slide gate actuator is not accessible without use of equipment. Need to have CVFPB review ABO and determine current owner. (O.Yakimov - DWR UCIP) 04/05/2013 Walkway to actuator slide gate is missing. No method of actuating slide gate. (W.Wylie - DWR UCIP) FIELD_STRUCT_DESC: 48-inch by 48-inch reinforced concrete box drainage culvert through the levee, 23 feet below the crown. Walkway to slide gate on the waterside (WS) end. Concrete headwalls on both ends. Service pole and anchor at the landside (LS) toe. Concrete headwalls on both ends. (four foot by four foot culvert [HLM 2.62] authorized under Automatic Board Order (ABO) issued as Permit No. 9307, 1974 - Azalene E. Lowe). [Additional Reference(s): DWR Levee Log, 1990. USACE Sacramento O&M Manual 127, June 1953, (Station 123+55.5)]. FS Date: 10/8/2019 10:14:53 AM

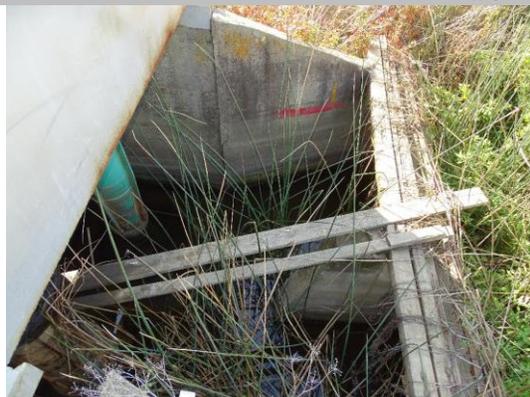
Photo 3 of 3 : UCIP_SP_2020_55711_82500.jpg

Concrete sump at pumping house

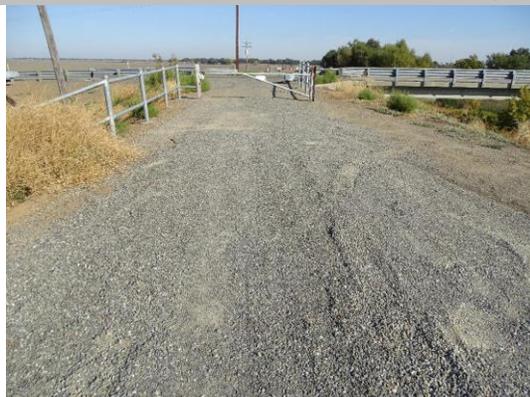
Photo 1 of 3 : UCIP_SP_2020_55712_82512.jpg

View of levee crown at the crossing

Comment Code					
Inspector Comment					
DS_ID:19392 FS_ID:55712 EP_NO: 9301 Repair Type: Non-Urgent Crossing Status: Found UCIP Comments: 10/8/2019 Record updated from No Action Needed to Non-Urgent. Need to have CVFPB review ABO and determine current owner. (O.Yakimov - DWR UCIP) FIELD_STRUCT_DESC: 2 of 2: 24-inch steel drainage pipe through the levee, 7.3 feet below the crown. Pump house mounted on concrete box in irrigation ditch at the landside (LS) toe. Siphon breaker in riser on the waterside (WS) slope. (one 24-inch and one 18-inch pipes [HLM 2.7] authorized under Automatic Board Order (ABO) issued as Permit No. 9301, 1974 - Reclamation District No. 730). [Additional Reference(s): DWR Levee Log, 1990. USACE Sacramento O&M Manual 127, June 1953, (Station 128+00)]. FS Date: 10/8/2019 1:07:27 PM

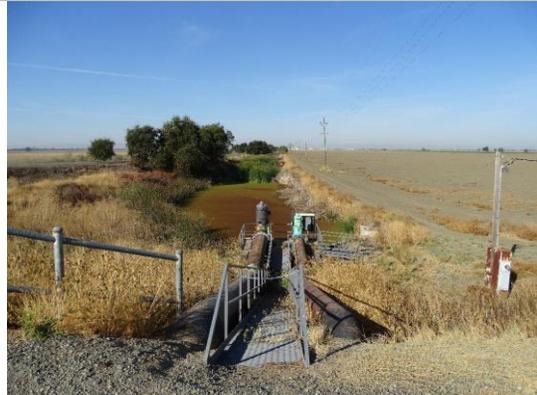
Photo 1 of 3 : UCIP_SP_2020_55722_82559.jpg

DS_ID:19395
 FS_ID:55722
 EP_NO: 8752
 Repair Type: Non-Urgent
 Crossing Status: Found
 UCIP Comments: 10/08/2019 Record has been updated from No Action Needed to Non-Urgent, signs of potential issues with levee. Top of concrete C-shaped headwall on LS berm is tilting towards the levee, cracks in concrete observed. Erosion around the headwall off LS levee toe. Although pipes don't seem to be leaning on the headwall, a sloughing may occur if headwall fails. Recommend closer observation of the crossing. (O.Yakimov - DWR UCIP)
 FIELD_STRUCT_DESC: 2 of 2: 24-inch steel drainage pipe through the levee, 3 feet below the crown. Siphon breaker on pipe on the waterside (WS) shoulder with a pump on a steel pile structure at the landside (LS) toe. Butterfly shutoff valve at the LS toe. (Permit No. 8752, 1973 - Reclamation District No. 730). Some design drawings available.
 [Additional Reference(s): DWR Levee Log, 1990. USACE Sacramento O&M Manual 127, June 1953, (Station 129+75), replaced in 1973 under PN 8752].

View of LS looking from levee crown

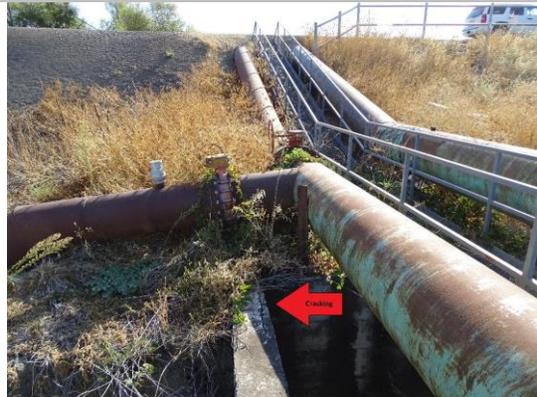
Photo 3 of 3 : UCIP_SP_2020_55722_82560.jpg

LS levee slope and pipe

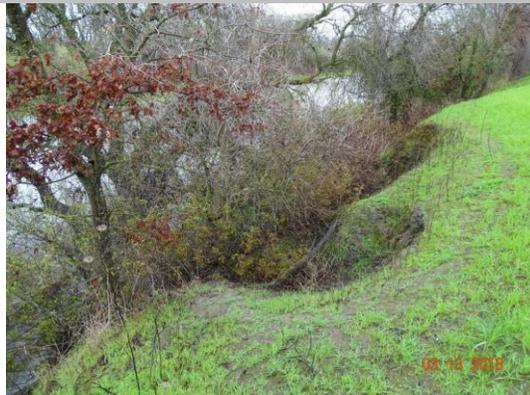
Photo 1 of 2 : SP_2020_NA0008_256_20_20200228_00005.jpg

LM Start	3.50	Rating **	M	Issue No.	20
LM End	3.50	Issue Type +	Ma	Location *	WS
Category	Earthen Levee		GPS Latitude/Longitude		
			Start	End	
Item	Erosion / Bank Caving		38.759910 °	38.759910 °	
			-121.696920 °	-121.696920 °	
DWR ID	DWR_NA0008_01_f_2015_20				
Comment Code					
E2 : Schedule repair of erosion site prior to the next inspection.					
Inspector Comment

View of erosion on the waterside slope. Spring 2018.

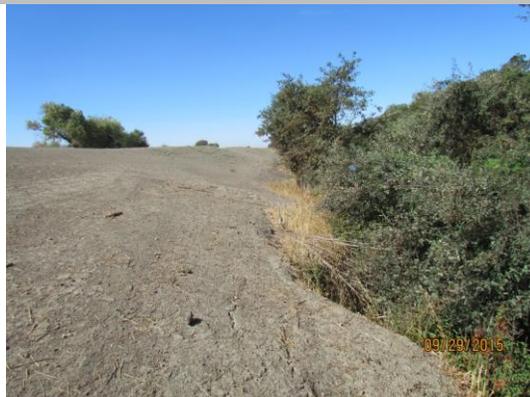
Photo 2 of 2 : SP_2020_NA0008_256_20_20200228_00006.jpg

View of the erosion on the waterward side of the levee looking upstream. Fall 2015.

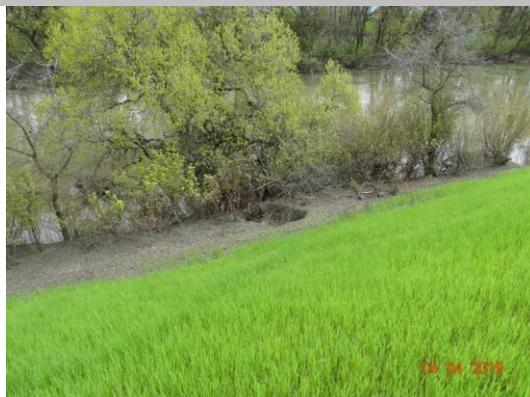
Photo 1 of 1 : SP_2020_NA0008_256_30_20200228_00009.jpg

LM Start	3.78	Rating **	M	Issue No.	30
LM End	3.78	Issue Type +	Ma	Location *	WS
Category	Earthen Levee		GPS Latitude/Longitude		
			Start	End	
Item	Erosion / Bank Caving		38.762886 °	38.762886 °	
			-121.700406 °	-121.700406 °	
DWR ID	DWR_NA0008_01_s_2017_30				
Comment Code					
E2 : Schedule repair of erosion site prior to the next inspection.					
Inspector Comment					
There is a hole from a fallen tree at the waterside toe.

View of hole at the waterside toe. Spring 2019.

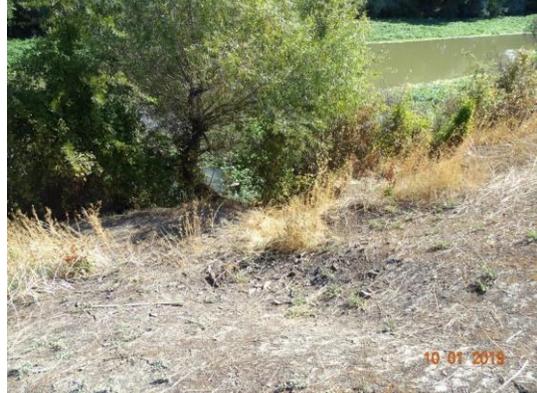
Photo 1 of 2 : SP_2020_NA0008_256_31_20200228_00010.jpg

View of the erosion at the waterside toe. Fall 2019.

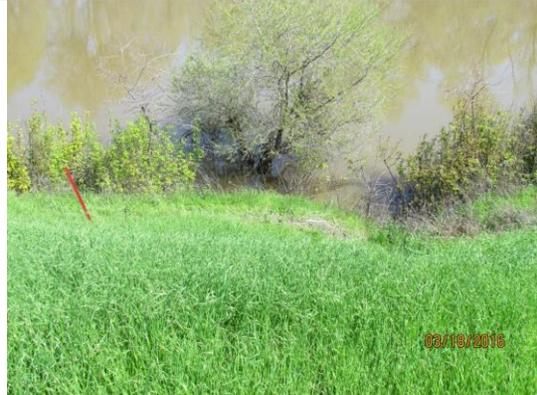
Photo 2 of 2 : SP_2020_NA0008_256_31_20200228_00011.jpg

View of the erosion at the toe of the levee on the waterward side. Spring 2016.

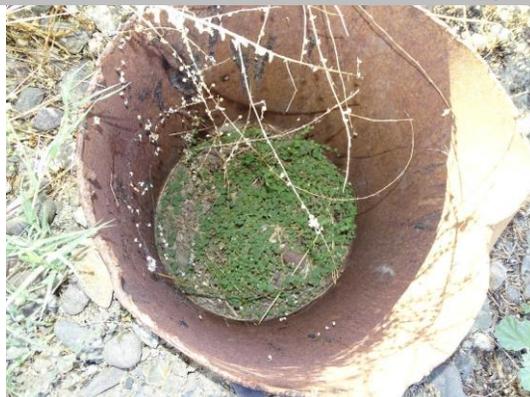
Photo 3 of 3 : UCIP_SP_2020_55745_82654.jpg

Siphon breaker in damaged 16-inch steel riser on LS shoulder

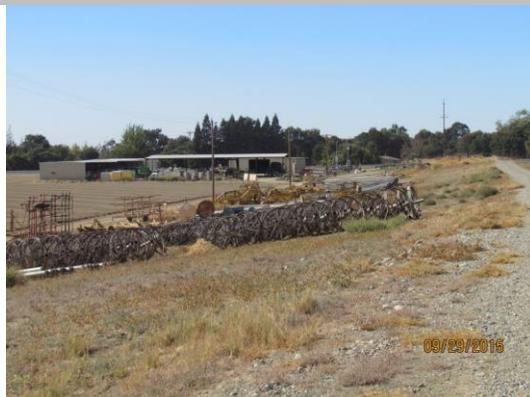
Photo 1 of 2 : SP_2020_NA0008_256_7_20200228_00001.jpg

LM Start	6.06	Rating **	M	Issue No.	7
LM End	6.34	Issue Type +	En	Location *	LS
Category	Earthen Levee			GPS Latitude/Longitude	
				Start	End
Item	Encroachments			38.789529 °	38.792433 °
				-121.722814 °	-121.726463 °
DWR ID	DWR_NA0008_01_f_2018_7				
Comment Code					
EQ : Equipment					
Inspector Comment					
Equipment and fence are on the landside slope of the levee.

View of the equipment on the landward side of the levee looking upstream. Fall 2015.

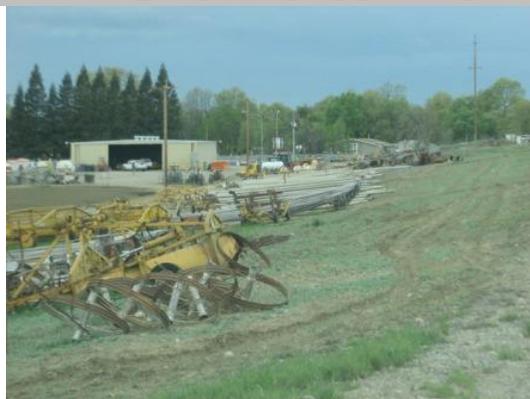
Photo 2 of 2 : SP_2020_NA0008_256_7_20200228_00002.jpg

A view of the equipment on the levee slope. Spring 2014

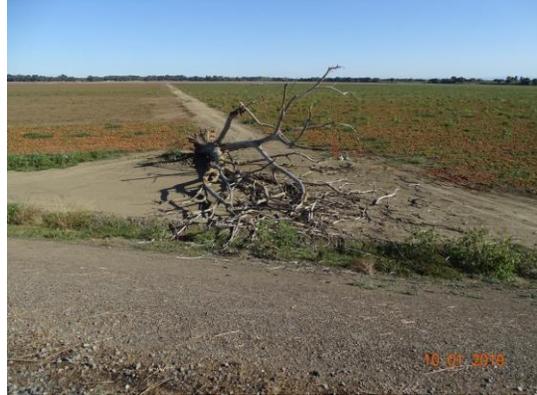
Photo 1 of 1 : SP_2020_NA0008_257_20_20200228_00007.jpg

View of the fallen tree at the landside toe. Fall 2019.

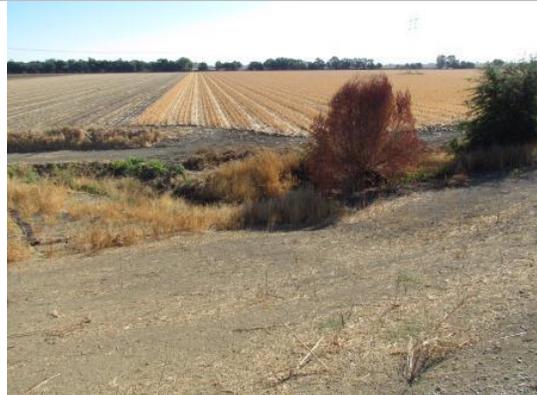
Photo 1 of 1 : SP_2020_NA0008_257_22_20200228_00008.jpg

View of a ditch near landside toe. Fall 2016.

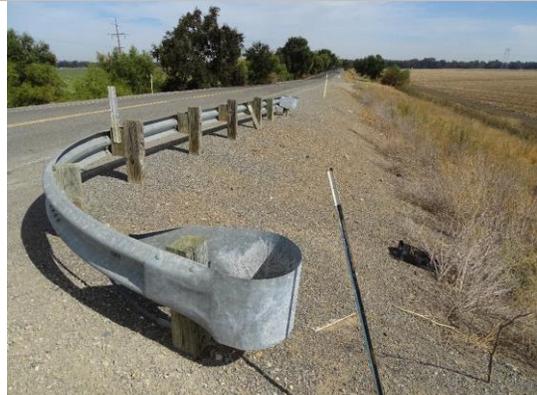
Photo 1 of 2 : UCIP_SP_2020_55764_82753.jpg

South shoulder of Co Rd 16 with gas line marker installed

Comment Code					
Inspector Comment					
DS_ID:19386 FS_ID:55764 EP_NO: 13164 Repair Type: Non-Urgent Crossing Status: Indicator Found UCIP Comments: 10/08/2019 Record remains Non-Urgent. No inspection records were available to determine status of line through the levee. (O.Yakimov - DWR UCIP) 09/16/2018 Crossing marker on levee Unit 02 is missing. Having a marker on County Road 16 shoulder is not enough to find exact crossing location on levee. Crossing has been downgraded to "Non-Urgent" due to reclassification of gas lines. (O.Yakimov - DWR UCIP)09/01/2016 - Markers present on the edges of Road 16. Alignment indicated by markers shows parallel alignment to the levee. Permit indicates pipe crosses levee and therefore should have markers indicating where it crosses the levee. (T. Hatch/UCIP)04/08/2013 - Need to have pipe located and marked properly if still in use. (W. Wylie/UCIP) FIELD_STRUCT_DESC: 4-inch steel natural gas collection pipe through the levee, 3.2 feet below the crown. Permit indicates that the pipe was installed on the northern shoulder of Road 16 and crosses the Knights Landing Ridge Cut on the northern side of the Road 16 bridge. (4-inch gas line authorized under Permit No. 13164, 1981 - Shell Oil Company). FS Date: 10/8/2019 2:37:40 PM

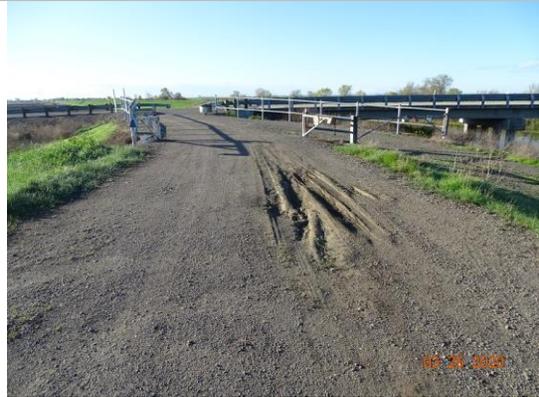
Photo 1 of 1 : SP_2020_NA0008_257_28_20200325_00046.jpg

View of tire ruts on the crown. Spring 2020.

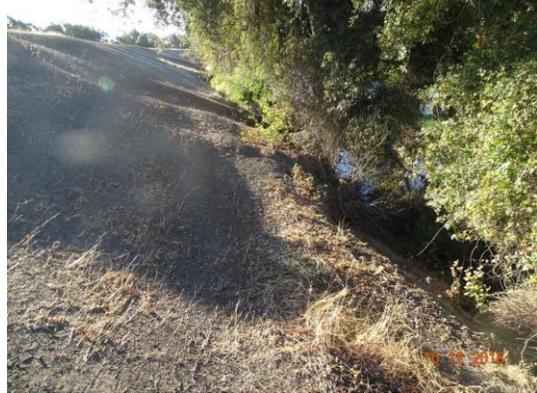
Photo 1 of 2 : SP_2020_NA0008_257_9_20200228_00003.jpg

View of the erosion on the waterside slope. Fall 2018.

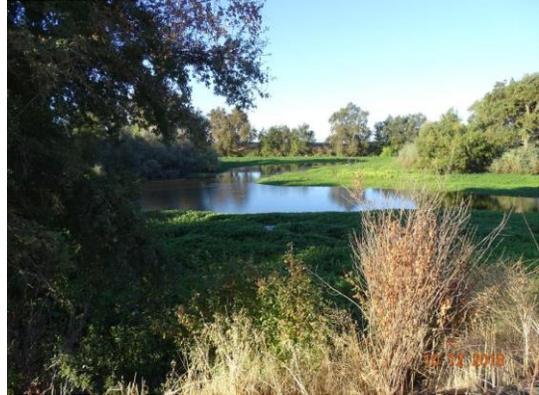
Photo 2 of 2 : SP_2020_NA0008_257_9_20200228_00004.jpg

View of the opening within the center channel. Fall 2018.

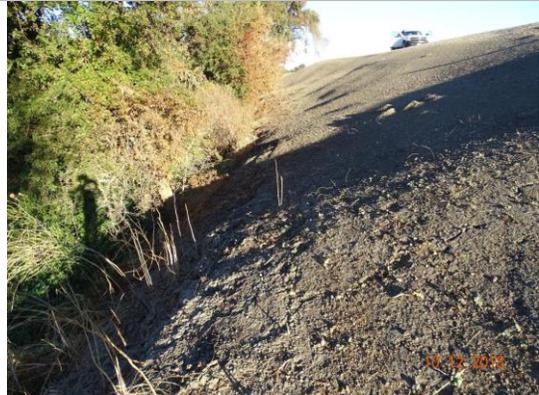
Photo 1 of 2 : SP_2020_NA0008_257_14_20200228_00005.jpg

View of erosion on the waterside slope. Fall 2018.

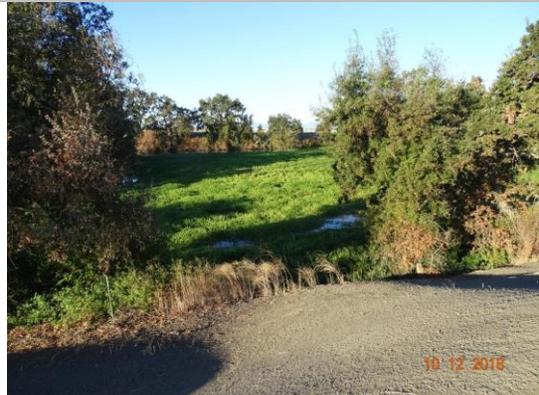
Photo 2 of 2 : SP_2020_NA0008_257_14_20200228_00006.jpg

View of the opening within the main channel, facing upstream. Fall 2018.

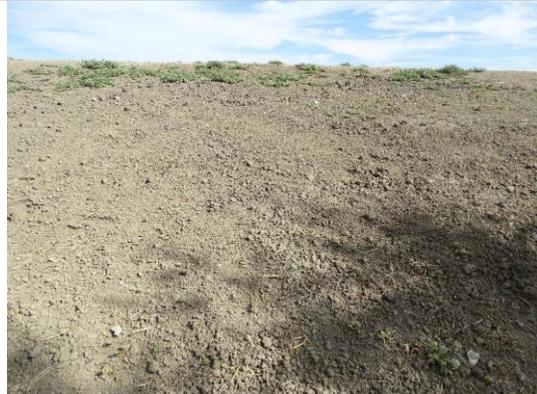
Photo 1 of 3 : UCIP_SP_2020_55774_82795.jpg

Signs of soil disturbed on WS levee slope

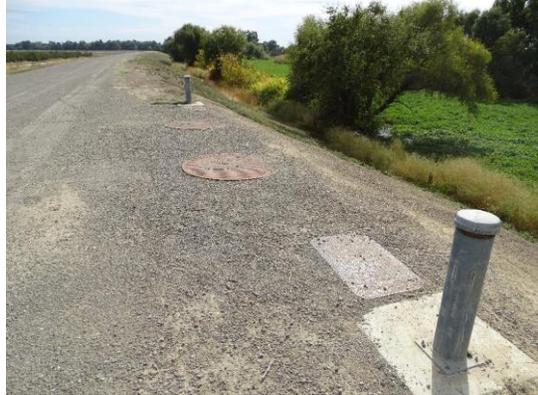
Photo 2 of 3 : UCIP_SP_2020_54351_82678.jpg

Siphon breaker and positive closure device on WS shoulder

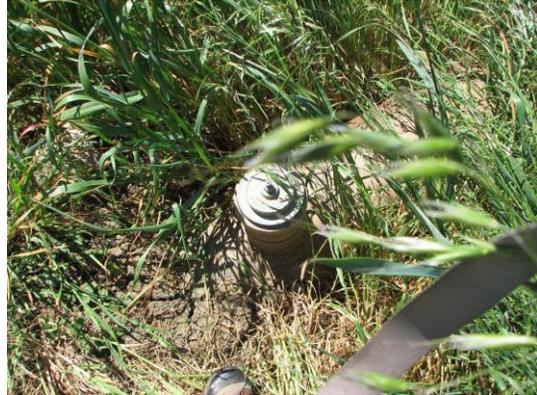
Photo 3 of 3 : UCIP_SP_2020_11293_18673.jpg

16-inch pipe with siphon breaker on WS shoulder.

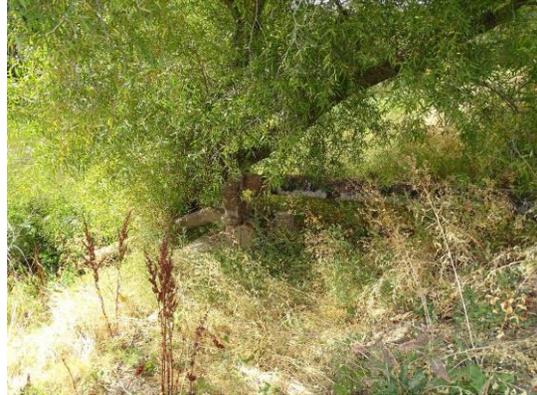
Photo 3 of 3 : UCIP_SP_2020_55779_82814.jpg

Abandoned pump on WS slope

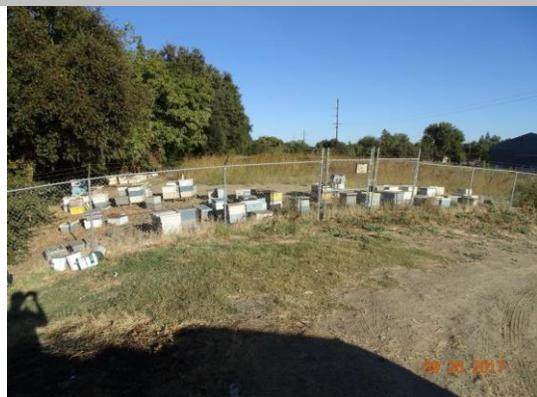
Photo 1 of 2 : SP_2020_NA0008_257_1_20200228_00001.jpg

View of the fence on the crown. Fall 2017.
