**Flood Control Project Maintenance
Levee Inspections**

Maintenance Issue Types Only, Levee Inspection Report By Mile - Spring 2020

Knights Landing Ridge Drainage District

Waterway	Bank	Unit Miles	Inspection Start/End	Inspector
Unit No. 01 Knights Landing Ridge Cut	Right	6.36	03/25/2020 03/25/2020	Zach Jojola

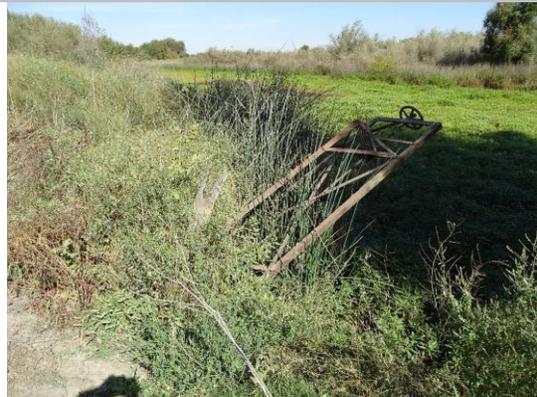
Photo 3 of 3 : UCIP_SP_2020_55381_81601.jpg

Slide gate on metal stand on WS toe needs removal

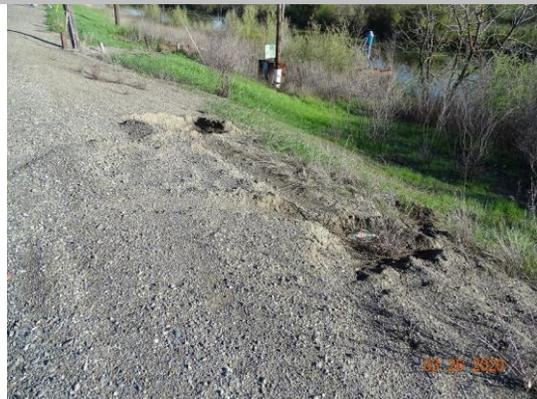
Photo 1 of 1 : SP_2020_NA0008_256_27_20200325_00047.jpg

LM Start	1.58	Rating **	M	Issue No.	27
LM End	1.58	Issue Type +	Ma	Location *	WS
Category	Earthen Levee		GPS Latitude/Longitude		
			Start	End	
Item	Slope Stability		38.735245 °	38.735245 °	
			-121.683928 °	-121.683928 °	
DWR ID	DWR_NA0008_01_s_2020_27				
Comment Code					
S3 : Repair the levee slope damaged by vehicle traffic and prevent access where possible.					
Inspector Comment					
Ruts on the waterside slope.

View of tire ruts on the waterside shoulder. Spring 2020.

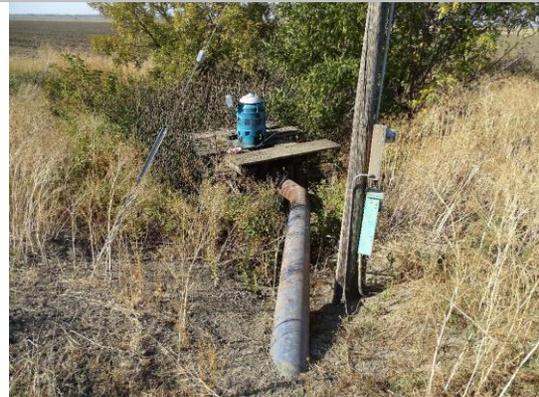
Photo 1 of 3 : UCIP_SP_2020_55698_82444.jpg

Comment Code					
Inspector Comment					
DS_ID:19364 FS_ID:55698 EP_NO: 9307 Repair Type: Non-Urgent Crossing Status: Found UCIP Comments: 0/08/2019 Record remains Non-Urgent, due to maintenance issue. Siphon breaker not found on LS slope: can be buried or broken off. Pipe outlet not found on WS. CVFPB is working with current owner to approve the removal and replacement of existing 14-inch pipe under draft Permit 9307-1. Work under permit 9307-1 not started. (O.Yakimov - DWR UCIP) 04/05/2013 Siphon breaker on LS buried or broken off and missing. (W.Wylie - DWR UCIP) FIELD_STRUCT_DESC: 14-inch steel drainage pipe through the levee, 5.4 feet below the crown. Pump house on a pile structure at the landside (LS) toe. Siphon breaker on the LS slope. Service pole and anchor at the LS toe. (14-inch pipe [HLM 2.62] authorized under Automatic Board Order (ABO) issued as Permit No. 9307, 1974 - Azalene E. Lowe; a 12-foot section of an existing 14-inch pipe on LS scheduled to be replaced and name change under DRAFT Permit No. 9307-1, 2016 - Ann Grube). [Additional Reference(s): DWR Levee Log, 1990. USACE Sacramento O&M Manual 127, June 1953, (Station 123+25)]. FS Date: 10/8/2019 8:30:25 AM

View of LS looking from levee crown

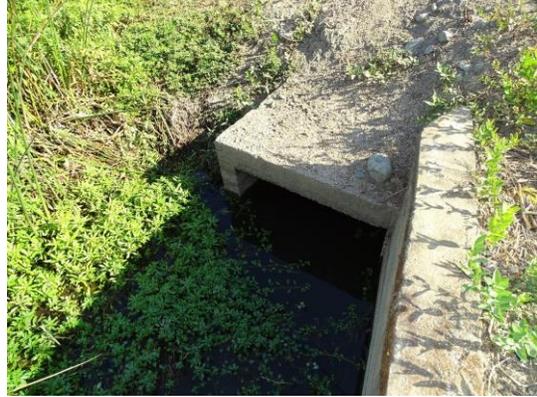
Photo 3 of 3 : UCIP_SP_2020_55708_82486.jpg

Inlet of 48 x 48 inch concrete culvert. View from LS

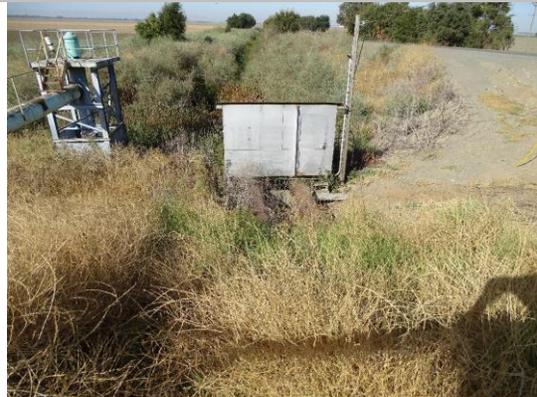
Photo 1 of 3 : UCIP_SP_2020_55711_82498.jpg

View of LS looking from levee crown

Comment Code					
Inspector Comment					
DS_ID:19365 FS_ID:55711 EP_NO: 9301 Repair Type: Non-Urgent Crossing Status: Found UCIP Comments: 10/8/2019 Record updated from No Action Needed to Non-Urgent. Need to have CVFPB review ABO and determine current owner. (O.Yakimov - DWR UCIP) FIELD_STRUCT_DESC: 1 of 2: 18-inch steel drainage pipe through the levee, 6.4 feet below the crown. Siphon breaker on the waterside (WS) slope. Pump house mounted on concrete box in irrigation ditch at the landside (LS) toe. (one 18-inch and one 24-inch pipes [HLM 2.7] authorized under Automatic Board Order (ABO) issued as Permit No. 9301, 1974 - Reclamation District No. 730). [Additional Reference(s): DWR Levee Log, 1990. USACE Sacramento O&M Manual 127, June 1953, (Station 128+00)]. FS Date: 10/8/2019 12:58:01 PM

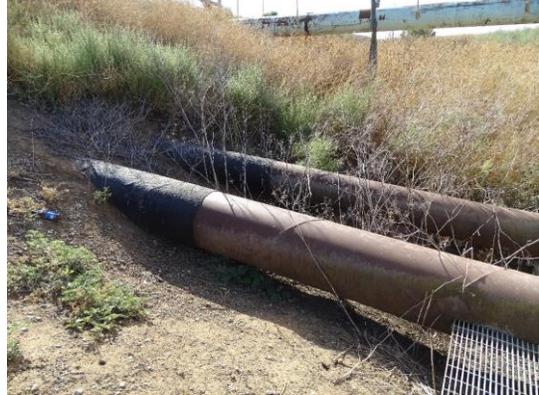
Photo 2 of 3 : UCIP_SP_2020_55711_82499.jpg

View of pipe on WS slope

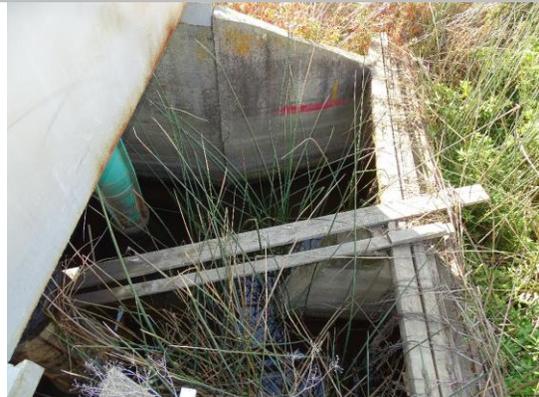
Photo 3 of 3 : UCIP_SP_2020_55711_82500.jpg

Concrete sump at pumping house

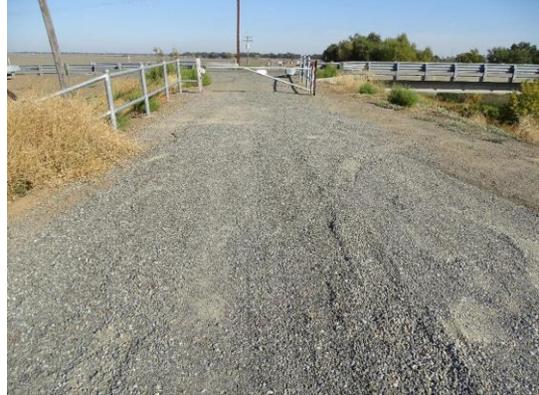
Photo 1 of 3 : UCIP_SP_2020_55712_82512.jpg

Comment Code					
Inspector Comment					
DS_ID:19392 FS_ID:55712 EP_NO: 9301 Repair Type: Non-Urgent Crossing Status: Found UCIP Comments: 10/8/2019 Record updated from No Action Needed to Non-Urgent. Need to have CVFPB review ABO and determine current owner. (O.Yakimov - DWR UCIP) FIELD_STRUCT_DESC: 2 of 2: 24-inch steel drainage pipe through the levee, 7.3 feet below the crown. Pump house mounted on concrete box in irrigation ditch at the landside (LS) toe. Siphon breaker in riser on the waterside (WS) slope. (one 24-inch and one 18-inch pipes [HLM 2.7] authorized under Automatic Board Order (ABO) issued as Permit No. 9301, 1974 - Reclamation District No. 730). [Additional Reference(s): DWR Levee Log, 1990. USACE Sacramento O&M Manual 127, June 1953, (Station 128+00)]. FS Date: 10/8/2019 1:07:27 PM

View of levee crown at the crossing

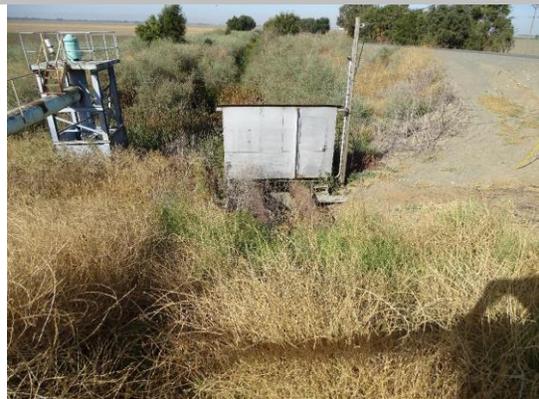
Photo 2 of 3 : UCIP_SP_2020_55712_82514.jpg

Pumphouse and pipe on LS toe

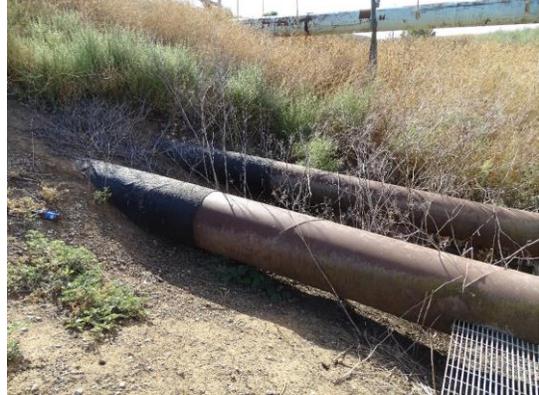
Photo 3 of 3 : UCIP_SP_2020_55712_82515.jpg

View of pipe on WS slope

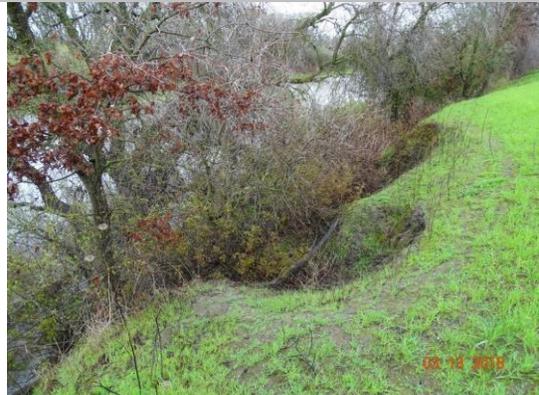
Photo 1 of 2 : SP_2020_NA0008_256_20_20200228_00005.jpg

LM Start	3.50	Rating **	M	Issue No.	20
LM End	3.50	Issue Type +	Ma	Location *	WS
Category	Earthen Levee			GPS Latitude/Longitude	
				Start	End
Item	Erosion / Bank Caving			38.759910 °	38.759910 °
				-121.696920 °	-121.696920 °
DWR ID	DWR_NA0008_01_f_2015_20				
Comment Code					
E2 : Schedule repair of erosion site prior to the next inspection.					
Inspector Comment

View of erosion on the waterside slope. Spring 2018.

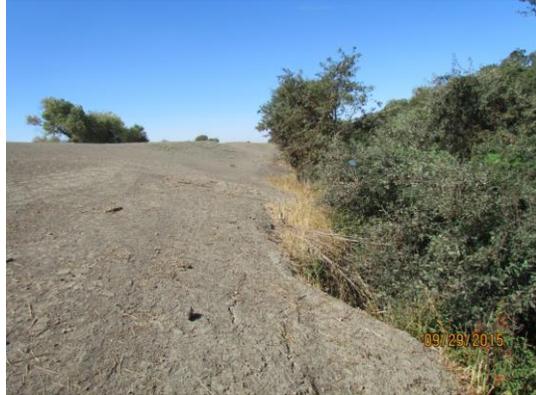
Photo 2 of 2 : SP_2020_NA0008_256_20_20200228_00006.jpg

View of the erosion on the waterward side of the levee looking upstream. Fall 2015.

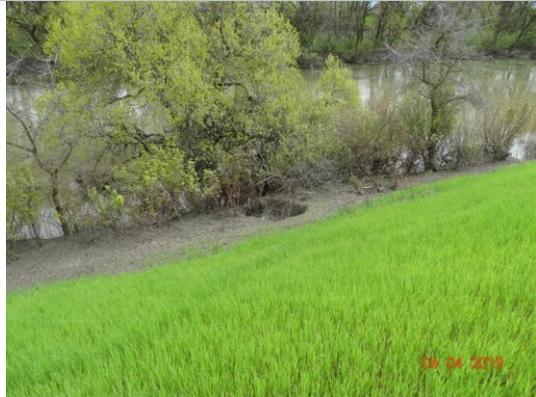
Photo 1 of 1 : SP_2020_NA0008_256_30_20200228_00009.jpg

LM Start	3.78	Rating **	M	Issue No.	30
LM End	3.78	Issue Type +	Ma	Location *	WS
Category	Earthen Levee		GPS Latitude/Longitude		
			Start	End	
Item	Erosion / Bank Caving		38.762886 °	38.762886 °	
			-121.700406 °	-121.700406 °	
DWR ID	DWR_NA0008_01_s_2017_30				
Comment Code					
E2 : Schedule repair of erosion site prior to the next inspection.					
Inspector Comment					
There is a hole from a fallen tree at the waterside toe.

View of hole at the waterside toe. Spring 2019.

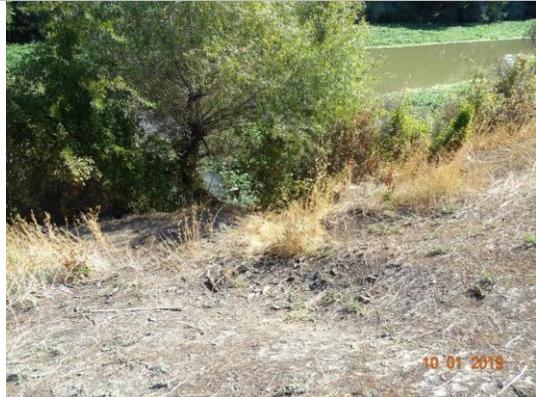
Photo 1 of 2 : SP_2020_NA0008_256_31_20200228_00010.jpg

LM Start	3.86	Rating **	A/W	Issue No.	31
LM End	3.86	Issue Type +	Ma	Location *	WS
Category	Earthen Levee		GPS Latitude/Longitude		
			Start	End	
Item	Erosion / Bank Caving		38.763751 °	38.763751 °	
			-121.701398 °	-121.701398 °	
DWR ID	DWR_NA0008_01_s_2018_31				
Comment Code					
E1 : Note and monitor erosion site.					
Inspector Comment					
The erosion appears to be stable. LMA continues to monitor.

View of the erosion at the waterside toe. Fall 2019.

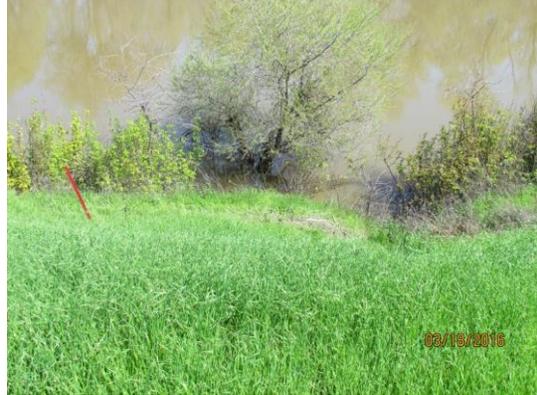
Photo 2 of 2 : SP_2020_NA0008_256_31_20200228_00011.jpg

View of the erosion at the toe of the levee on the waterward side. Spring 2016.

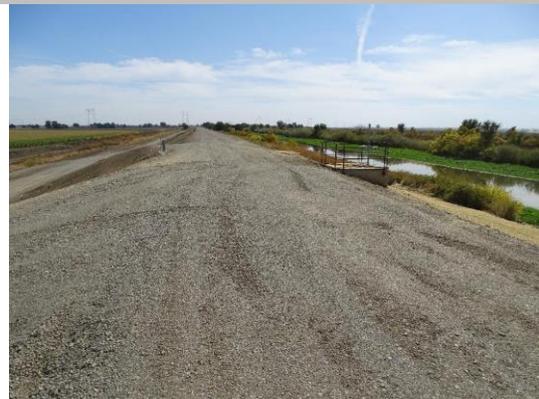
Photo 1 of 3 : UCIP_SP_2020_55761_82744.jpg

Comment Code					
Inspector Comment					
DS_ID:19399 FS_ID:55761 EP_NO: 9320 Repair Type: Non-Urgent Crossing Status: Found UCIP Comments: 10/08/2019 Record updated from No Action Needed to Non-Urgent. Pipe through levee has been replaced as part of the Knights Landing 2015 Levee Repair Project. A concrete box with slide gate was constructed on WS shoulder, a concrete pad with electrical wiring installed at LS toe, pipe inlet on LS is modified and revetted. New flap gate at WS end. Need to have CVFPB review ABO and determine current owner. Encroachment permit is missing. No details provided from Levee Improvement Project. (O.Yakimov - DWR UCIP) FIELD_STRUCT_DESC: *REMOVED & REPLACED with DSID 25597* 24-inch steel drainage pipe through the levee, 21 feet below the crown. Slide gate on the waterside (WS) end. Open on the landside (LS) end. LS toe cobble revetted. Service pole on the LS slope. (24-inch pipe [HLM 1.9] authorized under Automatic Board Order (ABO) issued as Permit No. 9320, 1974 - Ralph W. Pollock). [Additional Reference(s): DWR Levee Log, 1990. USACE Sacramento O&M Manual 127, June 1953, (Station 103+21.8)]. FS Date: 10/8/2019 2:13:30 PM

View of levee crown at the crossing

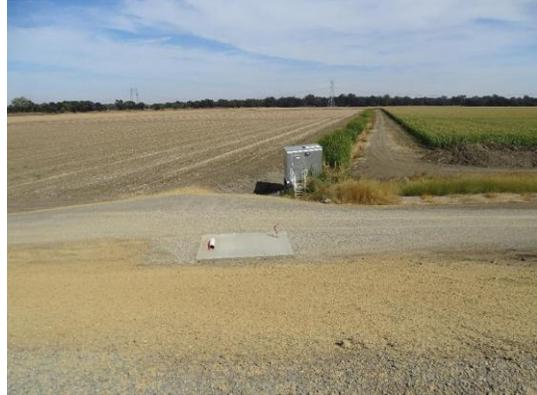
Photo 2 of 3 : UCIP_SP_2020_55761_82749.jpg

View of LS looking from levee crown

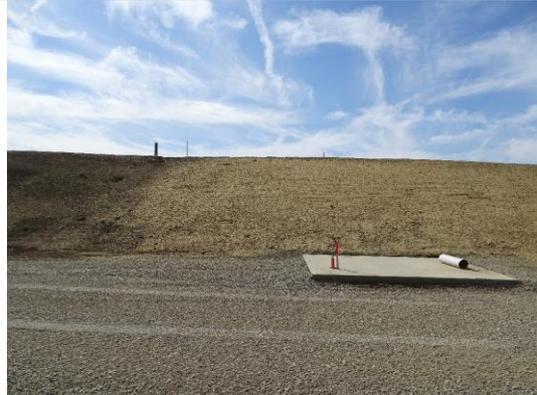
Photo 3 of 3 : UCIP_SP_2020_55761_82746.jpg

Concrete pad with electrical wiring at LS levee toe

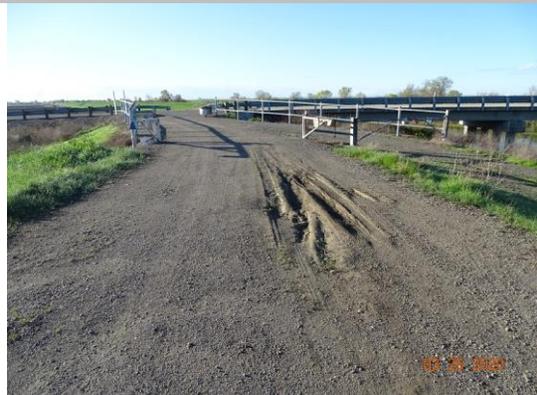
Photo 1 of 1 : SP_2020_NA0008_257_28_20200325_00046.jpg

LM Start	2.30	Rating **	M	Issue No.	28
LM End	2.30	Issue Type +	Ma	Location *	CR
Category	Earthen Levee			GPS Latitude/Longitude	
				Start	End
Item	Crown Surface / Depressions / Rutting			38.748862 °	38.748862 °
				-121.692804 °	-121.692804 °
DWR ID	DWR_NA0008_02_s_2020_28				
Comment Code					
C2 : Repair depressions or ruts in the crown or slope.					
Inspector Comment					
Tire ruts on the crown.

View of tire ruts on the crown. Spring 2020.

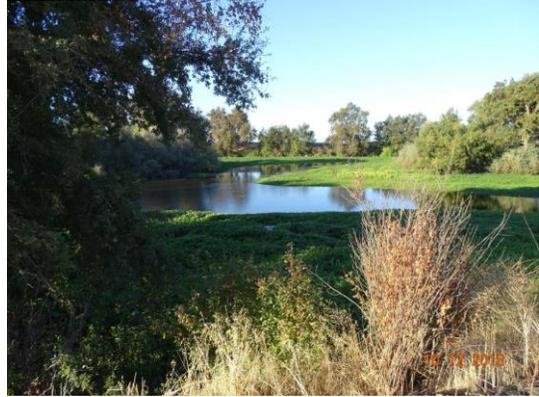
Photo 2 of 2 : SP_2020_NA0008_257_9_20200228_00004.jpg

View of the opening within the center channel. Fall 2018.

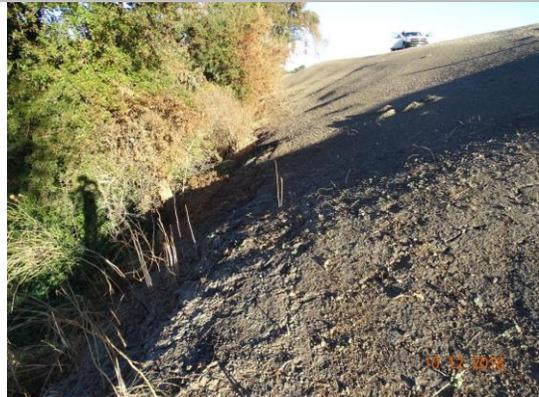
Photo 1 of 2 : SP_2020_NA0008_257_14_20200228_00005.jpg

View of erosion on the waterside slope. Fall 2018.

Inspector Comment
The primary channel changes course throughout the water year and erodes the slope through an opening in the center barrier. The slope appears to be stable and erosion is not within the prism. The levee is further reinforced by the newly constructed berm on the land side. Recommend monitoring.

Comment Code
E1 : Note and monitor erosion site.

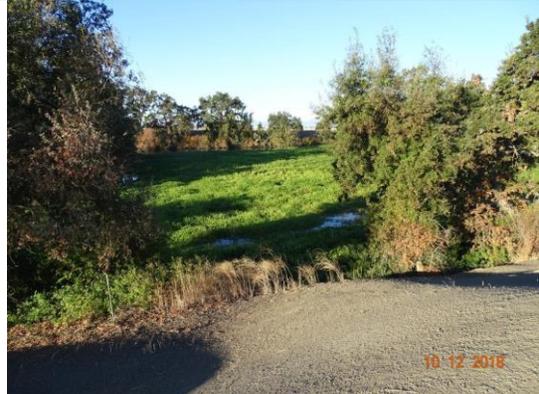
Photo 2 of 2 : SP_2020_NA0008_257_14_20200228_00006.jpg

View of the opening within the main channel, facing upstream. Fall 2018.

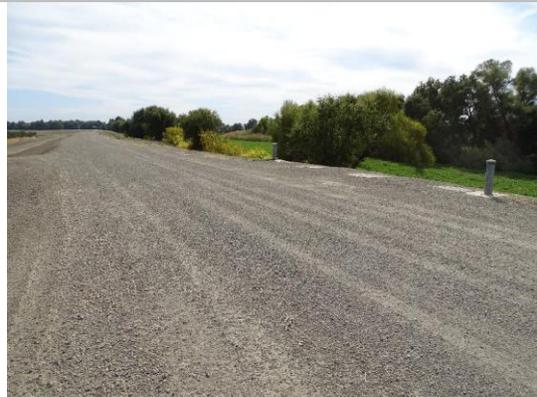
Photo 1 of 3 : UCIP_SP_2020_54351_82677.jpg

View of levee crown at the crossing

Comment Code					
Inspector Comment					
DS_ID:25572 FS_ID:54351 EP_NO: N/A Repair Type: No Action Needed Crossing Status: Found UCIP Comments: 10/08/2019 No issues recorded during inspection (O.Yakimov - DWR UCIP) FIELD_STRUCT_DESC: 24-inch steel discharge pipe through the levee, 6.5-feet below the crown. Pump house on pile structure in drainage ditch on the landward side. Siphon breaker and positive closure device butterfly valve with handwheel operator on the pipe on the waterward side. Pipe replaces a section of pipe through the levee butt welded to the original pipe approximately 37-feet from levee centerline on both levee slopes. Service pole on pump house. (Permit No. 9317-1, applicant - RD730, issued 07/10/2014 gives authorization of emergency removal and replacement of the pipe in September 2012.) FS Date: 10/8/2019

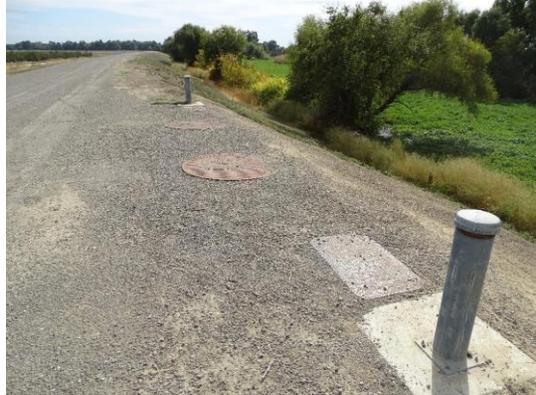
Photo 2 of 3 : UCIP_SP_2020_54351_82678.jpg

Siphon breaker and positive closure device on WS shoulder

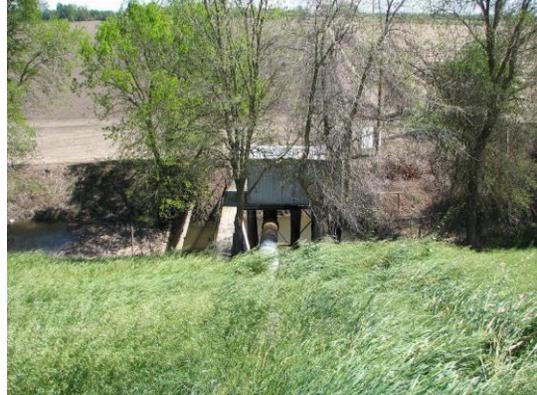
Photo 1 of 3 : UCIP_SP_2020_11293_18675.jpg

Comment Code					
Inspector Comment					
DS_ID:19374 FS_ID:11293 EP_NO: 9317 Repair Type: No Action Needed Crossing Status: Found UCIP Comments: 01/14/2019 Pipe has been replaved with a 16-inch pipe under permit 9317-1; new DS-ID 25571. (O.Yakimov - DWR UCIP) FIELD_STRUCT_DESC: *REMOVED* 1 of 2: 16-inch steel discharge pipe through the levee, 3 feet below the crown. Pump house on pile structure in drainage ditch on the landside (LS). Siphon breaker on the pipe on the waterside (WS). Service pole at the pump house. (16-inch pipe [HLM 3.97] authorized under Automatic Board Order (ABO) issued as Permit No. 9317, 1974 - Reclamation District No. 819). [Additional Reference(s): DWR Levee Log, 1990. USACE Sacramento O&M Manual 127, June 1953, (Station 211+05) (15-inch pipe listed)]. FS Date: 4/9/2013

Pump on LS toe.

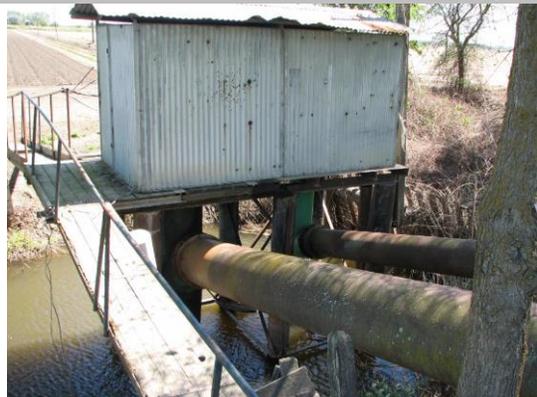
Photo 2 of 3 : UCIP_SP_2020_11293_18674.jpg

Pump and pipes on LS toe.

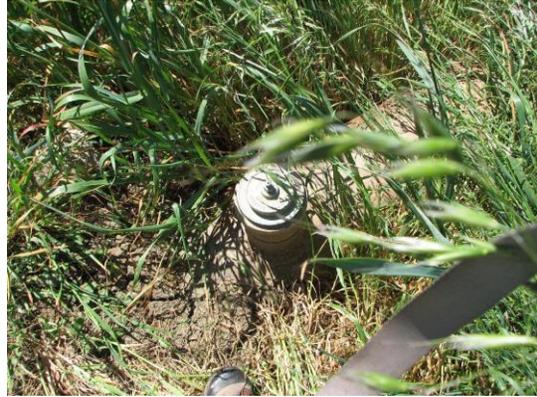
Photo 3 of 3 : UCIP_SP_2020_11293_18673.jpg

16-inch pipe with siphon breaker on WS shoulder.

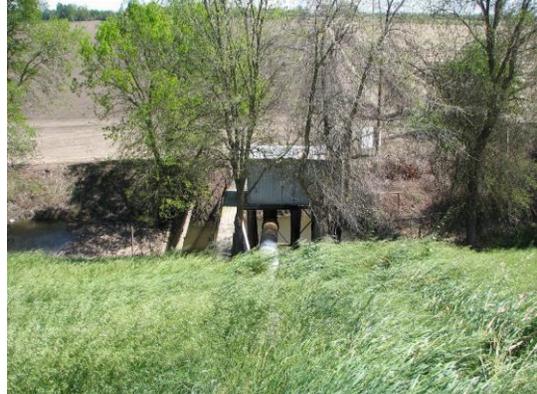
Photo 1 of 3 : UCIP_SP_2020_11291_18669.jpg

Pumphouse at LS toe.

Comment Code					
Inspector Comment					
DS_ID:19401 FS_ID:11291 EP_NO: 9317 Repair Type: No Action Needed Crossing Status: Found UCIP Comments: 01/14/2019 Pipe was removed replaced with a new 24-inch pipe through the levee. Permit 9317-1 issues authorization of emergency removal and replacement of the pipe in September 2012. New DS-ID 25572. (O.Yakimov - DWR UCIP) FIELD_STRUCT_DESC: *REMOVED* 2 of 2: 24-inch steel discharge pipe through the levee, 9 feet below the crown. Pump house on pile structure in drainage ditch on the landside (LS). Siphon breaker on the pipe on the waterside (WS) with a butterfly shutoff valve. Service pole at the pump house. (Permit No. 9317, 1974 - Reclamation District No. 819). Pipe replaced in 2012. [Additional Reference(s): DWR Levee Log, 1990. USACE Sacramento O&M Manual 127, June 1953, (Station 210+99)]. FS Date: 4/9/2013
