**Flood Control Project Maintenance
Levee Inspections**

Maintenance Issue Types Only, Levee Inspection Report By Mile - Fall 2019

Lake County Watershed Protection District

Waterway	Bank	Unit Miles	Inspection Start/End	Inspector
Unit No. 01 Middle Creek	Left	3.35	10/16/2019 10/16/2019	Luz Dial

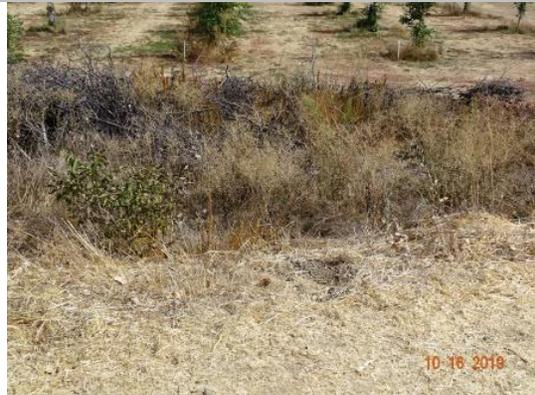
Photo 1 of 1 : FA_2019_NA0009_3_25_20191022_00041.jpg

View of rodent holes on the landside slope. Fall 2019

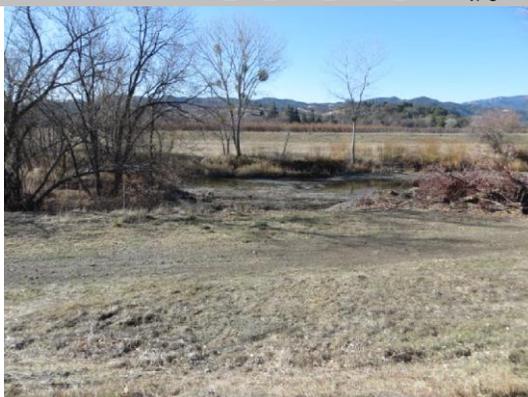
Photo 3 of 3 : UCIP_FA_2019_55702_49851.jpg

Comment Code					
Inspector Comment					
DS_ID:21240 FS_ID:55702 EP_NO: 11460 Repair Type: Non-Urgent Crossing Status: Found UCIP Comments: 10/16/2019 Record has been updated from No Action Needed to Non-Urgent; need to audit record to confirm owner. Crossing has been internally inspected under the DWR DMP Phase 1 project. Inspection report is still not available. The UCIP inspection was completed with DWR Inspector, L. Dial, and LMA representative, S. Webb. (O. Magana - DWR UCIP) FIELD_STRUCT_DESC: 1 of 2: 36-inch corrugated metal drainage pipe through the levee, 9 feet below the crown. Flap gate on the waterside (WS) end. Concrete headwalls on both ends. (two 36-inch pipes [HLM 2.26] retained under Automatic Board Order (ABO) issued as Permit No. 11460, 1975 - Robert L. and Lavona Gentry). [Additional Reference(s): DWR Levee Log, 2005. USACE Sacramento O&M Manual 506.2, August 1961, (HLM 2.26), Station M206+00, two 36-inch pipes, dwg no. CC-4-4-29, Index Sheet 4: page 4, 38 of 64]. FS Date: 10/16/2019 3:56:00 PM

Pipe, Concrete headwall, and flap gate visible on WS berm.

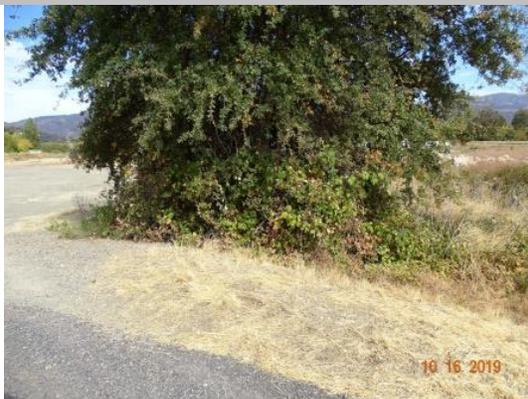
Photo 1 of 1 : FA_2019_NA0009_3_46_20191022_00042.jpg

LM Start	2.26	Rating **	M	Issue No.	46
LM End	2.40	Issue Type +	Ma	Location *	LS
Category	Earthen Levee			GPS Latitude/Longitude	
				Start	End
Item	Vegetation			39.160325 °	39.161655 °
				-122.913980 °	-122.912262 °
DWR ID	DWR_NA0009_01_s_ 2019_46				
Comment Code					
V2 : Remove the wild growth other than native grasses from the levee slopes.					
Inspector Comment

View of wild growth on the landside slope. Fall 2019

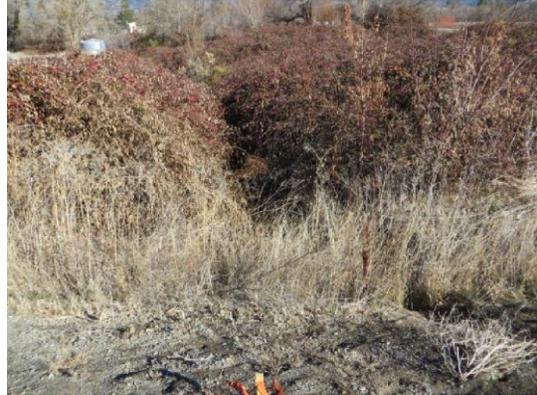
Photo 1 of 3 : UCIP_FA_2019_55703_49849.jpg

Comment Code					
Inspector Comment					
DS_ID:21197 FS_ID:55703 EP_NO: 11460 Repair Type: Non-Urgent Crossing Status: Found UCIP Comments: 10/16/2019 Record has been updated from No Action Needed to Non-Urgent; need to audit record to confirm owner. Crossing has been internally inspected under the DWR DMP Phase 1 project. Inspection report is still not available. The UCIP inspection was completed with DWR Inspector, L. Dial, and LMA representative, S. Webb. (O. Magana - DWR UCIP) FIELD_STRUCT_DESC: 2 of 2: 36-inch corrugated metal drainage pipe through the levee, 9 feet below the crown. Flap gate on the waterside (WS) end. Concrete U-shaped headwalls on both ends. (two 36-inch pipes [HLM 2.26] retained under Automatic Board Order (ABO) issued as Permit No. 11460, 1975 - Robert L. and Lavona Gentry). [Additional Reference(s): DWR Levee Log, 2005. USACE Sacramento O&M Manual 506.2, August 1961, (HLM 2.26), Station M206+00, two 36-inch pipes, dwg no. CC-4-4-29, Index Sheet 4: page 4, 38 of 64]. FS Date: 10/16/2019 3:59:00 PM

Concrete headwall and pipe visible on LS toe at end of drainage swale.

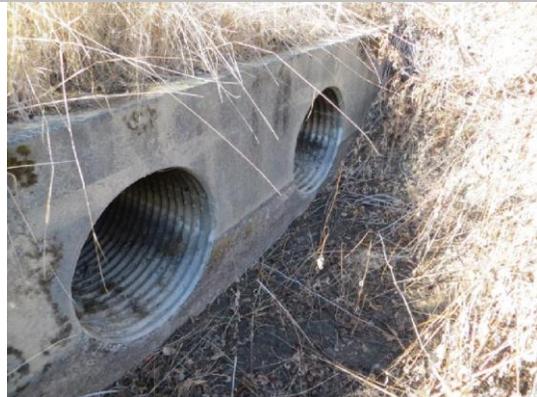
Photo 2 of 3 : UCIP_FA_2019_55703_49848.jpg

Concrete headwall and pipe visible on LS toe.

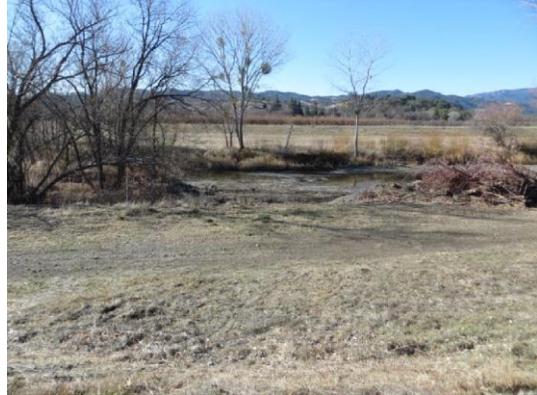
Photo 3 of 3 : UCIP_FA_2019_55703_49847.jpg

Concrete headwall and pipe visible on WS berm.

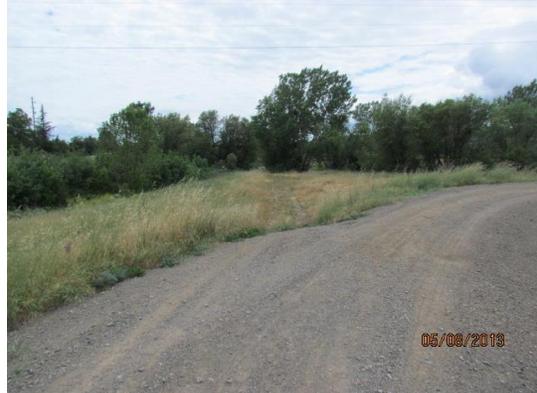
Photo 1 of 1 : FA_2019_NA0009_3_13_20190904_00007.jpg

LM Start	2.29	Rating **	M	Issue No.	13
LM End	2.29	Issue Type +	Ma	Location *	WS
Category	Earthen Levee			GPS Latitude/Longitude	
				Start	End
Item	Slope Stability			39.160285 °	39.160285 °
				-122.913481 °	-122.913481 °
DWR ID	DWR_NA0009_01_s_ 2013_13				
Comment Code					
S3 : Repair the levee slope damaged by vehicle traffic and prevent access where possible.					
Inspector Comment

View of the vehicle erosion along the waterside slope.

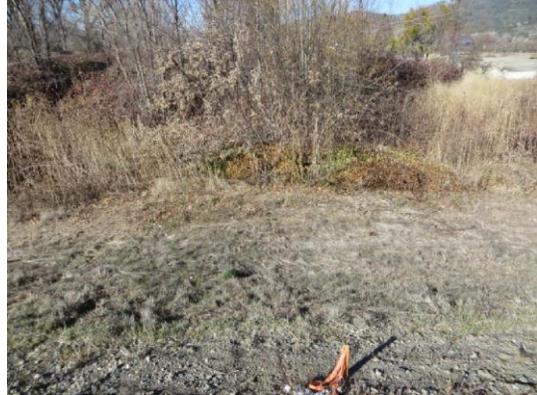
Photo 1 of 3 : UCIP_FA_2019_55705_49862.jpg

Comment Code					
Inspector Comment					
DS_ID:21199 FS_ID:55705 EP_NO: 11460 Repair Type: Non-Urgent Crossing Status: Found UCIP Comments: 10/16/2019 Record remains Non-Urgent, need to audit record to confirm owner. Crossing has been internally inspected under the DWR DMP Phase 1 project. Inspection report is still not available. The UCIP inspection was completed with DWR Inspector, L. Dial, and LMA representative, S. Webb. (O. Magana - DWR UCIP)01/14/2014 Heavy vegetation on LS at inlet should be remove. (W. Wylie - DWR UCIP) FIELD_STRUCT_DESC: 42-inch corrugated metal drainage pipe through the levee, 10 feet below the crown. Flap gate on the waterside (WS) end. Concrete headwall on both ends. (42-inch pipe [HLM 2.35] retained under Automatic Board Order (ABO) issued as Permit No. 11460, 1975 - Robert L. and Lavona Gentry). [Additional Reference(s): DWR Levee Log, 2005. USACE Sacramento O&M Manual 506.2, August 1961, (HLM 2.35), Station C4+90, 42-inch pipe, dwg no. CC-4-4-29, Index Sheet 4: page 4, 38 of 64]. FS Date: 10/16/2019 3:56:00 PM

Heavy vegetation at inlet on LS toe.

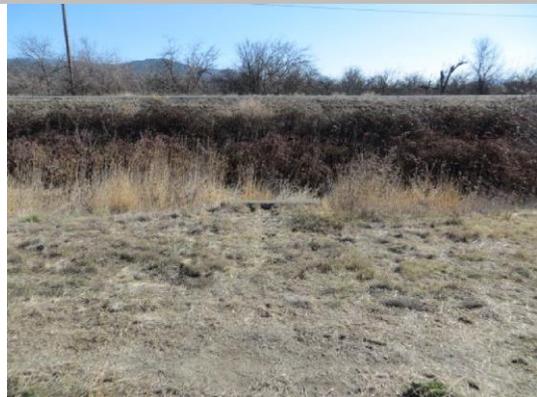
Photo 2 of 3 : UCIP_FA_2019_55705_49861.jpg

Concrete U-shaped headwall on WS berm.

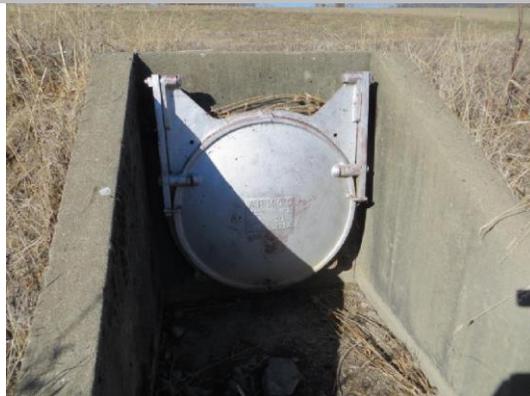
Photo 3 of 3 : UCIP_FA_2019_55705_49860.jpg

Concrete U-shaped headwall and flap gate on WS berm.

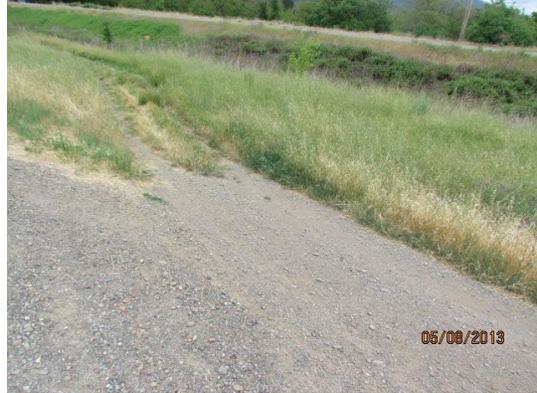
Photo 1 of 1 : FA_2019_NA0009_3_14_20190904_00008.jpg

LM Start	2.36	Rating **	A/W	Issue No.	14
LM End	2.36	Issue Type +	Ma	Location *	WS
Category	Earthen Levee		GPS Latitude/Longitude		
			Start	End	
Item	Slope Stability		39.161153°	39.161153°	
			-122.912740°	-122.912740°	
DWR ID	DWR_NA0009_01_s_2013_14				
Comment Code					
S3 : Repair the levee slope damaged by vehicle traffic and prevent access where possible.					
Inspector Comment

View of the vehicle erosion along the waterside slope. Spring 2013

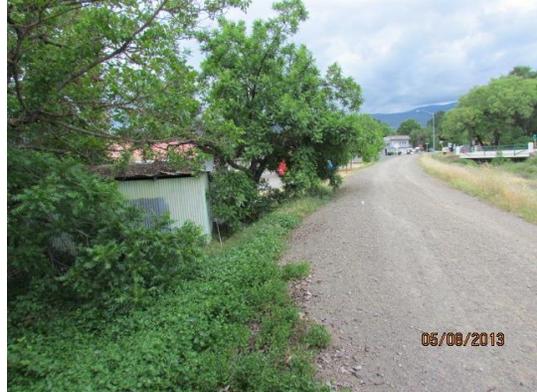
Photo 1 of 1 : FA_2019_NA0009_3_15_20190904_00009.jpg

LM Start	2.38	Rating **	M	Issue No.	15
LM End	2.43	Issue Type +	Ma	Location *	LS
Category	Earthen Levee		GPS Latitude/Longitude		
			Start	End	
Item	Trim / Thin Trees		39.161381°	39.161935°	
			-122.912551°	-122.911883°	
DWR ID	DWR_NA0009_01_s_2013_15				
Comment Code					
T1 : Trim trees to at least five feet above ground level.					
Inspector Comment					
Trim the trees to at least 5 feet above the ground for visibility, and remove the vegetation from the slope.

Trim the trees up 5 feet to allow visibility. Spring 2013

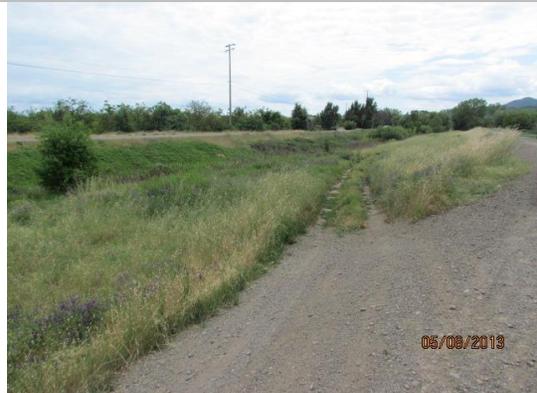
Photo 1 of 1 : FA_2019_NA0009_3_16_20190904_00010.jpg

LM Start	2.40	Rating **	M	Issue No.	16
LM End	2.40	Issue Type +	Ma	Location *	WS
Category	Earthen Levee		GPS Latitude/Longitude		
			Start	End	
Item	Slope Stability		39.161601°	39.161601°	
			-122.912303°	-122.912303°	
DWR ID	DWR_NA0009_01_s_2013_16				
Comment Code					
S3 : Repair the levee slope damaged by vehicle traffic and prevent access where possible.					
Inspector Comment

View of the vehicle erosion along the waterside slope. Spring 2013

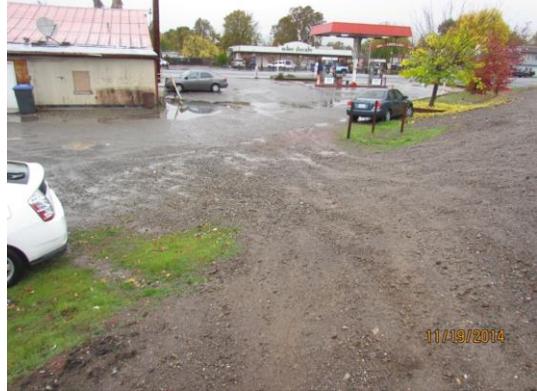
Photo 1 of 1 : FA_2019_NA0009_3_17_20190904_00011.jpg

LM Start	2.42	Rating **	M	Issue No.	17
LM End	2.42	Issue Type +	Ma	Location *	LS
Category	Earthen Levee		GPS Latitude/Longitude		
			Start	End	
Item	Slope Stability		39.161802°	39.161802°	
			-122.912020°	-122.912020°	
DWR ID	DWR_NA0009_01_s_2013_17				
Comment Code					
S3 : Repair the levee slope damaged by vehicle traffic and prevent access where possible.					
Inspector Comment

View of the erosion caused by vehicle traffic over the landside slope. Fall 2014

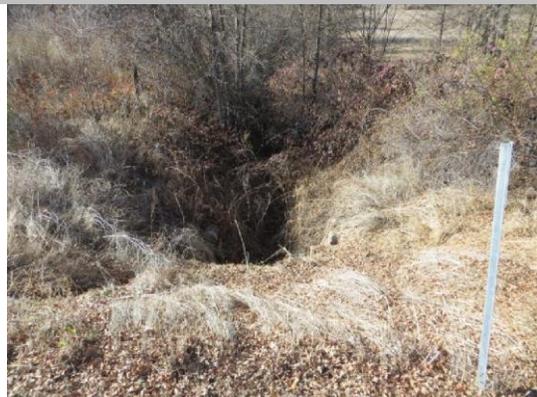
Photo 1 of 3 : UCIP_FA_2019_55713_50049.jpg

Comment Code					
Inspector Comment					
DS_ID:21201 FS_ID:55713 EP_NO: 11485 Repair Type: Non-Urgent Crossing Status: Found UCIP Comments: 10/23/2019 Record has been updated from No Action Needed to Non-Urgent; need to audit record to confirm owner. Crossing has been internally inspected under the DWR DMP Phase 1 project. Inspection report is still not available. The UCIP inspection was completed with DWR Inspector, L. Dial, and LMA representative, S. Webb. (O. Magana - DWR UCIP) FIELD_STRUCT_DESC: 42-inch corrugated metal drainage pipe through the levee, 8.5 feet below the crown. Flap gate on the waterside (WS). Concrete headwalls on both ends. (42-inch pipe [HLM 0.13] retained under Automatic Board Order (ABO) issued as Permit No. 11485, 1975 - John and Vivian Strickfaden). [Additional Reference(s): DWR Levee Log, 2005. USACE Sacramento O&M Manual 506.2, August 1961, (HLM 0.13), Station M315+75, 42-inch pipe, dwg no. CC-4-4-29, Index Sheet 6: page 6, 40 of 64]. FS Date: 10/23/2019 1:44:00 PM

Pipe and headwall visible at LS toe in drainage swale.

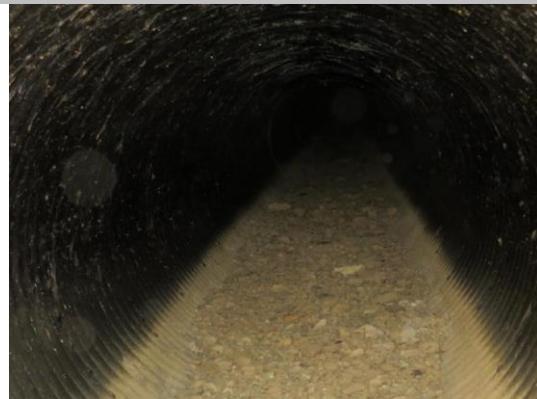
Photo 3 of 3 : UCIP_FA_2019_55713_50047.jpg

Pipe with some sediment at flowline.

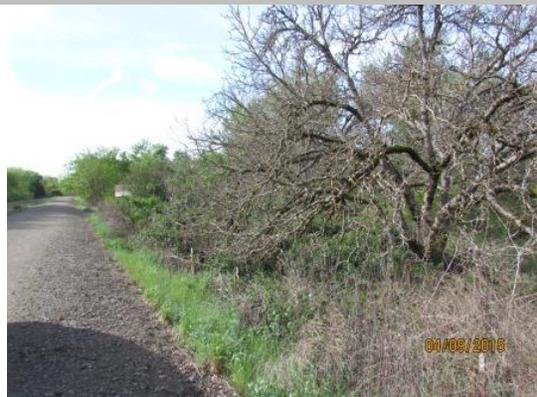
Photo 1 of 1 : FA_2019_NA0009_4_7_20190904_00004.jpg

View of the vegetation at the landside toe.

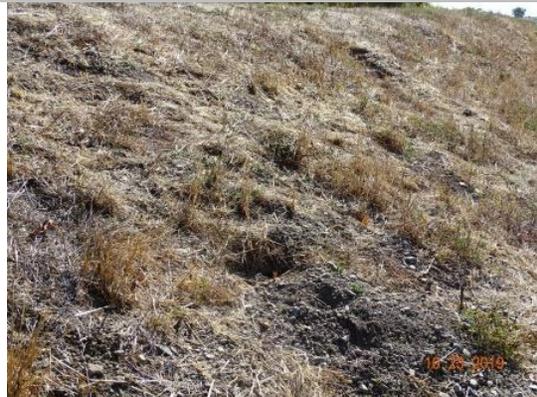
Photo 2 of 2 : FA_2019_NA0009_4_30_20191024_00054.jpg

View looking downstream at animal holes on the landside slope with recent activity. Fall 2019

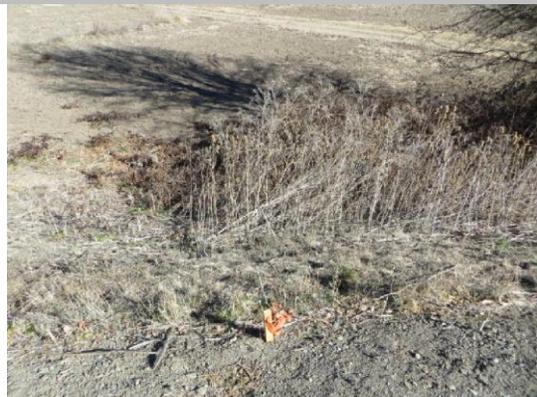
Photo 1 of 3 : UCIP_FA_2019_55769_51542.jpg

Pipe visible at LS toe covered with vegetation.

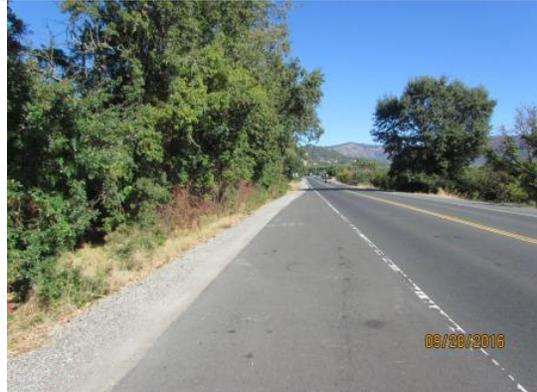
Photo 1 of 1 : FA_2019_NA0009_5_14_20190904_00004.jpg

View of the waterside vegetation looking upstream. Fall 2016

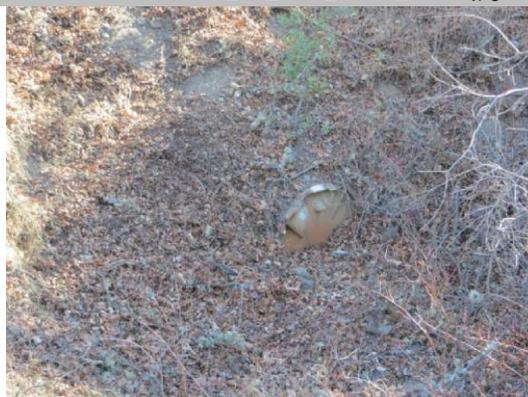
Photo 1 of 3 : UCIP_FA_2019_55781_51595.jpg

Plugged pipe visible on WS toe of roadway.

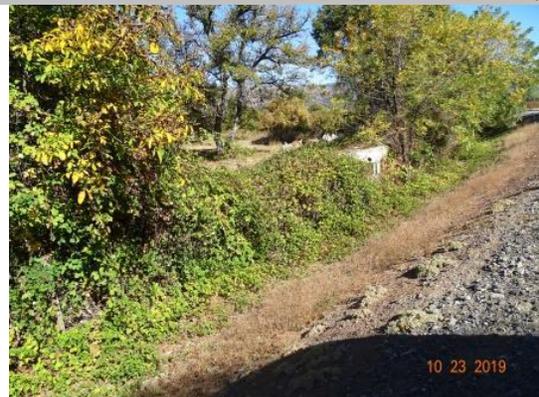
Photo 1 of 2 : FA_2019_NA0009_5_12_20191025_00044.jpg

View of vines covering the fence along the landside toe. Fall 2019

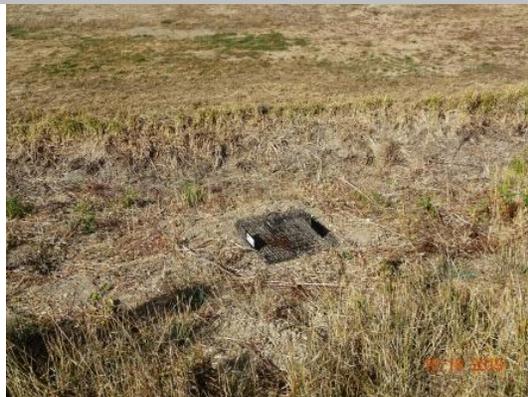
Photo 1 of 2 : FA_2019_NA0009_6_12_20191018_00023.jpg

View of animal traps on the landside slope. Fall 2019

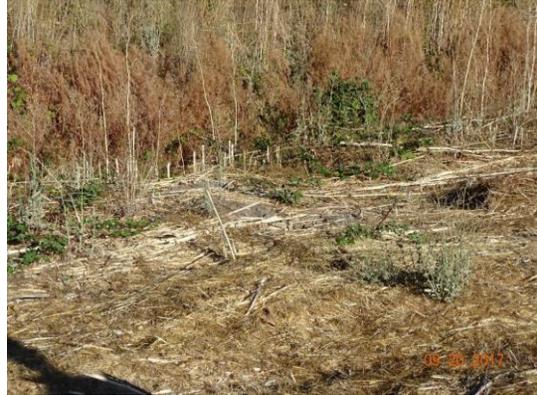
Photo 2 of 2 : FA_2019_NA0009_6_12_20190904_00003.jpg

View of the rodent holes along the landside slope & toe. Fall 2017

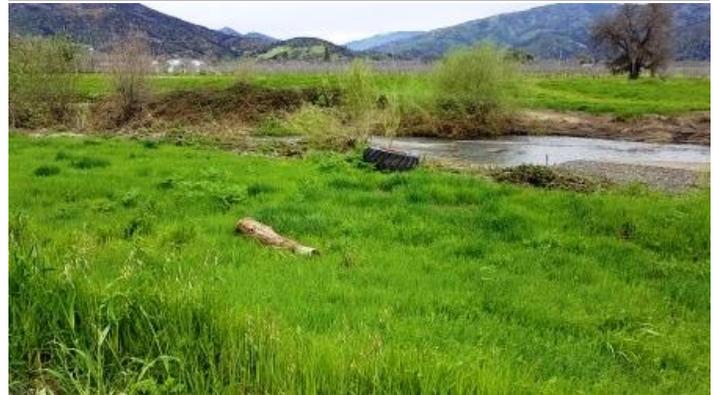
Photo 1 of 1 : FA_2019_NA0009_7_17_20190904_00005.jpg

View of large tire and tree log in the waterway. Spring 2019
