**Flood Control Project Maintenance
Levee Inspections**

Maintenance Issue Types Only, Levee Inspection Report By Mile - Spring 2020

Lake County Watershed Protection District

Waterway	Bank	Unit Miles	Inspection Start/End	Inspector
Unit No. 01 Middle Creek	Left	3.35	04/01/2020 04/02/2020	Luz Dial

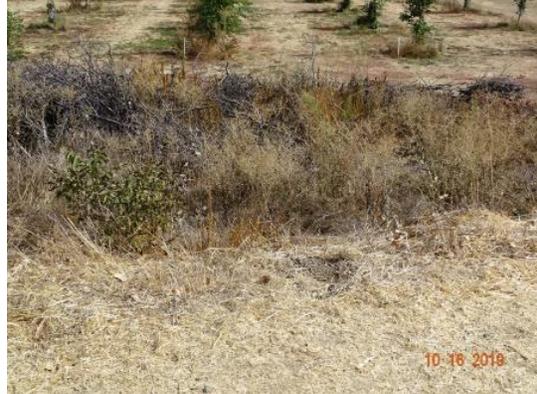
Photo 1 of 1 : SP_2020_NA0009_3_25_20200302_00011.jpg

View of rodent holes on the landside slope. Fall 2019

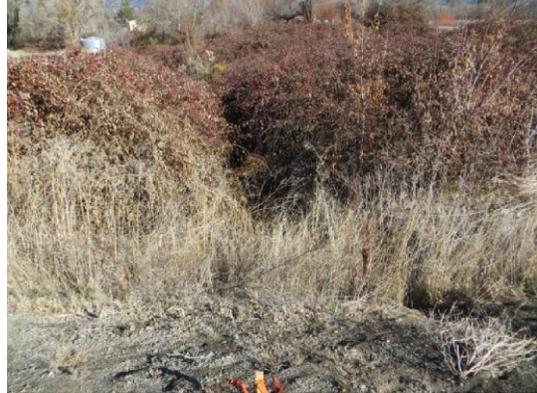
Photo 1 of 3 : UCIP_SP_2020_55702_49853.jpg

Comment Code					
Inspector Comment					
DS_ID:21240 FS_ID:55702 EP_NO: 11460 Repair Type: Non-Urgent Crossing Status: Found UCIP Comments: 10/16/2019 Record has been updated from No Action Needed to Non-Urgent; need to audit record to confirm owner. Crossing has been internally inspected under the DWR DMP Phase 1 project. Inspection report is still not available. The UCIP inspection was completed with DWR Inspector, L. Dial, and LMA representative, S. Webb. (O. Magana - DWR UCIP) FIELD_STRUCT_DESC: 1 of 2: 36-inch corrugated metal drainage pipe through the levee, 9 feet below the crown. Flap gate on the waterside (WS) end. Concrete headwalls on both ends. (two 36-inch pipes [HLM 2.26] retained under Automatic Board Order (ABO) issued as Permit No. 11460, 1975 - Robert L. and Lavona Gentry). [Additional Reference(s): DWR Levee Log, 2005. USACE Sacramento O&M Manual 506.2, August 1961, (HLM 2.26), Station M206+00, two 36-inch pipes, dwg no. CC-4-4-29, Index Sheet 4: page 4, 38 of 64]. FS Date: 10/16/2019 3:56:00 PM

Pipe and Concrete headwall visible on LS toe.

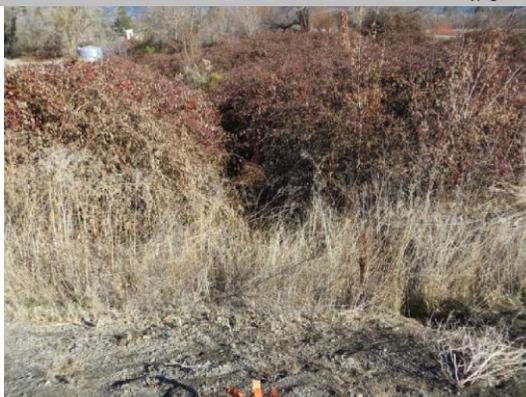
Photo 1 of 3 : UCIP_SP_2020_55703_49849.jpg

Concrete headwall and pipe visible on LS toe at end of drainage swale.

Comment Code					
Inspector Comment					
DS_ID:21197 FS_ID:55703 EP_NO: 11460 Repair Type: Non-Urgent Crossing Status: Found UCIP Comments: 10/16/2019 Record has been updated from No Action Needed to Non-Urgent; need to audit record to confirm owner. Crossing has been internally inspected under the DWR DMP Phase 1 project. Inspection report is still not available. The UCIP inspection was completed with DWR Inspector, L. Dial, and LMA representative, S. Webb. (O. Magana - DWR UCIP) FIELD_STRUCT_DESC: 2 of 2: 36-inch corrugated metal drainage pipe through the levee, 9 feet below the crown. Flap gate on the waterside (WS) end. Concrete U-shaped headwalls on both ends. (two 36-inch pipes [HLM 2.26] retained under Automatic Board Order (ABO) issued as Permit No. 11460, 1975 - Robert L. and Lavona Gentry). [Additional Reference(s): DWR Levee Log, 2005. USACE Sacramento O&M Manual 506.2, August 1961, (HLM 2.26), Station M206+00, two 36-inch pipes, dwg no. CC-4-4-29, Index Sheet 4: page 4, 38 of 64]. FS Date: 10/16/2019 3:59:00 PM

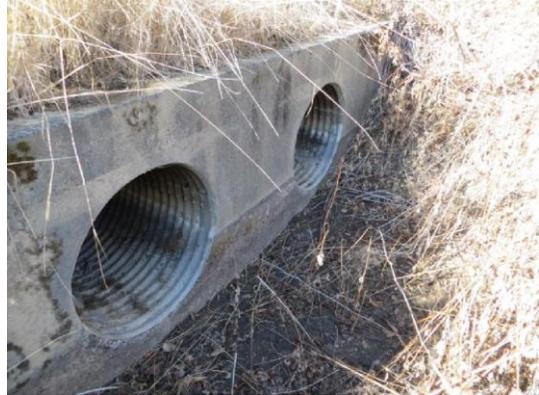
Photo 2 of 3 : UCIP_SP_2020_55703_49848.jpg

Concrete headwall and pipe visible on LS toe.

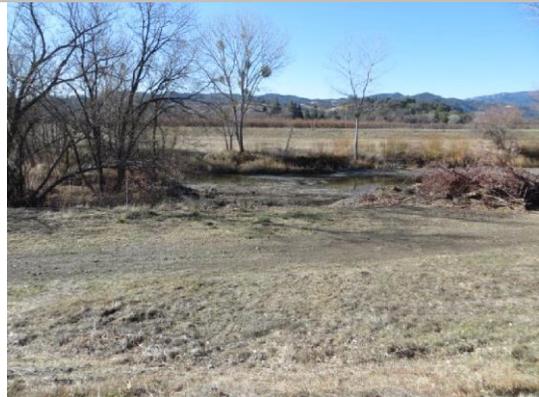
Photo 3 of 3 : UCIP_SP_2020_55703_49847.jpg

Concrete headwall and pipe visible on WS berm.

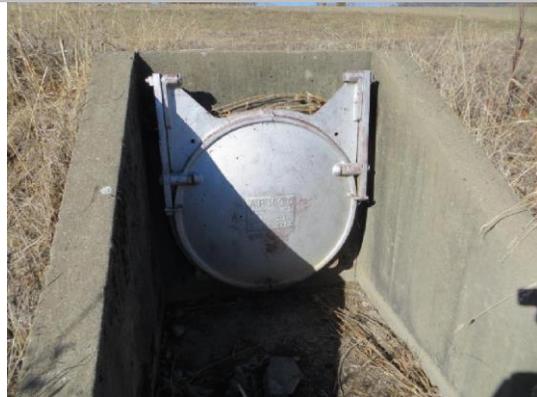
Photo 3 of 3 : UCIP_SP_2020_55705_49860.jpg

Concrete U-shaped headwall and flap gate on WS berm.

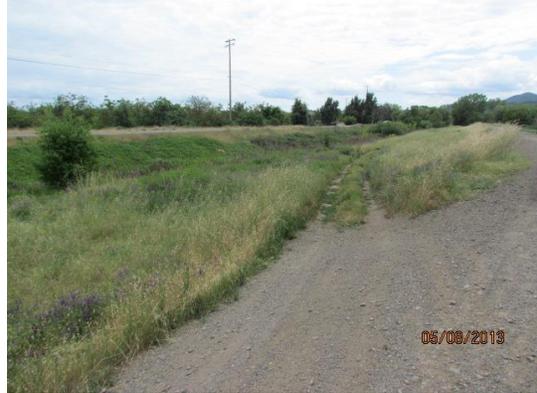
Photo 1 of 1 : SP_2020_NA0009_3_16_20200302_00008.jpg

LM Start	2.40	Rating **	M	Issue No.	16
LM End	2.40	Issue Type +	Ma	Location *	WS
Category	Earthen Levee		GPS Latitude/Longitude		
			Start	End	
Item	Slope Stability		39.161601 °	39.161601 °	
			-122.912303 °	-122.912303 °	
DWR ID	DWR_NA0009_01_s_2013_16				
Comment Code					
S3 : Repair the levee slope damaged by vehicle traffic and prevent access where possible.					
Inspector Comment

View of the vehicle erosion along the waterside slope. Spring 2013

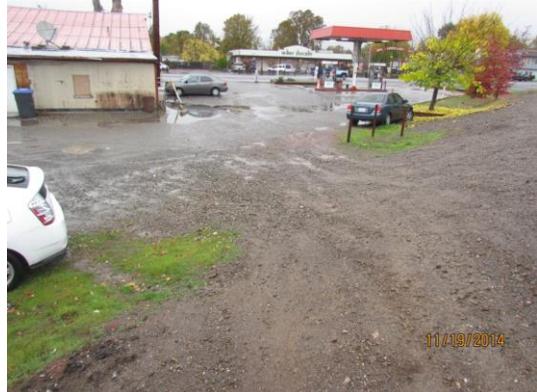
Photo 1 of 1 : SP_2020_NA0009_3_17_20200302_00009.jpg

LM Start	2.42	Rating **	M	Issue No.	17
LM End	2.42	Issue Type +	Ma	Location *	LS
Category	Earthen Levee		GPS Latitude/Longitude		
			Start	End	
Item	Slope Stability		39.161802 °	39.161802 °	
			-122.912020 °	-122.912020 °	
DWR ID	DWR_NA0009_01_s_2013_17				
Comment Code					
S3 : Repair the levee slope damaged by vehicle traffic and prevent access where possible.					
Inspector Comment

View of the erosion caused by vehicle traffic over the landside slope. Fall 2014

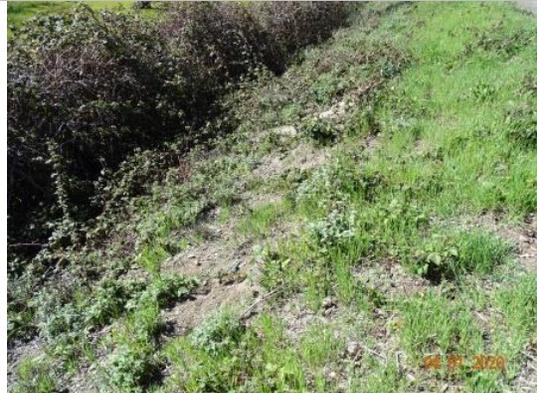
Photo 1 of 1 : SP_2020_NA0009_3_48_20200403_00044.jpg

LM Start	2.49	Rating **	U	Issue No.	48
LM End	2.52	Issue Type +	Ma	Location *	LS
Category	Earthen Levee		GPS Latitude/Longitude		
			Start	End	
Item	Animal Control		39.161472 °	39.161082 °	
			-122.911822 °	-122.912258 °	
DWR ID	DWR_NA0009_01_s_2019_48				
Comment Code					
A3 : No rodents visible, but rodent burrows visible; need to backfill and compact or grout burrows.					
Inspector Comment					
Backfill animal holes on both sides of the levee.

View of animal holes on the landside slope. Spring 2020

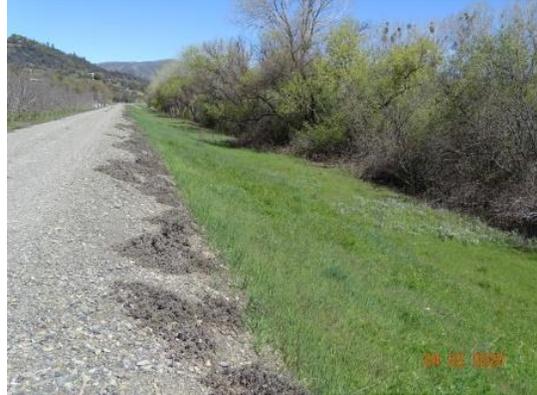
Photo 1 of 1 : SP_2020_NA0009_4_39_20200513_00068.jpg

View of well-maintained waterside vegetation. Spring 2020

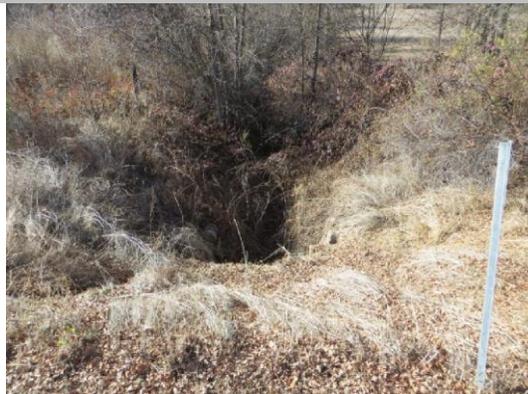
Photo 1 of 3 : UCIP_SP_2020_55713_50049.jpg

Comment Code					
Inspector Comment					
DS_ID:21201 FS_ID:55713 EP_NO: 11485 Repair Type: Non-Urgent Crossing Status: Found UCIP Comments: 10/23/2019 Record has been updated from No Action Needed to Non-Urgent; need to audit record to confirm owner. Crossing has been internally inspected under the DWR DMP Phase 1 project. Inspection report is still not available. The UCIP inspection was completed with DWR Inspector, L. Dial, and LMA representative, S. Webb. (O. Magana - DWR UCIP) FIELD_STRUCT_DESC: 42-inch corrugated metal drainage pipe through the levee, 8.5 feet below the crown. Flap gate on the waterside (WS). Concrete headwalls on both ends. (42-inch pipe [HLM 0.13] retained under Automatic Board Order (ABO) issued as Permit No. 11485, 1975 - John and Vivian Strickfaden). [Additional Reference(s): DWR Levee Log, 2005. USACE Sacramento O&M Manual 506.2, August 1961, (HLM 0.13), Station M315+75, 42-inch pipe, dwg no. CC-4-4-29, Index Sheet 6: page 6, 40 of 64]. FS Date: 10/23/2019 1:44:00 PM

Pipe and headwall visible at LS toe in drainage swale.

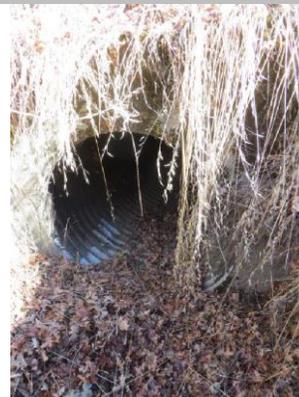
Photo 2 of 3 : UCIP_SP_2020_55713_50048.jpg

Pipe and headwall visible at LS toe in drainage swale.

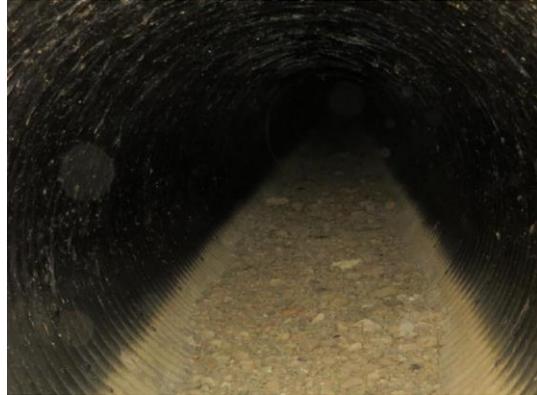
Photo 3 of 3 : UCIP_SP_2020_55713_50047.jpg

Pipe with some sediment at flowline.

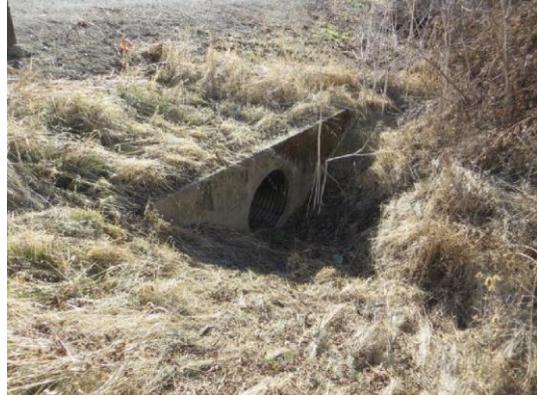
Photo 1 of 3 : UCIP_SP_2020_55717_50322.jpg

Comment Code					
Inspector Comment					
DS_ID:21204 FS_ID:55717 EP_NO: 11484 Repair Type: Non-Urgent Crossing Status: Found UCIP Comments: 10/23/2019 Record has been updated from No Action Needed to Non-Urgent; need to audit record to confirm owner. Crossing has been internally inspected under the DWR DMP Phase 1 project. Inspection report is still not available. The UCIP inspection was completed with DWR Inspector, L. Dial, and LMA representative, S. Webb. (O. Magana - DWR UCIP) FIELD_STRUCT_DESC: 36-inch corrugated metal drainage pipe through the levee, 6 feet below the crown. Flap gate on the waterside (WS) end. Concrete headwalls on both ends. (36-inch pipe [HLM 0.23] retained under Automatic Board Order (ABO) issued as Permit No. 11484, 1975 - Rodney Snow). [Additional Reference(s): DWR Levee Log, 2005. USACE Sacramento O&M Manual 506.2, August 1961, (HLM 0.23), Station M311+10, 36-inch pipe, dwg no. CC-4-4-29, Index Sheet 6: page 6, 40 of 64]. FS Date: 10/23/2019 1:46:00 PM

Concrete headwall and pipe on LS toe.

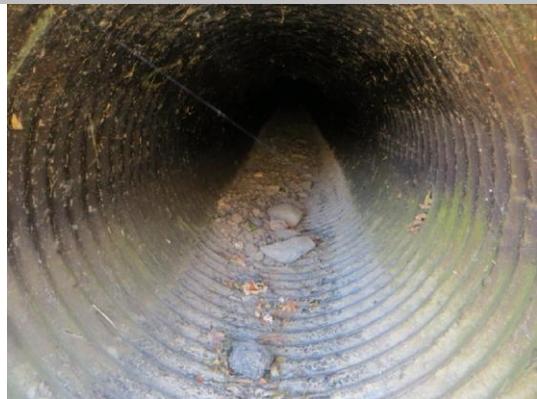
Photo 2 of 3 : UCIP_SP_2020_55717_50321.jpg

Pipe at inlet.

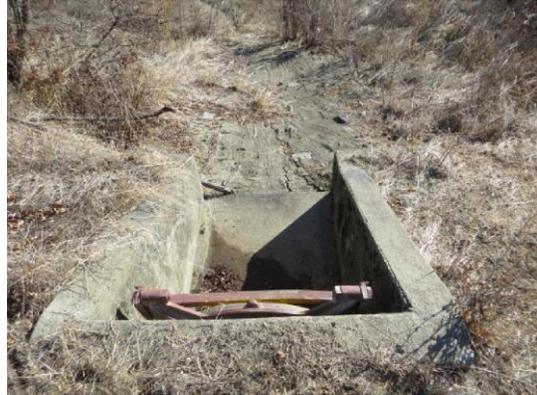
Photo 3 of 3 : UCIP_SP_2020_55717_50320.jpg

Flapgate and concrete headwall on WS toe.

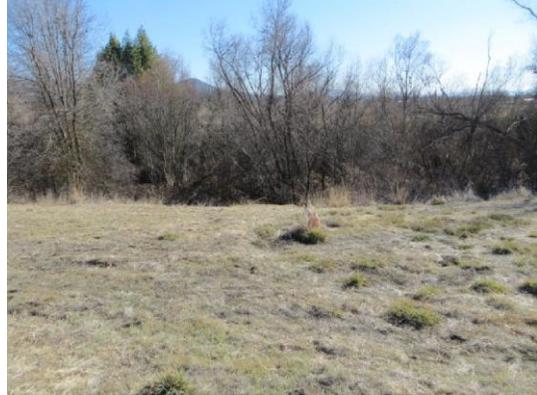
Photo 2 of 3 : UCIP_SP_2020_55718_50325.jpg

Flapgate and headwall off WS toe at berms edge.

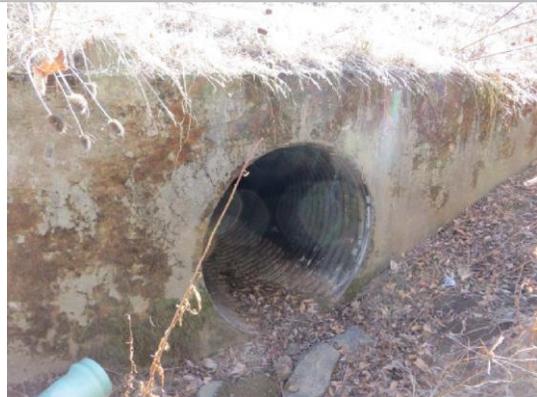
Photo 3 of 3 : UCIP_SP_2020_55718_50324.jpg

Pipe and concrete headwall at LS toe.

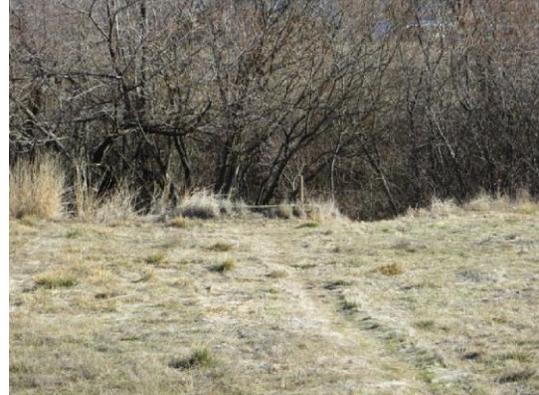
Photo 3 of 3 : UCIP_SP_2020_55723_50387.jpg

Concrete headwall and flapgate visible on waterside berm

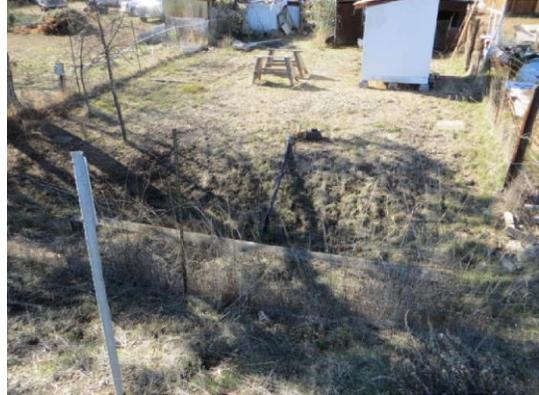
Photo 1 of 3 : UCIP_SP_2020_55730_50411.jpg

Comment Code					
Inspector Comment					
DS_ID:21210 FS_ID:55730 EP_NO: 11482 Repair Type: Non-Urgent Crossing Status: Found UCIP Comments: 10/23/2019 Record remains Non-Urgent; need to audit record to confirm owner. Property owner will also need to address access issue due to fence installed on the LS slope. Crossing has been internally inspected under the DWR DMP Phase 1 project. Inspection report is still not available. The UCIP inspection was completed with DWR Inspector, L. Dial, and LMA representative, S. Webb. (O. Magana - DWR UCIP)01/14/2014 Fence on LS slope creates access issue. (W. Wylie - DWR UCIP) FIELD_STRUCT_DESC: 36-inch corrugated metal drainage pipe through the levee, 9 feet below the crown. Flap gate on the waterside (WS) end. Concrete headwalls on both ends. (36-inch pipe [HLM 0.54] retained under ABO No. 11482, 1975 - George R. and Gladys Schneider). [Additional Reference(s): DWR Levee Log, 2005. USACE Sacramento O&M Manual 506.2, August 1961, (HLM 0.54), Station M294+00, 36-inch pipe, dwg no. CC-4-4-29, Index Sheet 6: page 6, 40 of 64]. FS Date: 10/23/2019 1:50:00 PM

Concrete headwall on LS toe.

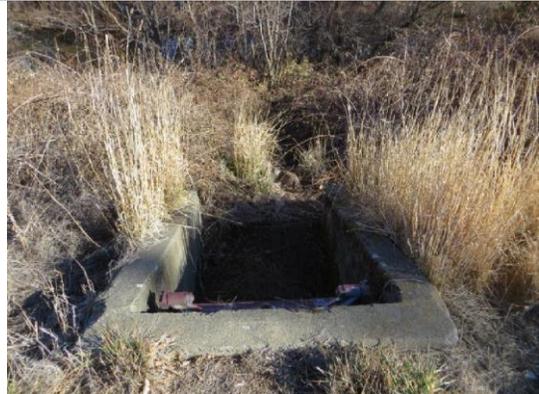
Photo 2 of 3 : UCIP_SP_2020_55730_50410.jpg

Flapgate and concrete headwall on WS berm.

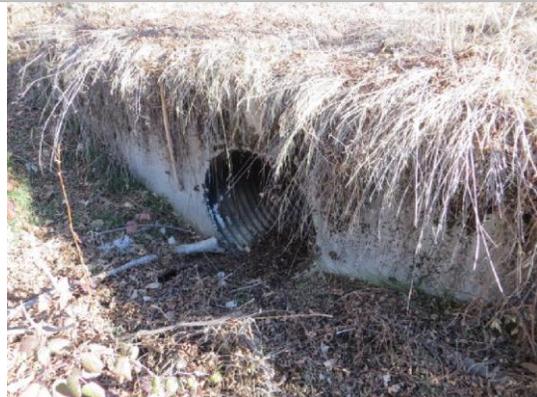
Photo 1 of 3 : UCIP_SP_2020_55740_51202.jpg

Comment Code					
Inspector Comment					
DS_ID:21211 FS_ID:55740 EP_NO: 11486 Repair Type: Non-Urgent Crossing Status: Found UCIP Comments: 10/23/2019 Record has been updated from No Action Needed to Non-Urgent; need to audit record to confirm owner. Crossing has been internally inspected under the DWR DMP Phase 1 project. Inspection report is still not available. The UCIP inspection was completed with DWR Inspector, L. Dial, and LMA representative, S. Webb. (O. Magana - DWR UCIP) FIELD_STRUCT_DESC: 36-inch corrugated metal drainage pipe through the levee, 7.3 feet below the crown. Flap gate on the waterside (WS) end. Concrete headwalls on both ends. Splash apron broken off on the WS end. (36-inch pipe [HLM 1.08] retained under Automatic Board Order (ABO) issued as Permit No. 11486, 1975 - Mary Truesdell). [Additional Reference(s): DWR Levee Log, 2005. USACE Sacramento O&M Manual 506.2, August 1961, (HLM 1.08), Station M269+00, 36-inch pipe, dwg no. CC-4-4-29, Index Sheet 5: page 5, 39 of 64]. FS Date: 10/23/2019 1:16:00 PM

Pipe visible at concrete inlet on LS toe.

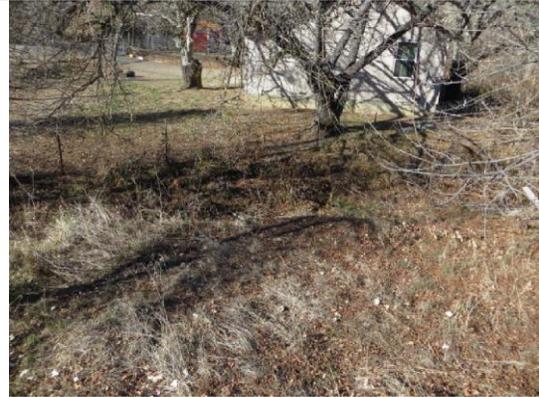
Photo 3 of 3 : UCIP_SP_2020_55740_51200.jpg

Pipe visible on LS toe.

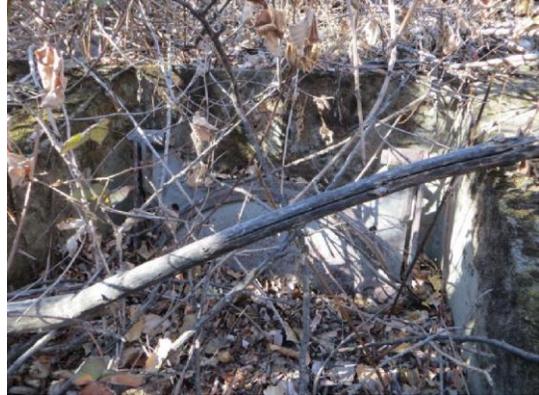
Photo 3 of 3 : UCIP_SP_2020_55741_51215.jpg

Flapgate and concrete headwall visible off WS berm.

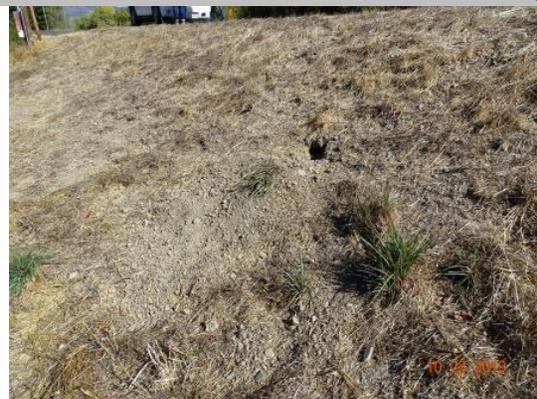
Photo 1 of 2 : SP_2020_NA0009_4_30_20200302_00009.jpg

View looking upstream at animal holes on the landside slope. Fall 2019

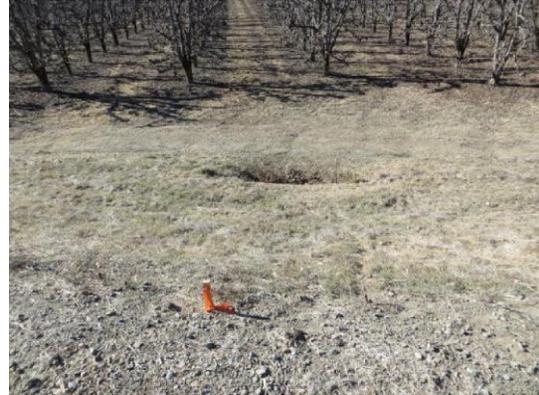
Photo 1 of 3 : UCIP_SP_2020_55756_51283.jpg

Comment Code					
Inspector Comment					
DS_ID:21215 FS_ID:55756 EP_NO: 11481 Repair Type: Non-Urgent Crossing Status: Found UCIP Comments: 10/23/2019 Record remains Non-Urgent; need to audit record to confirm owner. Crossing has been internally inspected under the DWR DMP Phase 1 project. Inspection report is still not available. The UCIP inspection was completed with DWR Inspector, L. Dial, and LMA representative, S. Webb. (O. Magana - DWR UCIP)01/22/2014 Soil partially blocking inlet and outlet. (W. Wylie - DWR UCIP) FIELD_STRUCT_DESC: 24-inch corrugated metal drainage pipe through the levee, 12 feet below the crown. Flap gate on the waterside (WS) end. Concrete headwalls on both ends. (24-inch pipe [HLM 2.93] retained under Automatic Board Order (ABO) issued as Permit No. 11481, 1975 - Dennis P. McCarthy). [Additional Reference(s): DWR Levee Log, 2005. USACE Sacramento O&M Manual 506.2, August 1961, (HLM 2.93), Station M173+00, 24-inch pipe, dwg no. CC-4-4-29, Index Sheet 4: page 4, 38 of 64]. FS Date: 10/23/2019 1:22:00 PM

Concrete headwall and pipe visible at LS toe.

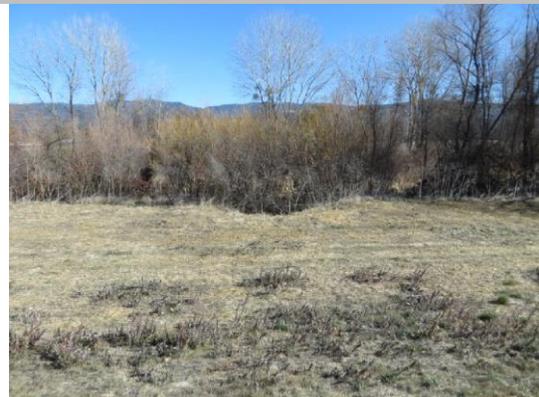
Photo 2 of 3 : UCIP_SP_2020_55756_51282.jpg

Concrete headwall and flapgate visible at WS berm.

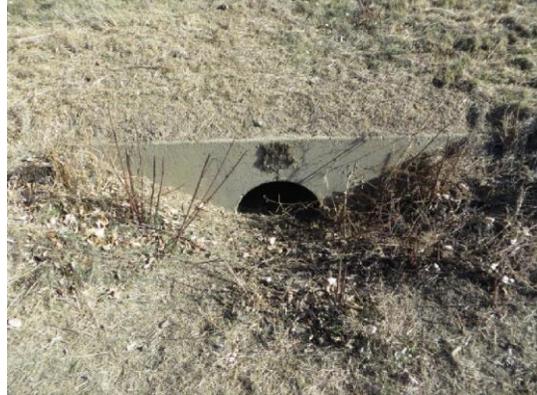
Photo 3 of 3 : UCIP_SP_2020_55756_51281.jpg

Concrete headwall and pipe visible at LS toe.

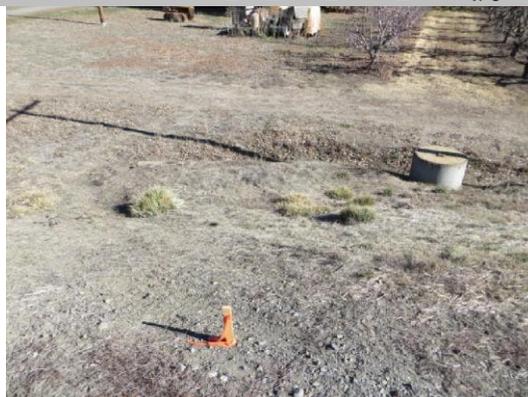
Photo 1 of 3 : UCIP_SP_2020_55778_51591.jpg

Concrete headwall visible next to concrete standpipe on LS toe.

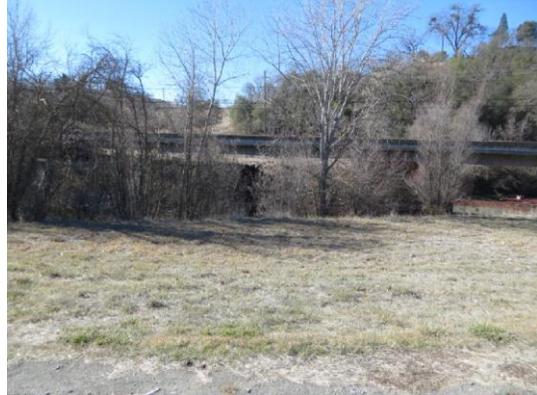
Photo 2 of 3 : UCIP_SP_2020_55778_51590.jpg

Concrete outfall visible off WS berm.

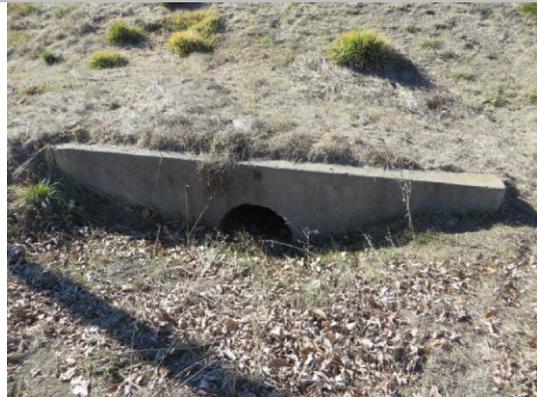
Photo 3 of 3 : UCIP_SP_2020_55778_51589.jpg

Concrete headwall visible at LS toe.

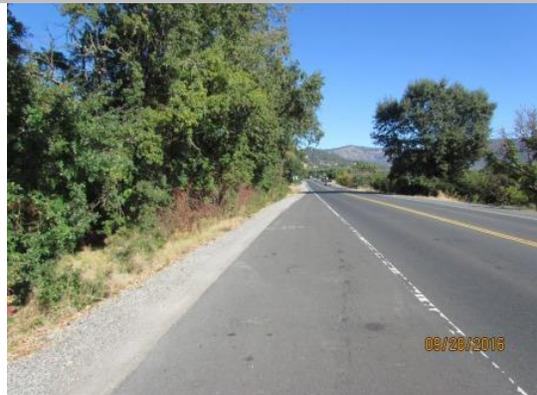
Photo 1 of 1 : SP_2020_NA0009_5_14_20200302_00005.jpg

View of the waterside vegetation looking upstream. Fall 2016

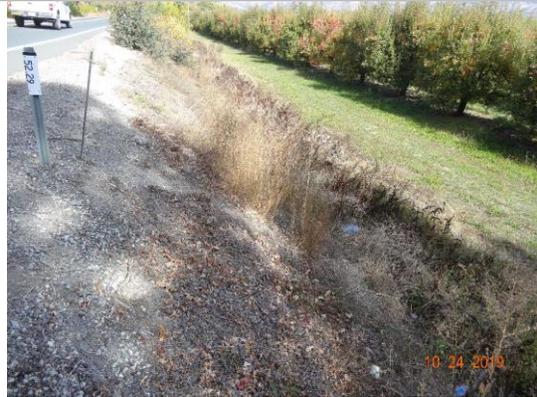
Photo 1 of 3 : UCIP_SP_2020_55781_82827.jpg

LS view: limited access to LS due to steep LS slope.

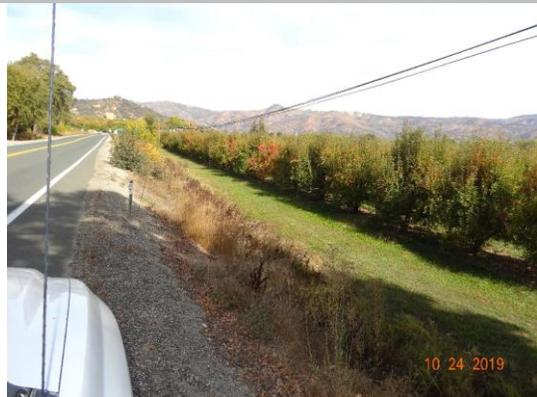
Photo 2 of 3 : UCIP_SP_2020_55781_82826.jpg

LS view: overview of LS.

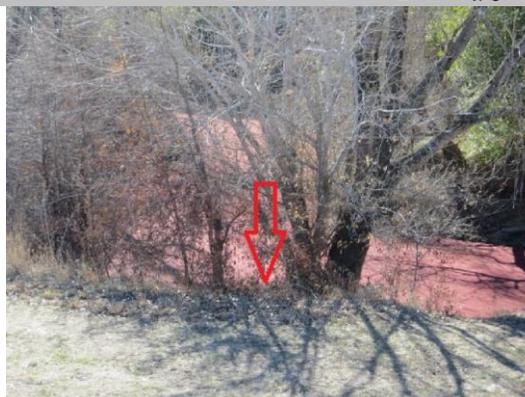
Photo 1 of 3 : UCIP_SP_2020_55782_51599.jpg

Flapgat and headwall off WS toe.

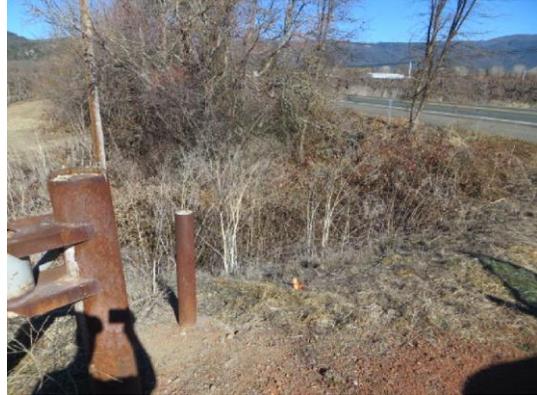
Photo 2 of 3 : UCIP_SP_2020_55782_51598.jpg

Concrete headwall on LS toe.

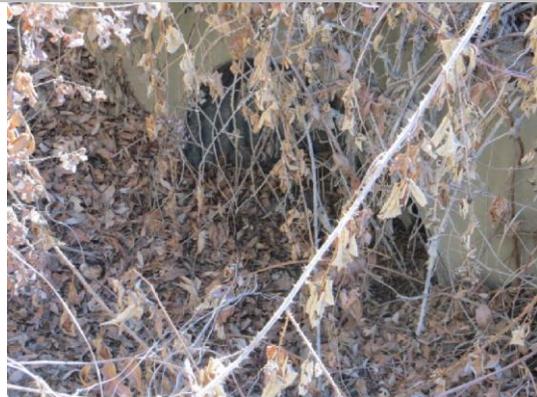
Photo 3 of 3 : UCIP_SP_2020_55782_51597.jpg

Concrete headwall on LS toe.

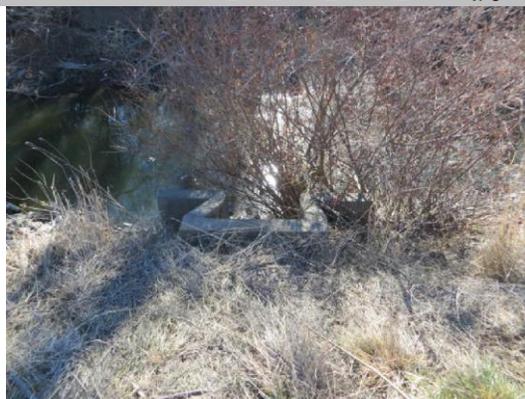
Photo 1 of 3 : UCIP_SP_2020_55784_51642.jpg

Concrete Headwall on WS berm.

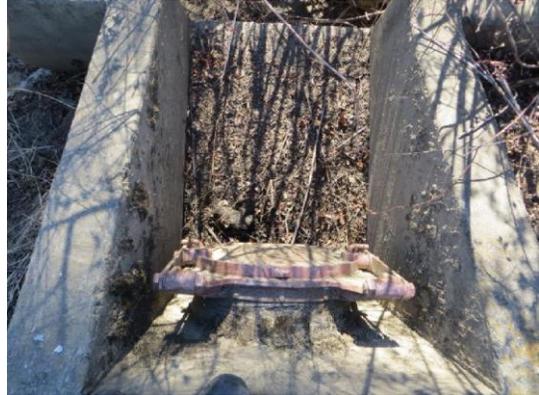
Photo 2 of 3 : UCIP_SP_2020_55784_51641.jpg

Headwall and flapgate on WS berm.

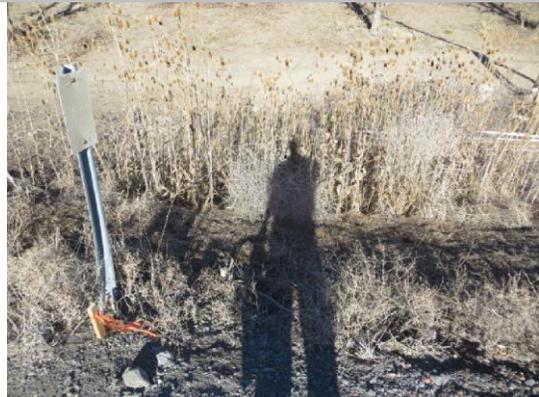
Photo 3 of 3 : UCIP_SP_2020_55784_51640.jpg

Pipe location marked on crown by flasher.

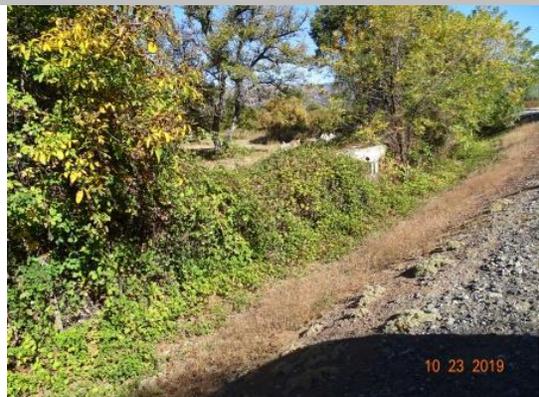
Photo 1 of 2 : SP_2020_NA0009_5_12_20200302_00002.jpg

View of vines covering the fence along the landside toe. Fall 2019

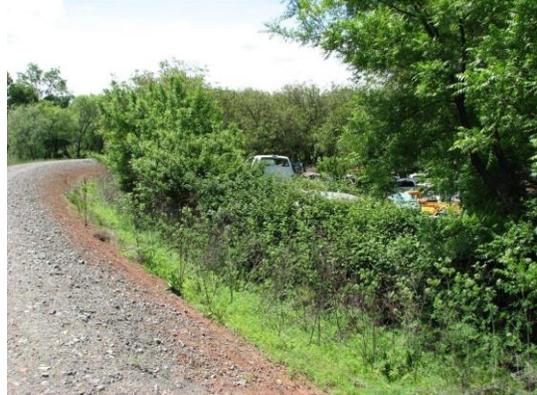
Photo 2 of 2 : SP_2020_NA0009_5_12_20200302_00003.jpg

5/2/2016: Dense bushes and vines covering fence along vehicle junk yard.

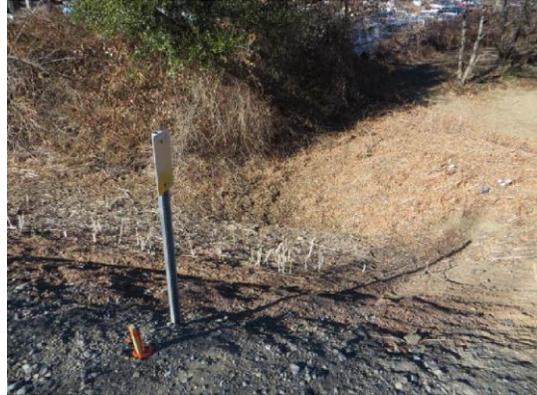
Photo 1 of 3 : UCIP_SP_2020_55785_51646.jpg

Flasher on crown marks pipe location.

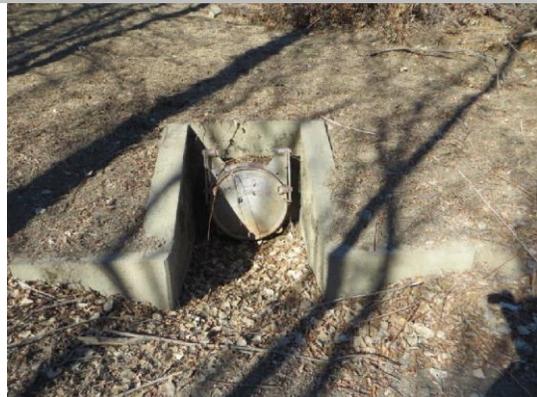
Photo 2 of 3 : UCIP_SP_2020_55785_51645.jpg

Flapgate and headwall visible on WS toe.

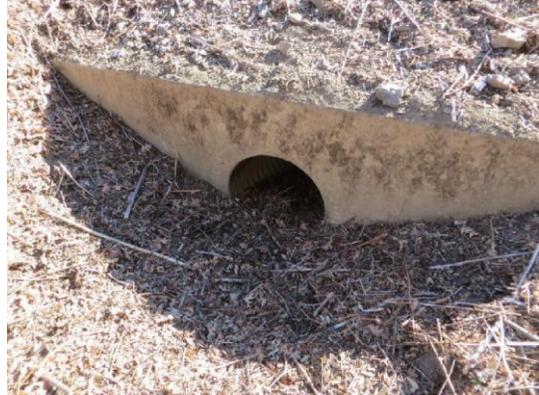
Photo 3 of 3 : UCIP_SP_2020_55785_51644.jpg

Concrete headwall on LS toe.

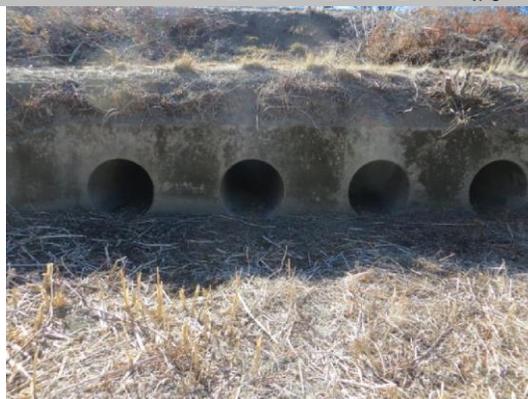
Photo 1 of 3 : UCIP_SP_2020_55787_51665.jpg

Pipe and headdwall on LS toe.

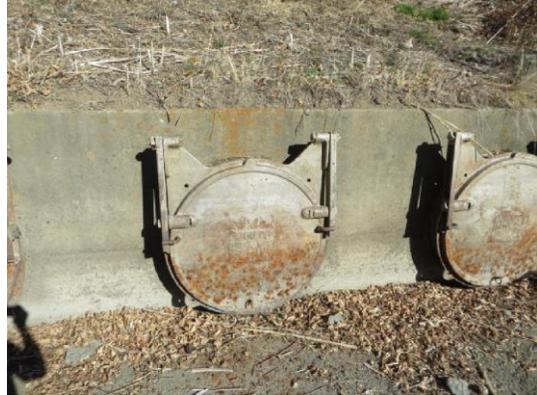
Photo 3 of 3 : UCIP_SP_2020_55788_51666.jpg

Flapgate on headwall at WS toe.

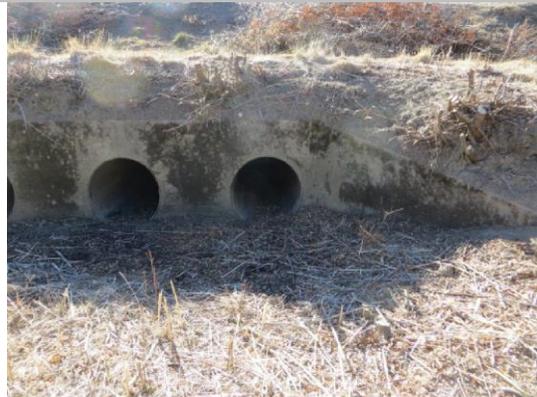
Photo 1 of 3 : UCIP_SP_2020_55789_51671.jpg

Pipe and concrete headwall on LS toe.

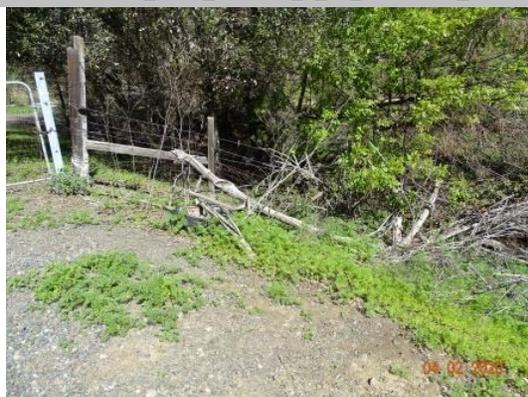
Photo 1 of 1 : SP_2020_NA0009_5_23_20200403_00052.jpg

View of prunings on the landside slope. Spring 2020

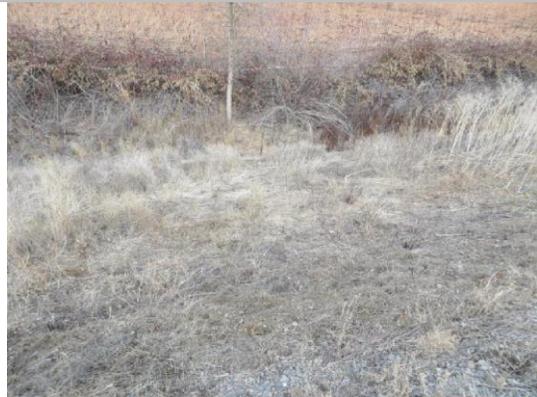
Photo 1 of 3 : UCIP_SP_2020_55812_49793.jpg

Concrete headwall visible on LS toe.

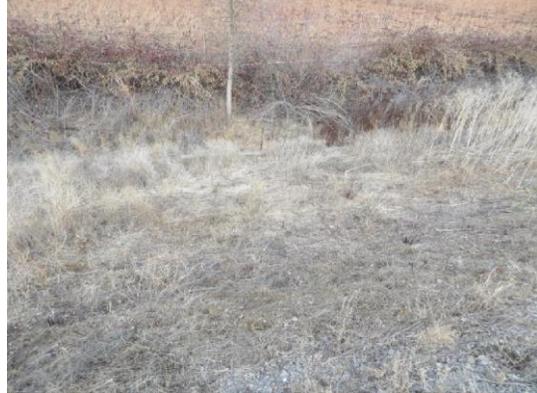
Photo 1 of 3 : UCIP_SP_2020_55813_49797.jpg

Concrete headwall and inlet visible on LS toe.

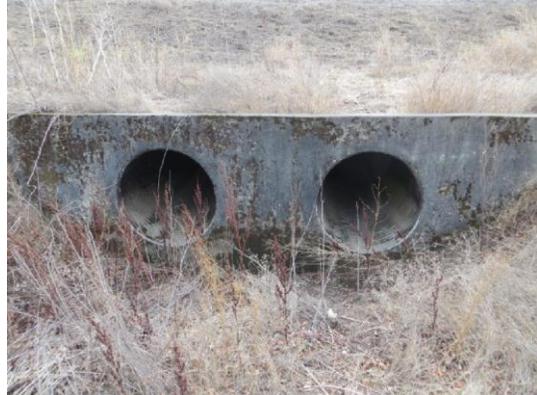
Photo 2 of 3 : UCIP_SP_2020_55813_49796.jpg

Concrete headwall and inlet visible on LS toe.

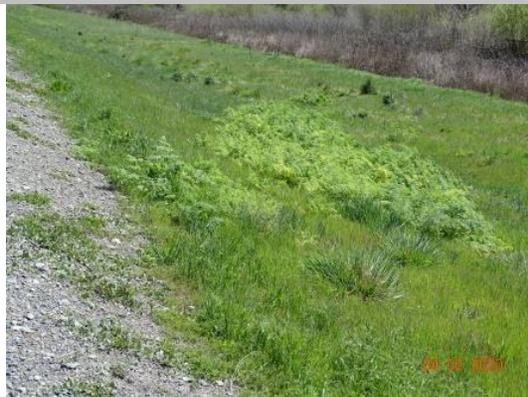
Photo 1 of 1 : SP_2020_NA0009_6_17_20200403_00023.jpg

View of wild growth on the waterside slope. Spring 2020

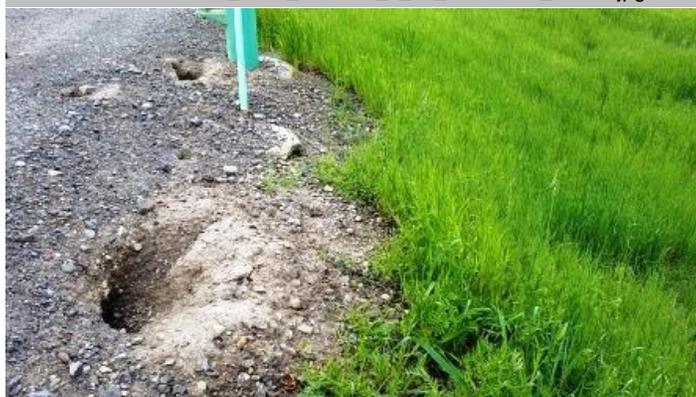
Photo 1 of 1 : SP_2020_NA0009_6_26_20200302_00007.jpg

View of rodent holes with animal activity near the gate. Spring 2019

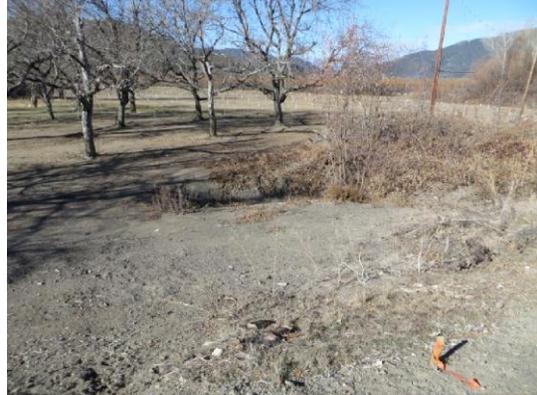
Photo 1 of 3 : UCIP_SP_2020_55816_49762.jpg

Drainpipe visible at LS toe.

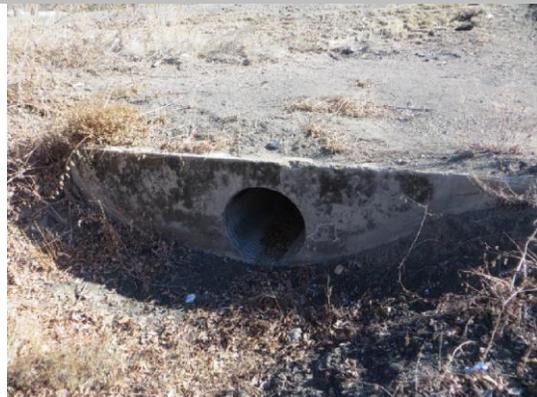
Photo 2 of 3 : UCIP_SP_2020_55816_49761.jpg

Concrete headwall and drainpipe visible at LS toe.

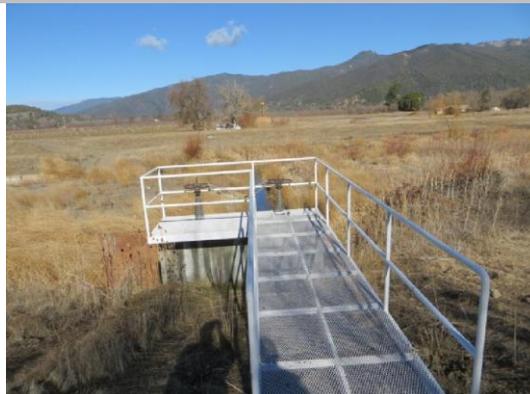
Photo 1 of 3 : UCIP_SP_2020_55848_49712.jpg

Slide gate at steel walkway on WS toe.

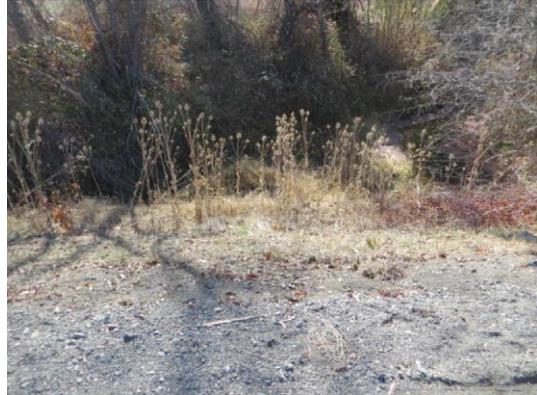
Photo 2 of 3 : UCIP_SP_2020_55853_49665.jpg

Outlet visible at concrete headwall on LS toe.

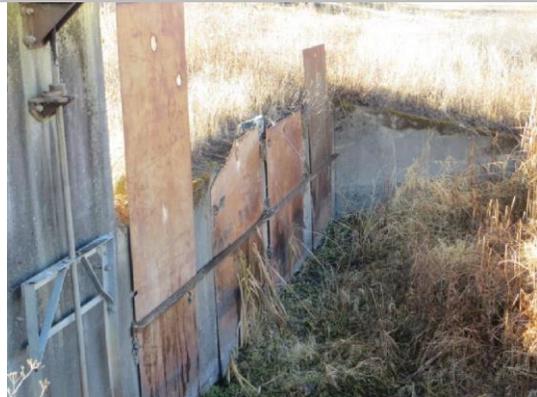
Photo 3 of 3 : UCIP_SP_2020_55853_49664.jpg

Steel slide gate visible at concrete headwall on WS toe.

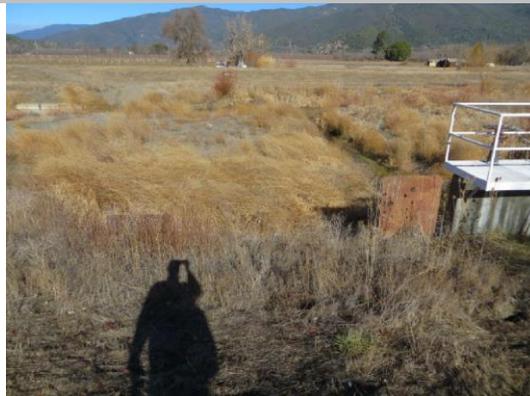
Photo 1 of 3 : UCIP_SP_2020_55854_49622.jpg

Metal slide gate visible at concrete headwall on WS toe.

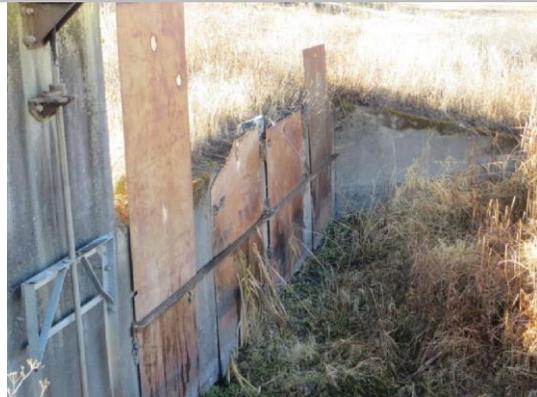
Photo 3 of 3 : UCIP_SP_2020_55854_49620.jpg

Metal slide gate visible at concrete headwall on WS toe.

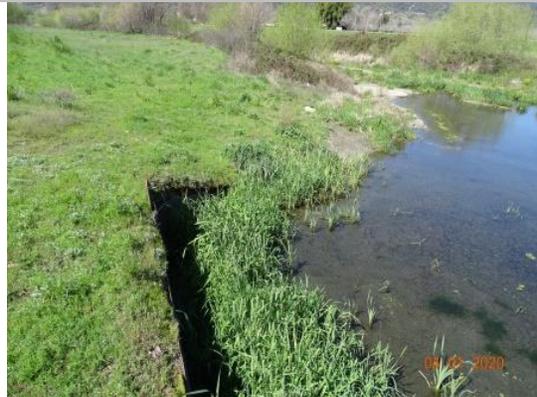
Photo 1 of 1 : SP_2020_NA0009_7_13_20200403_00042.jpg

View of erosion of the left bank downstream of the diversion structure.
Spring 2020

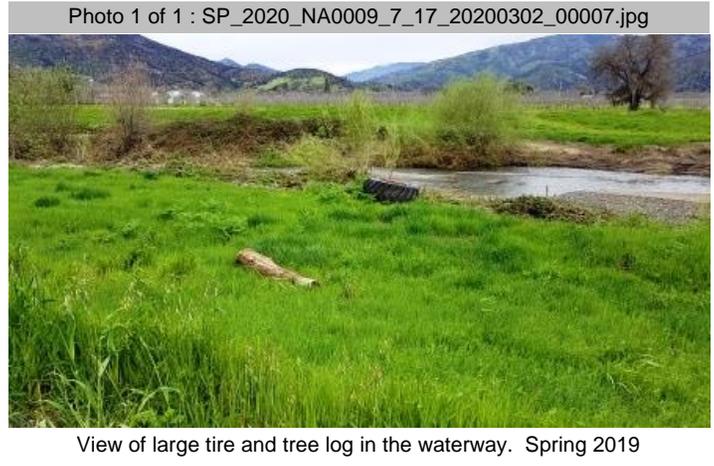
LM Start	0.33	Rating **	M	Issue No.	17
LM End	0.33	Issue Type +	Ma	Location *	WS
Category	Earthen Levee		GPS Latitude/Longitude		
			Start	End	
Item	Encroachments		39.176973 °	39.176973 °	
			-122.899228 °	-122.899228 °	
DWR ID	DWR_NA0009_05_s_2019_17				
Comment Code					
DE : Debris					
Inspector Comment					
Remove a large tire in the waterway.

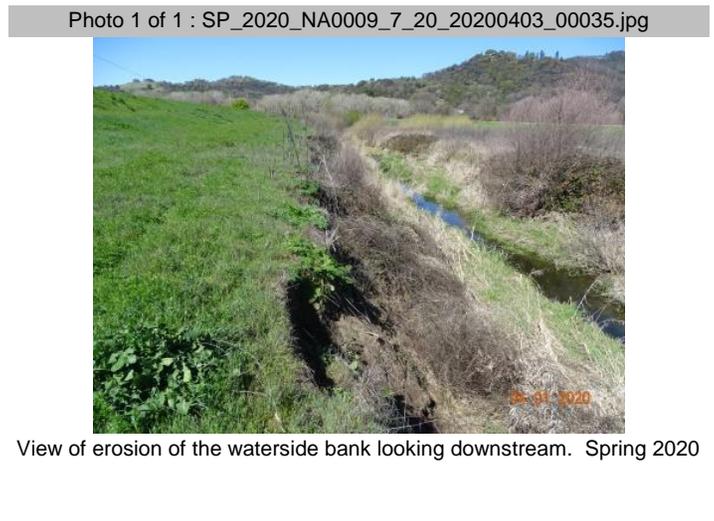
LM Start	0.82	Rating **	U	Issue No.	20
LM End	0.86	Issue Type +	Ma	Location *	WS
Category	Earthen Levee		GPS Latitude/Longitude		
			Start	End	
Item	Erosion / Bank Caving		39.175740 °	39.175750 °	
			-122.907980 °	-122.908710 °	
DWR ID	LCWPD-02				
Comment Code					
E1 : Note and monitor erosion site.					
Inspector Comment					
Levee Evaluation Comments					
Description:					
Site ID No:20					
Site Designation:LCWPD-02					
Notes: 5 - 7 ft deep erosion scarps, bank is normally near vertical but at a much smaller drop off, 1 - 3 ft. Erosion widened the creek downstream. The erosion might be past 20-30' from the levee toe.
