**Flood Control Project Maintenance  
Levee Inspections**

**2020 Channel Summary Report**

**Merced Streams Group**

**Levee Inspection Report By Mile - Channel 2020**

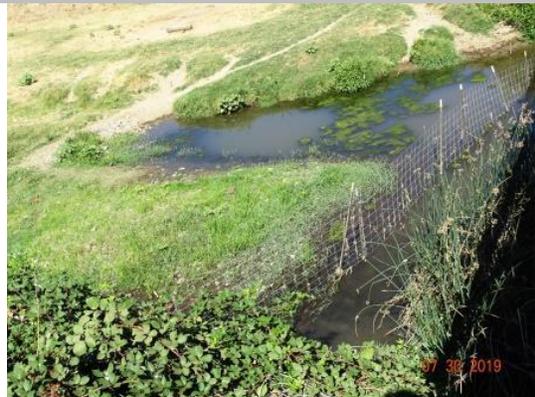
Photo 2 of 2 : CH\_2020\_NA0013\_32\_10\_20200622\_00003.jpg

View of wire fence across channel. Summer 2019

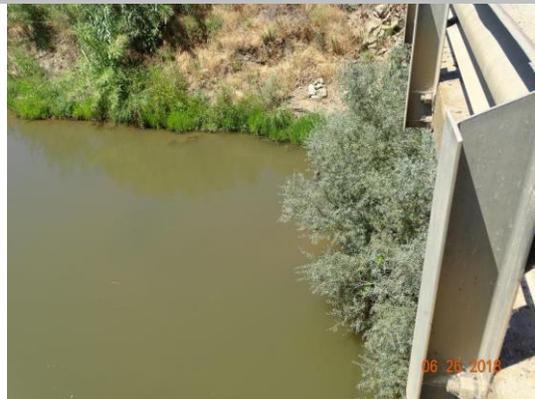
Photo 1 of 1 : CH\_2020\_NA0013\_32\_38\_20200622\_00016.jpg

View of erosion on right bank of channel downstream of the bridge. Summer 2018

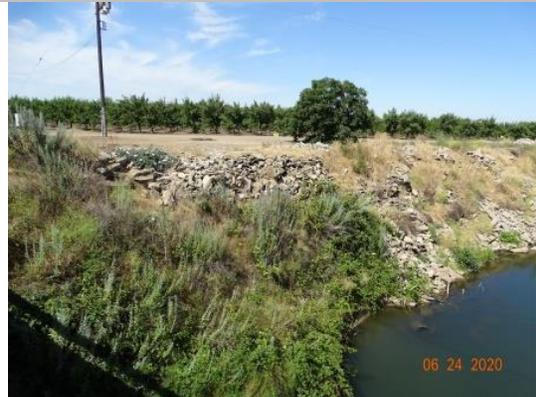
Photo 1 of 1 : CH\_2020\_NA0013\_32\_39\_20200703\_00082.jpg

View of broken concrete as riprap on the left bank. Summer 2020

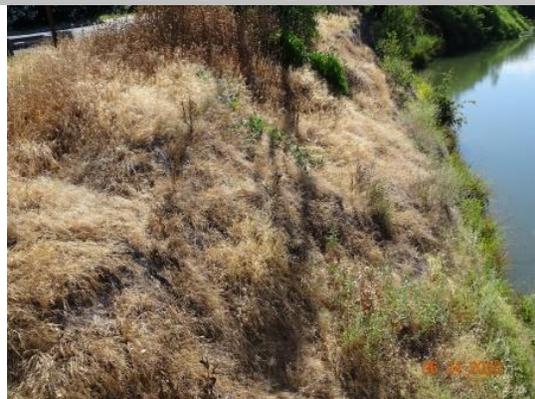
Photo 1 of 2 : CH\_2020\_NA0013\_32\_43\_20200701\_00074.jpg

Rating **	U	Issue No.	43
Issue Type +	Ma	Location *	37.309600 °
Category	Rivers, Channels & Designated Flood		-120.444500 °
Item	Erosion / Bank Caving		
DWR ID	DWR_NA0013_32_c_2016_43		
Action/Comments			
Inspector Comments: Erosion still present on the right bank upstream of McKee Rd. Bank should be repaired before Flood Season.

View of erosion on the right bank upstream of the McKee Road bridge. Summer 2020

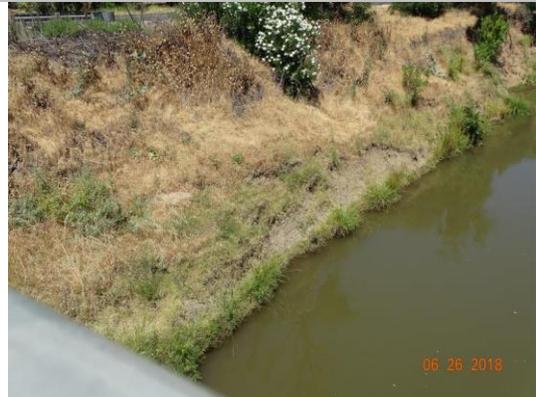
Photo 2 of 2 : CH\_2020\_NA0013\_32\_43\_20200622\_00023.jpg

Check Point / View				
<b>McKee Rd / Up (cont)</b>				
Rating **	U	Issue No.	<b>43 (cont)</b>	GPS Lat/Long
Issue Type +	Ma	Location *		37.309600 °
Category	Rivers, Channels & Designated Flood			-120.444500 °
Item	Erosion / Bank Caving			
DWR ID	DWR_NA0013_32_c_2016_43			
Action/Comments				
Inspector Comments: Erosion still present on the right bank upstream of McKee Rd. Bank should be repaired before Flood Season.

View of erosion on the right bank upstream of the McKee Road bridge. Summer 2018

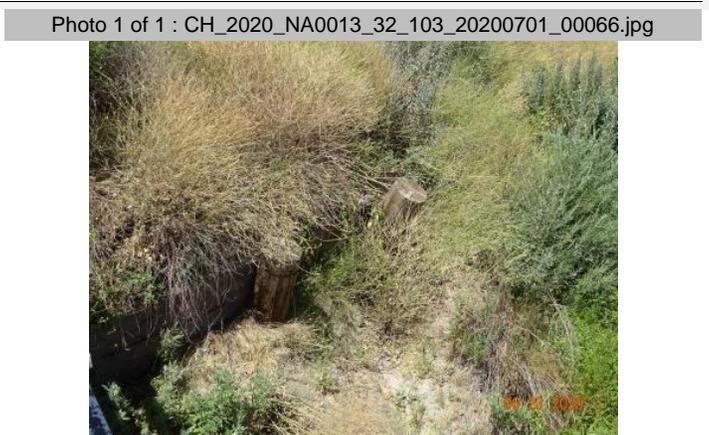
Rating **	A	Issue No.	<b>103</b>
Issue Type +	Ma	Location *	GPS Lat/Long
Category	Rivers, Channels & Designated Flood		37.256440 °
Item	Erosion / Bank Caving		-120.651870 °
DWR ID	DWR_NA0013_32_c_2016_103		
Action/Comments			
Inspector Comments: Erosion on the right bank is mitigated by a wooden retaining wall

View of a wooden retaining wall on the right bank. Summer 2020

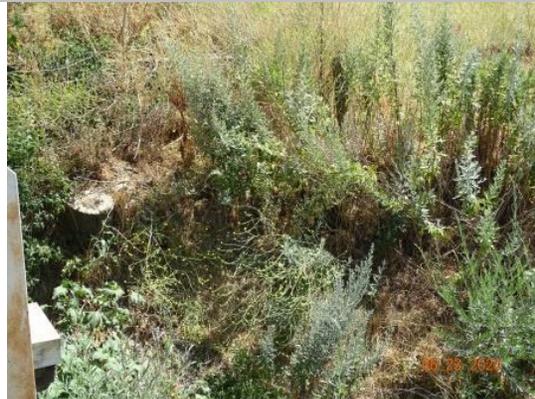
Photo 1 of 1 : CH\_2020\_NA0013\_32\_108\_20200701\_00069.jpg

View of erosion on the left bank mitigated by a wooden retaining wall. Summer 2020

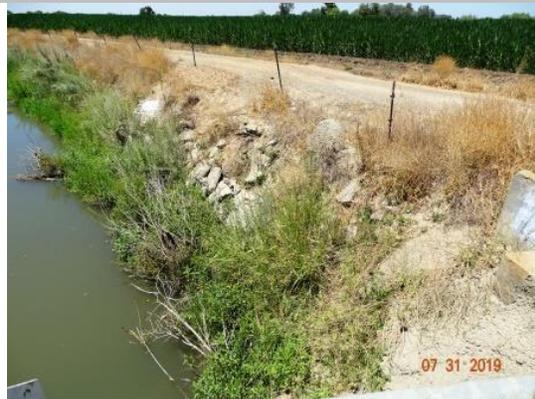
Photo 1 of 1 : CH\_2020\_NA0013\_32\_109\_20200622\_00054.jpg

View of broken concrete as riprap on the right bank. Summer 2019

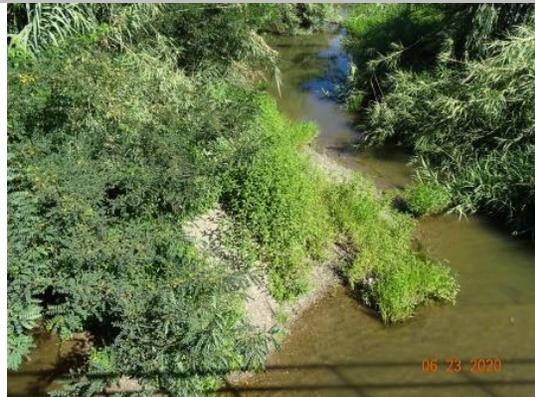
Photo 1 of 1 : CH\_2020\_NA0013\_33\_17\_20200701\_00054.jpg

View of shoaling with vegetation downstream of dam. Summer 2020

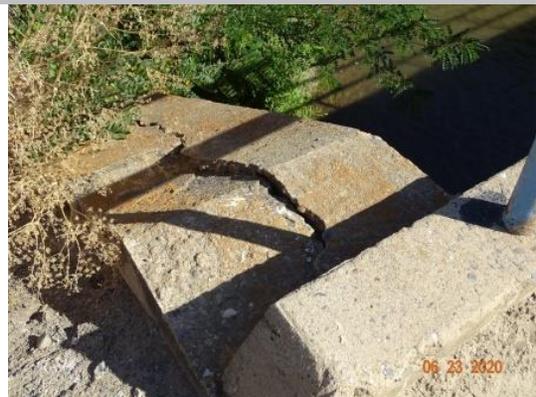
Photo 1 of 2 : CH\_2020\_NA0013\_33\_81\_20200701\_00060.jpg

View of cracking of the left bank bridge abutment downstream of Crocker Dam. Summer 2020

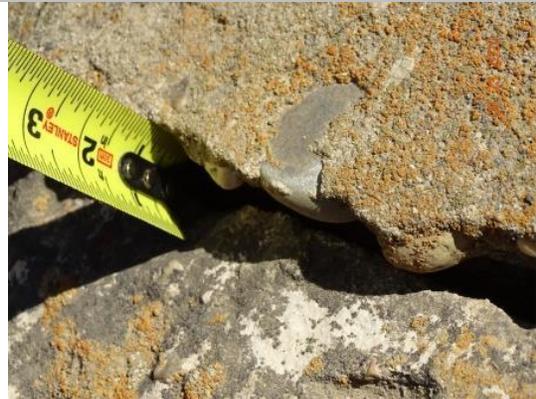
Photo 2 of 2 : CH\_2020\_NA0013\_33\_81\_20200701\_00061.jpg

View of settlement approximately 1" deep underneath the left bank bridge abutment. Summer 2020

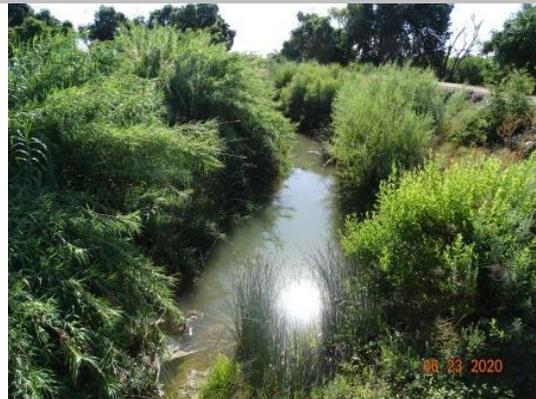
Photo 1 of 1 : CH\_2020\_NA0013\_33\_21\_20200701\_00048.jpg

View of vegetation looking upstream. Summer 2020

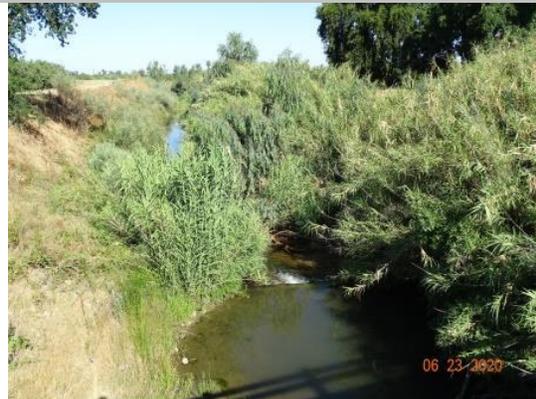
Photo 1 of 1 : CH\_2020\_NA0013\_33\_26\_20200701\_00050.jpg

View of vegetation downstream. Summer 2020

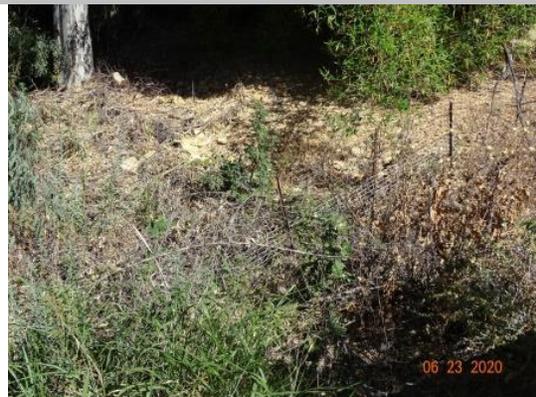
Photo 1 of 1 : CH\_2020\_NA0013\_33\_40\_20200701\_00057.jpg

View of wire fencing on the right bank of the Gurr Road crossing. Summer 2020

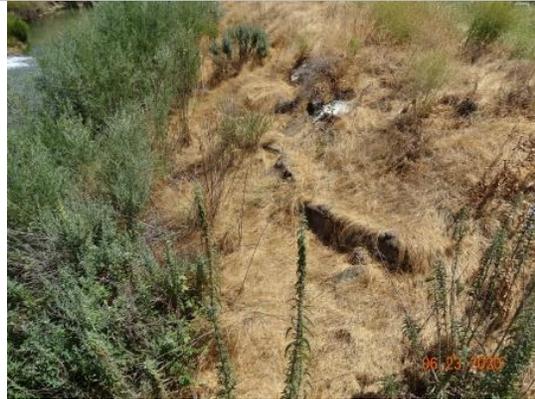
Photo 1 of 2 : CH\_2020\_NA0013\_33\_53\_20200701\_00067.jpg

View of erosion on the left bank. Summer 2020

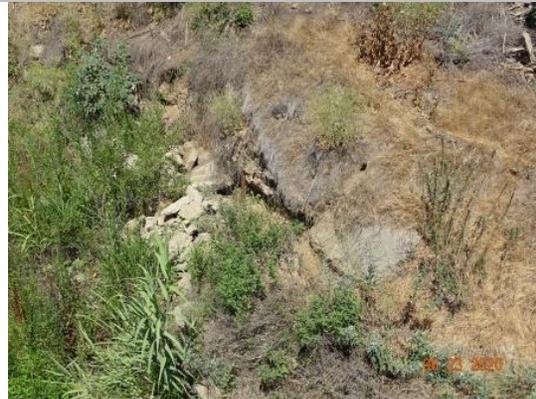
Photo 1 of 2 : CH\_2020\_NA0013\_33\_58\_20200701\_00064.jpg

View of erosion site on the right bank. Summer 2020

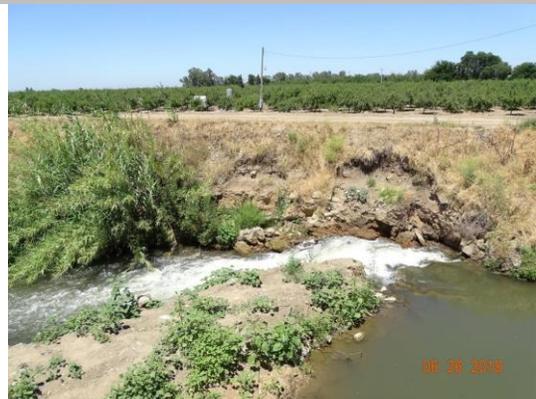
Photo 2 of 2 : CH\_2020\_NA0013\_33\_58\_20200622\_00030.jpg

Significant erosion on right bank downstream of Quinley Rd. crossing .  
Summer 2018

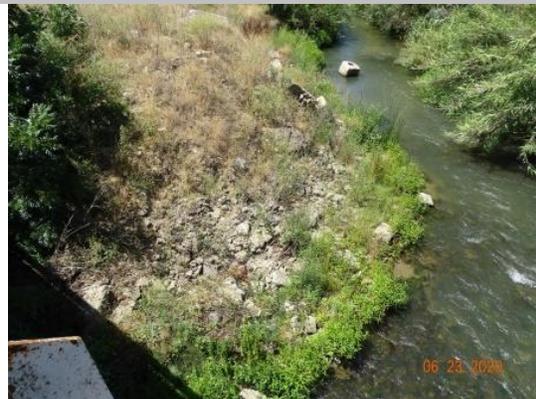
Photo 1 of 1 : CH\_2020\_NA0013\_33\_59\_20200701\_00065.jpg

View of broken concrete on the left bank. Summer 2020

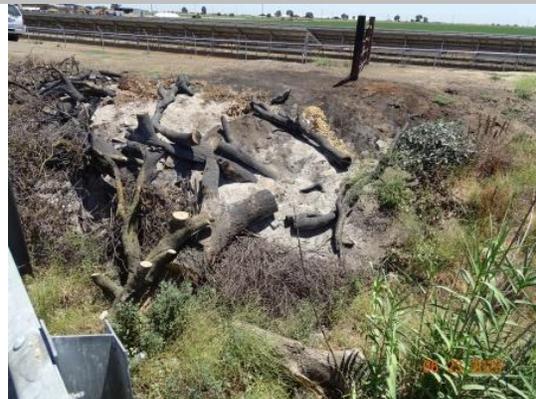
Photo 1 of 1 : CH\_2020\_NA0013\_33\_70\_20200701\_00070.jpg

View of tree debris on the left bank downstream of bridge. Summer 2020

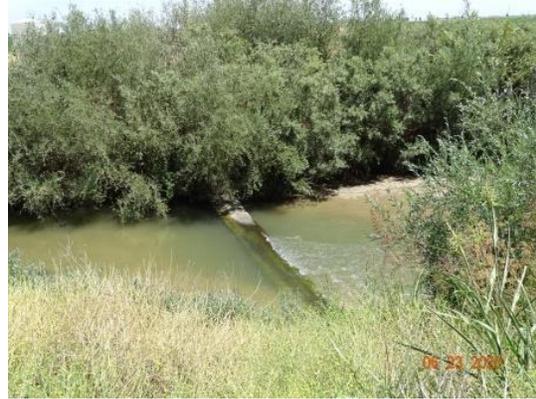
Photo 1 of 1 : CH\_2020\_NA0013\_33\_80\_20200701\_00072.jpg

View of weir or dam structure across channel. Summer 2020

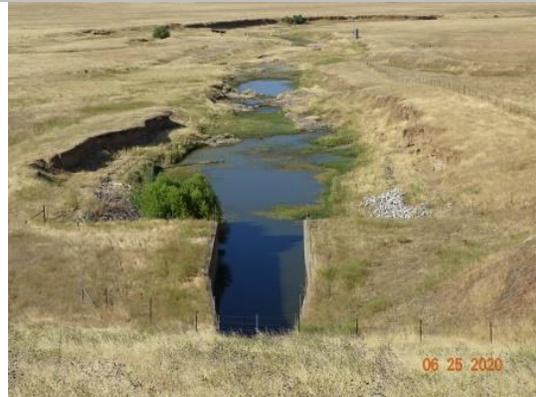
Photo 1 of 1 : CH\_2020\_NA0013\_34\_6\_20200703\_00032.jpg

View of vegetation downstream of the Burns Creek Dam. Summer 2020

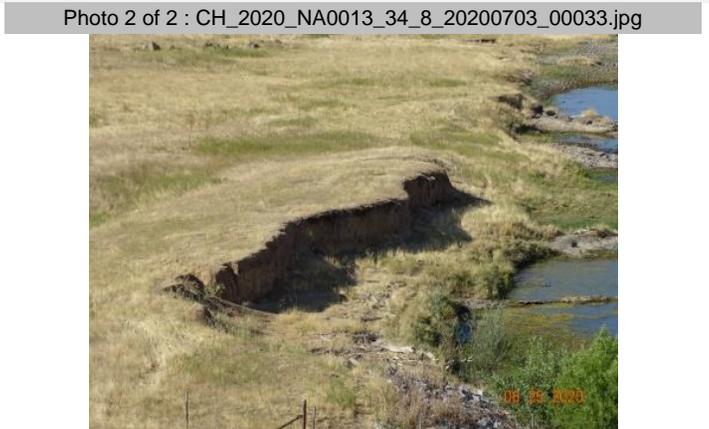
Check Point / View			
<b>Burns Creek Dam / Down (cont)</b>			
Rating **	A	Issue No.	<b>8 (cont)</b>
Issue Type +	Ma	Location *	GPS Lat/Long
Category	Rivers, Channels & Designated Flood		37.377220 °
Item	Erosion / Bank Caving		-120.276360 °
DWR ID	DWR_NA0013_34_c_2016_8		
Action/Comments			
Inspector Comments: Historic Erosion exists on left and right banks but it does not appear to be active.

View of historic erosion on the left bank at the Burns Creek Dam outlet. This erosion does not appear to be active. Summer 2020

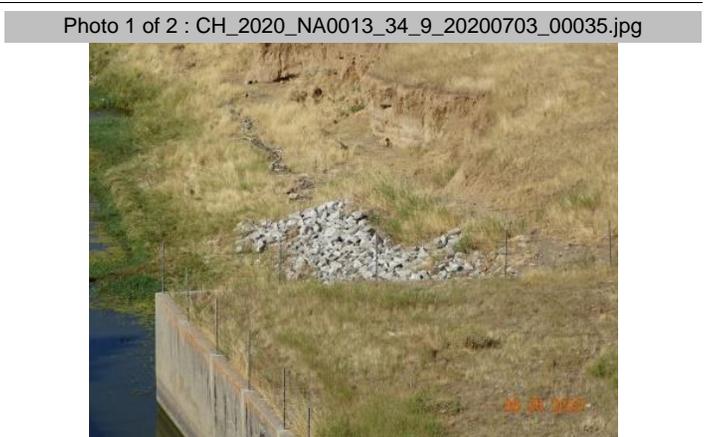
Check Point / View			
Rating **	M	Issue No.	<b>9</b>
Issue Type +	Ma	Location *	GPS Lat/Long
Category	Rivers, Channels & Designated Flood		37.377220 °
Item	Revetments		-120.276360 °
DWR ID	DWR_NA0013_34_c_2016_9		
Action/Comments			
Inspector Comments: The vegetation on the left bank growing within the riprap should be removed.

View of revetment on the right bank of the Burns Creek Dam outlet. Summer 2020

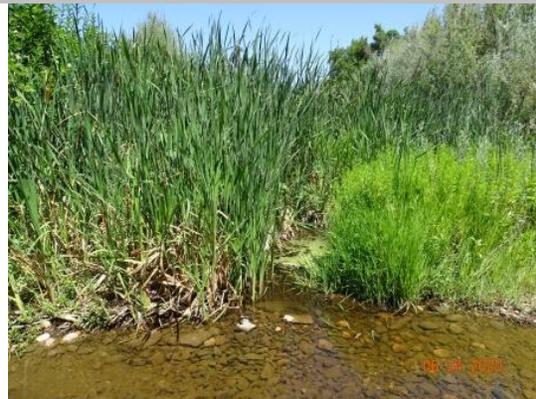
Photo 1 of 1 : CH\_2020\_NA0013\_34\_31\_20200703\_00029.jpg

View of vegetation upstream of the low water crossing on Burns Creek.  
Summer 2020

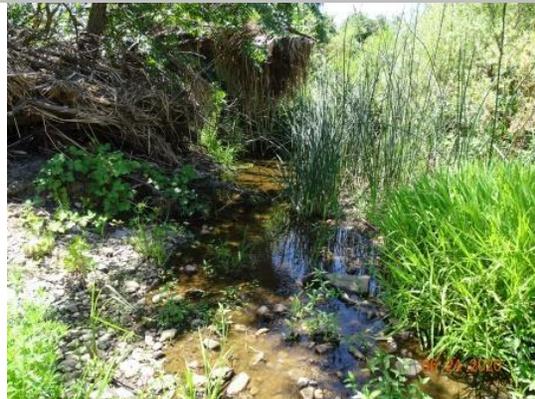
Photo 1 of 1 : CH\_2020\_NA0013\_34\_37\_20200703\_00030.jpg

View of vegetation downstream of the low water crossing on Burns Creek. Summer 2020

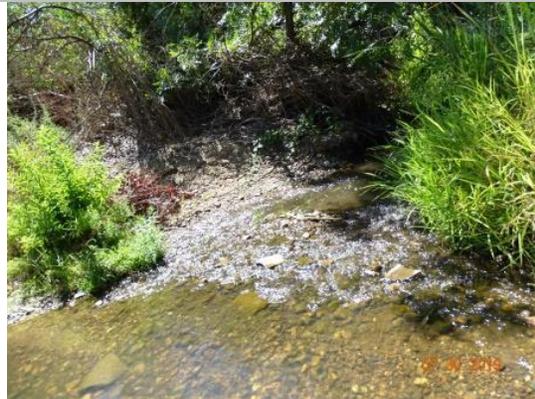
Photo 1 of 1 : CH\_2020\_NA0013\_34\_38\_20200622\_00023.jpg

View looking downstream at erosion on the left bank. Summer 2019

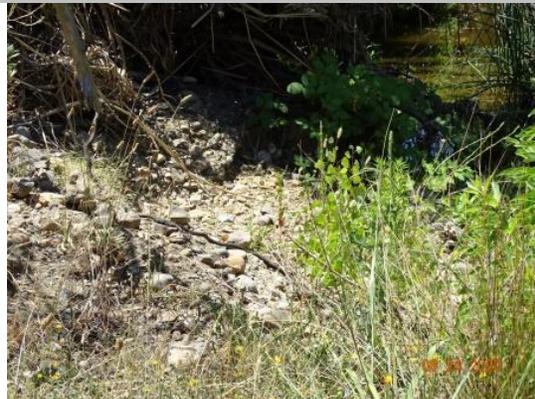
Photo 1 of 1 : CH\_2020\_NA0013\_34\_39\_20200703\_00031.jpg

View of minor erosion on the left bank. Summer 2020

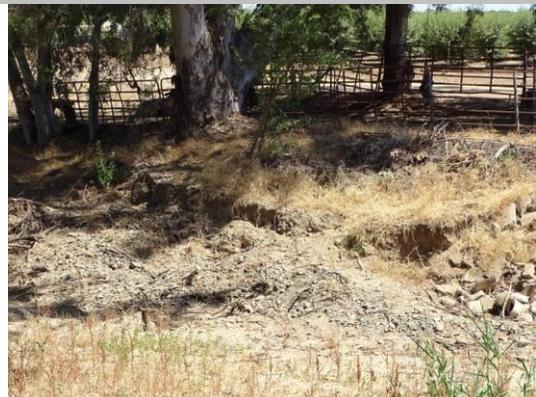
Photo 1 of 1 : CH\_2020\_NA0013\_35\_13\_20200622\_00008.jpg

View of erosion along left bank. Summer 2018

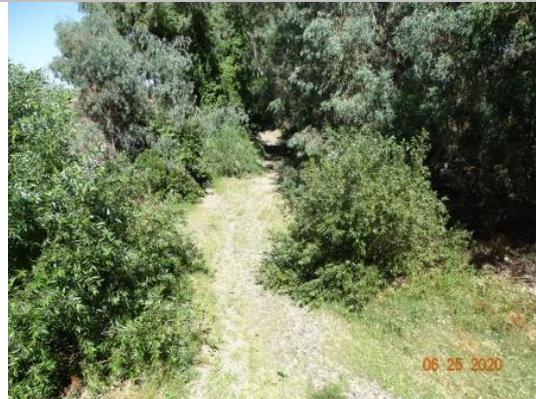
Photo 1 of 1 : CH\_2020\_NA0013\_35\_16\_20200703\_00094.jpg

View of vegetation downstream of Fresno Road crossing. Summer 2020

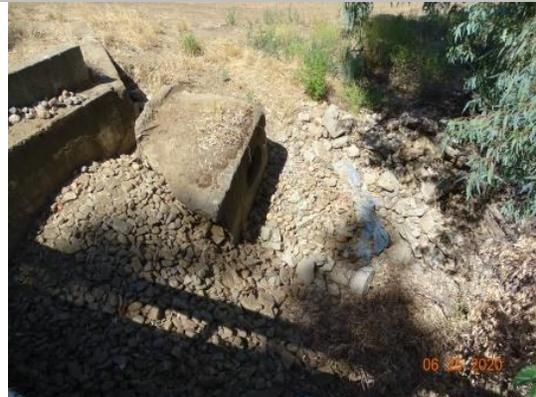
Photo 1 of 1 : CH\_2020\_NA0013\_35\_19\_20200703\_00095.jpg

View of broken concrete as riprap on the left bank downstream of Fresno Road crossing. Summer 2020

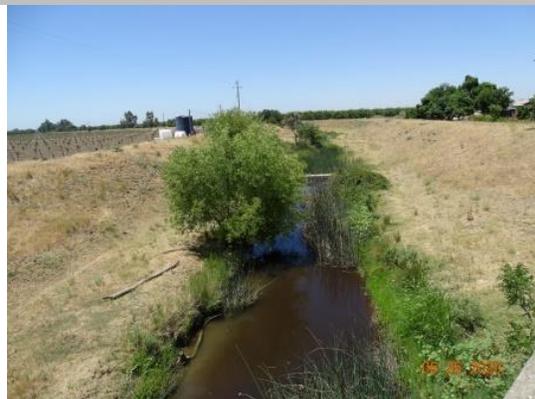
Photo 1 of 1 : CH\_2020\_NA0013\_35\_46\_20200703\_00108.jpg

View of vegetation downstream of Burchell Road. Summer 2020

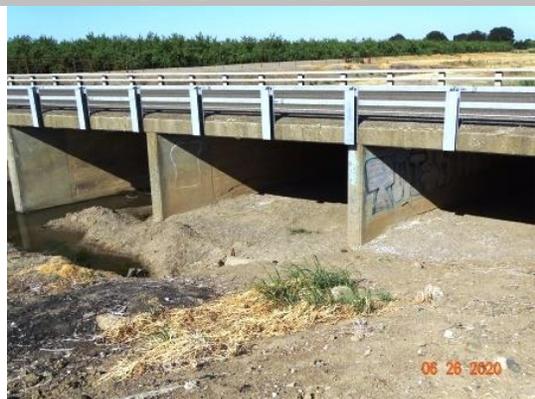
Photo 2 of 2 : CH\_2020\_NA0013\_35\_52\_20200716\_00115.jpg

View of sedimentation in two north bays. Summer 2020

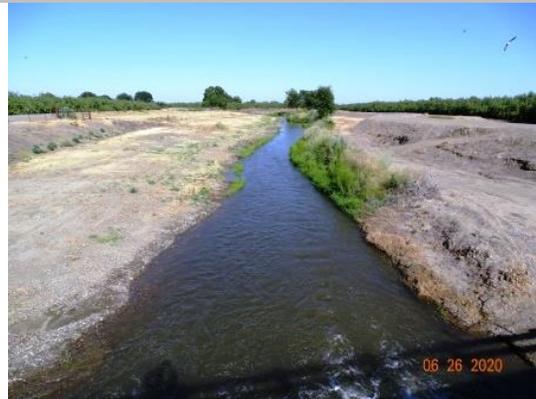
Photo 1 of 1 : CH\_2020\_NA0013\_35\_56\_20200716\_00119.jpg

View of vegetation downstream of Plainsburg Road crossing. Summer 2020

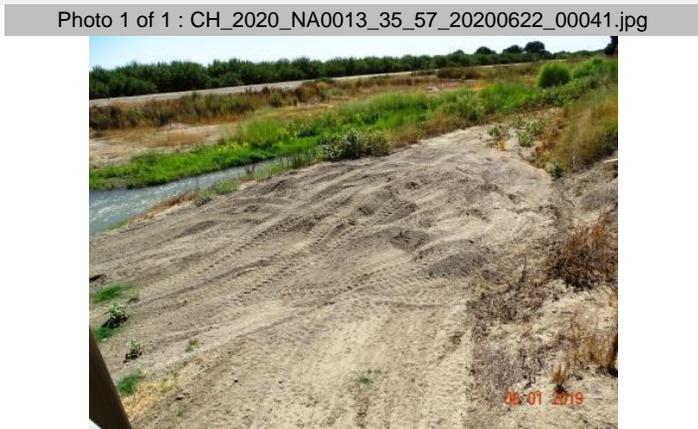
Check Point / View				
<b>Plainsburg Rd / Down (cont)</b>				
Rating **	M	Issue No.	<b>57</b>	GPS Lat/Long
Issue Type +	Ma	Location *		37.258430 °
Category	Rivers, Channels & Designated Flood			-120.325070 °
Item	Shoaling / Sedimentation			
DWR ID	DWR_NA0013_35_c_2016_57			
Action/Comments				
Inspector Comments: There is sedimentation in the channel, but flow does not appear to be impeded.

View of shoaling with vegetation on left bank and sedimentation on right bank. Summer 2019

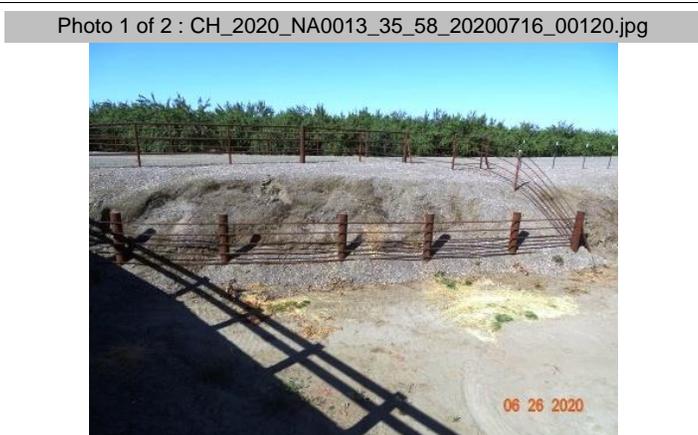
Rating **	U	Issue No.	<b>58</b>	GPS Lat/Long
Issue Type +	Ma	Location *		37.258430 °
Category	Rivers, Channels & Designated Flood			-120.325070 °
Item	Erosion / Bank Caving			
DWR ID	DWR_NA0013_35_c_2016_58			
Action/Comments				
Inspector Comments: Erosion is almost under the abutment and should be repaired.

View of erosion on the left bank. Summer 2020

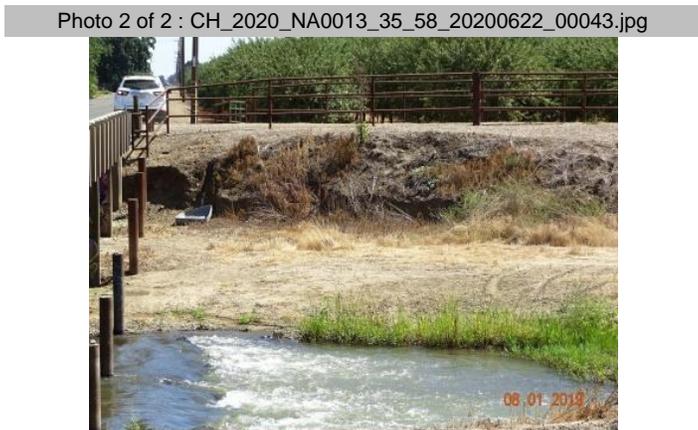
Rating **	U	Issue No.	<b>58 (cont)</b>	GPS Lat/Long
Issue Type +	Ma	Location *		37.258430 °
Category	Rivers, Channels & Designated Flood			-120.325070 °
Item	Erosion / Bank Caving			
DWR ID	DWR_NA0013_35_c_2016_58

View of erosion on the left bank. Summer 2019

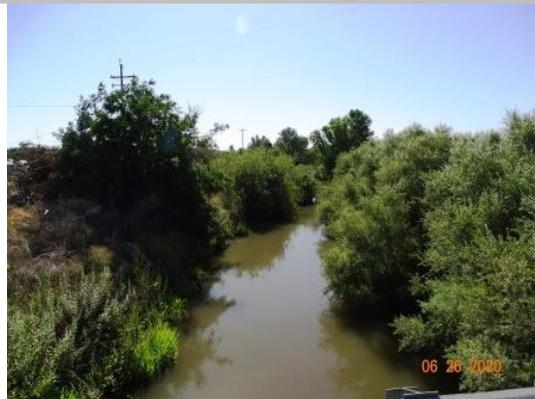
Photo 1 of 2 : CH\_2020\_NA0013\_35\_61\_20200716\_00123.jpg

View of vegetation upstream of Whealan Road. Summer 2020

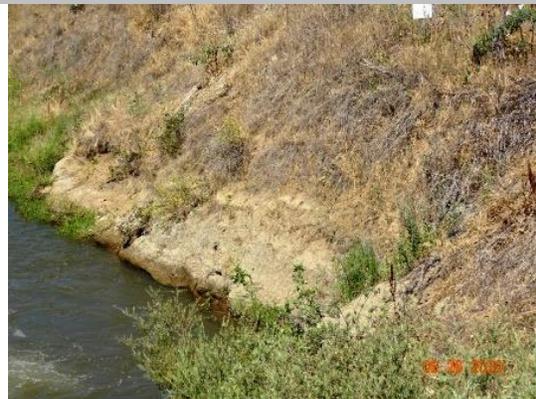
Photo 1 of 2 : CH\_2020\_NA0013\_35\_78\_20200716\_00128.jpg

View of erosion on the right bank. Summer 2020

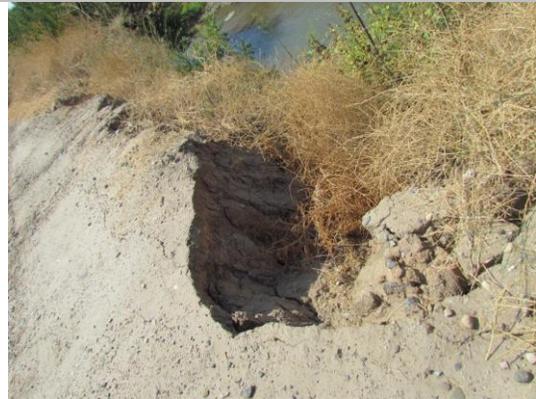
Photo 2 of 2 : CH\_2020\_NA0013\_35\_78\_20200622\_00061.jpg

View of erosion on the left bank.

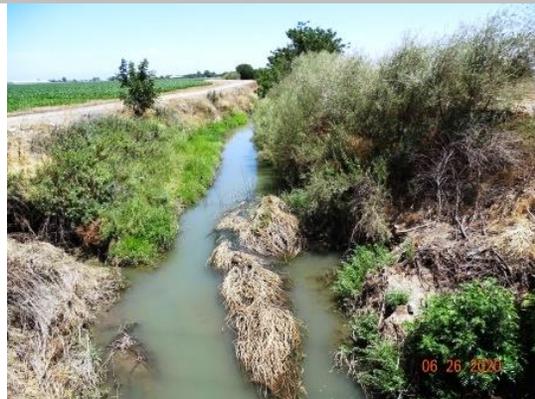
Photo 1 of 2 : CH\_2020\_NA0013\_35\_81\_20200716\_00129.jpg

View of vegetation upstream of Healy Road crossing. Summer 2020

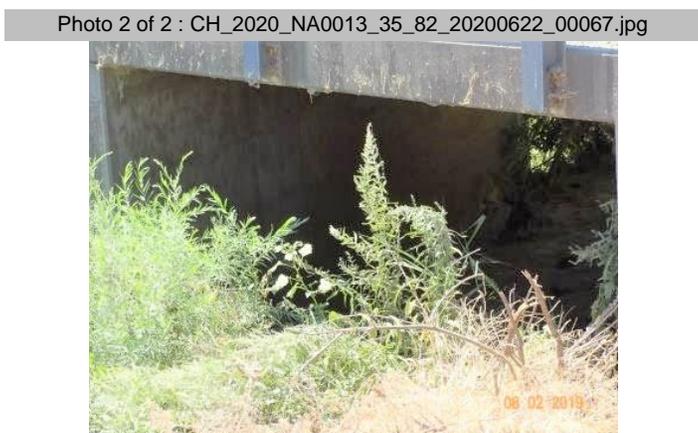
Rating **	M	Issue No.	<b>82 (cont)</b>	GPS Lat/Long
Issue Type +	Ma	Location *		37.246003 °
Category	Rivers, Channels & Designated Flood			-120.434235 °
Item	Shoaling / Sedimentation			
DWR ID	DWR_NA0013_35_c_2016_82

View of sedimentation in the northernmost bay. Summer 2019

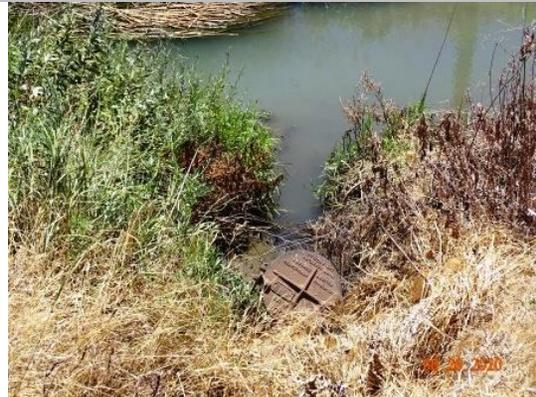
Photo 1 of 3 : CH\_2020\_NA0013\_35\_83\_20200716\_00133.jpg

View of erosion at the drainage outlet on the right bank. Summer 2020

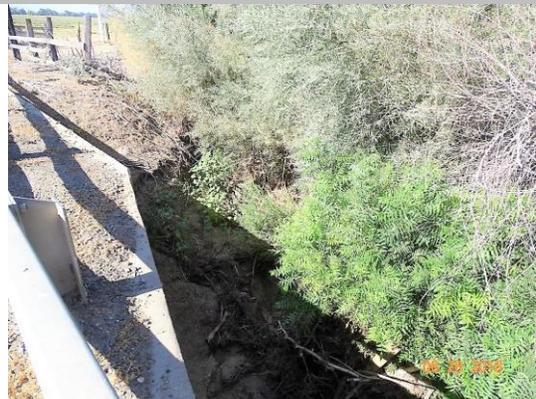
Photo 2 of 2 : CH\_2020\_NA0013\_35\_88\_20200622\_00073.jpg

View of erosion on the left bank. Summer 2018

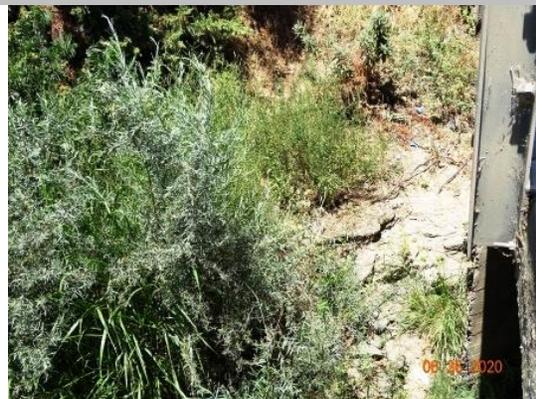
Photo 1 of 2 : CH\_2020\_NA0013\_35\_89\_20200716\_00138.jpg

View of revetment partially covered by vegetation. Summer 2020

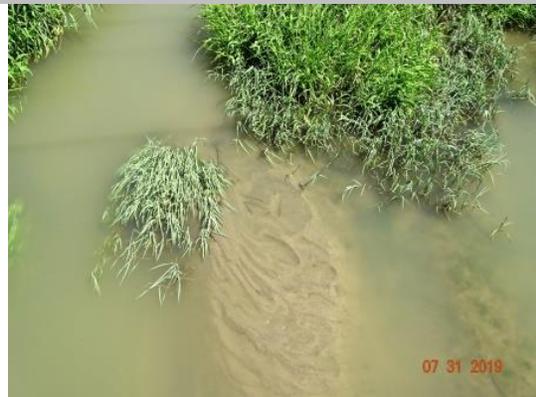
Photo 2 of 2 : CH\_2020\_NA0013\_35\_92\_20200622\_00078.jpg

View of shoaling with vegetation in the channel. Summer 2019

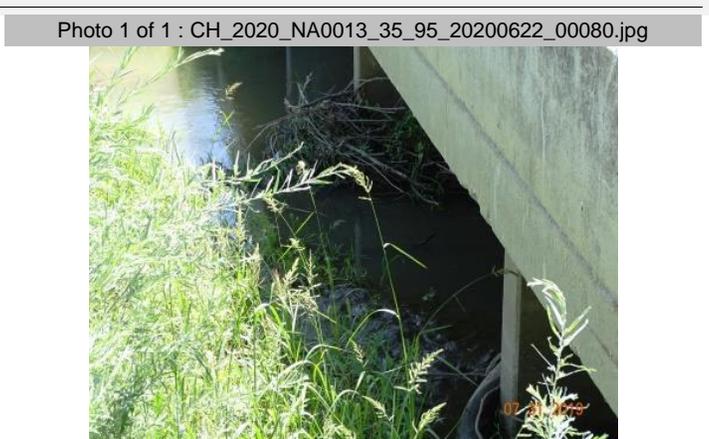
Rating **	M	Issue No. <b>95</b>	GPS Lat/Long
Issue Type +	Ma	Location *	37.233949 °
Category	Rivers, Channels & Designated Flood		-120.488009 °
Item	Encroachments		
DWR ID	DWR_NA0013_35_c_2016_95		
Action/Comments			
Inspector Comments: Remove debris from the upstream side of the bridge.

View of debris at upstream side of Hwy 59 crossing. Summer 2019

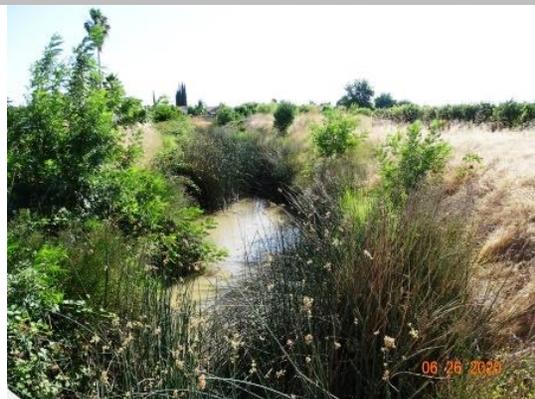
Photo 1 of 1 : CH\_2020\_NA0013\_36\_21\_20200703\_00076.jpg

View of vegetation upstream of Plainsburg Road crossing. Summer 2020

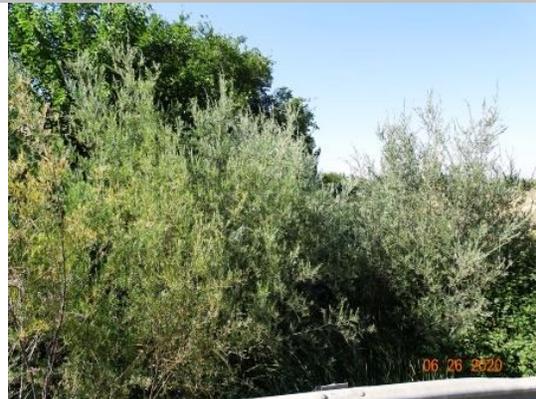
Photo 1 of 2 : CH\_2020\_NA0013\_36\_36\_20200716\_00081.jpg

View of vegetation downstream of Gerard Avenue crossing. Summer 2020

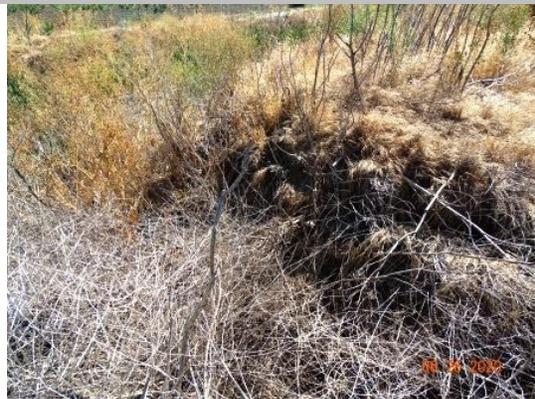
Photo 1 of 1 : CH\_2020\_NA0013\_36\_43\_20200716\_00083.jpg

View of erosion on the left bank. Summer 2020

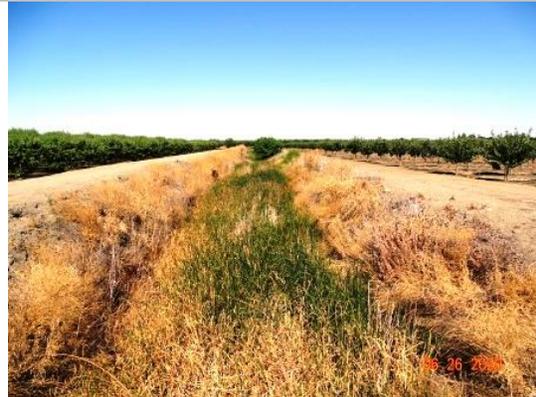
Photo 1 of 1 : CH\_2020\_NA0013\_36\_46\_20200716\_00086.jpg

View of vegetation downstream of Whealan Road crossing. Summer 2020

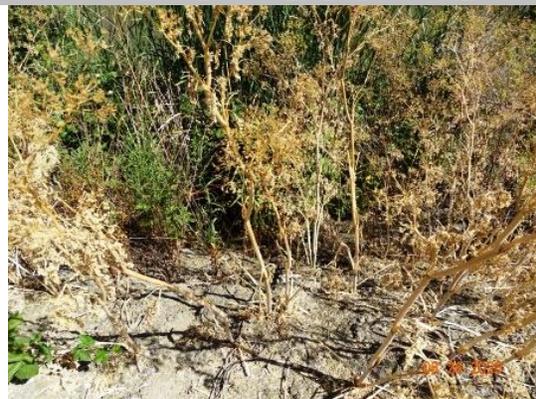
Photo 1 of 2 : CH\_2020\_NA0013\_36\_63\_20200716\_00091.jpg

View of the erosion on the left bank. Summer 2020

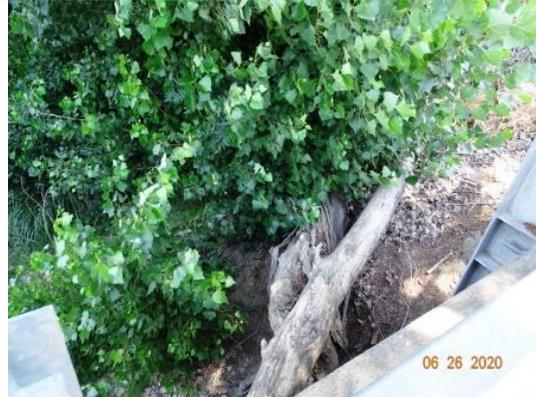
Photo 1 of 1 : CH\_2020\_NA0013\_36\_95\_20200716\_00110.jpg

View of tree log and prunings on the left bank. Summer 2020

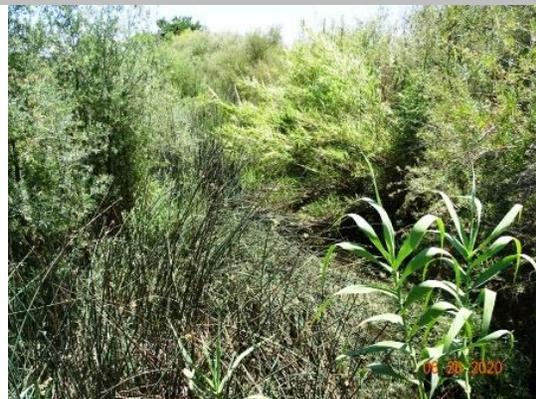
Photo 1 of 1 : CH\_2020\_NA0013\_36\_101\_20200716\_00111.jpg

View of Arundo and woody vegetation upstream of the Hwy 59 crossing. Summer 2020

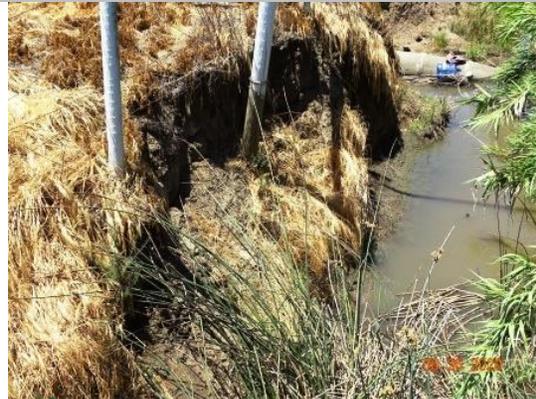
Photo 1 of 2 : CH\_2020\_NA0013\_36\_108\_20200716\_00113.jpg

View of erosion on the left bank. Summer 2020

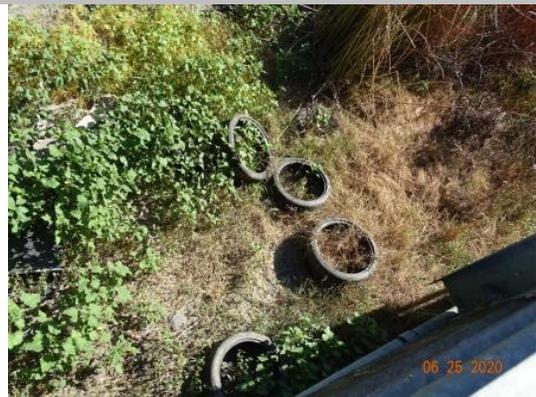
Photo 1 of 1 : CH\_2020\_NA0013\_37\_15\_20200703\_00035.jpg

View of tires in the channel. Summer 2020

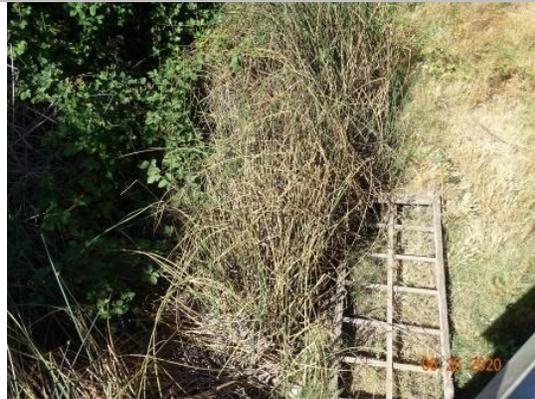
Photo 1 of 1 : CH\_2020\_NA0013\_37\_20\_20200703\_00037.jpg

View of pallet debris downstream of the bridge. Summer 2020

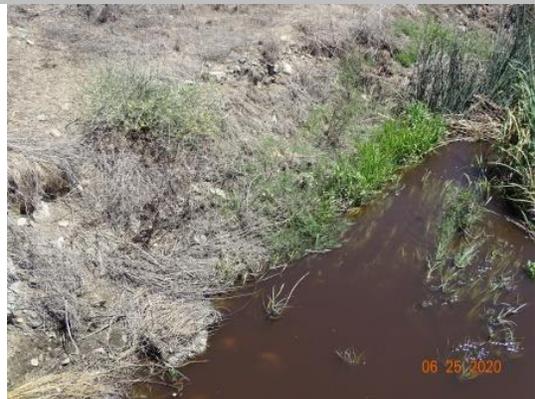
Photo 1 of 1 : CH\_2020\_NA0013\_37\_28\_20200703\_00042.jpg

View of minor erosion on the left bank. Summer 2020

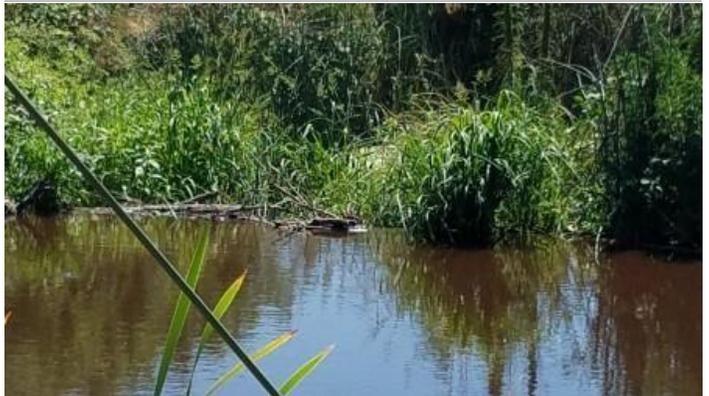
Photo 1 of 1 : CH\_2020\_NA0013\_37\_35\_20200703\_00048.jpg

View of earth dam or beaver dam across the channel. Summer 2020
