**Flood Control Project Maintenance
Levee Inspections**

Maintenance Issue Types Only, Levee Inspection Report By Mile - Fall 2019

Plumas County

Waterway	Bank	Unit Miles	Inspection Start/End	Inspector
Unit No. 01 North Fork Feather River	Left	1.89	10/21/2019 10/21/2019	Sterling York

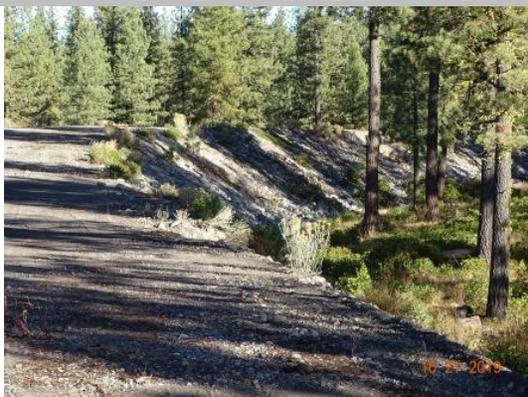
Photo 1 of 1 : FA_2019_NA0015_337_5_20191029_00007.jpg

LM Start	0.00	Rating **	A	Issue No.	5
LM End	1.86	Issue Type +	Ma	Location *	LS
Category	Earthen Levee		GPS Latitude/Longitude		
			Start	End	
Item	Vegetation		40.273190°	40.296893°	
			-121.244775°	-121.257239°	
DWR ID	DWR_NA0015_01_f_2019_5				
Comment Code					
V1 : Control annual grass and weeds on the levee slopes and easements.					
Inspector Comment					
The annual vegetation is well maintained, Fall 2019.

View looking upstream landside of the well maintained annual vegetation, Fall 2019.

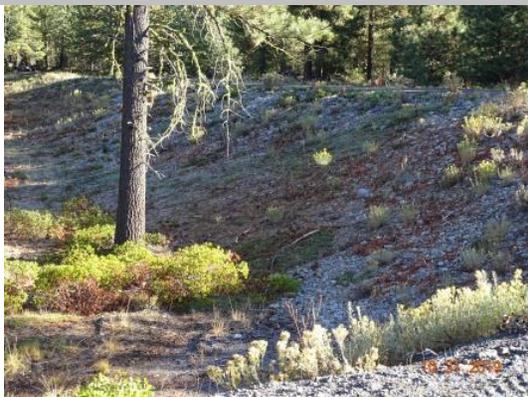
Photo 1 of 1 : FA_2019_NA0015_337_6_20191029_00008.jpg

LM Start	0.00	Rating **	A	Issue No.	6
LM End	1.86	Issue Type +	Ma	Location *	WS
Category	Earthen Levee		GPS Latitude/Longitude		
			Start	End	
Item	Vegetation		40.273190°	40.296896°	
			-121.244775°	-121.257236°	
DWR ID	DWR_NA0015_01_f_2019_6				
Comment Code					
V1 : Control annual grass and weeds on the levee slopes and easements.					
Inspector Comment					
The annual vegetation is well maintained, Fall 2019.

View looking upstream waterside of the well maintained annual vegetation, Fall 2019.

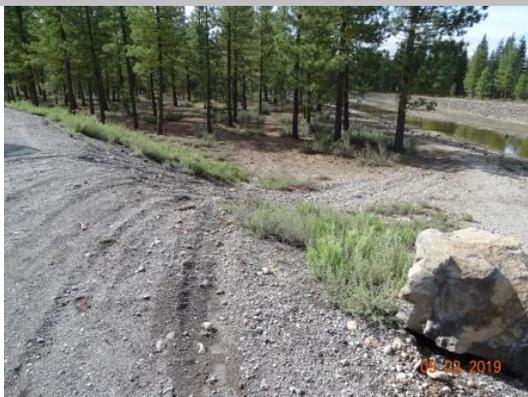
Photo 1 of 1 : FA_2019_NA0015_337_8_20190904_00001.jpg

LM Start	0.54	Rating **	A/W	Issue No.	8
LM End	0.54	Issue Type +	Ma	Location *	WS
Category	Earthen Levee		GPS Latitude/Longitude		
			Start	End	
Item	Slope Stability		40.279775°	40.279775°	
			-121.249648°	-121.249648°	
DWR ID	DWR_NA0015_01_f_2018_8				
Comment Code					
S3 : Repair the levee slope damaged by vehicle traffic and prevent access where possible.					
Inspector Comment					
The vehicle erosion on the waterside slope is not a threat to the levee slope but should be monitored, Fall 2019.

View of vehicle erosion on the waterside slope, Spring 2019

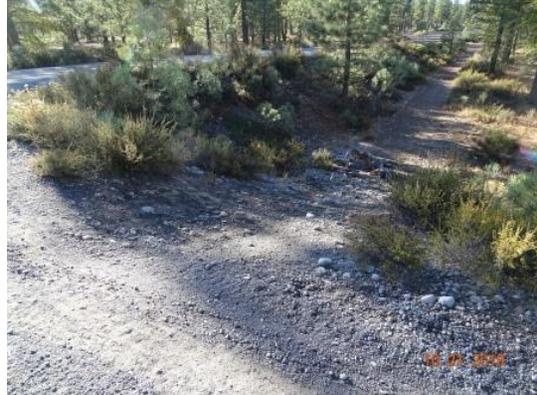
Photo 1 of 1 : FA_2019_NA0015_338_4_20191029_00010.jpg

LM Start	0.55	Rating **	M	Issue No.	4
LM End	0.55	Issue Type +	Ma	Location *	LS
Category	Earthen Levee			GPS Latitude/Longitude	
				Start	End
Item	Slope Stability			40.281950 °	40.281950 °
				-121.253710 °	-121.253710 °
DWR ID	DWR_NA0015_02_s_2012_4				
Comment Code					
S3 : Repair the levee slope damaged by vehicle traffic and prevent access where possible.					
Inspector Comment					
There is no sign of slope instability but should be monitored for the next year. The access has been blocked, Fall 2019.

View of the undesignated vehicle access along the landside slope, there is no sign of slope instability but should be monitored for the next year, Fall 2019.

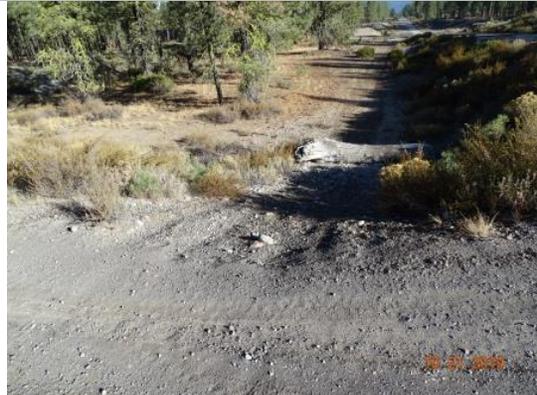
Photo 1 of 1 : FA_2019_NA0015_338_5_20191029_00009.jpg

LM Start	0.55	Rating **	A/W	Issue No.	5
LM End	0.55	Issue Type +	Ma	Location *	WS
Category	Earthen Levee			GPS Latitude/Longitude	
				Start	End
Item	Slope Stability			40.281950 °	40.281950 °
				-121.253710 °	-121.253710 °
DWR ID	DWR_NA0015_02_s_2012_5				
Comment Code					
S3 : Repair the levee slope damaged by vehicle traffic and prevent access where possible.					
Inspector Comment					
There is no sign of slope instability but should be monitored for the next year. The access has been blocked, Fall 2019.

View of the undesignated vehicle access along the waterside slope, there is no sign of slope instability but should be monitored for the next year, Fall 2019.
