**Flood Control Project Maintenance  
Levee Inspections  
2020 Channel Summary Report  
Overall Unit and Item Ratings**

**San Joaquin County Flood Control and Water Conservation District**

**Levee Inspection Report By Mile - Channel 2020**

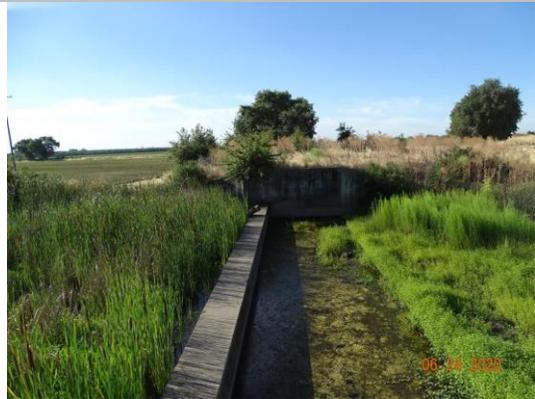
Photo 1 of 3 : CH\_2020\_NA0017\_43\_31\_20200701\_00016.jpg

Check Point / View			
<b>Diversion Structure / Down</b>			
Rating **	A	Issue No.	<b>31</b>
Issue Type +	Ma	Location *	37.938270 °
Category	Rivers, Channels & Designated Flood		-120.990130 °
Item	Vegetation & Obstructions		
DWR ID	DWR_NA0017_43_c_2012_31		
Action/Comments			
Inspector Comments: Flow is not impeded by the minimal vegetation within the channel.

View of downstream vegetation within the channel weir looking towards left bank. Summer 2020

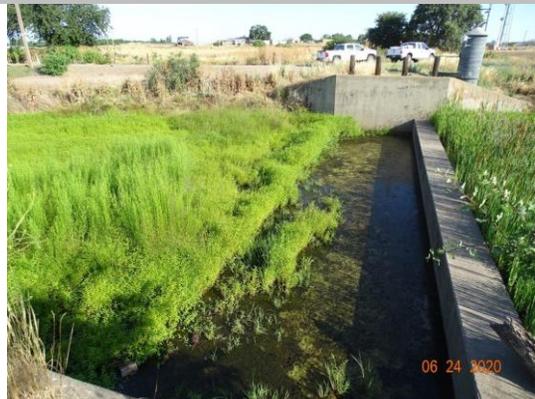
Photo 2 of 3 : CH\_2020\_NA0017\_43\_31\_20200701\_00017.jpg

View of downstream vegetation within the channel weir looking towards right bank. Summer 2020

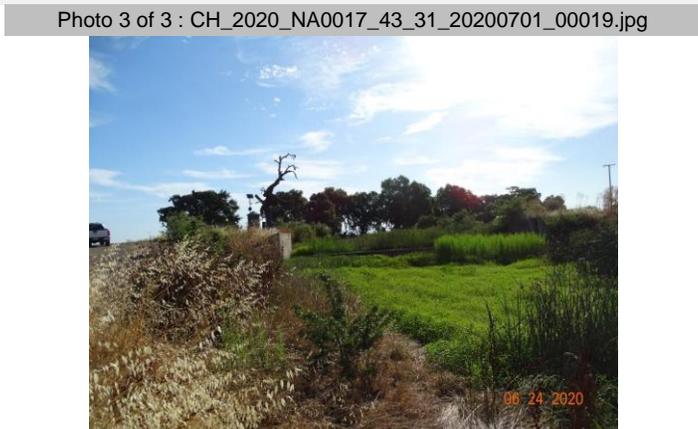
Check Point / View				
<b>Diversion Structure / Down (cont)</b>				
Rating **	A	Issue No.	<b>31 (cont)</b>	GPS Lat/Long
Issue Type +	Ma	Location *		37.938270 °
Category	Rivers, Channels & Designated Flood			-120.990130 °
Item	Vegetation & Obstructions			
DWR ID	DWR_NA0017_43_c_2012_31			
Action/Comments				
Inspector Comments: Flow is not impeded by the minimal vegetation within the channel.

View of downstream vegetation within the channel weir looking upstream. Summer 2020

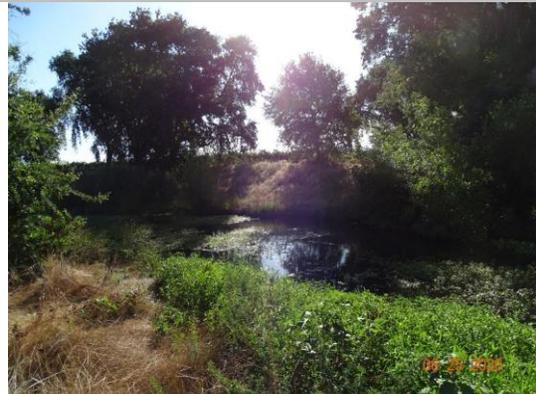
Photo 1 of 1 : CH\_2020\_NA0017\_43\_23\_20200701\_00028.jpg

Rating **	A	Issue No. <b>23</b>	GPS Lat/Long
Issue Type +	Ma	Location *	37.925730 °
Category	Rivers, Channels & Designated Flood		-120.992290 °
Item	Erosion / Bank Caving		
DWR ID	DWR_NA0017_43_c_2012_23		
Action/Comments			
Inspector Comments: Minimal erosion on left bank observed. It does not appear to encroach into the designed grade.

View of minor bank erosion on left bank upstream of the confluence. Summer 2020

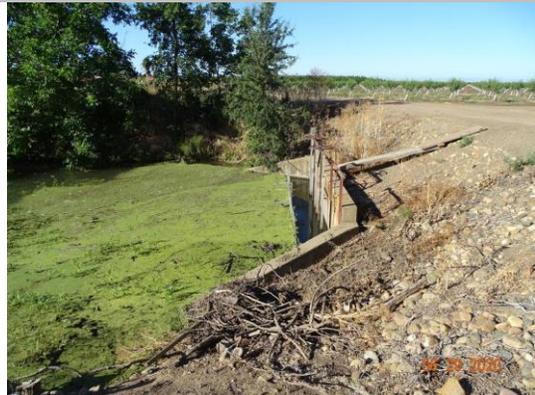
Photo 1 of 1 : CH\_2020\_NA0017\_42\_113\_20200706\_00048.jpg

View of slides gates on the upstream side . Slide gates are operational and well maintained. Summer 2020

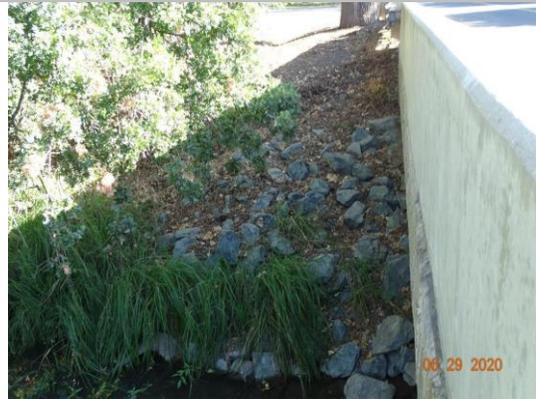
Photo 1 of 1 : CH\_2020\_NA0017\_42\_29\_20200706\_00052.jpg

View of riprap that is in place and well maintained on the downstream side. Summer 2020

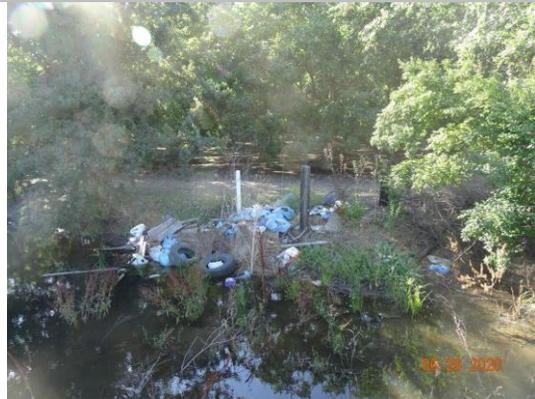
Photo 1 of 1 : CH\_2020\_NA0017\_42\_35\_20200706\_00054.jpg

View of trash and debris within the channel looking upstream. Summer 2020

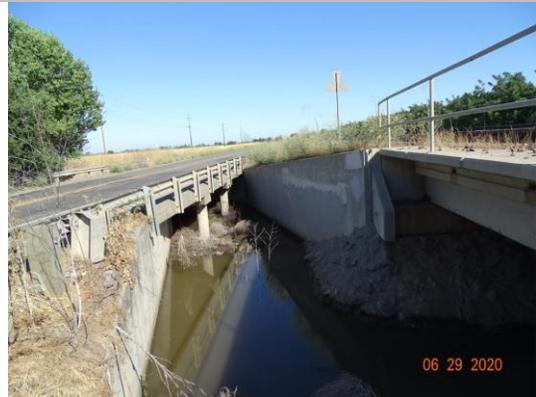
Photo 1 of 1 : CH\_2020\_NA0017\_42\_44\_20200706\_00059.jpg

View of concrete culvert and rip rap on the upstream side. Revetments are well placed and maintained. Summer 2020

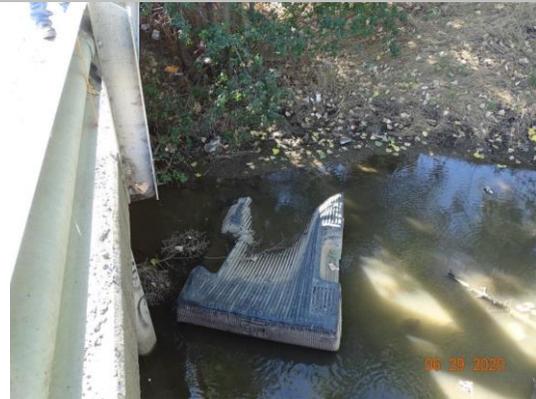
Photo 1 of 1 : CH\_2020\_NA0017\_42\_50\_20200706\_00061.jpg

There is a bed liner within the channel which may impede flows further downstream. Summer 2020

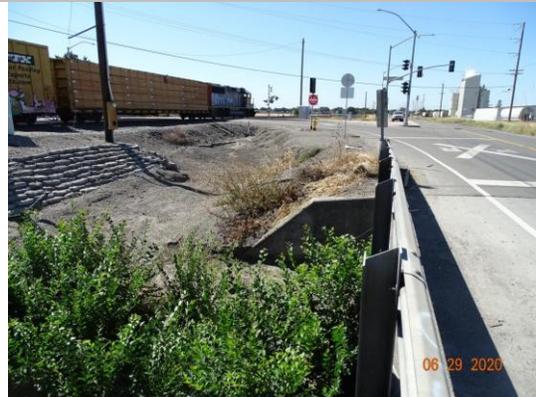
Photo 1 of 1 : CH\_2020\_NA0017\_42\_104\_20200706\_00075.jpg

View of concrete wingwall which is well maintained. Summer 2020

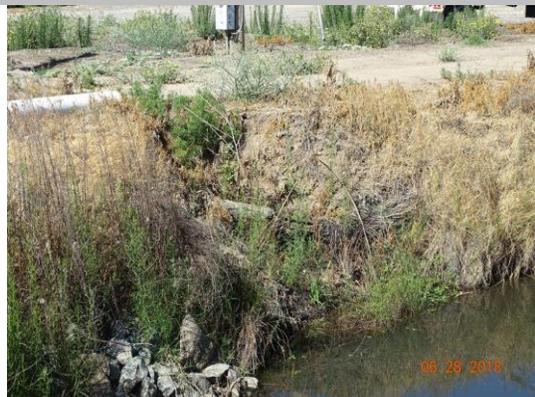
Photo 3 of 3 : CH\_2020\_NA0017\_45\_18\_20200617\_00006.jpg

View of bank erosion on the downstream of the channel. Summer 2018

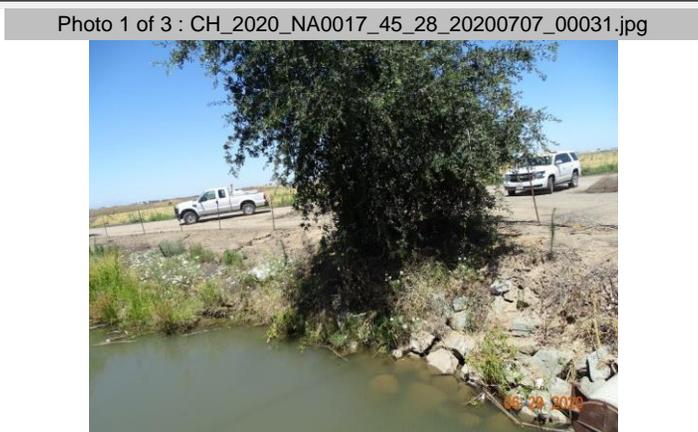
Rating **	M	Issue No.	<b>28</b>	GPS Lat/Long
Issue Type +	Ma	Location *		37.886056 °
Category	Rivers, Channels & Designated Flood			-121.183664 °
Item	Erosion / Bank Caving			
DWR ID	DWR_NA0017_45_c_2012_28			
Action/Comments				
Inspector Comments: There is erosion on the right bank of the channel.

View of the erosion on the right bank of the channel. Summer 2020
