Flood Control Project Maintenance

2020 Structure Inspection Results

San Joaquin County Flood Control and Water Conservation District

Structure	
Duck Creek Diversion Weir And Control Structure

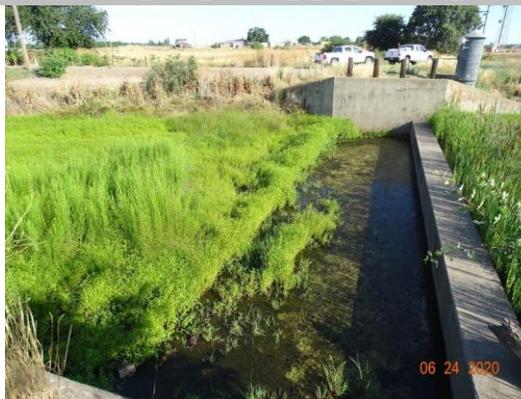
Photo 1 of 6 : ST_2020_NA0017_5_24_20200708_00013.jpg

View of weir from the left bank. Summer 2020

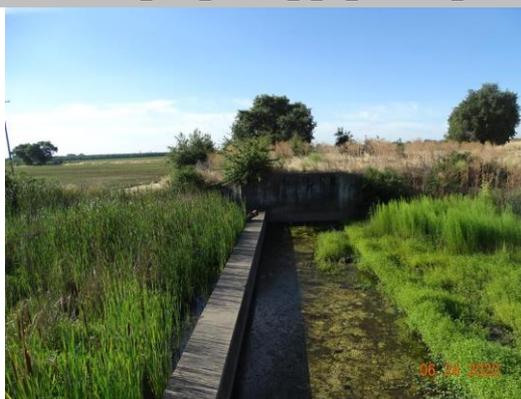
Photo 2 of 6 : ST_2020_NA0017_5_24_20200708_00018.jpg

View of weir from the right bank. Summer 2020

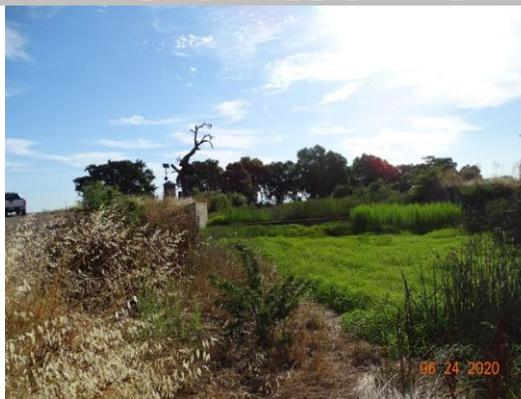
Photo 3 of 6 : ST_2020_NA0017_5_24_20200708_00017.jpg

View of weir looking upstream. Summer 2020

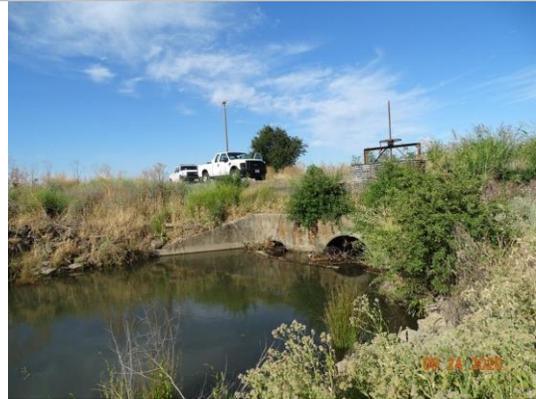
Photo 4 of 6 : ST_2020_NA0017_5_24_20200708_00019.jpg

View of inlet control structure. Summer 2020

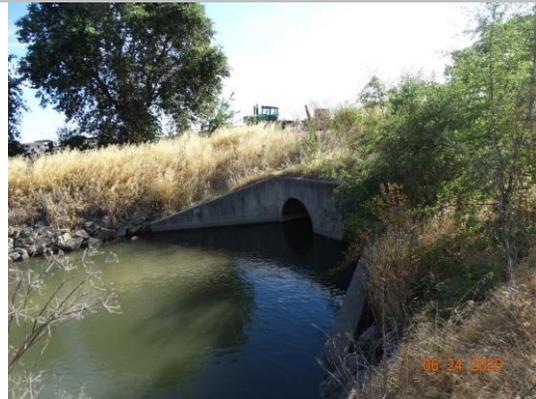
Photo 5 of 6 : ST_2020_NA0017_5_24_20200708_00021.jpg

View of outlet at control structure. Summer 2020

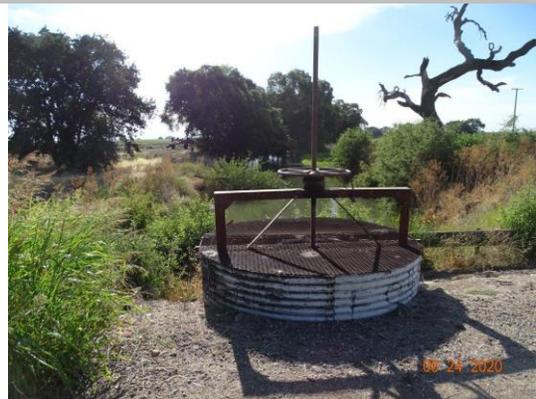
Photo 6 of 6 : ST_2020_NA0017_5_24_20200708_00020.jpg

View of slide gate at control structure. Summer 2020

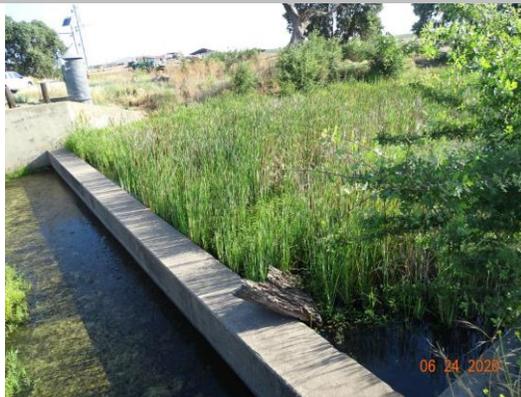
Photo 1 of 2 : ST_2020_NA0017_5_2_20200708_00022.jpg

View of vegetation looking upstream of weir. Summer 2020

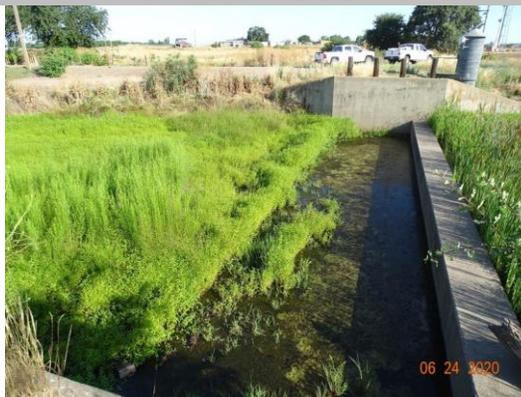
Photo 2 of 2 : ST_2020_NA0017_5_2_20200708_00027.jpg

View of vegetation looking downstream of weir. Summer 2020

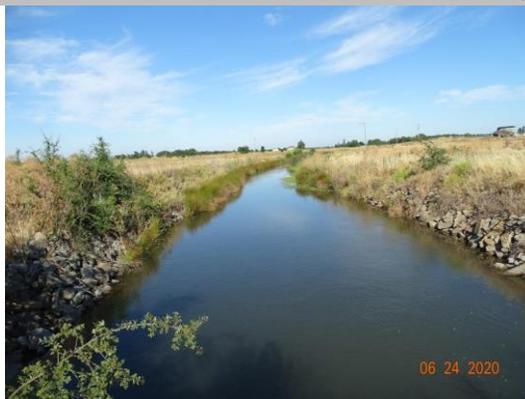
Photo 1 of 1 : ST_2020_NA0017_5_5_20200708_00030.jpg

View of revetment downstream of culvert. Summer 2020

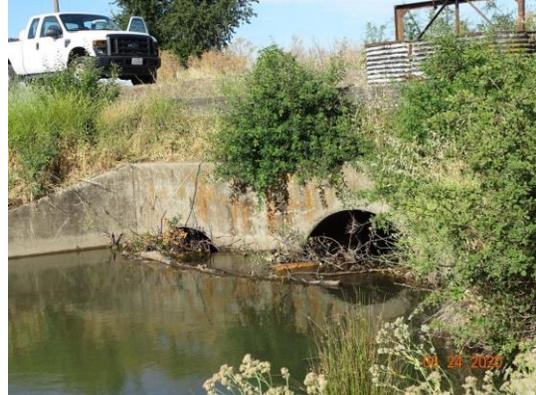
Photo 1 of 2 : ST_2020_NA0017_5_7_20200708_00029.jpg

View of inlets at culvert. Summer 2020

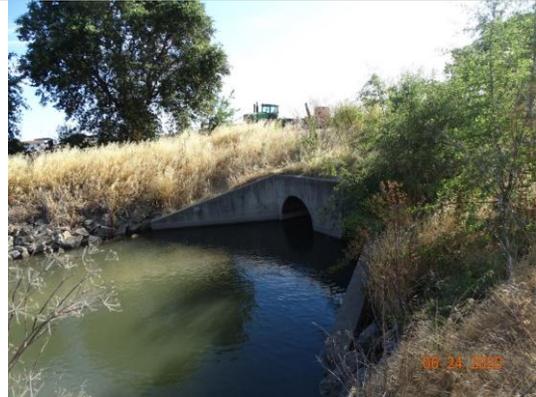
Photo 2 of 2 : ST_2020_NA0017_5_7_20200708_00028.jpg

View of outlets at culvert. Summer 2020

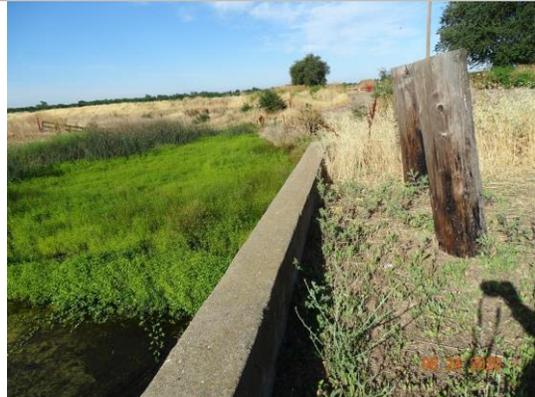
Photo 1 of 3 : ST_2020_NA0017_5_15_20200708_00032.jpg

LM Start	0.00	Rating **	A	Issue No.	15
LM End	0.00	Issue Type +	Ma	Location *	
Category	Structures & Concrete Lined Channels			GPS Latitude/Longitude	
				Start	End
Item	Concrete Surfaces			37.938383 °	37.938383 °
				-120.990133 °	-120.990133 °
DWR ID	DWR_NA0017_5_t_2012_15				
Action/Comments					
Inspector Comments: The concrete surfaces are in good condition.

View of the concrete surface at the weir. Summer 2020

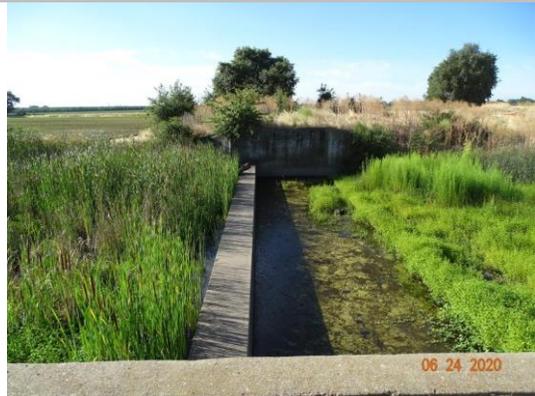
Photo 2 of 3 : ST_2020_NA0017_5_15_20200708_00033.jpg

View of the concrete surface at the weir. Summer 2020

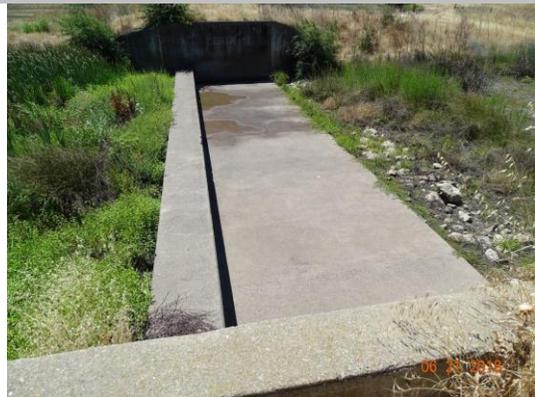
Photo 3 of 3 : ST_2020_NA0017_5_15_20200617_00008.jpg

View of the weir and the concrete surface during 2018 inspection.

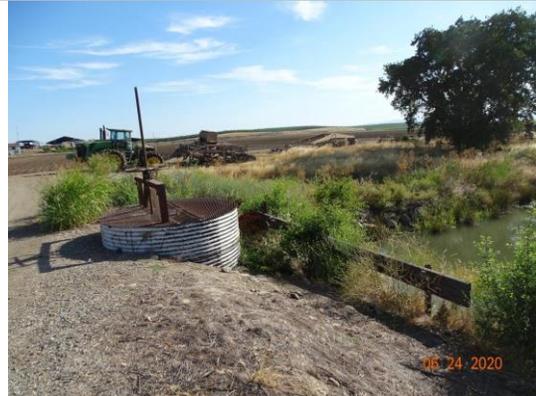
Photo 1 of 1 : ST_2020_NA0017_5_18_20200708_00034.jpg

LM Start	0.00	Rating **	A	Issue No.	18
LM End	0.00	Issue Type +	Ma	Location *	
Category	Structures & Concrete Lined Channels		GPS Latitude/Longitude		
			Start	End	
Item	Security Fencing		37.938383 °	37.938383 °	
			-120.990133 °	-120.990133 °	
DWR ID	DWR_NA0017_5_t_2012_18				
Action/Comments					
Inspector Comments: A wood railing next to the slide gate structure at the top of the culvert is providing fall hazard protection.

View of wood rail next to slide gate at the top of the culvert. Summer 2020

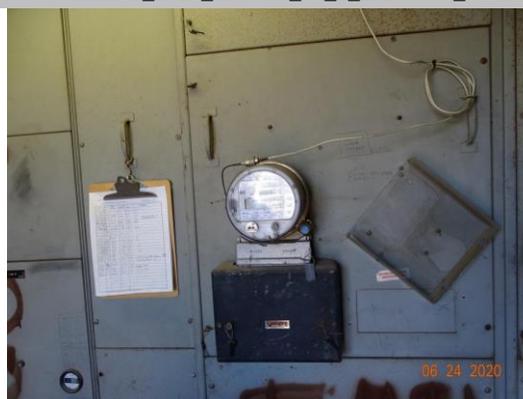
Photo 1 of 1 : ST_2020_NA0017_18_2_20200708_00019.jpg

LM Start	0.00	Rating **	U	Issue No.	2
LM End	0.00	Issue Type +	Ma	Location *	
Category	Pump Stations		GPS Latitude/Longitude		
			Start	End	
Item	Operation & Maintenance Manual		37.989633 °	37.989633 °	
			-121.266933 °	-121.266933 °	
DWR ID	DWR_NA0017_18_t_2012_2				
Action/Comments					
Inspector Comments: The O&M Manual is not posted in the pumping plant.

View of O&M manual not posted in the pumping plant. Summer 2020

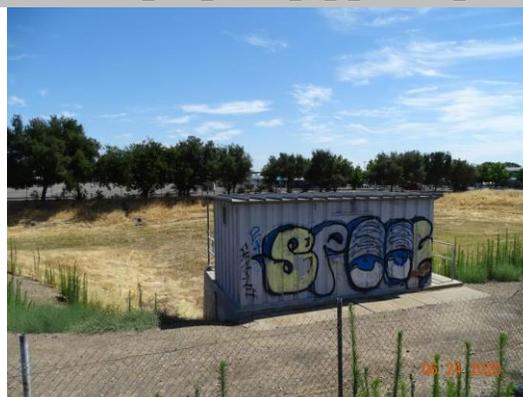
Photo 1 of 1 : ST_2020_NA0017_18_3_20200708_00020.jpg

LM Start	0.00	Rating **	M	Issue No.	3
LM End	0.00	Issue Type +	Ma	Location *	
Category	Pump Stations		GPS Latitude/Longitude		
			Start	End	
Item	Plant Building		37.989633 °	37.989633 °	
			-121.266933 °	-121.266933 °	
DWR ID	DWR_NA0017_18_t_2012_3				
Action/Comments					
Inspector Comments: The plant building is routinely inspected and repaired as necessary.

View of pumping plant. Summer 2020

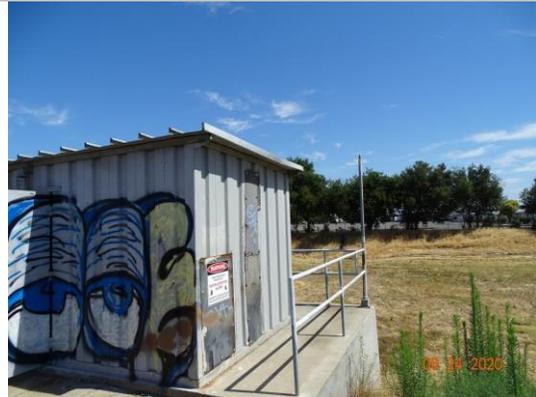
Photo 1 of 2 : ST_2020_NA0017_18_5_20200708_00024.jpg

View of guard rails at the plant. Summer 2020

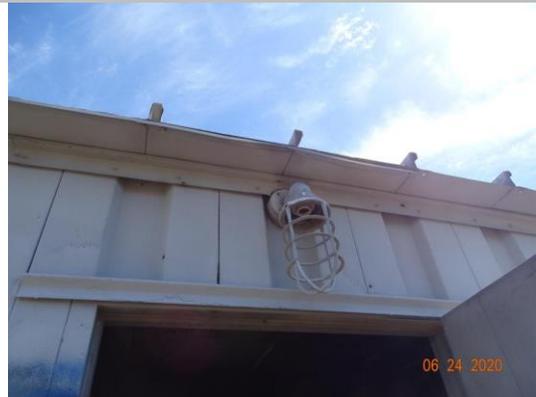
Photo 2 of 2 : ST_2020_NA0017_18_5_20200708_00023.jpg

LM Start	0.00	Rating **	M	Issue No.	5
LM End	0.00	Issue Type +	Ma	Location *	
Category	Pump Stations		GPS Latitude/Longitude		
			Start	End	
Item	Safety		37.989633 °	37.989633 °	
			-121.266933 °	-121.266933 °	
DWR ID	DWR_NA0017_18_t_2012_5				
Action/Comments					
Inspector Comments: The guard rails around the structure are in good condition. The light bulb above the main door needs to be installed.

View of missing light bulb above main door. Summer 2020

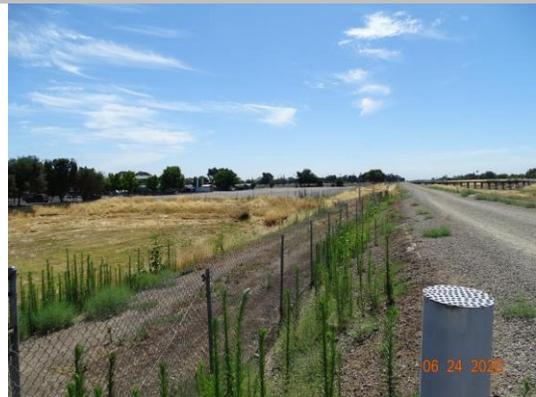
Photo 1 of 3 : ST_2020_NA0017_18_21_20200708_00033.jpg

LM Start	0.00	Rating **	M	Issue No.	21
LM End	0.00	Issue Type +	Ma	Location *	
Category	Pump Stations		GPS Latitude/Longitude		
			Start	End	
Item	Security Fencing		37.989633 °	37.989633 °	
			-121.266933 °	-121.266933 °	
DWR ID	DWR_NA0017_18_t_2012_21				
Action/Comments					
Inspector Comments: Security fence is routinely inspected and repaired as necessary. Fence near entrance appears to be damaged which may allow unauthorized entrance.

View of security fence at pumping plant. Summer 2020

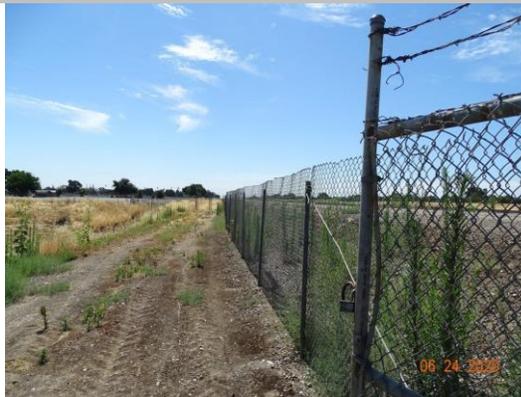
Photo 2 of 3 : ST_2020_NA0017_18_21_20200708_00034.jpg

LM Start	0.00	Rating **	M	Issue No.	21 (cont)
LM End	0.00	Issue Type +	Ma	Location *	
Category	Pump Stations			GPS Latitude/Longitude	
				Start	End
Item	Security Fencing			37.989633 °	37.989633 °
				-121.266933 °	-121.266933 °
DWR ID	DWR_NA0017_18_t_2012_21				
Action/Comments					
Inspector Comments: Security fence is routinely inspected and repaired as necessary. Fence near entrance appears to be damaged which may allow unauthorized entrance.

View of security fence at pumping plant. Summer 2020

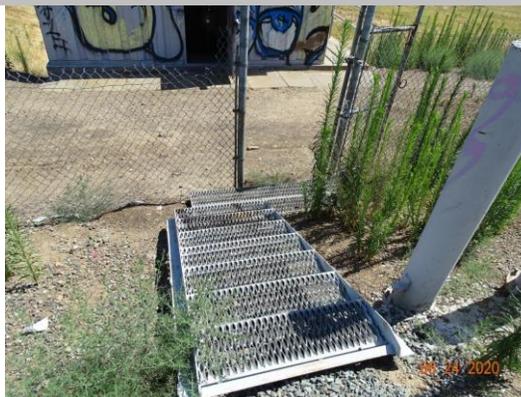
Photo 3 of 3 : ST_2020_NA0017_18_21_20200708_00035.jpg

View of security gate and stairs at pumping plant. Summer 2020

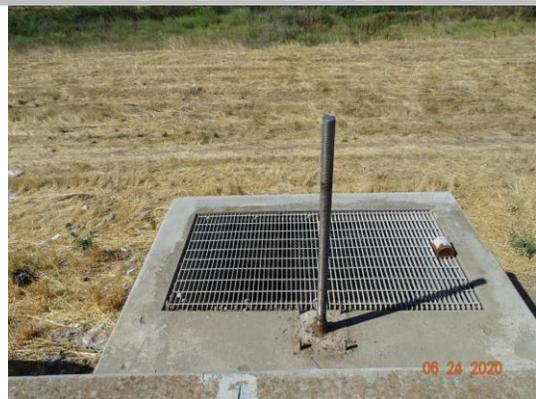
Photo 1 of 2 : ST_2020_NA0017_19_15_20200708_00024.jpg

View of vandalized slide gate housing unit. Summer 2020

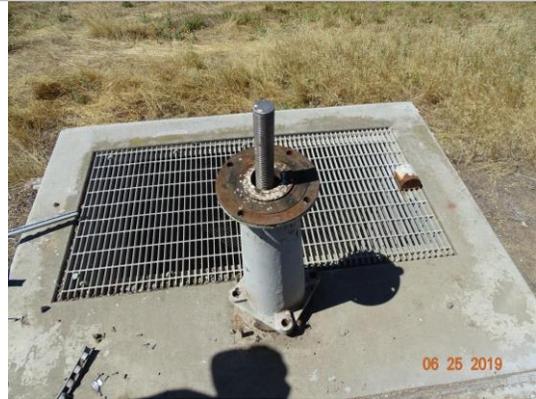
Photo 2 of 2 : ST_2020_NA0017_19_15_20200617_00012.jpg

View of slide gate in need of repair. Summer 2019

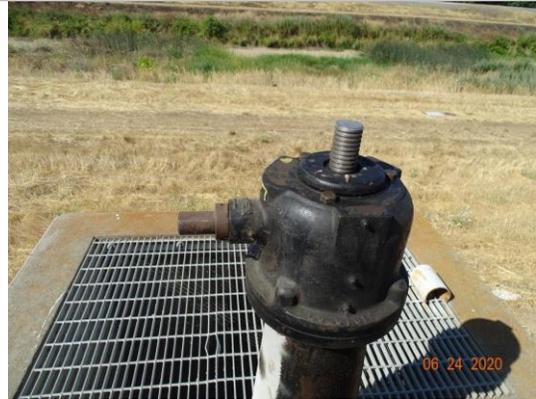
Photo 1 of 1 : ST_2020_NA0017_20_17_20200708_00028.jpg

View of slide gate housing unit with wheel removed for security purposes. Summer 2020
