**Flood Control Project Maintenance  
Levee Inspections**

**Fall 2019 Levee Maintenance Deficiency Summary Report**

**California Department of Fish and Game Shea Levee**

**Levee Inspection Report By Mile - Fall 2019**

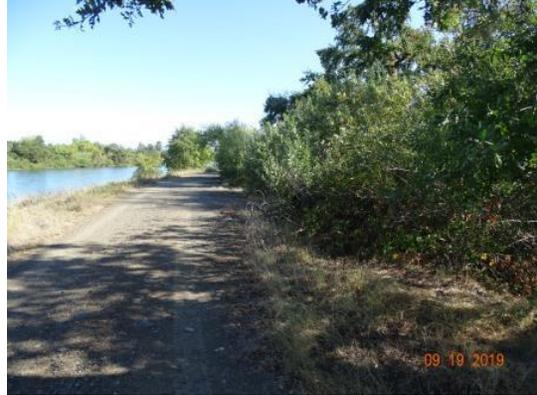
Photo 1 of 1 : FA\_2019\_NA0018\_269\_3\_20190920\_00007.jpg

LM Start	<b>0.00</b>	Rating **	M	Issue No.	<b>3</b>
LM End	<b>0.07</b>	Issue Type +	Ma	Location *	LS
Category	Earthen Levee		GPS Latitude/Longitude		
			Start	End	
Item	Vegetation		40.507738 °	40.508665 °	
			-122.363682 °	-122.362983 °	
DWR ID	DWR_NA0018_01_f_2017_3				
Comment Code					
V2 : Remove the wild growth other than native grasses from the levee slopes.					
Inspector Comment

View of wild growth along the landside slope. Fall 2019.

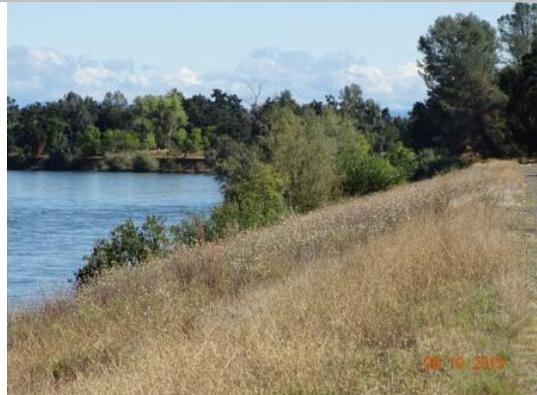
Photo 1 of 1 : FA\_2019\_NA0018\_269\_1\_20190920\_00008.jpg

LM Start	<b>0.00</b>	Rating **	M	Issue No.	<b>1</b>
LM End	<b>0.30</b>	Issue Type +	Ma	Location *	WS
Category	Earthen Levee		GPS Latitude/Longitude		
			Start	End	
Item	Vegetation		40.507697 °	40.510670 °	
			-122.363683 °	-122.361203 °	
DWR ID	DWR_NA0018_01_s_2012_1				
Comment Code					
V1 : Control annual grass and weeds on the levee slopes and easements.					
Inspector Comment

View of the vegetation along the waterside slope. Fall 2019.

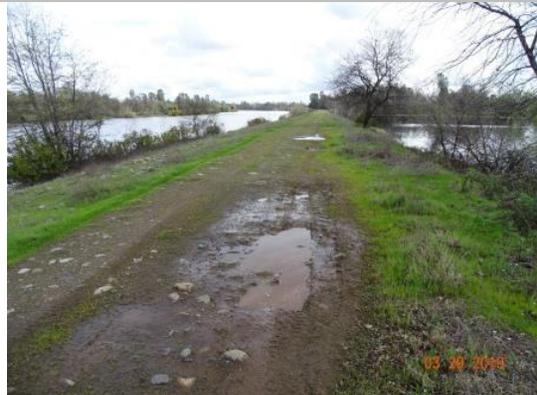
Photo 1 of 1 : FA\_2019\_NA0018\_269\_4\_20190822\_00006.jpg

LM Start	<b>0.05</b>	Rating **	M	Issue No.	<b>4</b>
LM End	<b>0.05</b>	Issue Type +	Ma	Location *	CR
Category	Earthen Levee		GPS Latitude/Longitude		
			Start	End	
Item	Crown Surface / Depressions / Rutting		40.508401 °	40.508401 °	
			-122.363261 °	-122.363261 °	
DWR ID	DWR_NA0018_01_s_2019_4				
Comment Code					
C3 : Add appropriate gravel or road base. Grade and compact.					
Inspector Comment

View of the crown surface with depressions and no gravel.

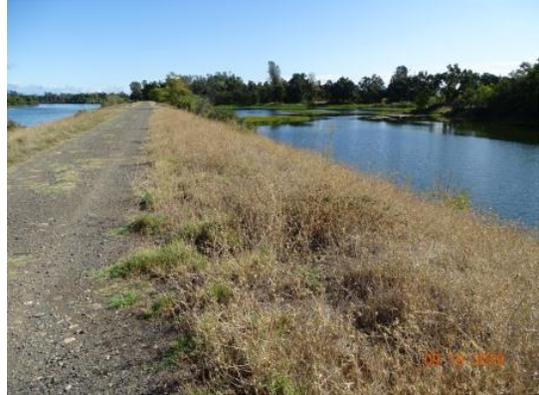
Photo 1 of 1 : FA\_2019\_NA0018\_269\_2\_20190920\_00009.jpg

LM Start	<b>0.08</b>	Rating **	M	Issue No.	<b>2</b>
LM End	<b>0.13</b>	Issue Type +	Ma	Location *	LS
Category	Earthen Levee			GPS Latitude/Longitude	
				Start	End
Item	Vegetation			40.508707°	40.509343°
				-122.362935°	-122.362276°
DWR ID	DWR_NA0018_01_s_2012_2				
Comment Code					
V1 : Control annual grass and weeds on the levee slopes and easements.					
Inspector Comment

View of the vegetation along the landside slope. Fall 2019.

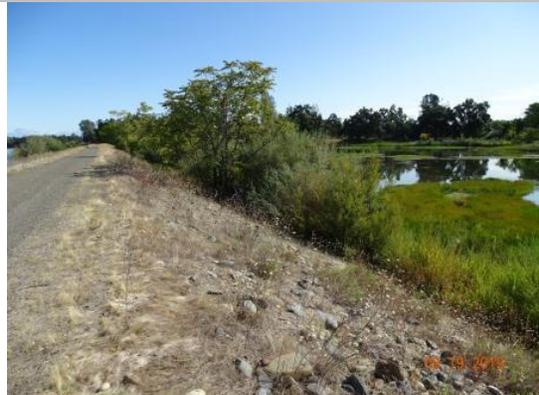
Photo 1 of 1 : FA\_2019\_NA0018\_269\_5\_20190920\_00010.jpg

LM Start	<b>0.13</b>	Rating **	M	Issue No.	<b>5</b>
LM End	<b>0.30</b>	Issue Type +	Ma	Location *	LS
Category	Earthen Levee			GPS Latitude/Longitude	
				Start	End
Item	Vegetation			40.509343°	40.511278°
				-122.362276°	-122.360328°
DWR ID	DWR_NA0018_01_f_2019_5				
Comment Code					
V2 : Remove the wild growth other than native grasses from the levee slopes.					
Inspector Comment

View of the wild growth along the landside slope. Fall 2019.
