**Flood Control Project Maintenance
Levee Inspections**

Fall 2019 Levee Maintenance Deficiency Summary Report

**Flood Control Project Maintenance
Levee Inspections
LMA District Cover Sheet
Fall 2019 Levee Inspection Results**

Tehama County Flood Control and Water Conservation District

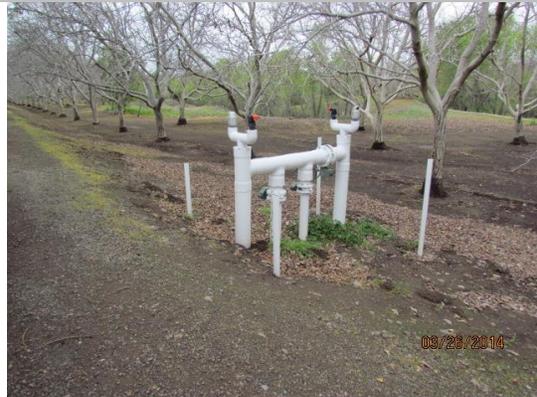
Photo 1 of 1 : FA_2019_NA0019_78_275_20190822_00019.jpg

View of the irrigation pipe along the waterside slope.

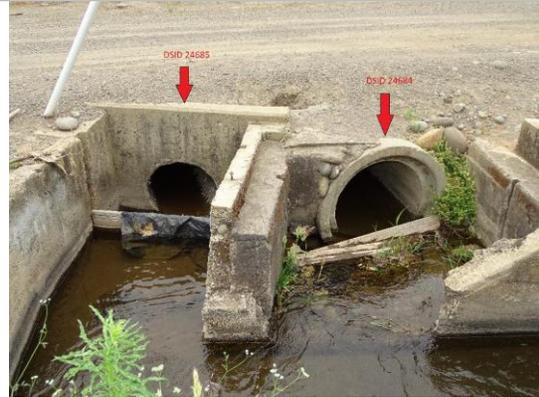
Photo 1 of 3 : UCIP_FA_2019_53998_79242.jpg

LM Start	0.17	Rating **	M	Issue No.	277
LM End	0.17	Issue Type +	En	Location *	
Category	Supplemental		GPS Latitude/Longitude		
			Start	End	
Item	DRAFT DWR UCIP Field Study		39.973302°	39.973302°	
			-121.983538°	-121.983538°	
DWR ID	24684				
Comment Code					
Inspector Comment					
DS_ID:24684 FS_ID:53998 EP_NO: N/A Repair Type: Non-Urgent Crossing Status: Found UCIP Comments: 05/14/2019 Pipe is designed to drain excess of water from irrigation canal to Deer Creek. Backflow prevention device is absent on this crossing. (O.Yakimov - DWR UCIP)No permit identified for this crossing. FIELD_STRUCT_DESC: 36-inch reinforced concrete irrigation pipe through the levee, 0.5 feet below the crown. Concrete canal and distribution structure on the landside (LS) shoulder. FS Date: 5/14/2019 2:33:44 PM

Concrete headwall at irrigation canal on LS shoulder

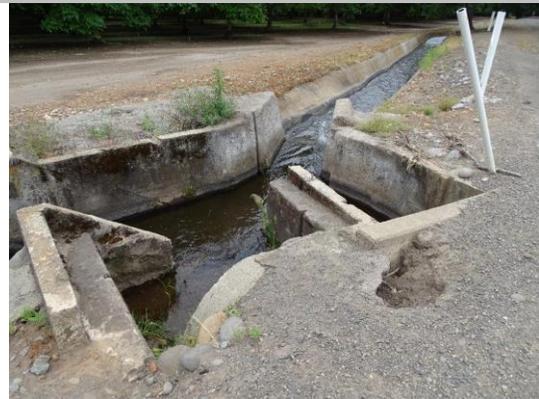
Photo 2 of 3 : UCIP_FA_2019_53998_79243.jpg

Irrigation canal at LS shoulder

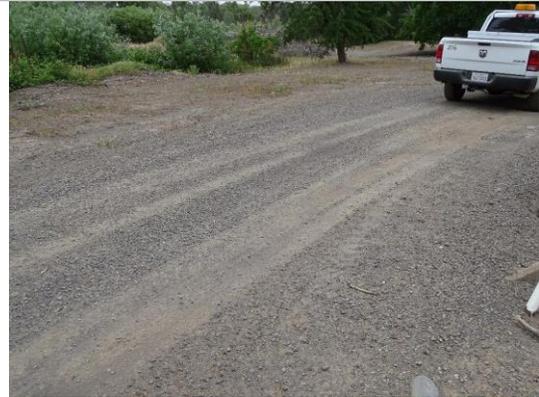
Photo 3 of 3 : UCIP_FA_2019_53998_79246.jpg

View of levee crown at the crossing

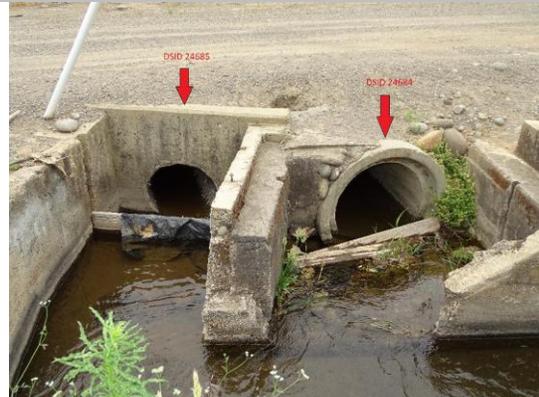
Photo 1 of 3 : UCIP_FA_2019_53999_79247.jpg

LM Start	0.17	Rating **	M	Issue No.	278
LM End	0.17	Issue Type +	En	Location *	
Category	Supplemental			GPS Latitude/Longitude	
				Start	End
Item	DRAFT DWR UCIP Field Study			39.973285°	39.973285°
				-121.983531°	-121.983531°
DWR ID	24685				
Comment Code					
Inspector Comment					
DS_ID:24685 FS_ID:53999 EP_NO: N/A Repair Type: Non-Urgent Crossing Status: Found UCIP Comments: 05/14/2019 Pipe is designed to drain excess of water from irrigation canal to Deer Creek. (O.Yakimov - DWR UCIP)No permit identified for this crossing. FIELD_STRUCT_DESC: 24-inch reinforced concrete irrigation pipe through the levee, 2 feet below the crown. Concrete canal and distribution structure on the landside (LS) shoulder. Concrete U-shaped headwall and flap gate on the waterside (WS) toe. FS Date: 5/14/2019 3:06:17 PM

Concrete headwall at irrigation canal on LS shoulder

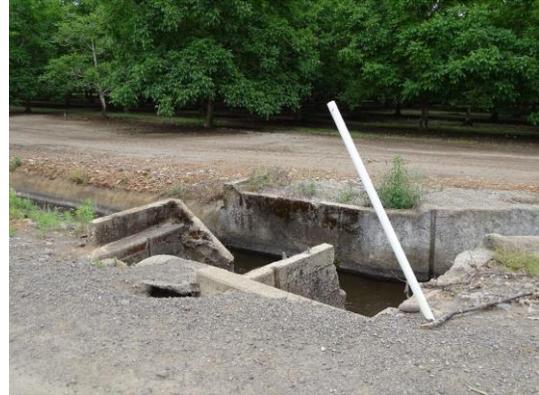
Photo 2 of 3 : UCIP_FA_2019_53999_79248.jpg

Irrigation canal at LS shoulder

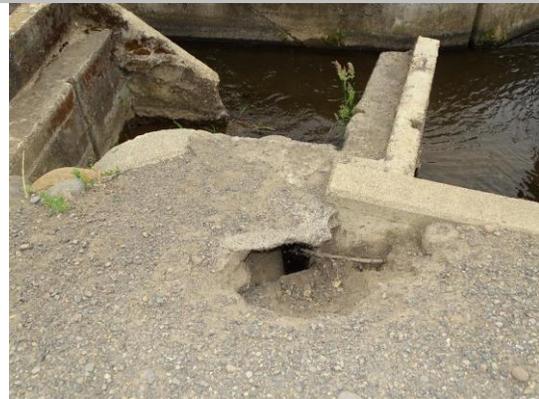
Photo 3 of 3 : UCIP_FA_2019_53999_79249.jpg

Erosion at concrete headwall

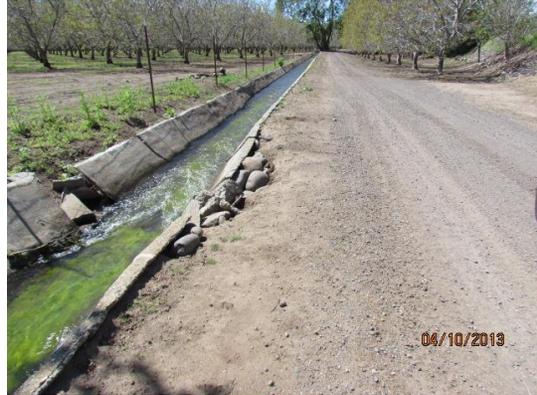
Photo 1 of 1 : FA_2019_NA0019_78_18_20190822_00006.jpg

View of the erosion along the landside slope.

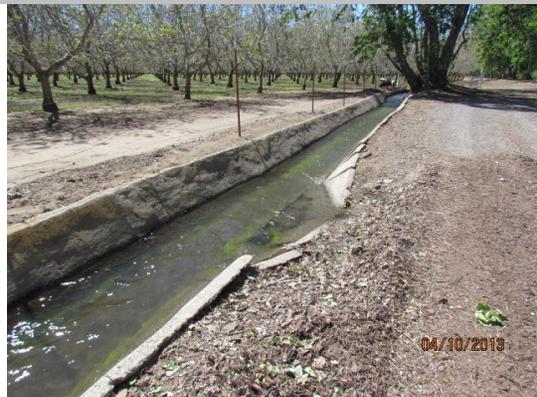
Photo 1 of 1 : FA_2019_NA0019_78_19_20190822_00007.jpg

View of the erosion along the landside slope.

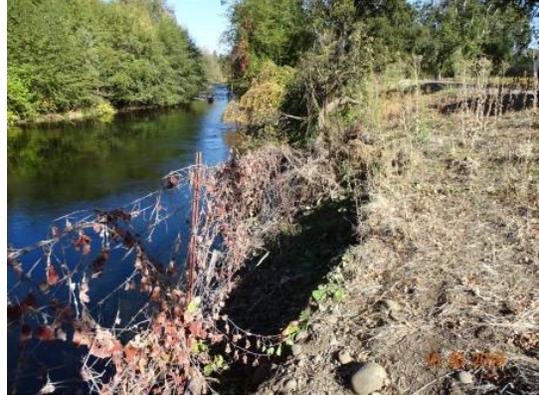
Photo 1 of 3 : FA_2019_NA0019_78_42_20191101_00072.jpg

LM Start	1.55	Rating **	A/W	Issue No.	42
LM End	1.58	Issue Type +	Ma	Location *	WS
Category	Earthen Levee		GPS Latitude/Longitude		
			Start	End	
Item	Erosion / Bank Caving		39.969193°	39.969052°	
			-122.008458°	-122.008920°	
DWR ID	DWR_NA0019_01_s_2017_42				
Comment Code					
E2 : Schedule repair of erosion site prior to the next inspection.					
Inspector Comment

View of the erosion along the waterside toe. Fall 2019.

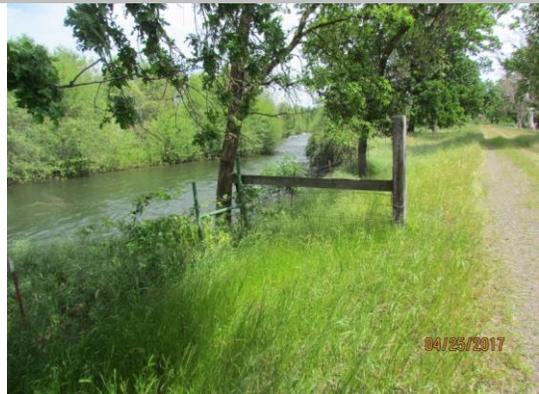
Photo 3 of 3 : FA_2019_NA0019_78_42_20190822_00014.jpg

View of the erosion along the waterside toe.

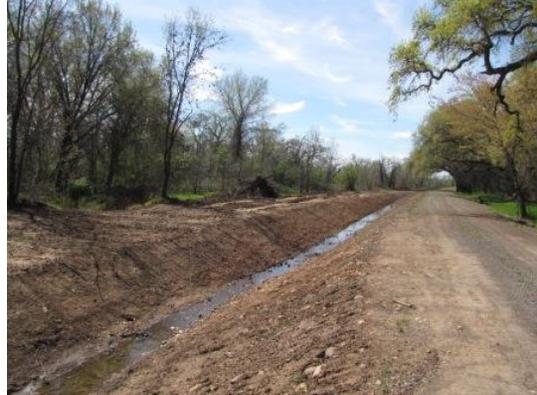
Photo 2 of 2 : FA_2019_NA0019_78_2_20190822_00002.jpg

LM Start	1.79	Rating **	U	Issue No.	2 (cont)
LM End	2.22	Issue Type +	En	Location *	LS
Category	Earthen Levee			GPS Latitude/Longitude	
				Start	End
Item	Encroachments			39.969443°	39.966921°
				-122.012261°	-122.019469°
DWR ID	DWR_NA0019_01_s_2012_2				
Comment Code					
DT : Ditch					
Inspector Comment					
Repair the cleaned out irrigation ditch along the landside toe.

View of an agricultural ditch along the levee toe.

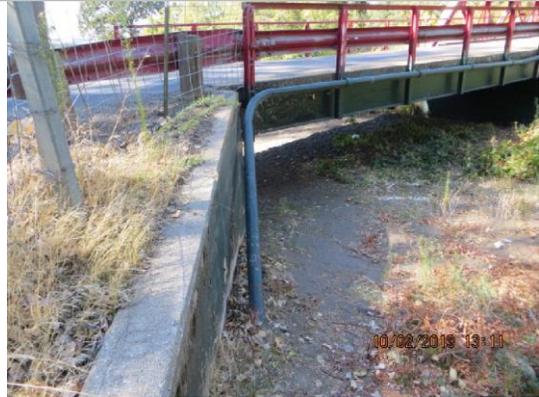
Photo 1 of 3 : UCIP_FA_2019_54007_39065.jpg

LM Start	1.88	Rating **	M	Issue No.	286
LM End	1.88	Issue Type +	En	Location *	
Category	Supplemental			GPS Latitude/Longitude	
				Start	End
Item	DRAFT DWR UCIP Field Study			39.969156°	39.969156°
				-122.013809°	-122.013809°
DWR ID	24690				
Comment Code					
Inspector Comment					
DS_ID:24690 FS_ID:54007 EP_NO: N/A Repair Type: Non-Urgent Crossing Status: Found UCIP Comments: 05/14/2019 No changes to the crossing. (O.Yakimov - DWR UCIP)No permit identified for this crossing. FIELD_STRUCT_DESC: 4-inch steel communications conduit through the levee, at an unknown depth. Junction box off the landside (LS) toe next to JP and roadway. Conduit visible on upstream side of bridge at Deer Creek crossing. FS Date: 5/14/2019 3:54:01 PM

Conduit visible at upstream side of bridge

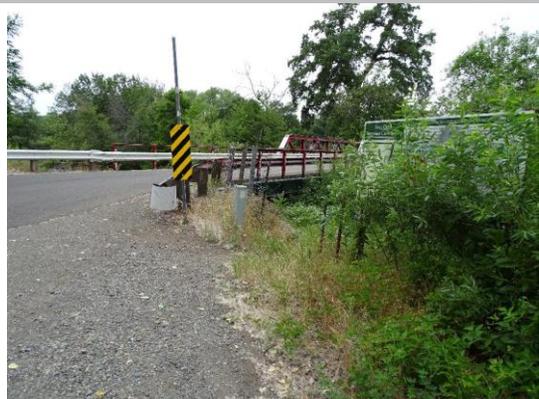
Photo 2 of 3 : UCIP_FA_2019_54007_79265.jpg

Leninger Rd bridge looking north. Communication box on road shoulder

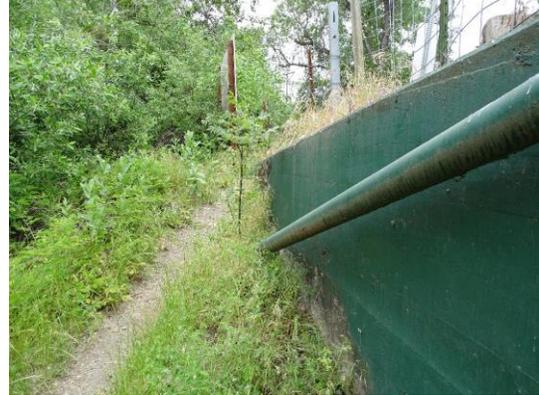
Photo 3 of 3 : UCIP_FA_2019_54007_79266.jpg

Underground conduit goes toward the levee

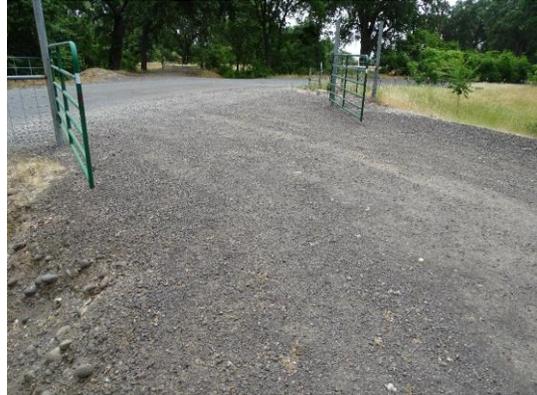
Photo 1 of 3 : UCIP_FA_2019_54008_79270.jpg

Overview of levee crown where pipe crosses

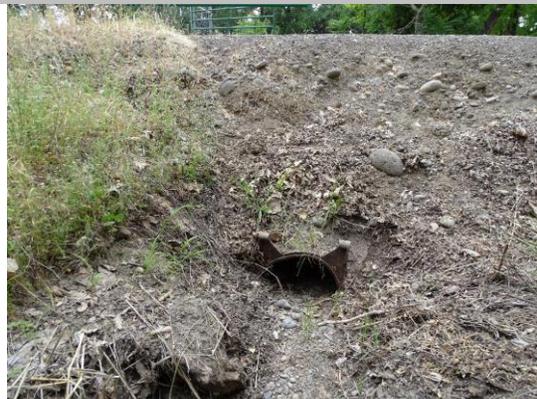
Photo 2 of 3 : UCIP_FA_2019_54008_79271.jpg

Partially silted pipe at WS toe missing flap gate

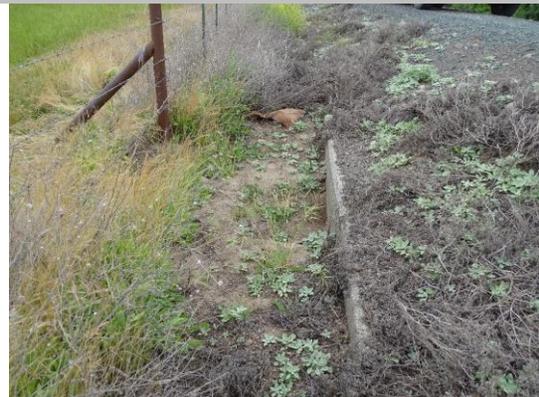
Photo 1 of 3 : UCIP_FA_2019_54011_79272.jpg

Concrete headwall on LS toe

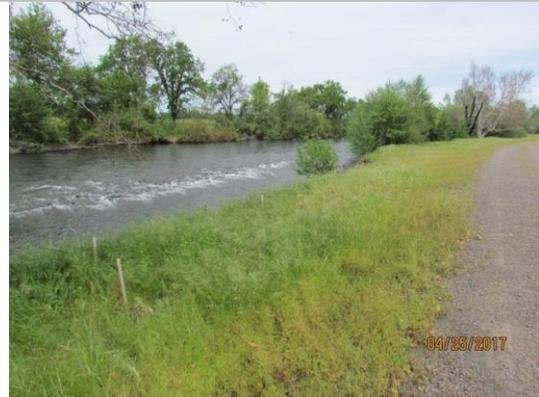
Photo 1 of 1 : FA_2019_NA0019_78_43_20190822_00016.jpg

View of erosion along waterside toe.

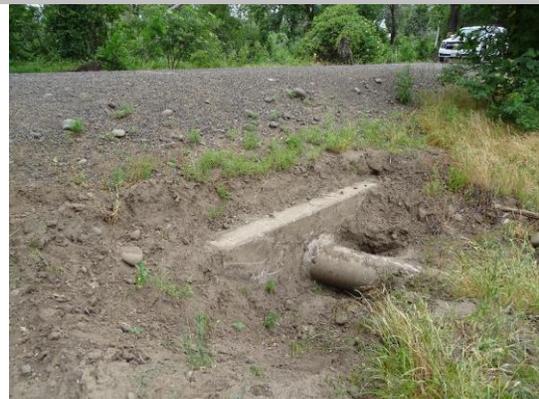
Photo 1 of 3 : UCIP_FA_2019_54012_79276.jpg

Headwal and concrete pipe at LS toe

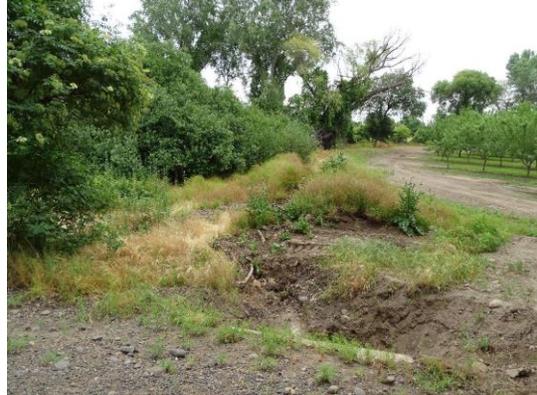
Photo 2 of 3 : UCIP_FA_2019_54012_79277.jpg

View of landside with headwall at the toe

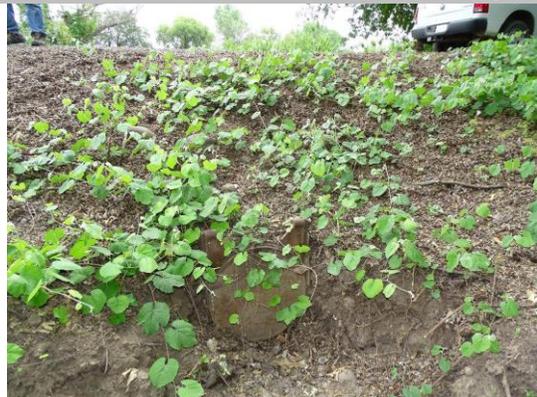
Photo 3 of 3 : UCIP_FA_2019_54012_79278.jpg

Pipe outlet with flap gate at WS toe

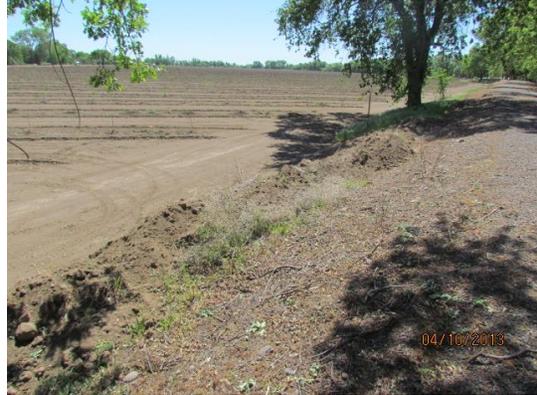
Photo 1 of 1 : FA_2019_NA0019_78_20_20190822_00008.jpg

View of the instability along the landside slope.

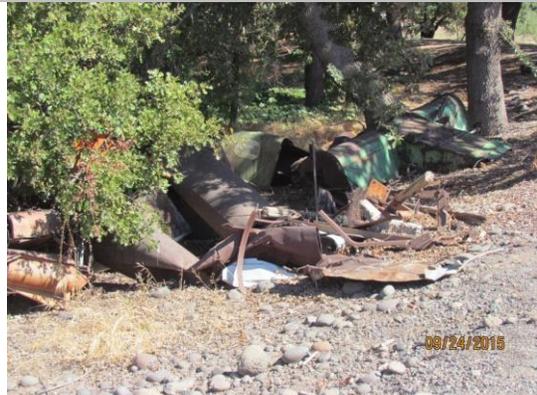
Photo 1 of 1 : FA_2019_NA0019_78_37_20190822_00012.jpg

View of the scrap equipment along the waterside toe.

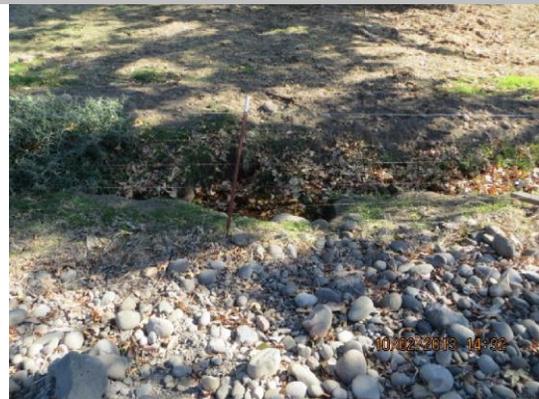
Photo 1 of 3 : UCIP_FA_2019_54013_38952.jpg

Low spot with water on LS toe.

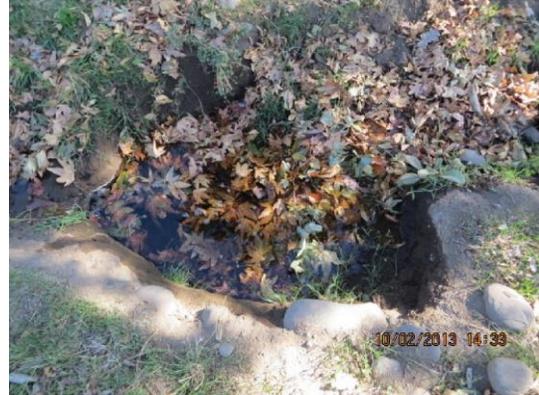
Photo 2 of 3 : UCIP_FA_2019_54013_38951.jpg

Low spot with water on LS toe.

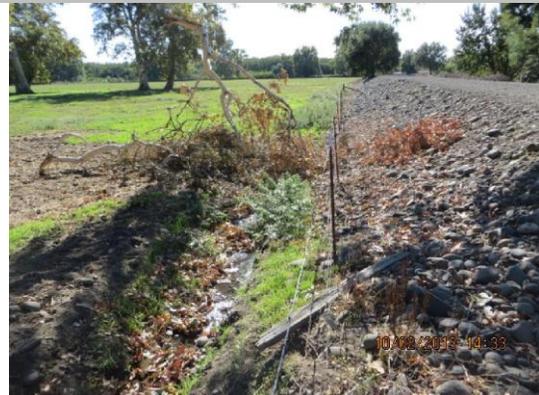
Photo 3 of 3 : UCIP_FA_2019_54013_38953.jpg

Low spot on LS toe where water disappears from levee toe. Unable to identify exact location of pipe on LS toe.

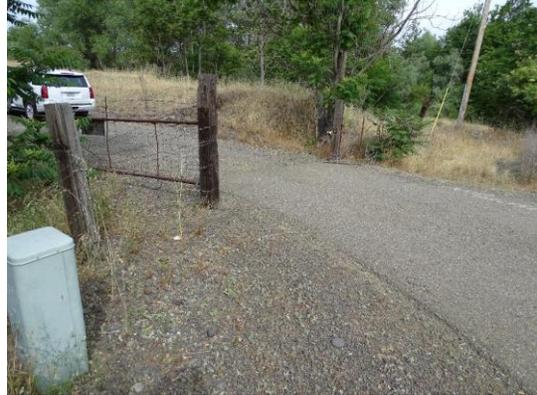
Photo 1 of 3 : UCIP_FA_2019_54014_79281.jpg

View of levee crown at the crossing. Communication box on LS shoulder

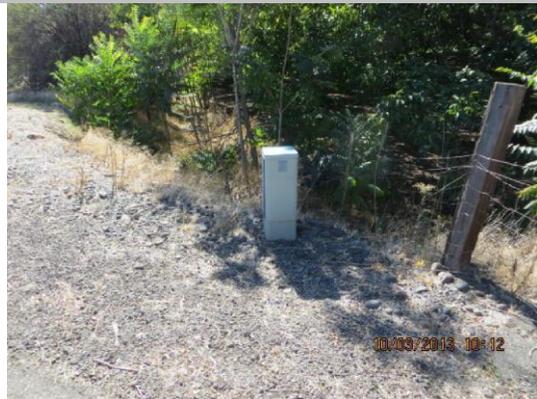
Photo 2 of 3 : UCIP_FA_2019_54014_39143.jpg

Communication cable junction box on LS shoulder.

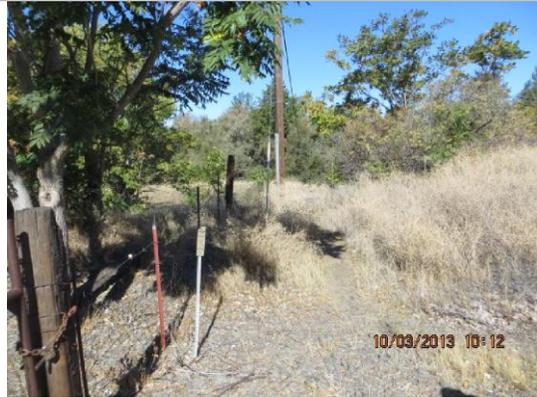
Photo 3 of 3 : UCIP_FA_2019_54014_39142.jpg

Communication cable visible at joint pole on WS slope

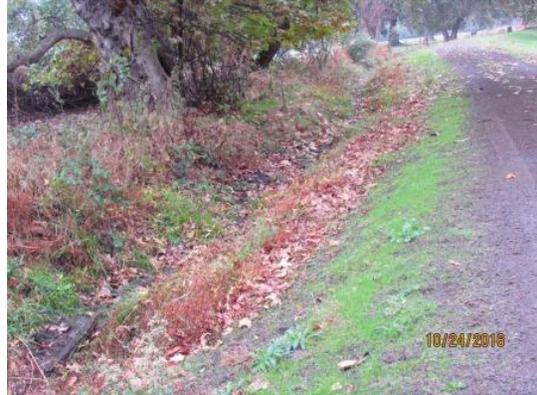
Photo 1 of 1 : FA_2019_NA0019_78_35_20190822_00011.jpg

View of the vegetation along the landside slope and toe.

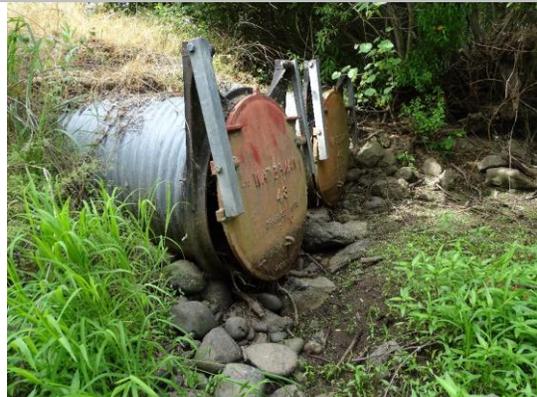
Photo 1 of 3 : UCIP_FA_2019_54016_79282.jpg

View of pipe outlet on WS

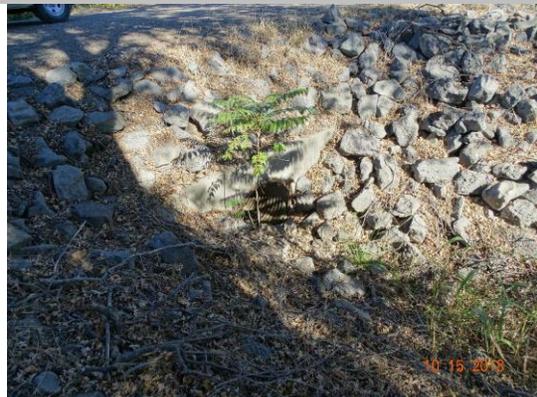
Photo 2 of 3 : UCIP_FA_2019_54018_78195.jpg

Pipe inlet at LS toe

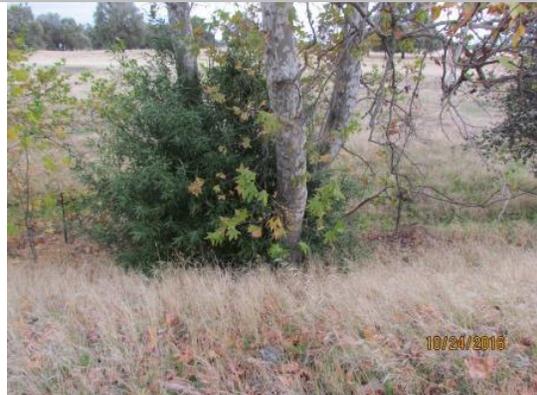
Photo 1 of 1 : FA_2019_NA0019_79_13_20190822_00007.jpg

View of a tree with new thick growth blocking visibility.

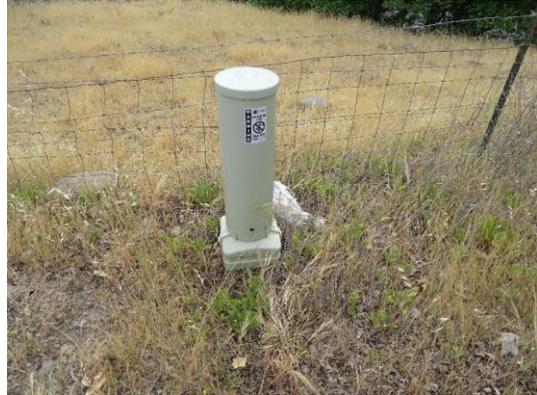
Photo 1 of 3 : UCIP_FA_2019_53996_79235.jpg

Communication line access box on east side of Leninger Rd

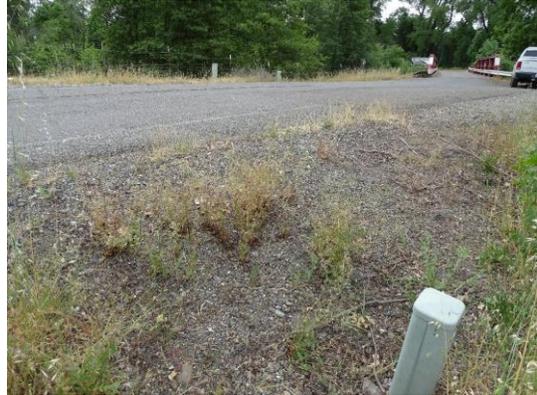
Photo 3 of 3 : UCIP_FA_2019_53996_79237.jpg

Two AT&T underground cable boxes located on east side of Leninger Rd

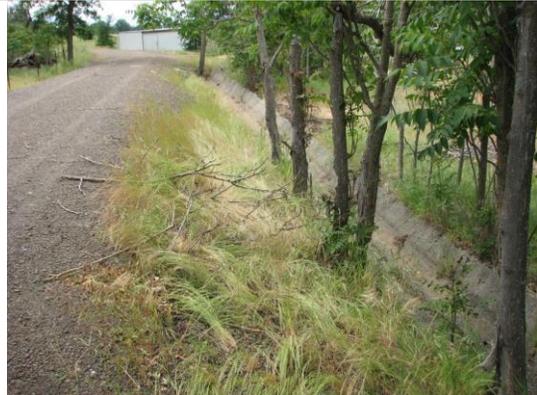
Photo 1 of 1 : FA_2019_NA0019_79_11_20190822_00005.jpg

View of a concrete-lined ditch along the levee toe.

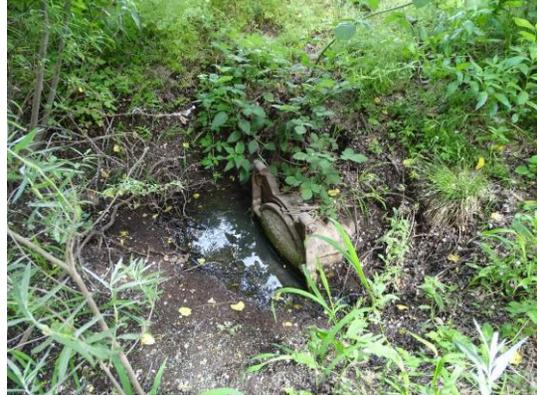
Photo 2 of 3 : UCIP_FA_2019_53997_79241.jpg

Flapgate on WS outlet

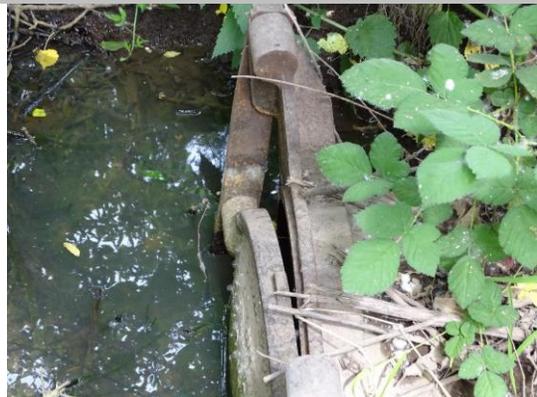
Photo 3 of 3 : UCIP_FA_2019_53997_79238.jpg

Flapgate gap due to sediment buildup at the bottom of pipe

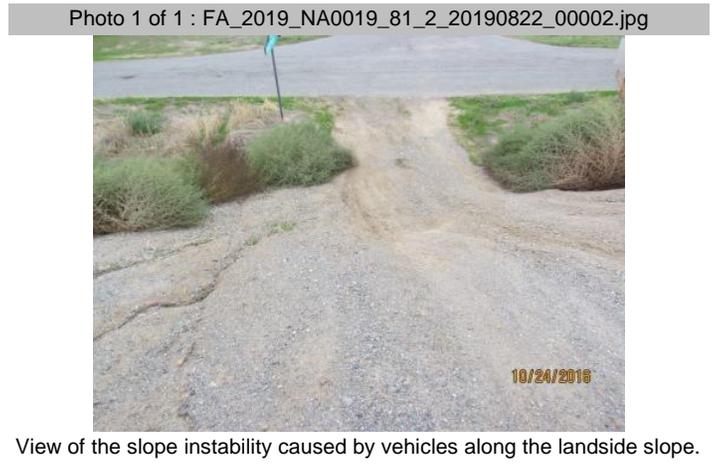
LM Start	2.51	Rating **	M	Issue No.	2
LM End	2.51	Issue Type +	Ma	Location *	LS
Category	Earthen Levee			GPS Latitude/Longitude	
				Start	End
Item	Slope Stability			40.052872°	40.052872°
				-122.145495°	-122.145495°
DWR ID	DWR_NA0019_04_s_2012_2				
Comment Code					
S3 : Repair the levee slope damaged by vehicle traffic and prevent access where possible.					
Inspector Comment

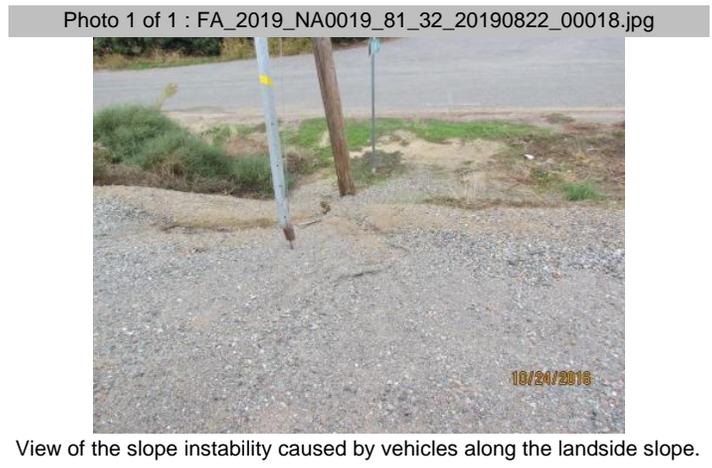
LM Start	2.58	Rating **	M	Issue No.	32
LM End	2.58	Issue Type +	Ma	Location *	LS
Category	Earthen Levee			GPS Latitude/Longitude	
				Start	End
Item	Slope Stability			40.053767°	40.053767°
				-122.144719°	-122.144719°
DWR ID	DWR_NA0019_04_f_2016_32				
Comment Code					
S2 : Repair the levee slope damaged by foot traffic and prevent access where possible.					
Inspector Comment

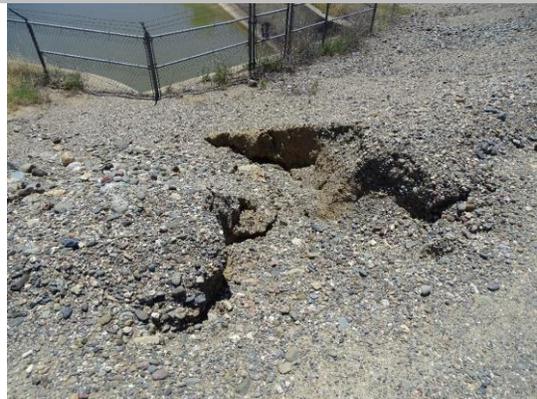
Photo 2 of 3 : UCIP_FA_2019_54060_79349.jpg

Closeup view of subsidence on LS slope

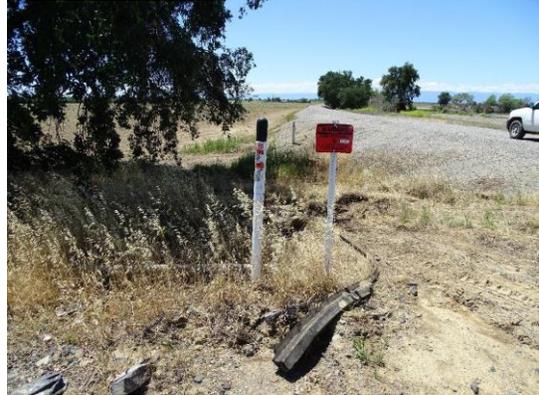
Photo 2 of 3 : UCIP_FA_2019_54079_79413.jpg

Fiber optic line markers on LS shoulder

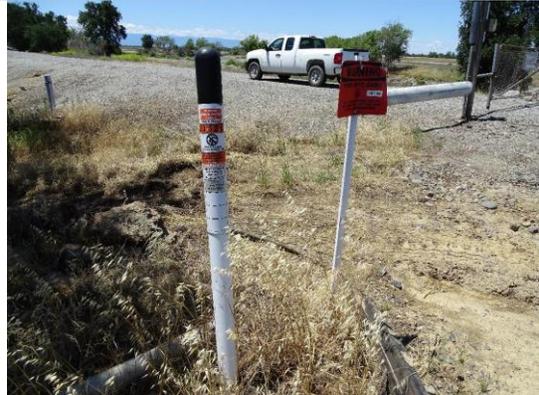
Photo 3 of 3 : UCIP_FA_2019_54079_79414.jpg

Closeup view of fiber optic line markers
