**Flood Control Project Maintenance  
Levee Inspections**

**Maintenance Issue Types Only, Levee Inspection Report By Mile - Spring 2020**

**Tehama County Flood Control and Water Conservation District**

Waterway	Bank	Unit Miles	Inspection Start/End	Inspector
Unit No. 01 Deer Creek	Left	4.22	04/07/2020 04/07/2020	Makar Sokol

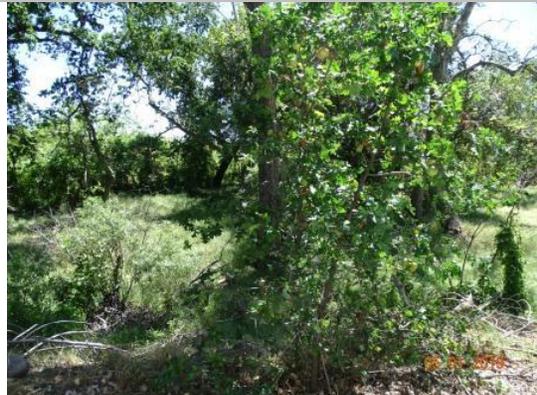
Photo 1 of 1 : SP\_2020\_NA0019\_78\_30\_20200226\_00007.jpg

View of a small tree on the landside toe. Spring 2019.

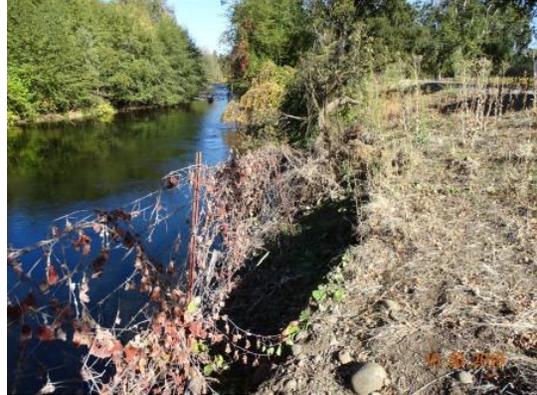
Photo 1 of 1 : SP\_2020\_NA0019\_78\_49\_20200416\_00072.jpg

LM Start	<b>1.55</b>	Rating **	A/W	Issue No.	<b>49</b>
LM End	<b>1.58</b>	Issue Type +	Ma	Location *	WS
Category	Supplemental		GPS Latitude/Longitude		
			Start	End	
Item	2017 Storm Damage		39.969193 °	39.969052 °	
			-122.008458 °	-122.008920 °	
DWR ID	LMA-500				
Comment Code					
Inspector Comment					
Planned For Repair. Significant erosion on the waterside slope, 8-10 foot vertical bank for approximately 100-150 feet Site ID No:585 Site Designation:LMA-500 Rating:Critical Field Date:9/6/2017

View of erosion along waterside toe. Fall 2019.

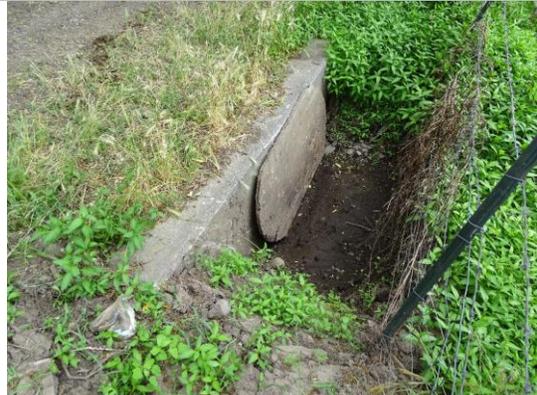
Photo 1 of 3 : UCIP\_SP\_2020\_54006\_79261.jpg

Item	DWR UCIP LMA Responsibility		39.968642 °	39.968642 °	
			-122.010494 °	-122.010494 °	
DWR ID	20770				
Comment Code					
Inspector Comment					
DS_ID:20770 FS_ID:54006 EP_NO: N/A Repair Type: Non-Urgent Crossing Status: Found UCIP Comments: 05/14/2019 Pipe end on WS has been cleared from sediment buildup to let flap gate close properly, but the rest of pipe is still silted inside. Flap gate was fixed and operable now. (O.Yakimov - DWR UCIP)10/15/2018 Flap gate on WS end stuck open. Lower part of pipe is silted that makes impossible flap gate to fully close. Needs sediment cleanup around pipe outlet on WS. (O.Yakimov - DWR)12/05/2016 Sediment buildup inside pipe (see photo) and sediment buildup on WS blocking flap gate. Crossing has been downgraded from Urgent to Non-Urgent crossing was closed on both WS and LS. (O. Magana - DWR UCIP)10/02/2013 Flapgate blocked by soil buildup. (W. Wylie - DWR UCIP) FIELD_STRUCT_DESC: 24-inch steel drainage pipe through the levee, 1.5 feet below the crown. Flap gate on the waterside (WS) toe. [Additional Reference(s): DWR Levee Log, 1992. USACE Sacramento O&M Manual Unit 509, March 1957, As-built drawings available 50-4-2394 (Station 185+40)]. FS Date: 5/14/2019 3:33:54 PM

LS view of concrete headwall with wood panel blocking opening

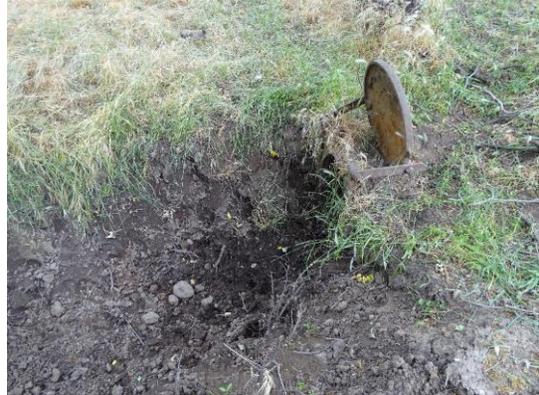
Photo 2 of 3 : UCIP\_SP\_2020\_54006\_79262.jpg

Flap gate at WS toe

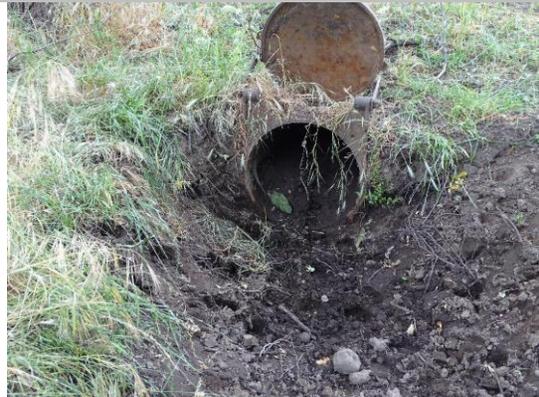
Photo 3 of 3 : UCIP\_SP\_2020\_54006\_79263.jpg

Sediment was cleared around flap gate

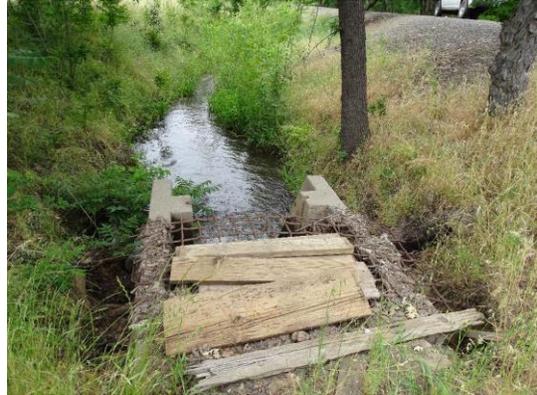
Photo 3 of 3 : UCIP\_SP\_2020\_54008\_79268.jpg

Concrete outfall structure at LS toe and irrigation canal

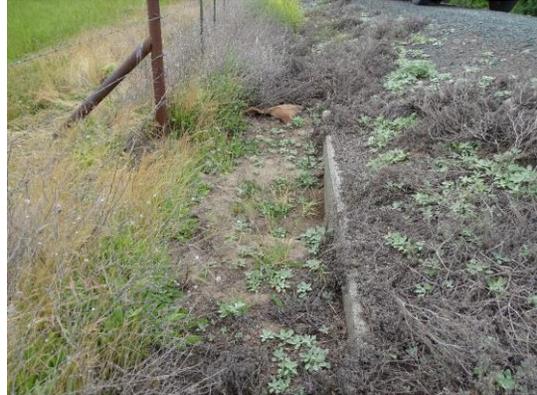
Photo 1 of 3 : UCIP\_SP\_2020\_54011\_79272.jpg

Item	DWR UCIP LMA Responsibility			39.966363 °	39.966363 °
				-122.025755 °	-122.025755 °
DWR ID	20877				
Comment Code					
Inspector Comment					
DS_ID:20877 FS_ID:54011 EP_NO: N/A Repair Type: Non-Urgent Crossing Status: Found UCIP Comments: 05/14/2019 Pipe outlet and headwall were excavated to evaluate pipe condition. Pipe is completely filled with soil that makes impossible to clear it for DMP internal video inspection. Pipe may be rehabilitated under DMP Phase II or removed. Excavated soil was backfilled. (O.Yakimov - DWR UCIP)Headwall covered with soil. Needs to be cleared at both ends. FIELD_STRUCT_DESC: 24-inch corrugated metal pipe through the levee 5-feet below the crown. Calco automatic drainage gate. Originally included in O+M manual (1957). As-built drawings available 50-4-2394. FS Date: 5/14/2019 8:37:31 AM

Concrete headwall on LS toe

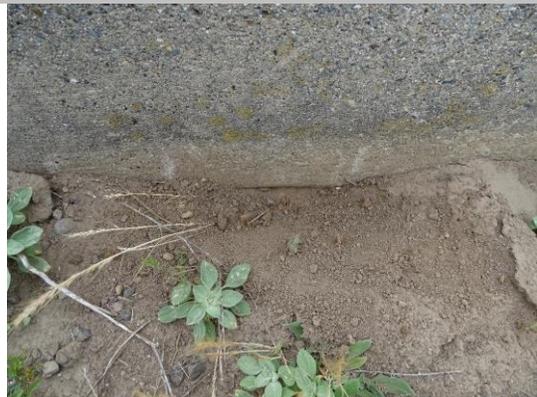
Photo 2 of 3 : UCIP\_SP\_2020\_54011\_79273.jpg

Concrete headwall on LS toe: top of pipe visible

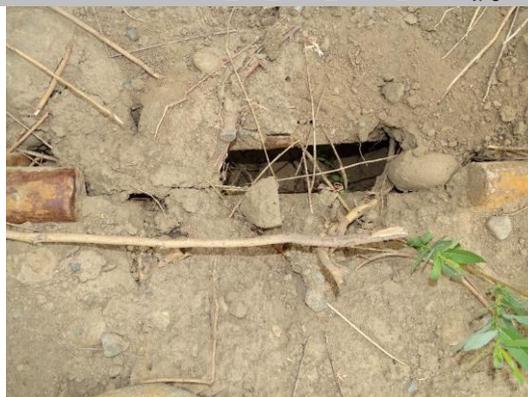
Photo 3 of 3 : UCIP\_SP\_2020\_54011\_79274.jpg

Pipe outlet discovered at WS toe. Visible gap between flap gate and pipe

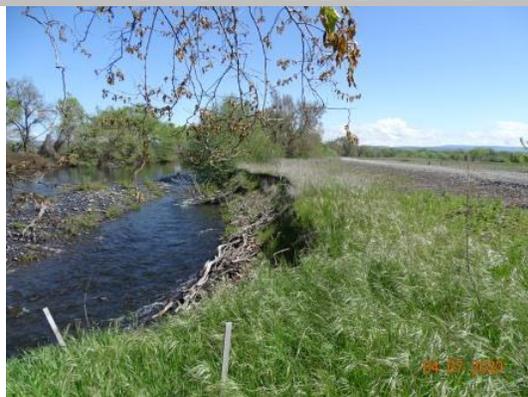
Photo 1 of 1 : SP\_2020\_NA0019\_78\_43\_20200416\_00073.jpg

LM Start	<b>2.76</b>	Rating **	M	Issue No.	<b>43</b>
LM End	<b>2.78</b>	Issue Type +	Ma	Location *	WS
Category	Earthen Levee			GPS Latitude/Longitude	
				Start	End
Item	Erosion / Bank Caving			39.964990 °	39.964763 °
				-122.028740 °	-122.029082 °
DWR ID	DWR_NA0019_01_s_2017_43				
Comment Code					
E2 : Schedule repair of erosion site prior to the next inspection.					
Inspector Comment					
Significant erosion at the waterside toe. Site ID No:271 Site Designation:LMA-72

View of erosion along the waterside toe. Spring 2020.

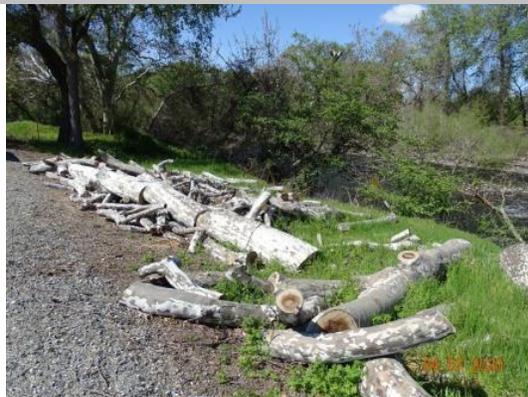
Photo 1 of 1 : SP\_2020\_NA0019\_78\_52\_20200416\_00074.jpg

LM Start	<b>2.79</b>	Rating **	M	Issue No.	<b>52</b>
LM End	<b>2.79</b>	Issue Type +	Ma	Location *	WS
Category	Earthen Levee			GPS Latitude/Longitude	
				Start	End
Item	Encroachments			39.964619 °	39.964619 °
				-122.029234 °	-122.029234 °
DWR ID	DWR_NA0019_01_s_2020_52				
Comment Code					
TR : Tree or limb					
Inspector Comment

View of tree limbs along the waterside toe. Spring 2020.

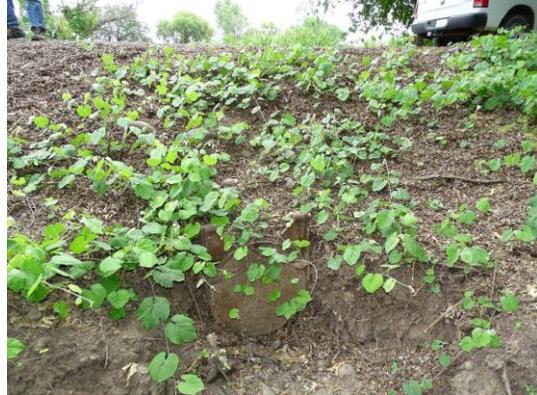
Photo 3 of 3 : UCIP\_SP\_2020\_54012\_79278.jpg

Pipe outlet with flap gate at WS toe

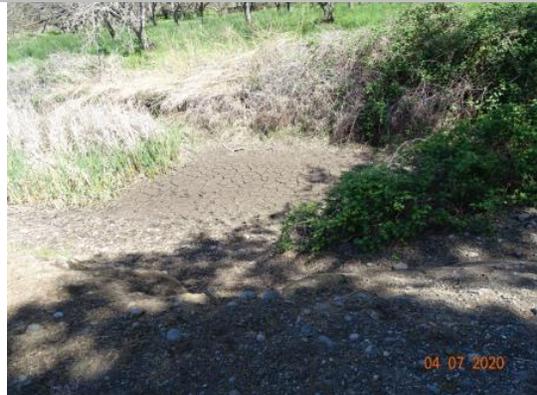
Photo 1 of 1 : SP\_2020\_NA0019\_78\_15\_20200413\_00071.jpg

LM Start	<b>3.68</b>	Rating **	M	Issue No.	<b>15</b>
LM End	<b>3.68</b>	Issue Type +	Ma	Location *	LS
Category	Earthen Levee			GPS Latitude/Longitude	
				Start	End
Item	Slope Stability			39.945045 °	39.945045 °
				-122.053469 °	-122.053469 °
DWR ID	DWR_NA0019_01_f_2012_15				
Comment Code					
S1 : Repair slope instability.					
Inspector Comment

View of slope erosion caused by livestock along the landside slope. Spring 2020.

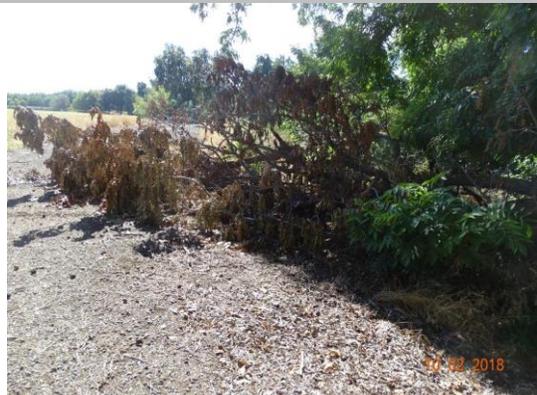
Photo 1 of 1 : SP\_2020\_NA0019\_78\_44\_20200226\_00014.jpg

View of the tree limb along the waterside slope.

LM Start	<b>3.99</b>	Rating **	M	Issue No.	<b>44</b>
LM End	<b>3.99</b>	Issue Type +	Ma	Location *	WS
Category	Earthen Levee			GPS Latitude/Longitude	
				Start	End
Item	Encroachments			39.941990 °	39.941990 °
				-122.057140 °	-122.057140 °
DWR ID	DWR_NA0019_01_f_2018_44				
Comment Code					
TR : Tree or limb					
Inspector Comment					
The tree should be removed from the waterside slope.

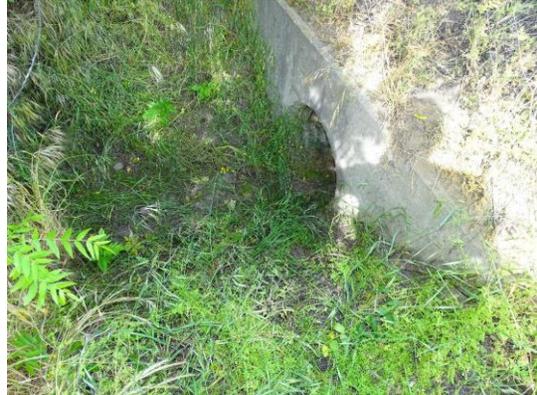
Photo 1 of 3 : UCIP\_SP\_2020\_54023\_79298.jpg

LM Start	<b>4.03</b>	Rating **	M	Issue No.	<b>301</b>
LM End	<b>4.03</b>	Issue Type +	Ma	Location *	
Category	Supplemental			GPS Latitude/Longitude	
				Start	End
Item	DWR UCIP LMA Responsibility			39.941574 °	39.941574 °
				-122.057597 °	-122.057597 °
DWR ID	20760				
Comment Code					
Inspector Comment					
DS_ID:20760 FS_ID:54023 EP_NO: N/A Repair Type: Non-Urgent Crossing Status: Found UCIP Comments: 05/14/2019 No issues recorded during inspection. (O.Yakimov - DWR UCIP) FIELD_STRUCT_DESC: 24-inch corrugated metal drainage pipe through the levee, 5 feet below the crown. Flap gate on the waterside (WS) end. Headwalls on both sides of levee. [Additional Reference(s): DWR Levee Log, 1992. USACE Sacramento O&M Manual 509, March 1957, (Assumed Station 5+00) Drawing No. 50-4-2394]. FS Date: 5/14/2019 10:53:58 AM

Headwall and pipe inlet at LS toe

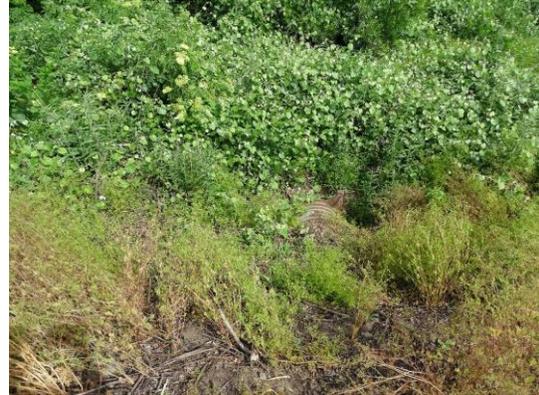
Photo 3 of 3 : UCIP\_SP\_2020\_54023\_79300.jpg

Pipe and flap gate at WS slope

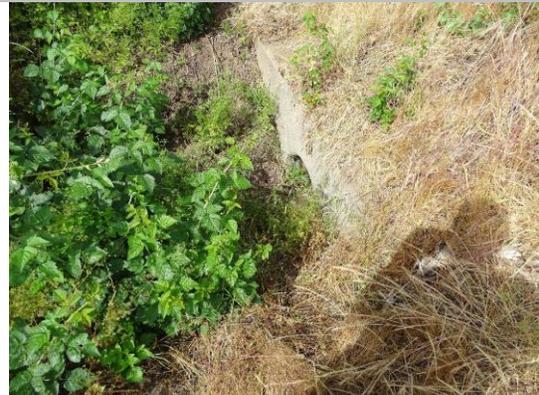
Photo 1 of 3 : UCIP\_SP\_2020\_54024\_79304.jpg

Headwall and inlet at LS toe

Comment Code					
Inspector Comment					
DS_ID:20762 FS_ID:54024 EP_NO: N/A Repair Type: Urgent Crossing Status: Found UCIP Comments: 05/14/2019 Missing flap gate, pipe outlet is silted. (O.Yakimov - DWR UCIP)10/15/2018 Missing flap gate at WS end of the pipe. Pipe is partially blocked with silt. Updated coordinates and CLM. (O.Yakimov - DWR)12/05/2016 unable to complete inspection -- unable to locate. (O. Magana - DWR UCIP)10/03/2013 Gate missing from WS toe. (W. Wylie - DWR UCIP) FIELD_STRUCT_DESC: 24-inch corrugated metal drainage pipe through the levee, 5.5 feet below the crown. Flap gate located on the waterside (WS) end. Concrete headwall located on the landside (LS) toe. [Additional Reference(s): DWR Levee Log, 1992. USACE Sacramento O&M Manual Unit 509, March 1957, As-built drawing no. 50-4-2394 (Station 0+65)]. FS Date: 5/14/2019 11:01:16 AM

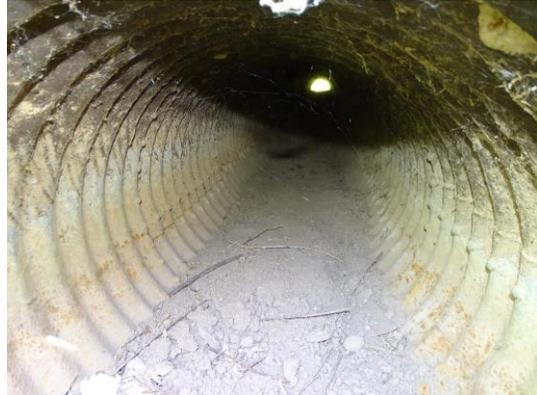
Photo 2 of 3 : UCIP\_SP\_2020\_54024\_79305.jpg

Inside view of pipe looking from LS

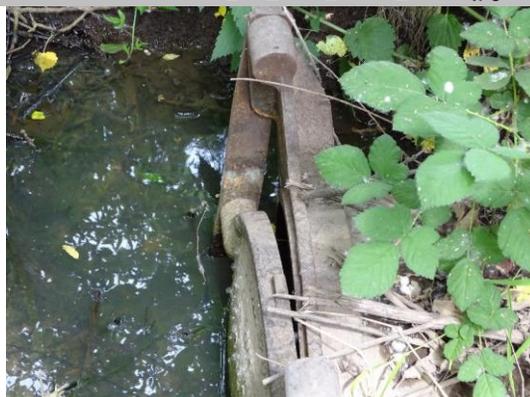
Photo 3 of 3 : UCIP\_SP\_2020\_53997\_79238.jpg

Flapgate gap due to sediment buildup at the bottom of pipe

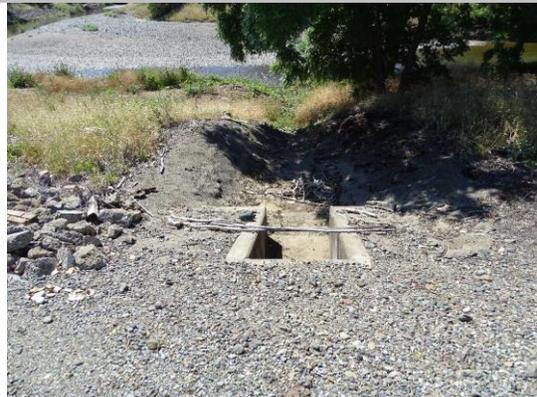
Photo 2 of 3 : UCIP\_SP\_2020\_54120\_79578.jpg

Concrete U-shaped headwall on WS toe

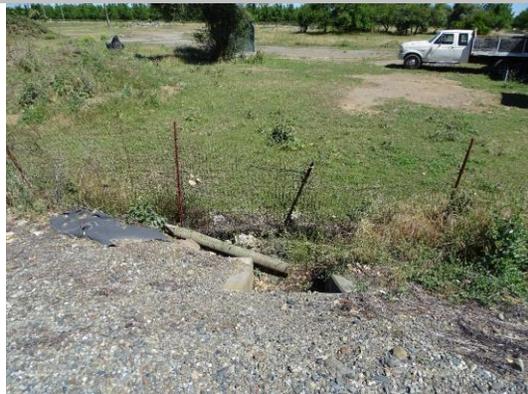
Photo 3 of 3 : UCIP\_SP\_2020\_54120\_79579.jpg

Concrete U-shaped headwall at LS toe

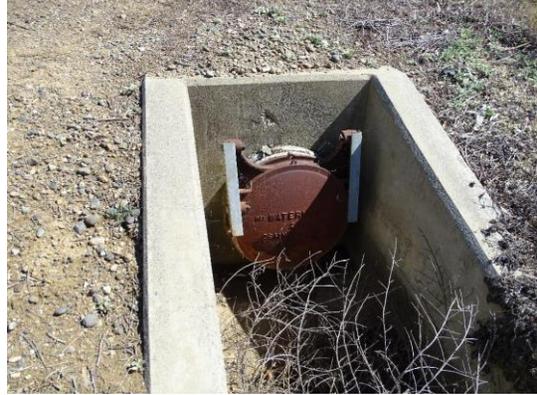
Photo 2 of 3 : UCIP\_SP\_2020\_54121\_79583.jpg

Concrete U-shaped headwall and flapgates on WS toe

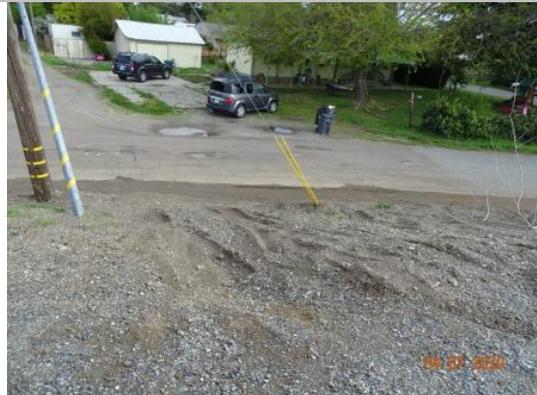
Photo 1 of 1 : SP\_2020\_NA0019\_81\_12\_20200413\_00086.jpg

View of the damaged landside slope caused by vehicle traffic. Spring 2020.

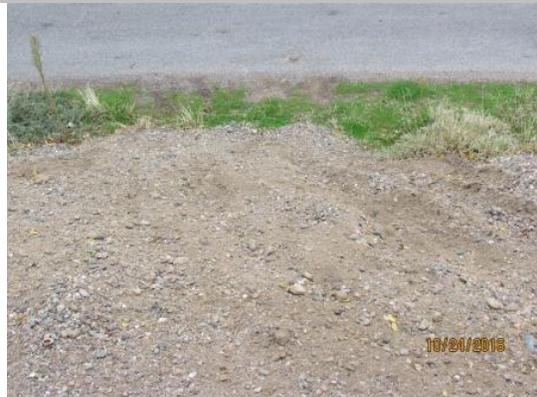
Photo 1 of 1 : SP\_2020\_NA0019\_81\_30\_20200226\_00011.jpg

View of the slope instability caused by vehicles along the landside slope.

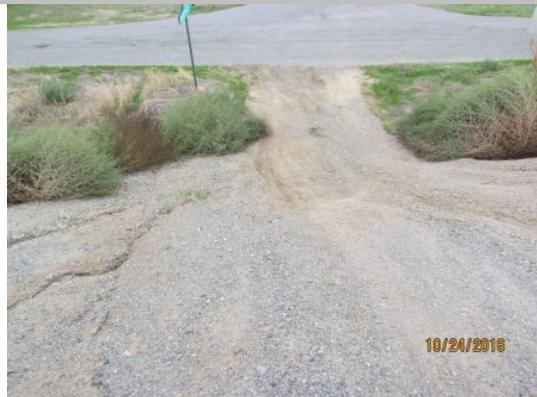
Photo 1 of 1 : SP\_2020\_NA0019\_81\_2\_20200226\_00002.jpg

View of the slope instability caused by vehicles along the landside slope.

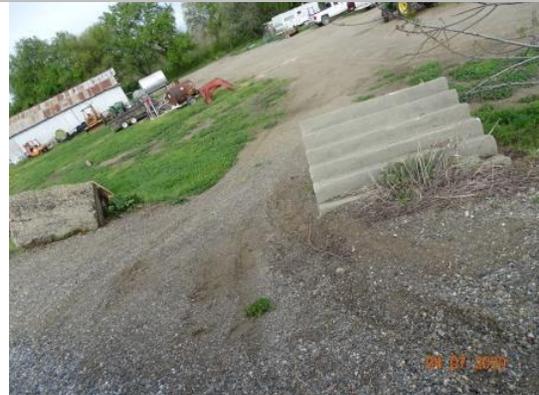
Photo 1 of 1 : SP\_2020\_NA0019\_81\_25\_20200413\_00087.jpg

View of the damaged landside slope caused by vehicle traffic. Spring 2020.

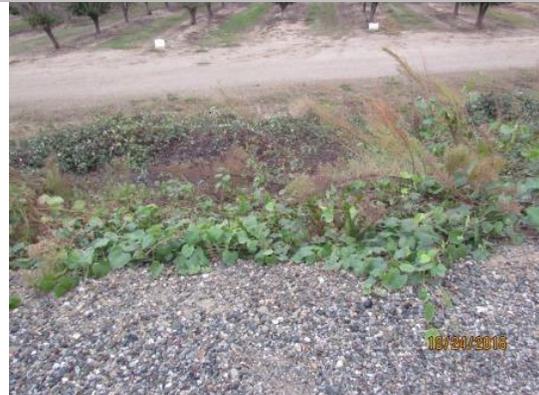
Photo 1 of 1 : SP\_2020\_NA0019\_81\_39\_20200226\_00013.jpg

View of the blackberries along the landside slope blocking visibility and access.

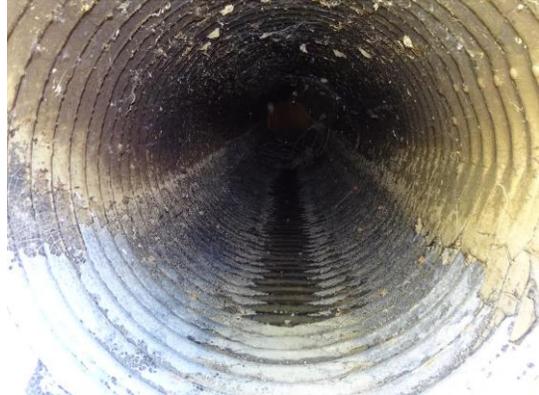
Photo 3 of 3 : UCIP\_SP\_2020\_54066\_79379.jpg

Inside of pipe looking from LS inlet

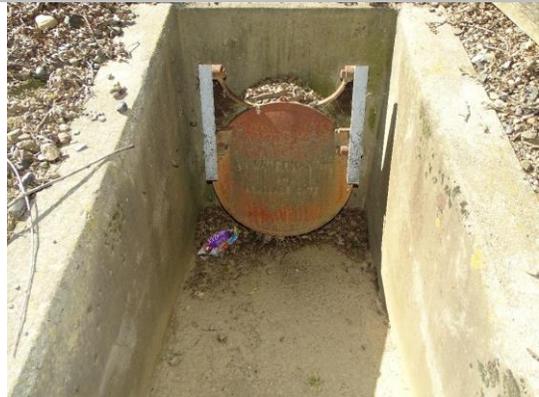
Photo 3 of 3 : UCIP\_SP\_2020\_54069\_79396.jpg

Flap gate at WS toe

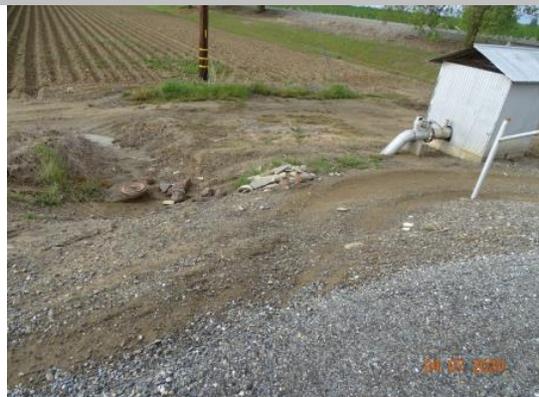
Photo 1 of 1 : SP\_2020\_NA0019\_82\_12\_20200413\_00021.jpg

View of the landside slope instability due to vehicle traffic. Spring 2020.
