**Flood Control Project Maintenance
Levee Inspections
2020 Channel Summary Report
Overall Unit and Item Ratings**

Adin Community Service District

2020 Channel Inspection Results

Levee Inspection Report By Mile - Channel 2020

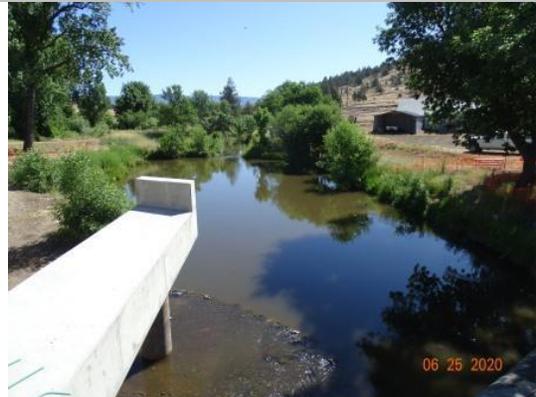
Photo 1 of 1 : CH_2020_NA0030_1_1_20200701_00015.jpg

View of the Ash Creek upstream of the Highway 299 bridge.

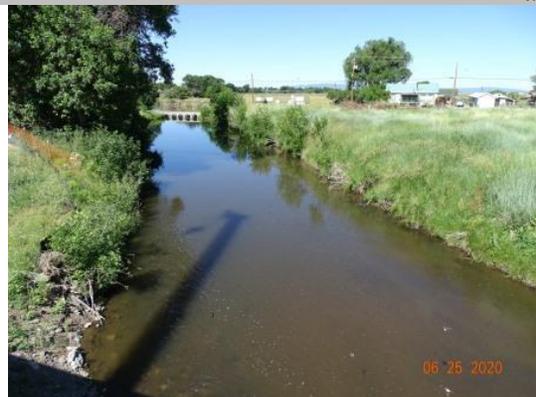
Photo 1 of 1 : CH_2020_NA0030_1_6_20200701_00016.jpg

Downstream view of Ash Creek from the Highway 299 bridge.

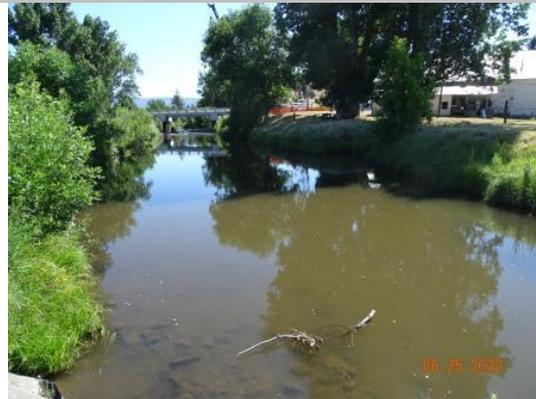
Photo 1 of 1 : CH_2020_NA0030_1_11_20200701_00017.jpg

Upstream view of Ash Creek from the Ash Street crossing.

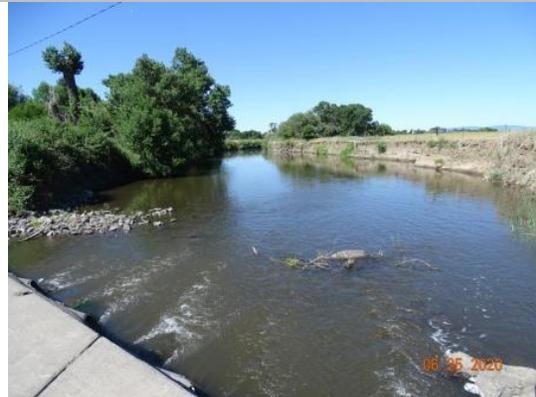
Photo 1 of 1 : CH_2020_NA0030_1_16_20200701_00018.jpg

Downstream view of Ash Creek from the Ash Street crossing.

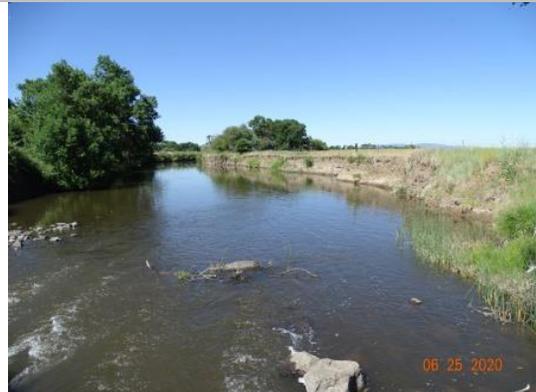
Photo 1 of 1 : CH_2020_NA0030_1_18_20200701_00019.jpg

| Rating ** | M | Issue No. 18 | GPS Lat/Long |
|---|---|---|---|
| Inspector Comments: During low flows you can see the two gravel bars in channel. Monitor erosion during high flows. | | | |

View of the gravel bars and moderate erosion on right bank.

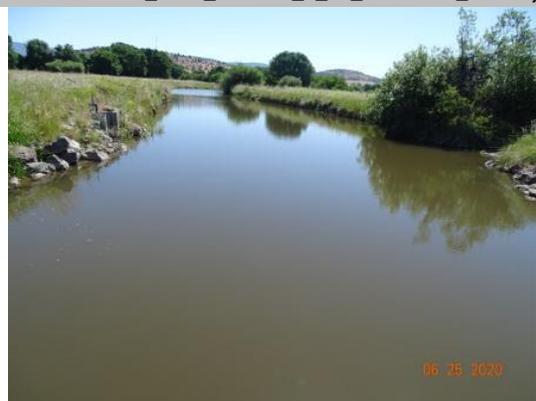
Photo 1 of 1 : CH_2020_NA0030_1_31_20200701_00020.jpg

Upstream view of Ash Creek from the weir.

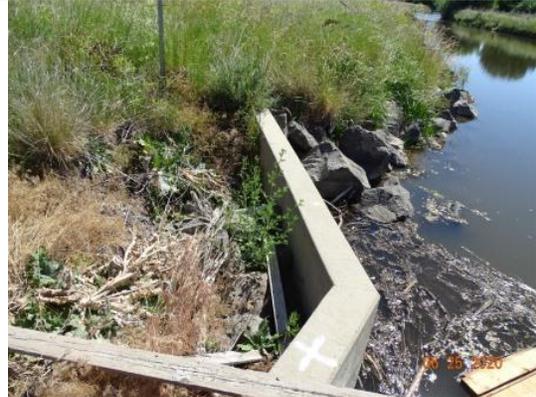
Photo 1 of 1 : CH_2020_NA0030_1_33_20200701_00021.jpg

| Inspector Comments: There is minor erosion along right side of the structure. | | | |

View of the erosion along the right side of the weir.

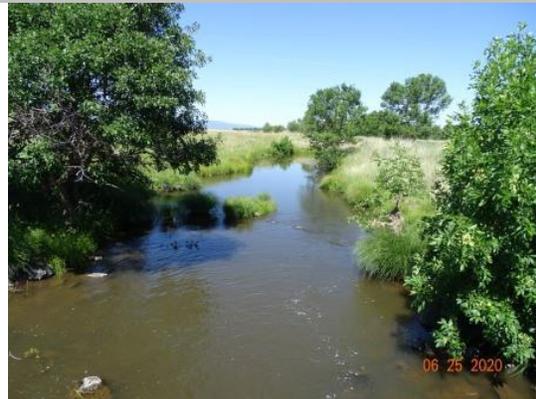
Photo 1 of 1 : CH_2020_NA0030_1_36_20200701_00022.jpg

| Check Point / View | | | |
|--|---|---|---|
| Inspector Comments: The channel is clear of vegetation & obstructions. | | | |

Downstream view of Ash Creek from the weir.

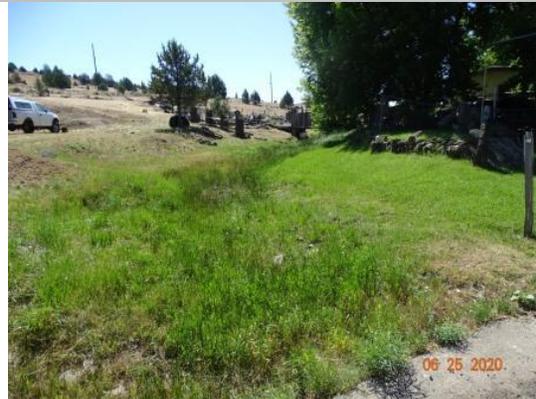
Photo 1 of 1 : CH_2020_NA0030_2_1_20200701_00009.jpg

Upstream view of the Dry Creek from Adin Street.

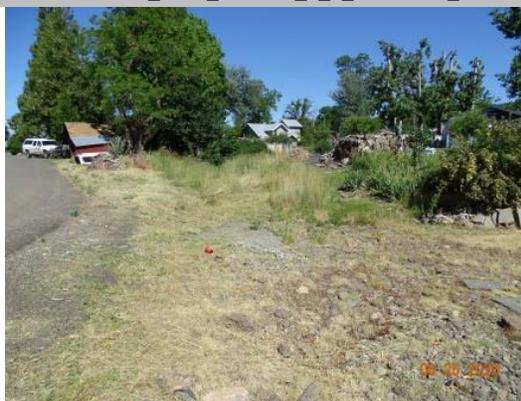
Photo 1 of 1 : CH_2020_NA0030_2_6_20200701_00010.jpg

| Check Point / View | | | |
|--|---|---|---|
| Inspector Comments: The vegetation currently does not impede the flow. However, it should be removed before it gets too dense. | | | |

Downstream view of Dry Creek from Adin Street.

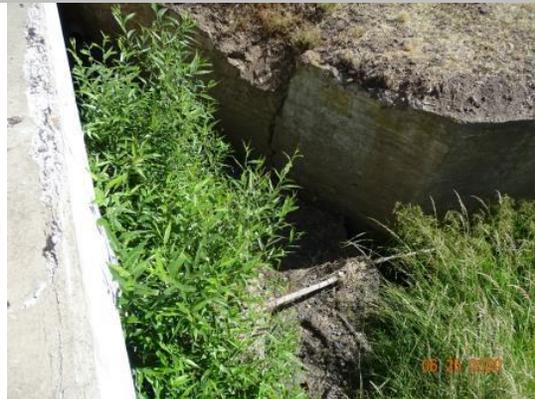
Photo 1 of 2 : CH_2020_NA0030_2_11_20200701_00012.jpg

View of the brush at the upstream side of the Main Street bridge and culverts.

| Check Point / View | | | |
|---|---|---|---|
| Inspector Comments: Remove all vegetation in channel before winter. | | | |

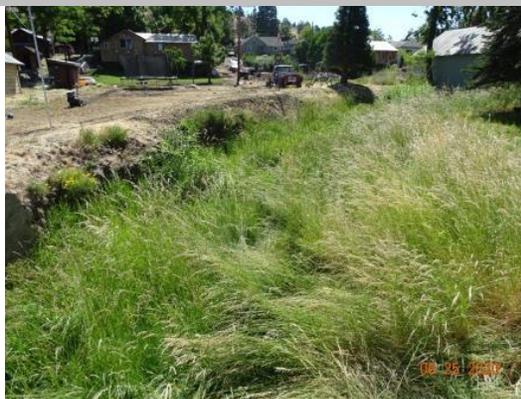
Photo 2 of 2 : CH_2020_NA0030_2_11_20200701_00011.jpg

Upstream view of Dry Creek from Main Street.

| Rating ** | M | Issue No. | 11 (cont) | GPS Lat/Long |
|---|---|---|---|---|
| Inspector Comments: Remove all vegetation in channel before winter. | | | | |

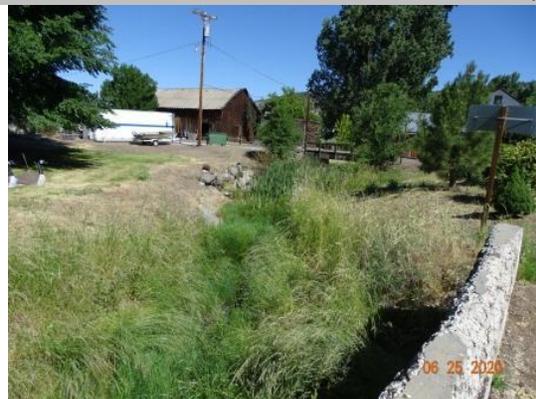
Photo 1 of 1 : CH_2020_NA0030_2_16_20200701_00013.jpg

Downstream view of Dry Creek from Main Street.

| Check Point / View | | | |
|---|---|---|---|
| Inspector Comments: Remove all vegetation in channel before winter. | | | |
